Interim Reclamation Inspection

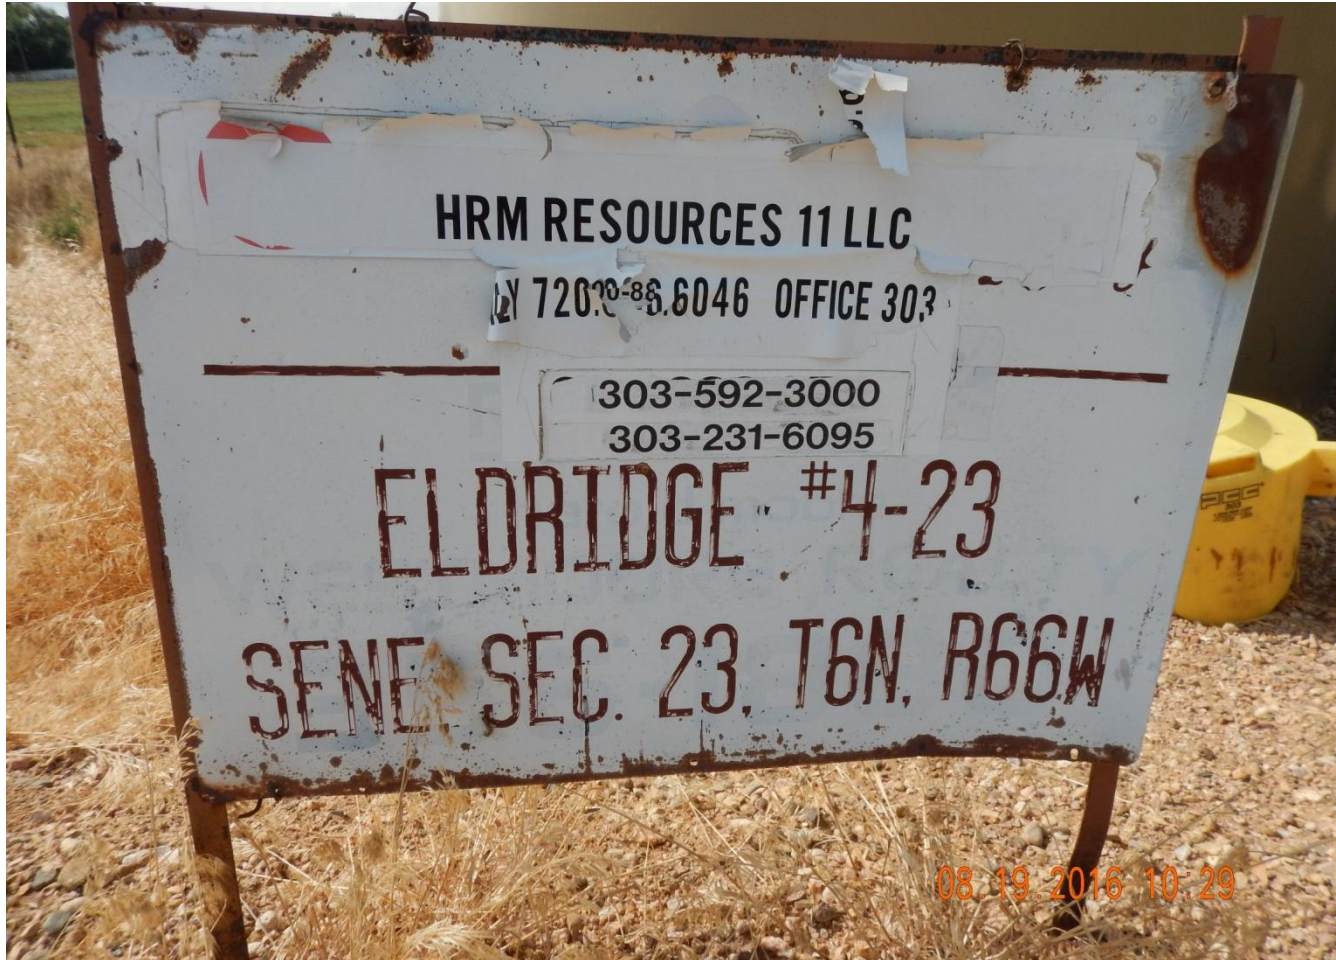
Photo 1. Photo taken of PR well sign for API 123-13177. Emergency contact on sign is not legible and not complete.

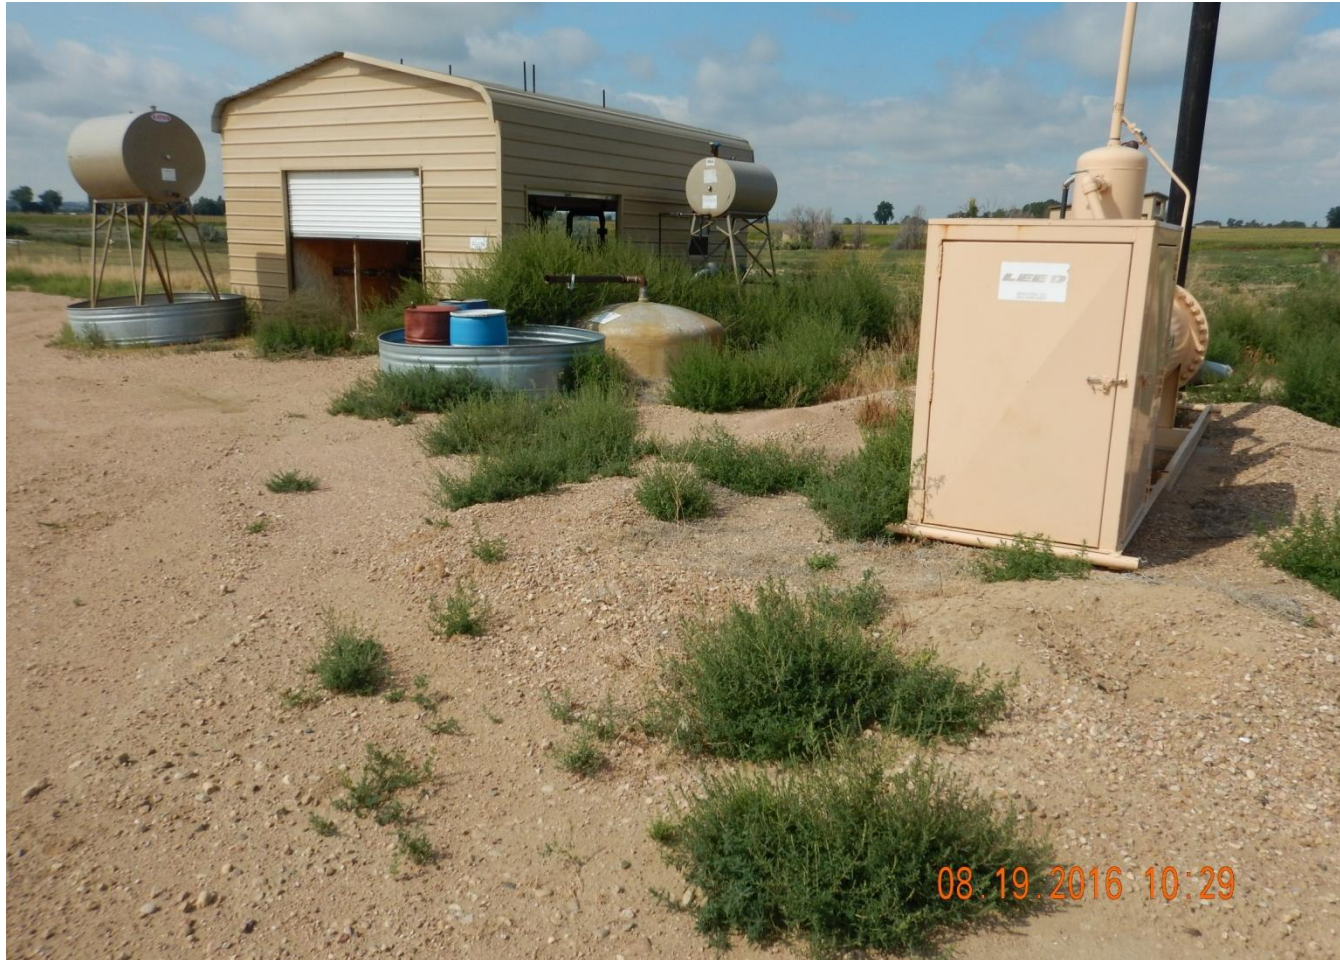
Photo 2. Photo taken from central location, facing Southwest. Control weeds around all equipment at location. Weeds within 25 feet of operating oil and gas equipment are a potential safety or fire concern per Rule 603.f.

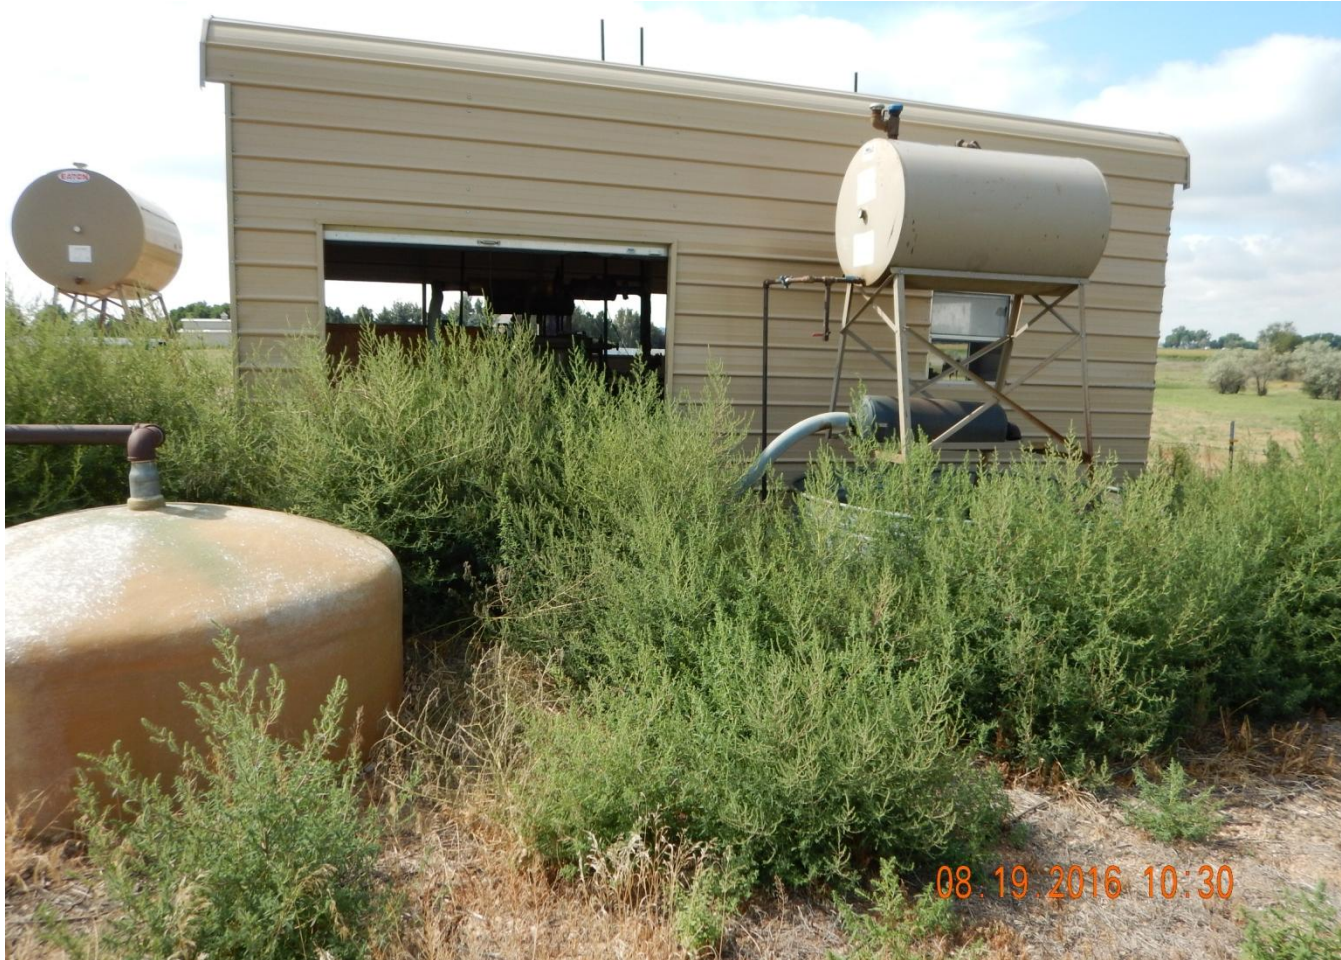
Photo 3. Photo taken from northwestern location, facing South. Control weeds around all equipment at location. Weeds within 25 feet of operating oil and gas equipment are a potential safety or fire concern per Rule 603.f.
