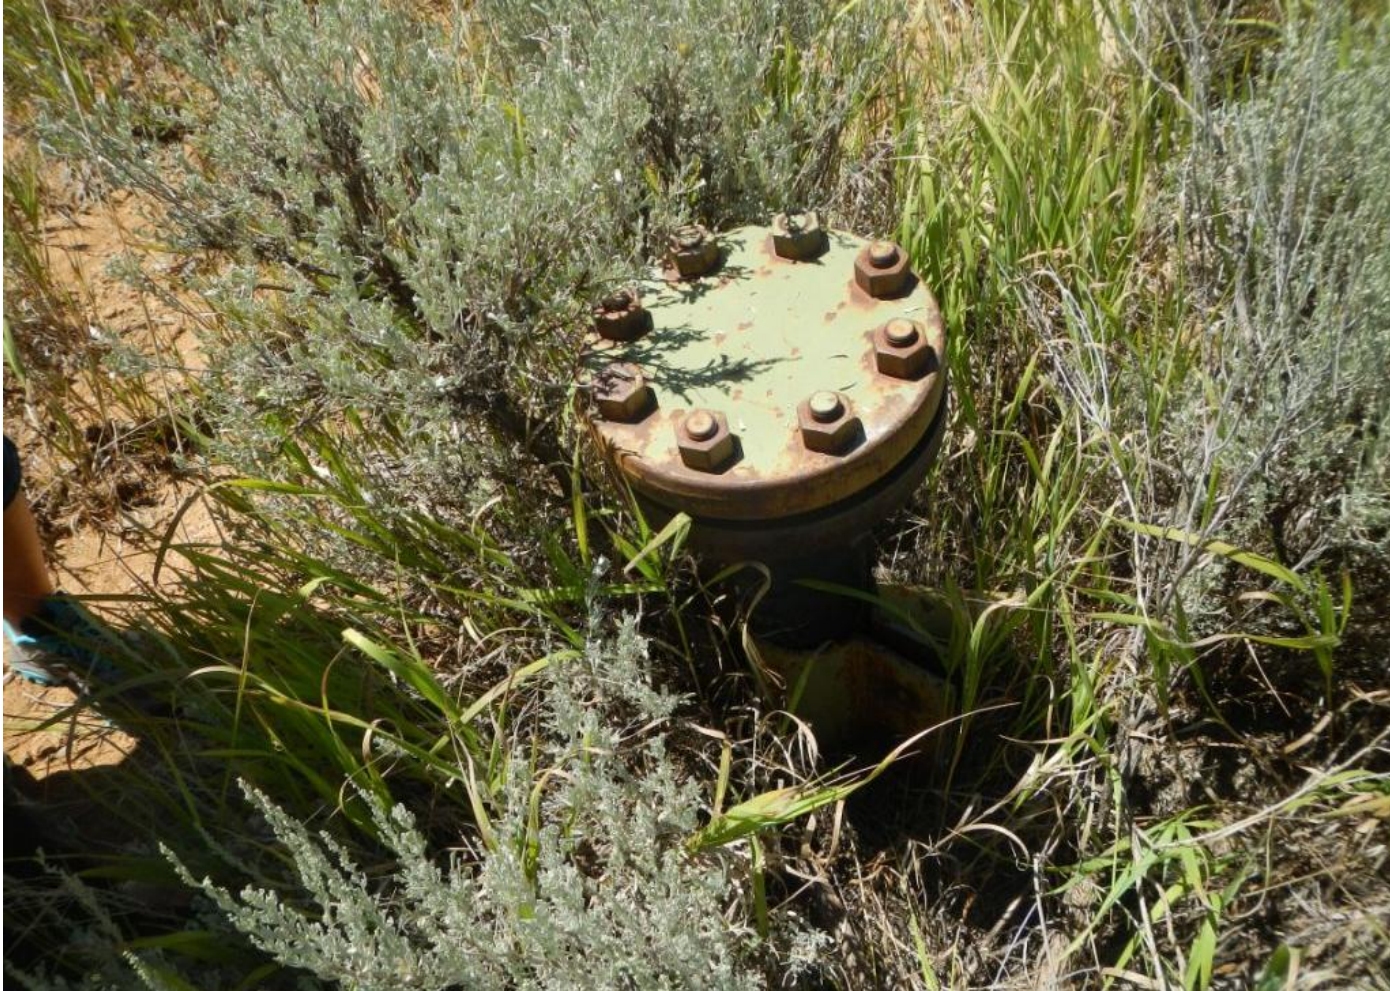
Photo 1. View of riser still in place near the entrance to the well pad.

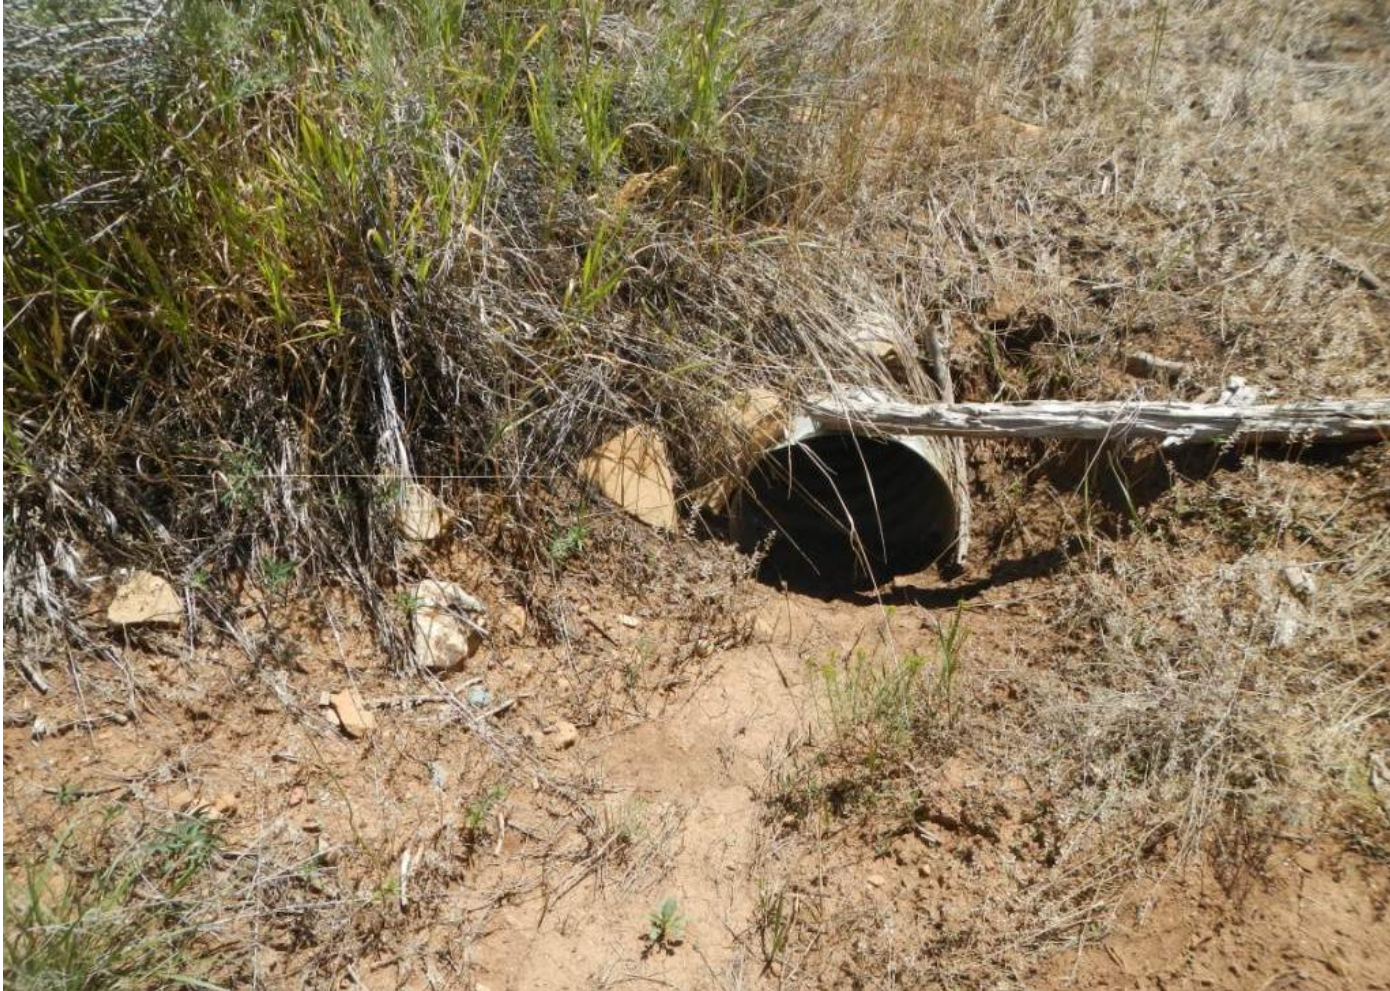
Photo 2. View of culvert in place at the entrance to the well pad.

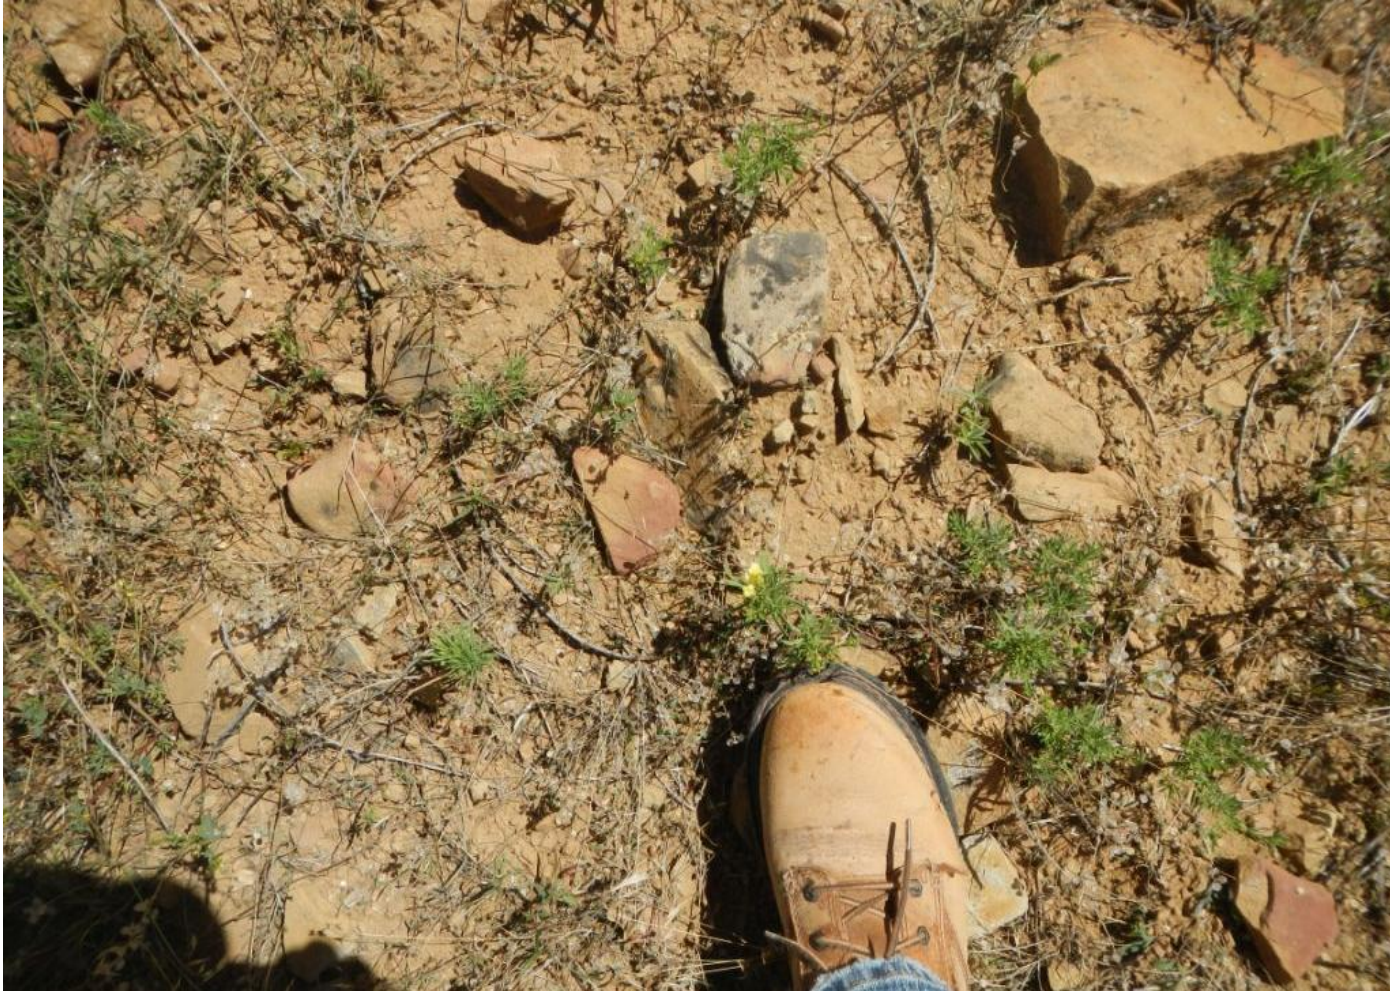
Photo 3. View of yellow toadflax growing in the southern cutslope of the well pad.

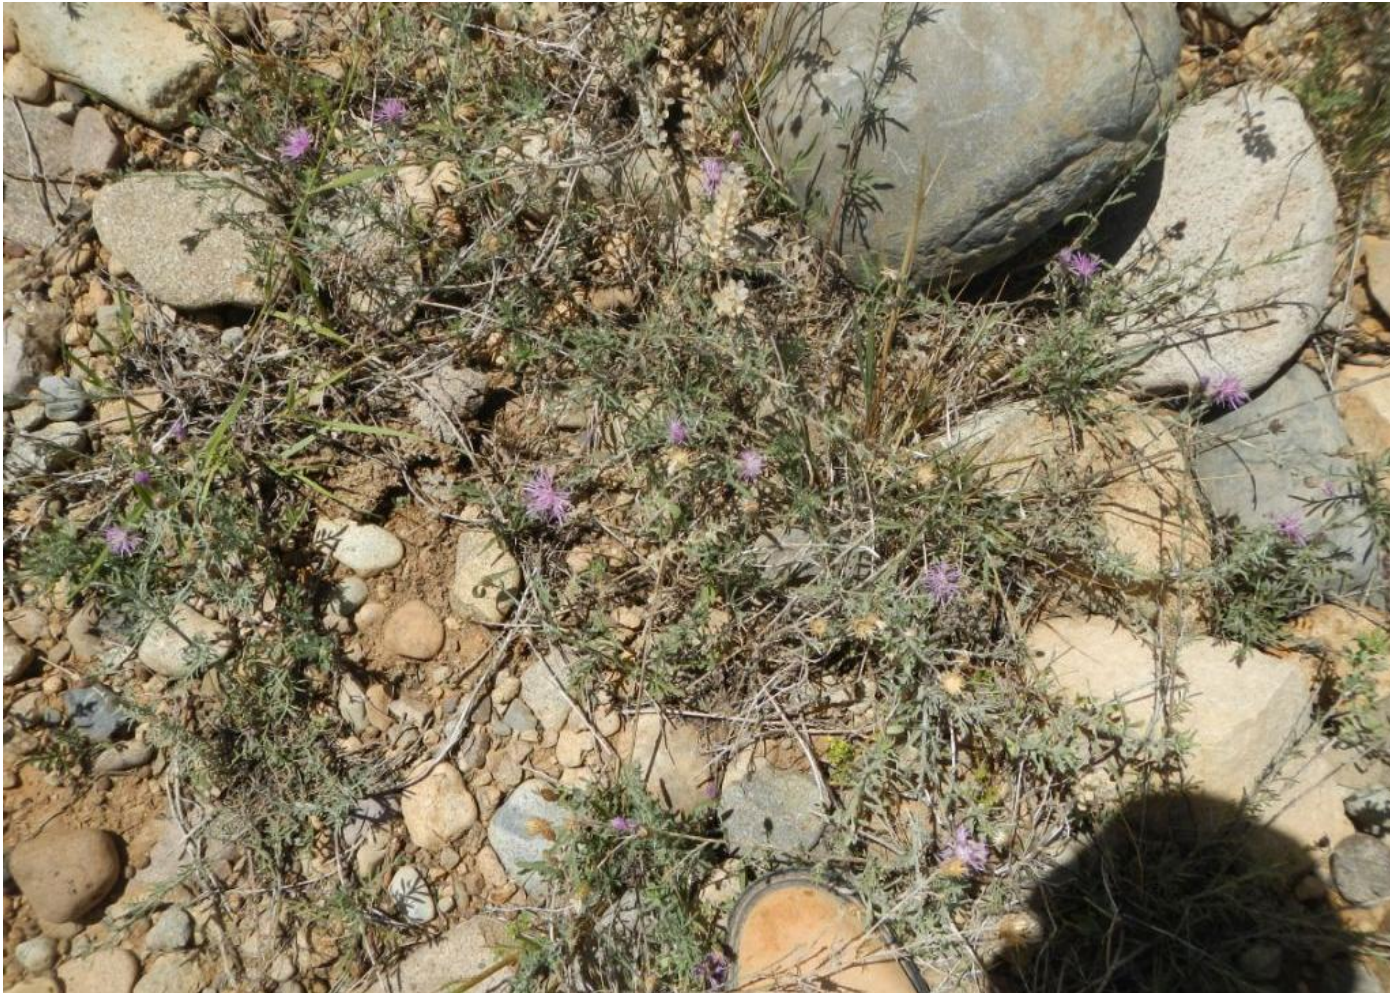
Photo 4. View of spotted knapweed growing throughout the project area.

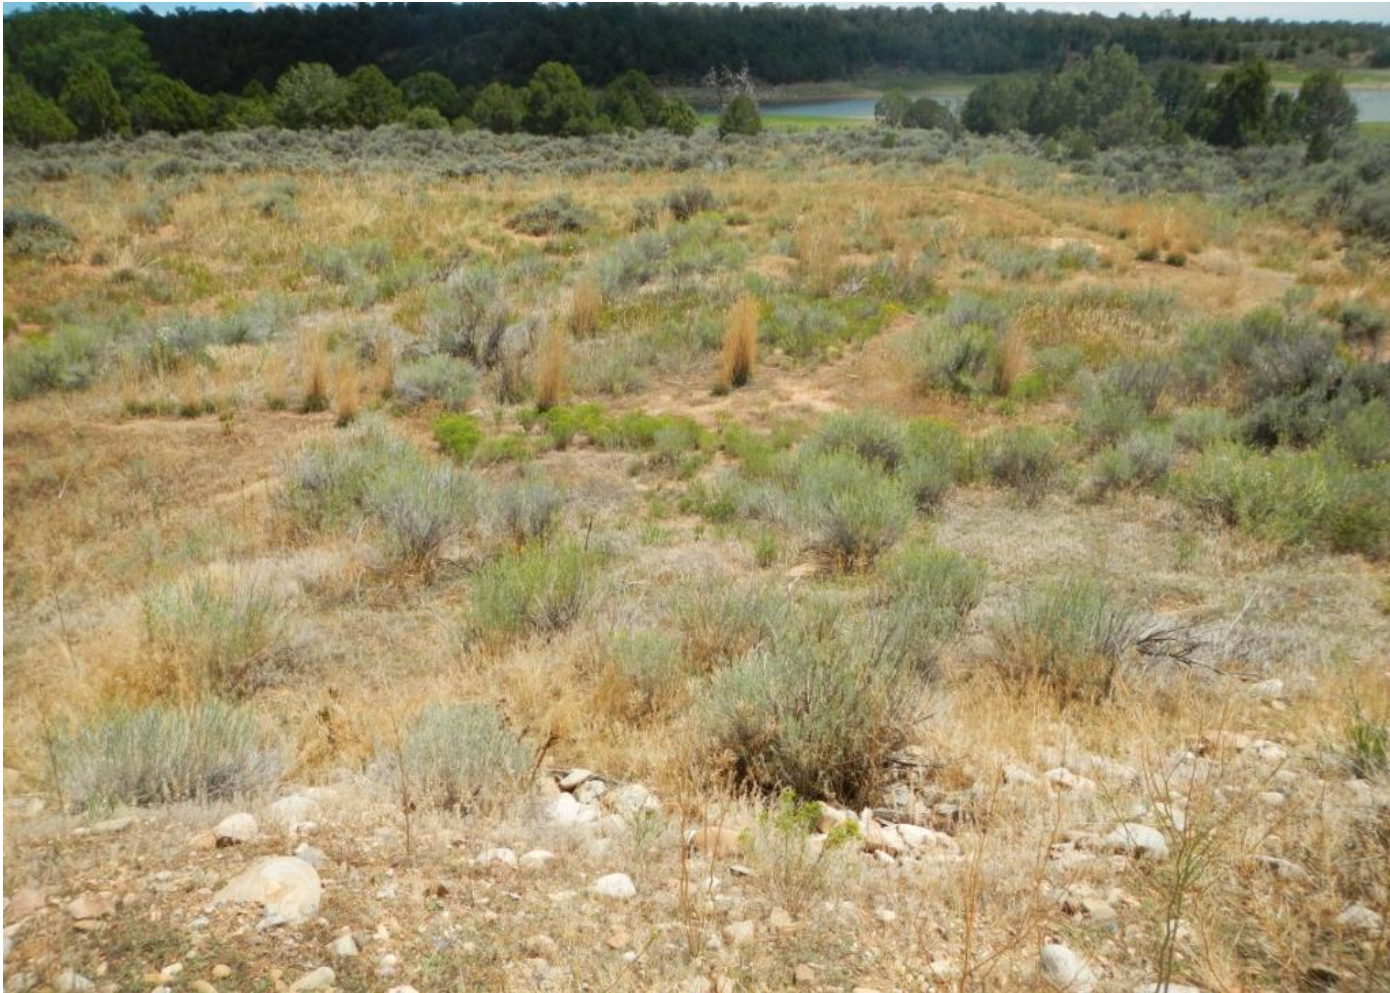
Photo 9. Pit area in northeastern portion of project area has not been recontoured.
