Final Reclamation Inspection

07/14/2016

Operator: H&R Well Services

Location ID: 389360

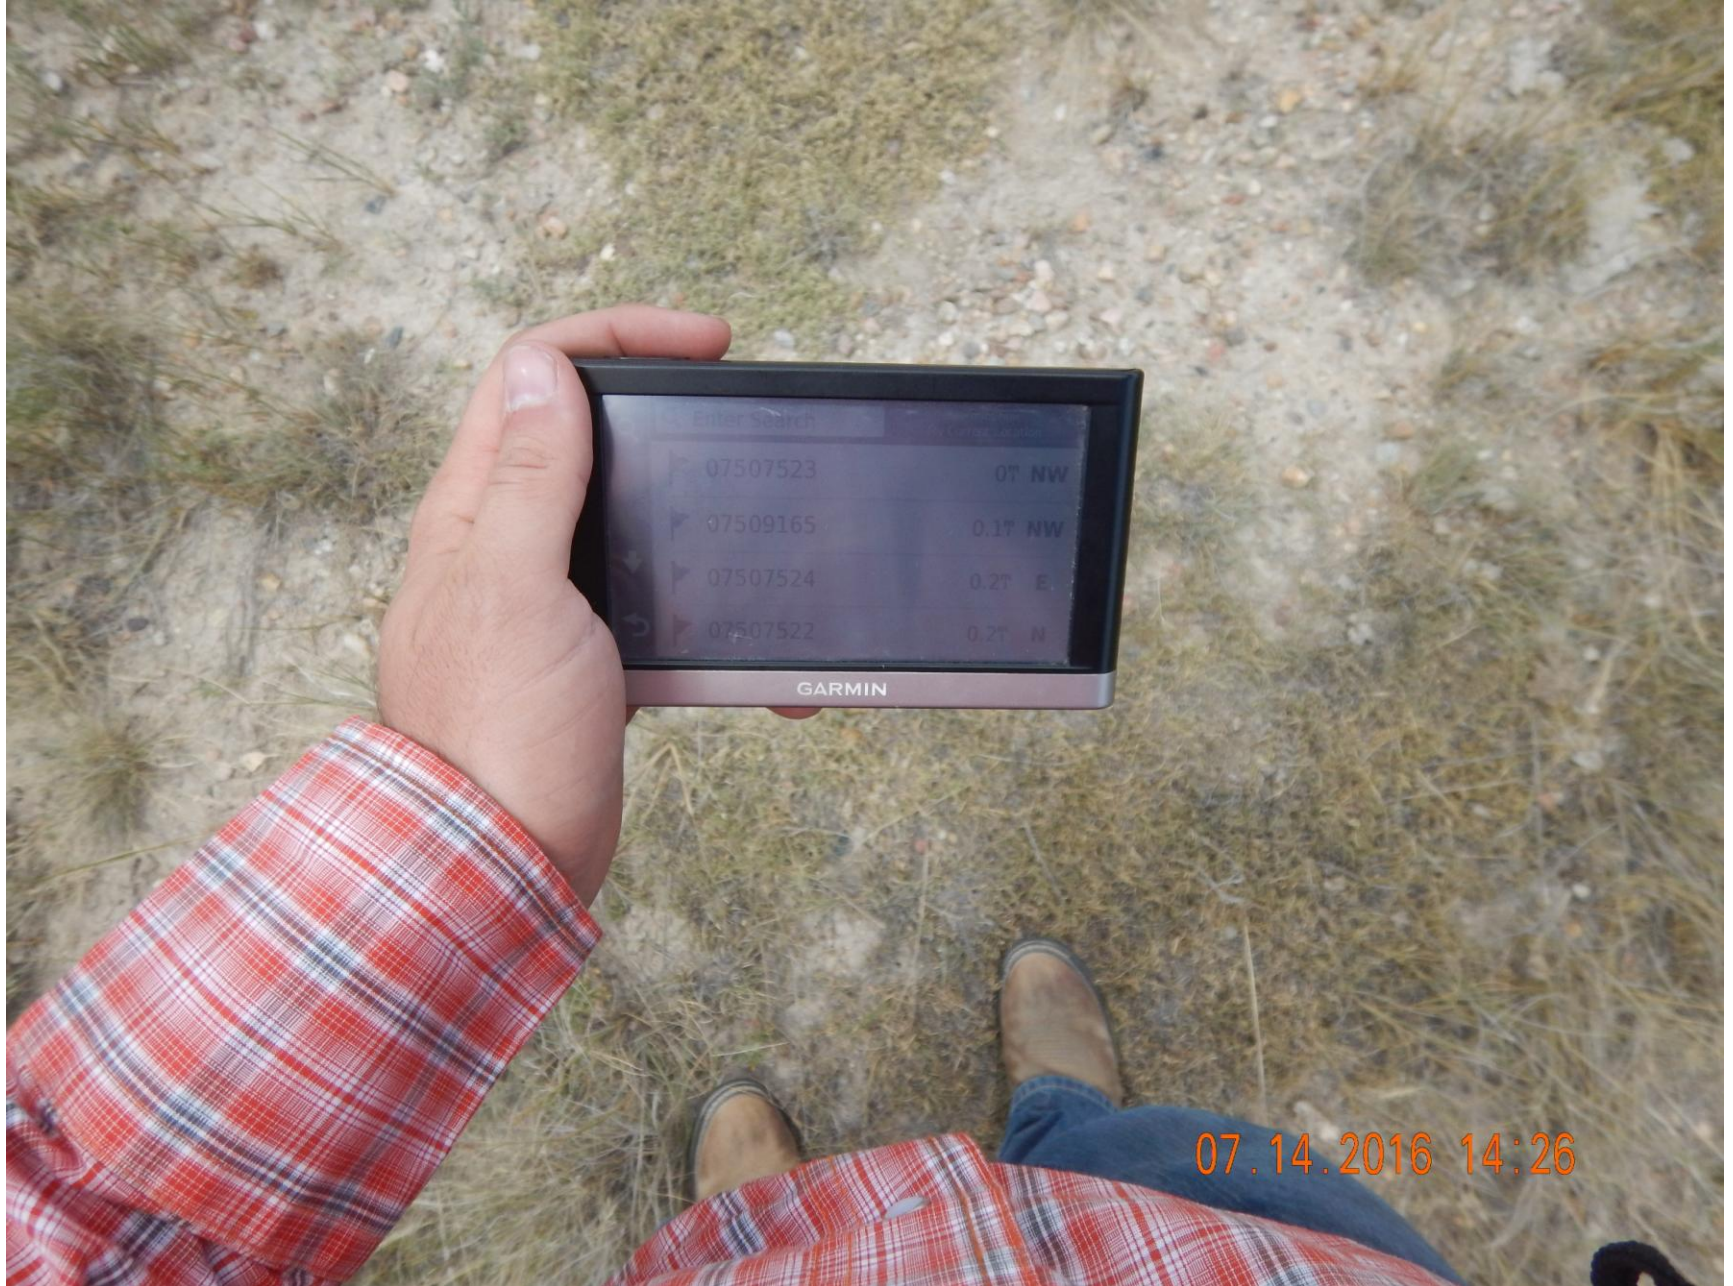
Figure 1: Photo of GPS confirming well locaiton.

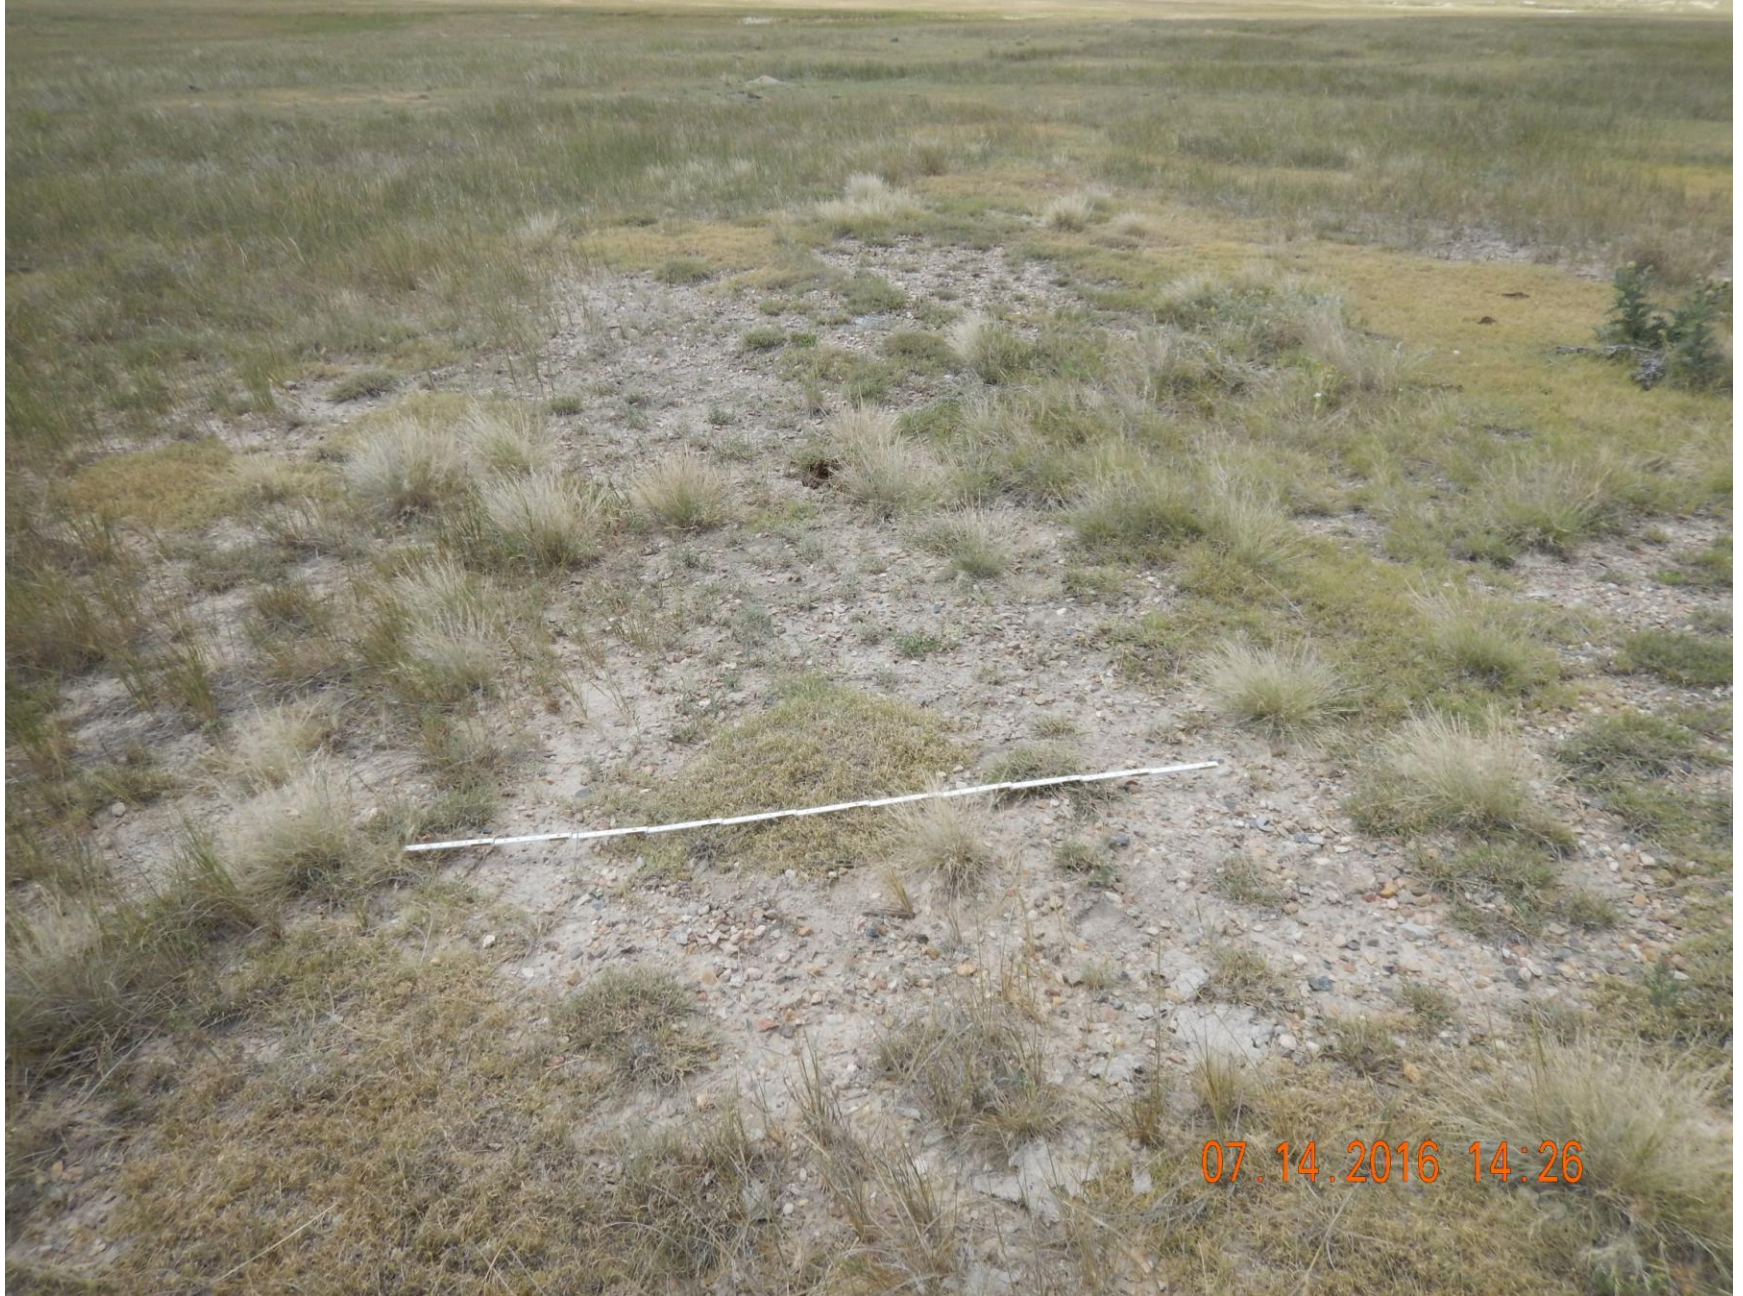
Figure 2: Photo taken from the area of the well, on the north end of the location, facing northwest. Photo shows well site has not achieved uniform vegetative cover. Photo shows gravel remaining at well site. 6' measuring stick for reference.

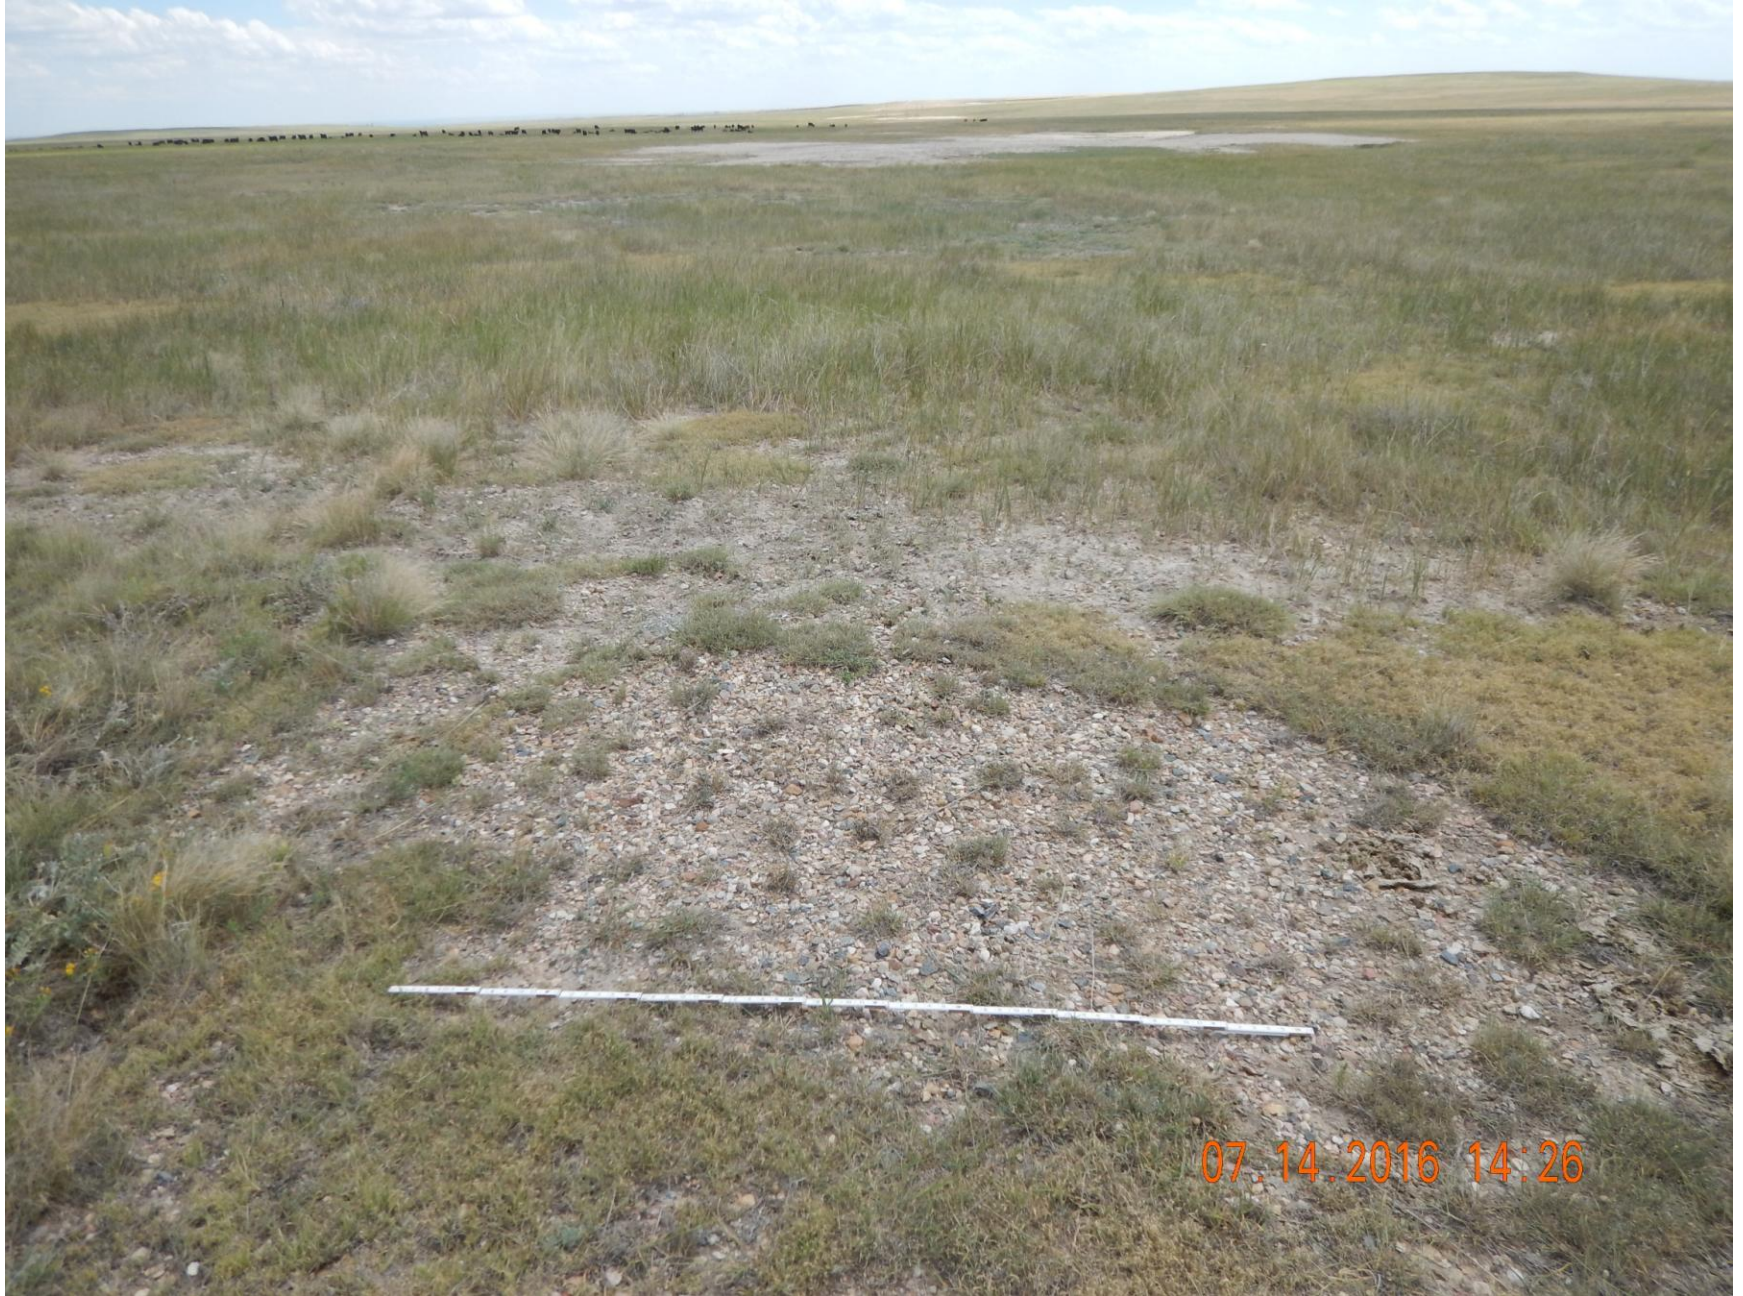
Figure 3: Photo taken from the area of the well, on the north end of the location, facing south. Photo shows well site has not achieved uniform vegetative cover. Photo shows gravel remaining at well site. 6' measuring stick for reference.

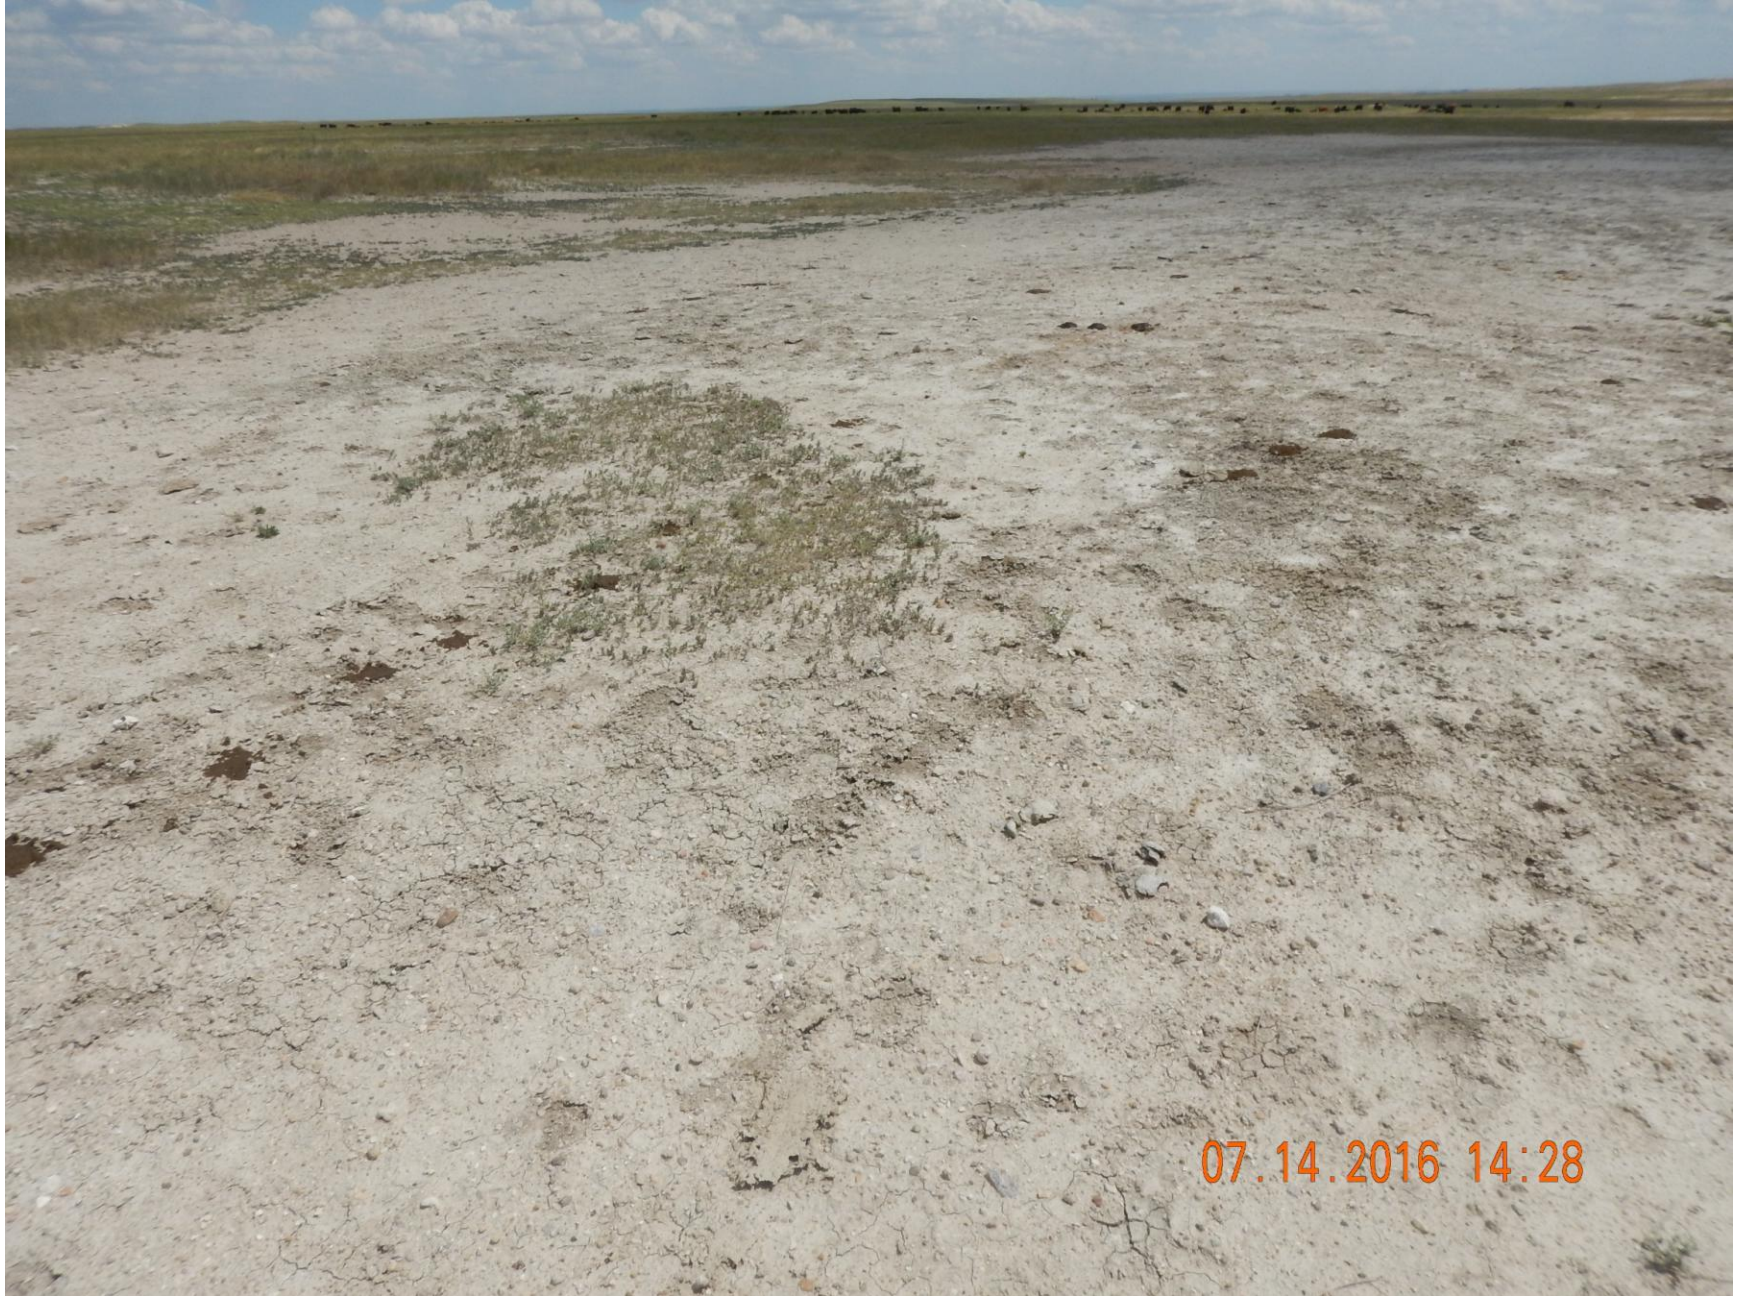
Figure 4: Photo taken from north end of the possible salt kill, facing southeast.

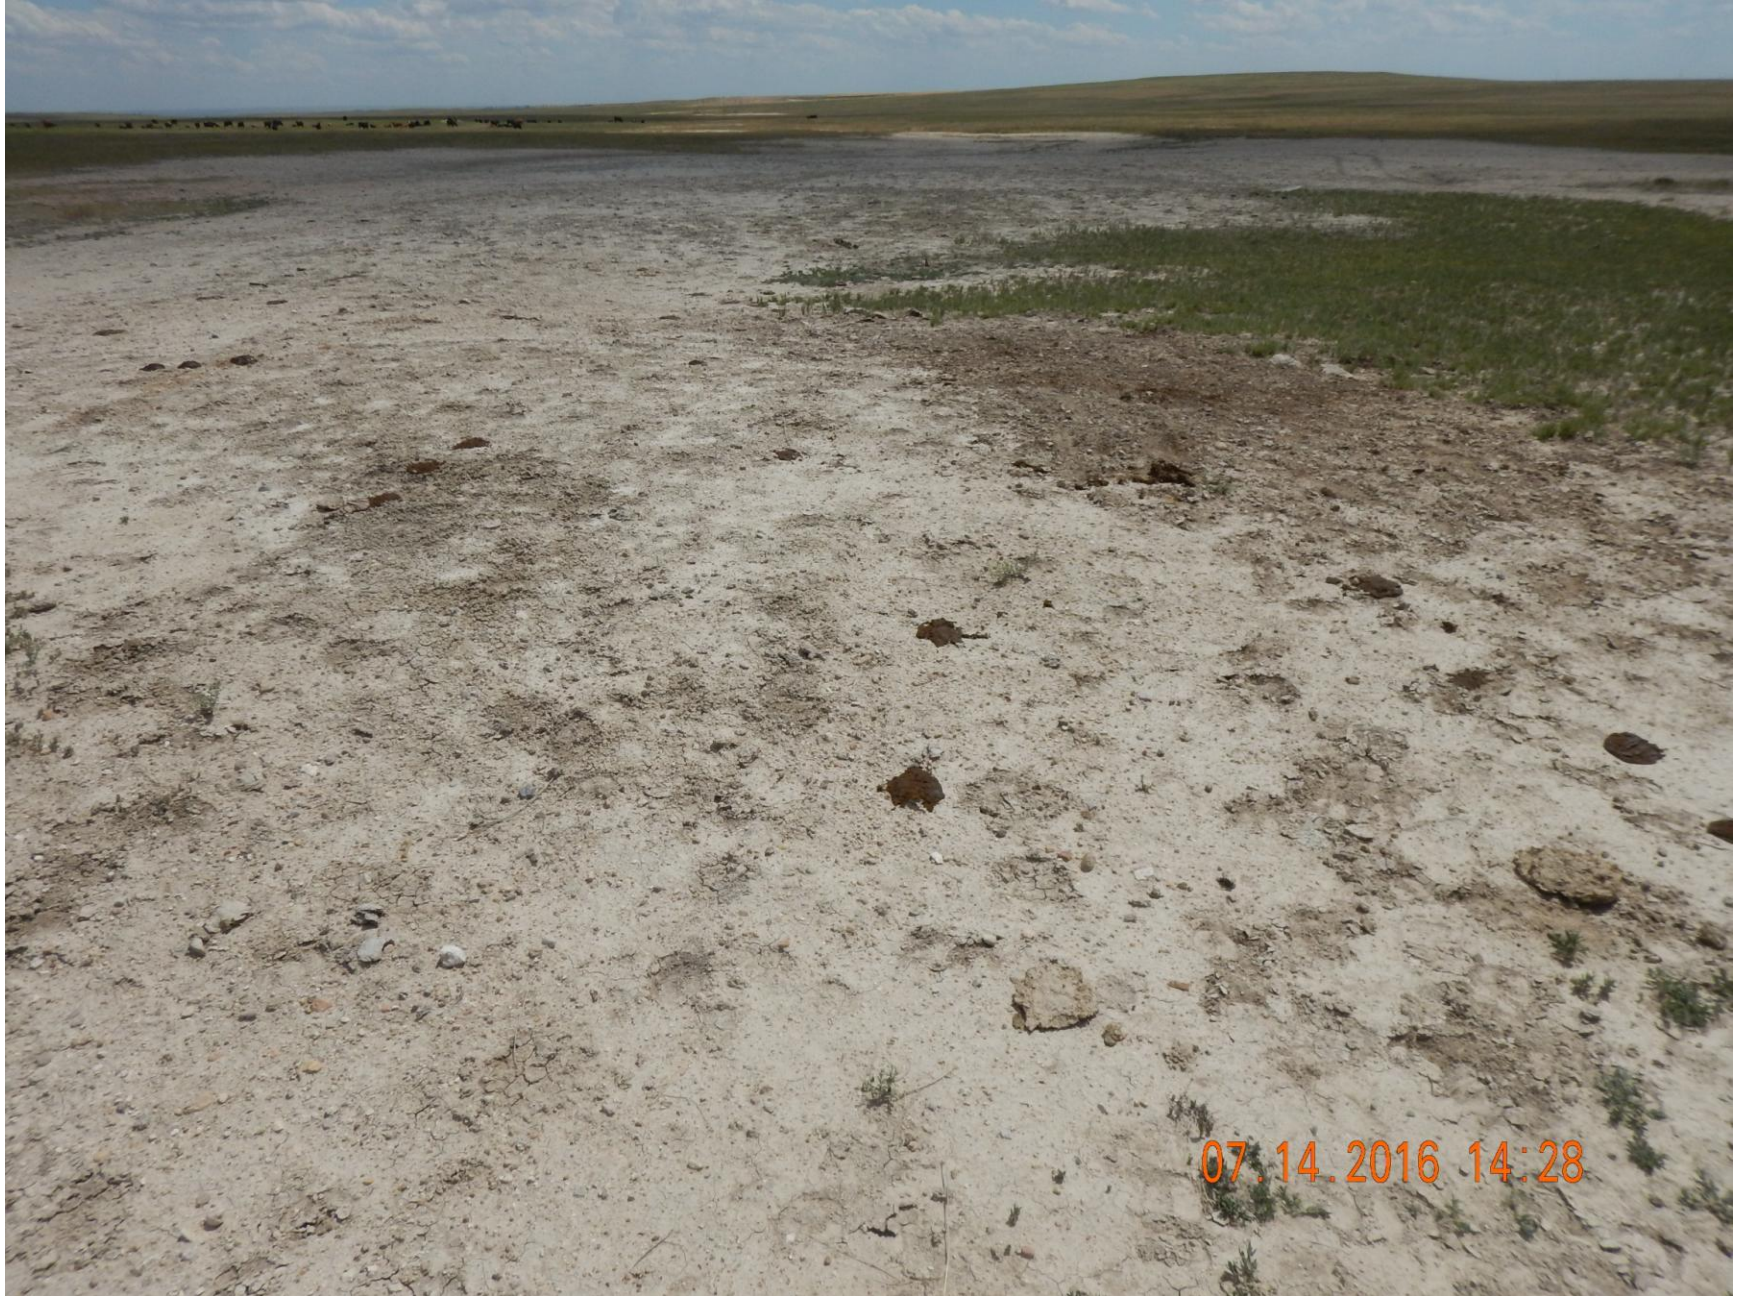
Figure 5: Photo taken from north end of the possible salt kill, facing south.

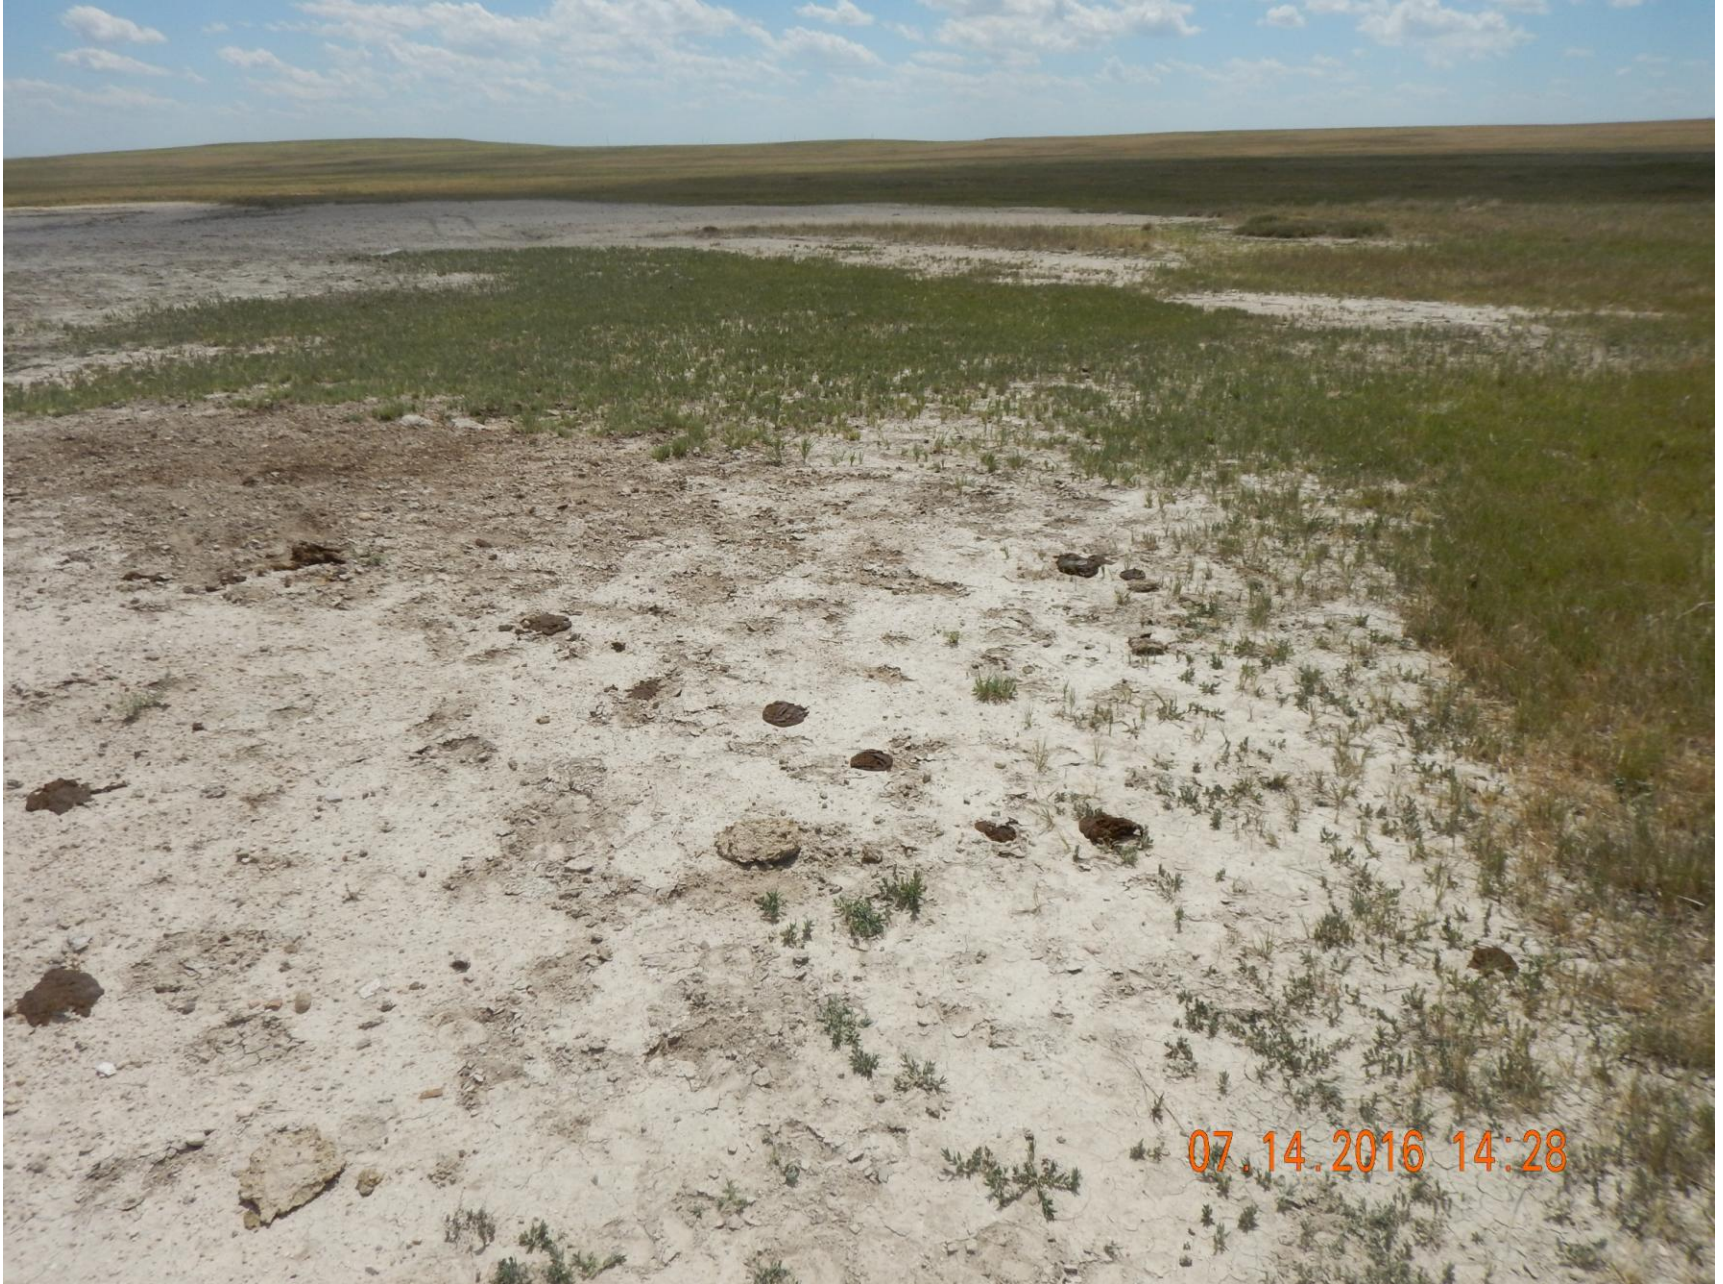
Figure 6: Photo taken from north end of the possible salt kill, facing southwest.

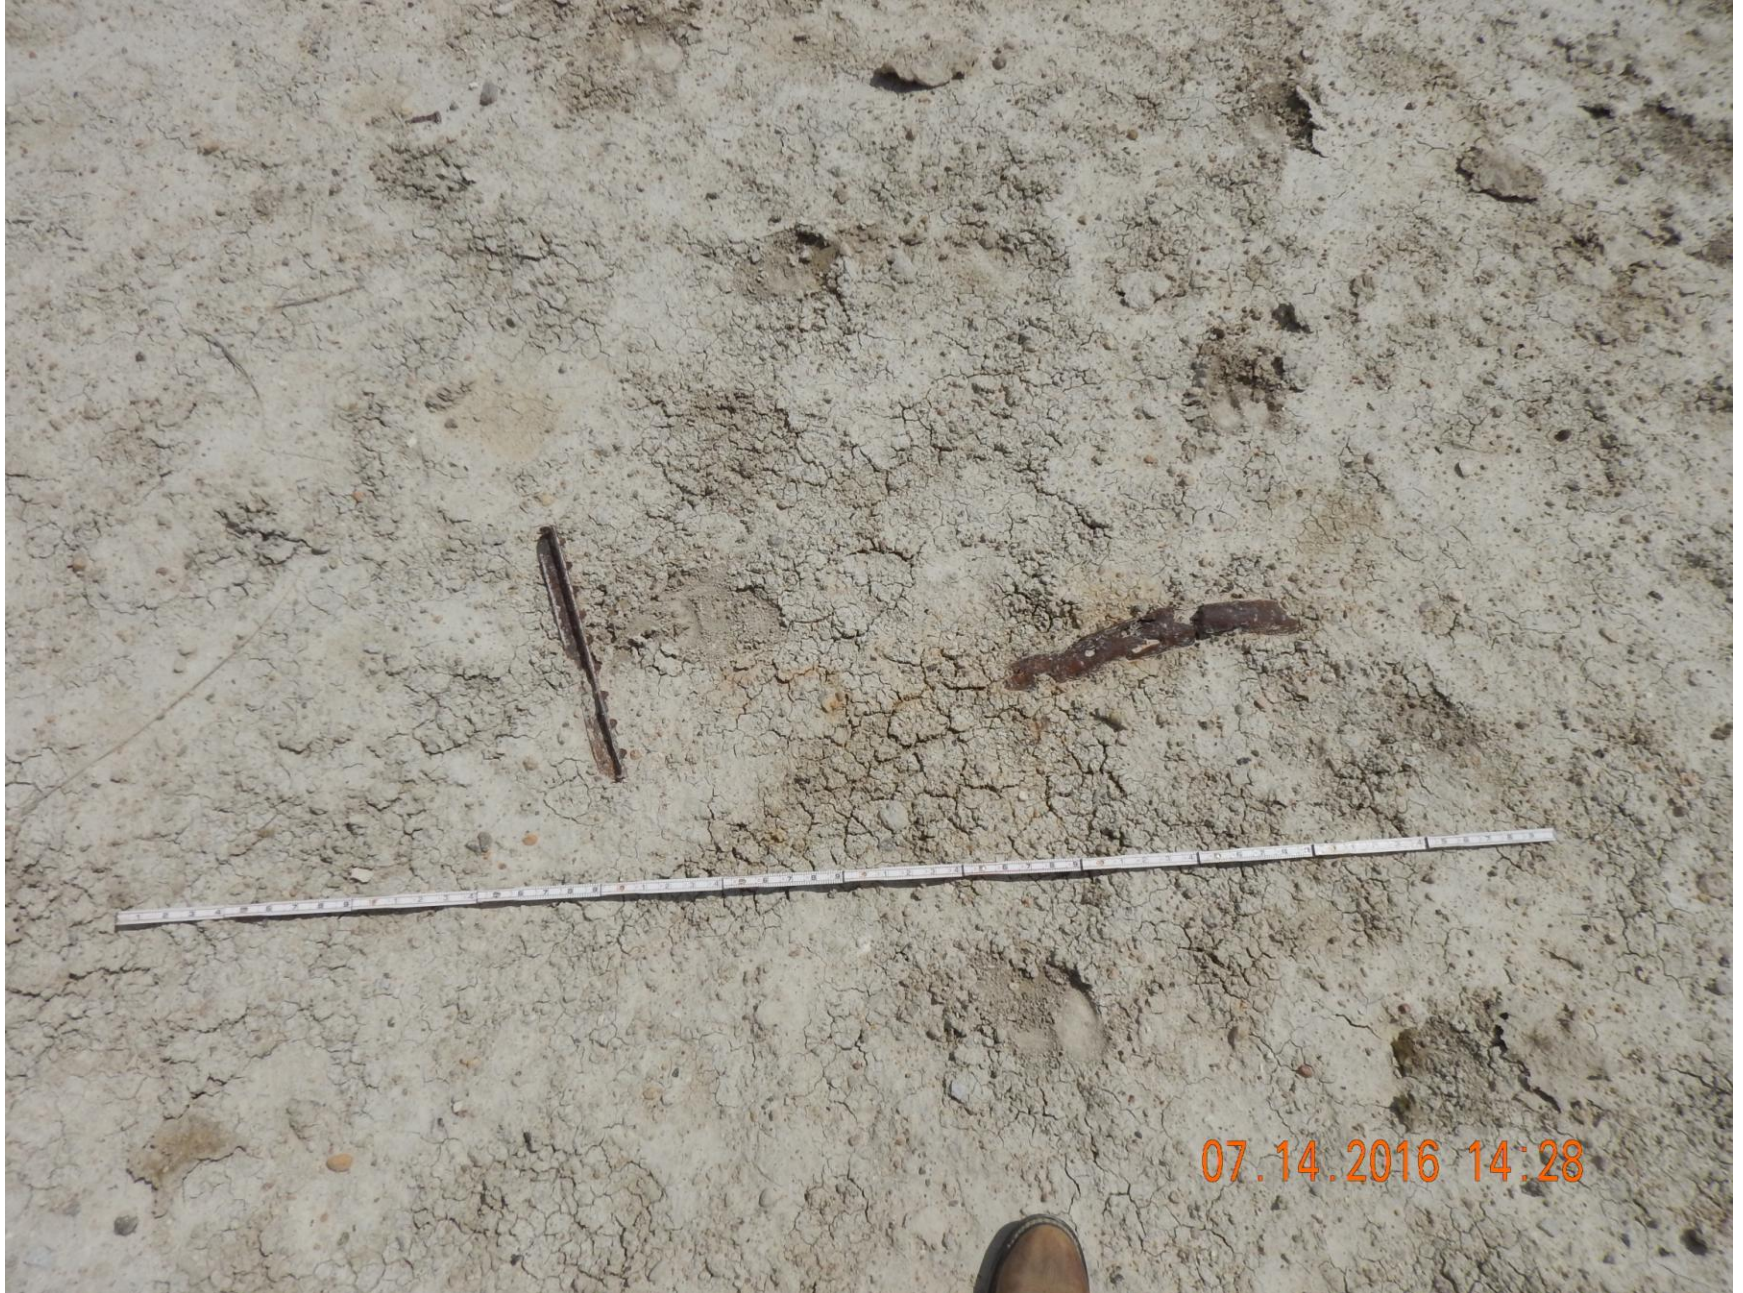
Figure 7: Photo taken from the possible salt kill. Photo shows pipe equipment and debris found in the possible salt kill. 6' measuring stick for reference.

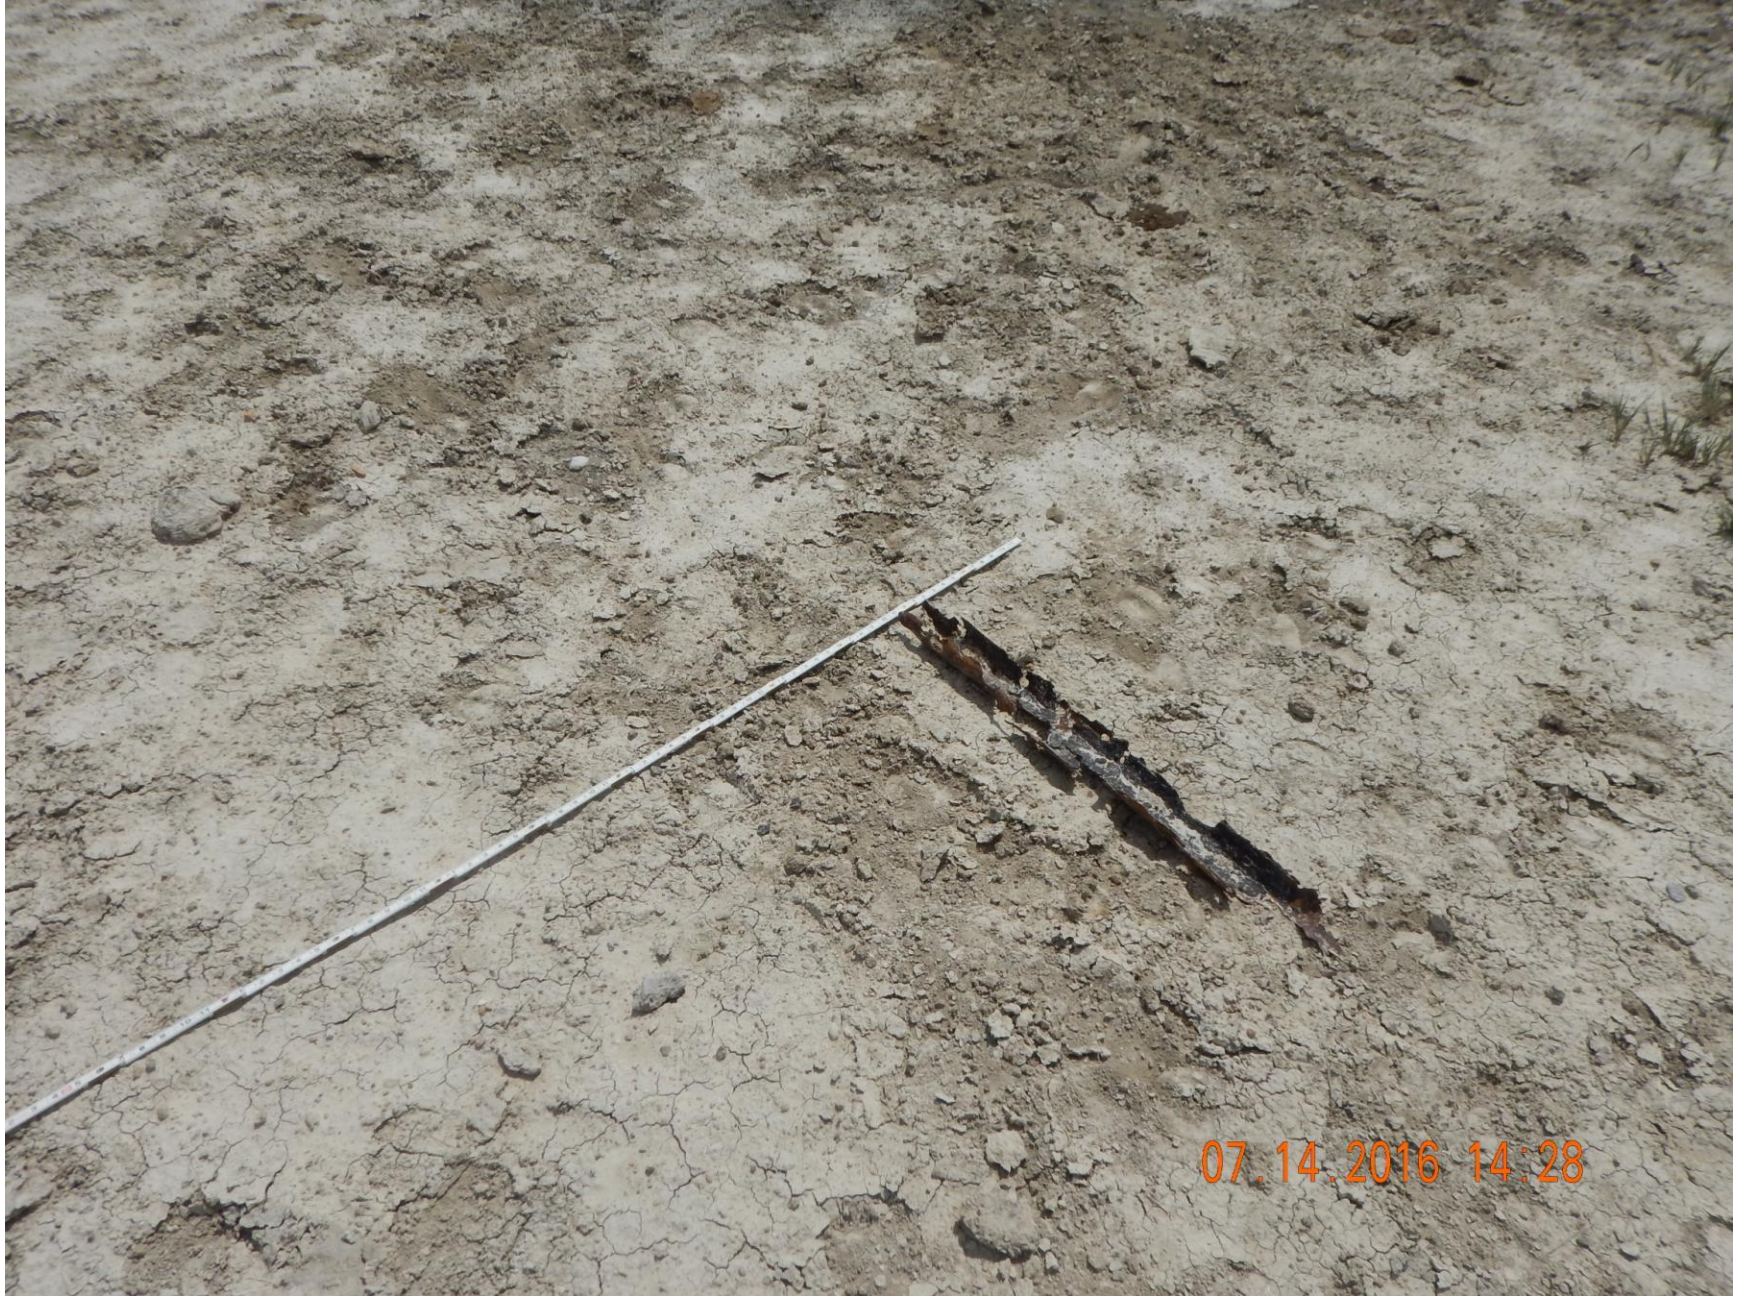
Figure 8: Photo taken from the possible salt kill. Photo shows pipe equipment and debris found in the possible salt kill. 6' measuring stick for reference.

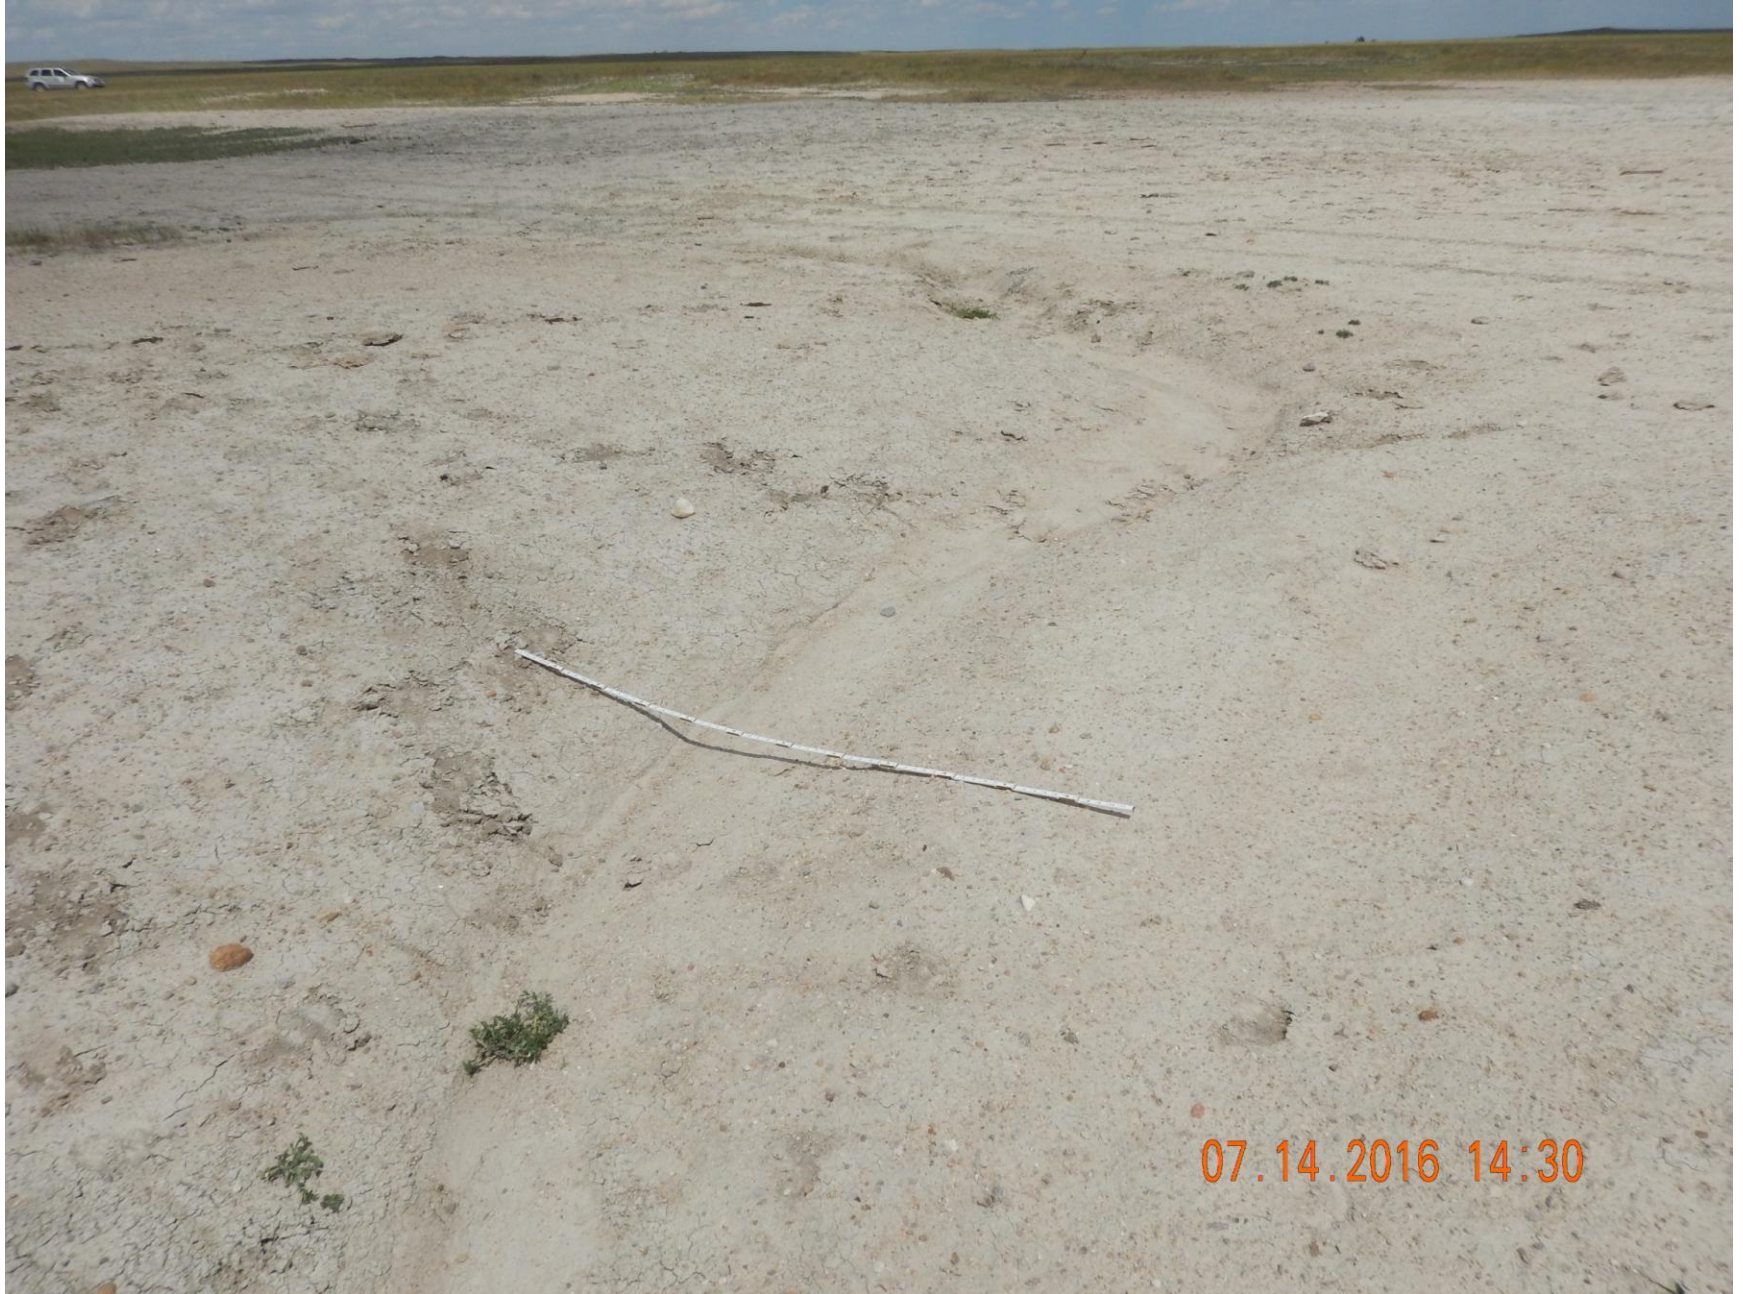
Figure 9: Photo taken from the west end of the possible salt kill, facing east. Photo shows degradation occurring in the area due to stormwater erosion.

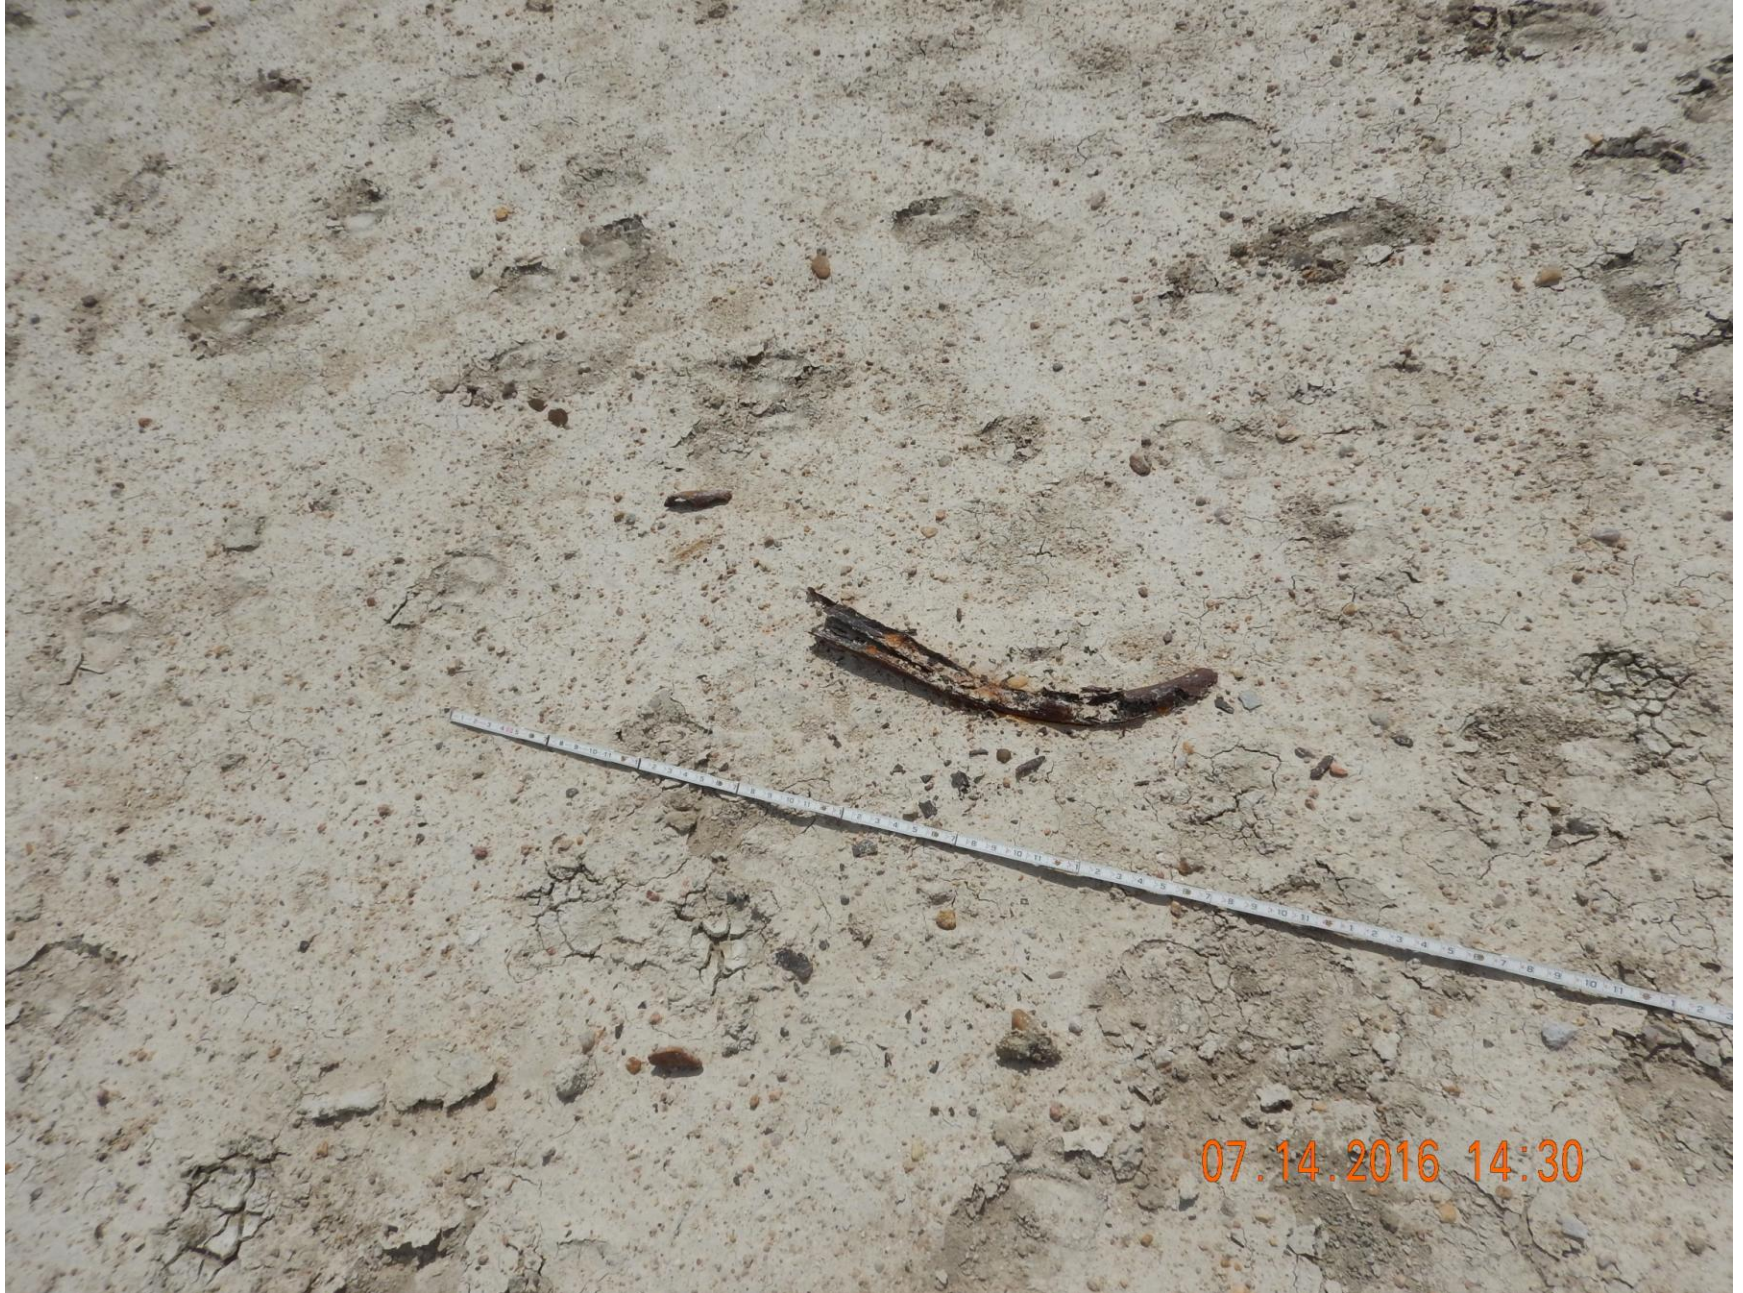
Figure 10: Photo taken from the possible salt kill. Photo shows pipe equipment and debris found in the possible salt kill. 6' measuring stick for reference.
