Final Reclamation Inspection

07/14/2016

Operator: H&R Well Services

Location ID: 389360

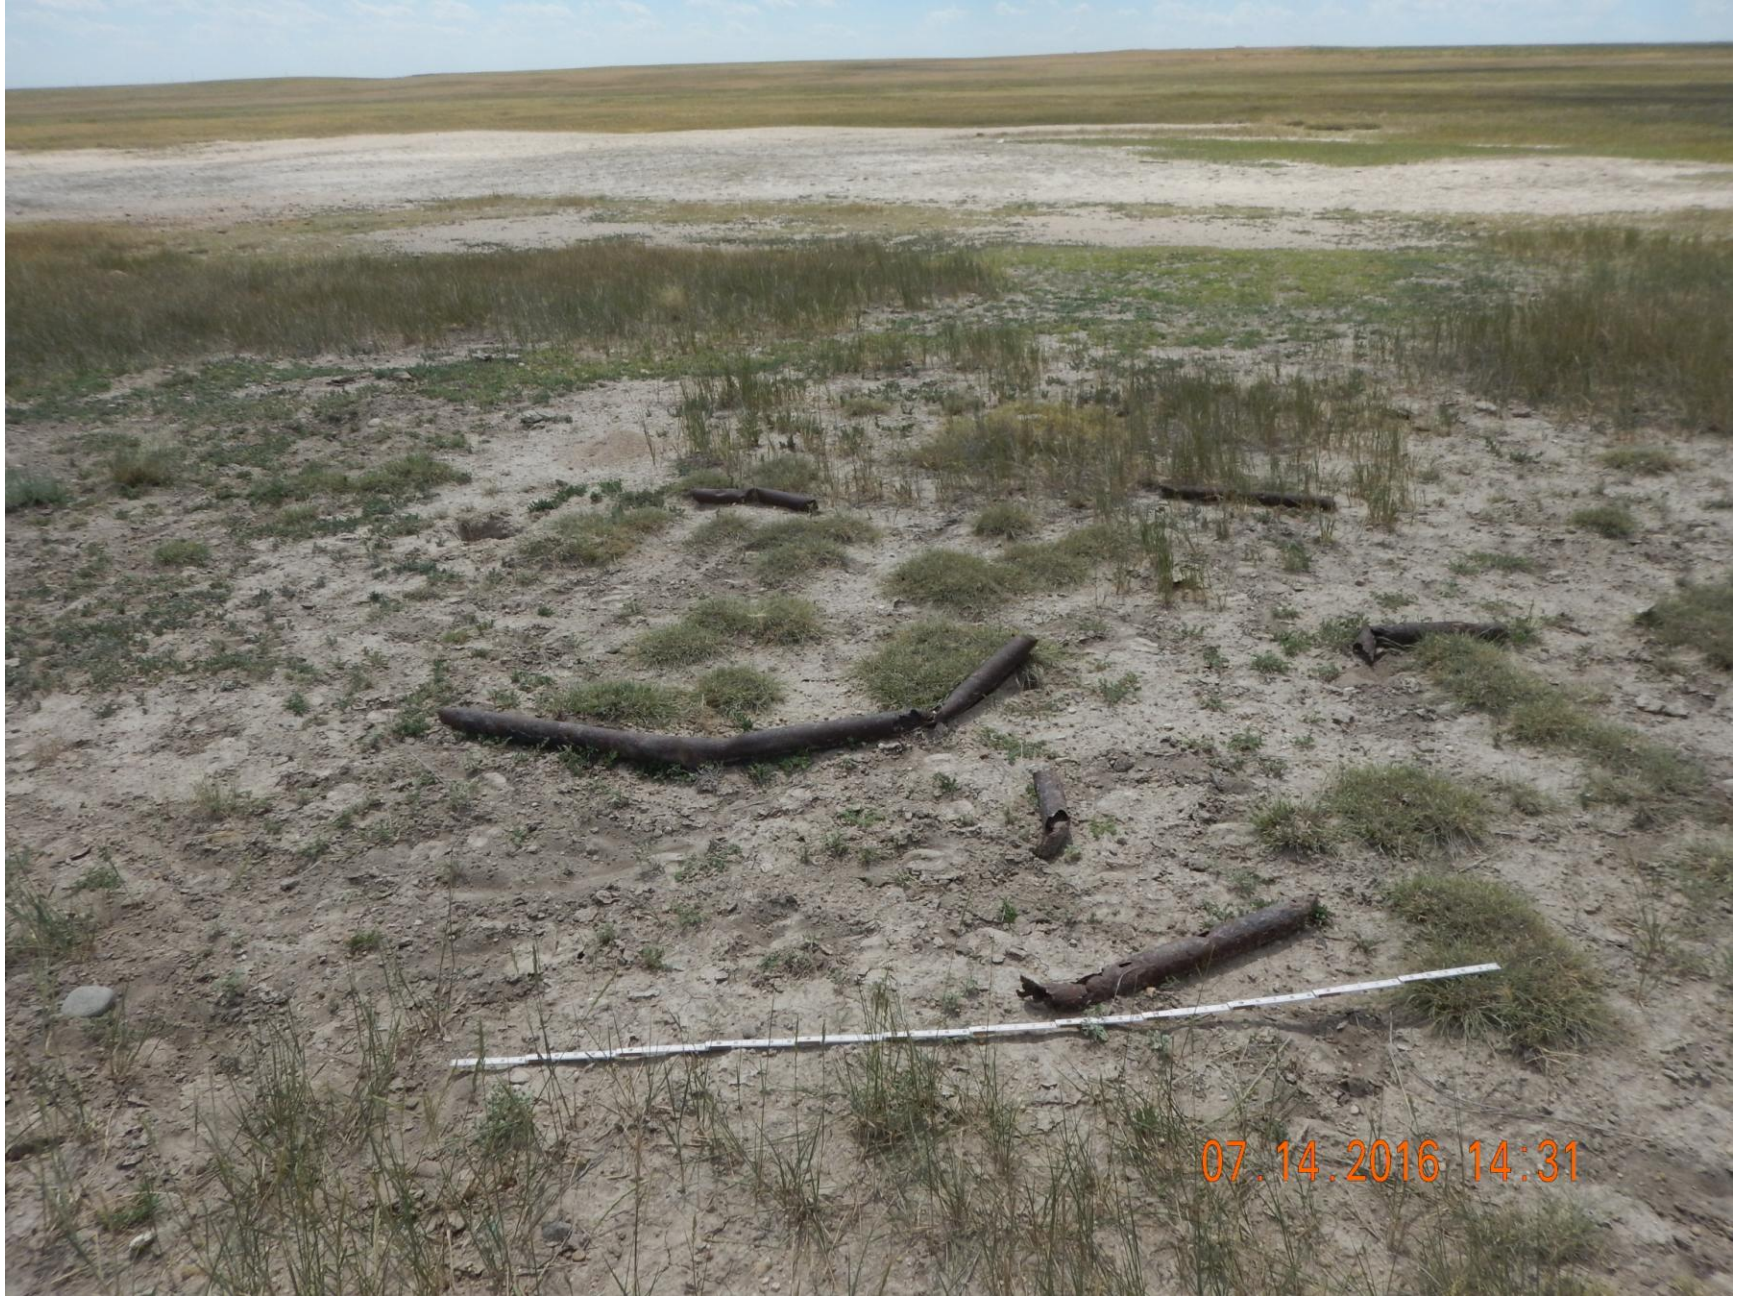
Figure 11: Photo taken from the east end of the possible salt kill, facing west. Photo shows pipe equipment and debris. 6' measuring stick for reference.

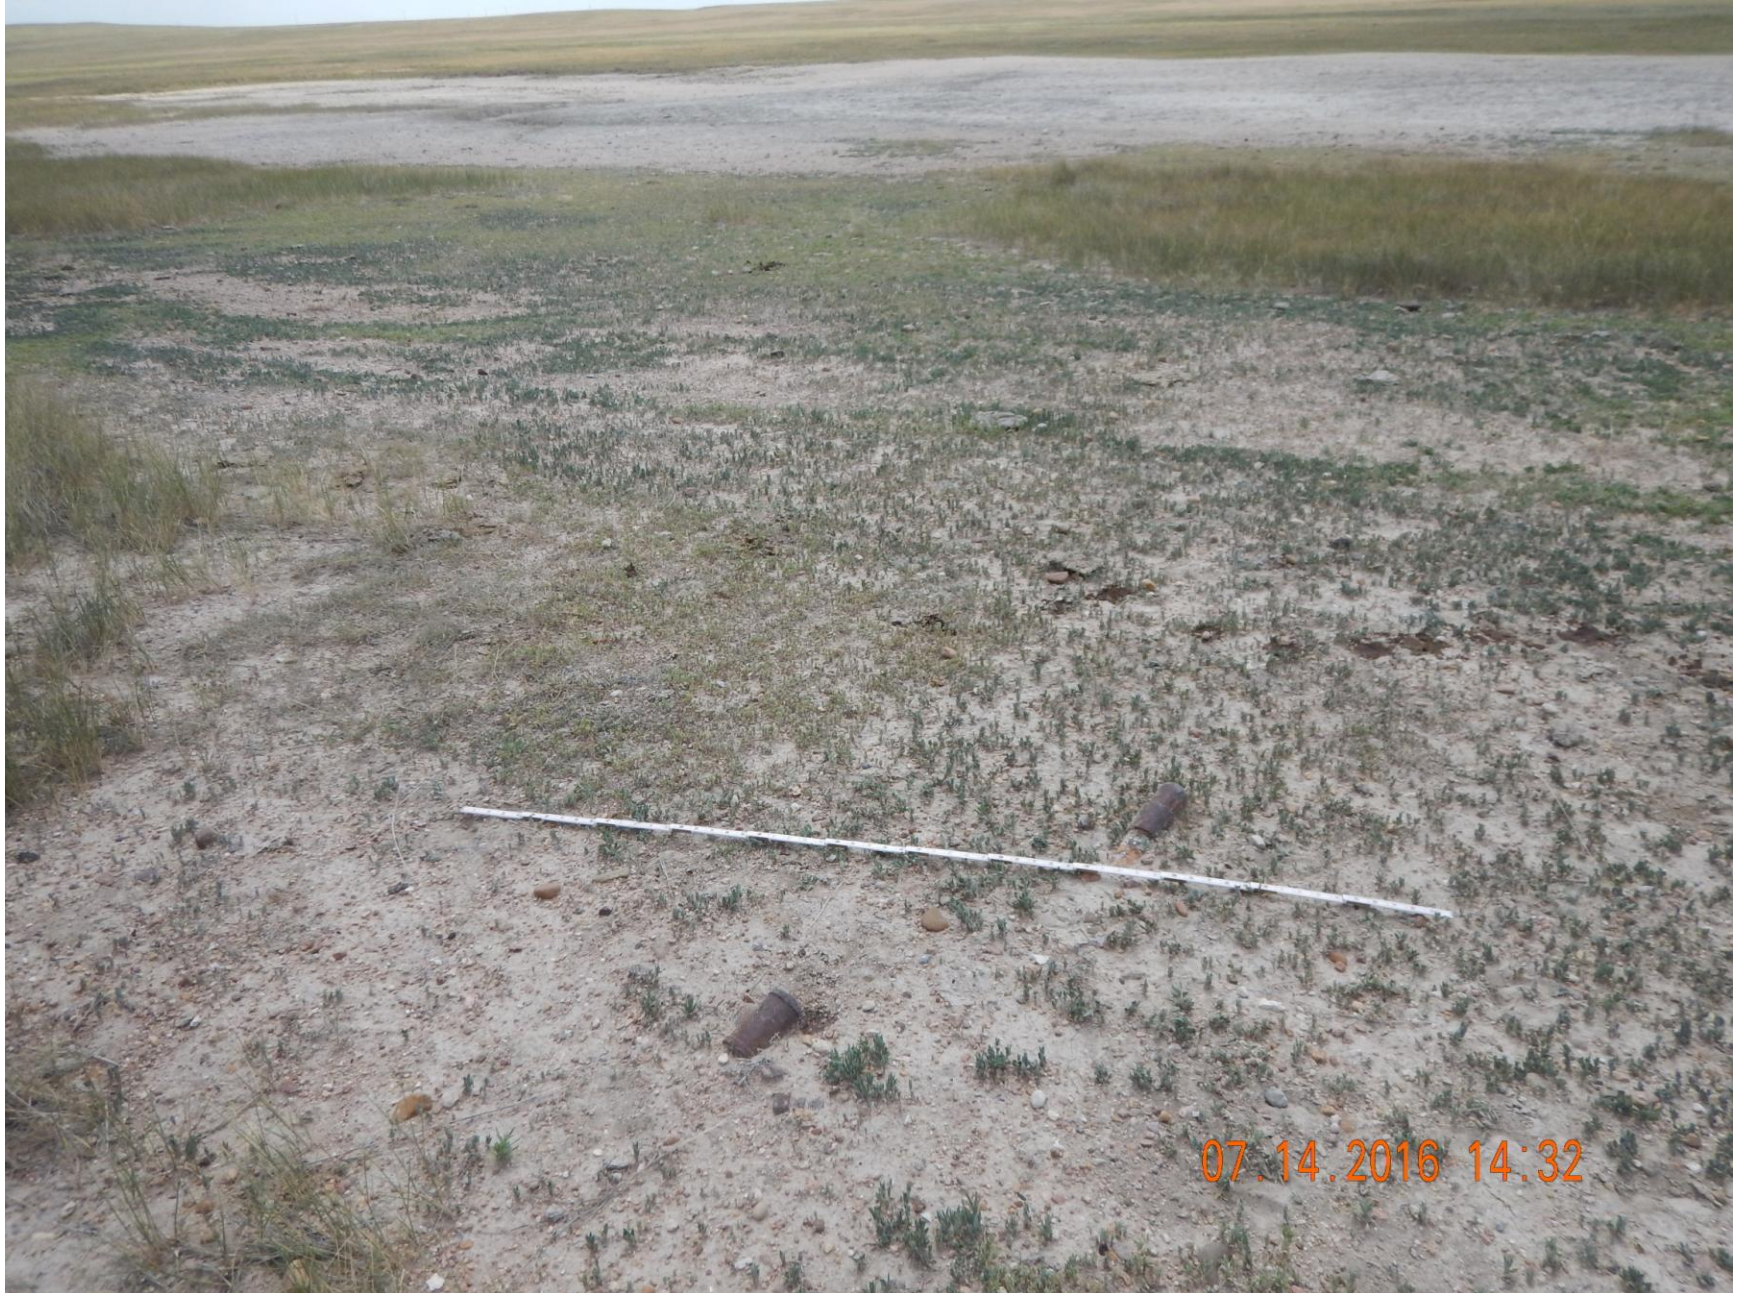
Figure 12: Photo taken from the east end of the possible salt kill, facing west. Photo shows pipe equipment and debris. 6' measuring stick for reference.

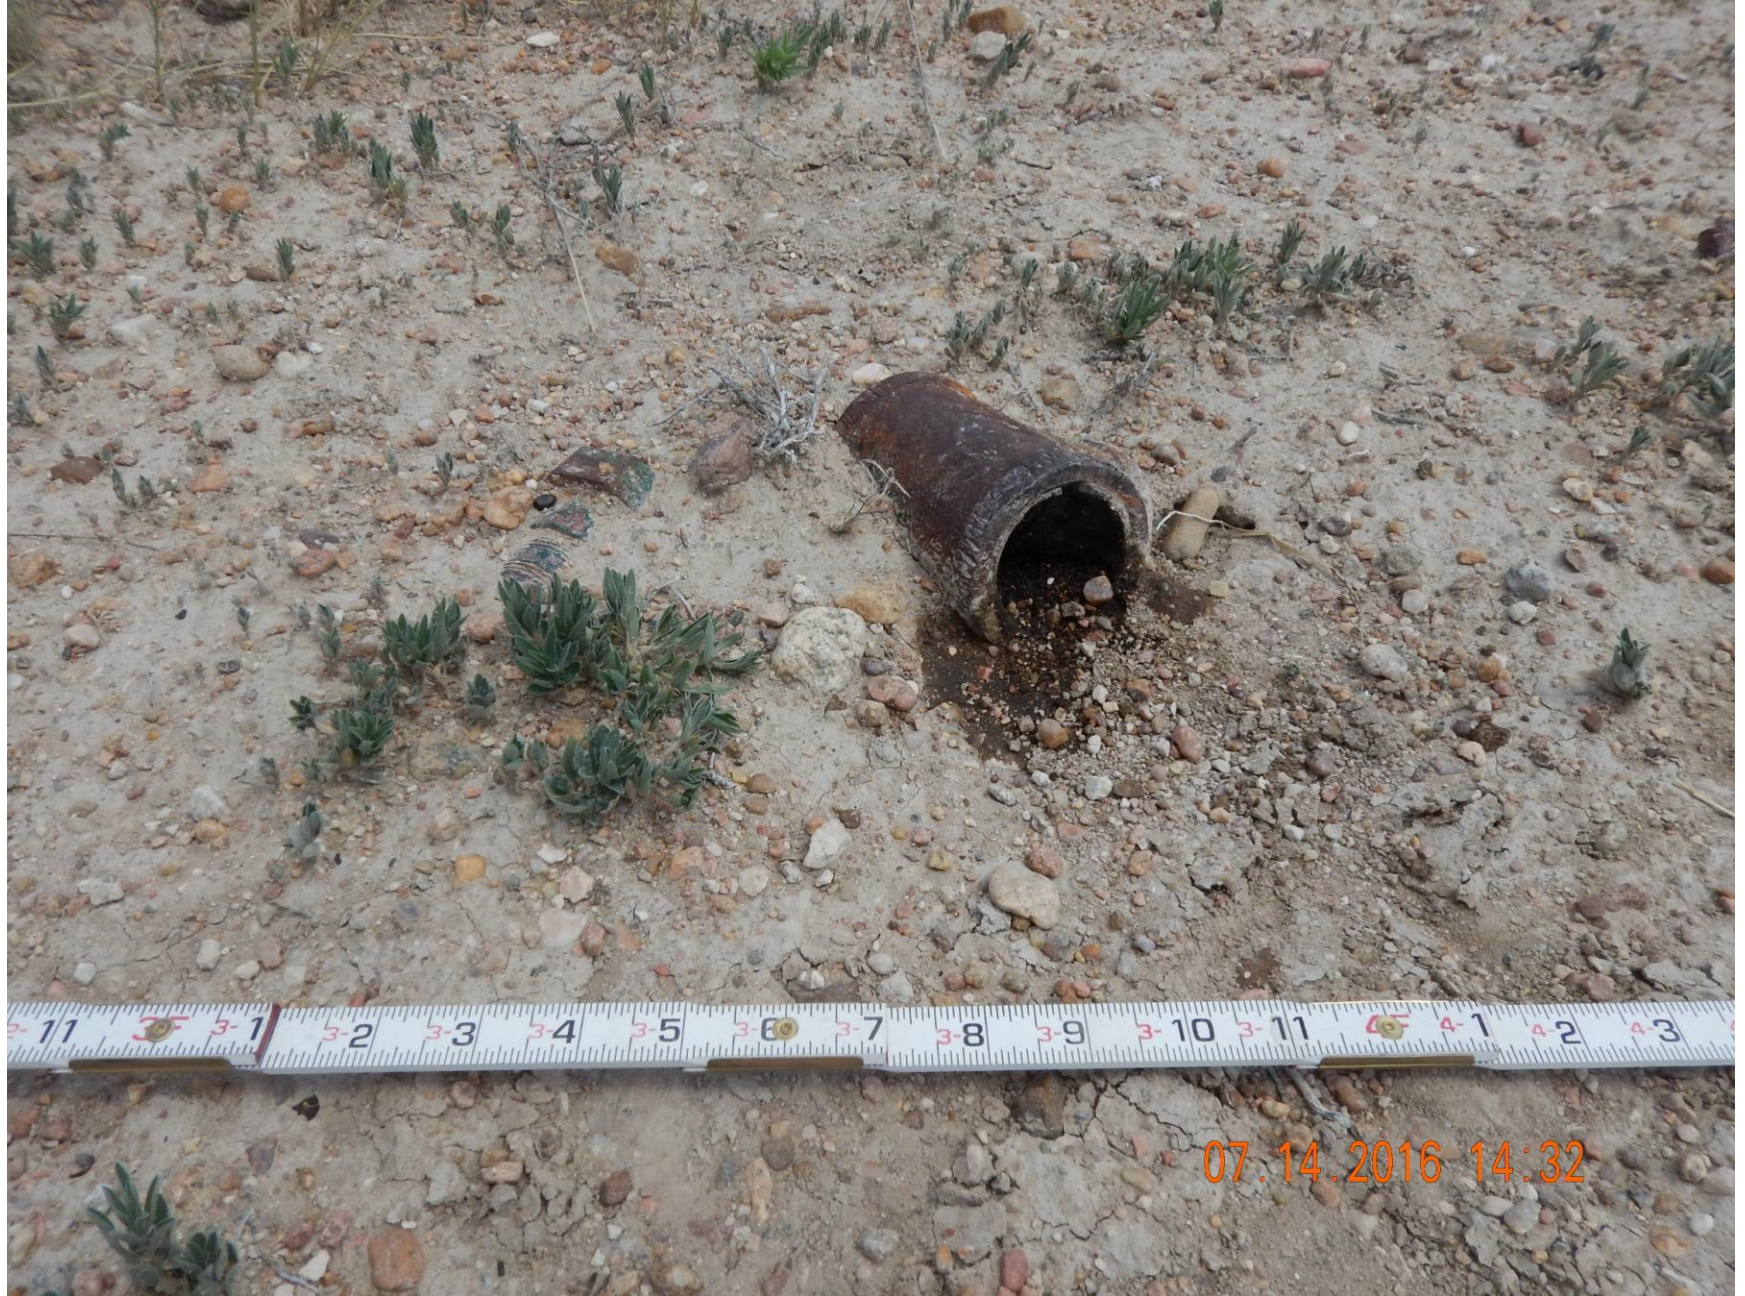
Figure 13: Photo taken from the east end of the possible salt kill. Photo shows pipe equipment on location with oily substance seeping from pipe onto soil.

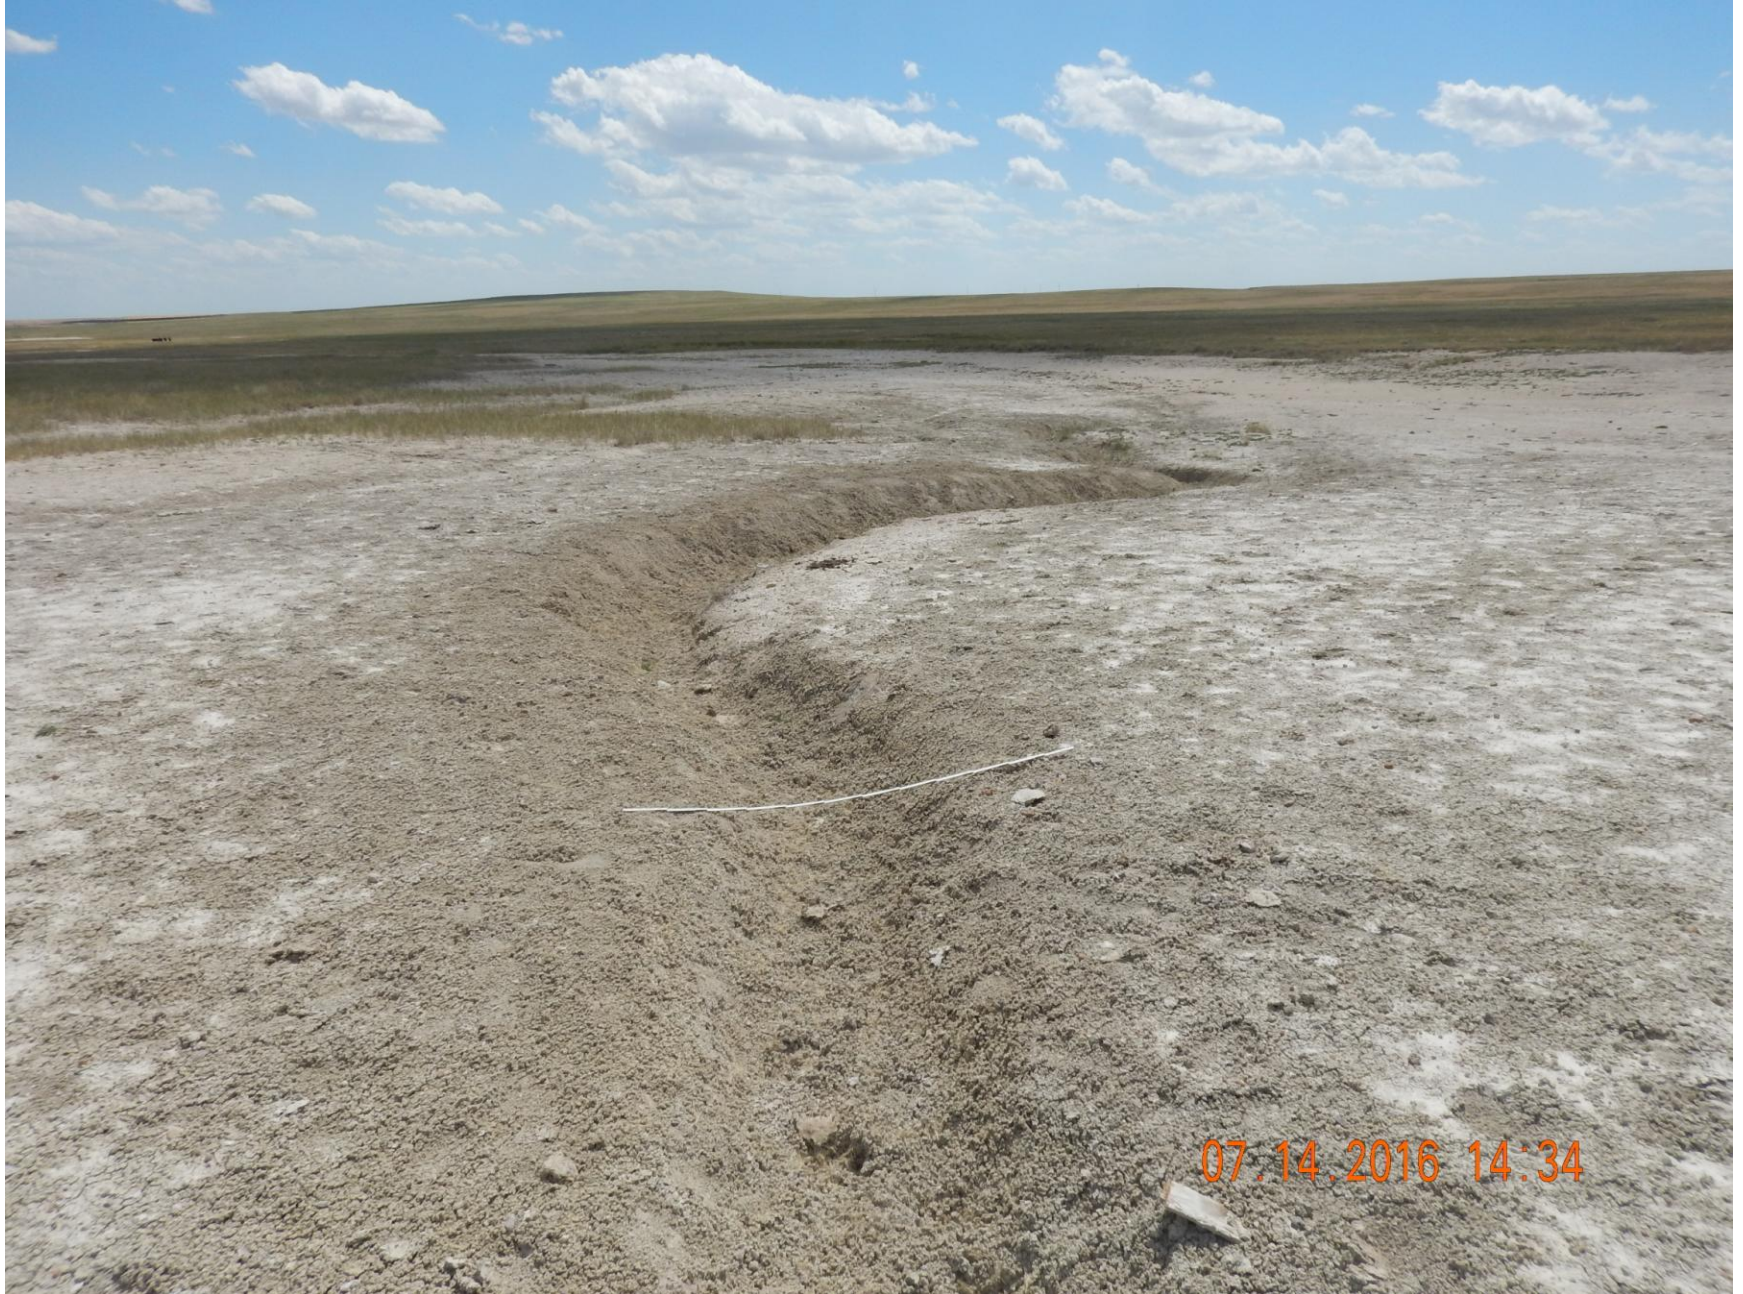
Figure 14: Photo taken from the east end of the possible salt kill, facing southwest. Photo shows degradation occurring in the area due to stormwater erosion.

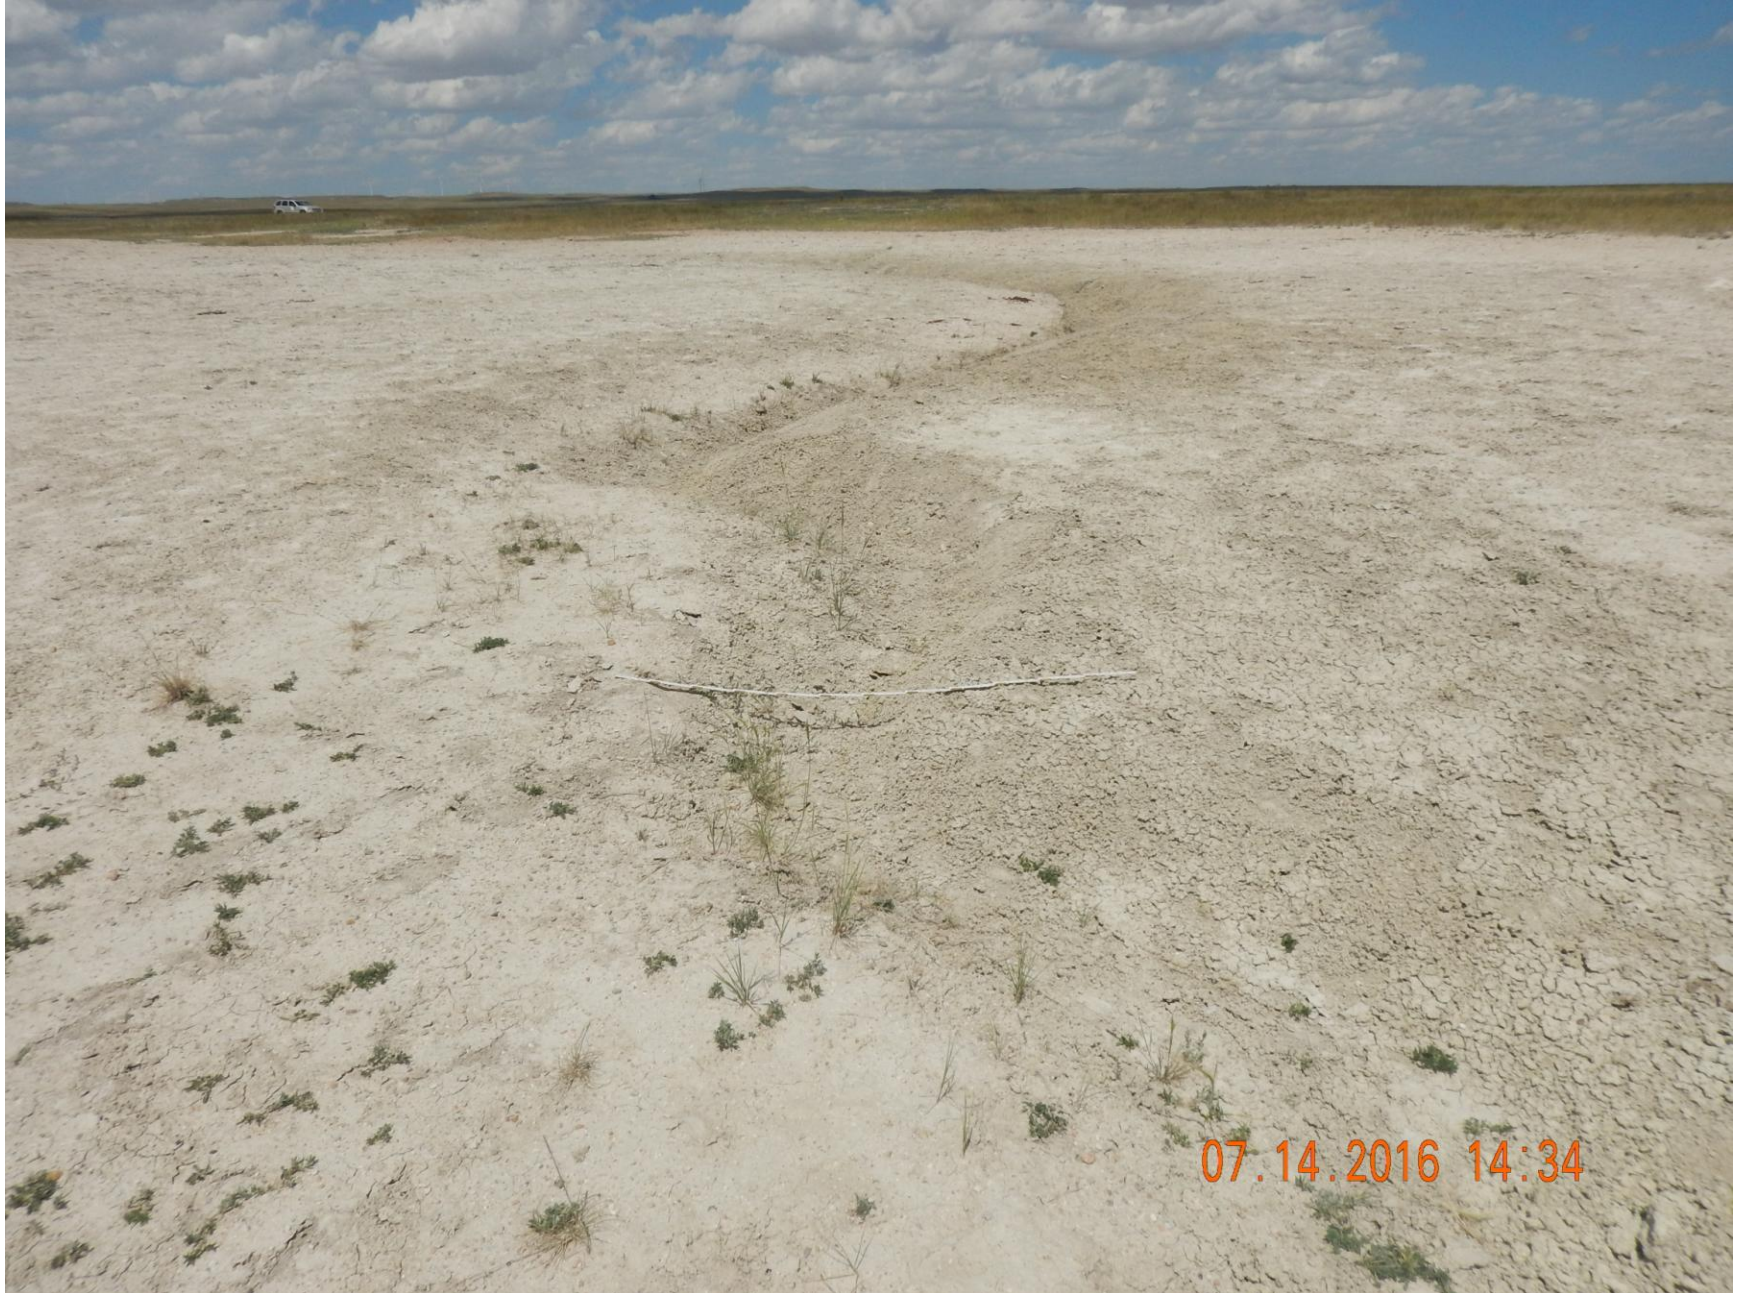
Figure 15: Photo taken from the south end of the possible salt kill, facing northeast. Photo shows degradation occurring in the area due to stormwater erosion.

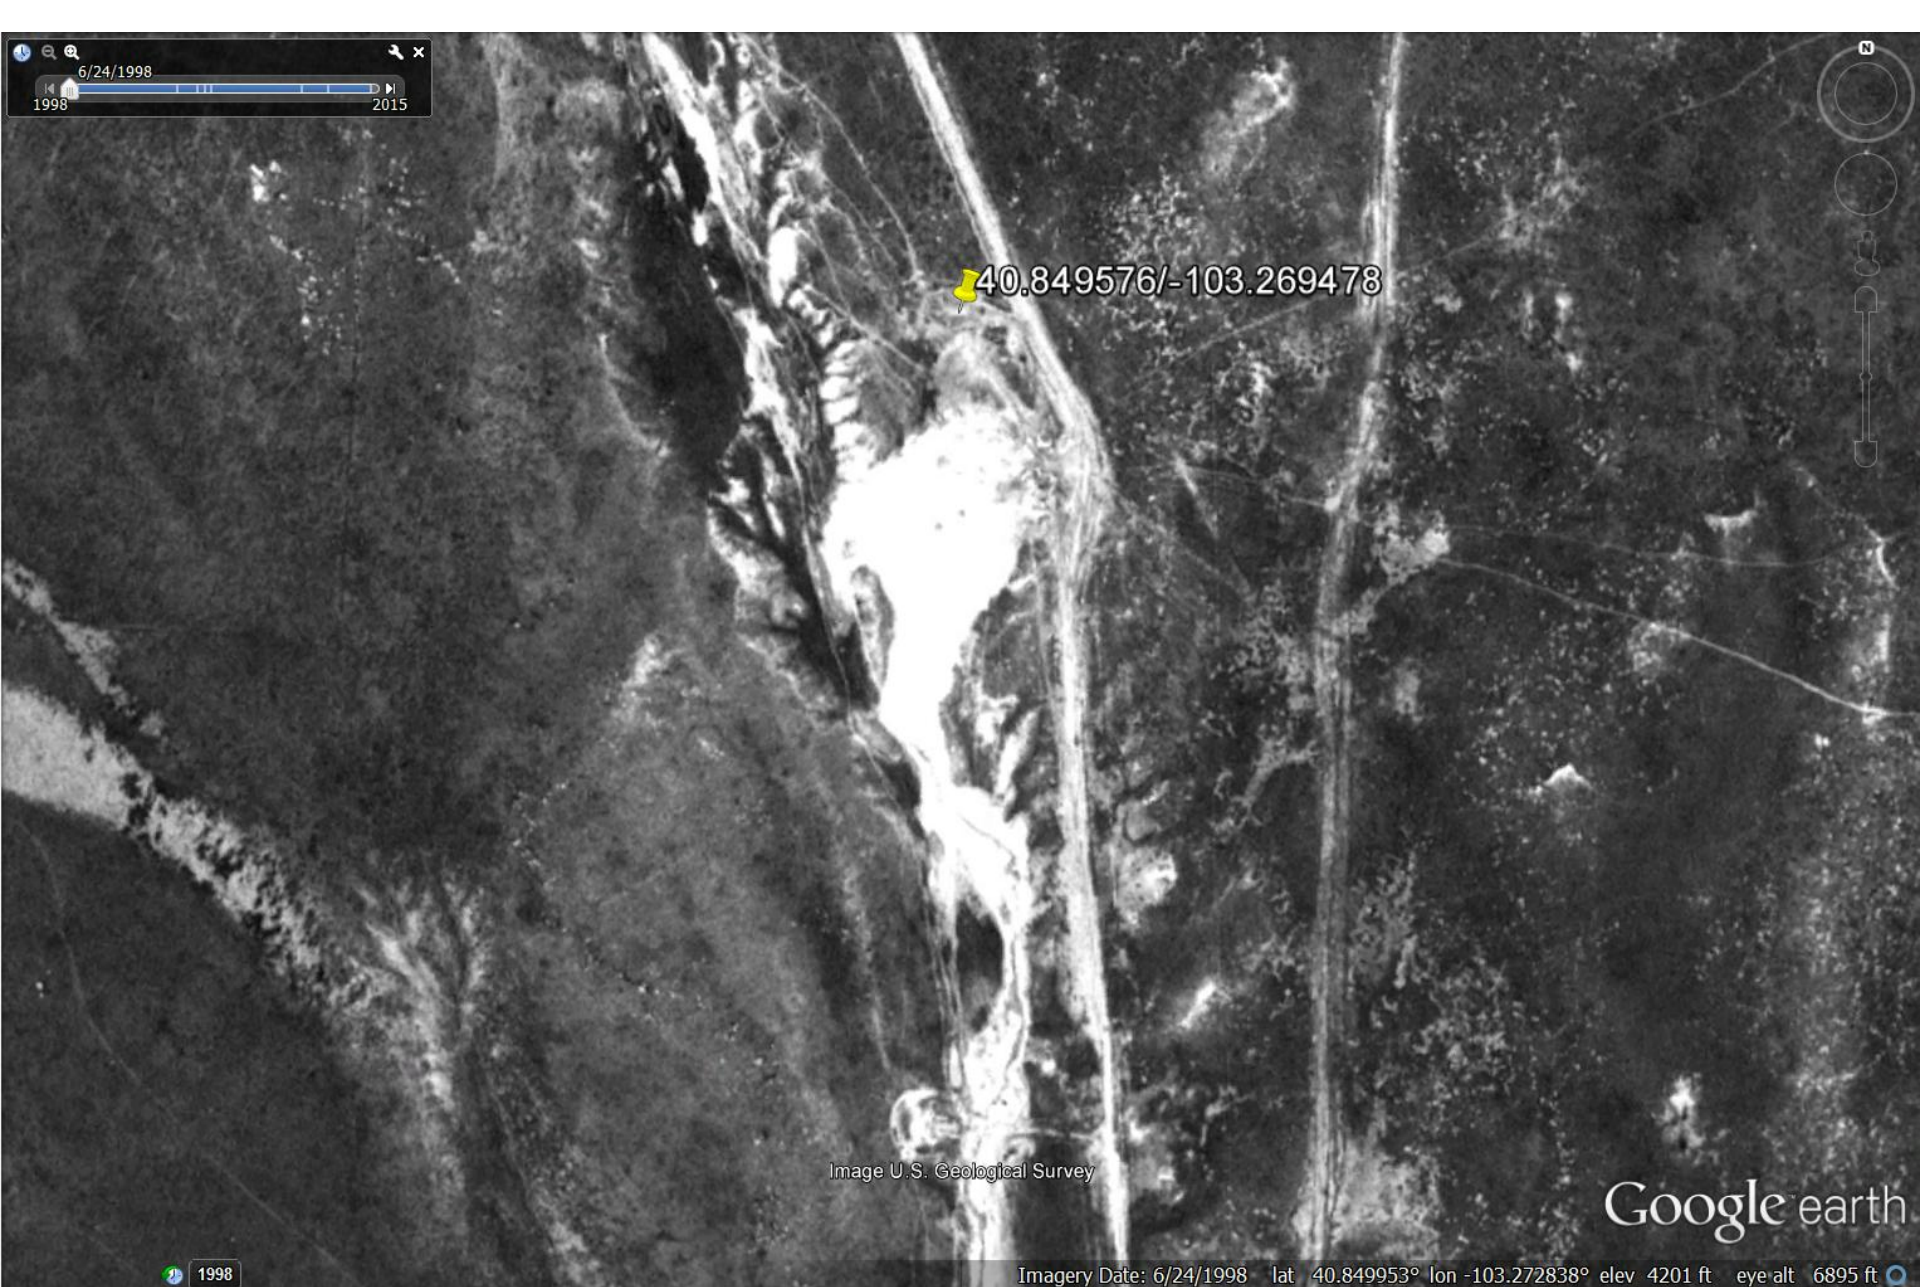
Figure 16: 1998 aerial imagery of well site, location and possible salt kill. Records show well PA 1995.

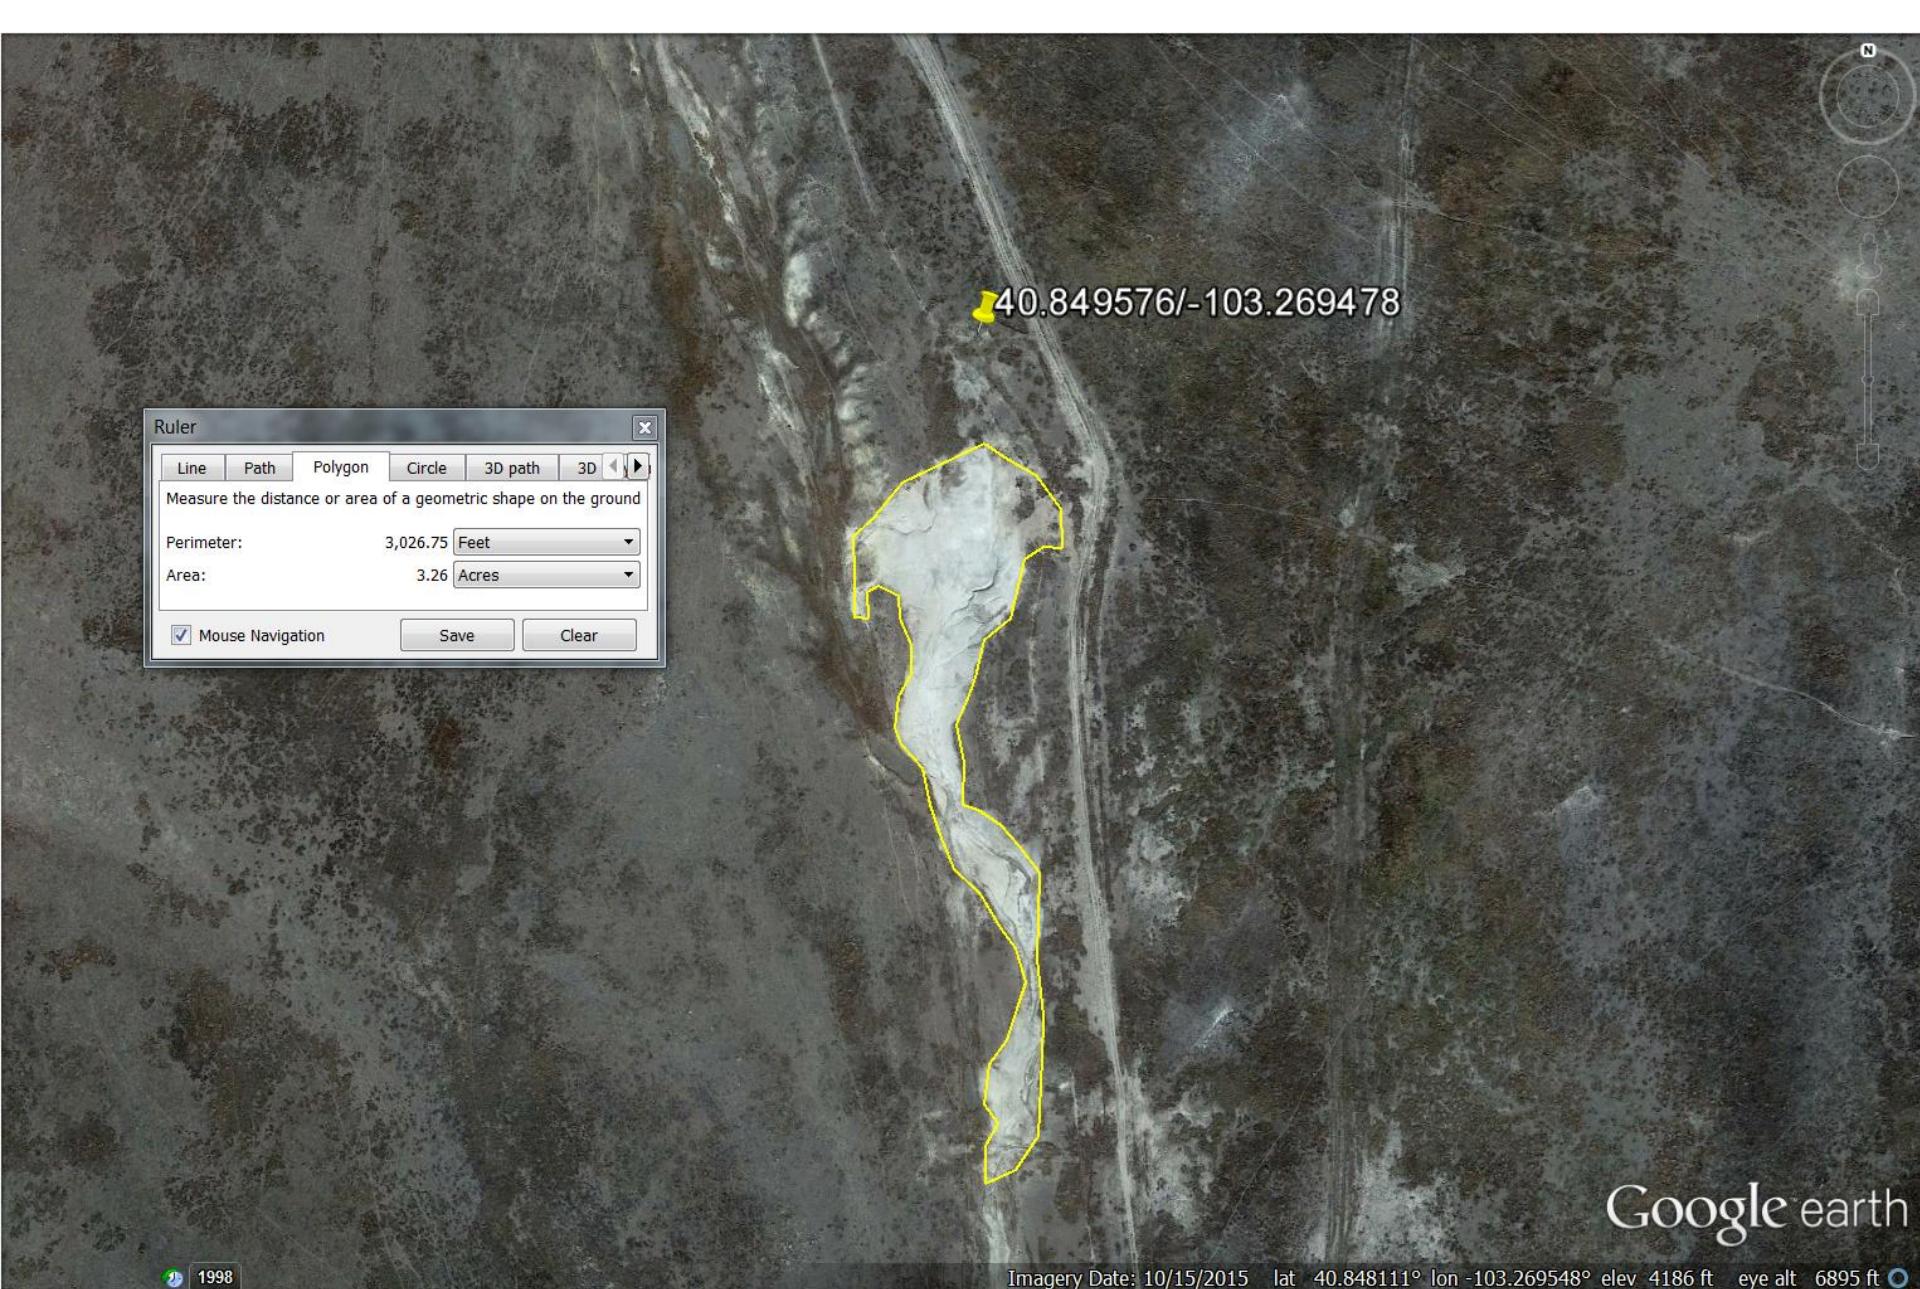
Figure 17: Most current aerial imagery (2015) of well site, location and possible salt kill. Approximate area of possible salt kill site is 3.26 acres.
