Reclamation Inspection

08/19/2016

Operator: Walsh Production Inc

Location ID: 408424

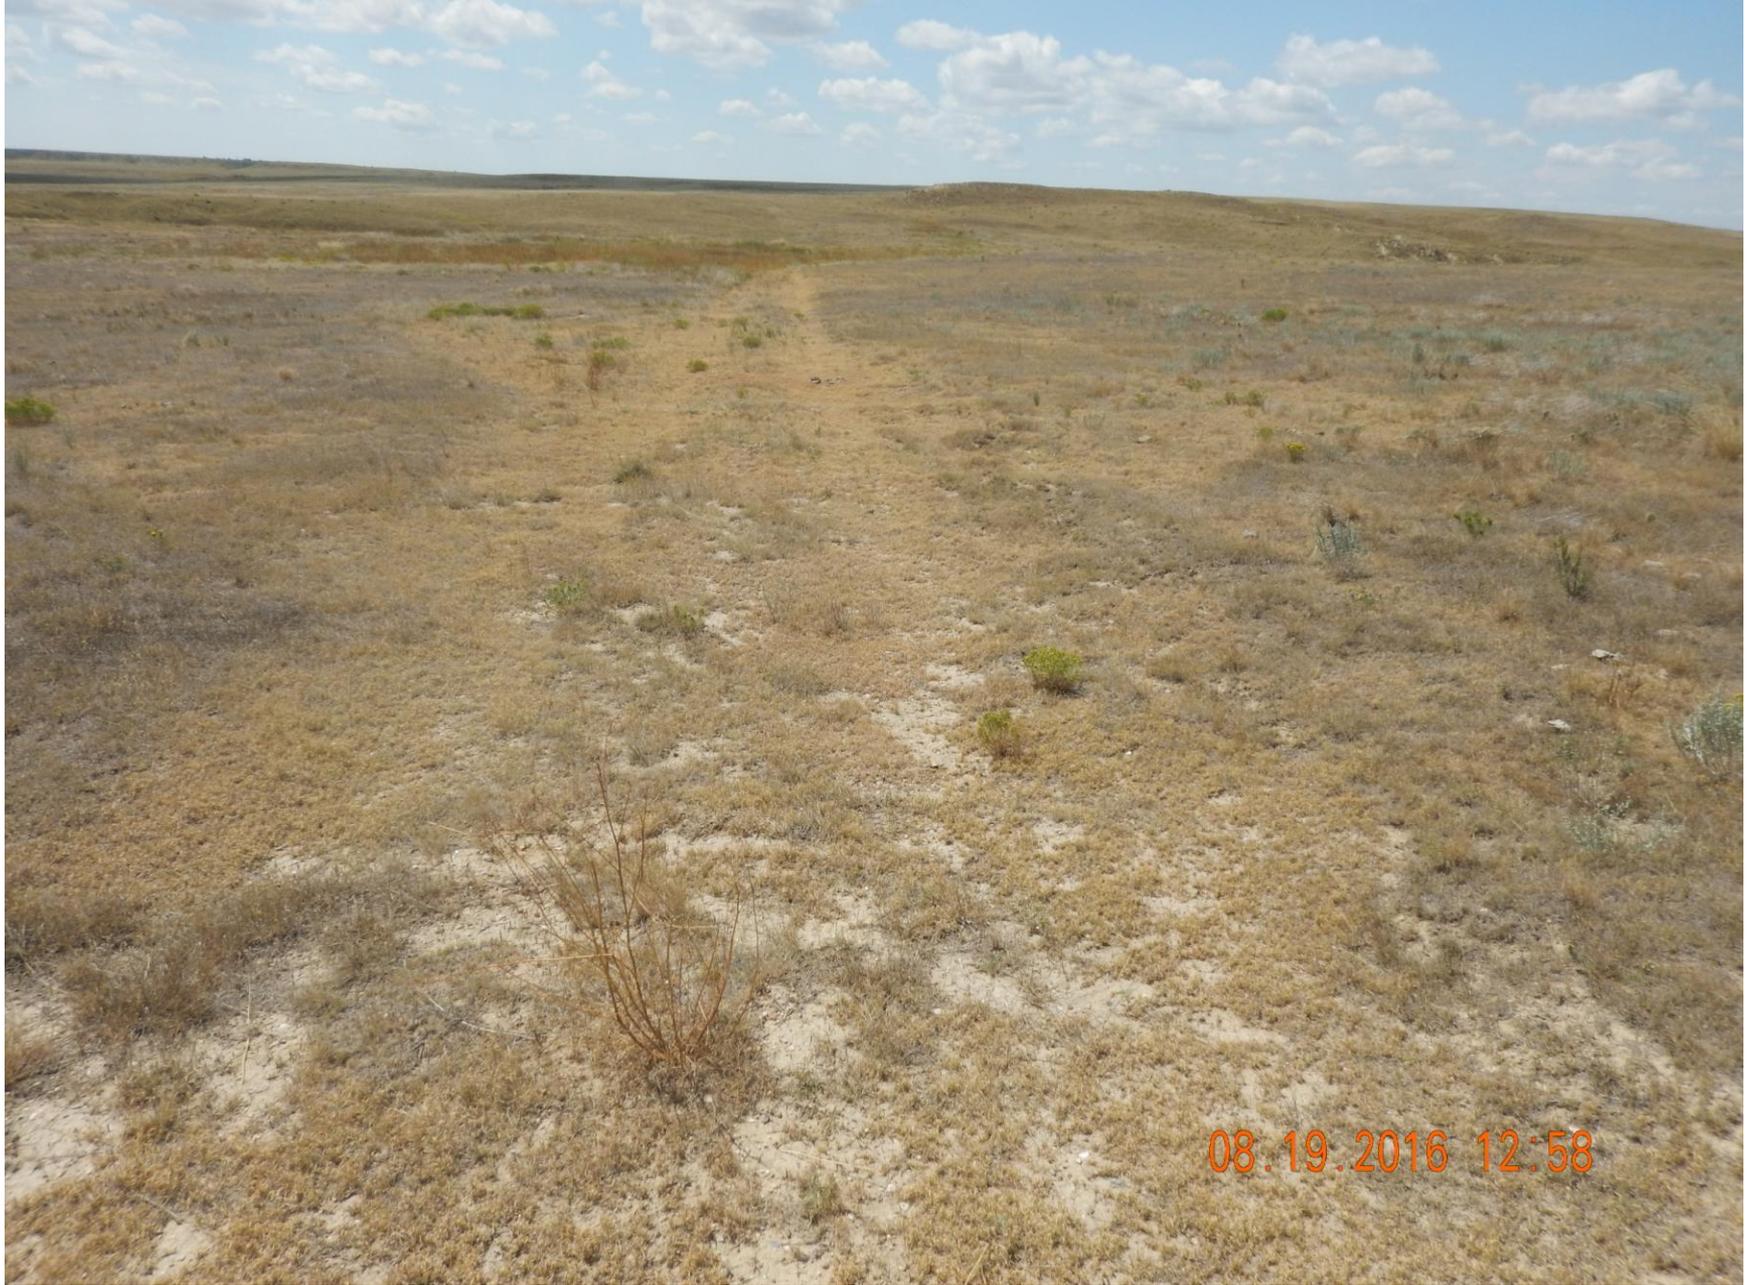
Figure 1: Photo taken east of the location, facing west. Photo shows vegetation over the access road.

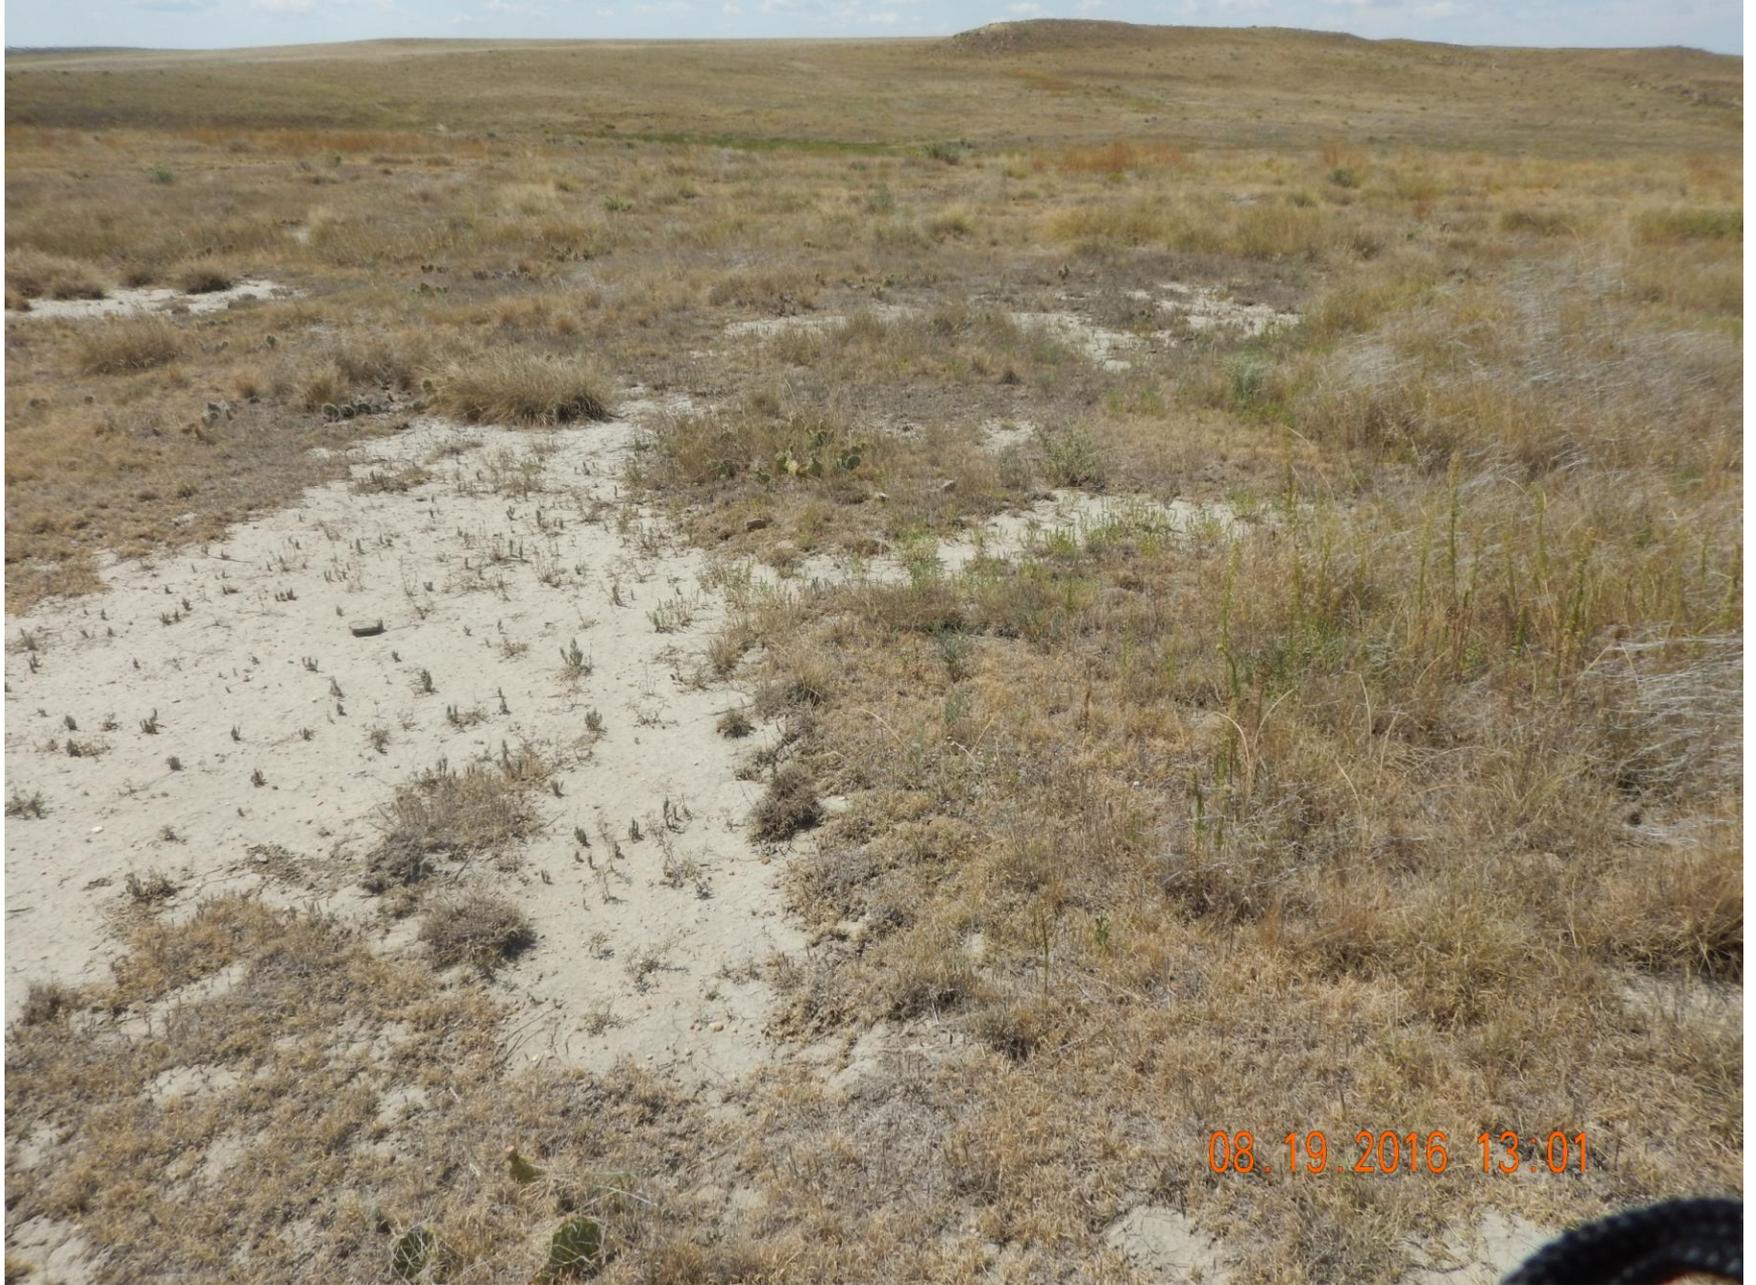
Figure 2: Photo taken from the north end of the pit location, facing southwest. Photo shows multiple large unvegetated areas over pit location. These areas need to be reclaimed.

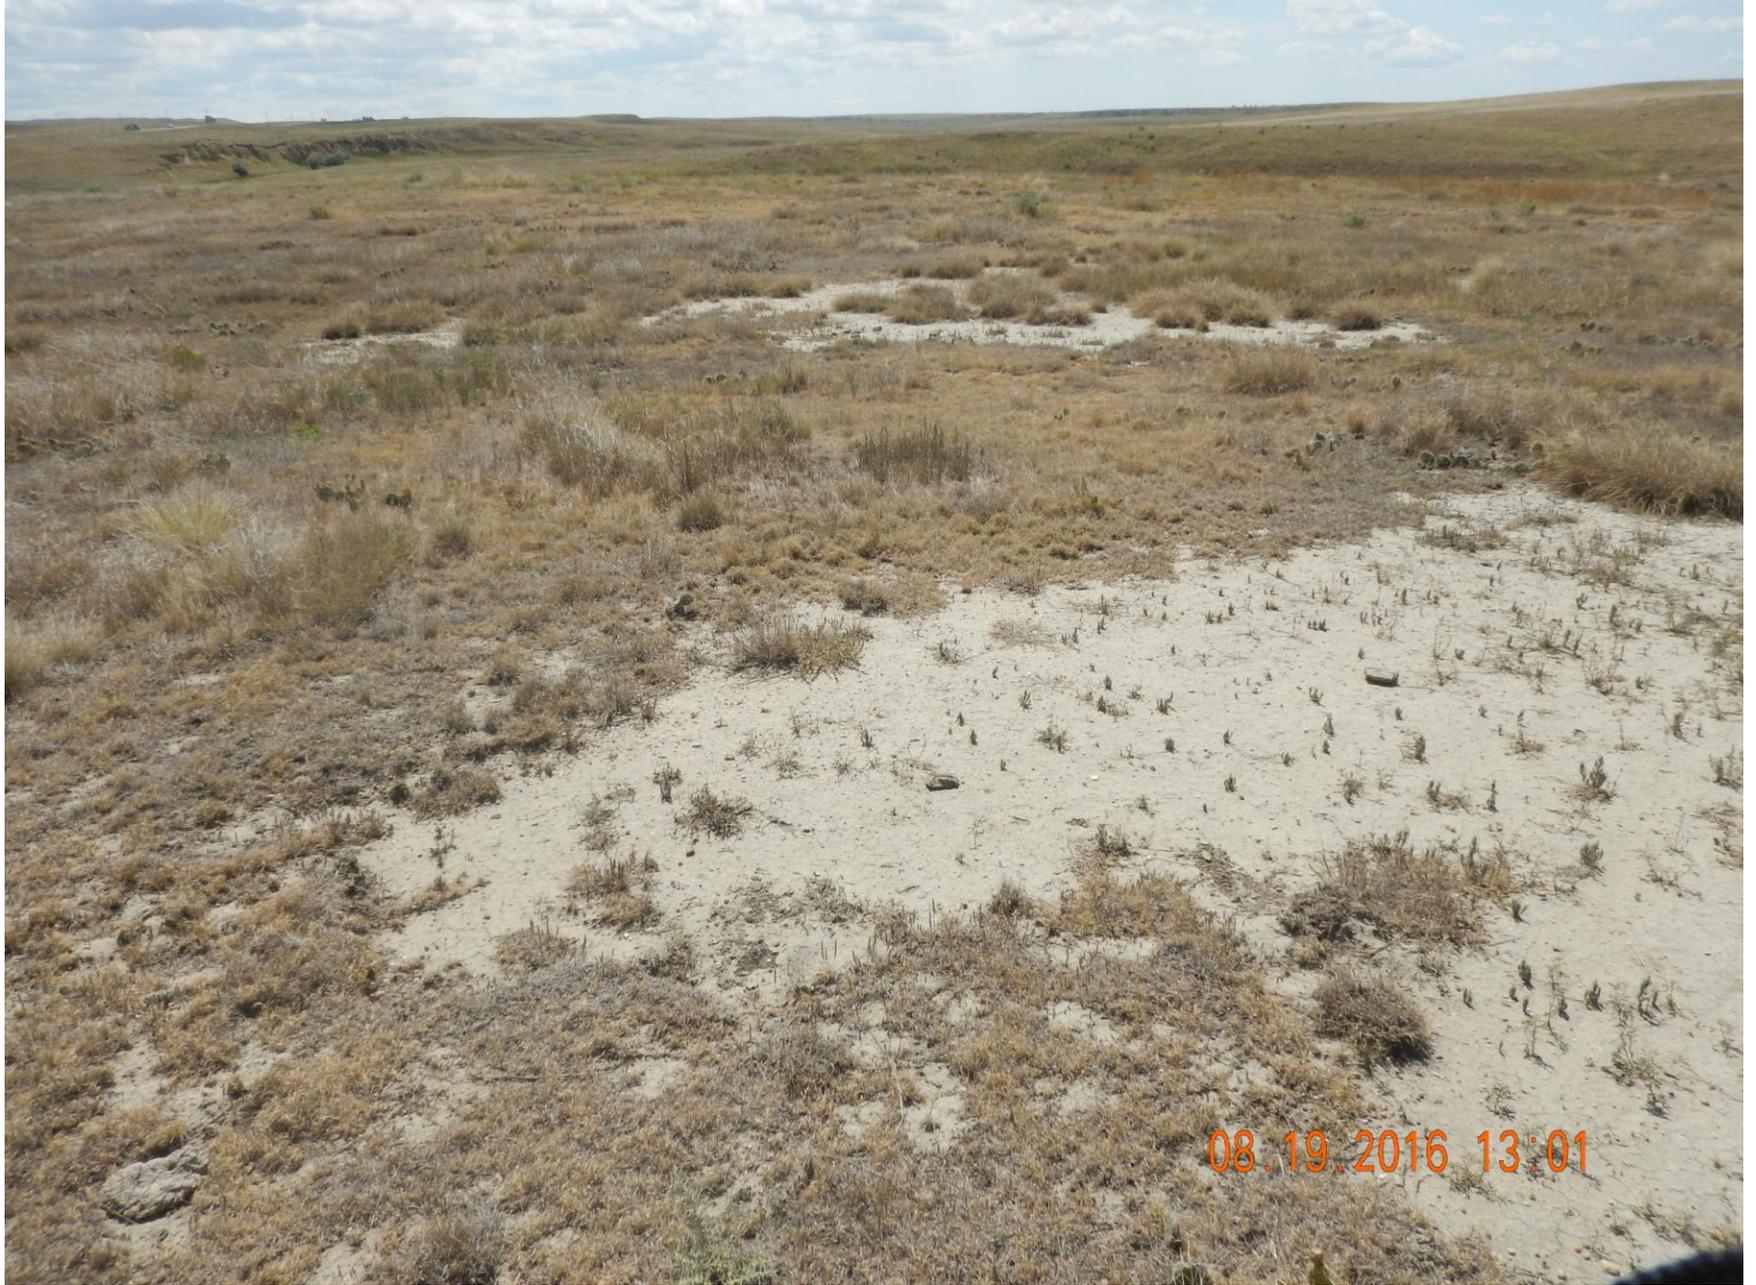
Figure 3: Photo taken from the north end of the pit location, facing southwest. Photo shows multiple large unvegetated areas over pit location. These areas need to be reclaimed.

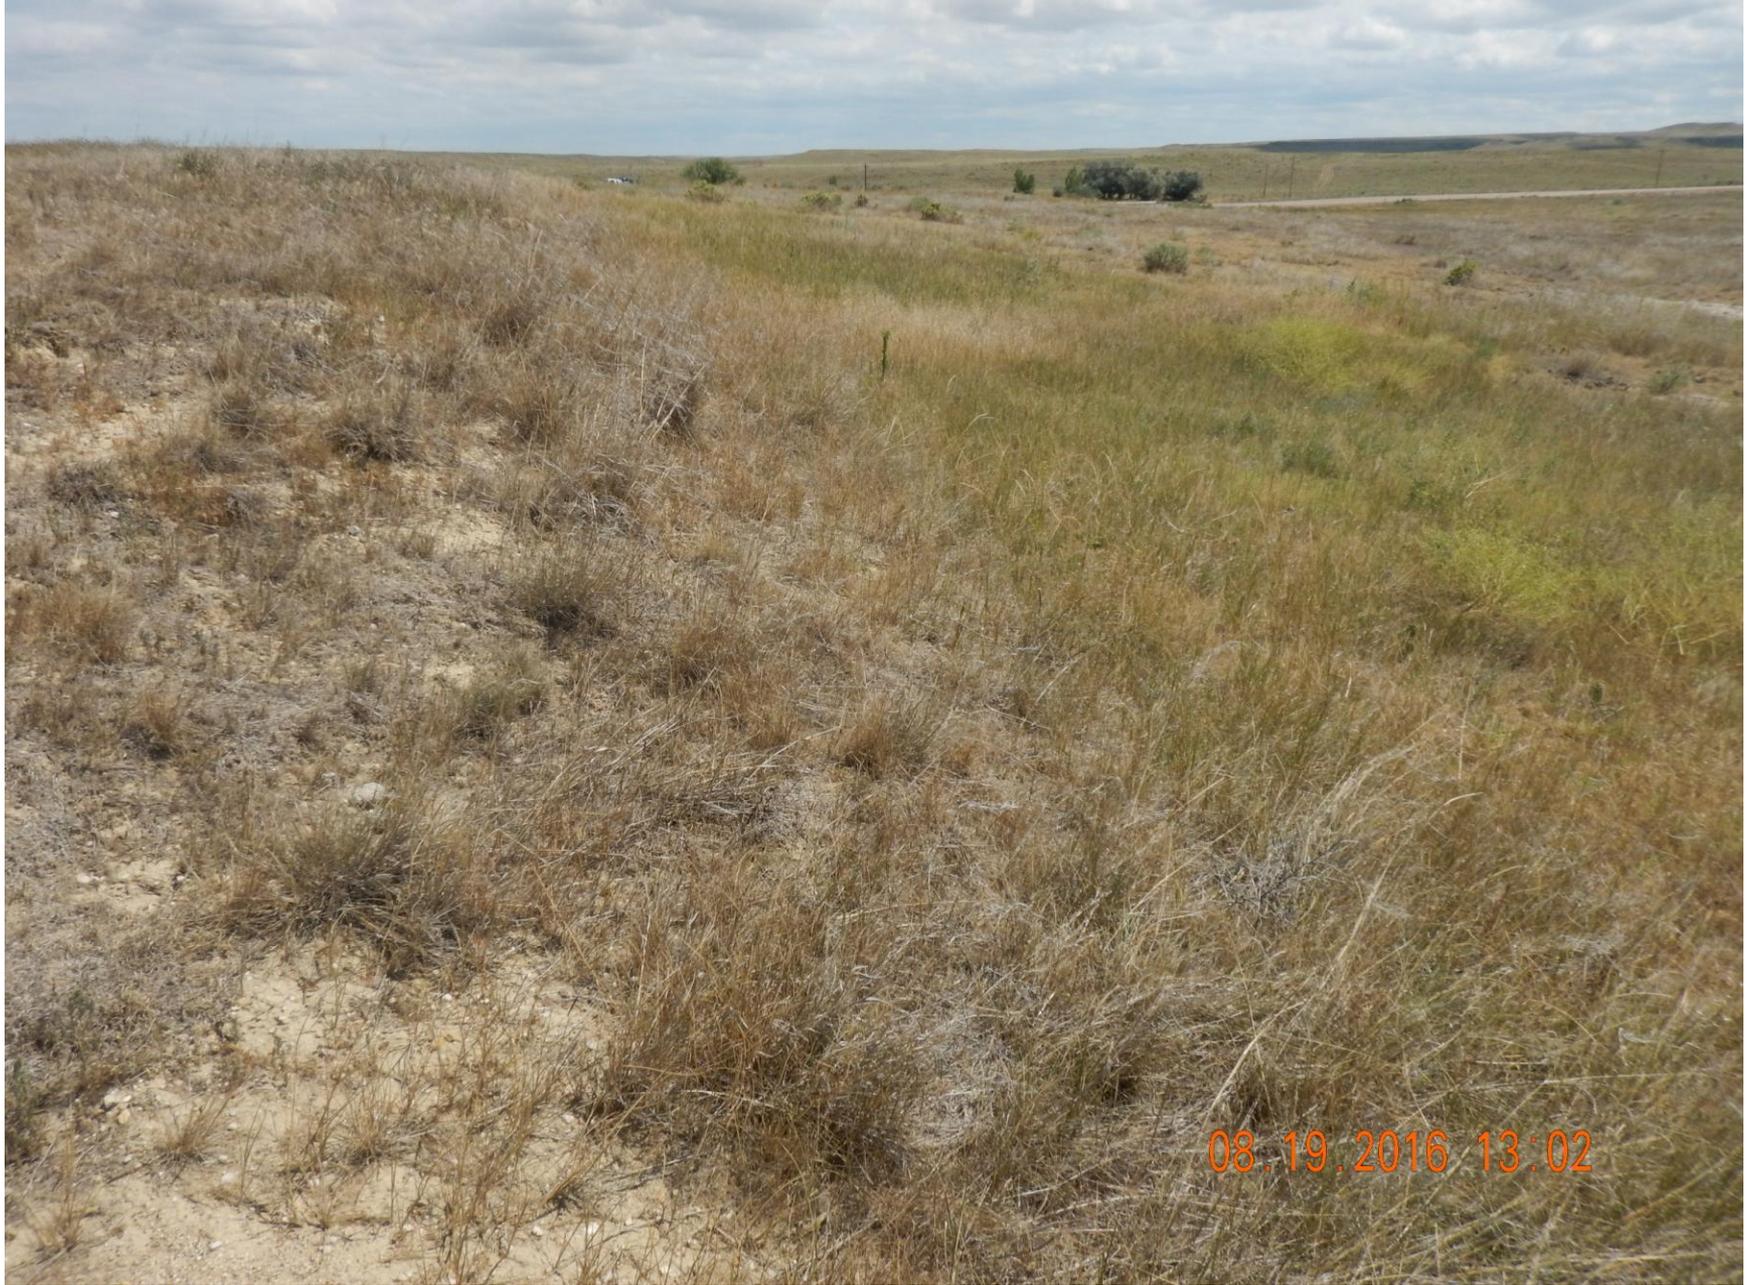
Figure 4: Photo taken from the southwest end of the well location, facing east. Photo shows slope on the south end of the location indicating location has not been re-contoured.

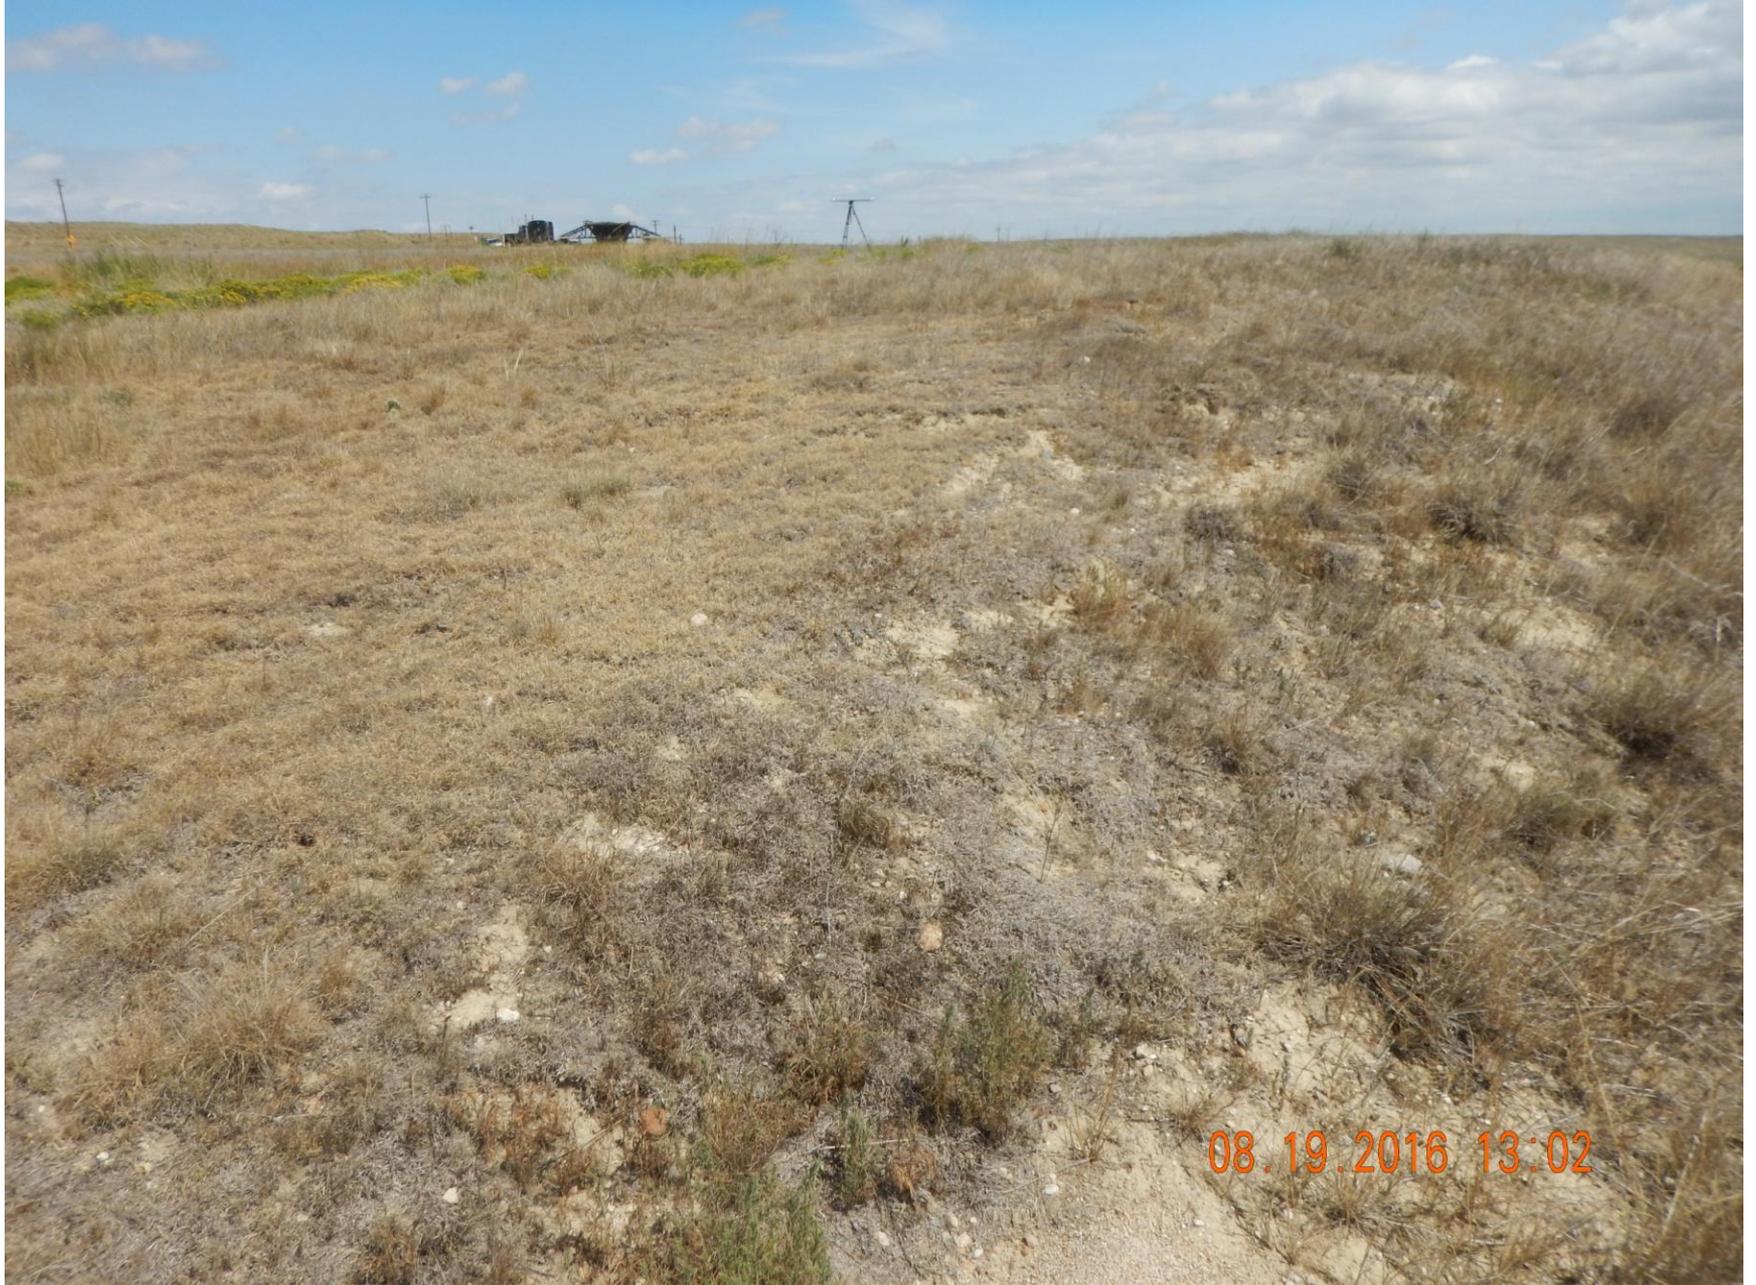
Figure 5: Photo taken from the southwest end of the well location, facing east. Photo shows slope on the south end of the location indicating location has not been re-contoured.

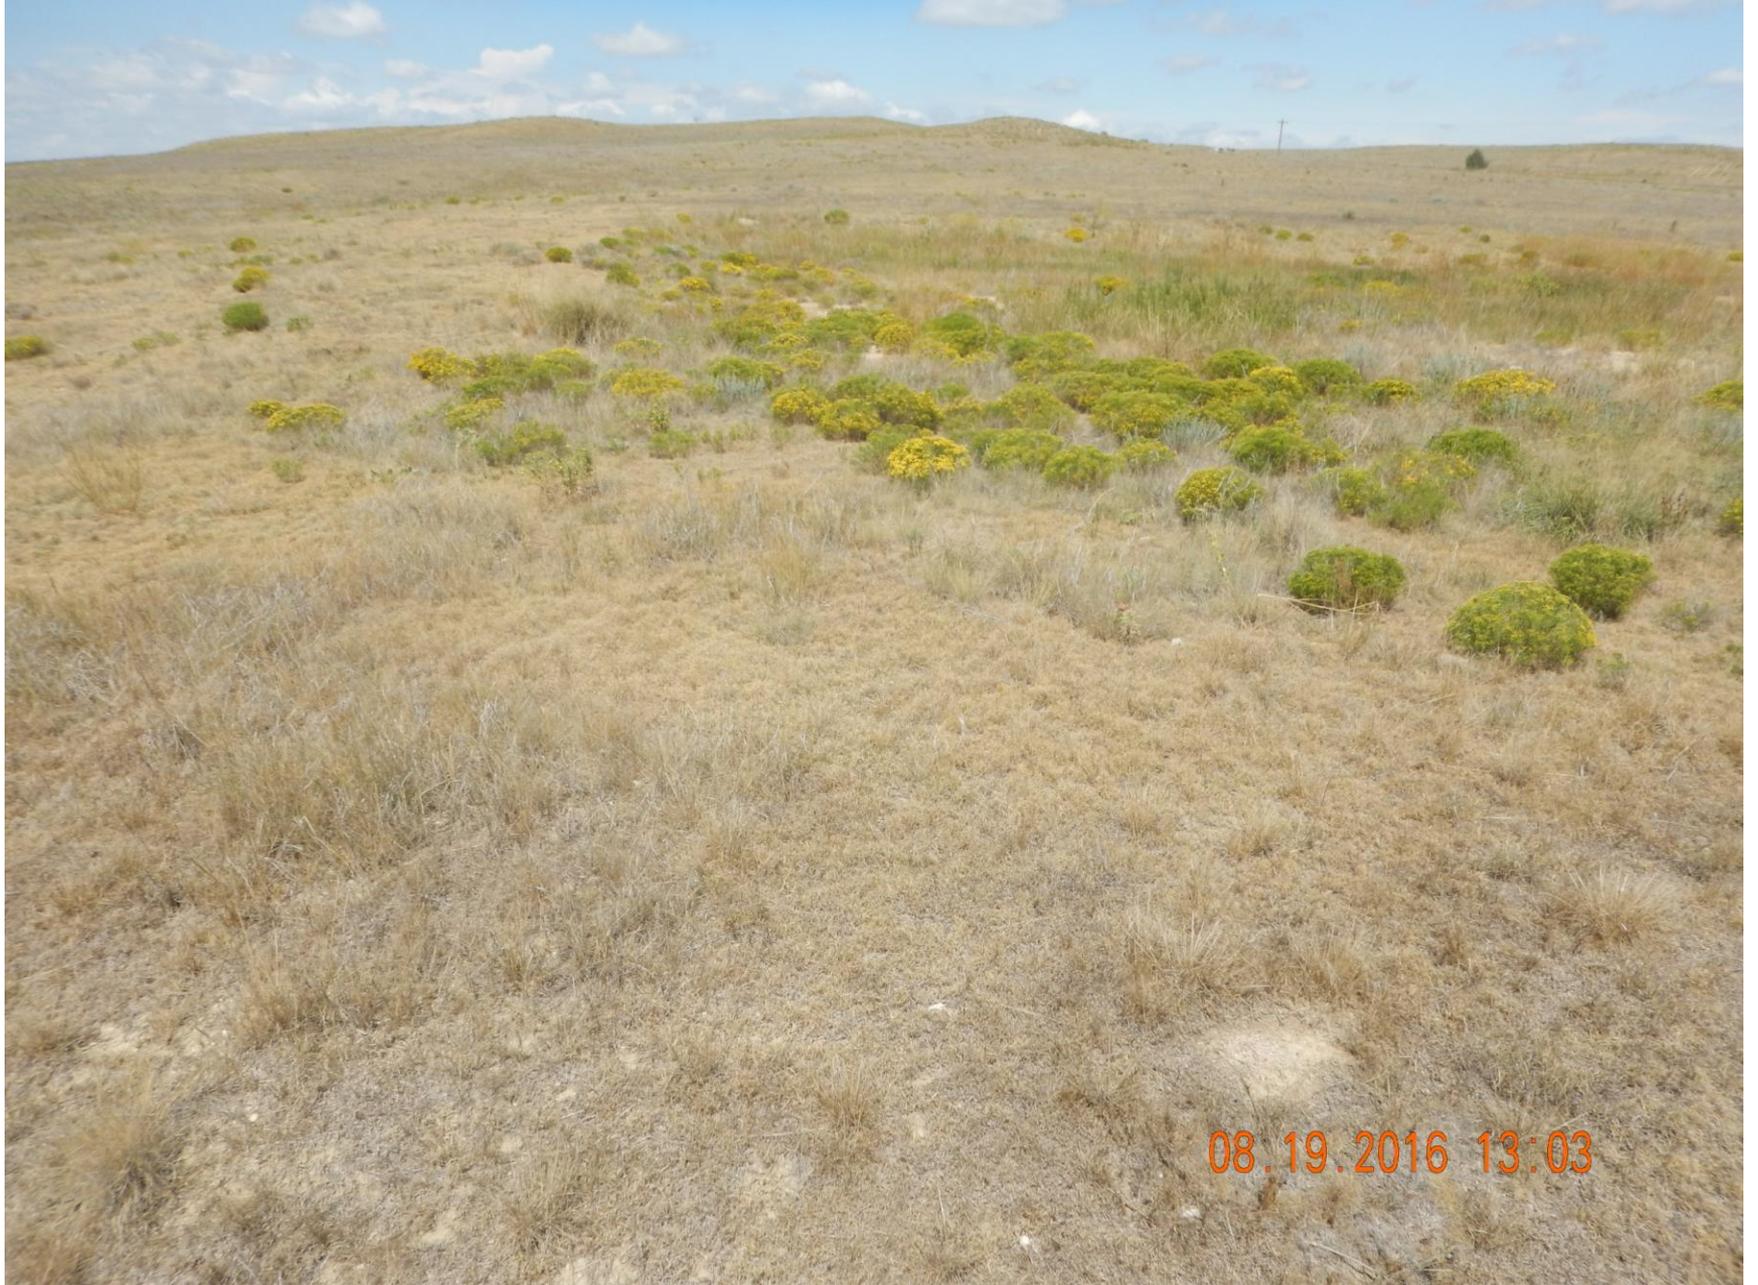
Figure 6: Photo taken from the southwest corner of the location, facing north. Photo shows vegetation over the reclamation area.

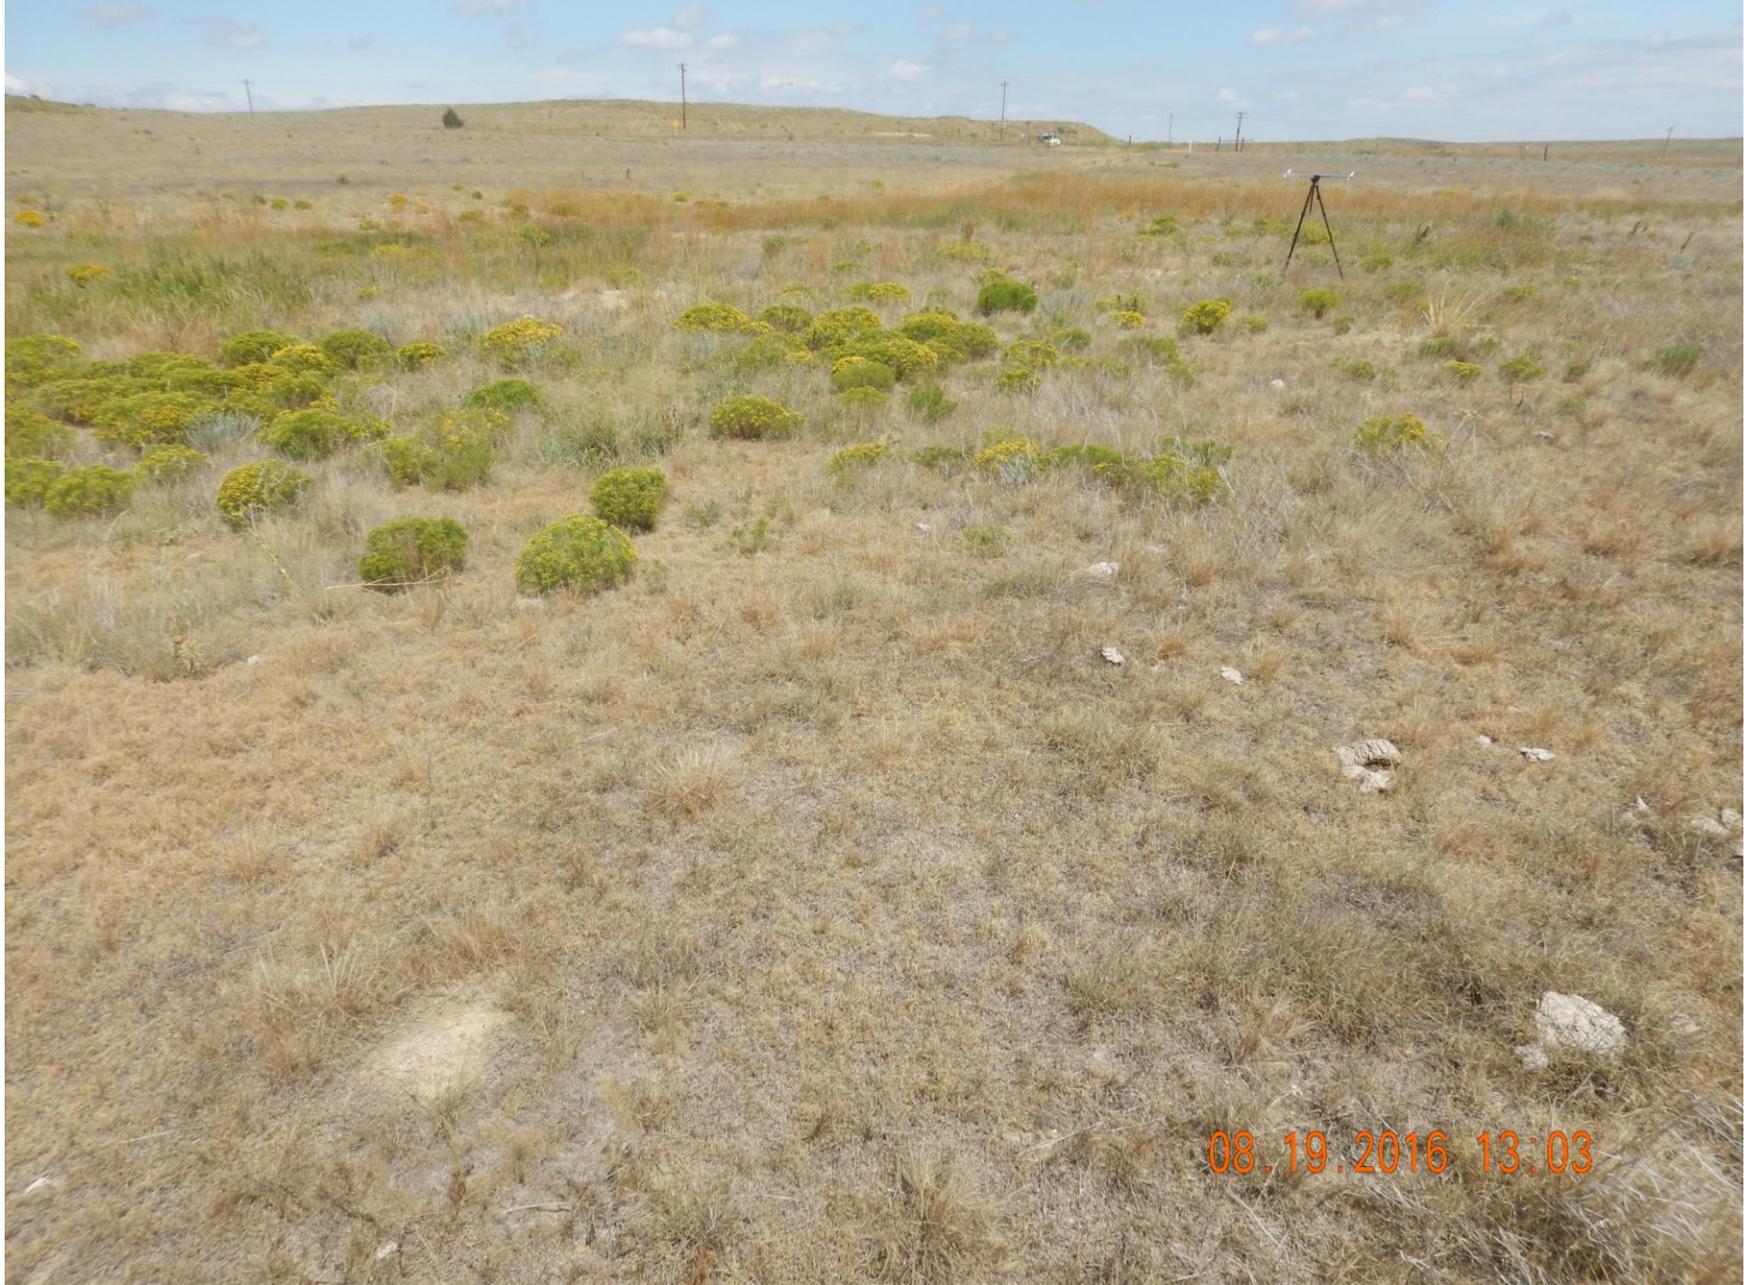
Figure 7: Photo taken from the southwest corner of the location, facing northeast. Photo shows vegetation over the reclamation area.

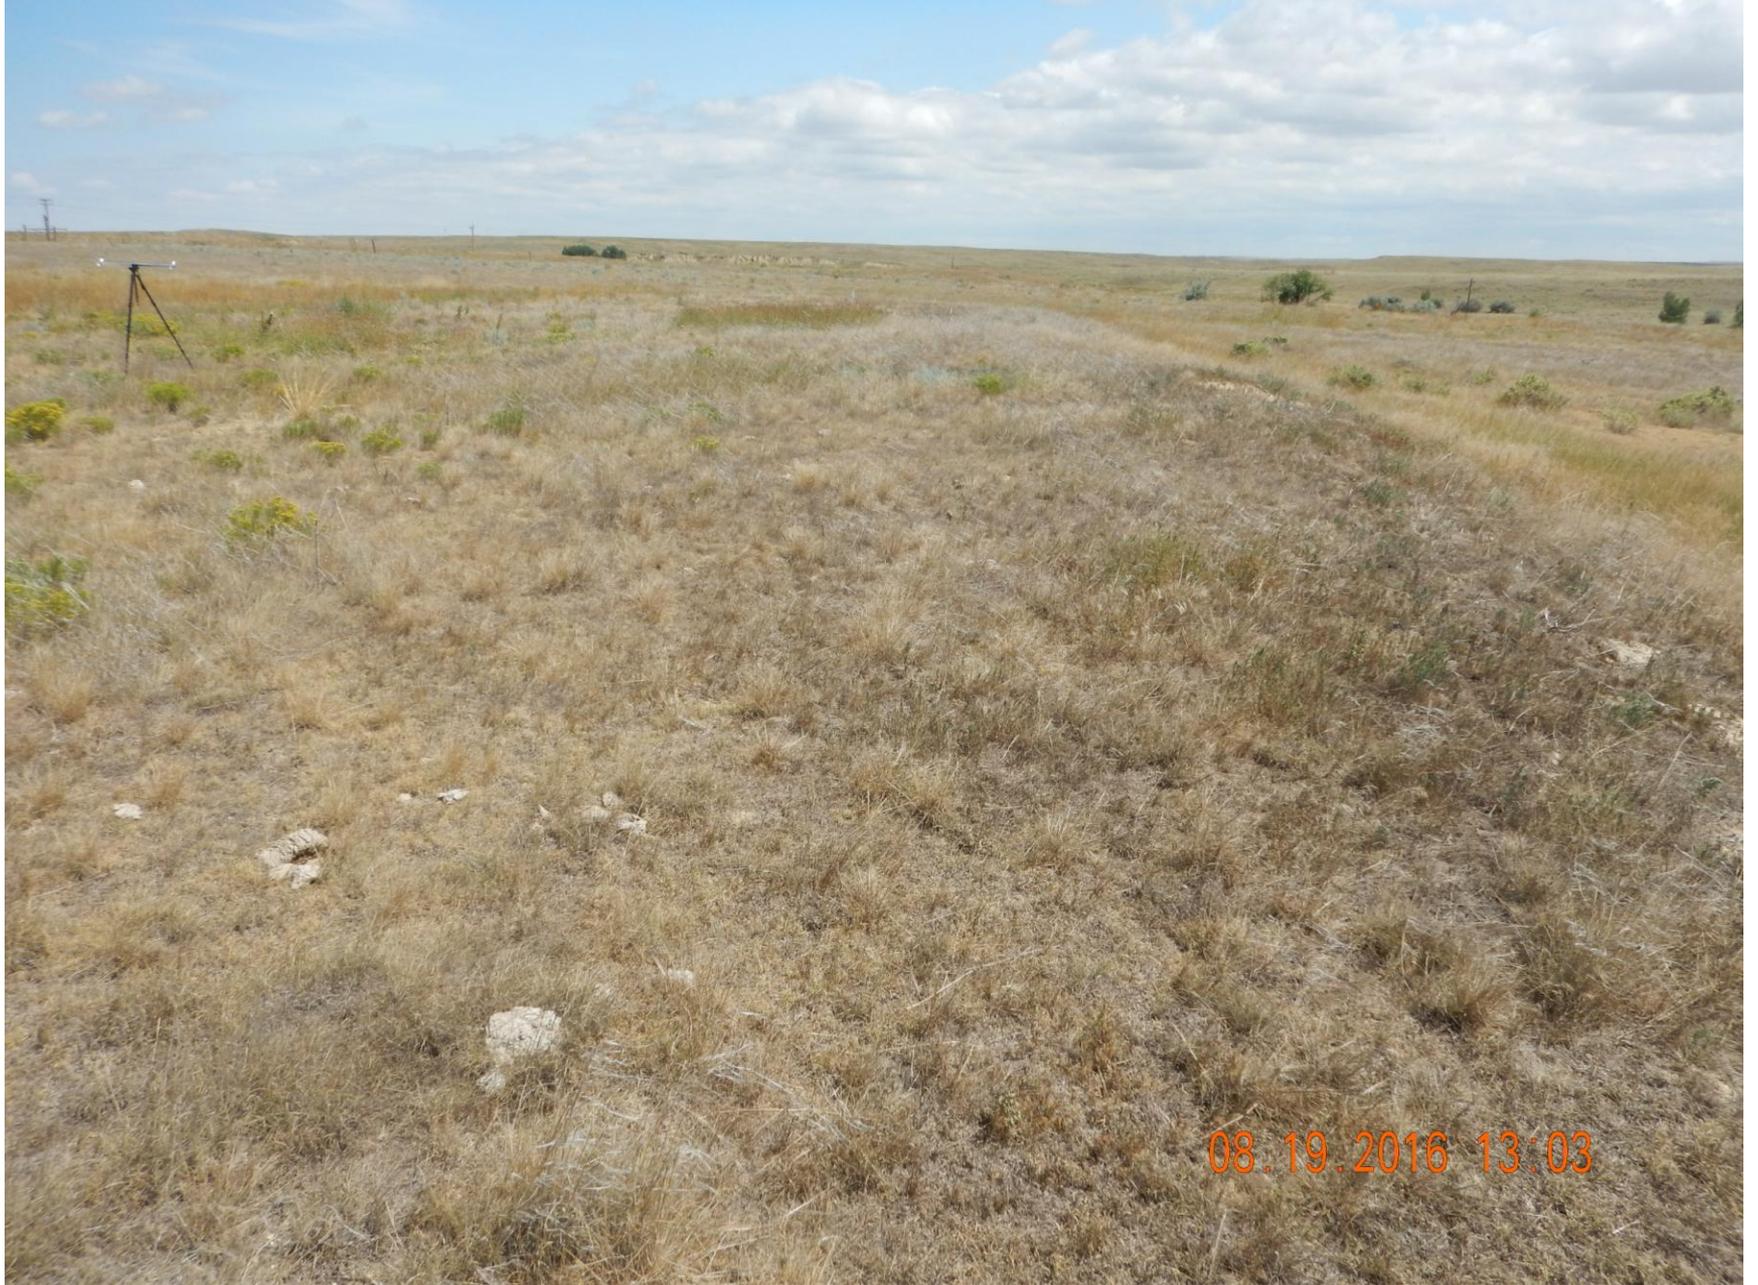
Figure 8: Photo taken from the southwest corner of the location, facing east. Photo shows vegetation over the reclamation area.

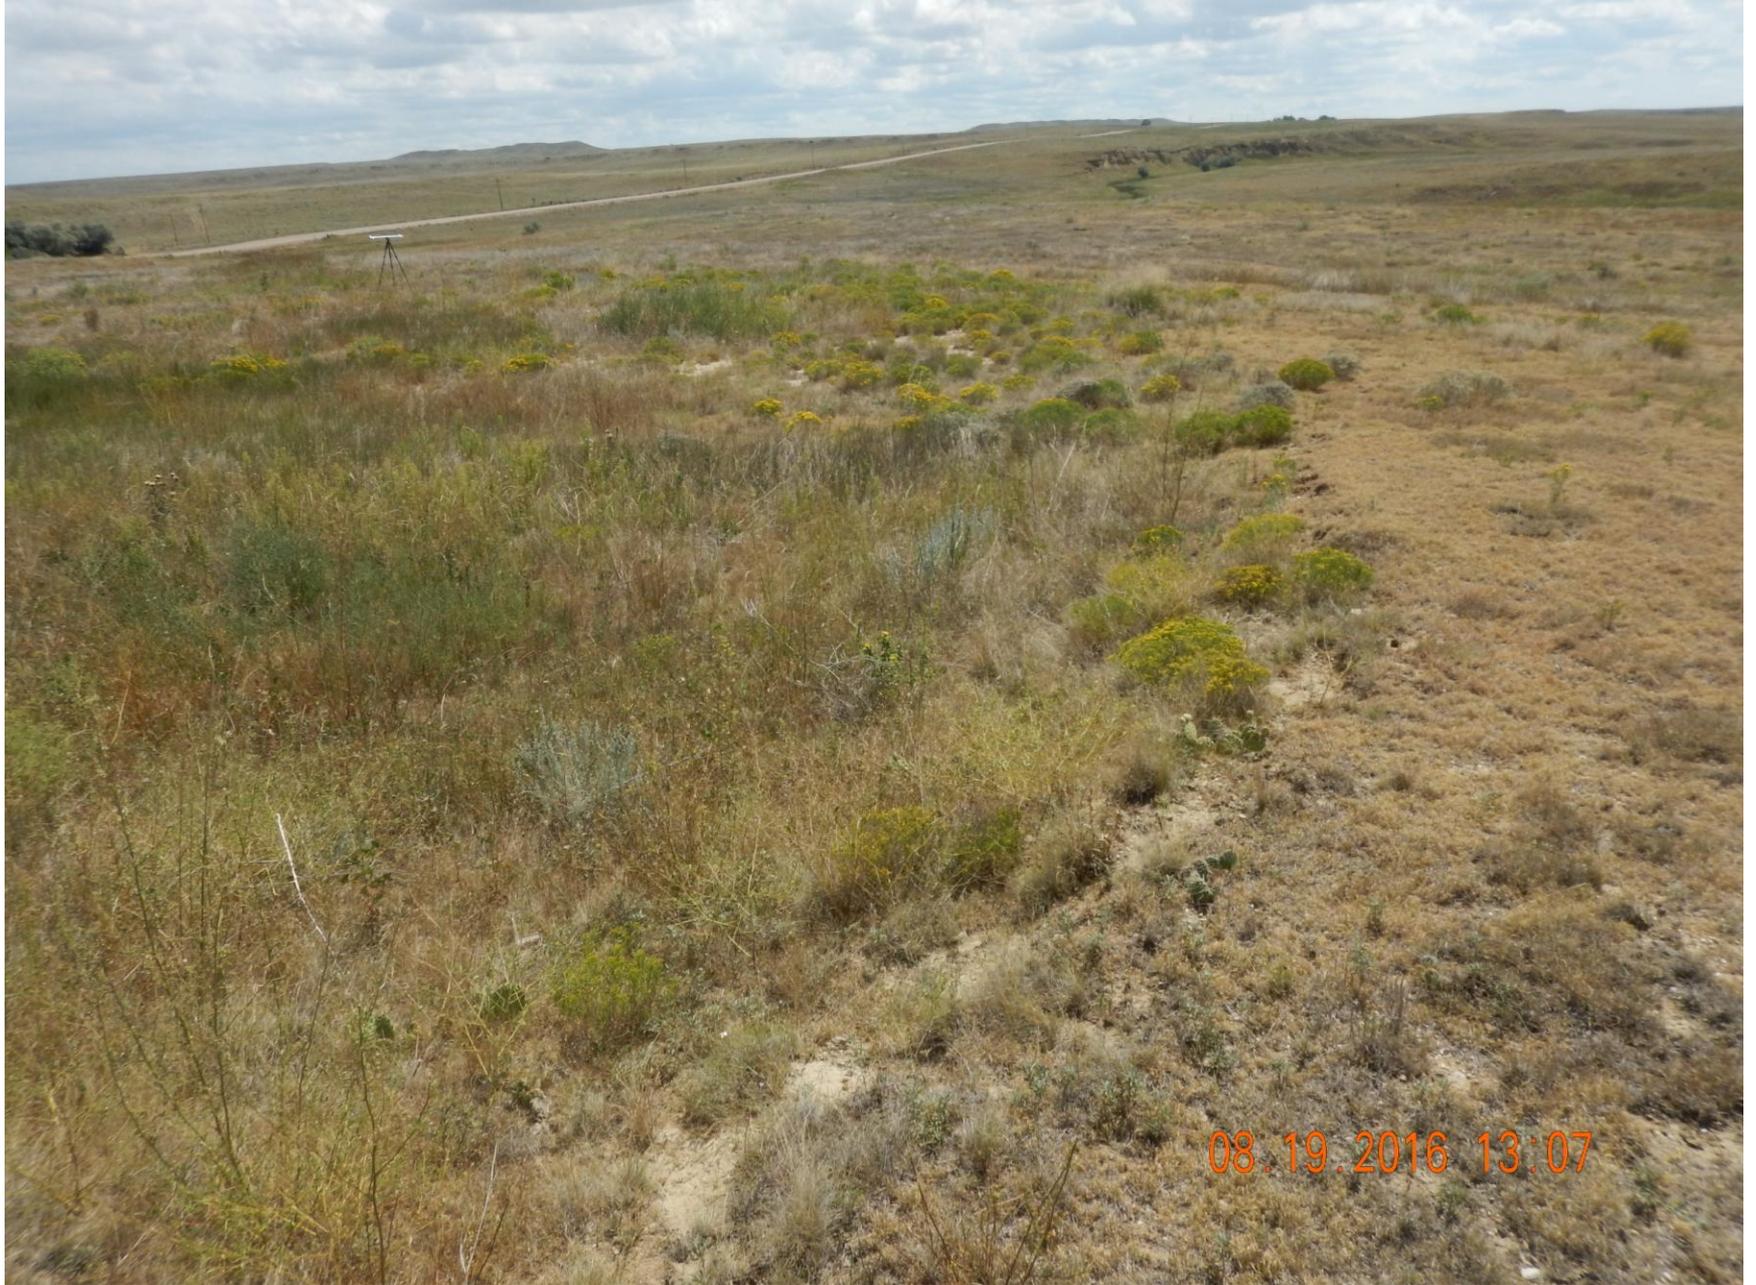
Figure 9: Photo taken from the northwest corner of the location, facing south. Photo shows vegetation over the reclamation area. Note areas of slope seeing erosion. Location has not been re-contoured.

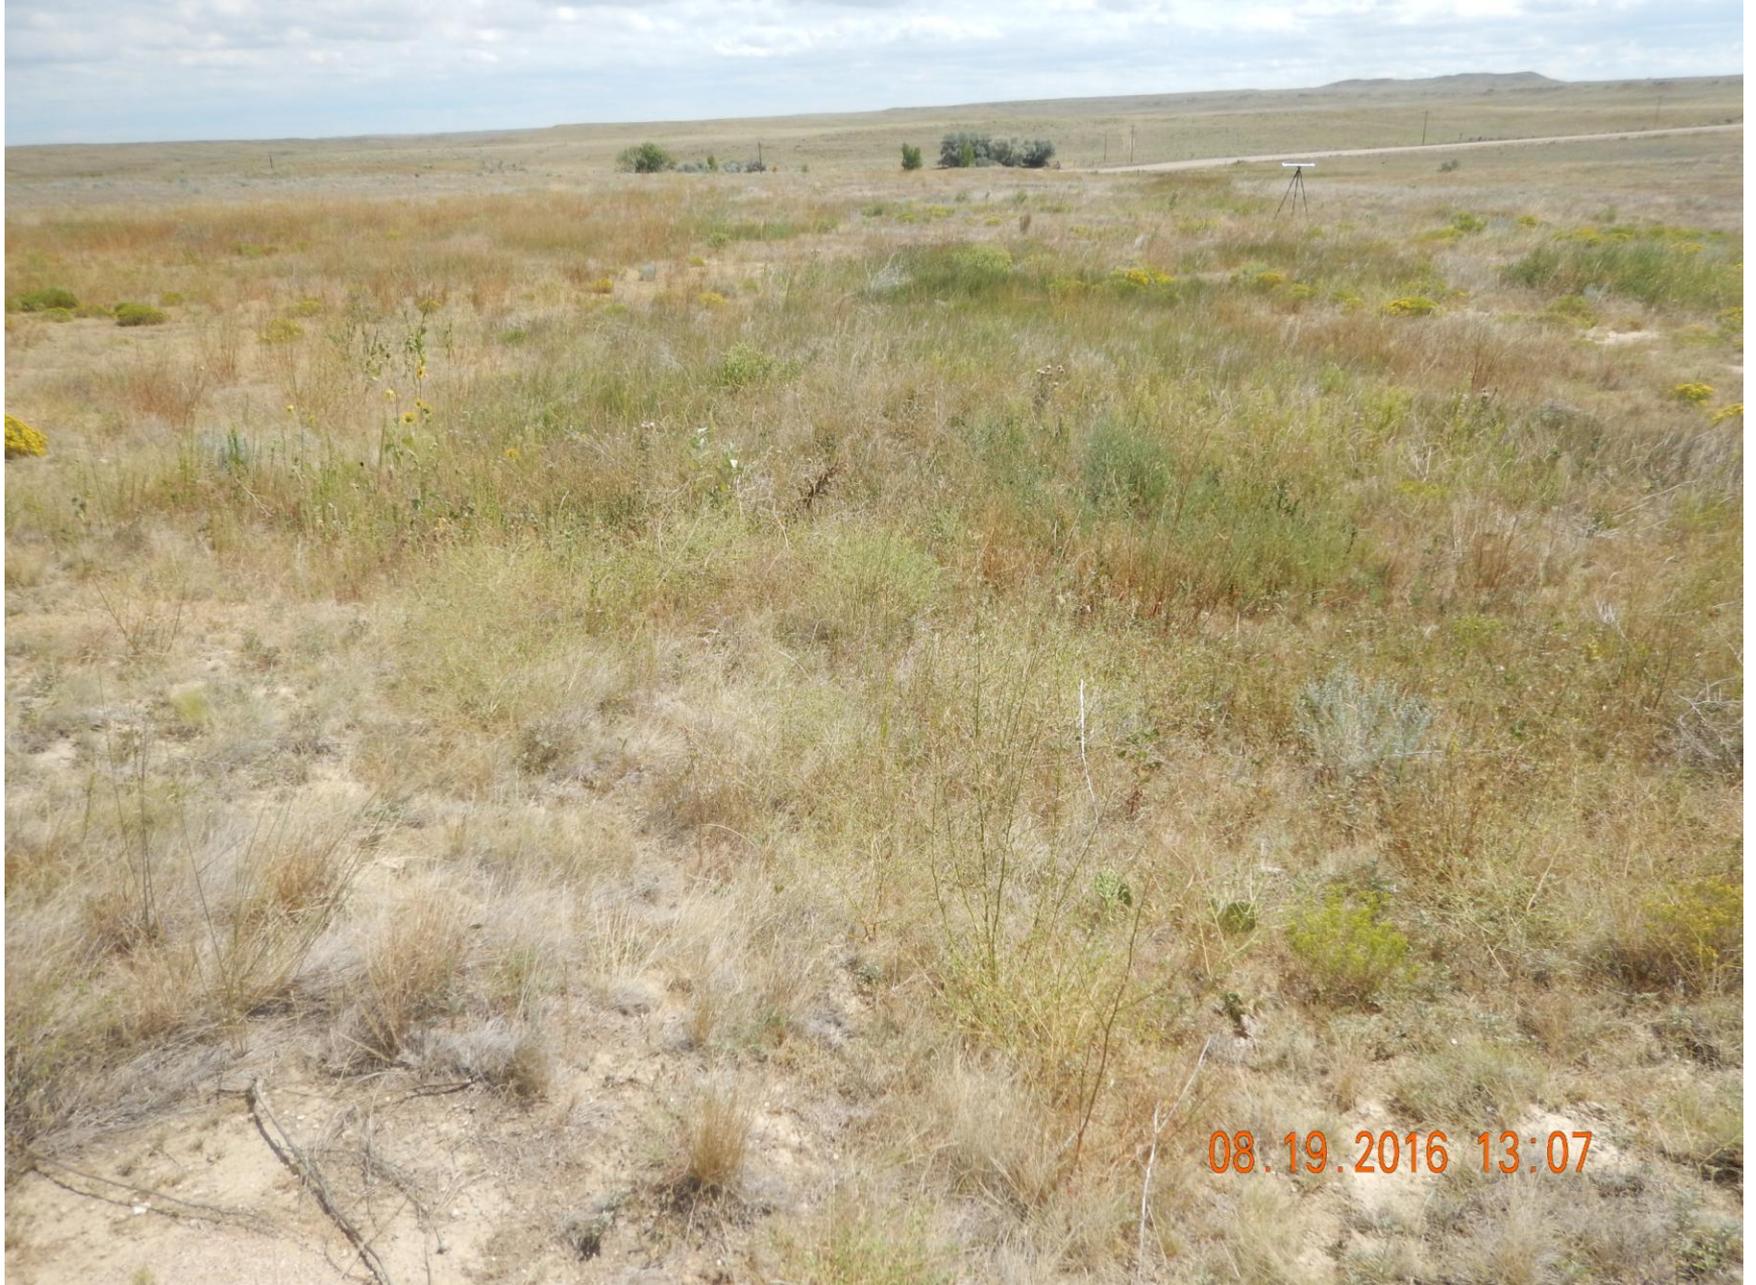
Figure 10: Photo taken from the northwest corner of the location, facing southeast. Photo shows vegetation over the reclamation area.
