Reclamation Inspection

08/19/2016

Operator: Walsh Production Inc

Location ID: 408424

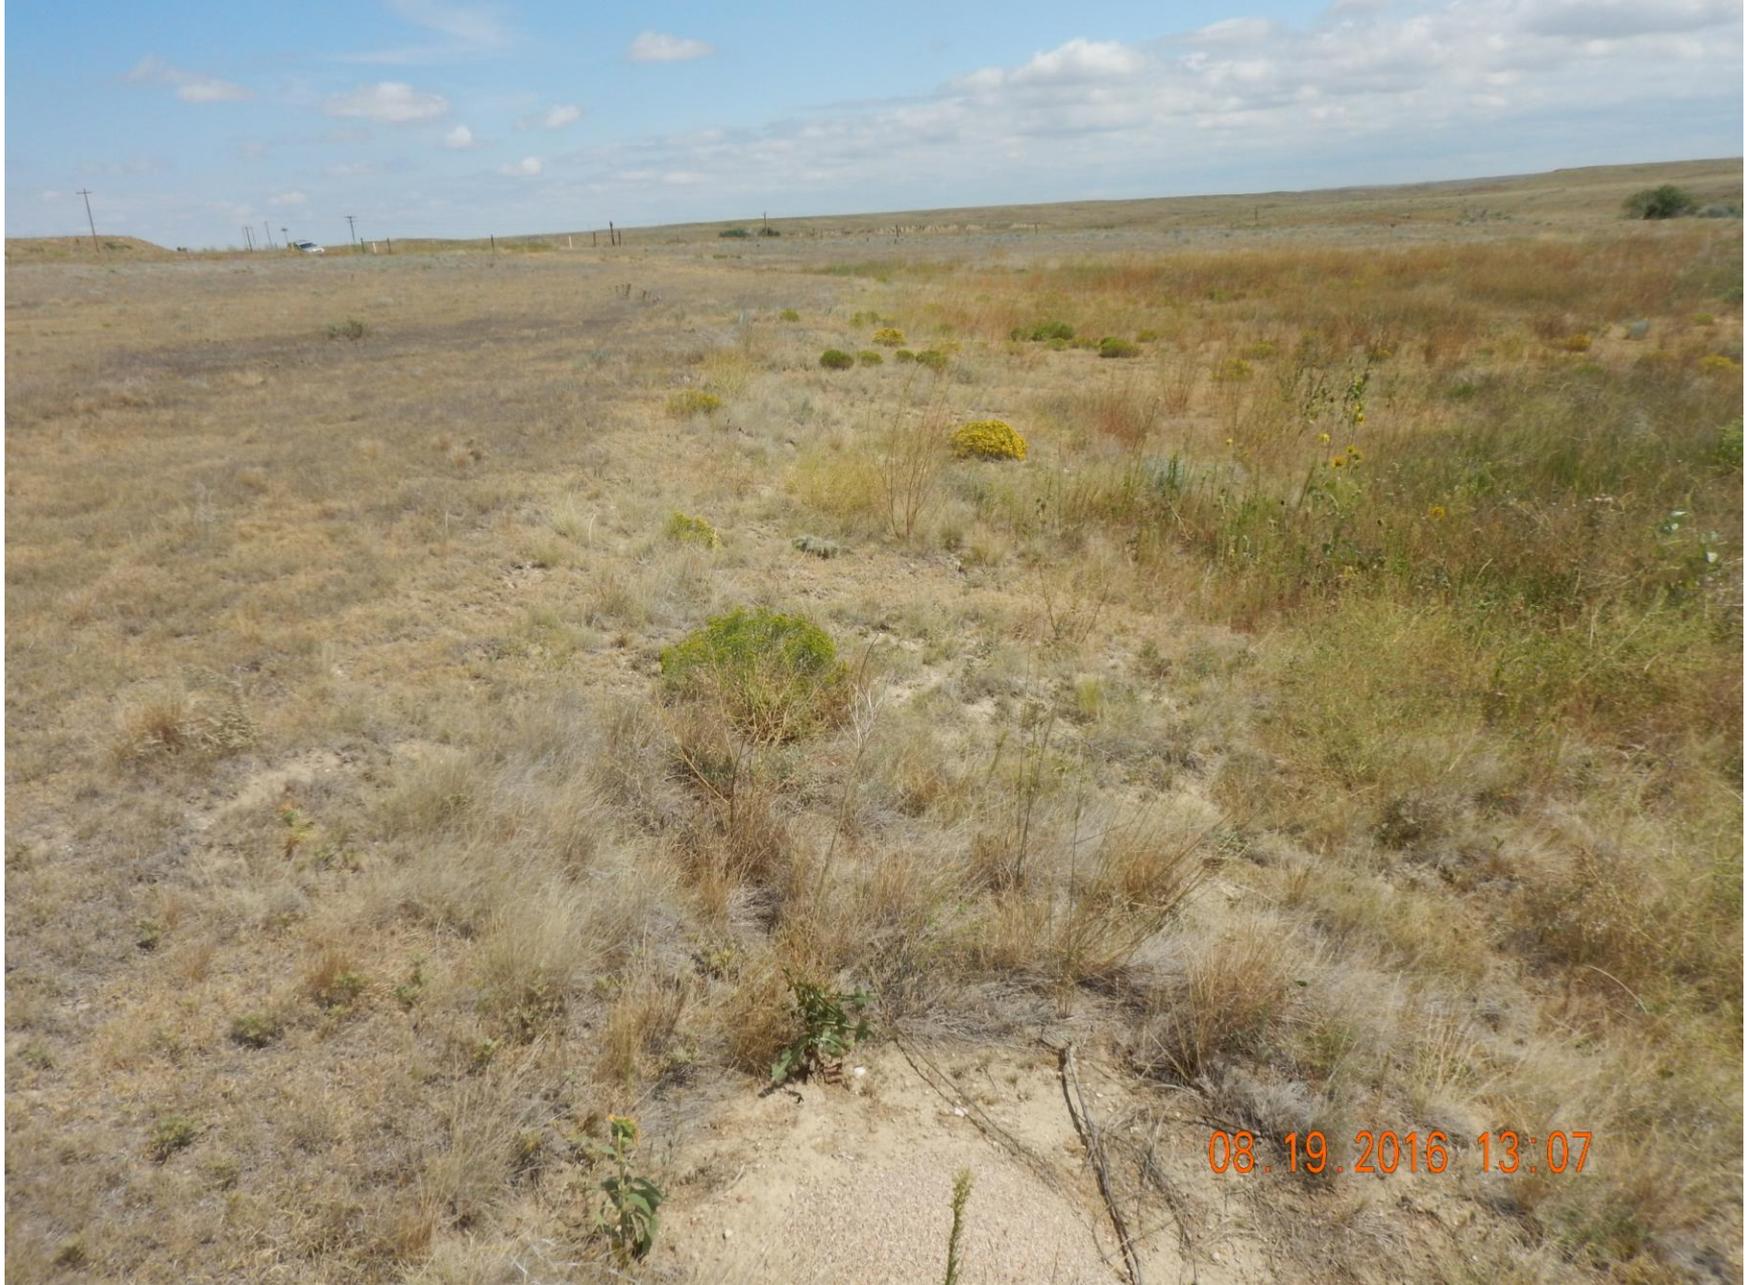
Figure 11: Photo taken from the northwest corner of the location, facing east. Photo shows vegetation over the reclamation area.

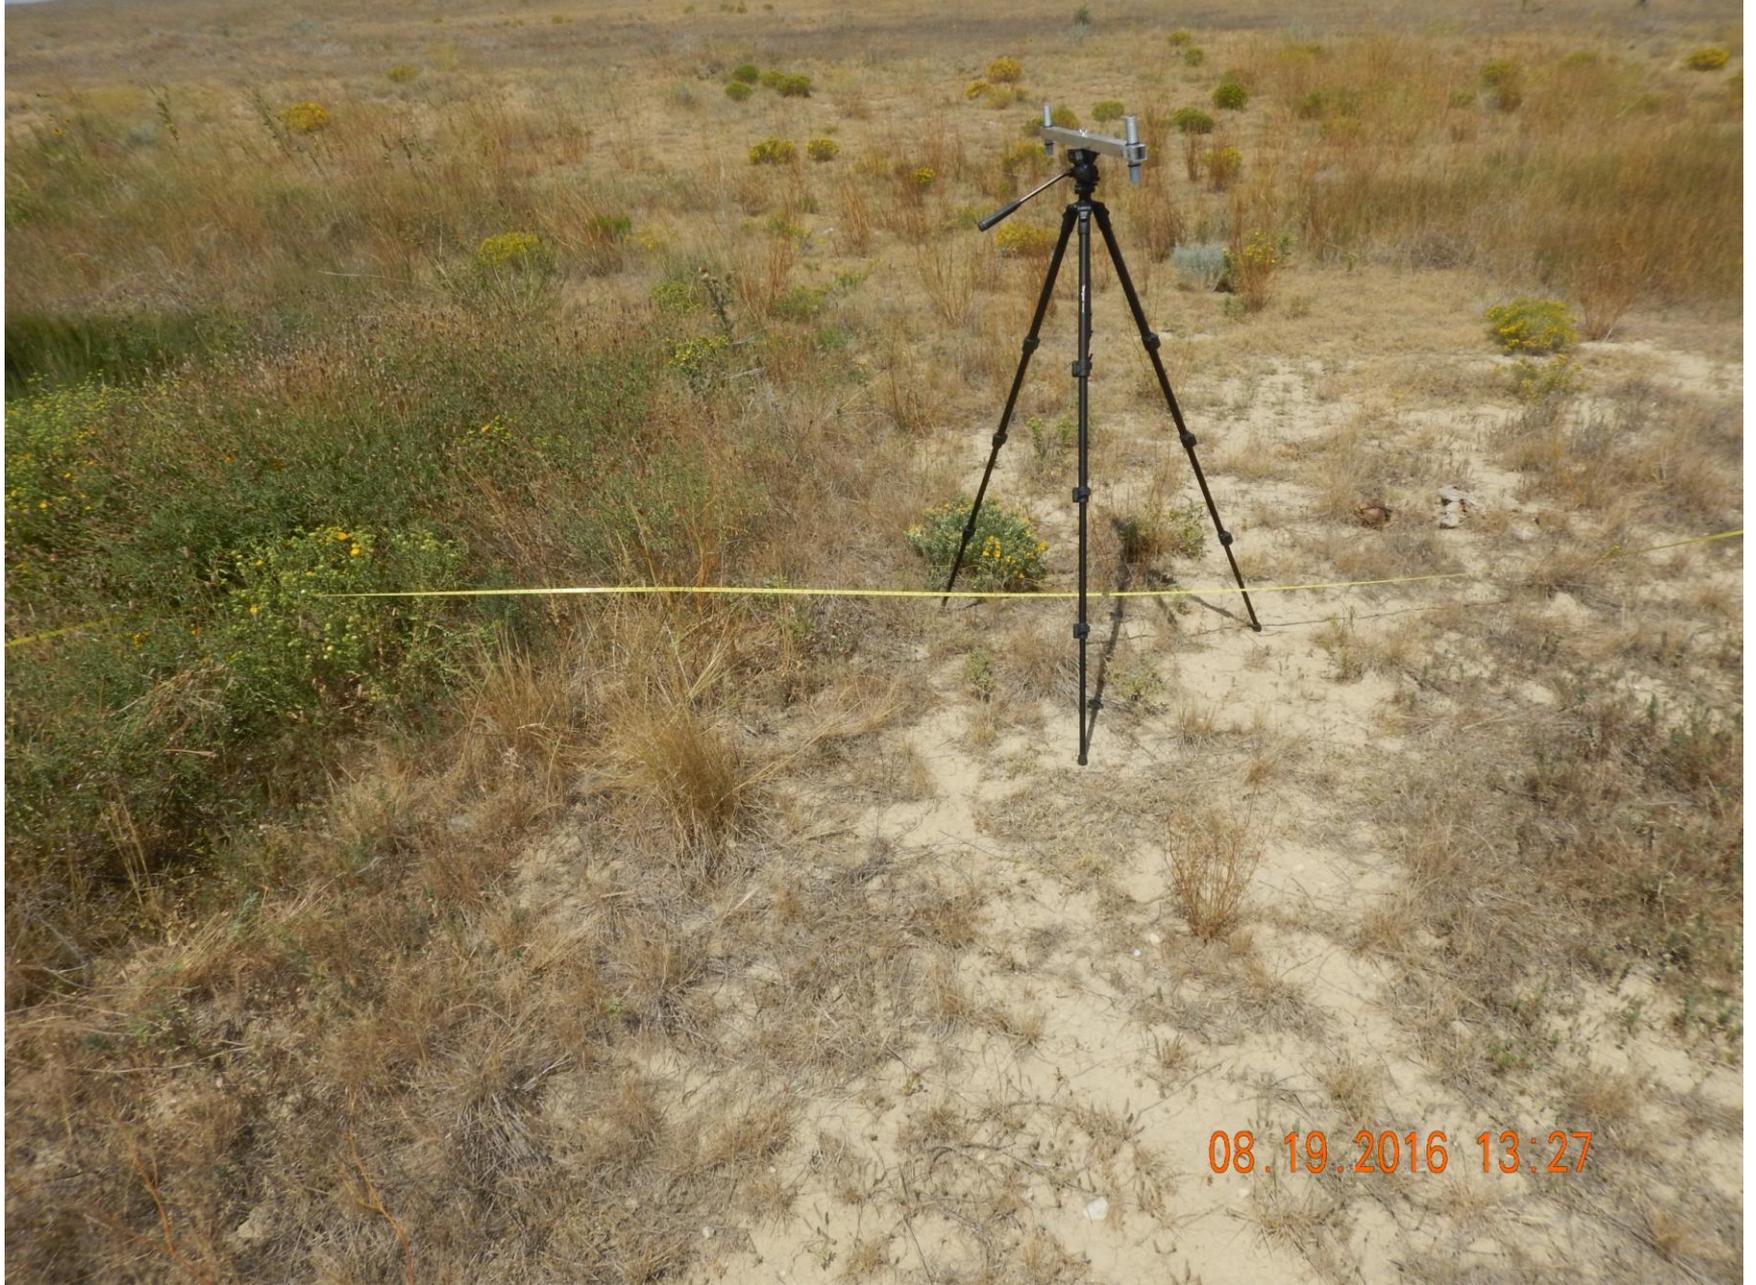
Figure 13: Photo of the 50th point for the disturbance transect, facing north. Photo shows vegetation over the reclamation area.

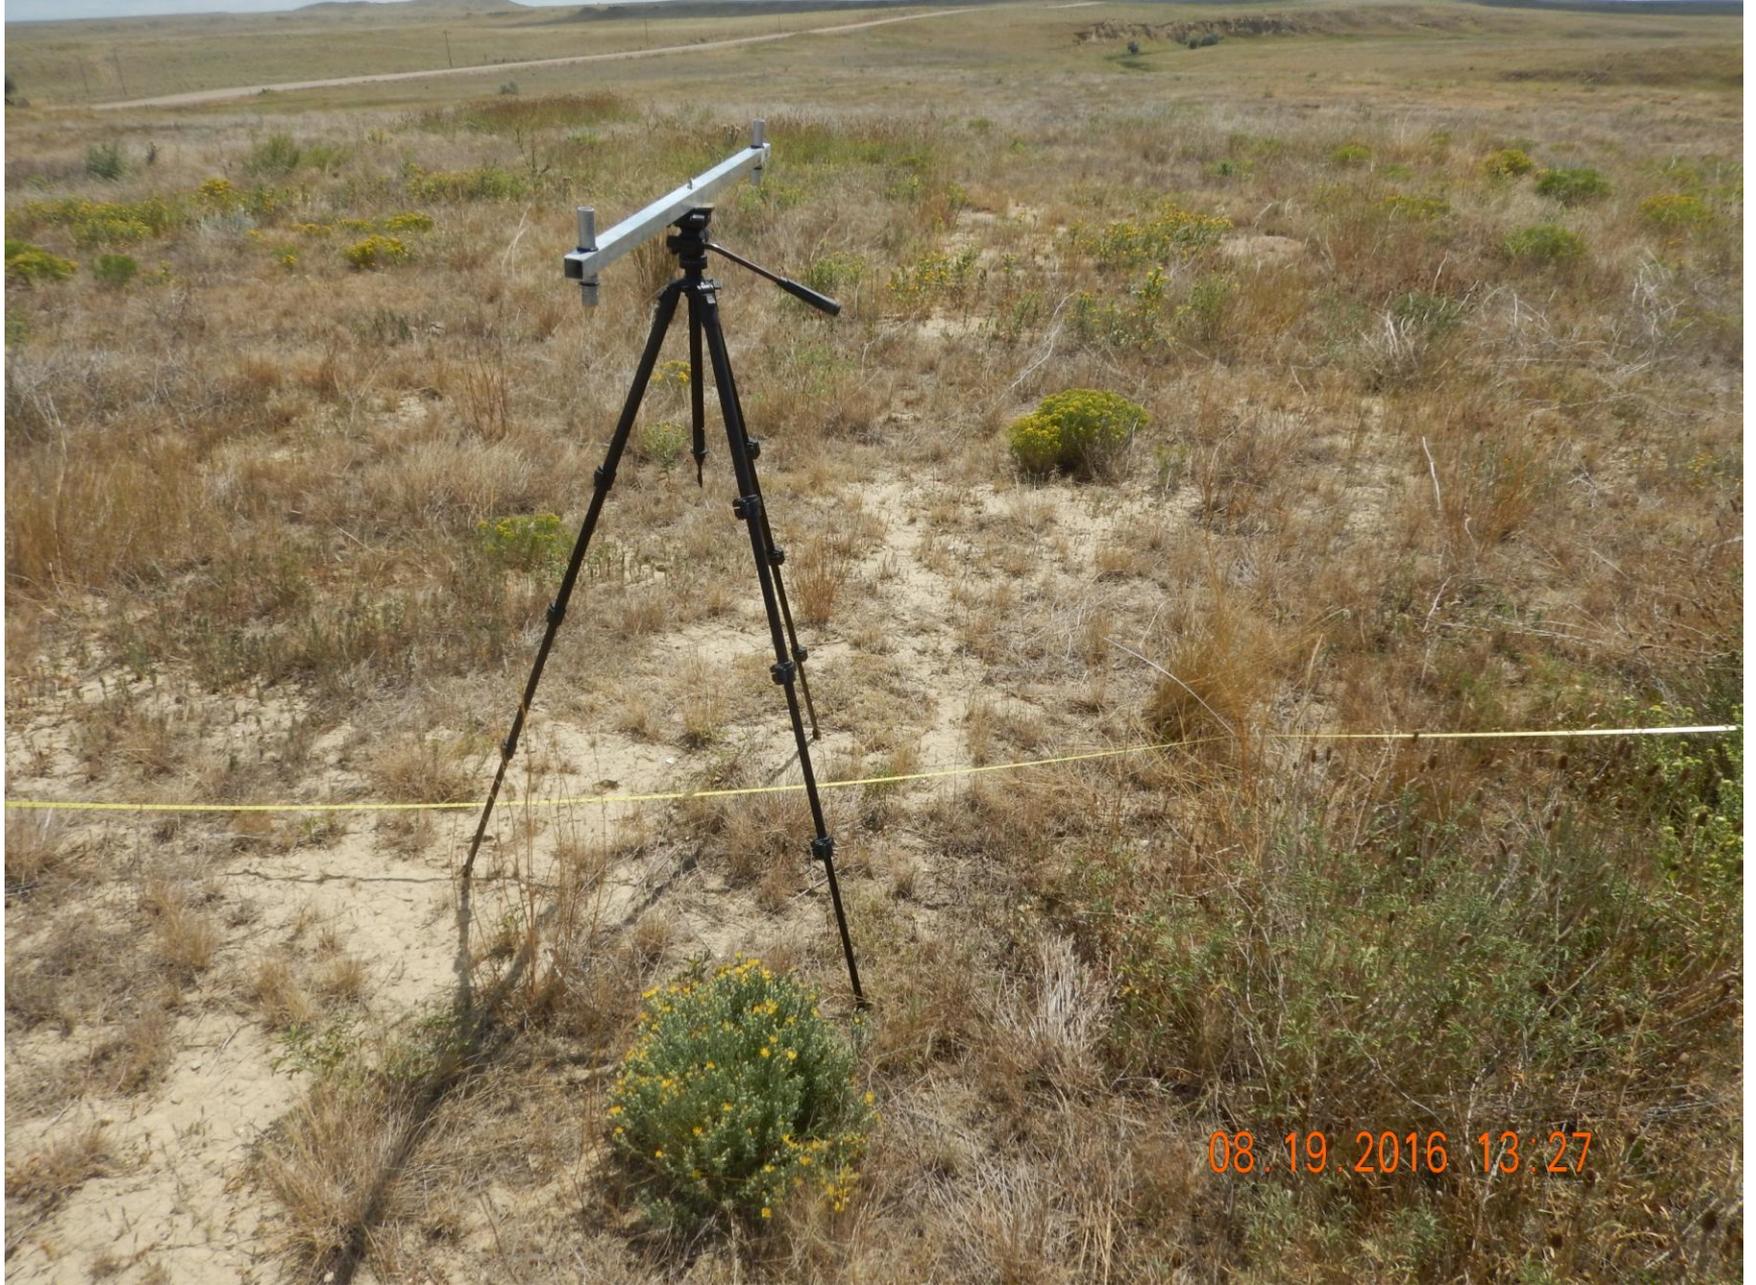
Figure 14: Photo of the 50th point for the disturbance transect, facing south. Photo shows vegetation over the reclamation area.

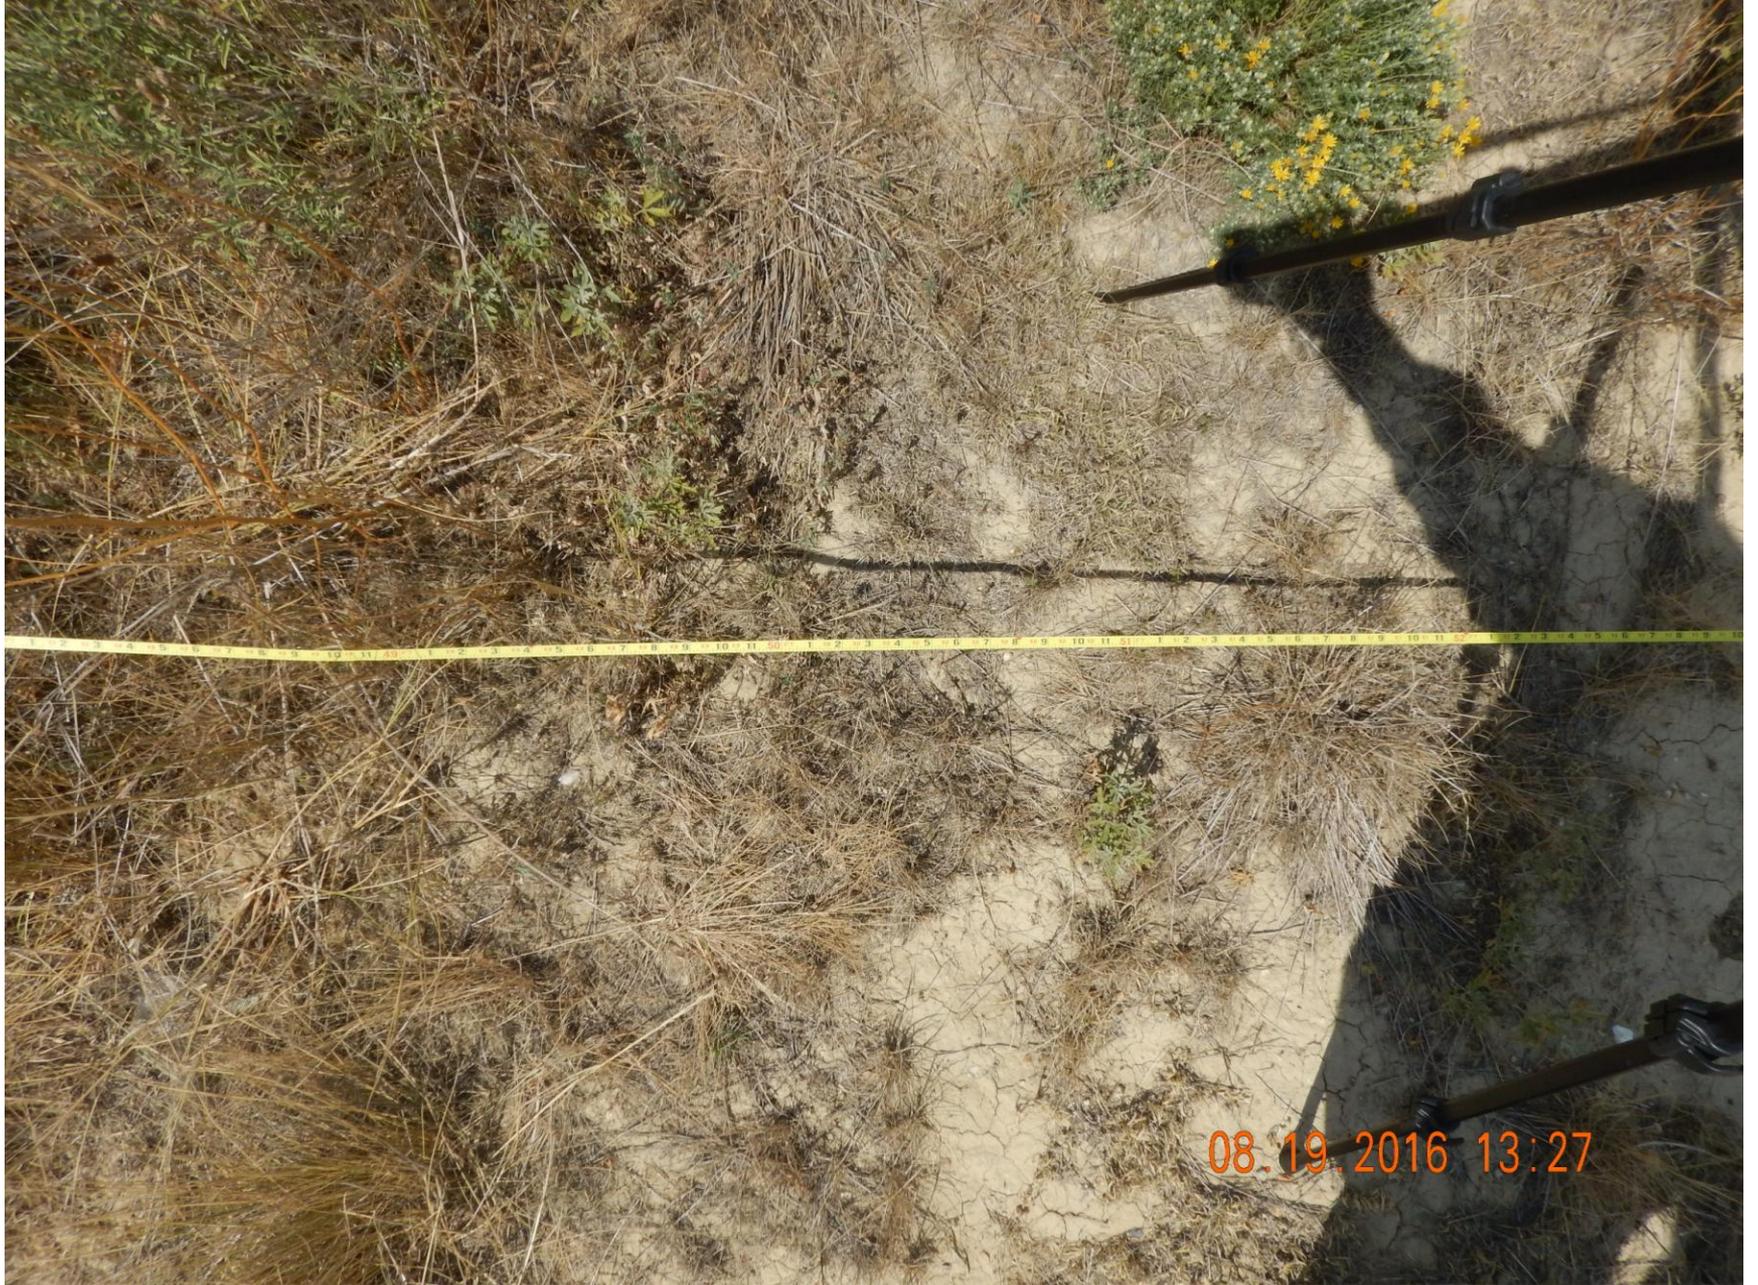
Figure 15: Photo of the 50th point of the disturbance transect. Photo shows vegetation on the reclamation area.

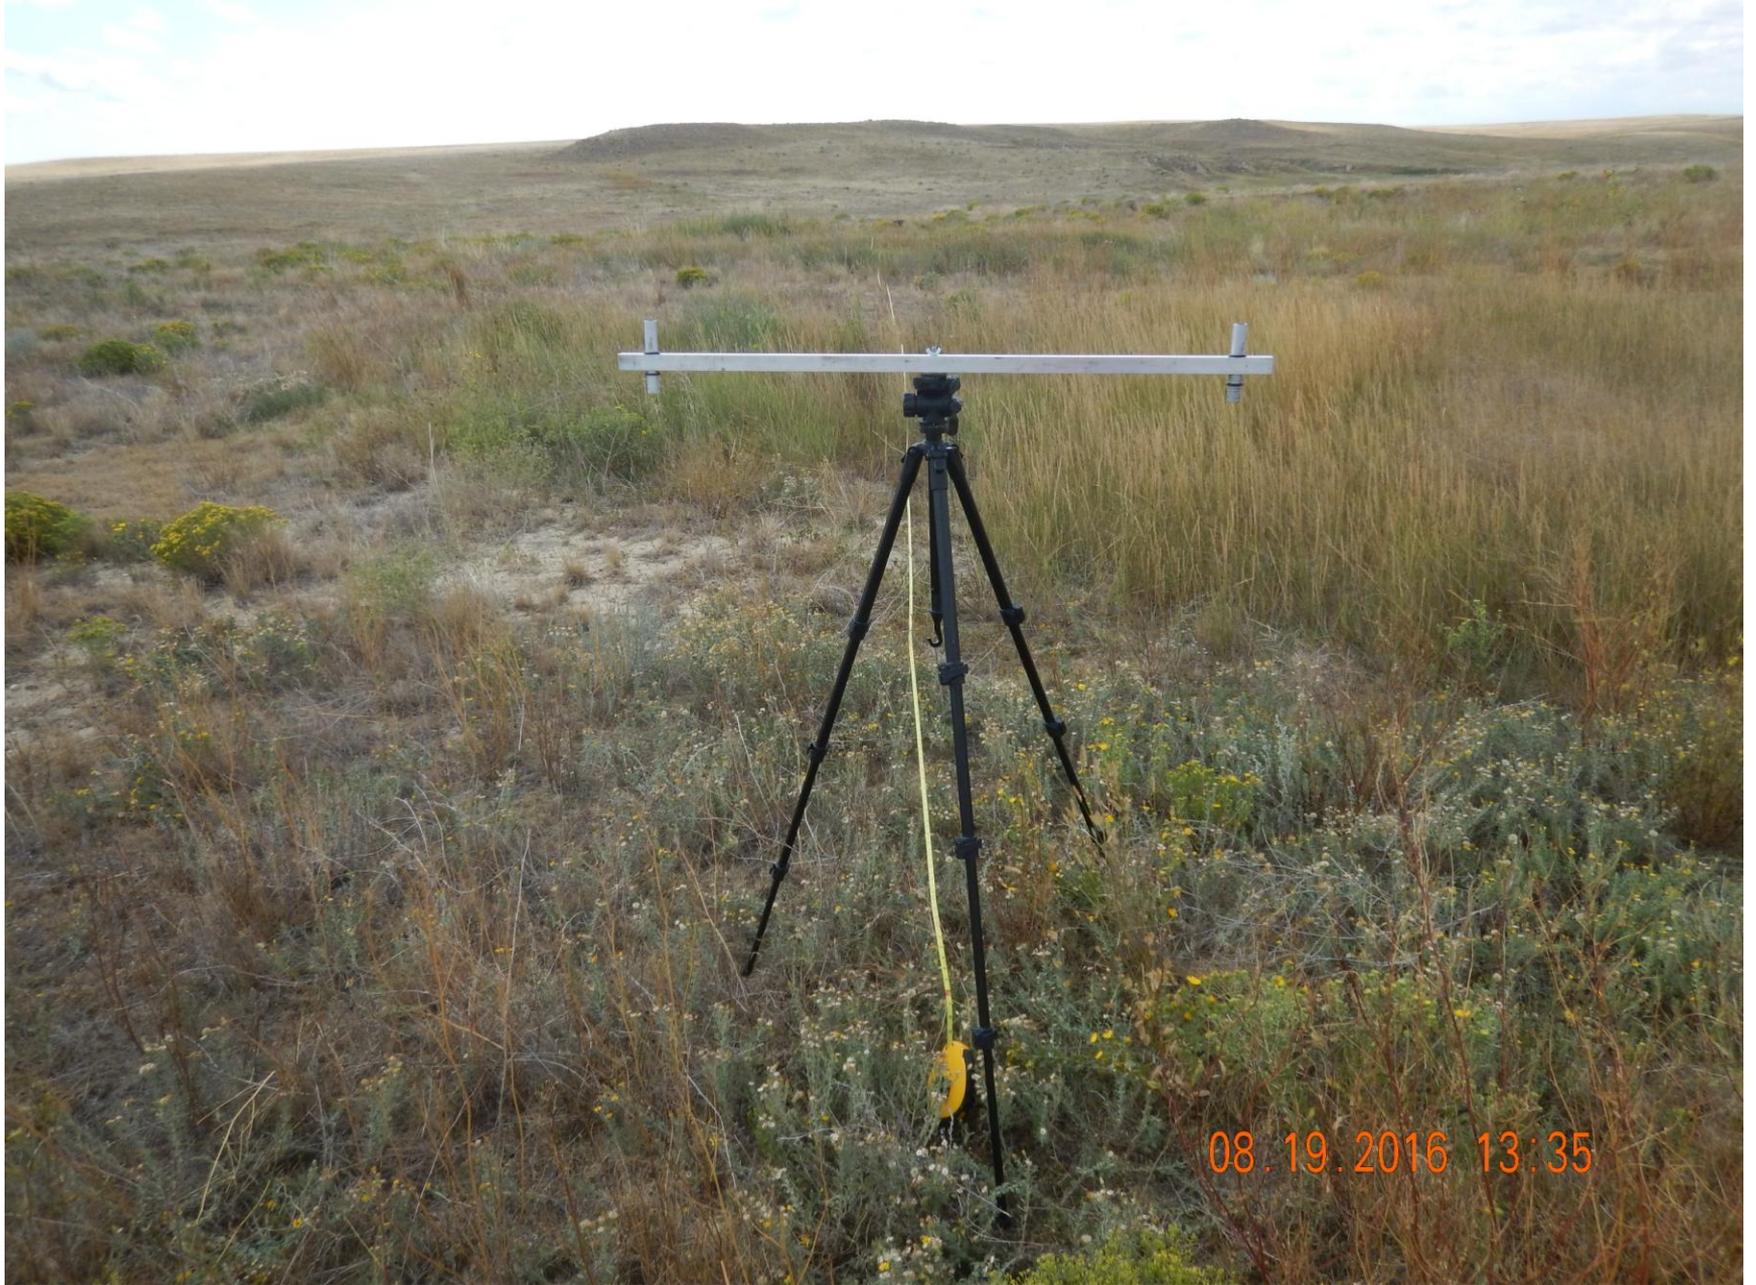
Figure 16: Photo of the end point for the disturbance transect on location, facing west. Photo shows vegetation over the reclamation area.

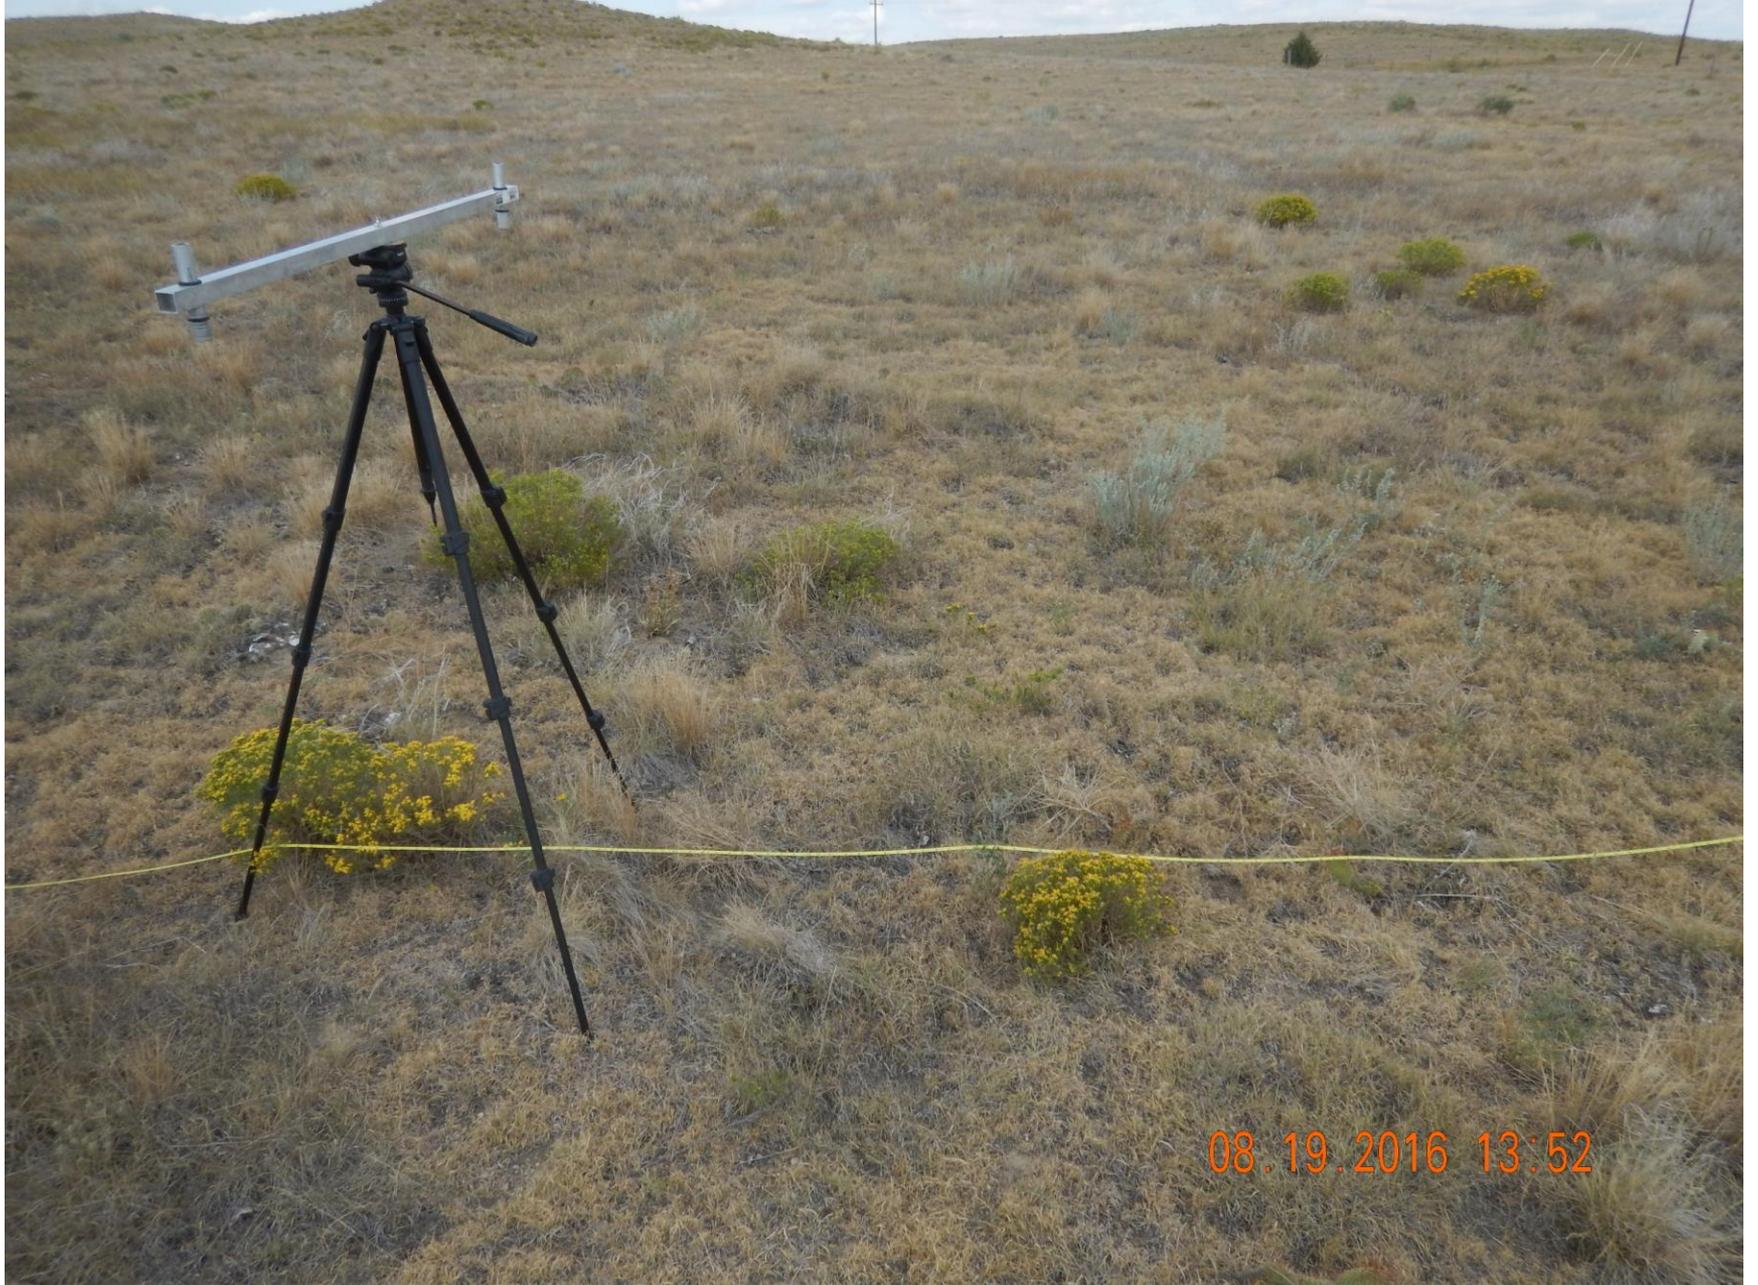
Figure 18: Photo of the 50th point for the reference transect, facing north. Photo shows vegetation over the reference area.

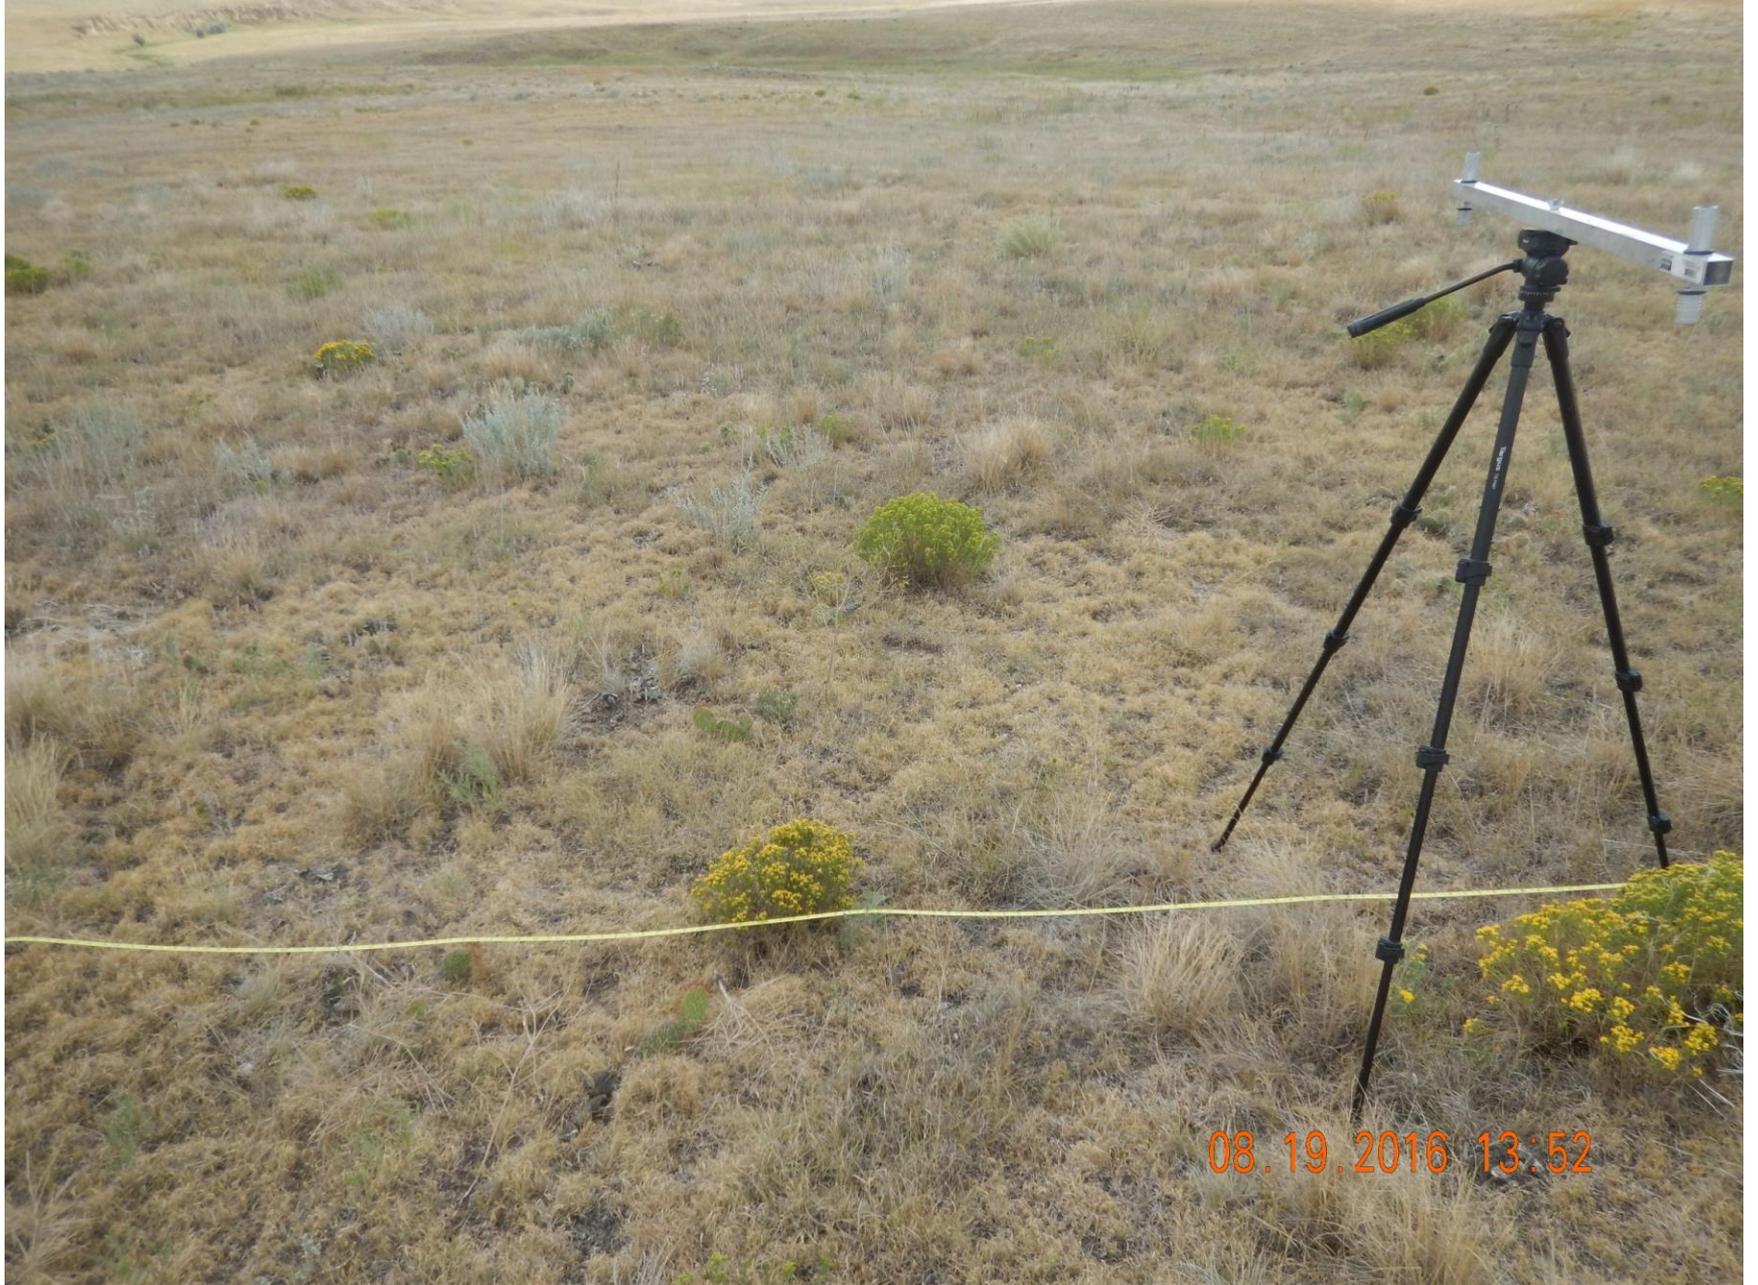
Figure 19: Photo of the 50th point for the reference transect, facing south. Photo shows vegetation over the reference area.

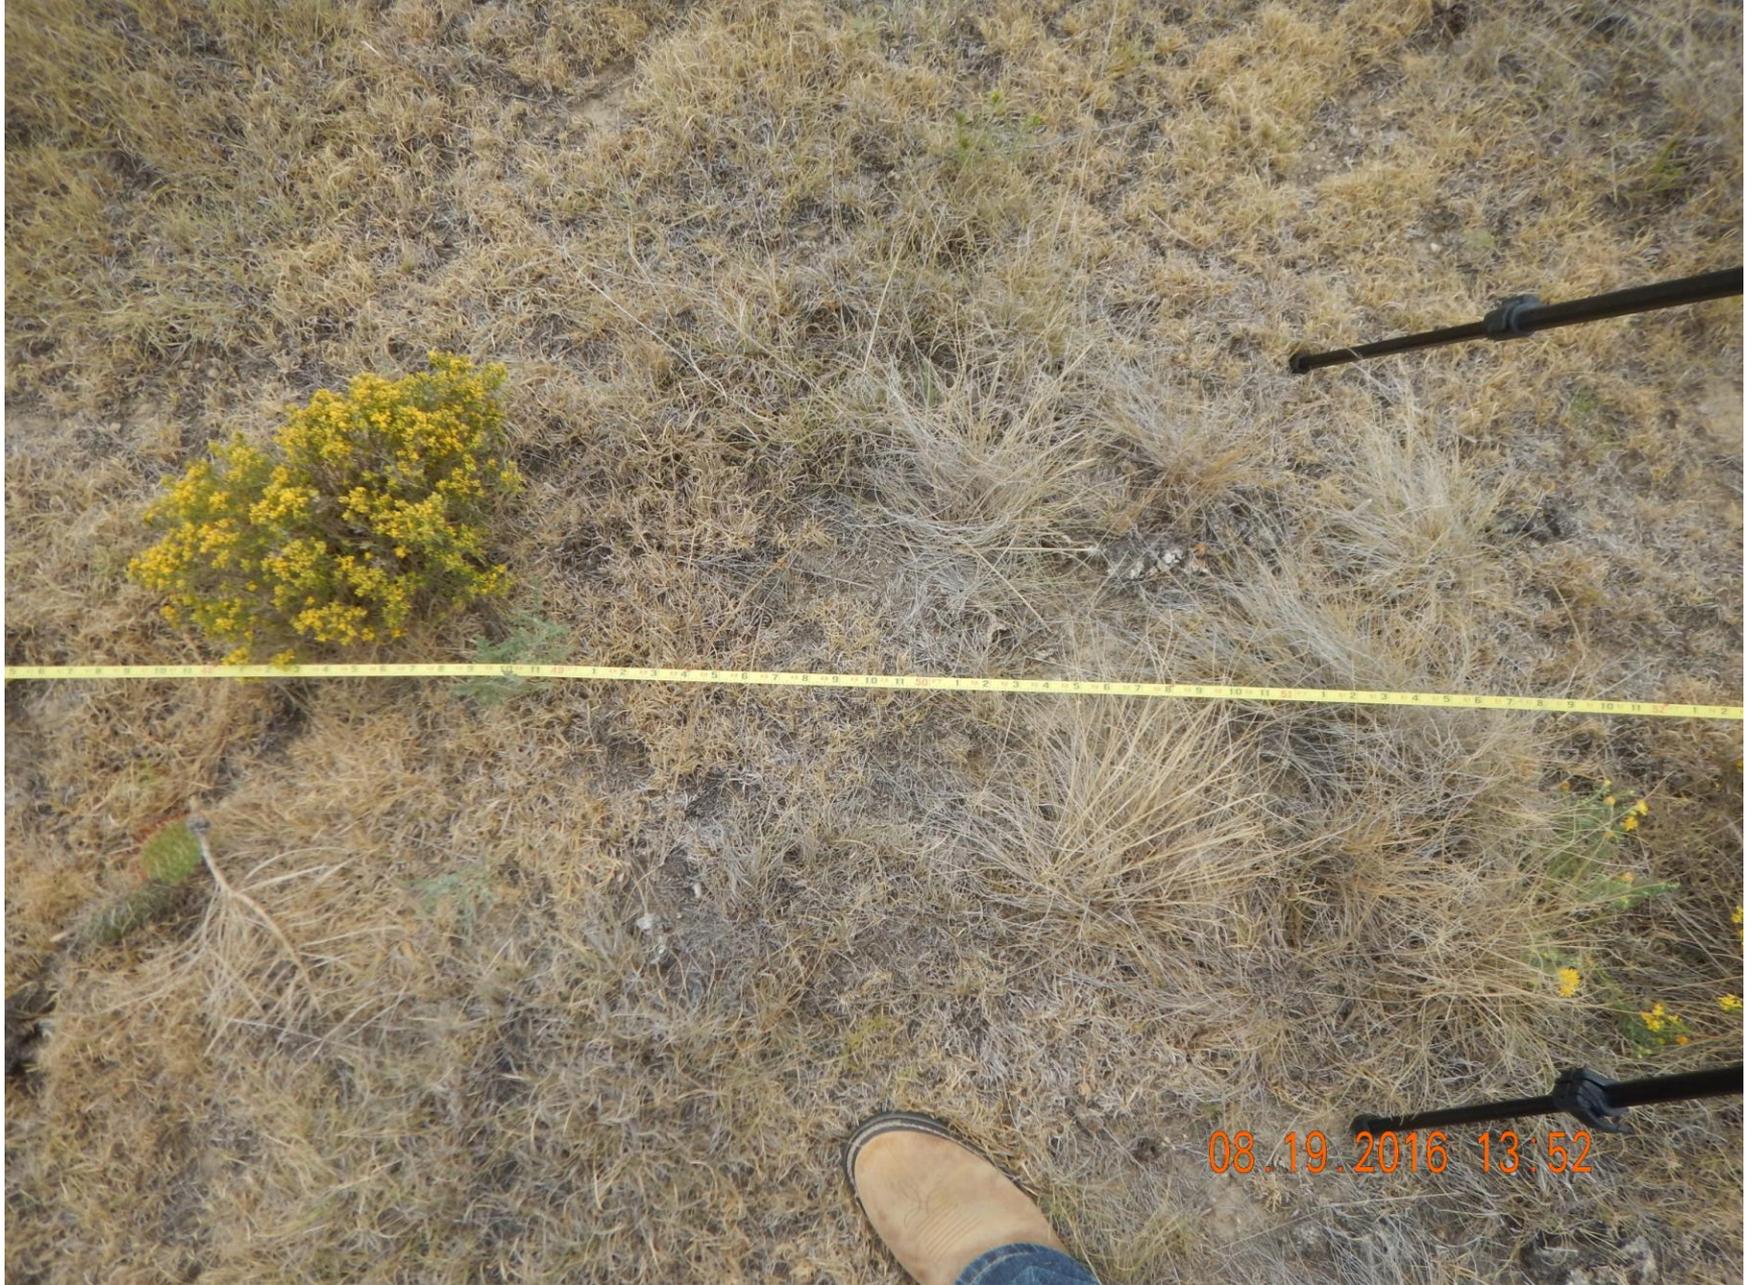
Figure 20: Photo of the 50th point for the reference transect. Photo shows vegetation over the reference area.

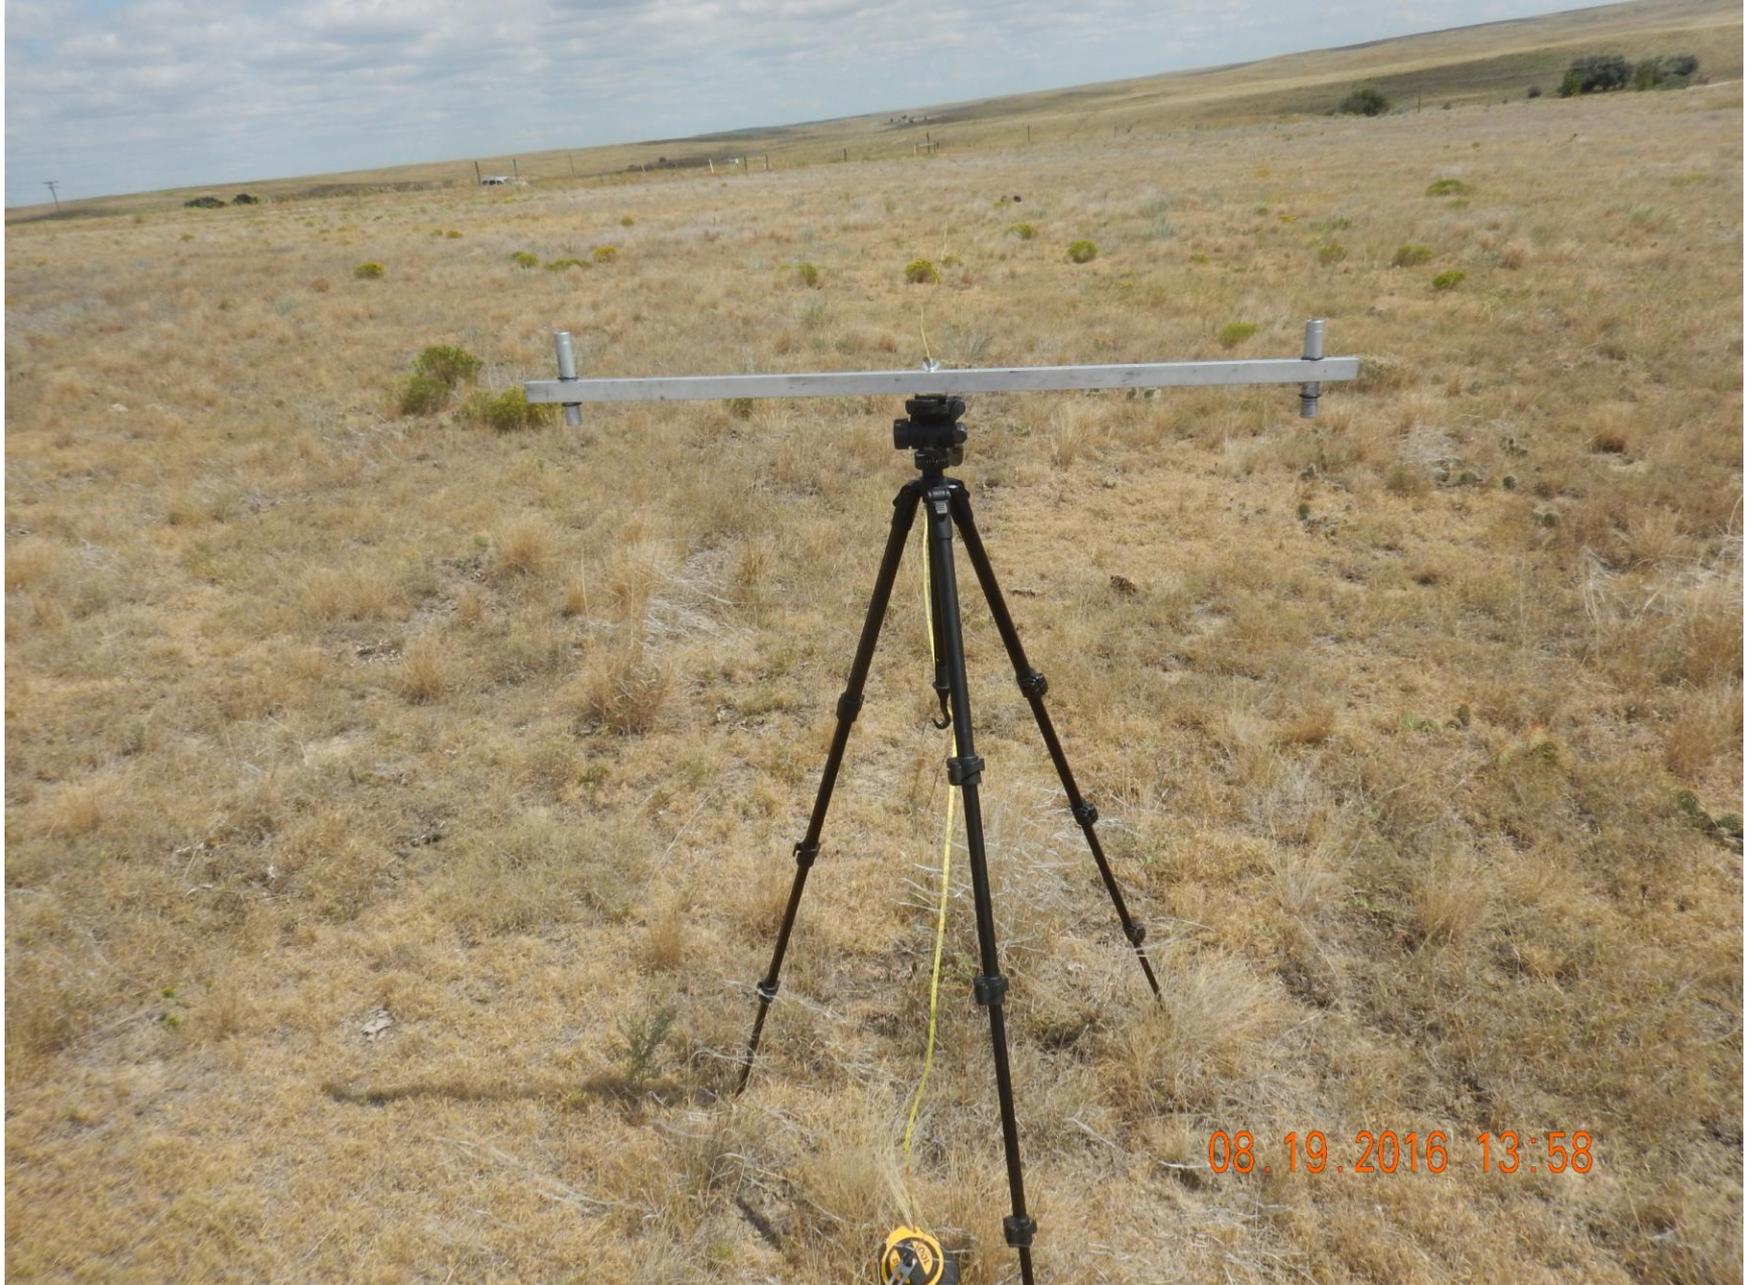
Figure 21: Photo of the end point for the reference transect on location, facing east. Photo shows vegetation over the reference area.
