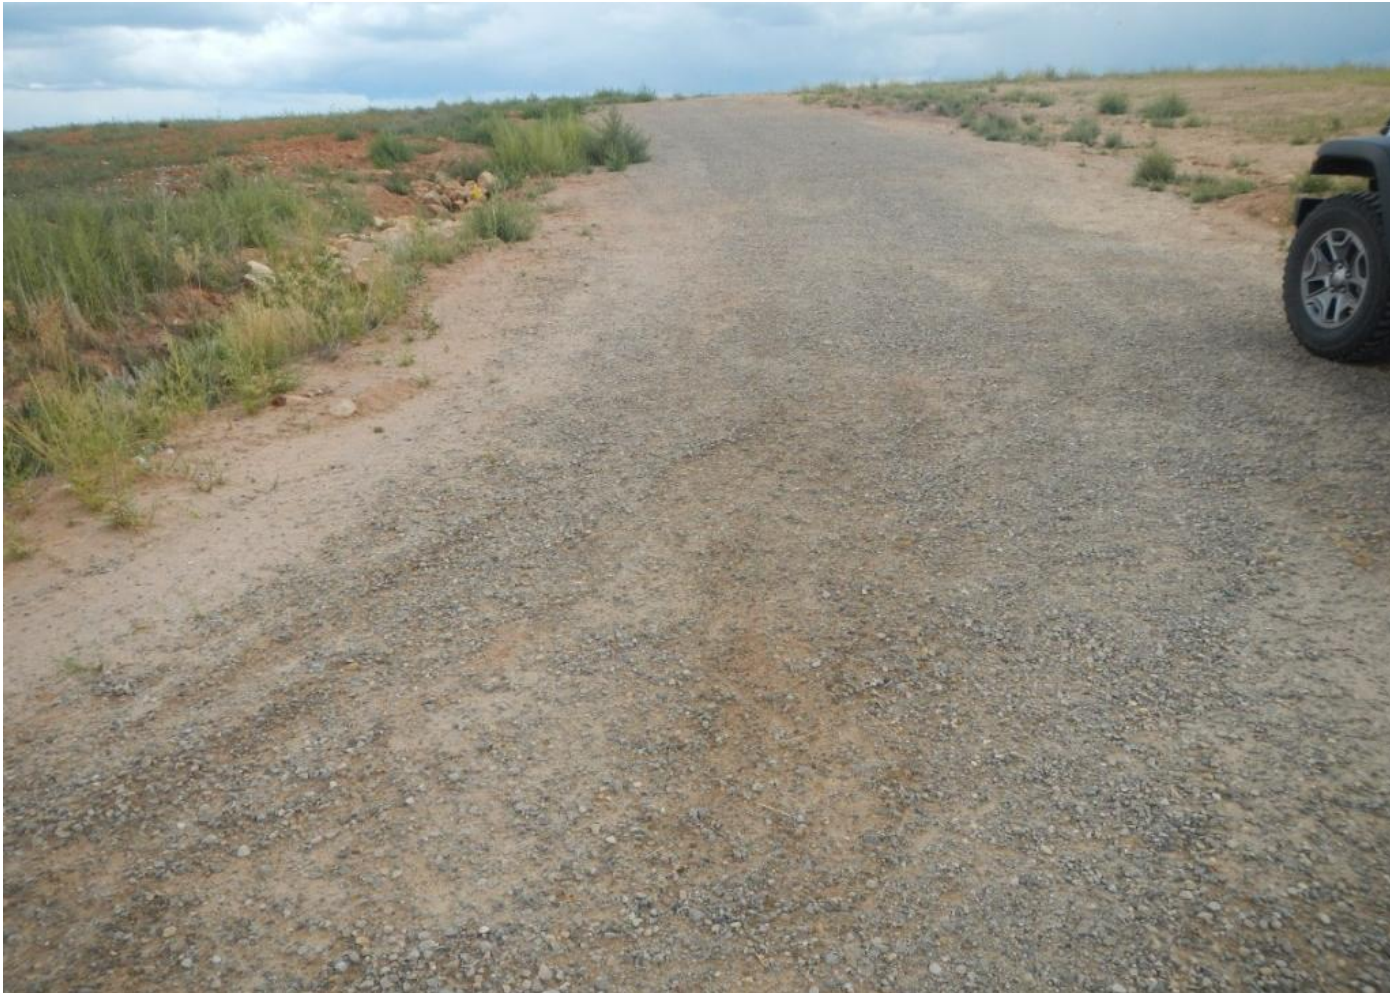
Photo 1. View at the entrance to the access road facing eastward. Access road has not been reclaimed.

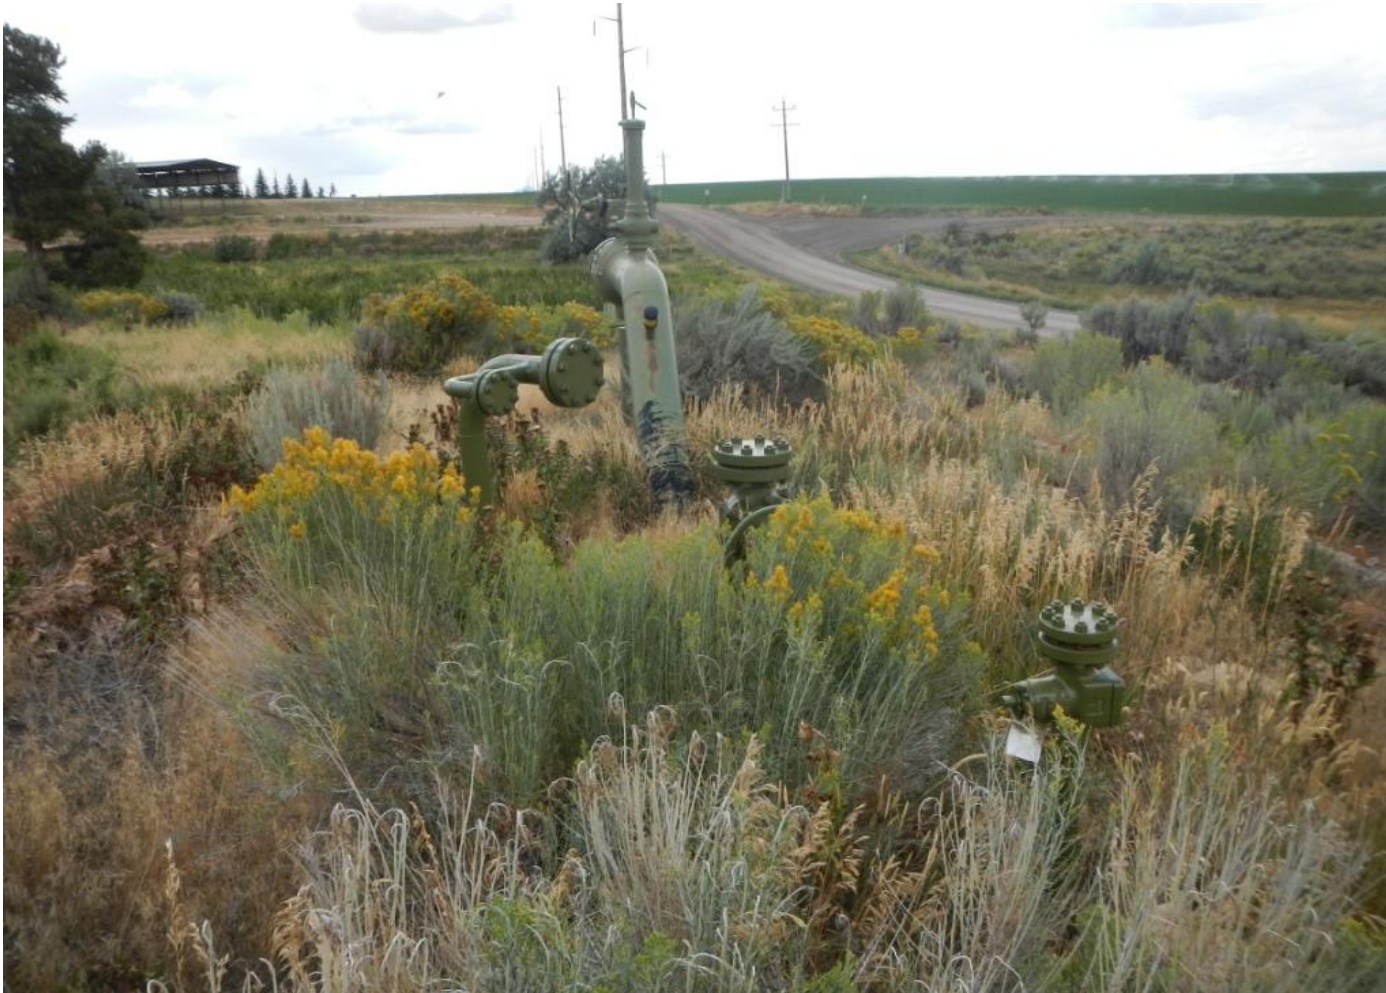
Photo 2. View of pipeline riser south of the access road that needs to be removed or documentation provided showing that it is in use.

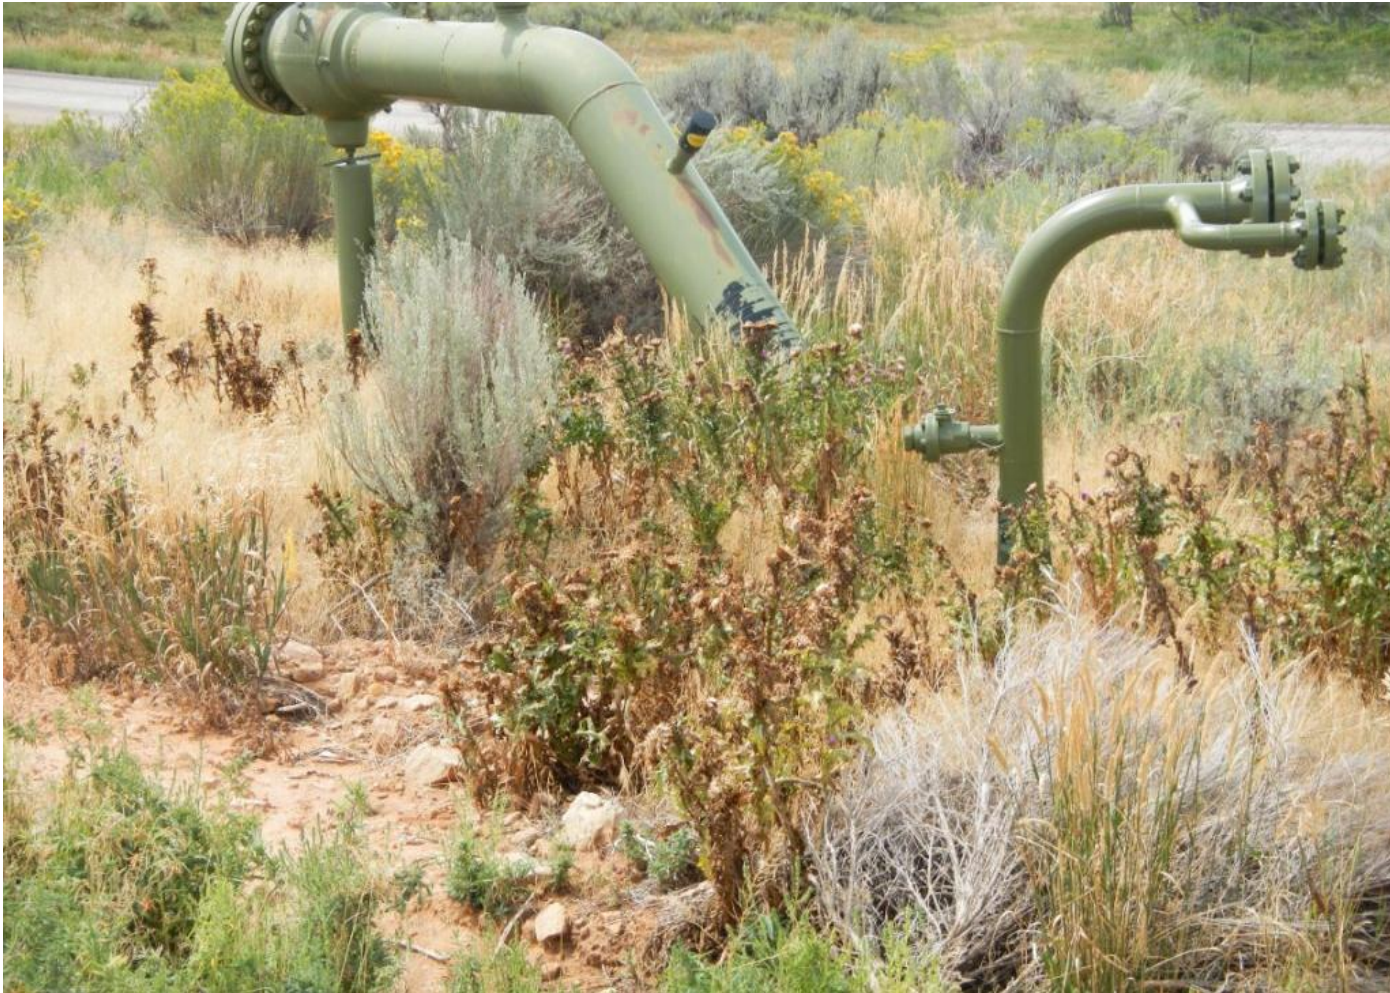
Photo 3. View of musk thistles (*Carduus nutans*) growing around the pipeline riser.

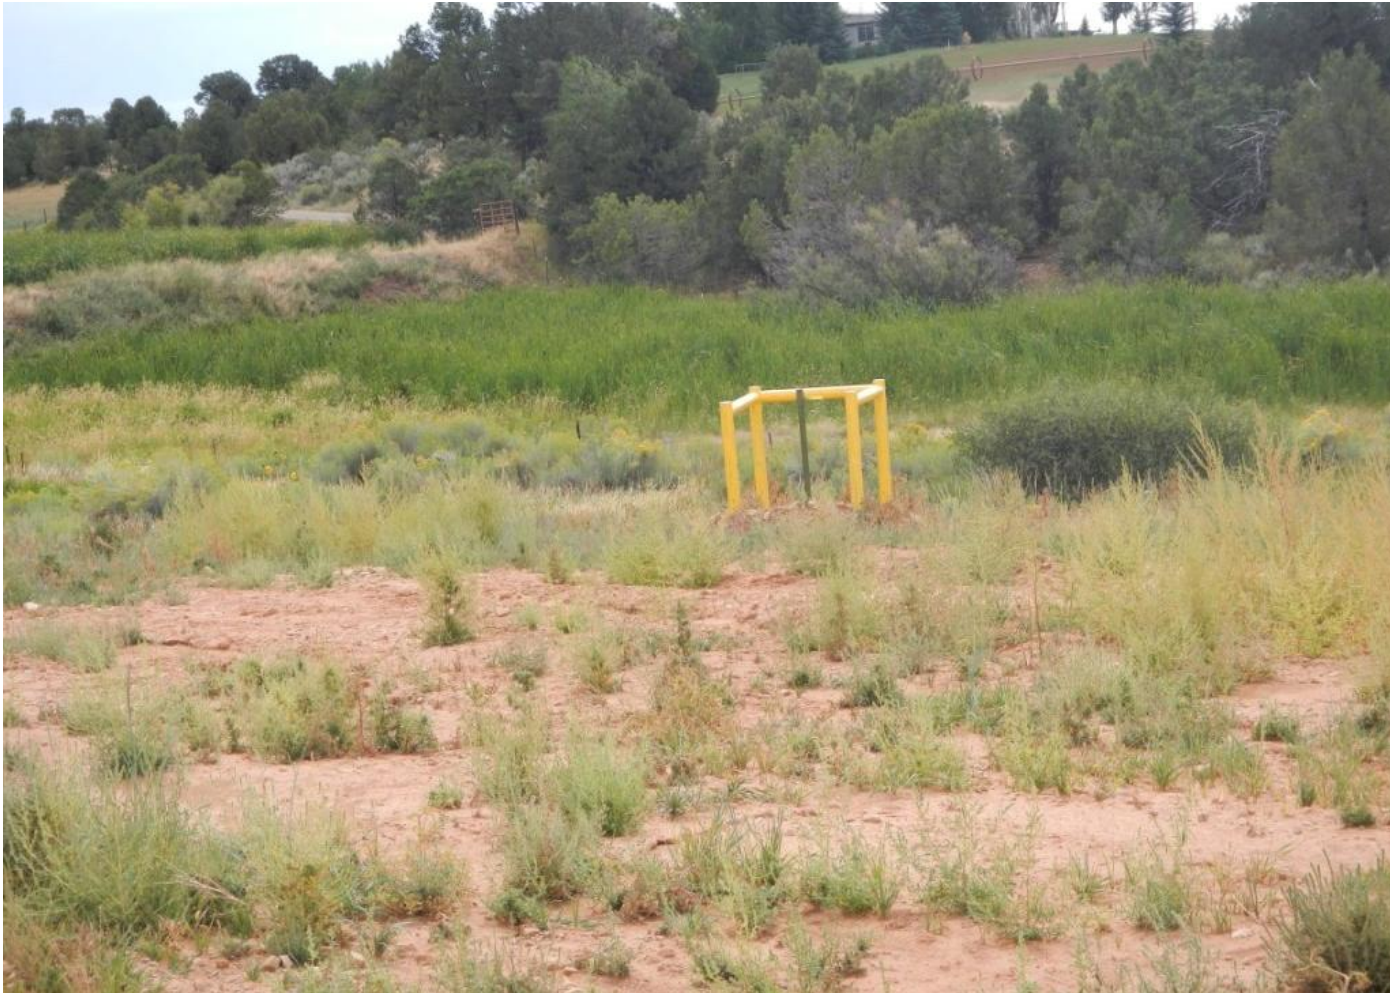
Photo 4. View of another riser that needs to be removed south of the project area.

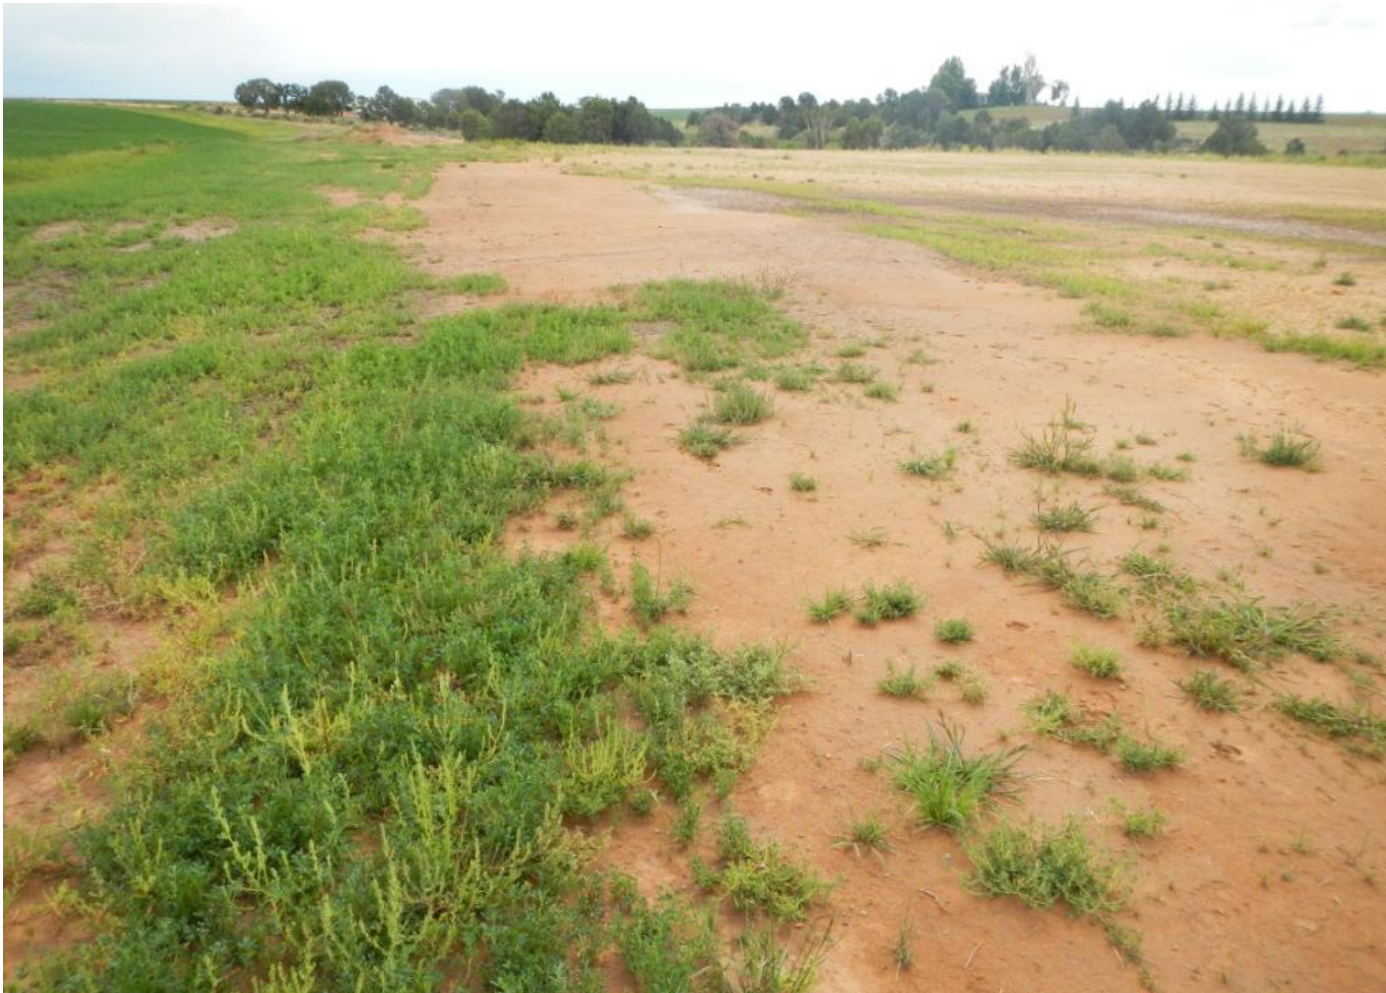
Photo 5. View of the northeastern portion of the project area from the northern corner facing southeastward. The majority of the well pad is devoid of vegetation.

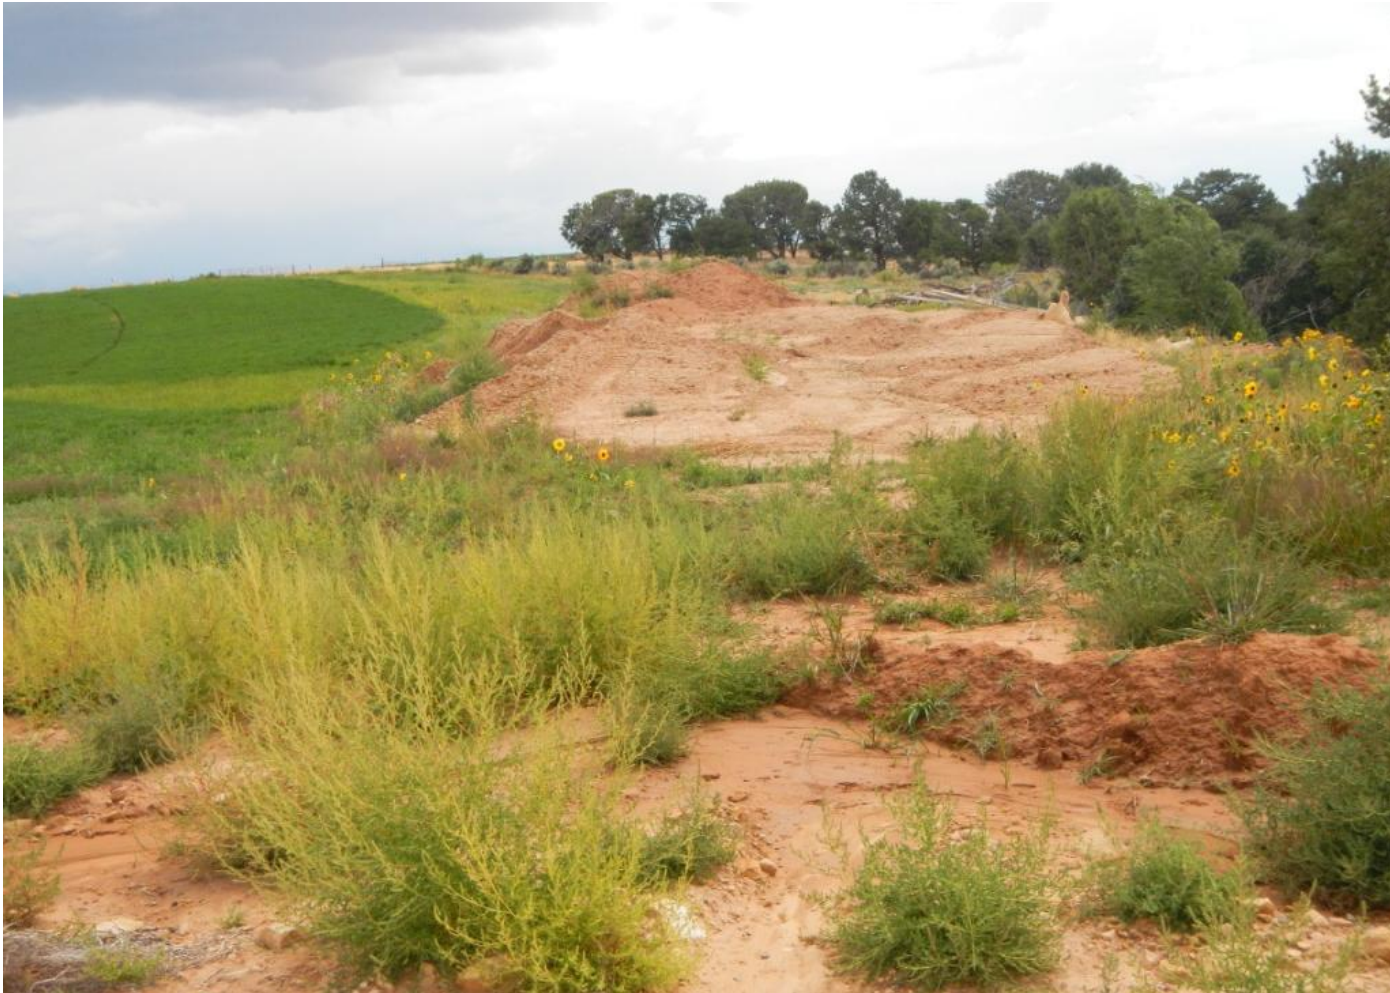
Photo 9. View of soil piles, unclear if this is topsoil (?) in the southeastern portion of the project area.
