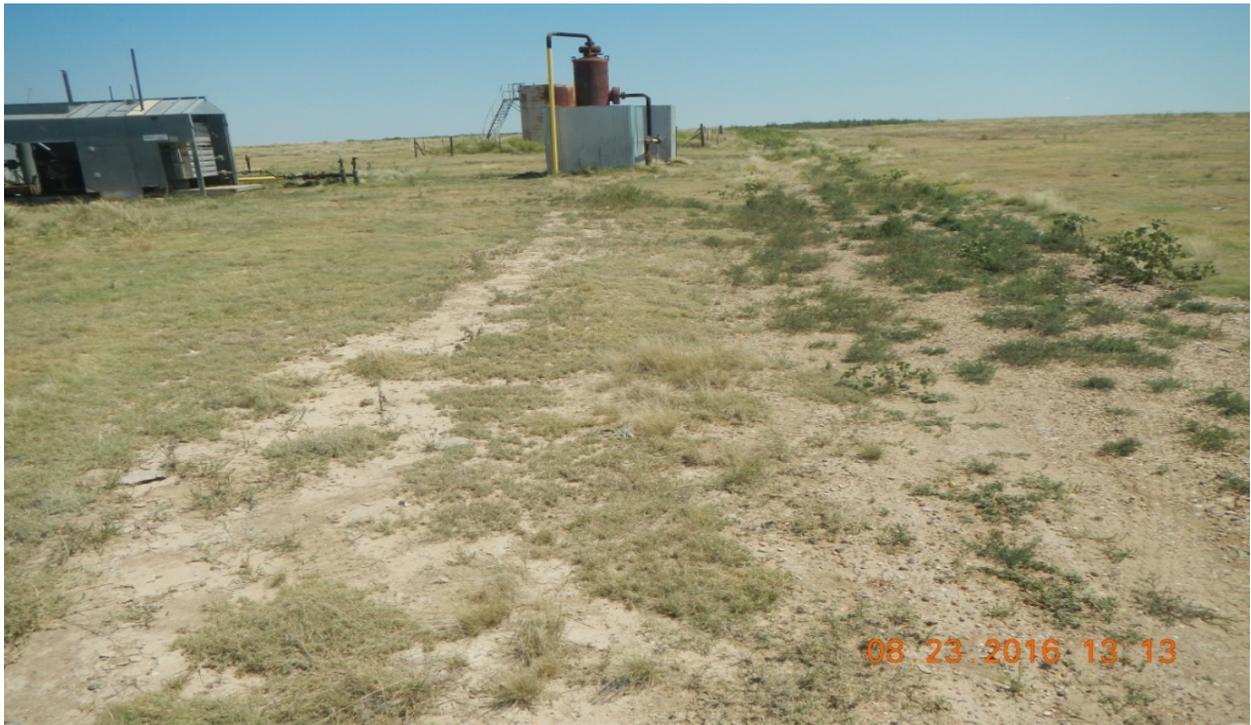
**photo 1:** Facing east along the access road toward the location. Compressor equipment in the upper left of the photo.

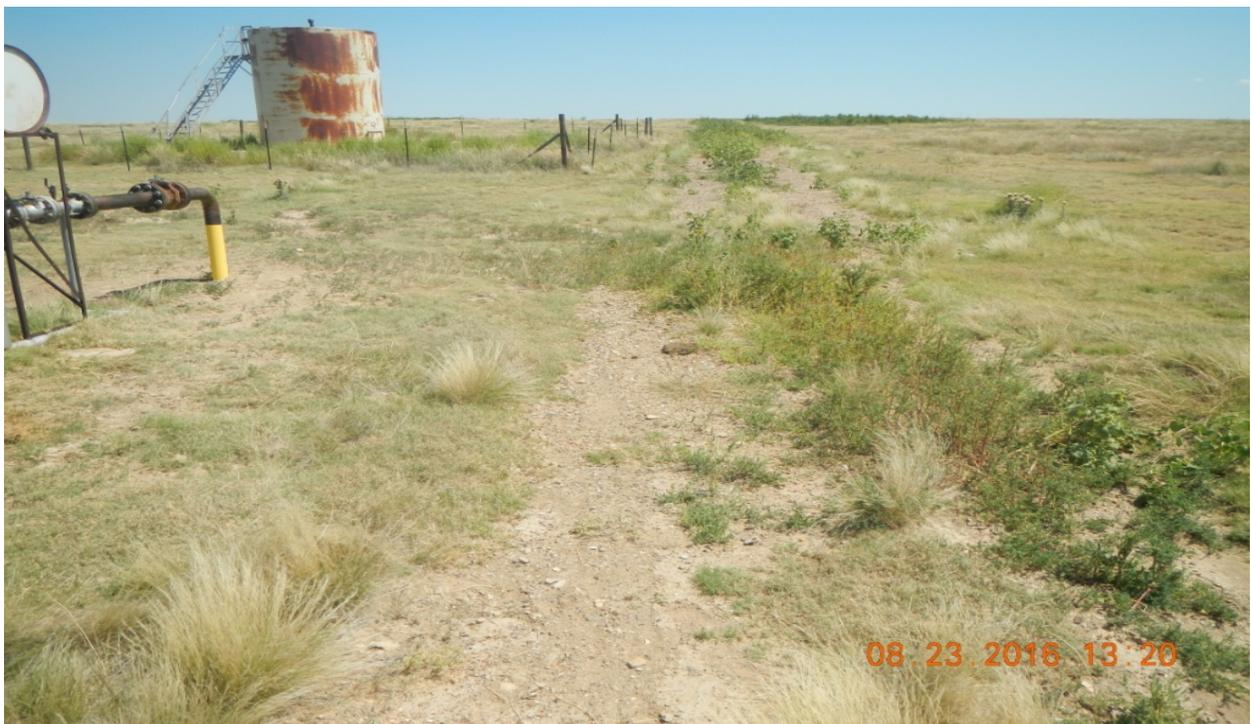
**photo 2:** Facing east along the access road toward the location.

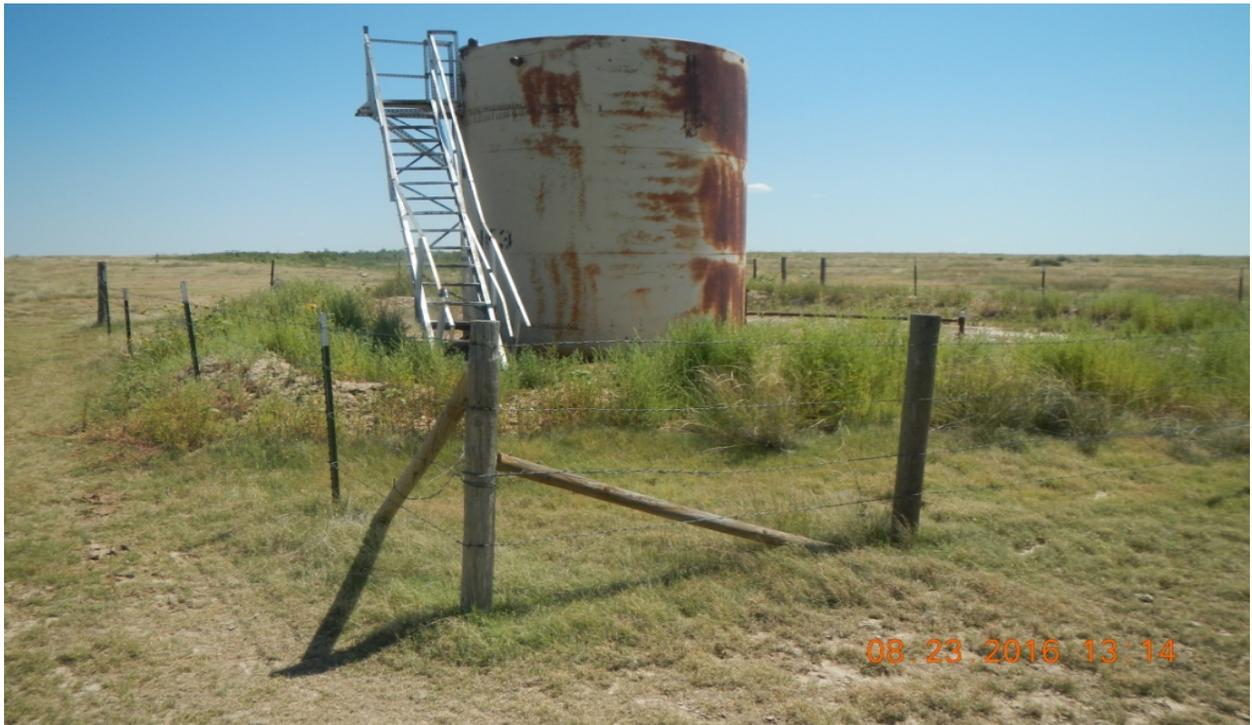
**photo 3:** Tank battery remains near the west side of the location.

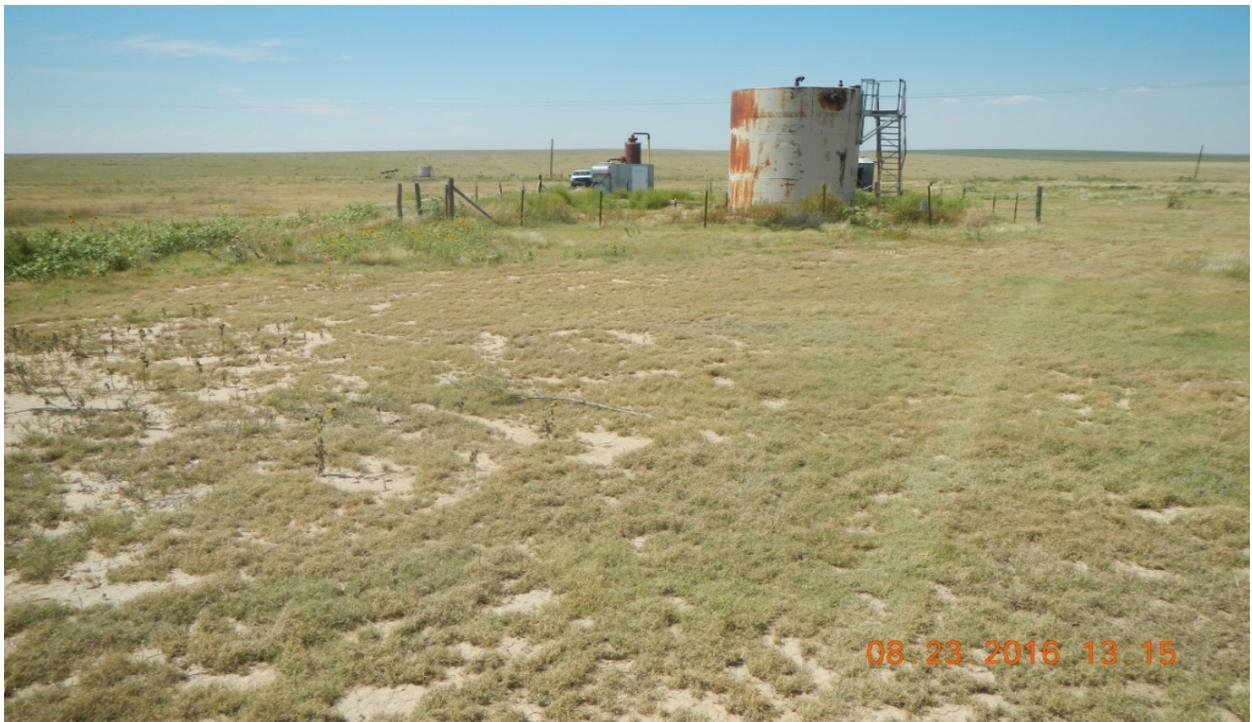
**photo 4:** Facing west toward the tank battery. Unused equipment which was in this area has been removed.

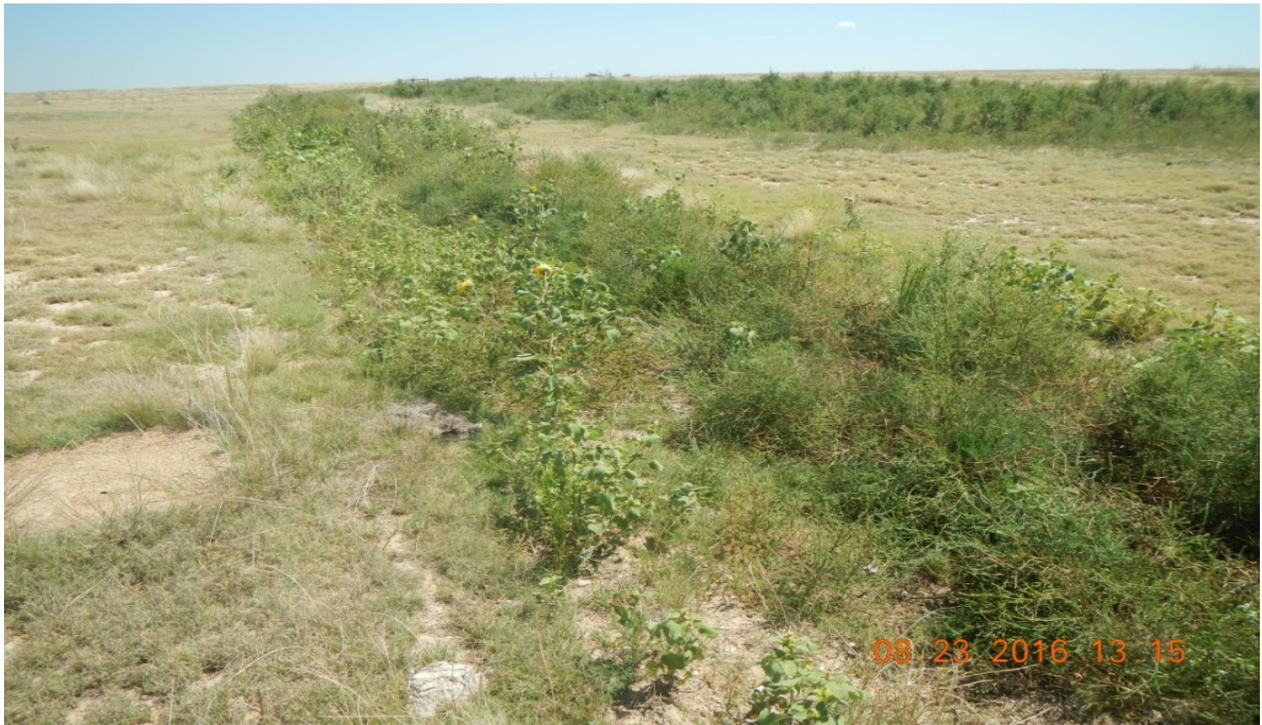
**photo 5:** Facing east toward the location.

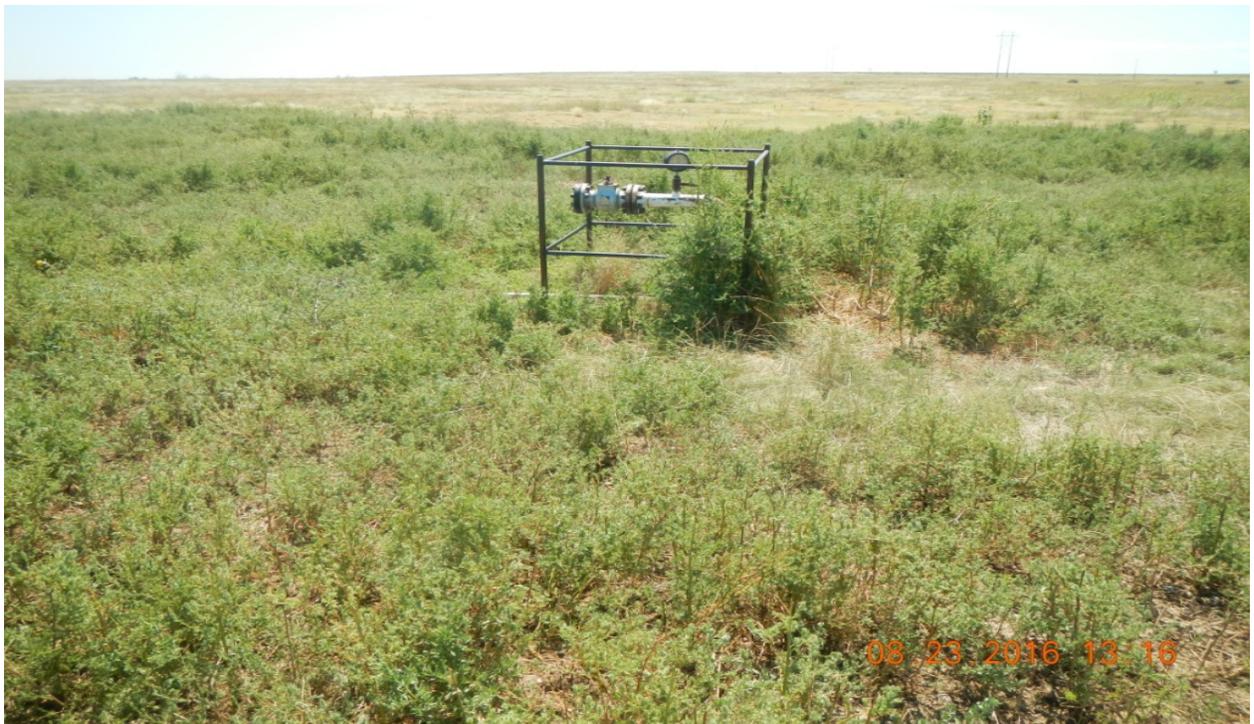
**photo 6:** Pipe riser remains at the center of the location. Lat/Long:37.95992,-102.50066

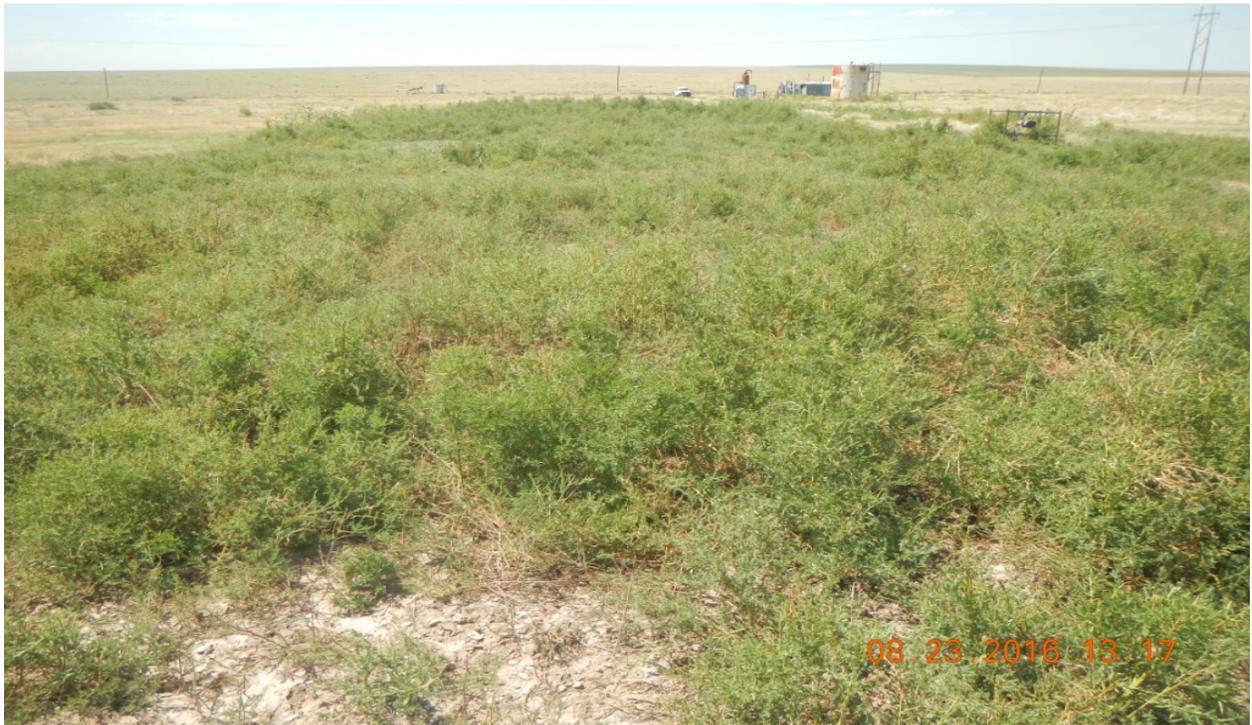
**photo 7:** East side of the location facing west. Undesirable weed growth noticed throughout the location.

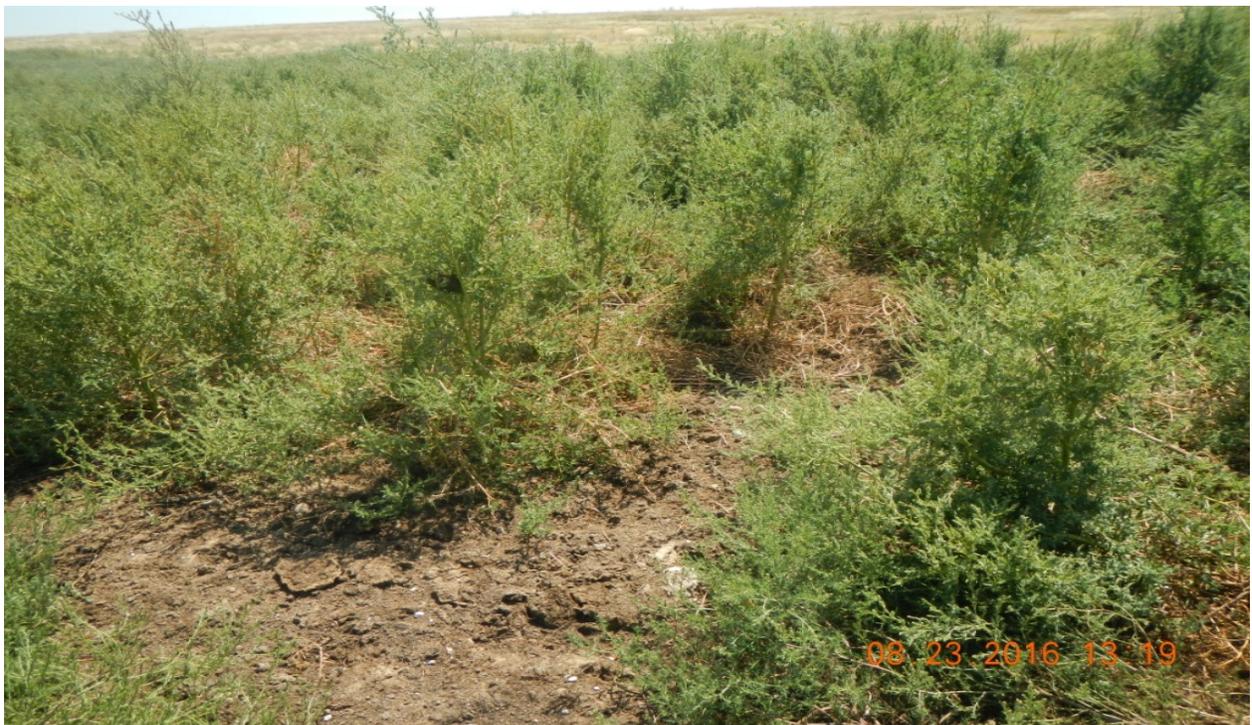
**photo 8:** Facing east at center of the location. Undesirable weed growth noticed throughout the location.

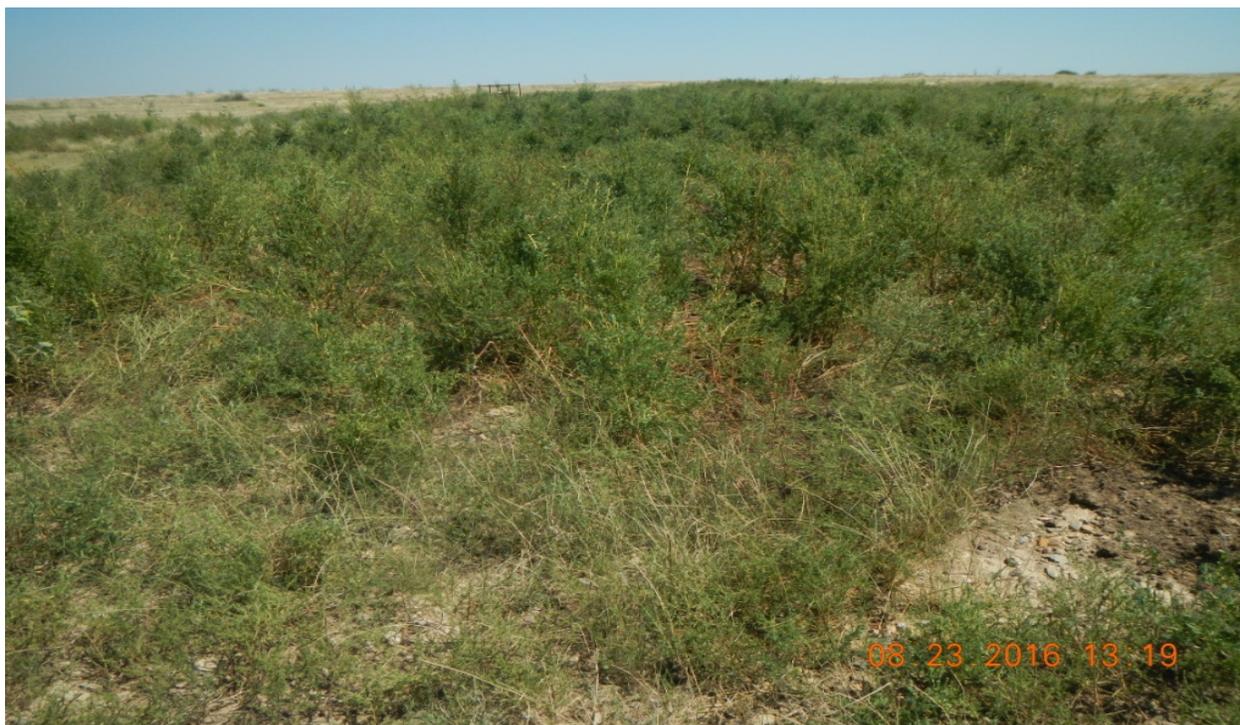
**photo 9:** West side of the location facing east.

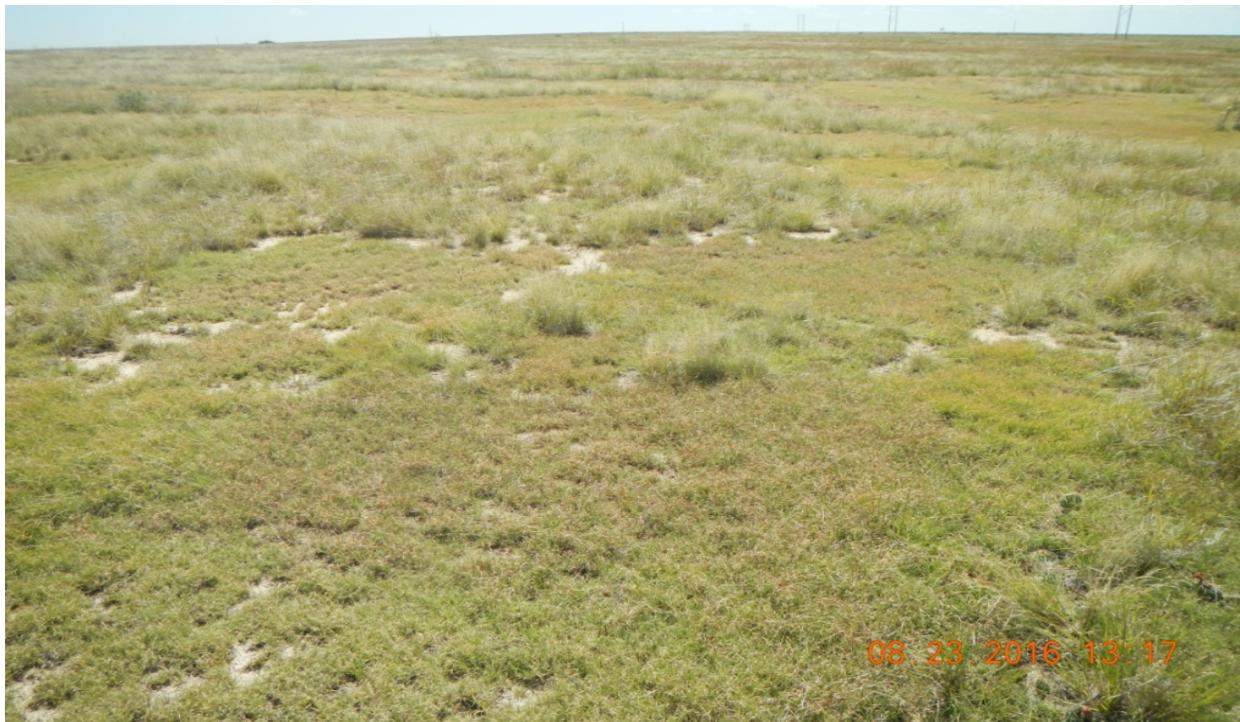
**photo 10:** Facing south toward the surrounding undisturbed pasture (reference area). There is no undesirable vegetation found in this area outside of the location.
