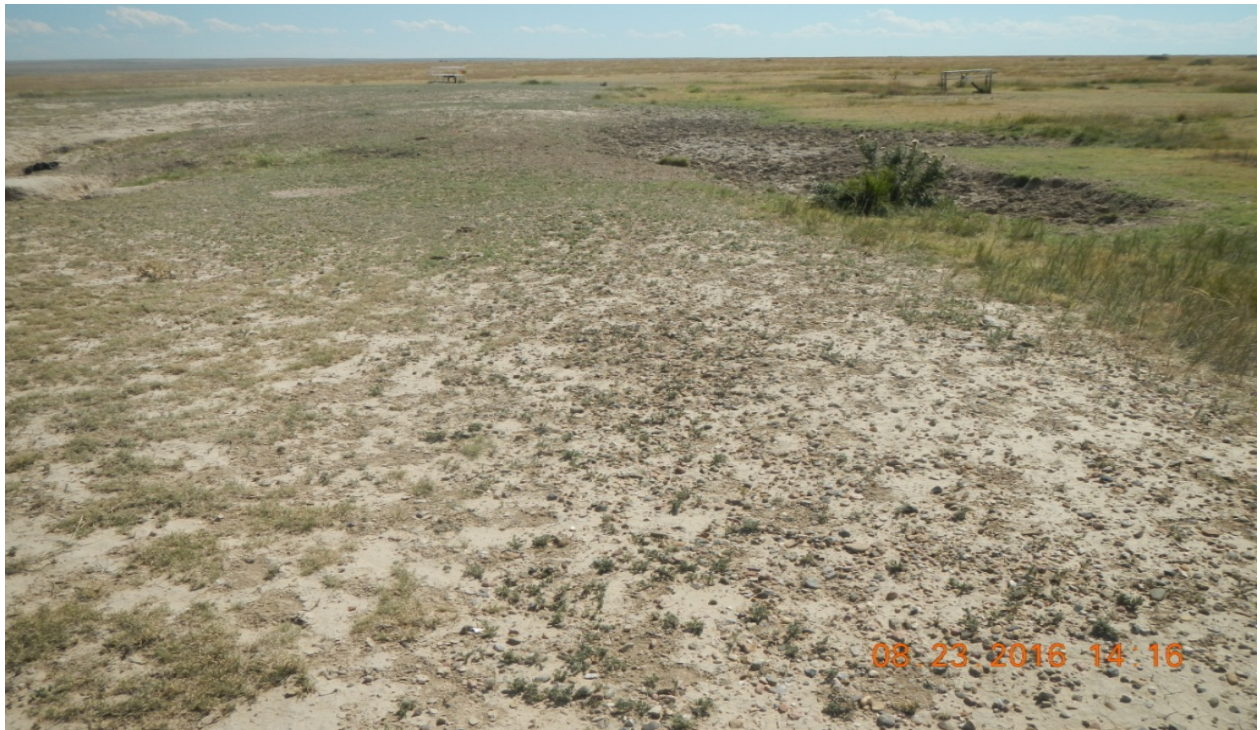
photo 1: Facing south toward the location.

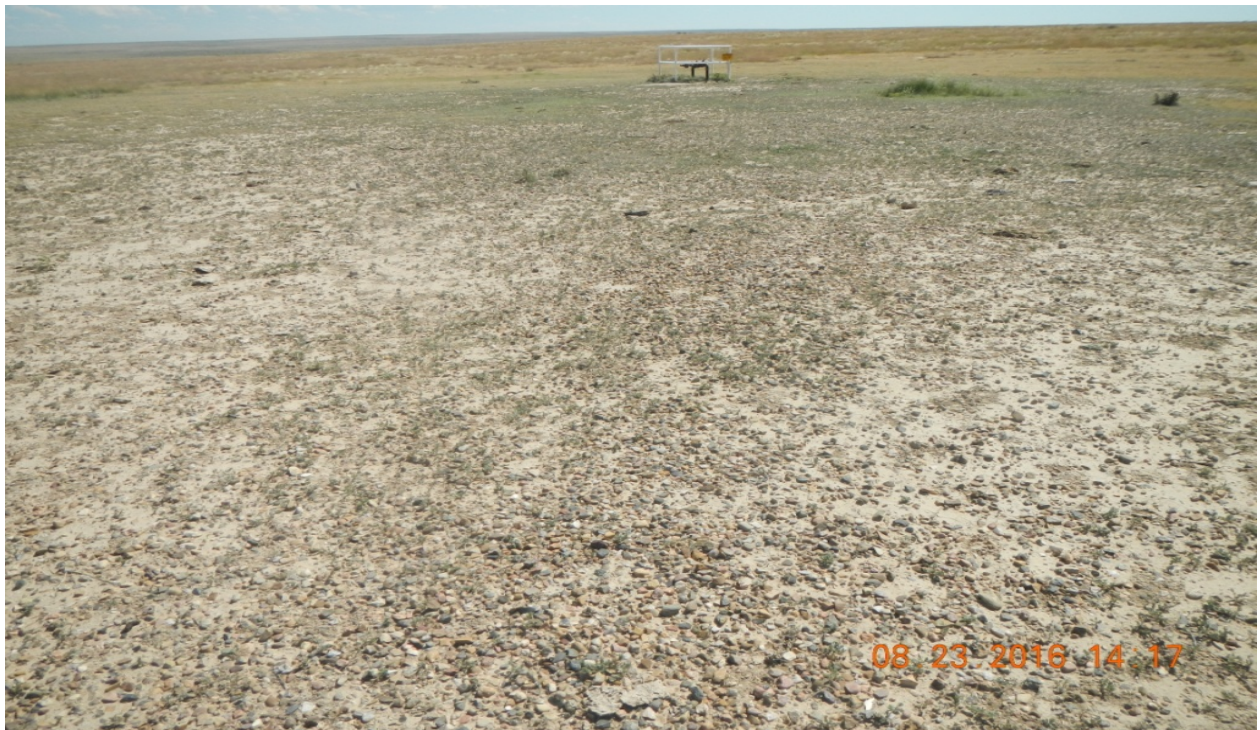
photo 2: Center of the location facing south. Vegetation has not established in this area. The soils seemed to be compacted and there is gravel that remains.

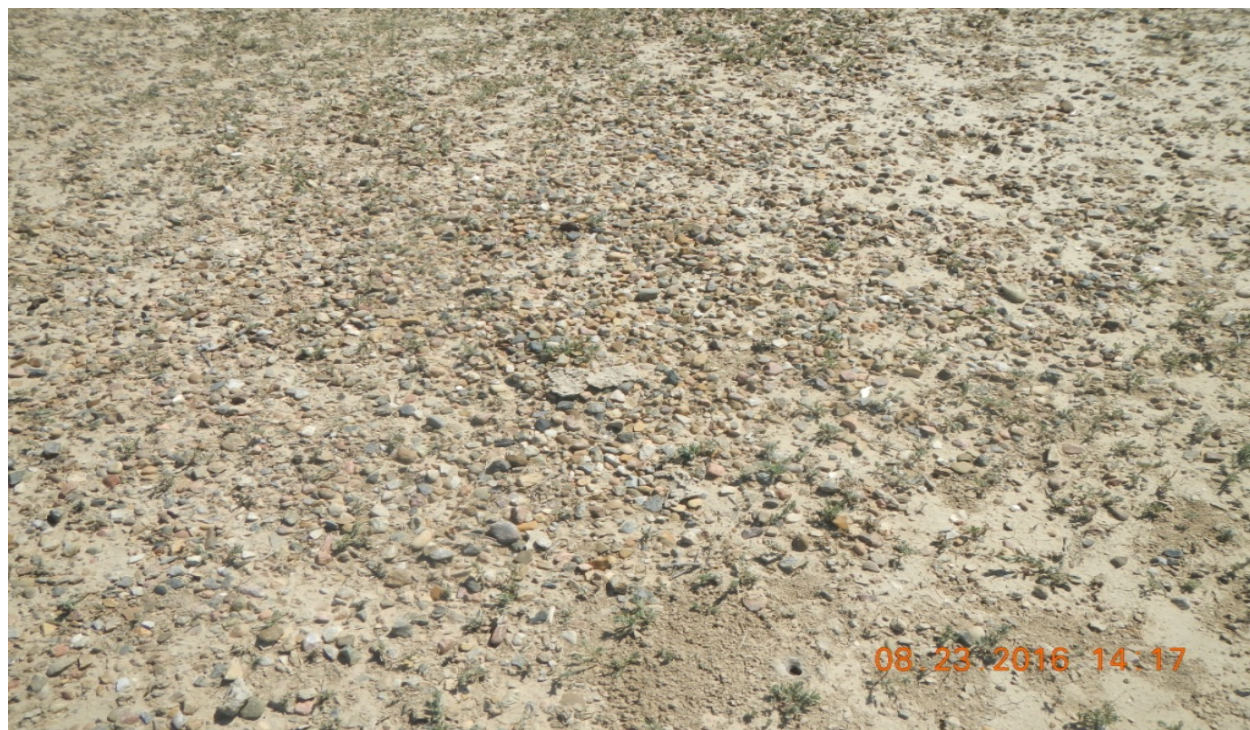
photo 3: View of groundcover at the center of the location. Vegetation has not established in this area. The soils seemed to be compacted and there is gravel that remains.

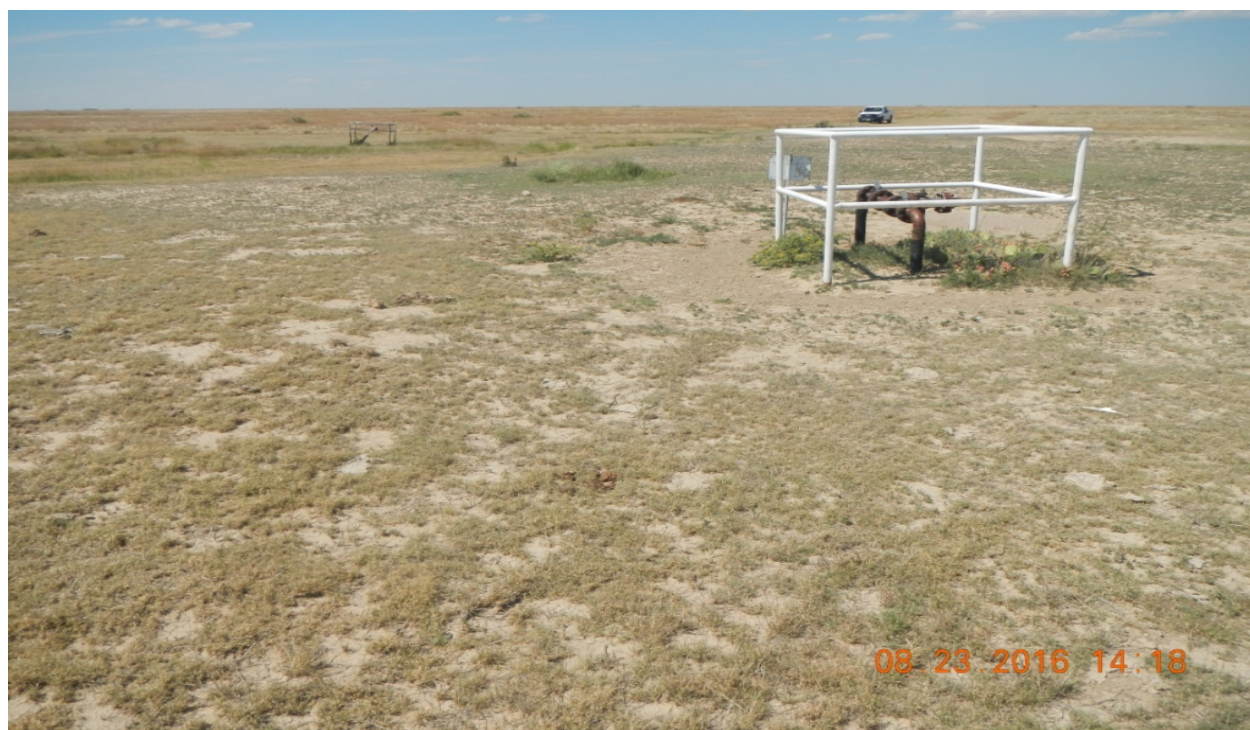
photo 4: South side of the location facing north. The pipe riser has not been removed.

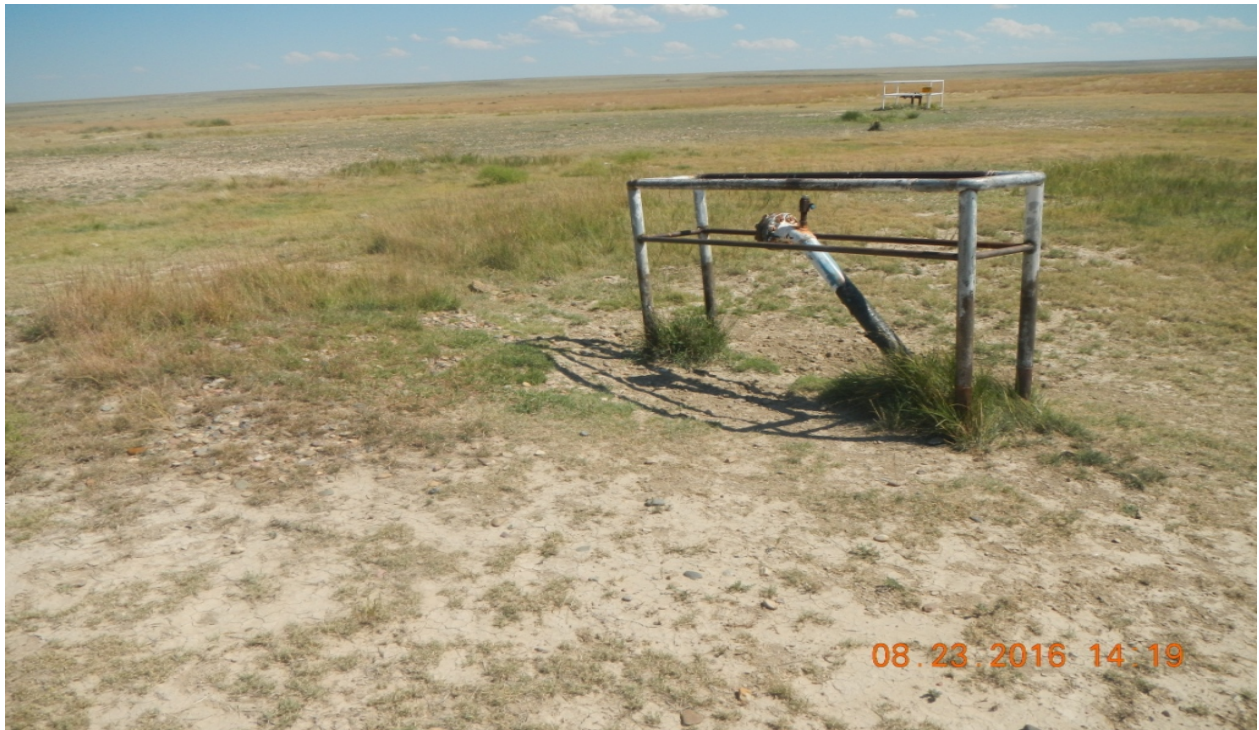
photo 5: West side of the location facing southeast. The pipe riser remains at the west side of the location.

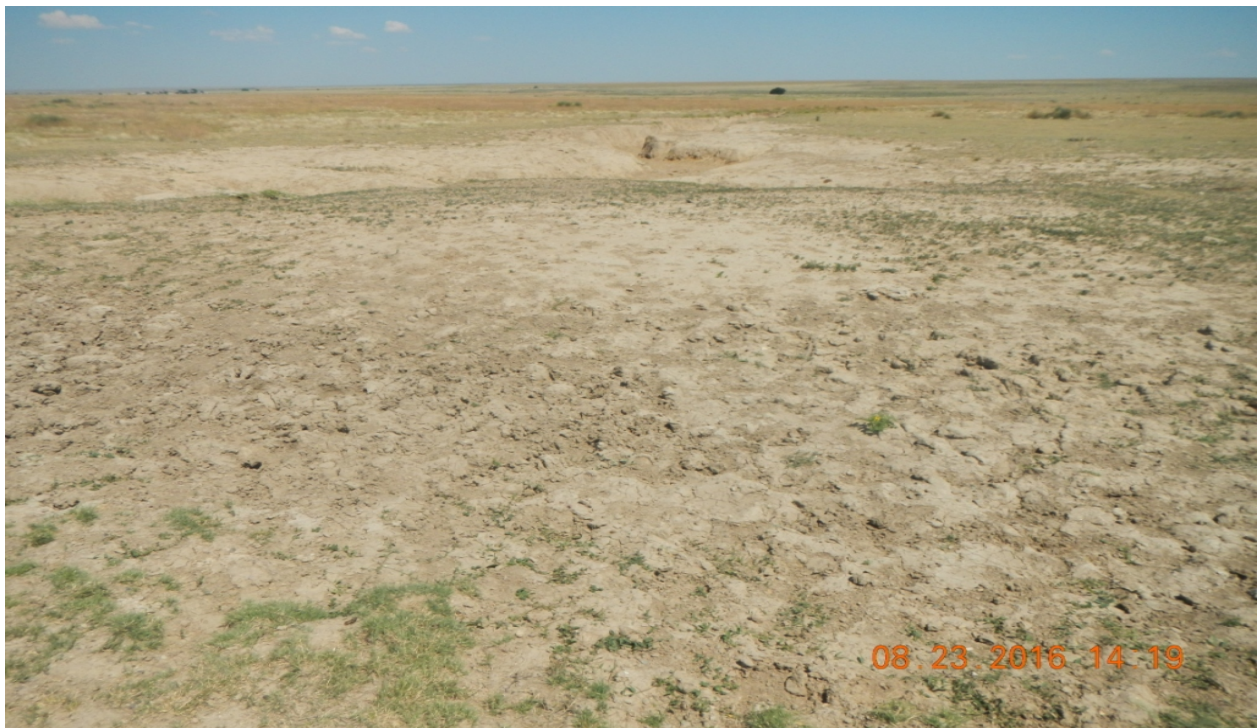
photo 6: Northeast side of the location facing east. Vegetation has not established in this area.

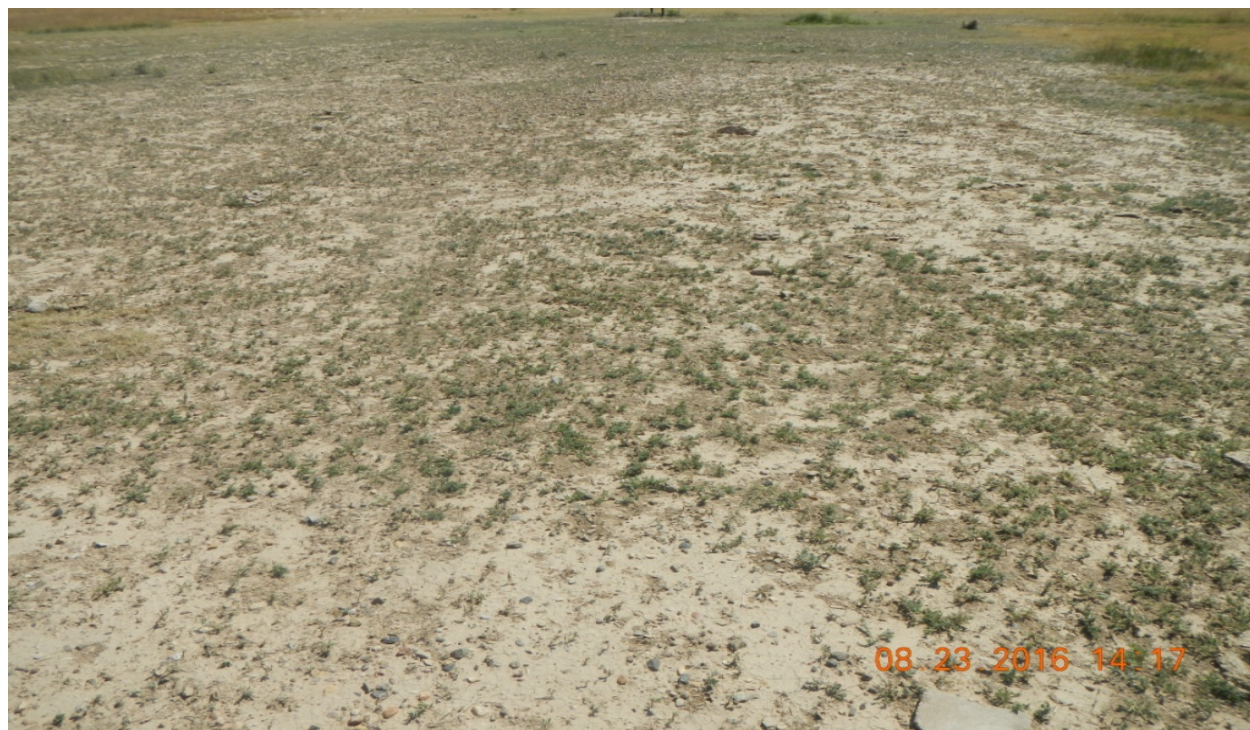
photo 7: View of the ground cover at the northeast side of the location. Vegetation has not established in this area.

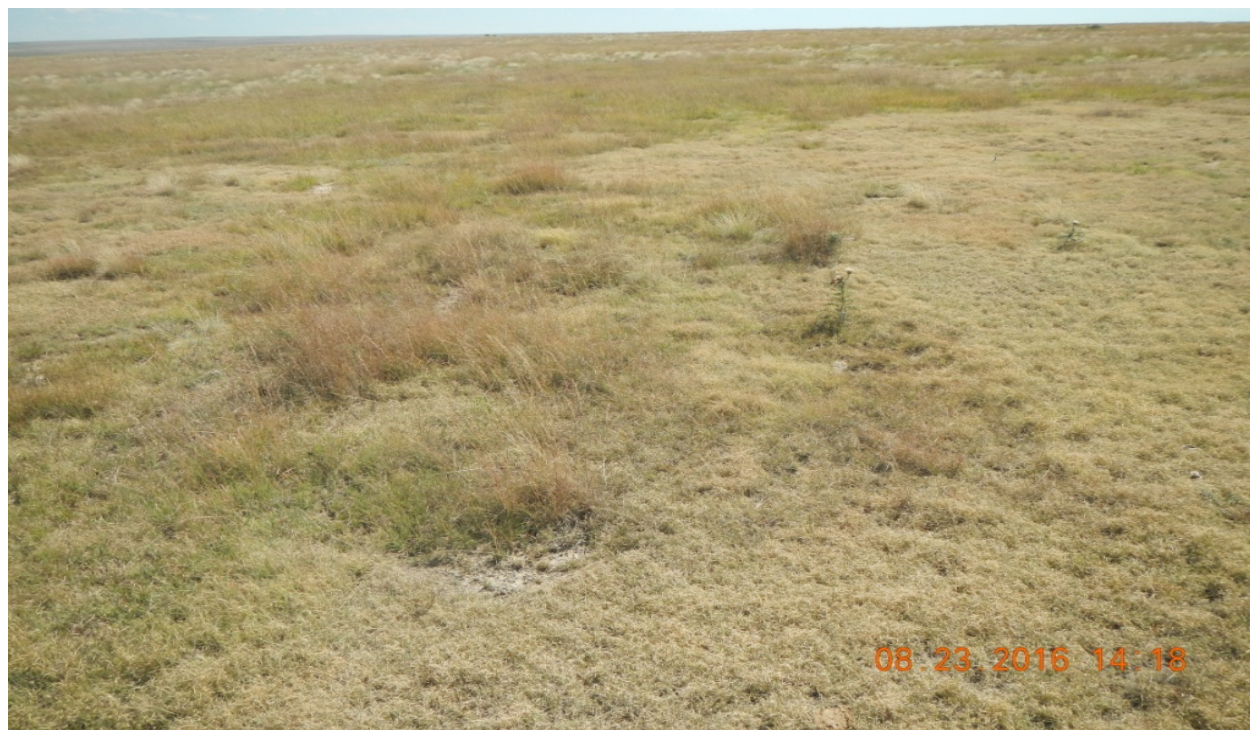
photo 8: Facing south toward the surrounding undisturbed pasture (reference area).
