Final Reclamation Inspection

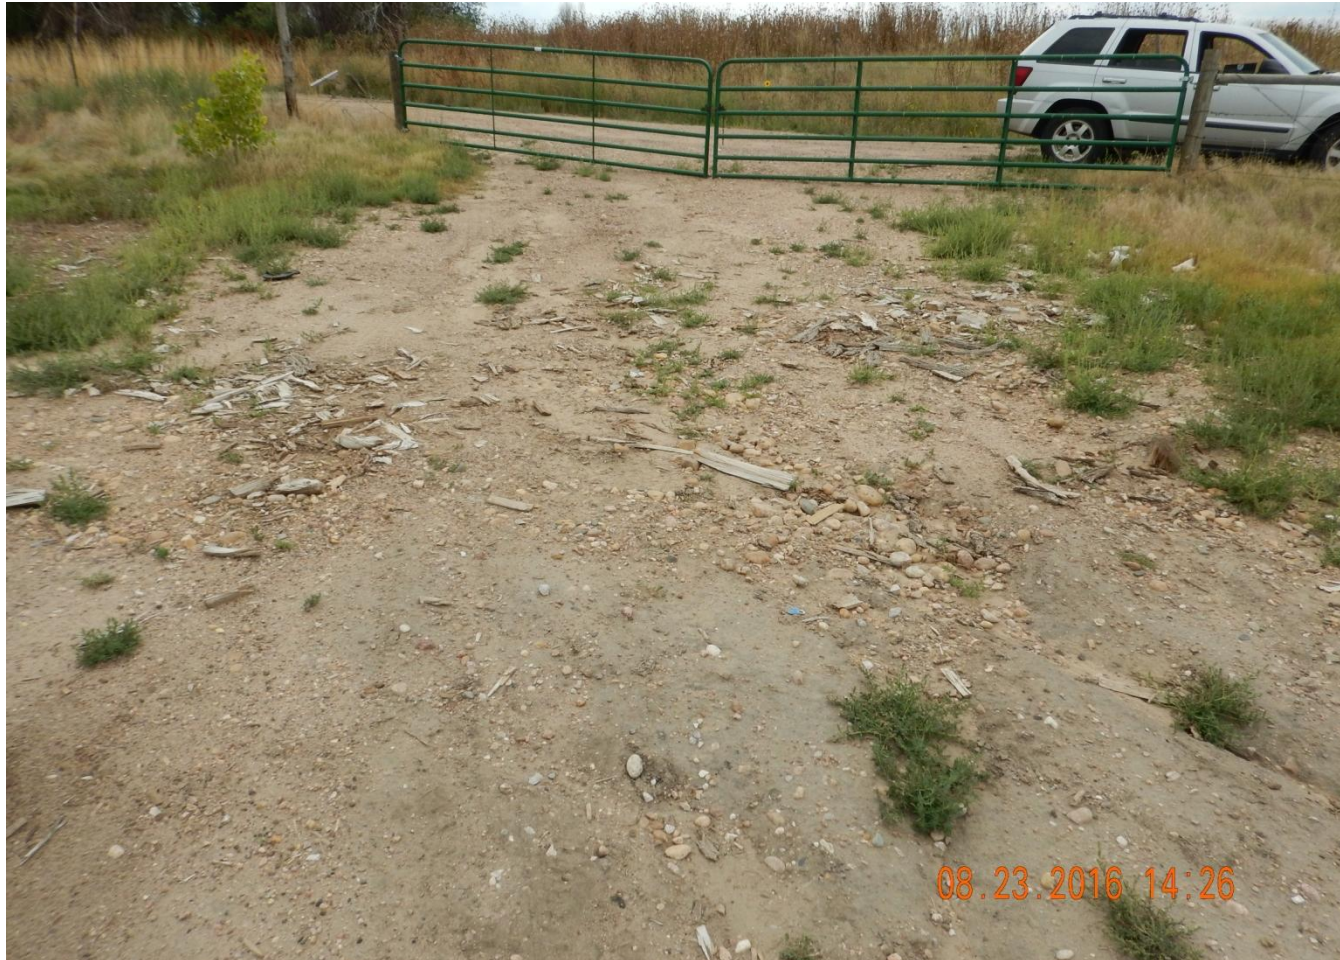
Photo 1. Photo taken from entrance of location, facing West. Large portions have no native, perennial vegetative growth as shown with this photo.

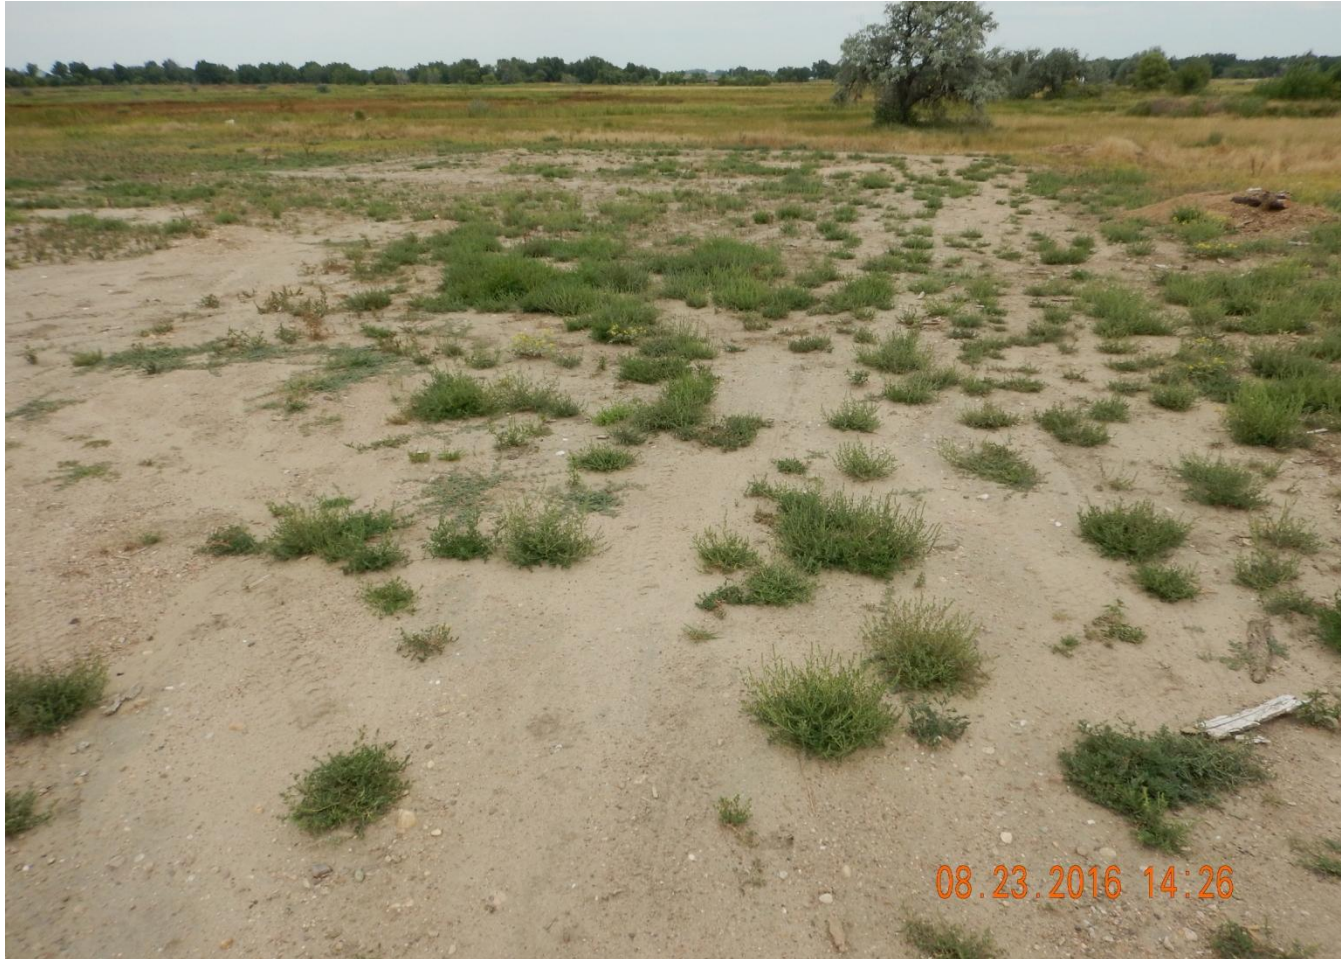
Photo 2. Photo taken from entrance of location, facing East. Large portions have no native, perennial vegetative growth as shown with this photo. Majority of vegetative growth are weedy, annual plants.

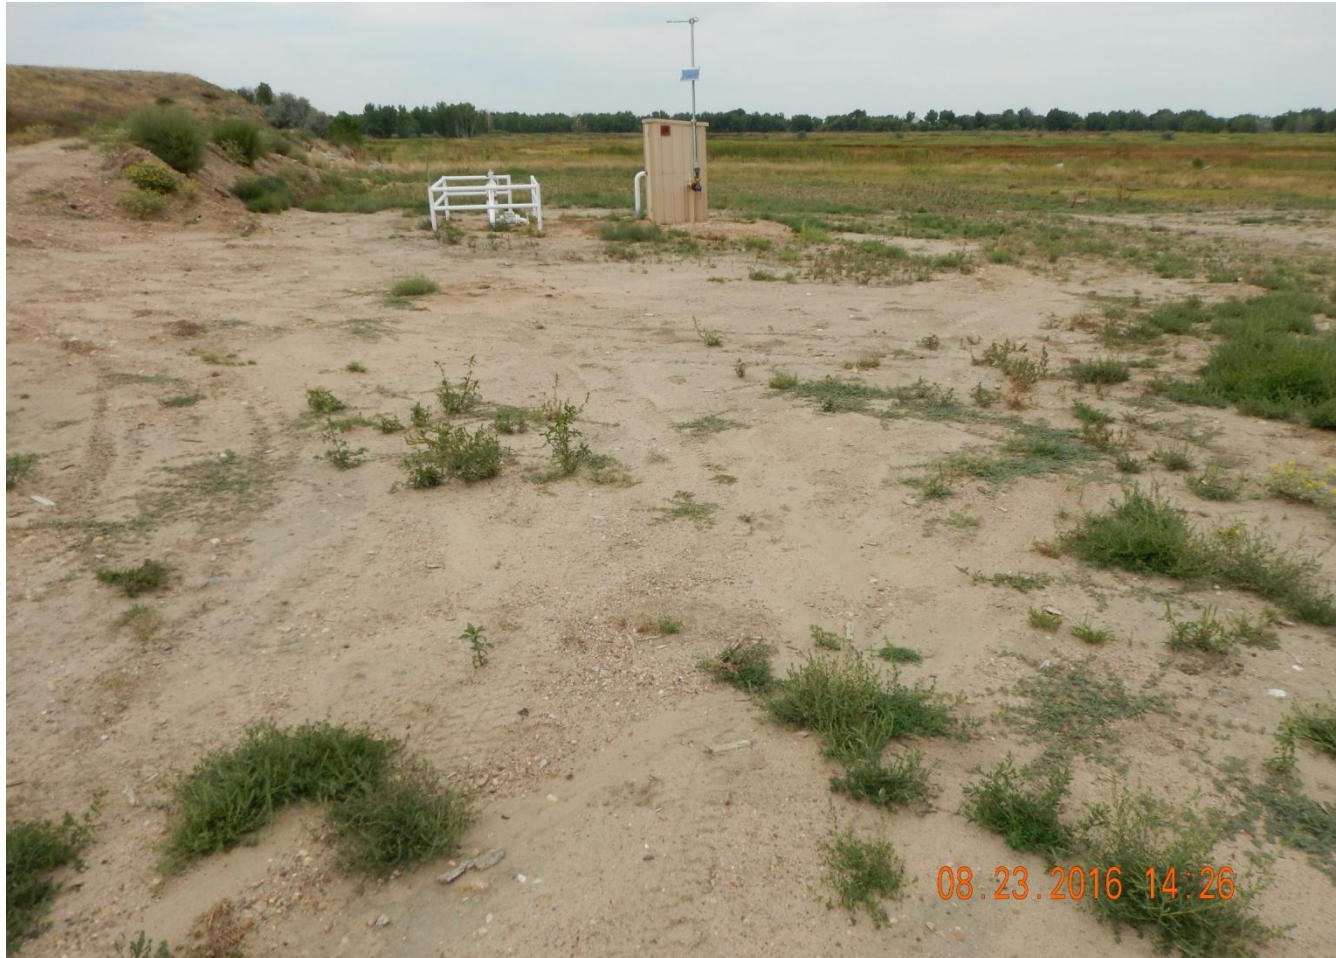
Photo 3. Photo taken from entrance of location, facing North. Large portions have no native, perennial vegetative growth as shown with this photo. Majority of vegetative growth are weedy, annual plants. Equipment remains at location and a well release will not be granted until all equipment is removed.

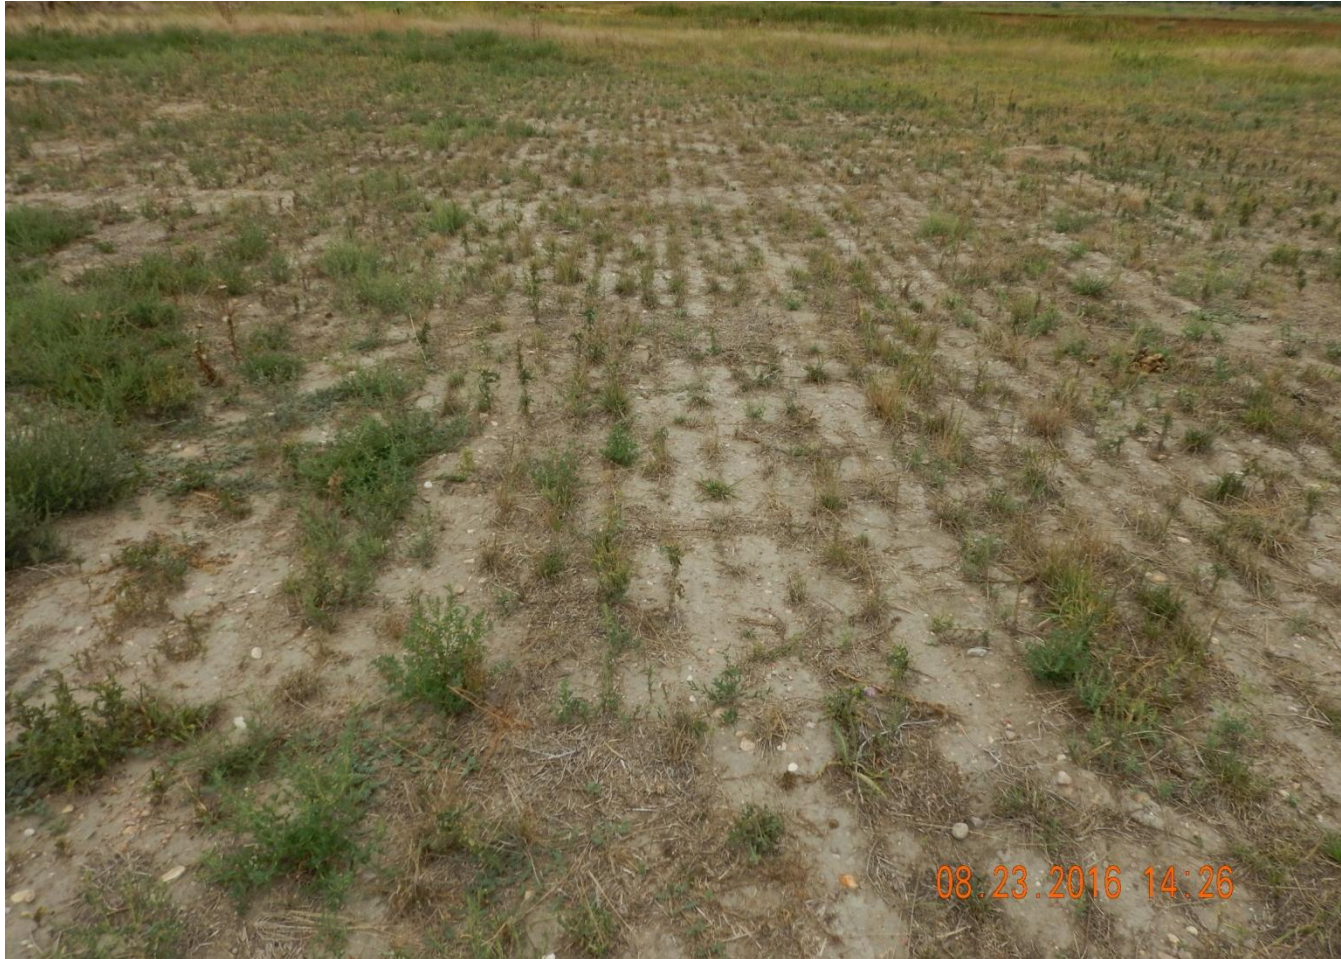
Photo 4. Photo taken from the northern location, facing North. Vegetative growth appears to be establishing along northern the location.

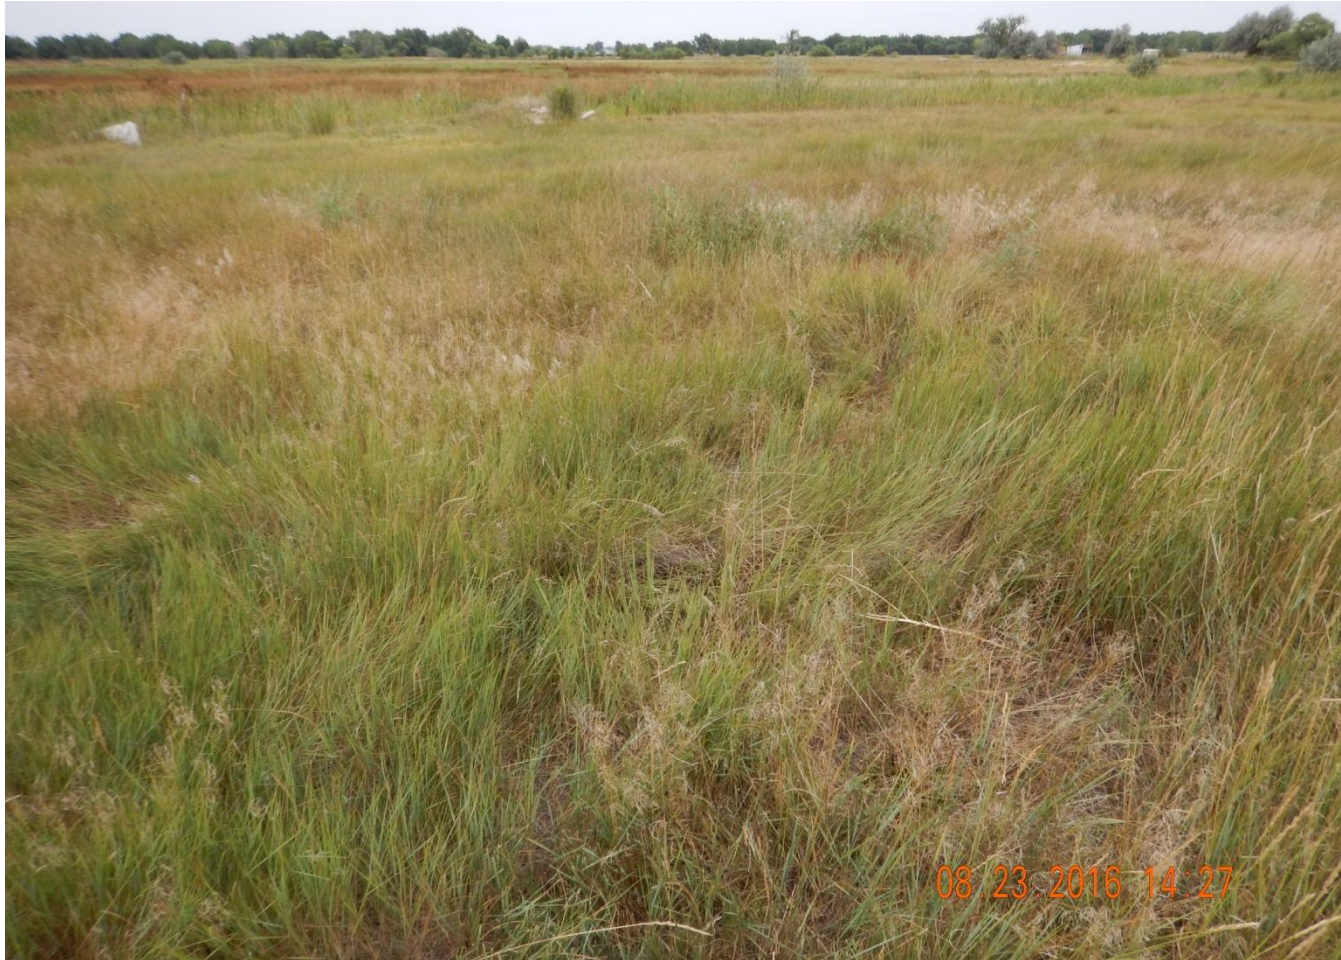
Photo 5. Reference photo taken north of location illustrating native, perennial vegetative growth.
