Final Reclamation Inspection

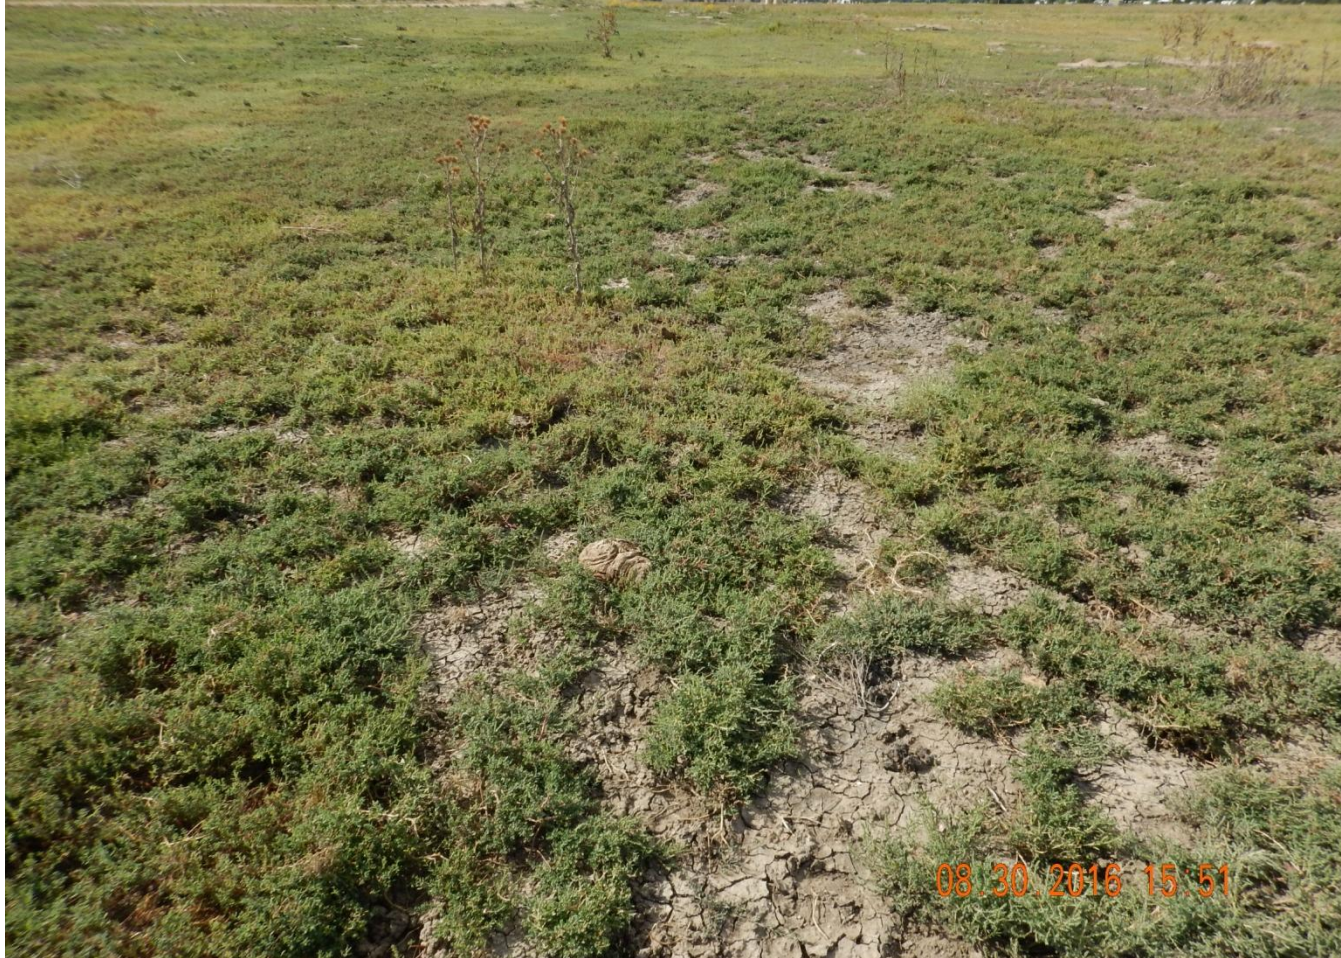
Photo 1. Photo taken from center of location, facing North. Location has not been reclaimed per Rule 1004. Little to no perennial vegetative growth has established at location. Weedy, annual vegetation dominates location which is not reflective or reference areas.

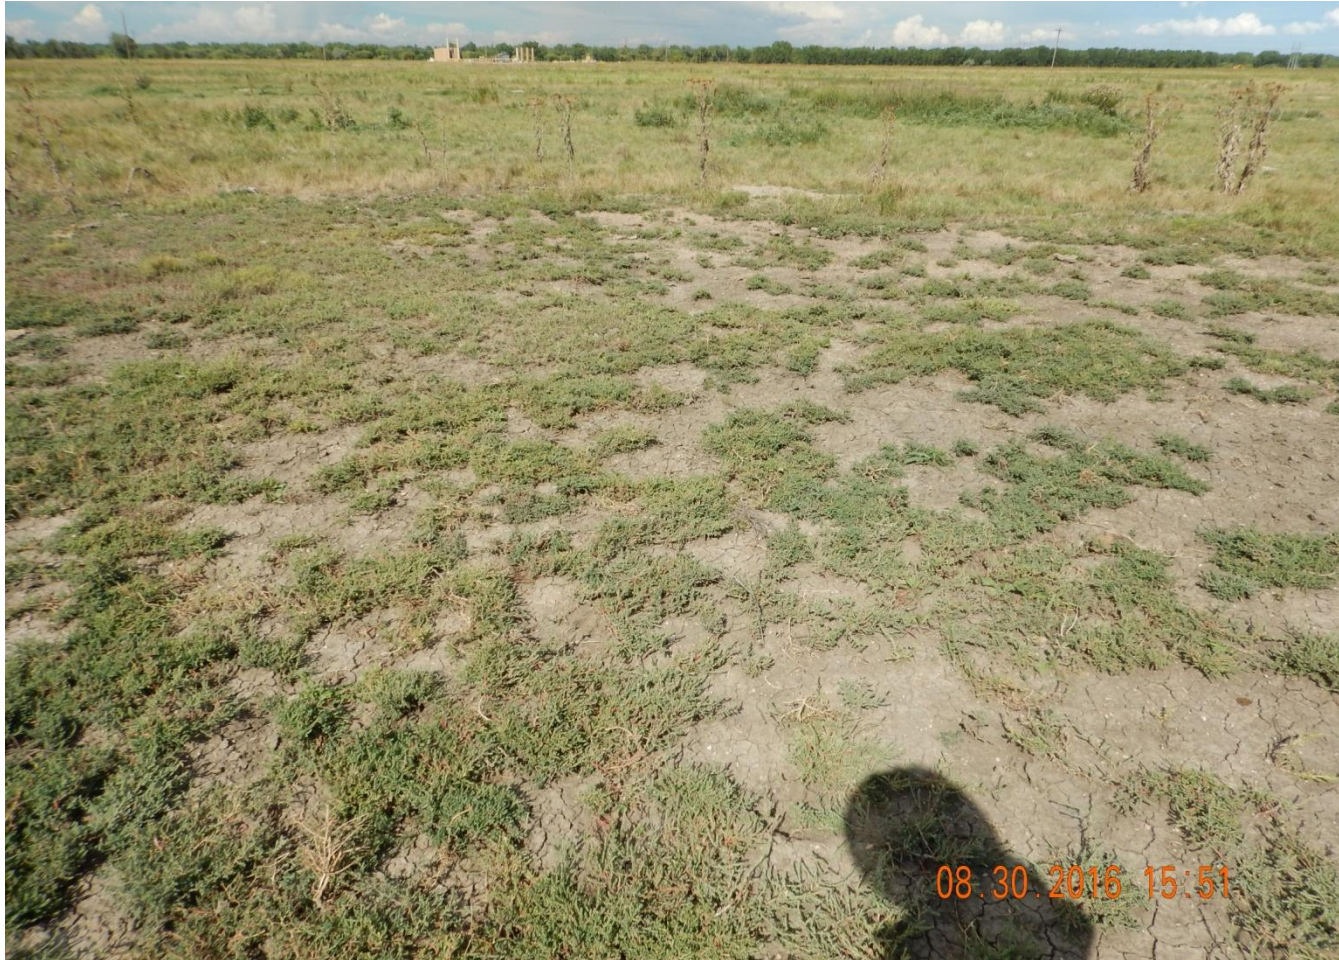
Photo 2. Photo taken from center of location, facing East. Location has not been reclaimed per Rule 1004. Little to no perennial vegetative growth has established at location. Weedy, annual vegetation dominates location which is not reflective or reference areas.

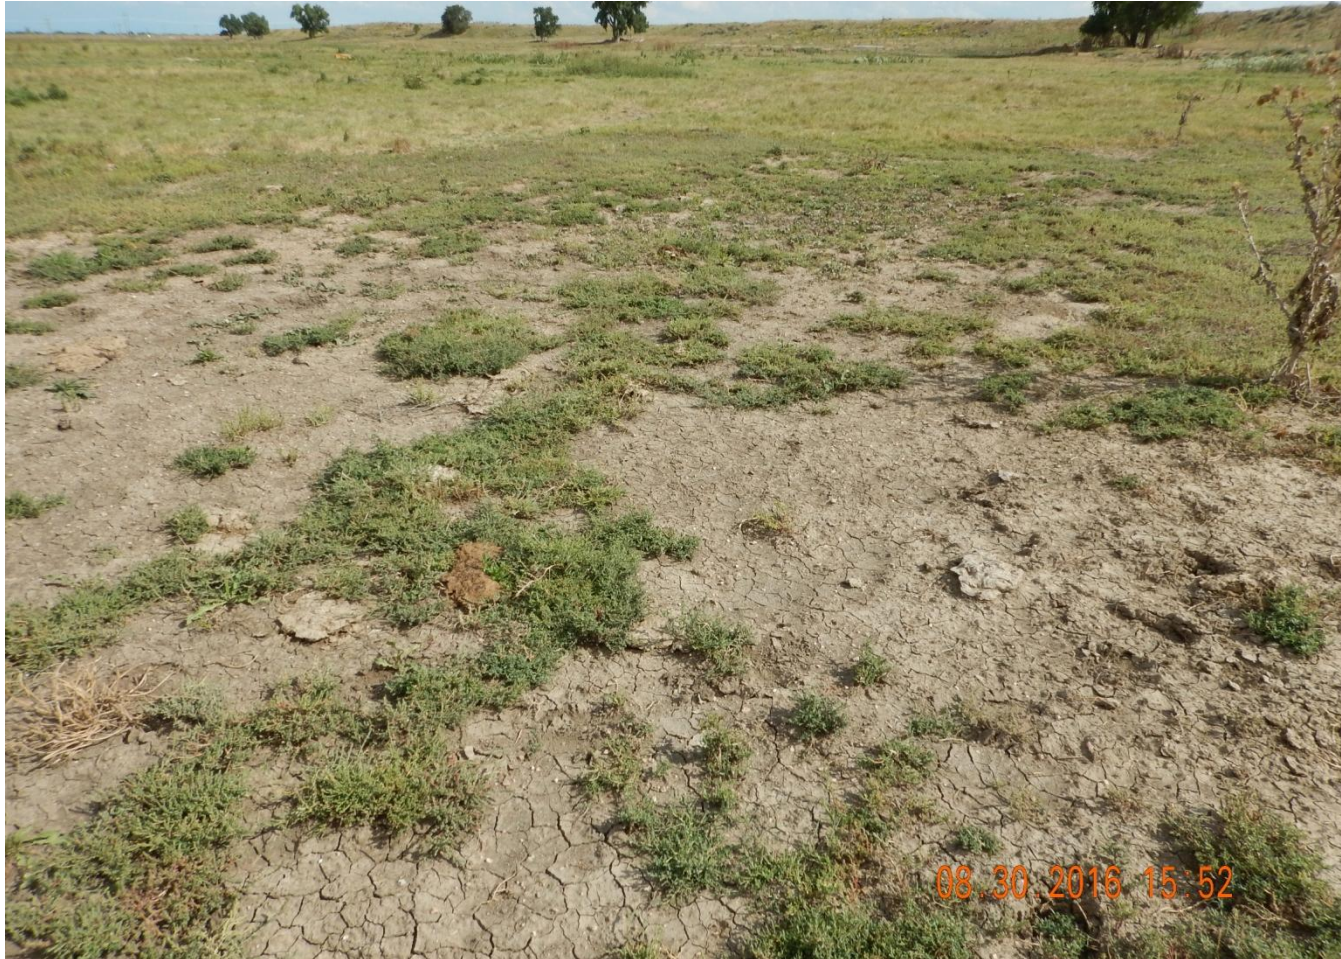
Photo 3. Photo taken from center of location, facing South. Location has not been reclaimed per Rule 1004. Little to no perennial vegetative growth has established at location. Weedy, annual vegetation dominates location which is not reflective of reference areas.

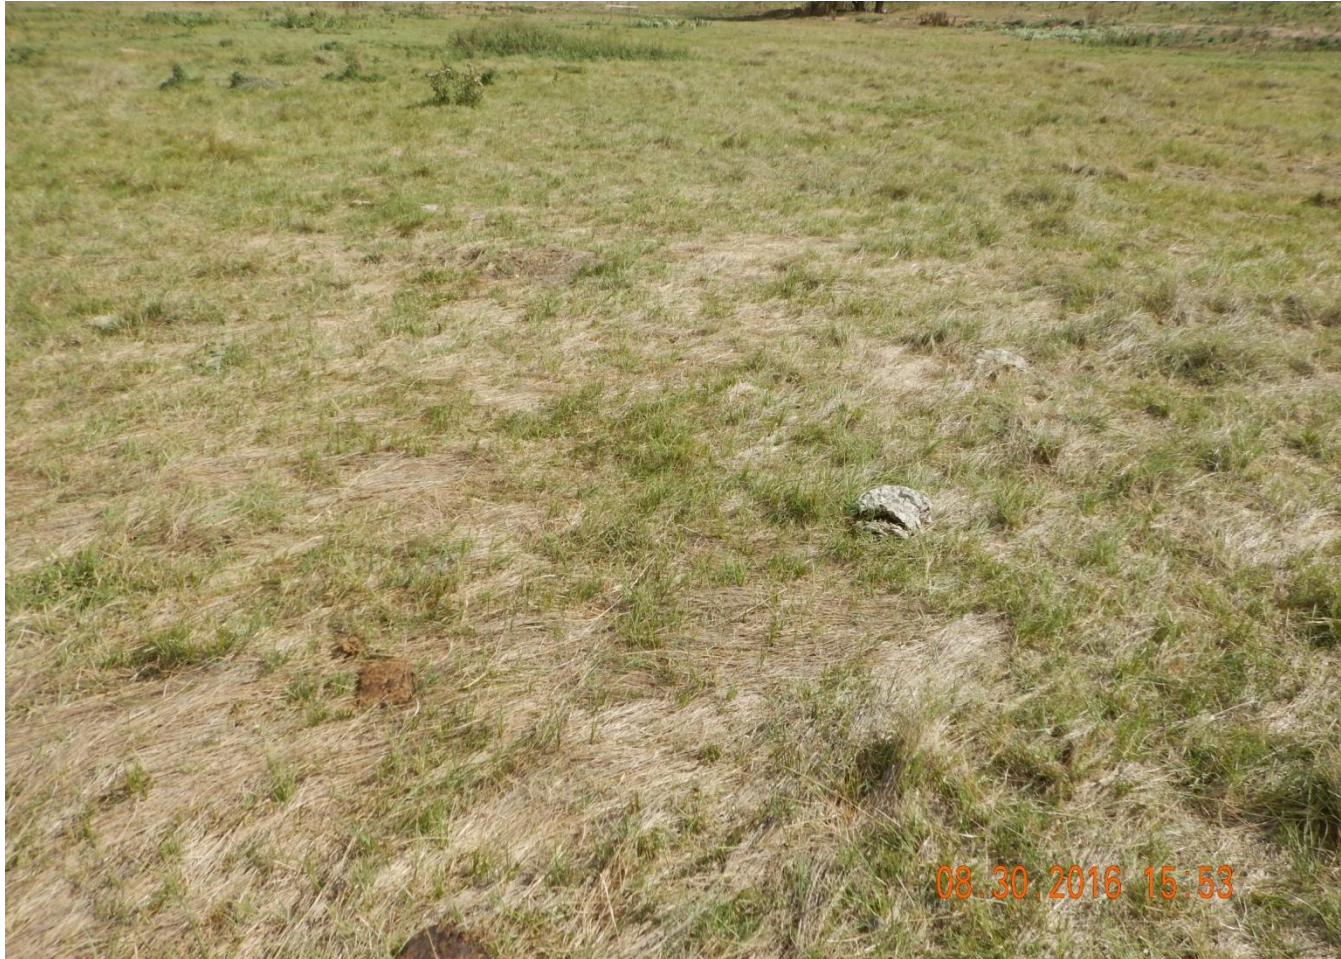
Photo 4. Reference photo taken south of location, facing South. Vegetative growth does not appear to be reflective of reference areas.

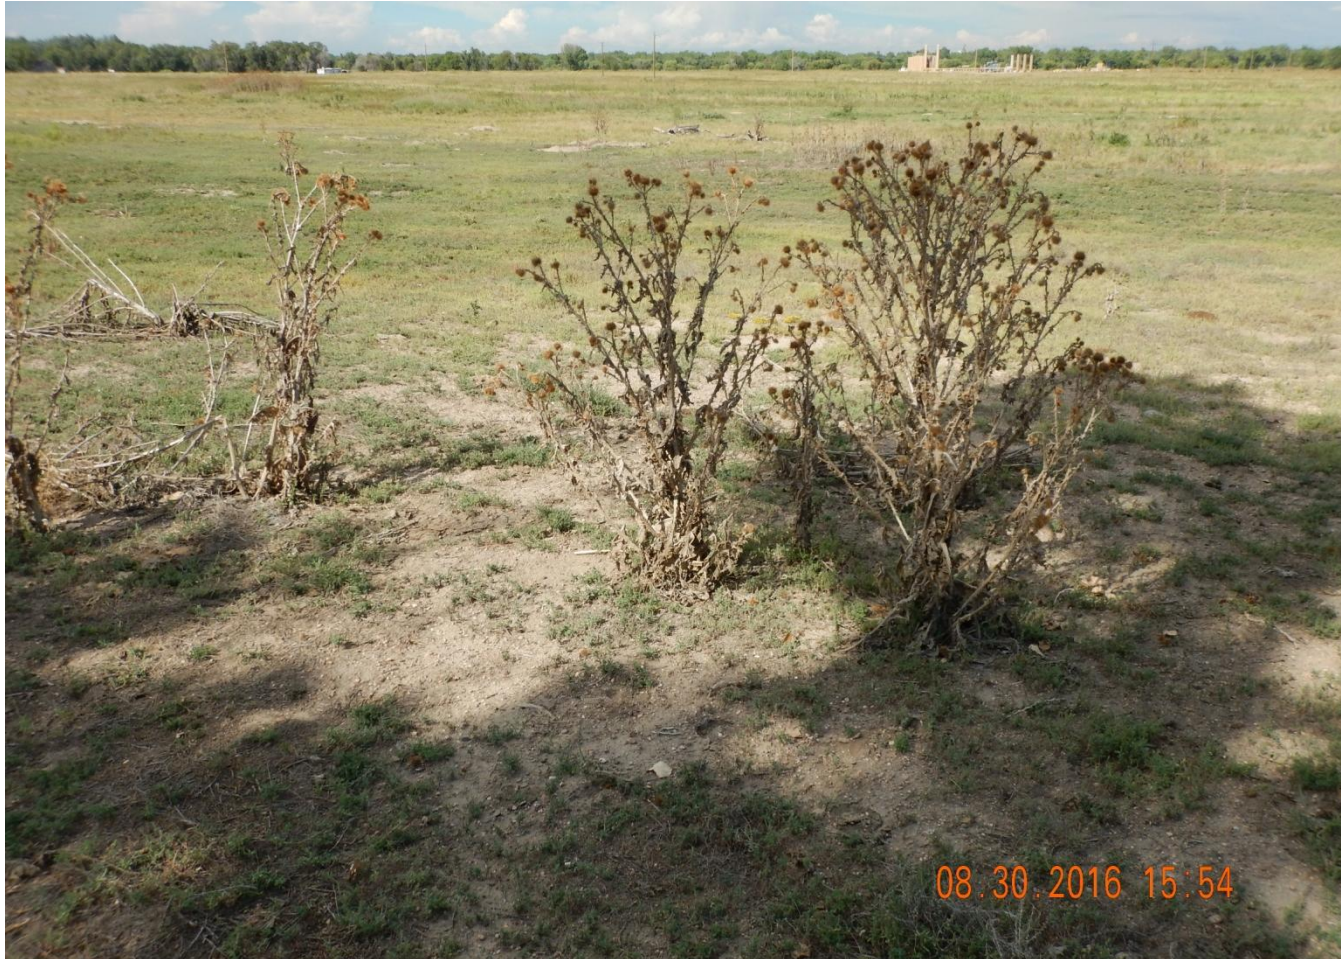
Photo 5. Photo taken from western location, facing East. A List B Colorado Noxious weed species, Musk thistle (*Carduus nutans*), appears to have been sprayed at location.
