Sooner Unit- Southern Tank battery (Location ID 447525)

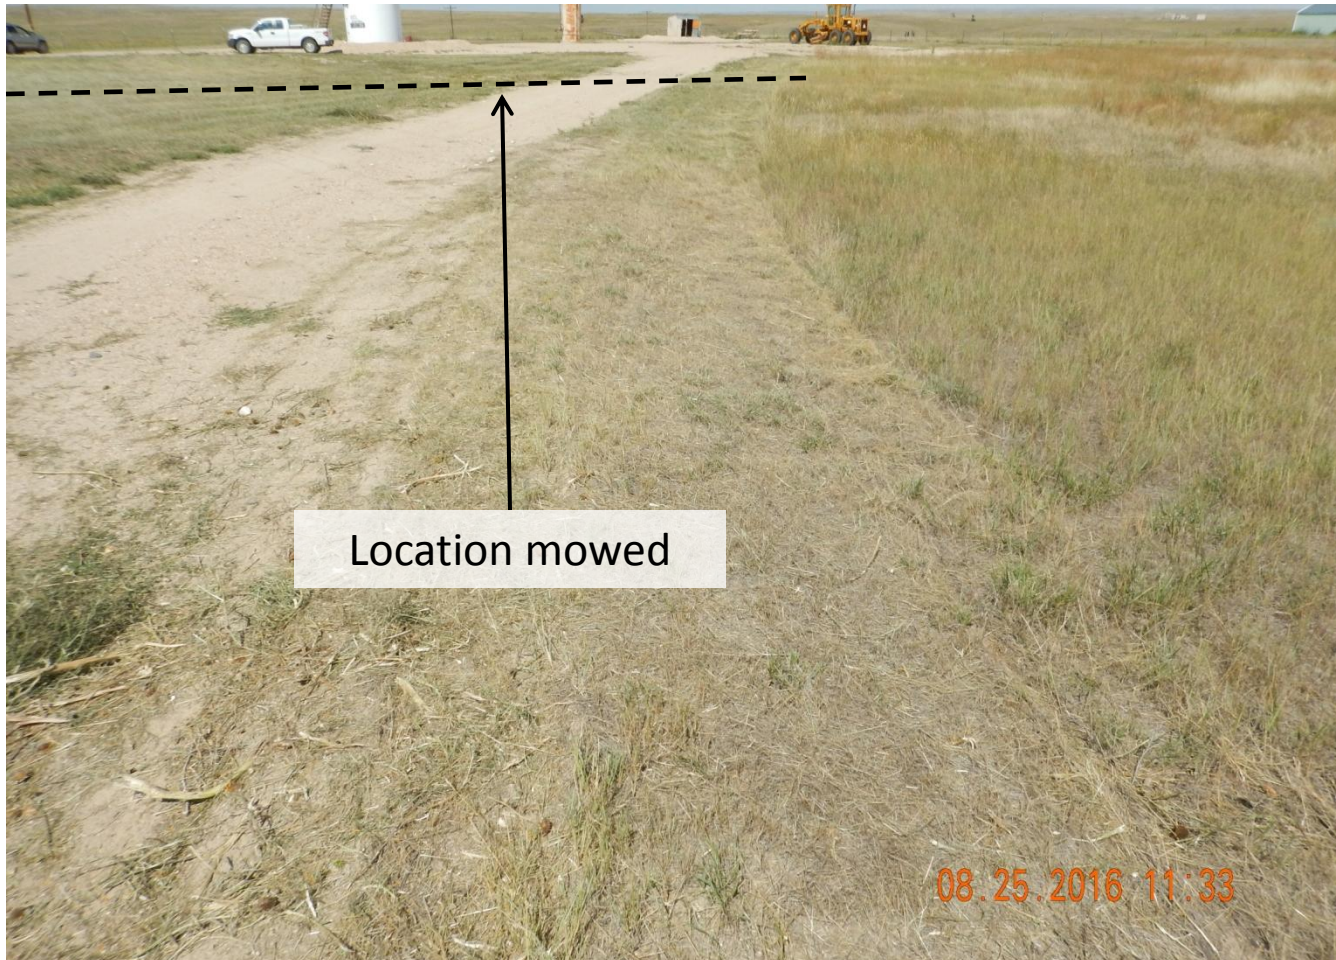
Photo 1. Photo taken from entrance of location, facing West. Location was mowed within the last 2 days based off conversations with other COGCC staff. Complainant has pulled and bagged Diffuse knapweed from this location. A handful of individual Diffuse knapweeds left behind. Diffuse knapweed seed heads were observed in the mowed cuttings.

- 3) Southern Tank battery was mowed. Knapweed was observed in the cuttings and only a handful of individual knapweeds left behind. Foundation instructed on 8/25/16 to pull and bag remaining plants. Foundation instructed on 8/30/16 to collect, remove, and dispose weed debris and seed heads properly from areas that were mowed.

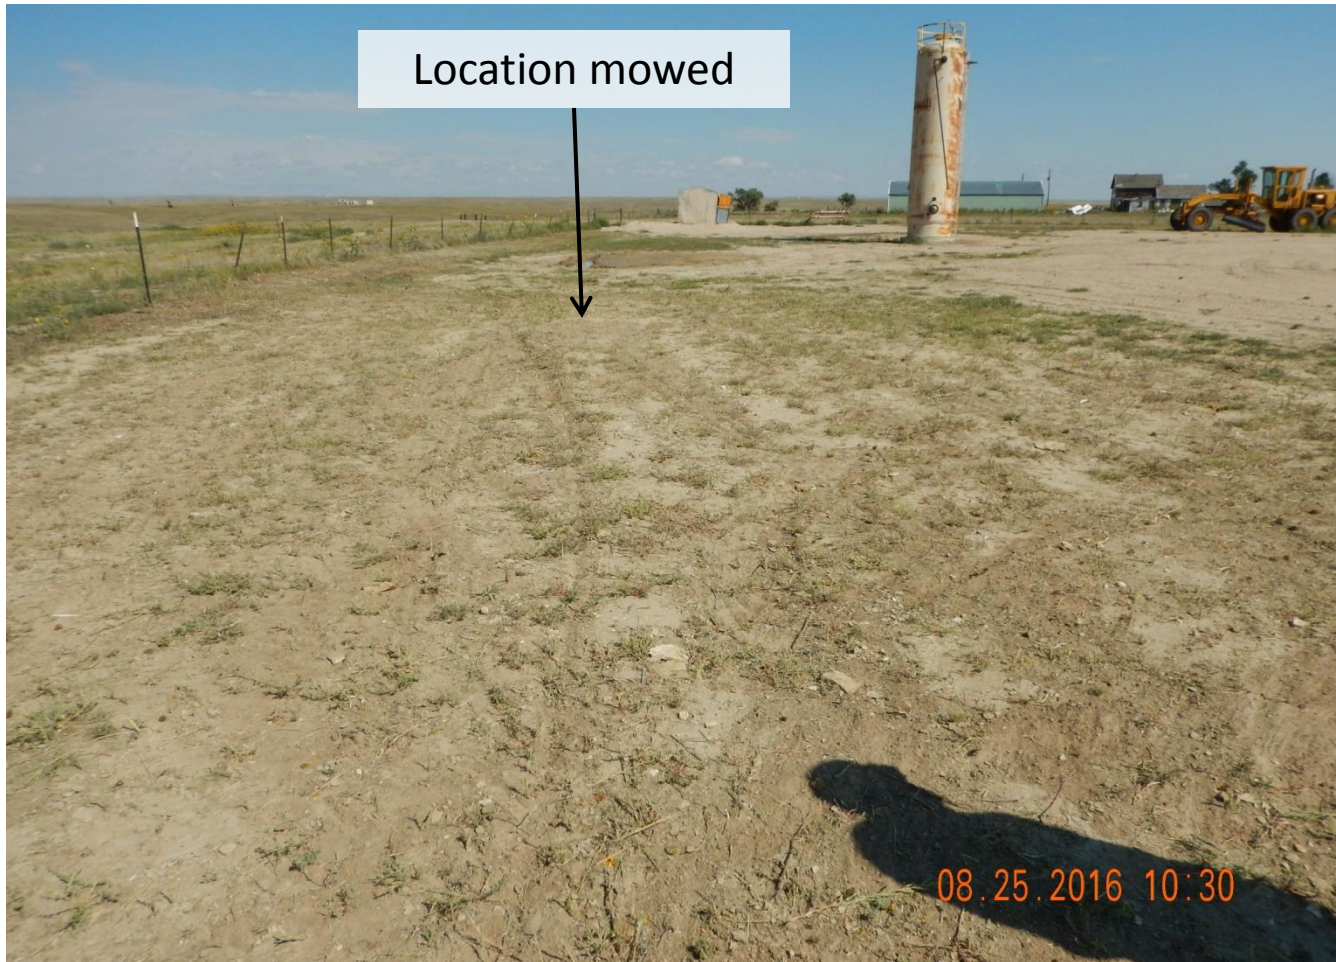
Sooner Unit- Southern Tank battery (Location ID 447525)

Photo 2. Photo taken from southwest location, facing North. Location was mowed within the last 2 days based off conversations with other COGCC staff. Complainant has pulled and bagged Diffuse knapweed from this location. A handful of individual Diffuse knapweeds left behind were observed along the western area.
