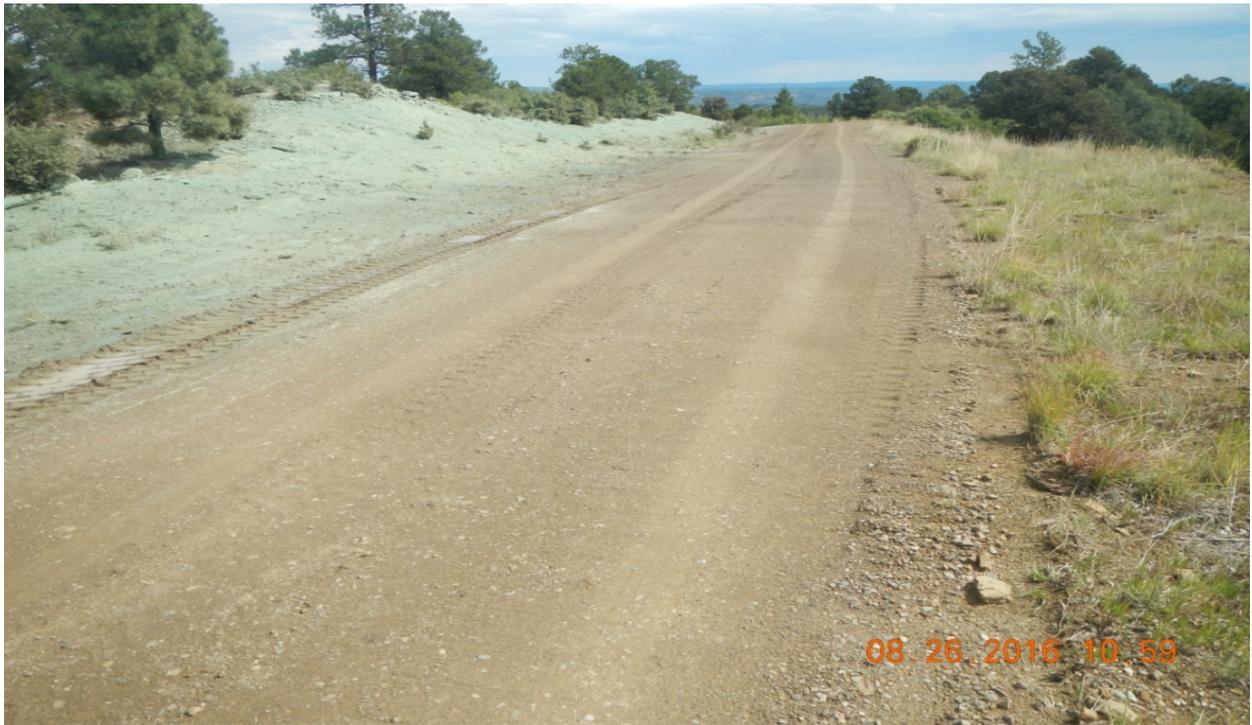
photo 1: Facing north along the access road. The side of the access road was recently seeded and hydro-mulched.

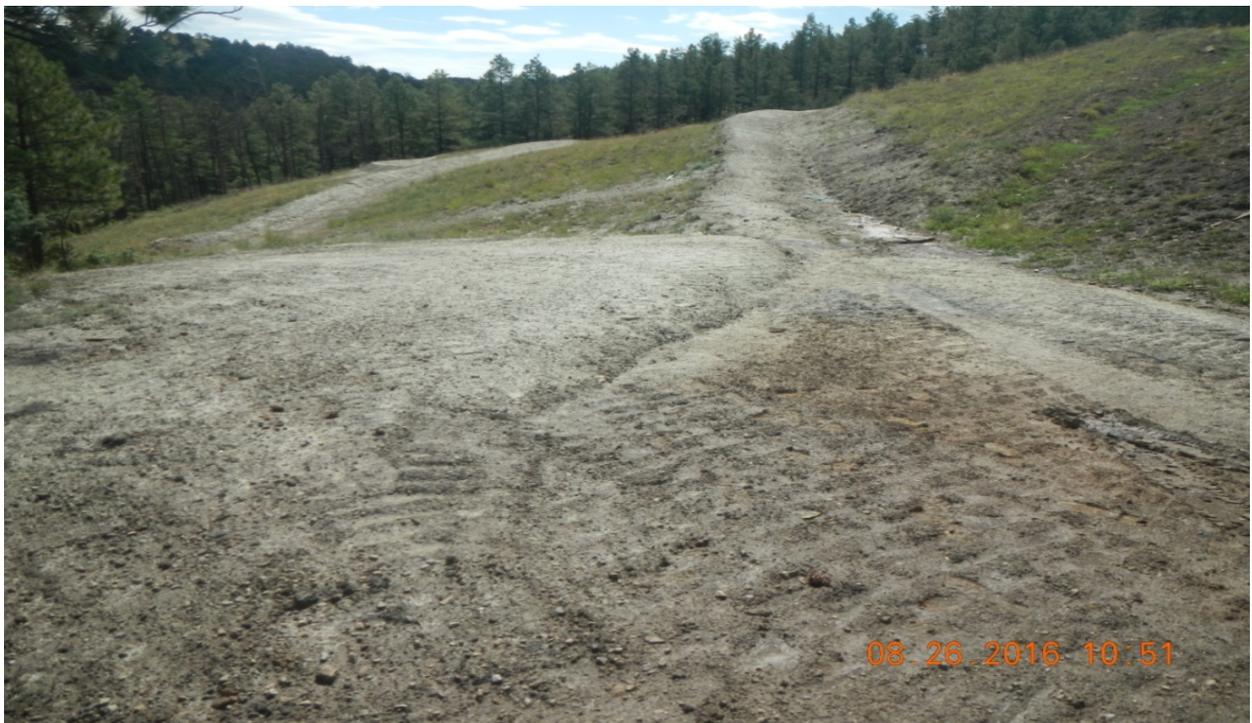
photo 2: Facing east toward the location.
