Foundation Overview- Diffuse knapweed (*Centarea diffusa*)

Sooner Unit- Location ID 447525

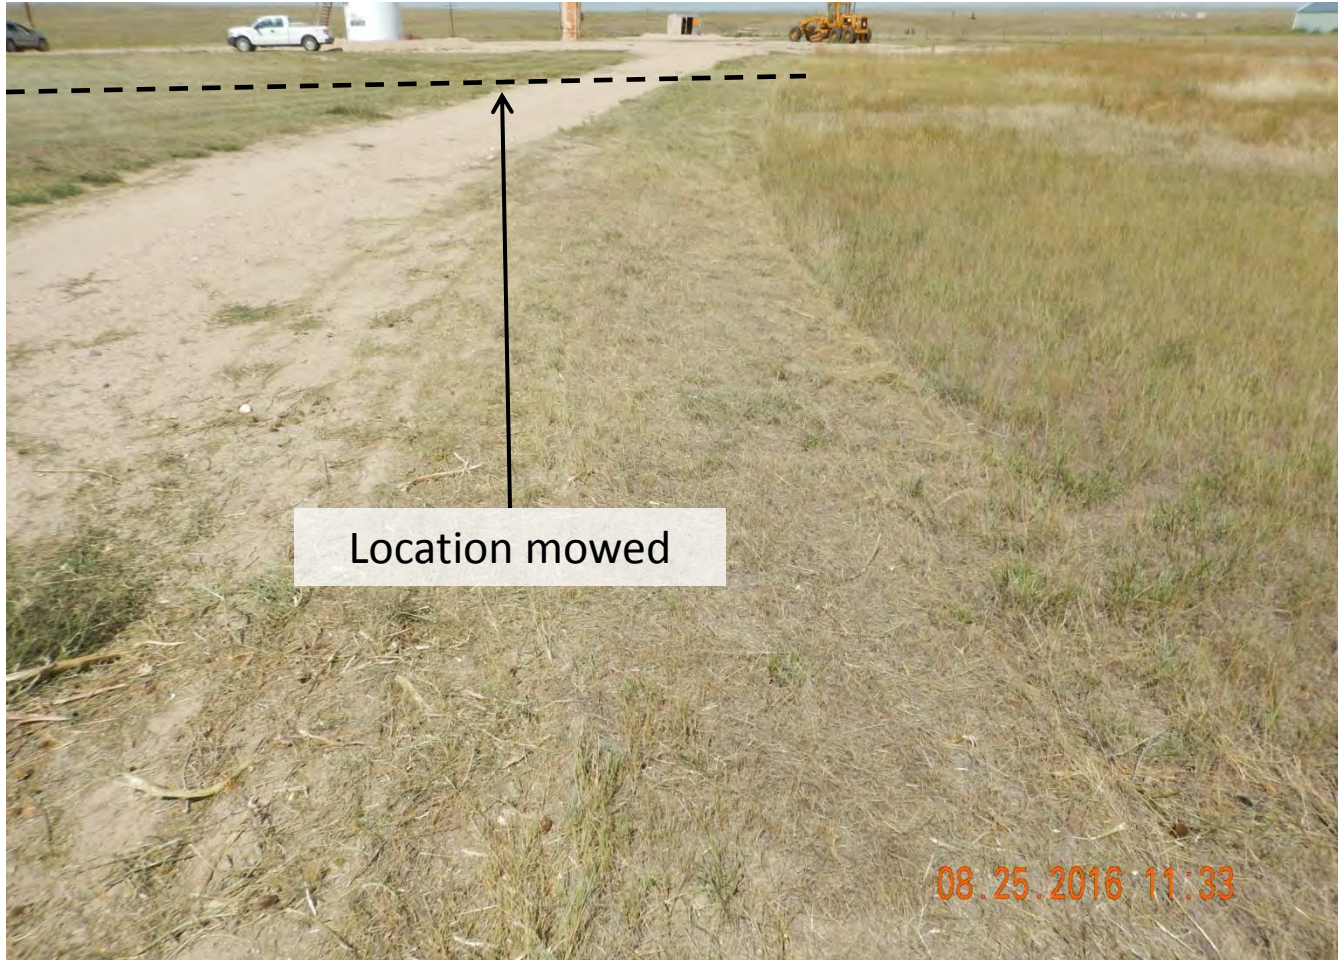
Sooner Unit- Southern Tank battery (Location ID 447525)

- 3) Southern Tank battery was mowed. Knapweed was observed in the cuttings and only a handful of individual knapweeds left behind. Foundation instructed on 8/25/16 to pull and bag remaining plants. Foundation instructed on 8/30/16 to collect, remove, and dispose weed debris and seed heads properly from areas that were mowed.

Photo 1. Photo taken from entrance of location, facing West. Location was mowed within the last 2 days based off conversations with other COGCC staff. Complainant has pulled and bagged Diffuse knapweed from this location. A handful of individual Diffuse knapweeds left behind. Diffuse knapweed seed heads were observed in the mowed cuttings.

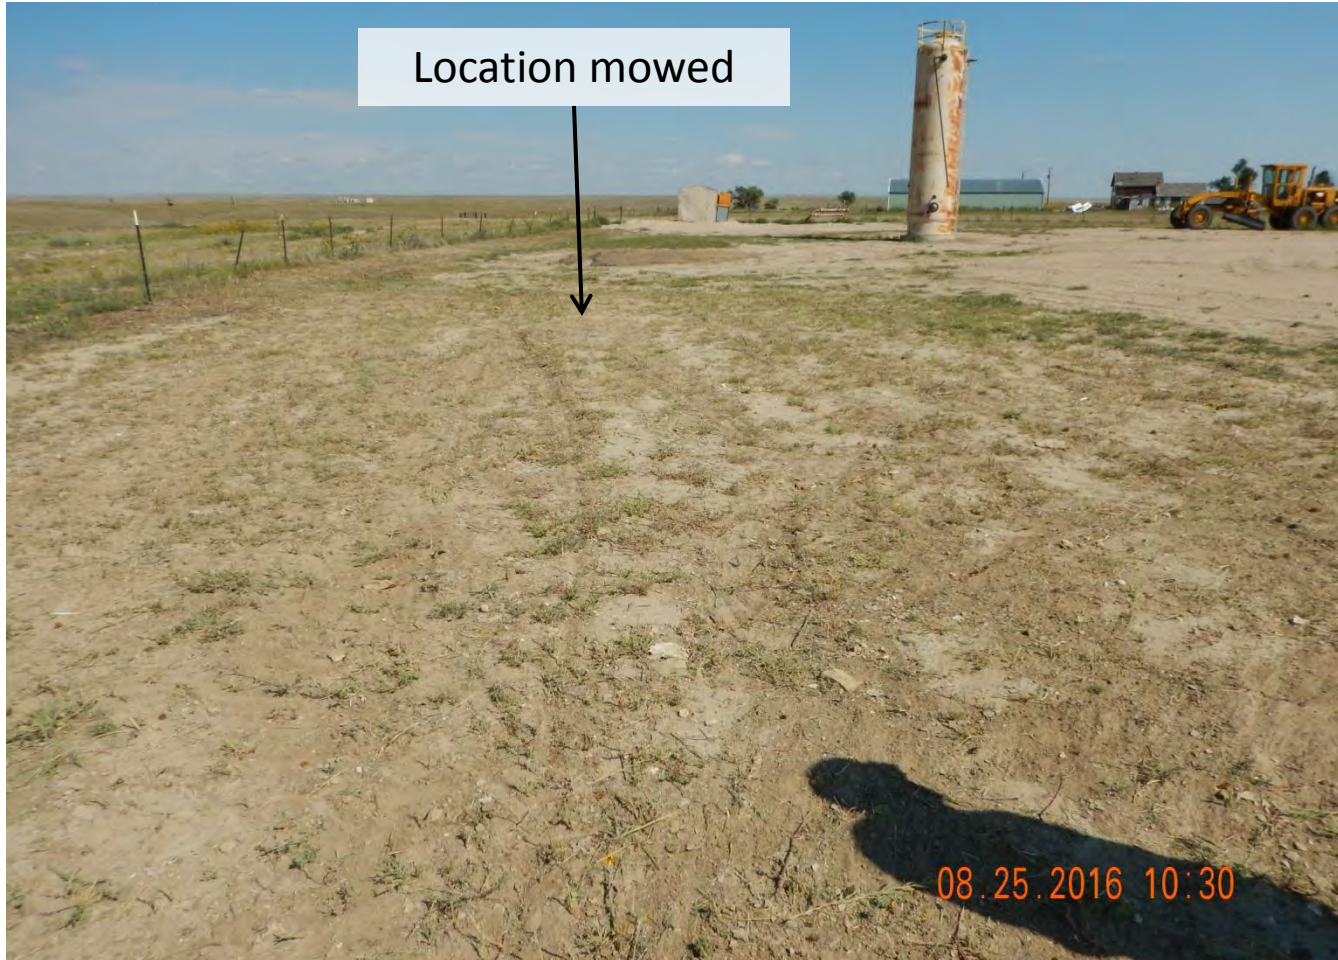
Sooner Unit- Southern Tank battery (Location ID 447525)

Photo 2. Photo taken from southwest location, facing North. Location was mowed within the last 2 days based off conversations with other COGCC staff. Complainant has pulled and bagged Diffuse knapweed from this location. A handful of individual Diffuse knapweeds left behind were observed along the western area.
