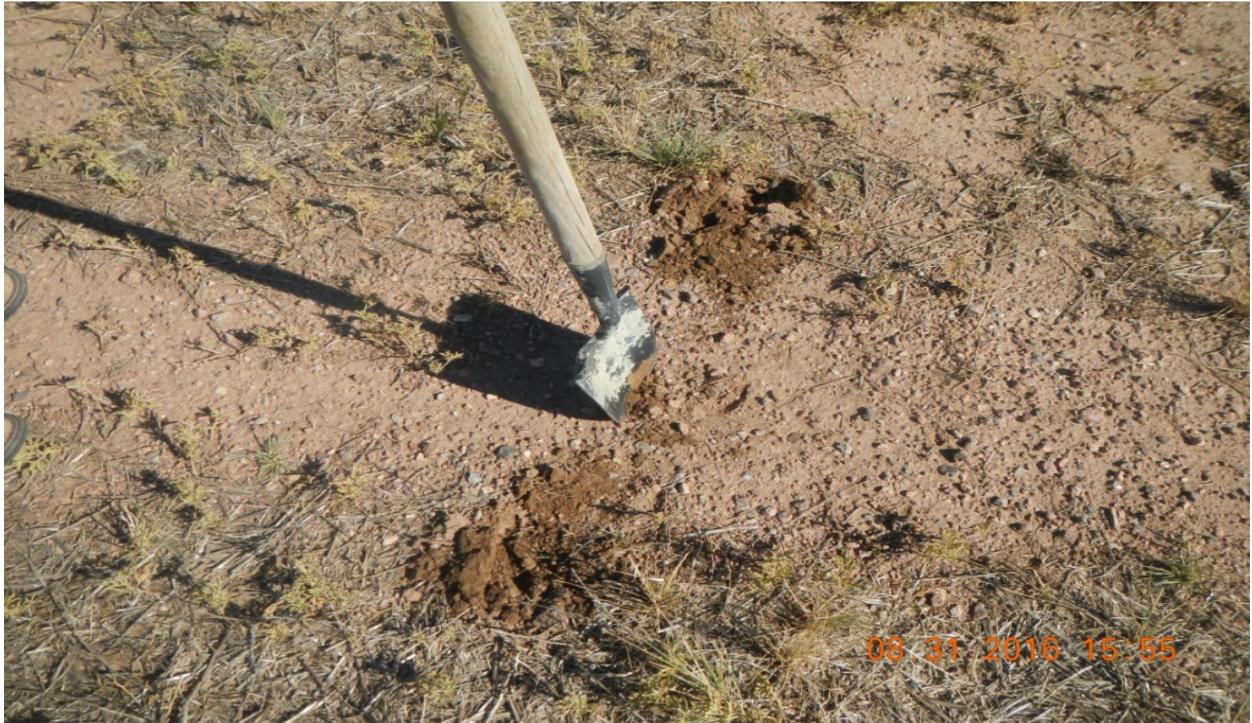
photo 9: The soils were checked for compaction along the access road. There were areas that seemed to be compacted.
