Construction Inspection

09/09/2016

Operator: Grynberg Petroleum Co

Location ID: 386901

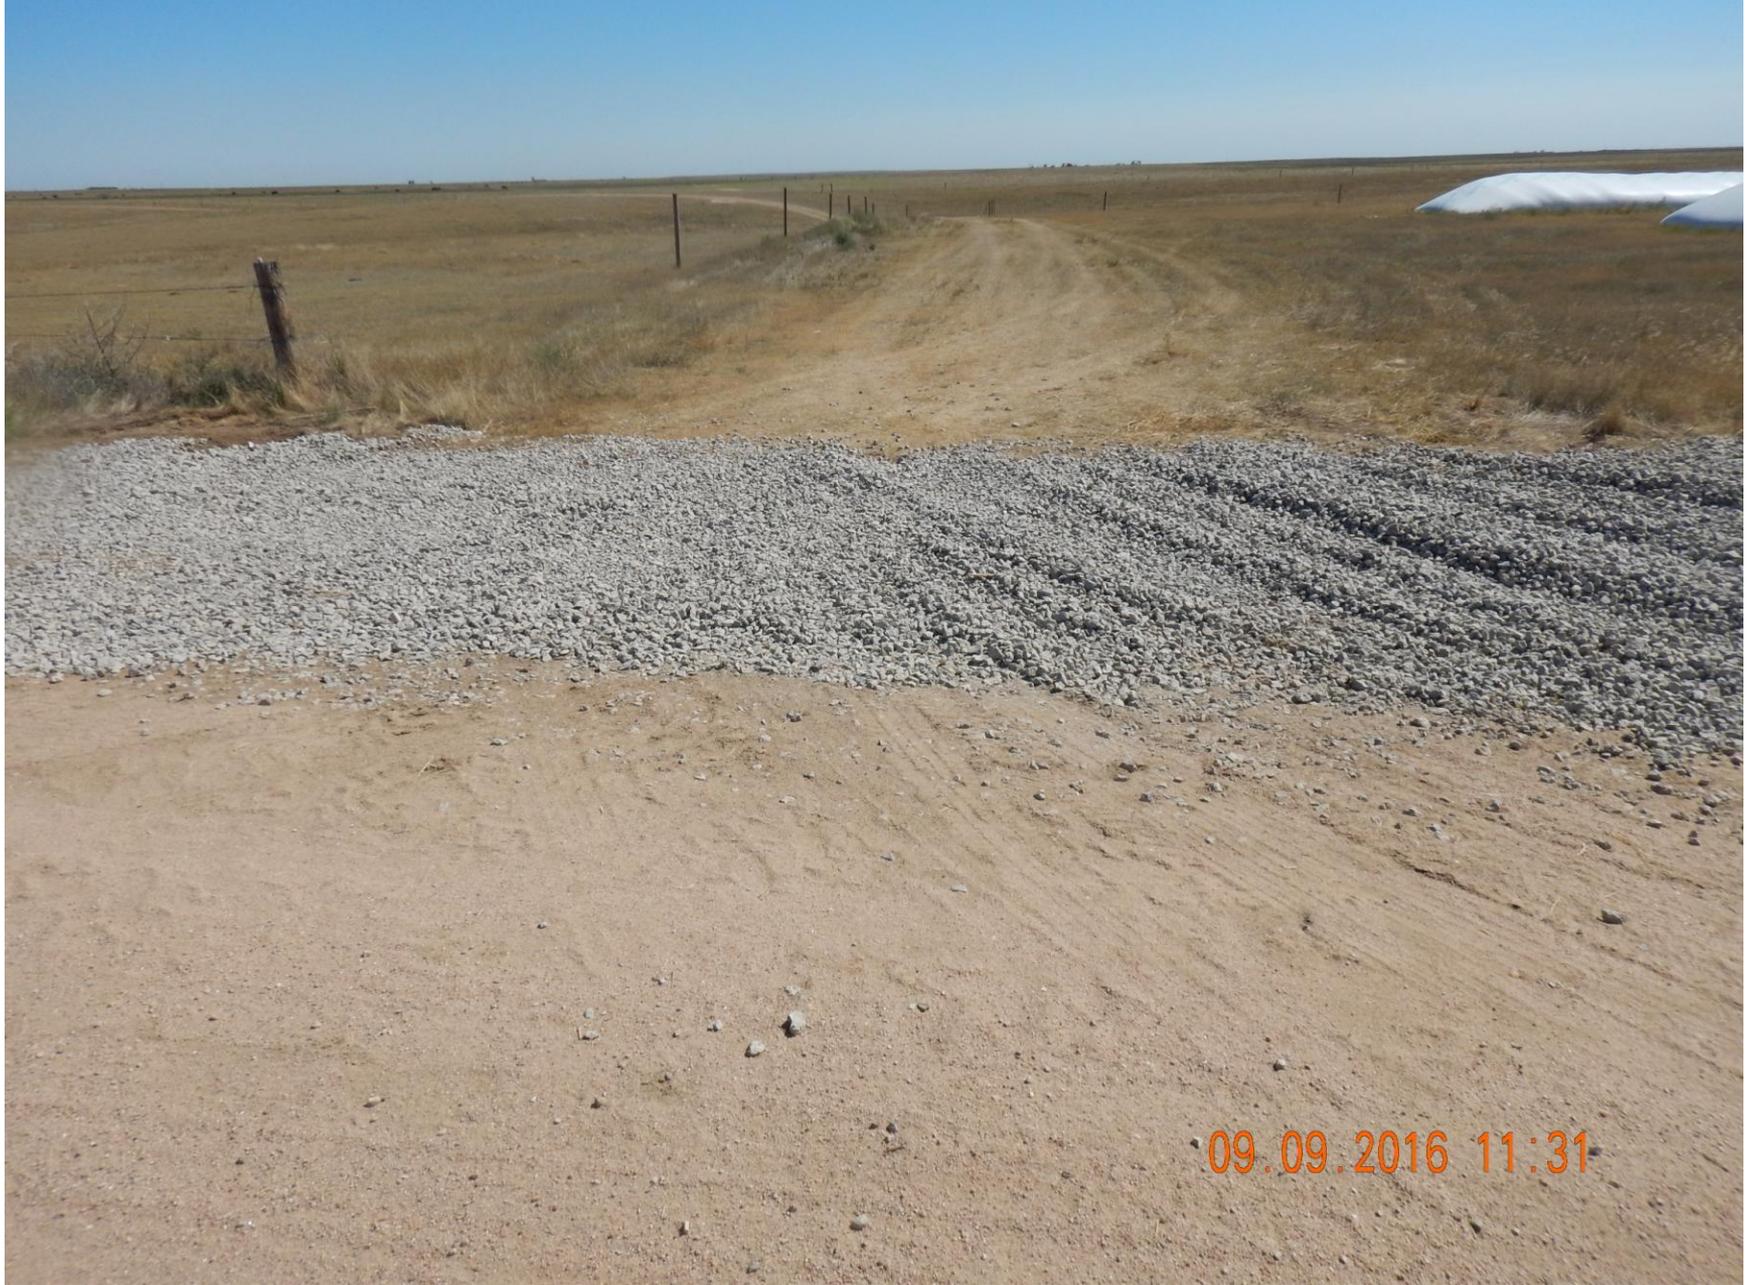
Figure 1: Photo taken from CR 46, facing east. Photo shows vehicle tracking BMP installed at access road entrance.

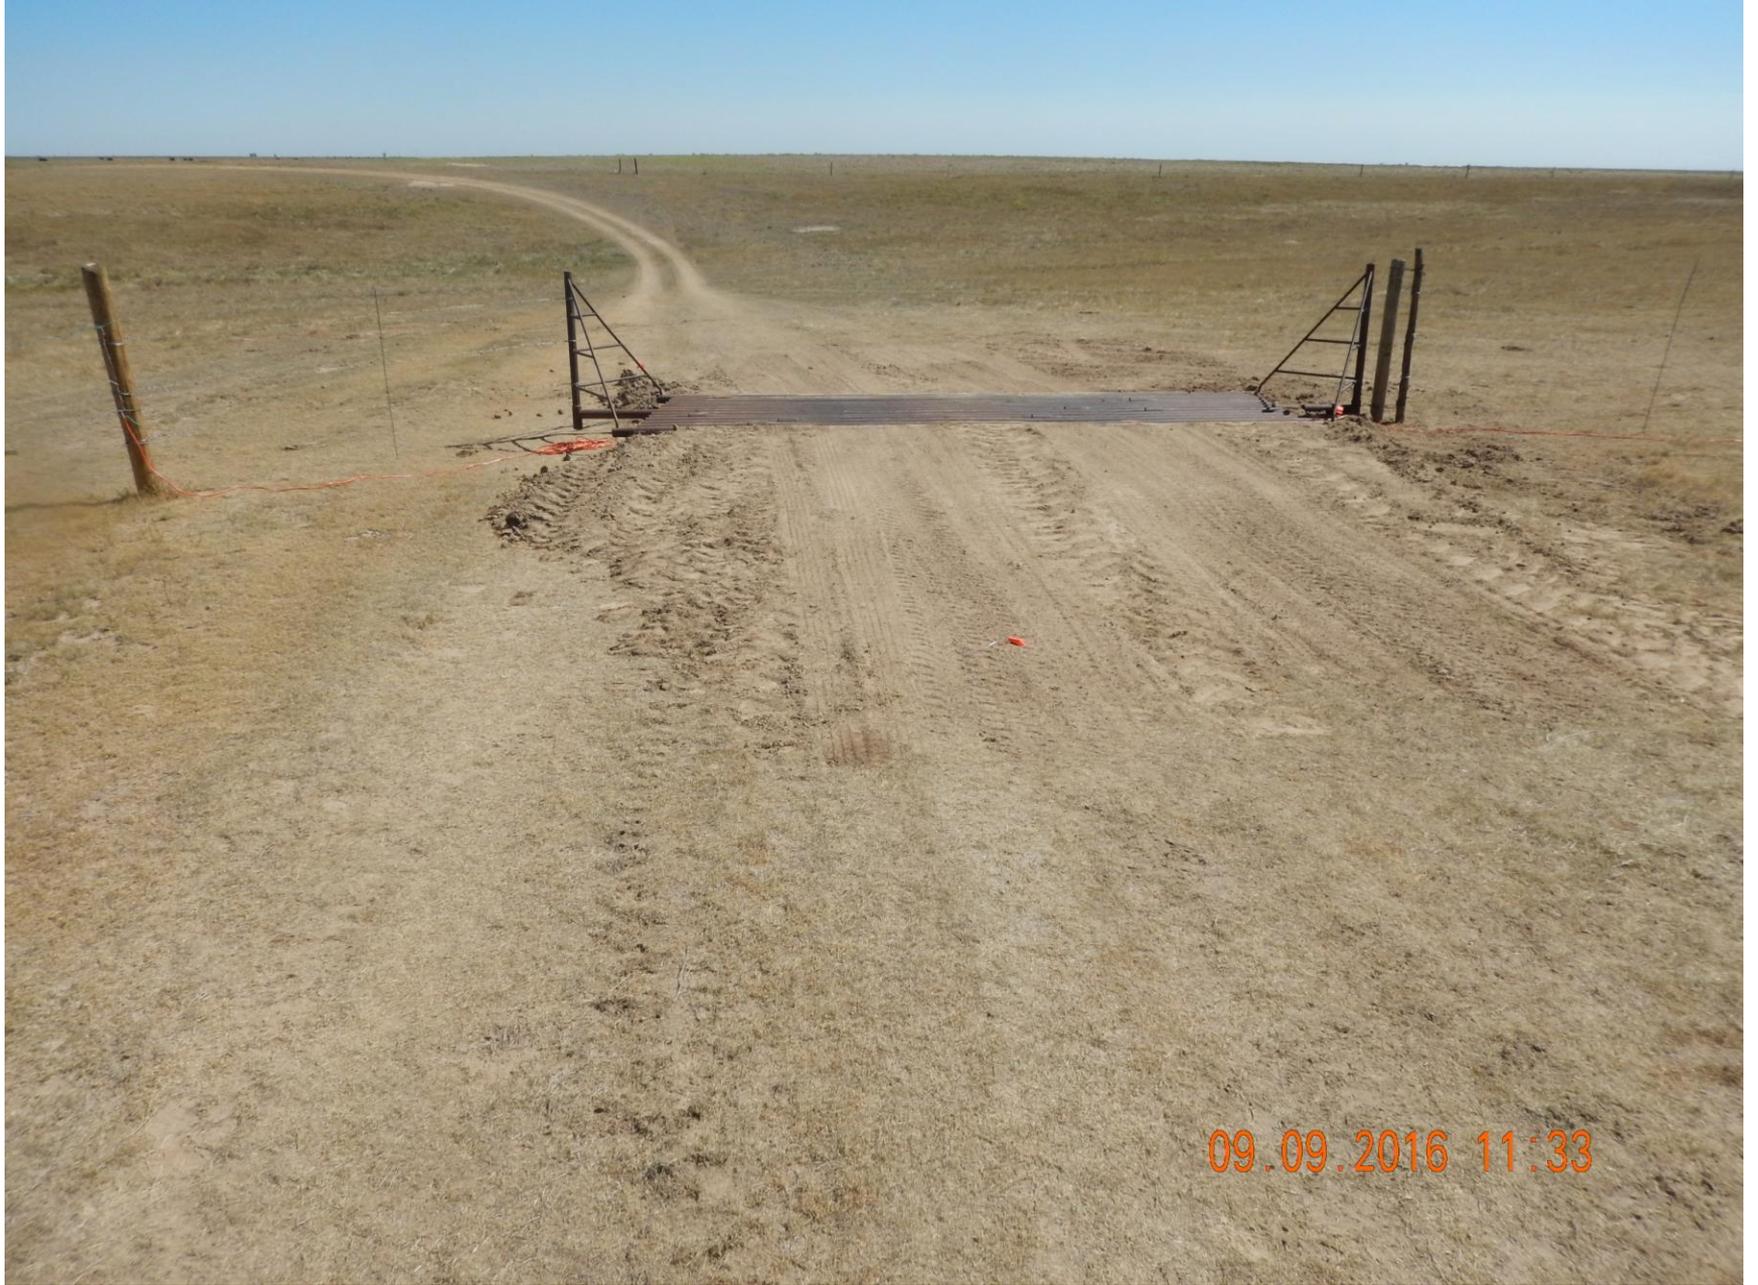
Figure 2: Photo taken from the access road, facing east. Photo shows cattle guard installed on access road.

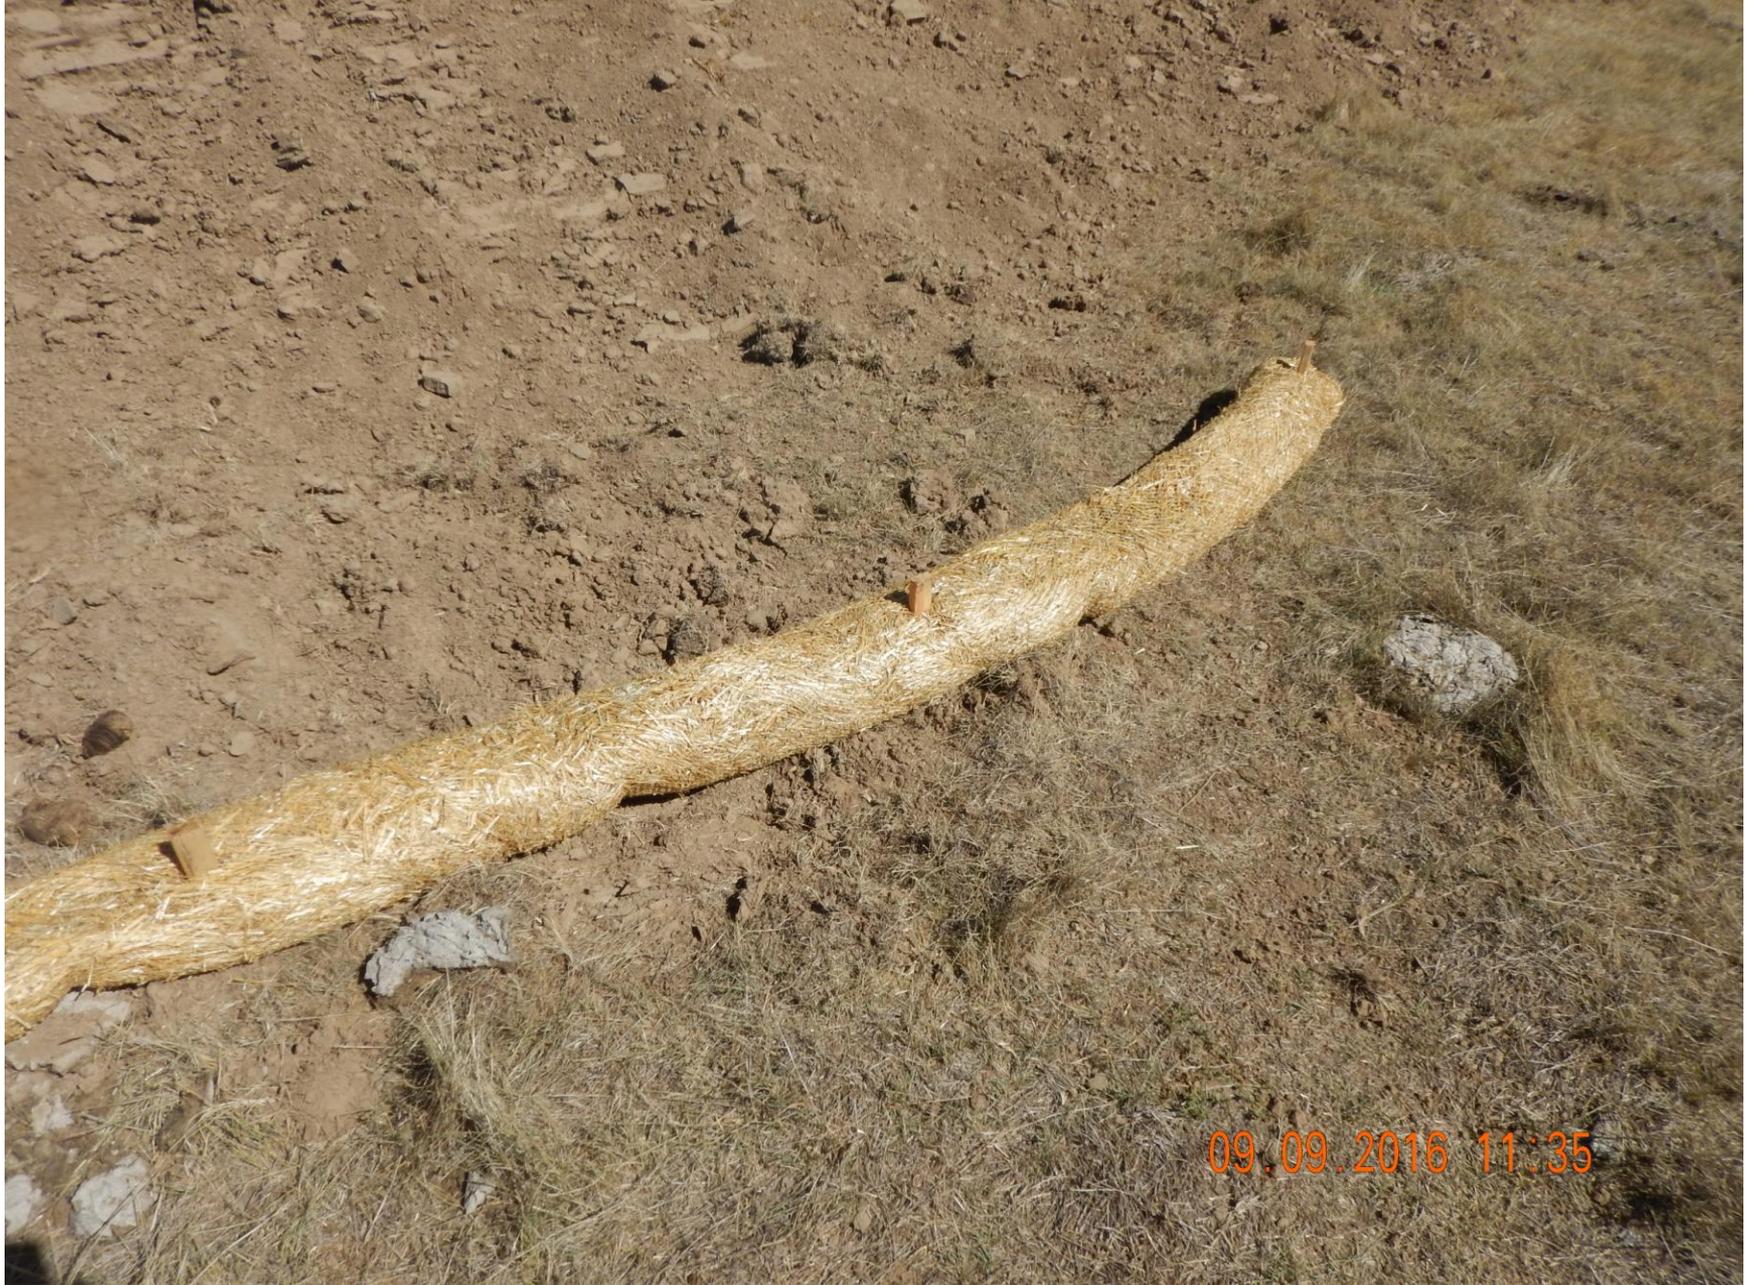
Figure 7: Photo taken from the southwest corner of the location. Photo shows straw wattle used as a stormwater and sediment control BMP improperly installed. Wattles need to be entrenched in order to be in proper functioning condition.

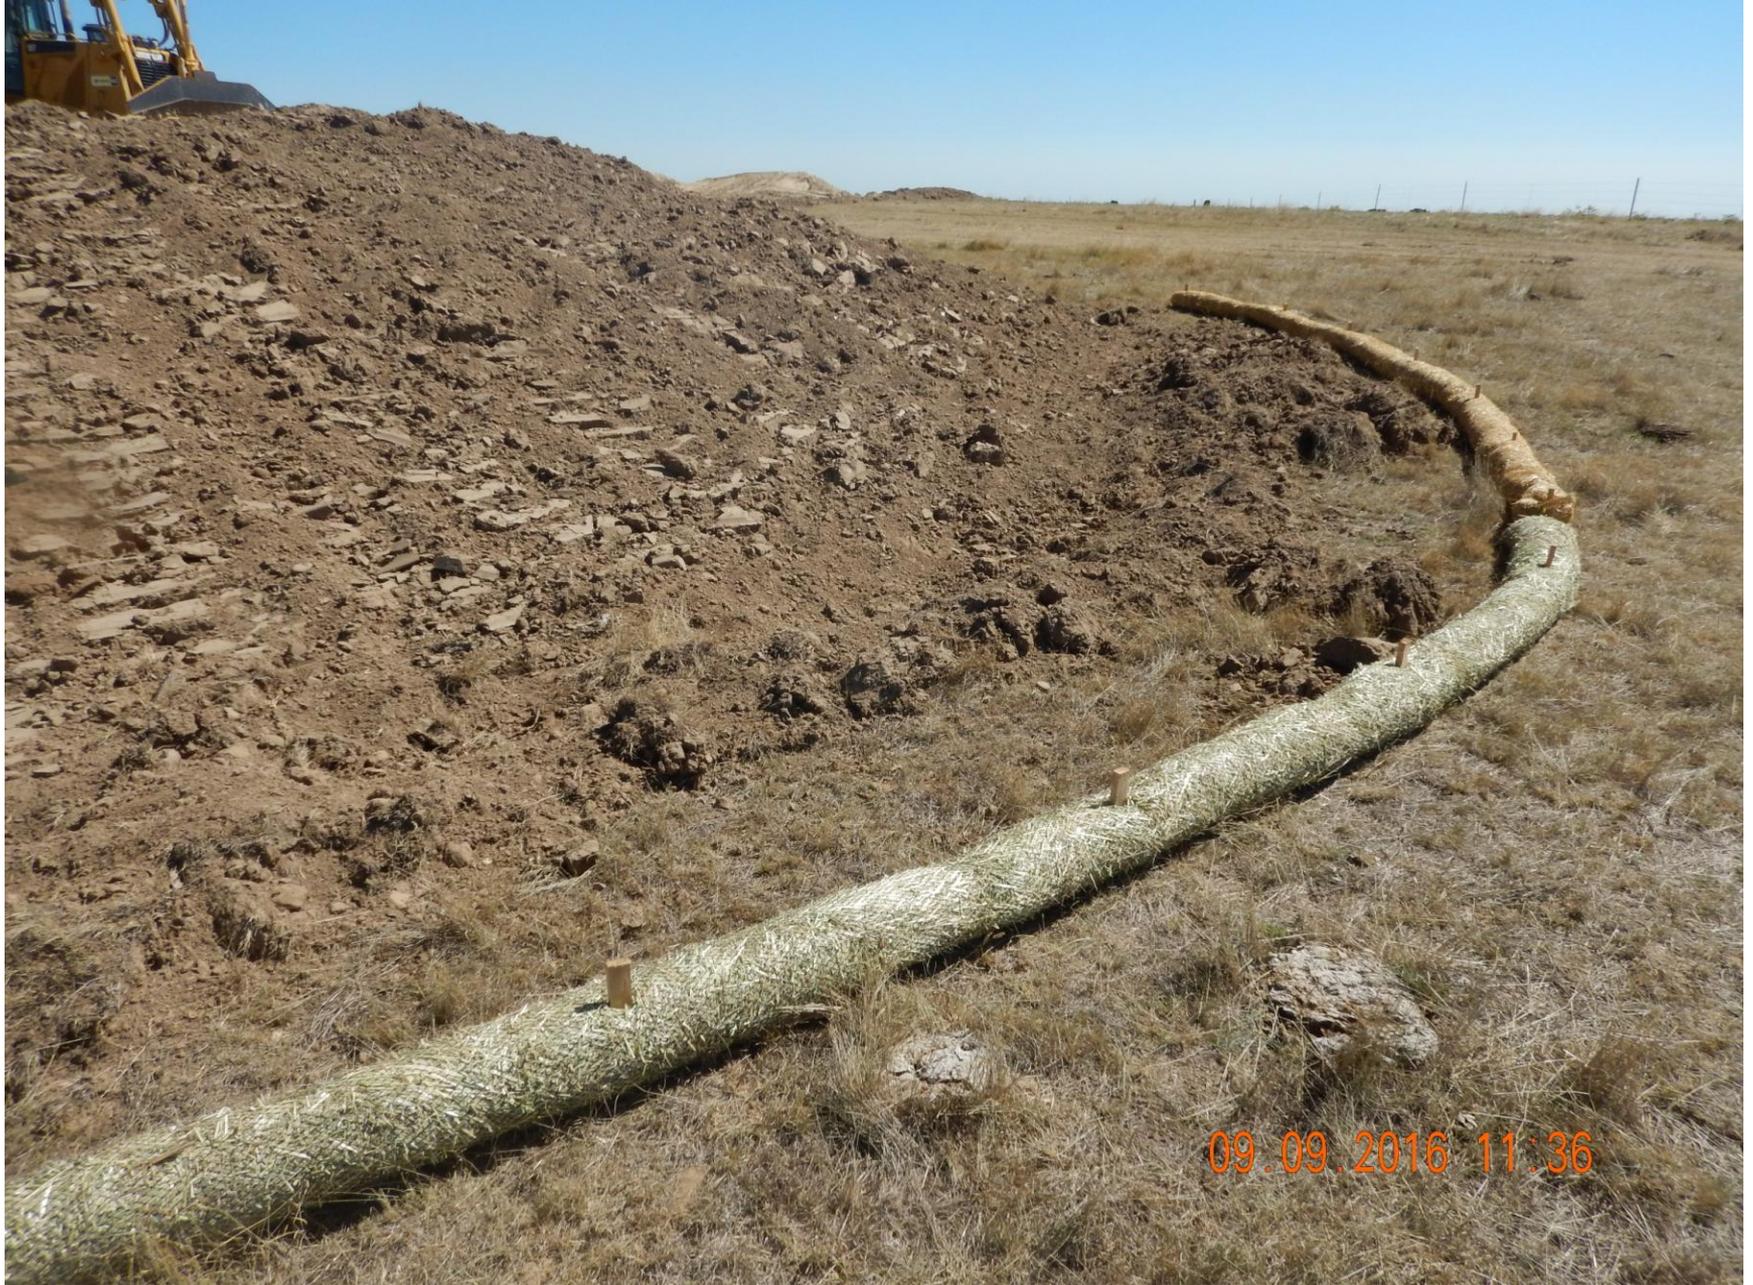
Figure 8: Photo taken from the southwest corner of the location, facing east. Photo shows straw wattles at base of the western end of the location. Wattles improperly installed; need to be entrenched in order to be in proper functioning condition.

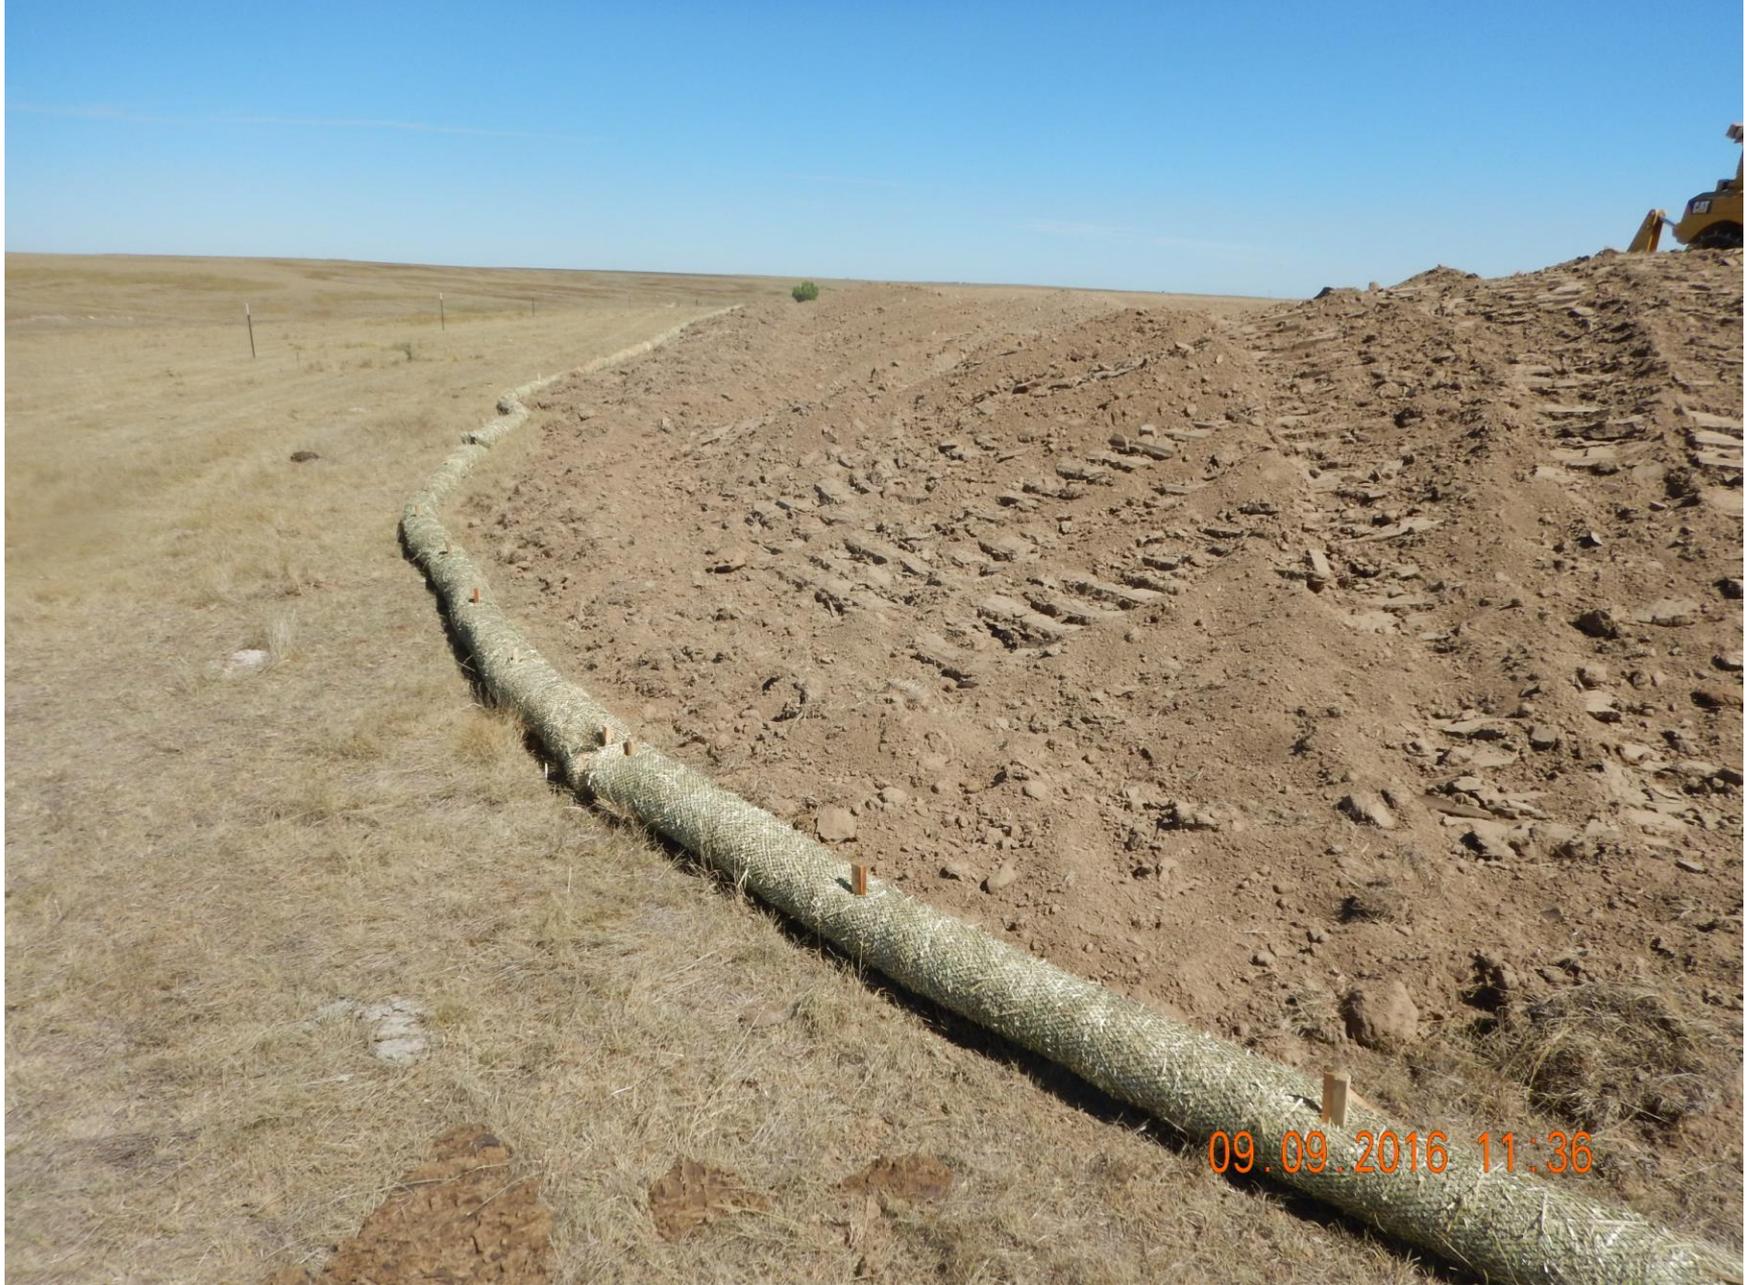
Figure 9: Photo taken from the southwest corner of the location, facing north. Photo shows straw wattles at base of the western end of the location. Wattles improperly installed; need to be entrenched in order to be in proper functioning condition. Unclear if soil seen on perimeter is topsoil.

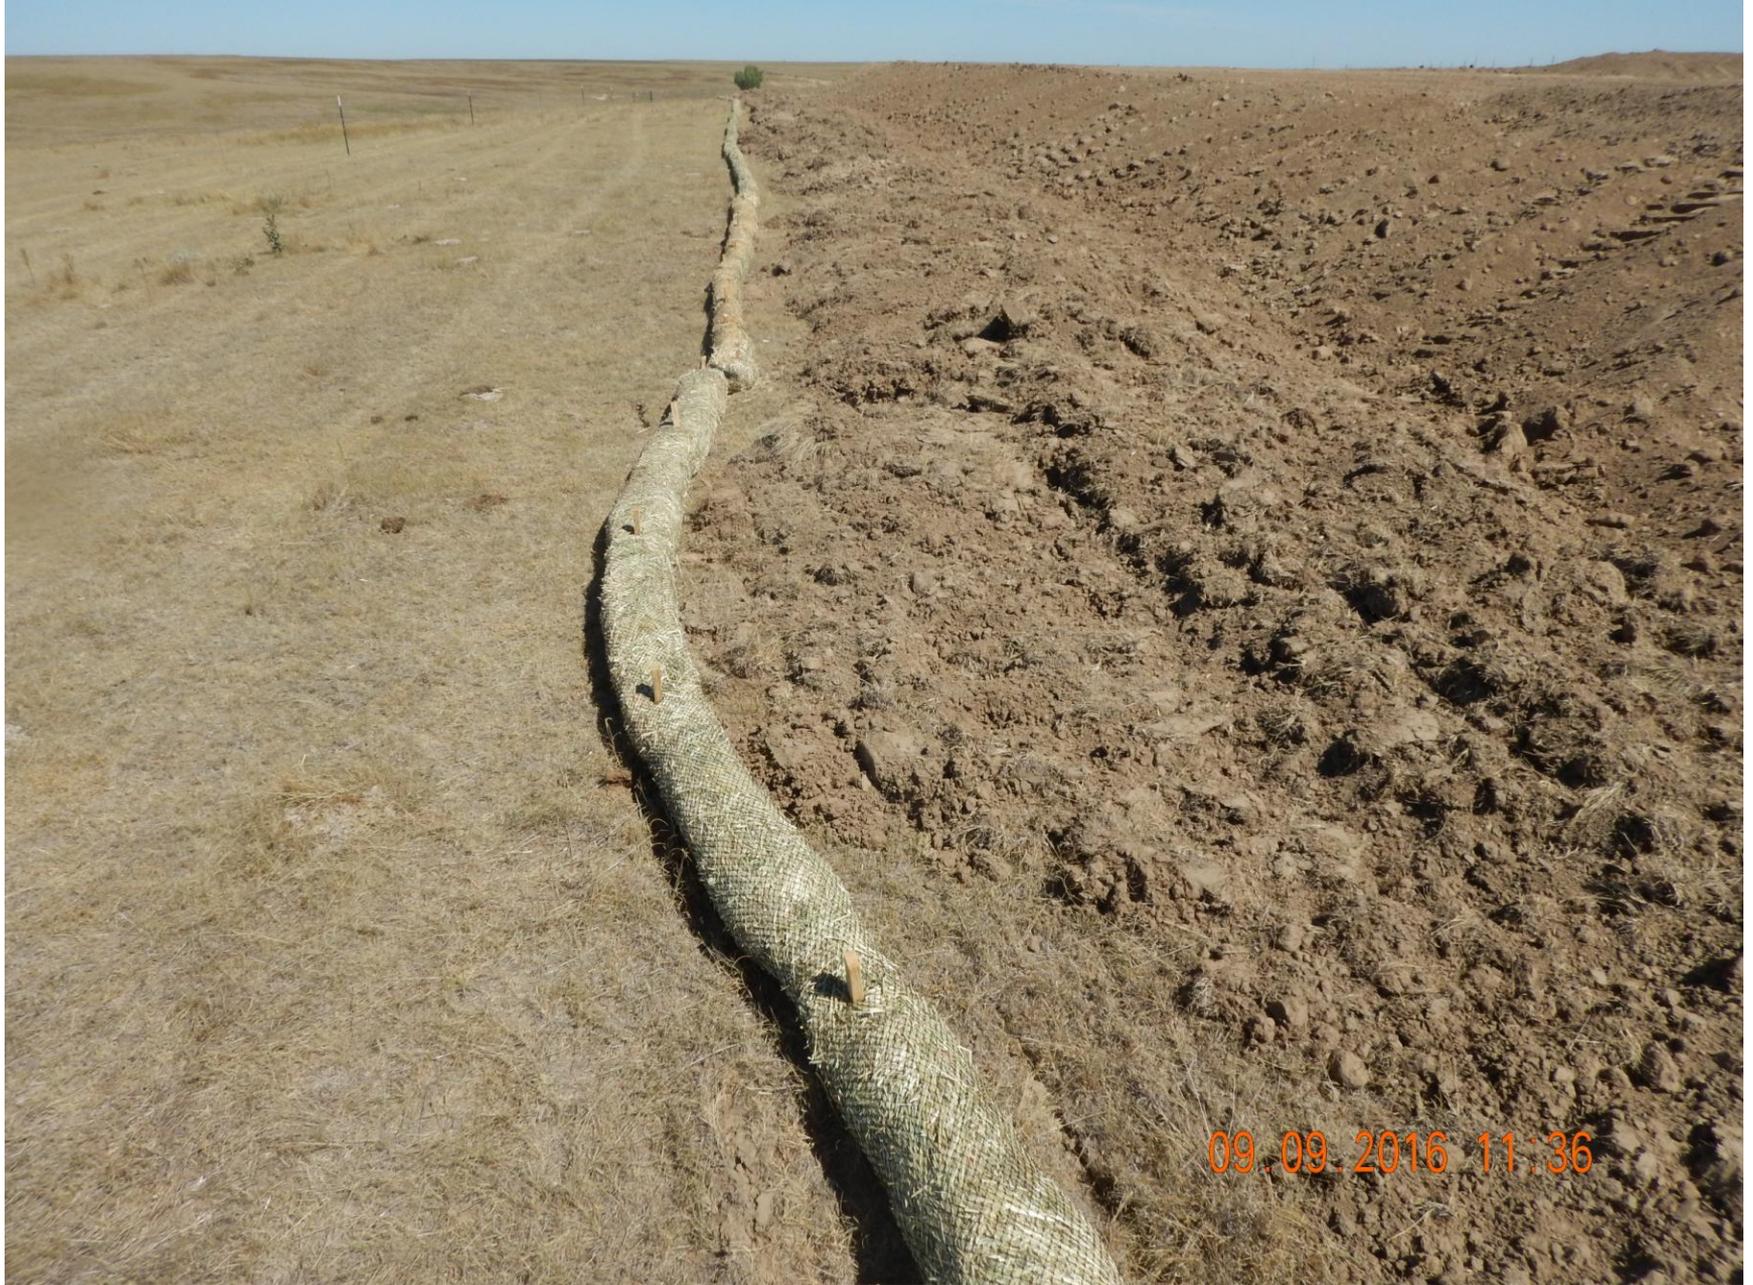
Figure 10: Photo taken from the west end of the location, facing west. Wattles improperly installed; need to be entrenched in order to be in proper functioning condition. It is unclear if soil seen on perimeter is topsoil.

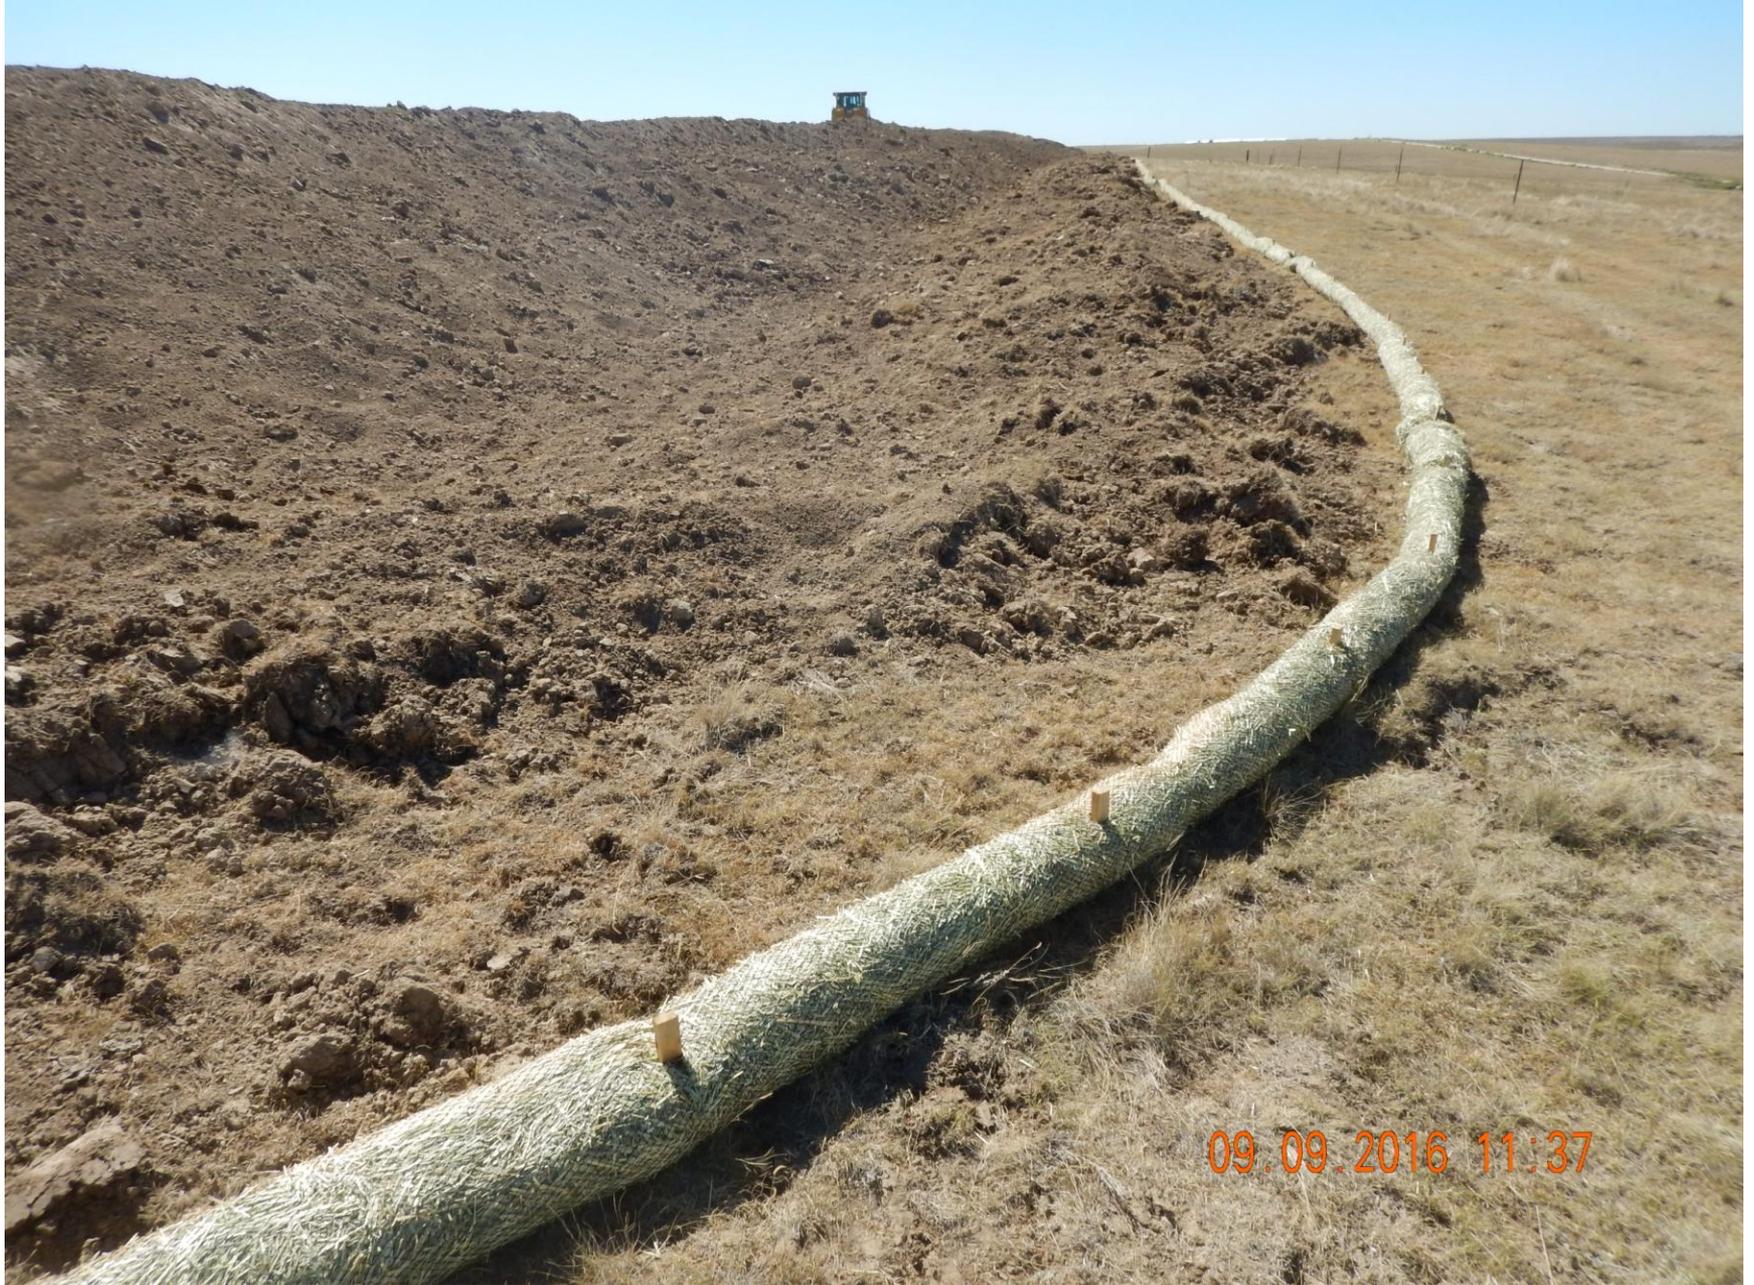
Figure 11: Photo taken from the northwest corner of the location, facing north. Photo shows straw wattles at base of the western end of the location. Wattles improperly installed; need to be entrenched in order to be in proper functioning condition. Unclear if soil seen on perimeter is topsoil.

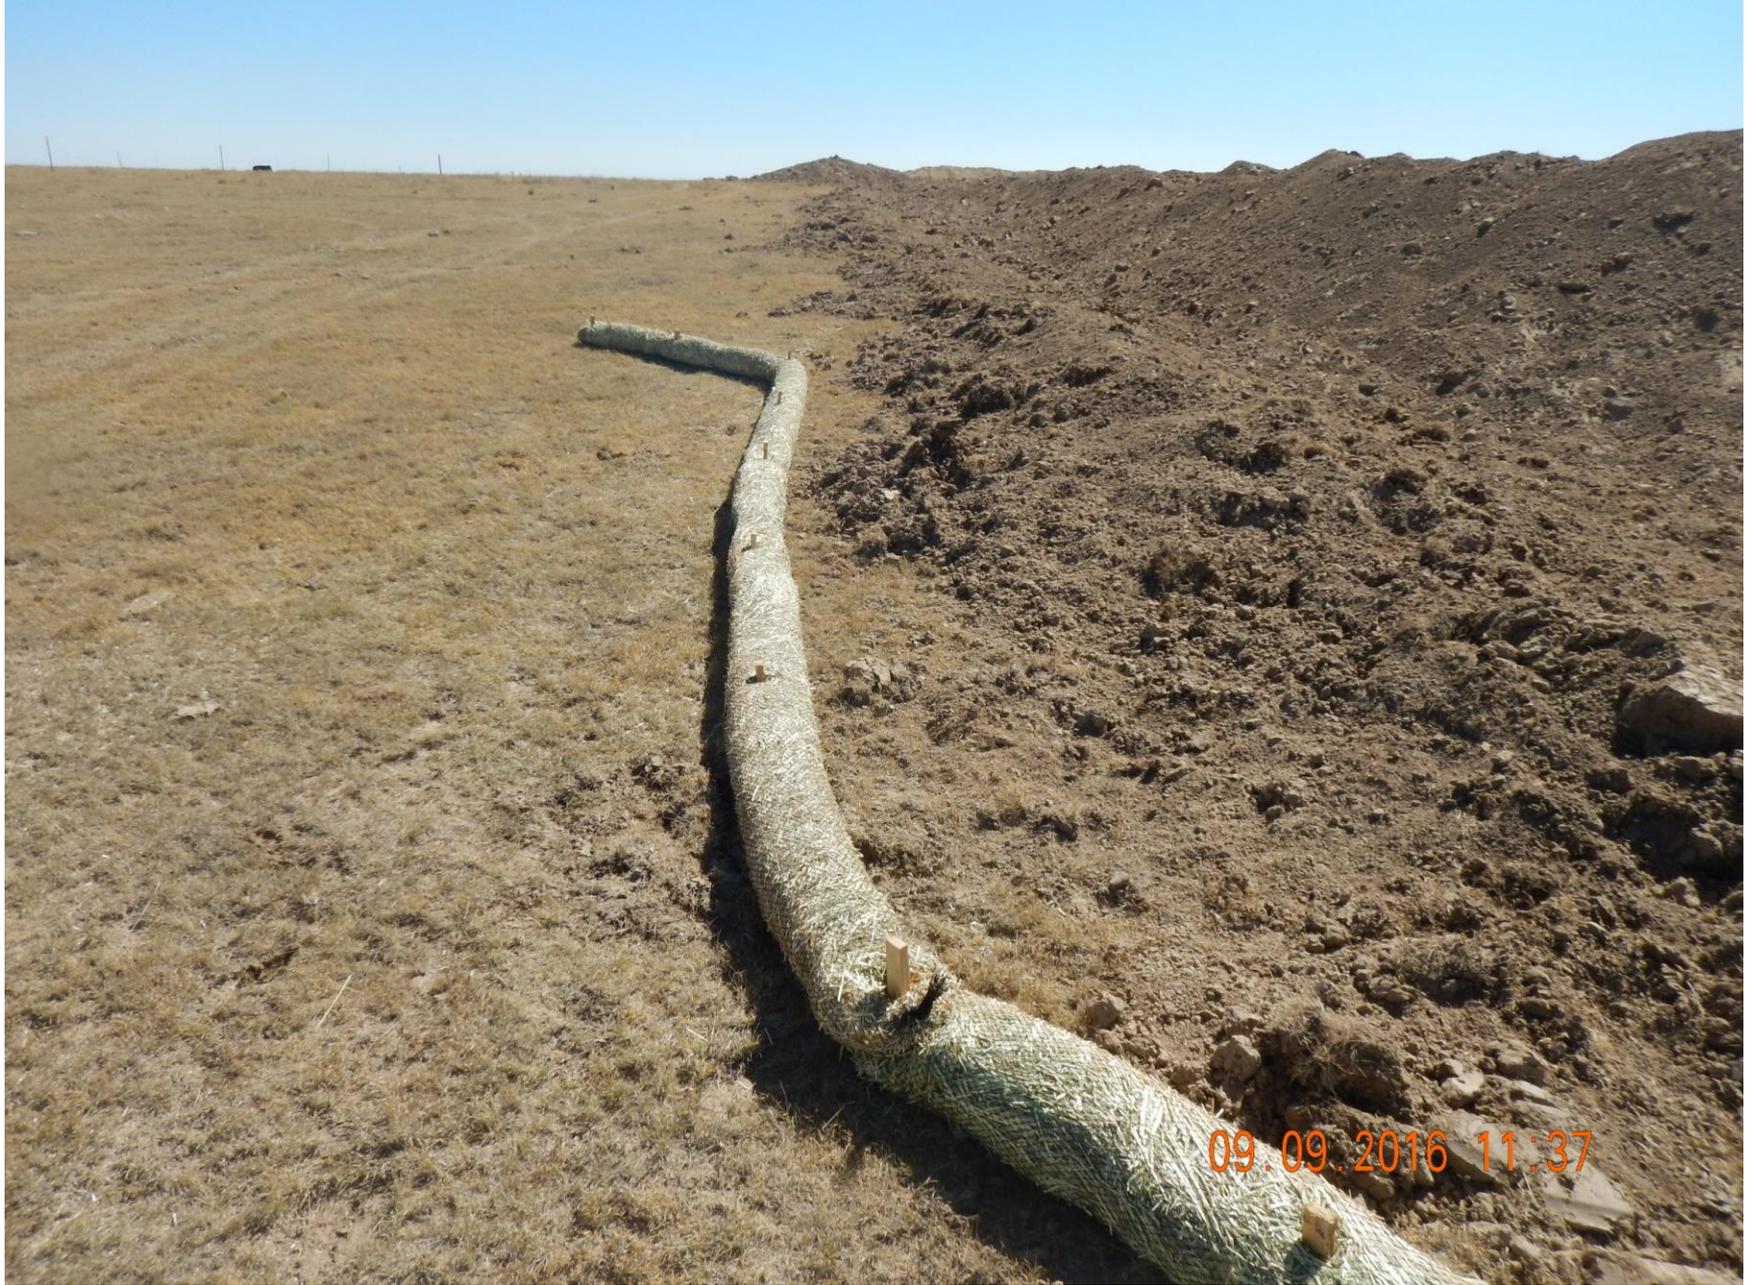
Figure 12: Photo taken from the northwest corner of the location, facing east. Photo shows straw wattles at base of the western end of the location. Wattles improperly installed; need to be entrenched in order to be in proper functioning condition. Unclear if soil seen on perimeter is topsoil.

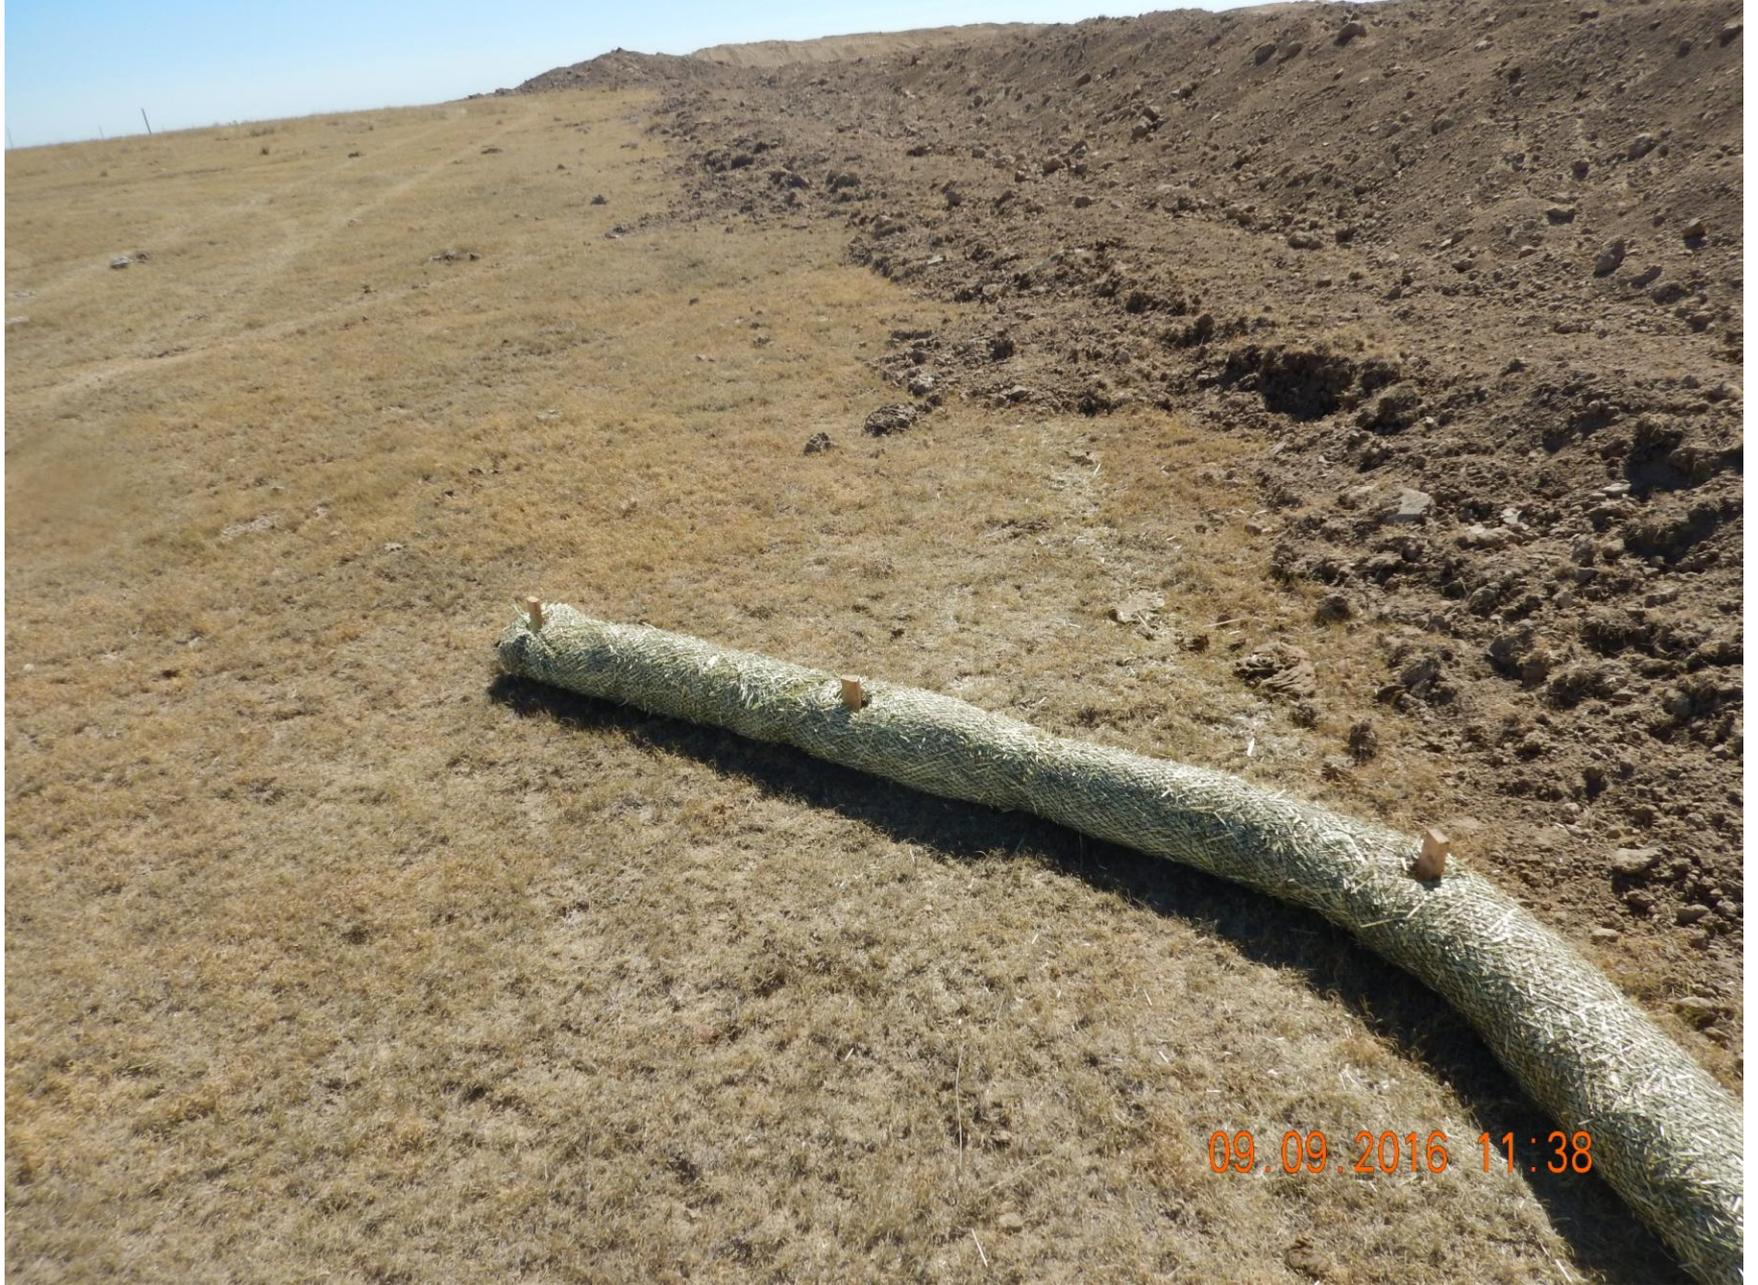
Figure 13: Photo taken from the northwest corner of the location, facing east. Photo shows wattles improperly installed; need to be entrenched in order to be in proper functioning condition. Note: “J-hook” seen here does not appear to be large enough to capture stormwater from the north end of the location. **Advise increasing size of “j-hook”**

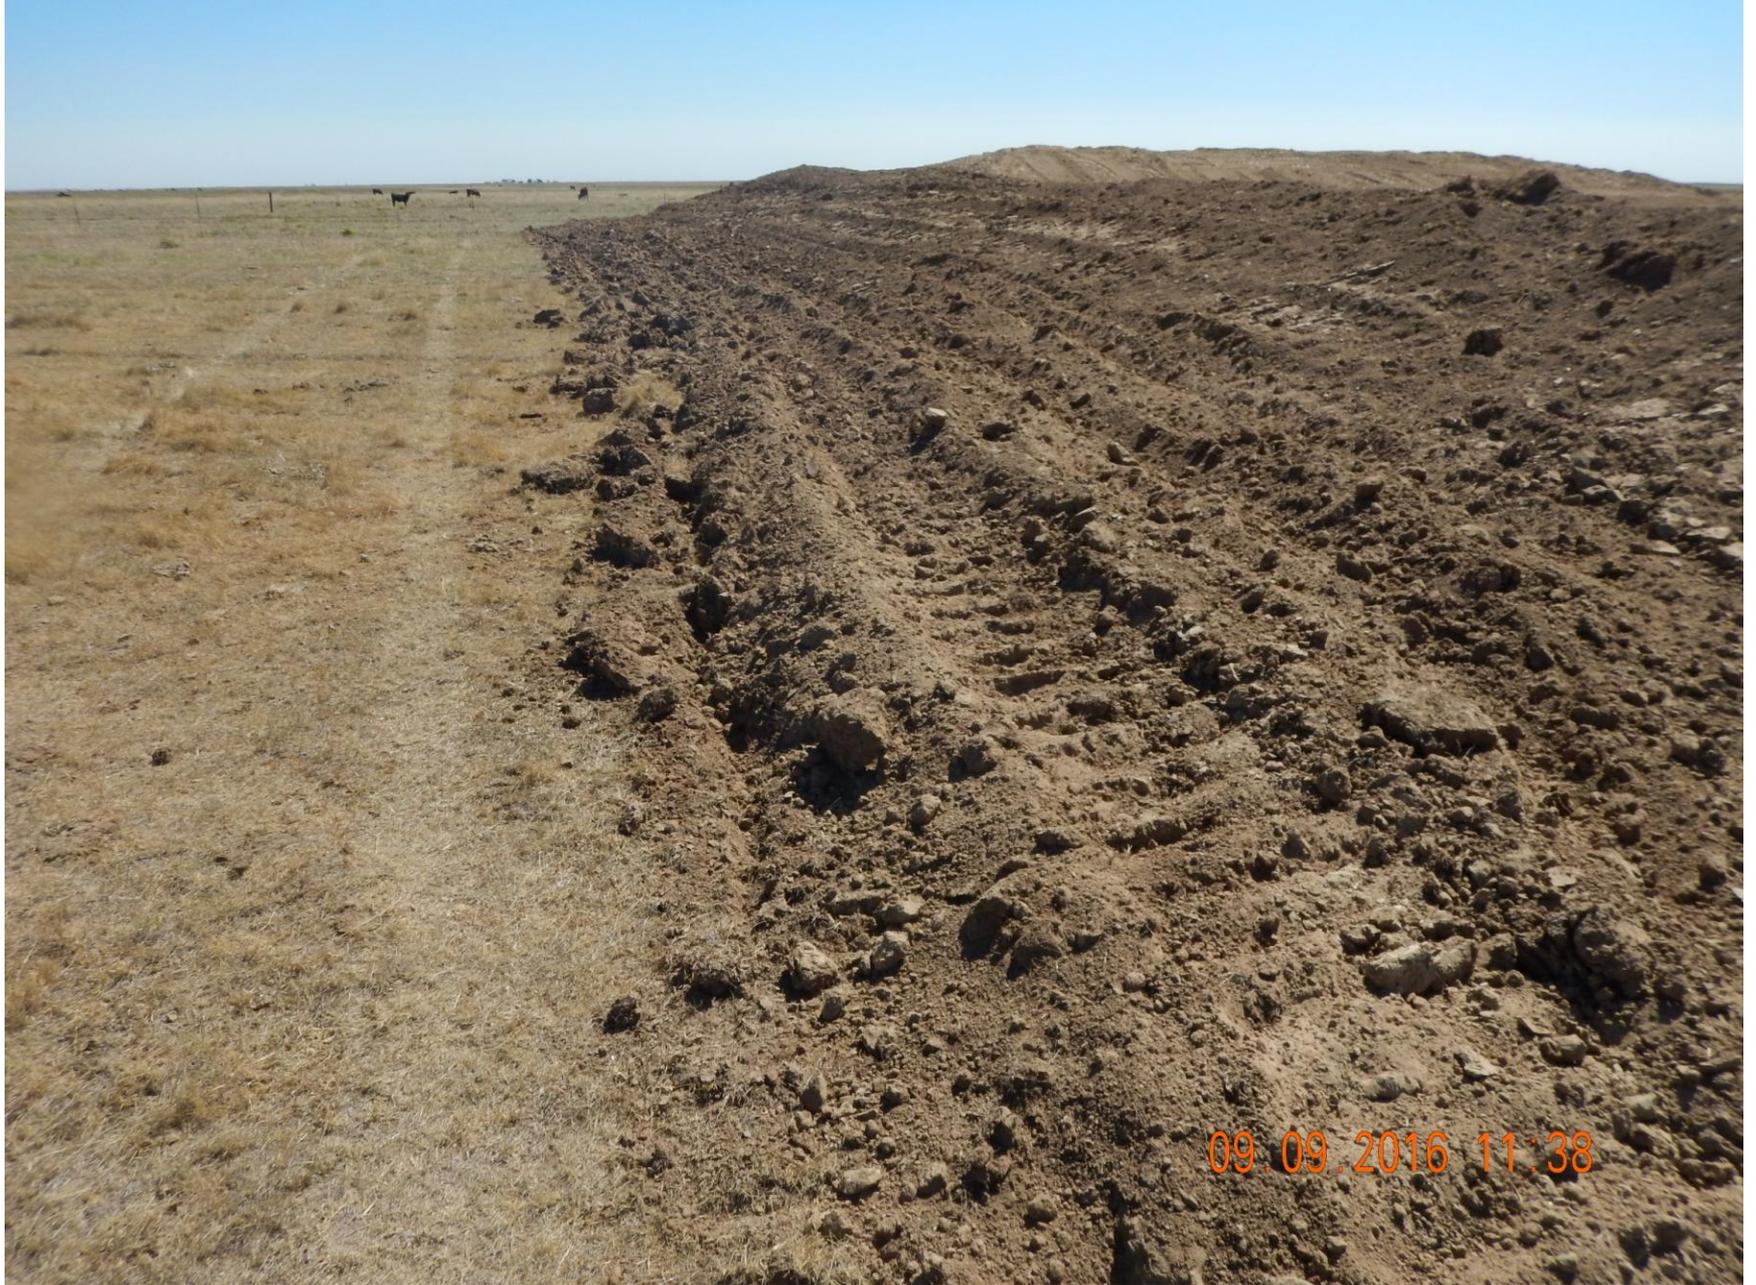
Figure 14: Photo taken from the north end of the location, facing east. Photo shows surface roughening used as a stormwater and sediment control BMP on the northeast end of the location. Surface roughening is a BMP that should be used in conjunction with other BMPs. However, with as large as the surface roughening is, and with the topography of this portion of the location being relatively flat, surface roughening alone appears to be sufficient.
