Construction Inspection

09/09/2016

Operator: Grynberg Petroleum Co

Location ID: 386901

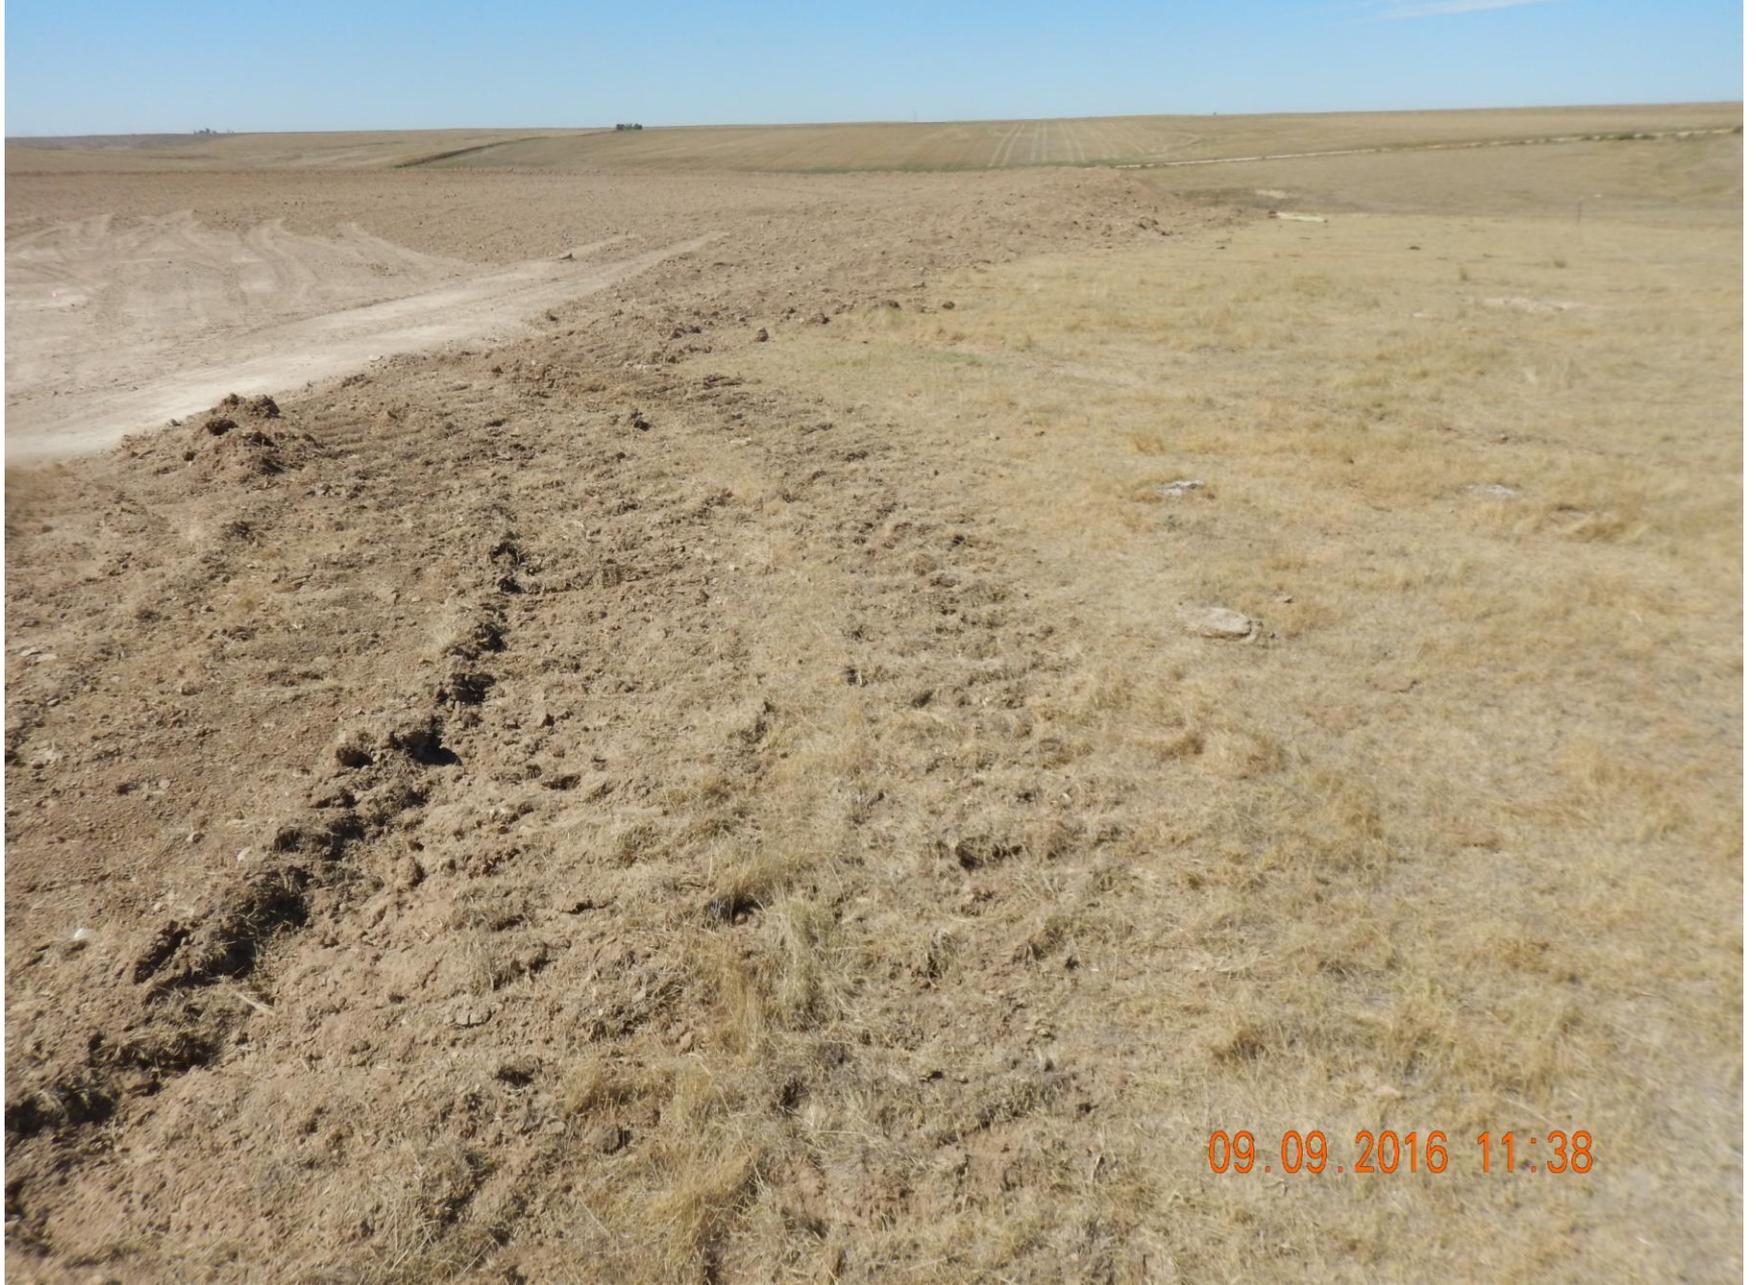
Figure 15: Photo taken from the north end of the location, facing west. Photo shows straw wattle “j-hook” as only stormwater and sediment control BMP in place on the northwest end of the location. Note: “J-hook” seen here does not appear to be large enough to capture stormwater from the north end of the location. **Advise increasing size of “j-hook”**

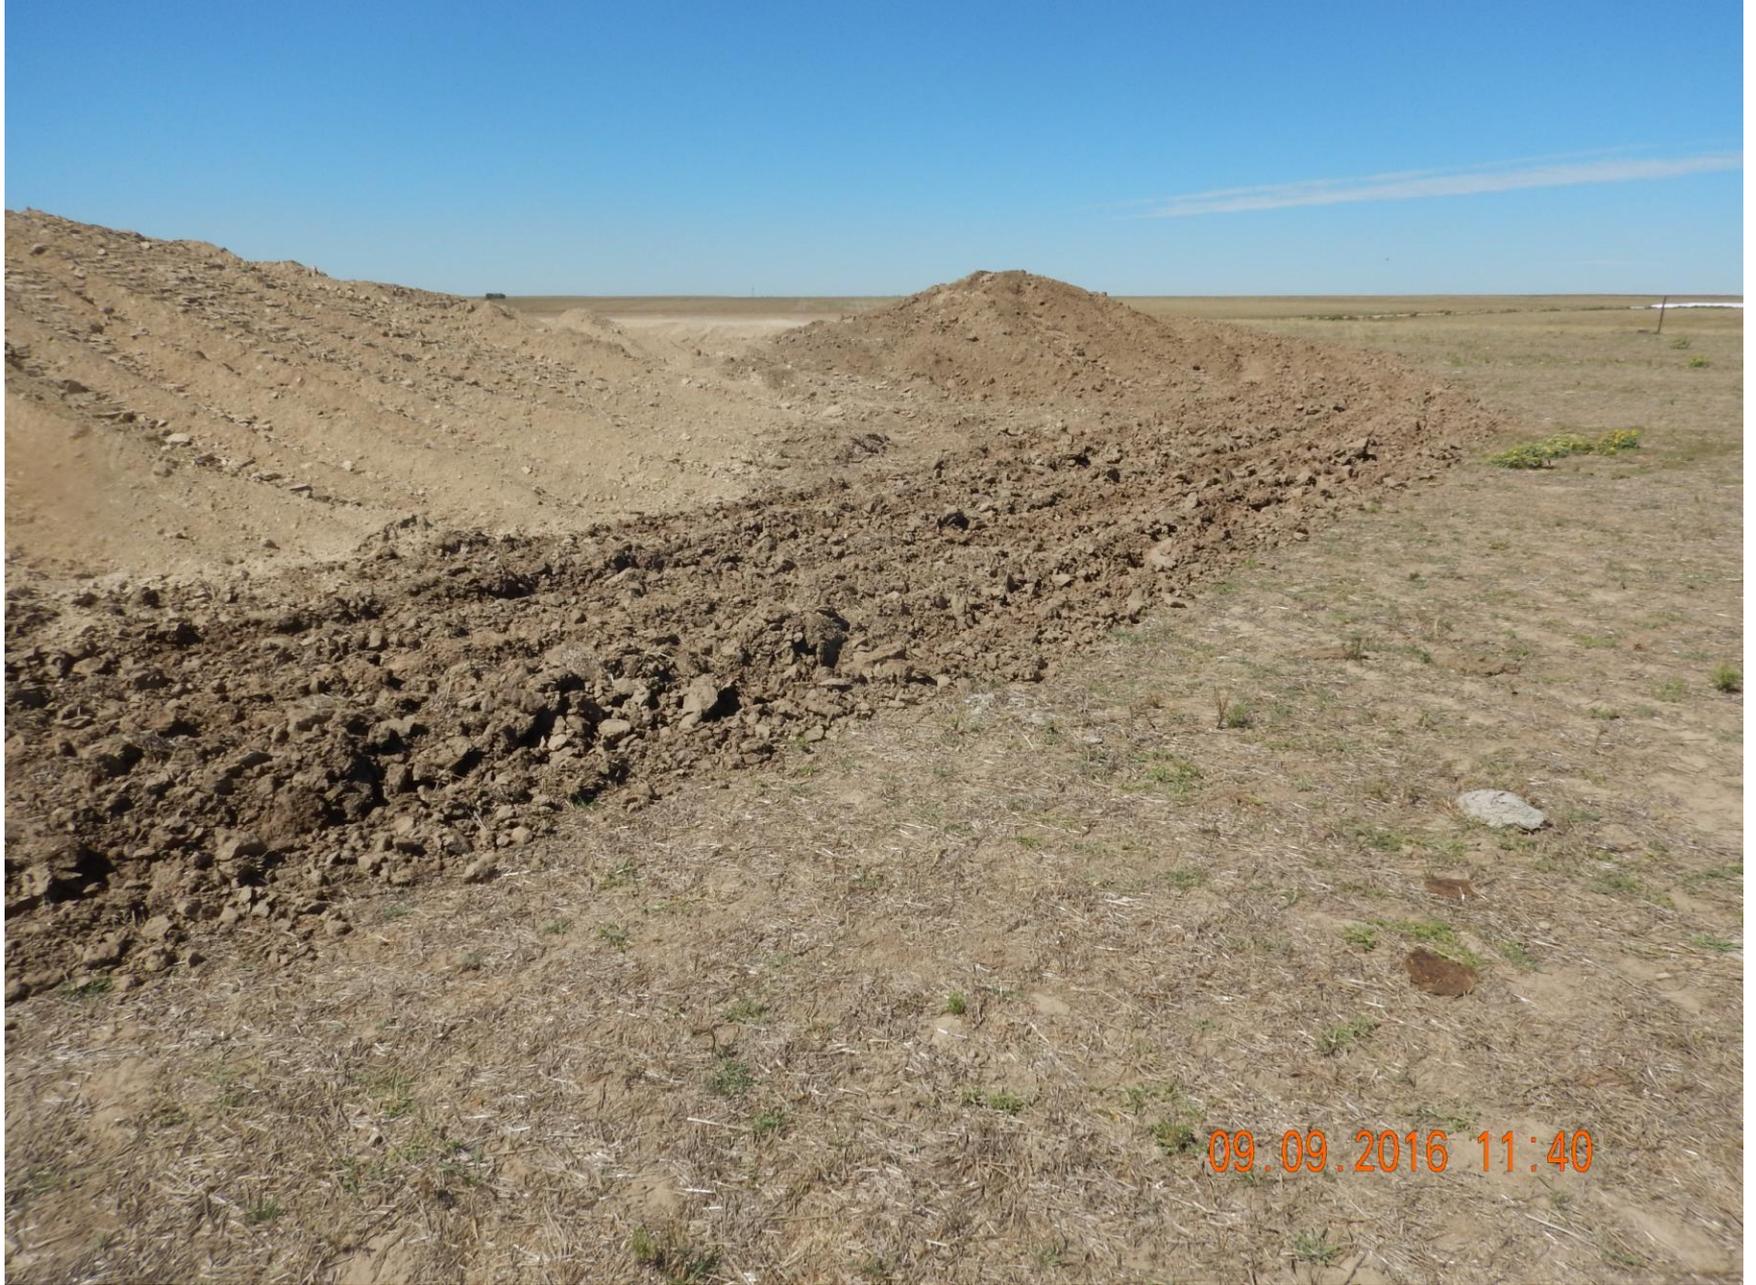
Figure 16: Photo taken from the northeast end of the location, facing west. Photo shows surface roughening used as a stormwater and sediment control BMP on the northeast end of the location. Surface roughening is a BMP that should be used in conjunction with other BMPs. However, with as large as the surface roughening is, and with the topography of this portion of the location being relatively flat, surface roughening alone appears to be sufficient. It is unclear what soil stockpile seen in photo is topsoil, or soil from pits.

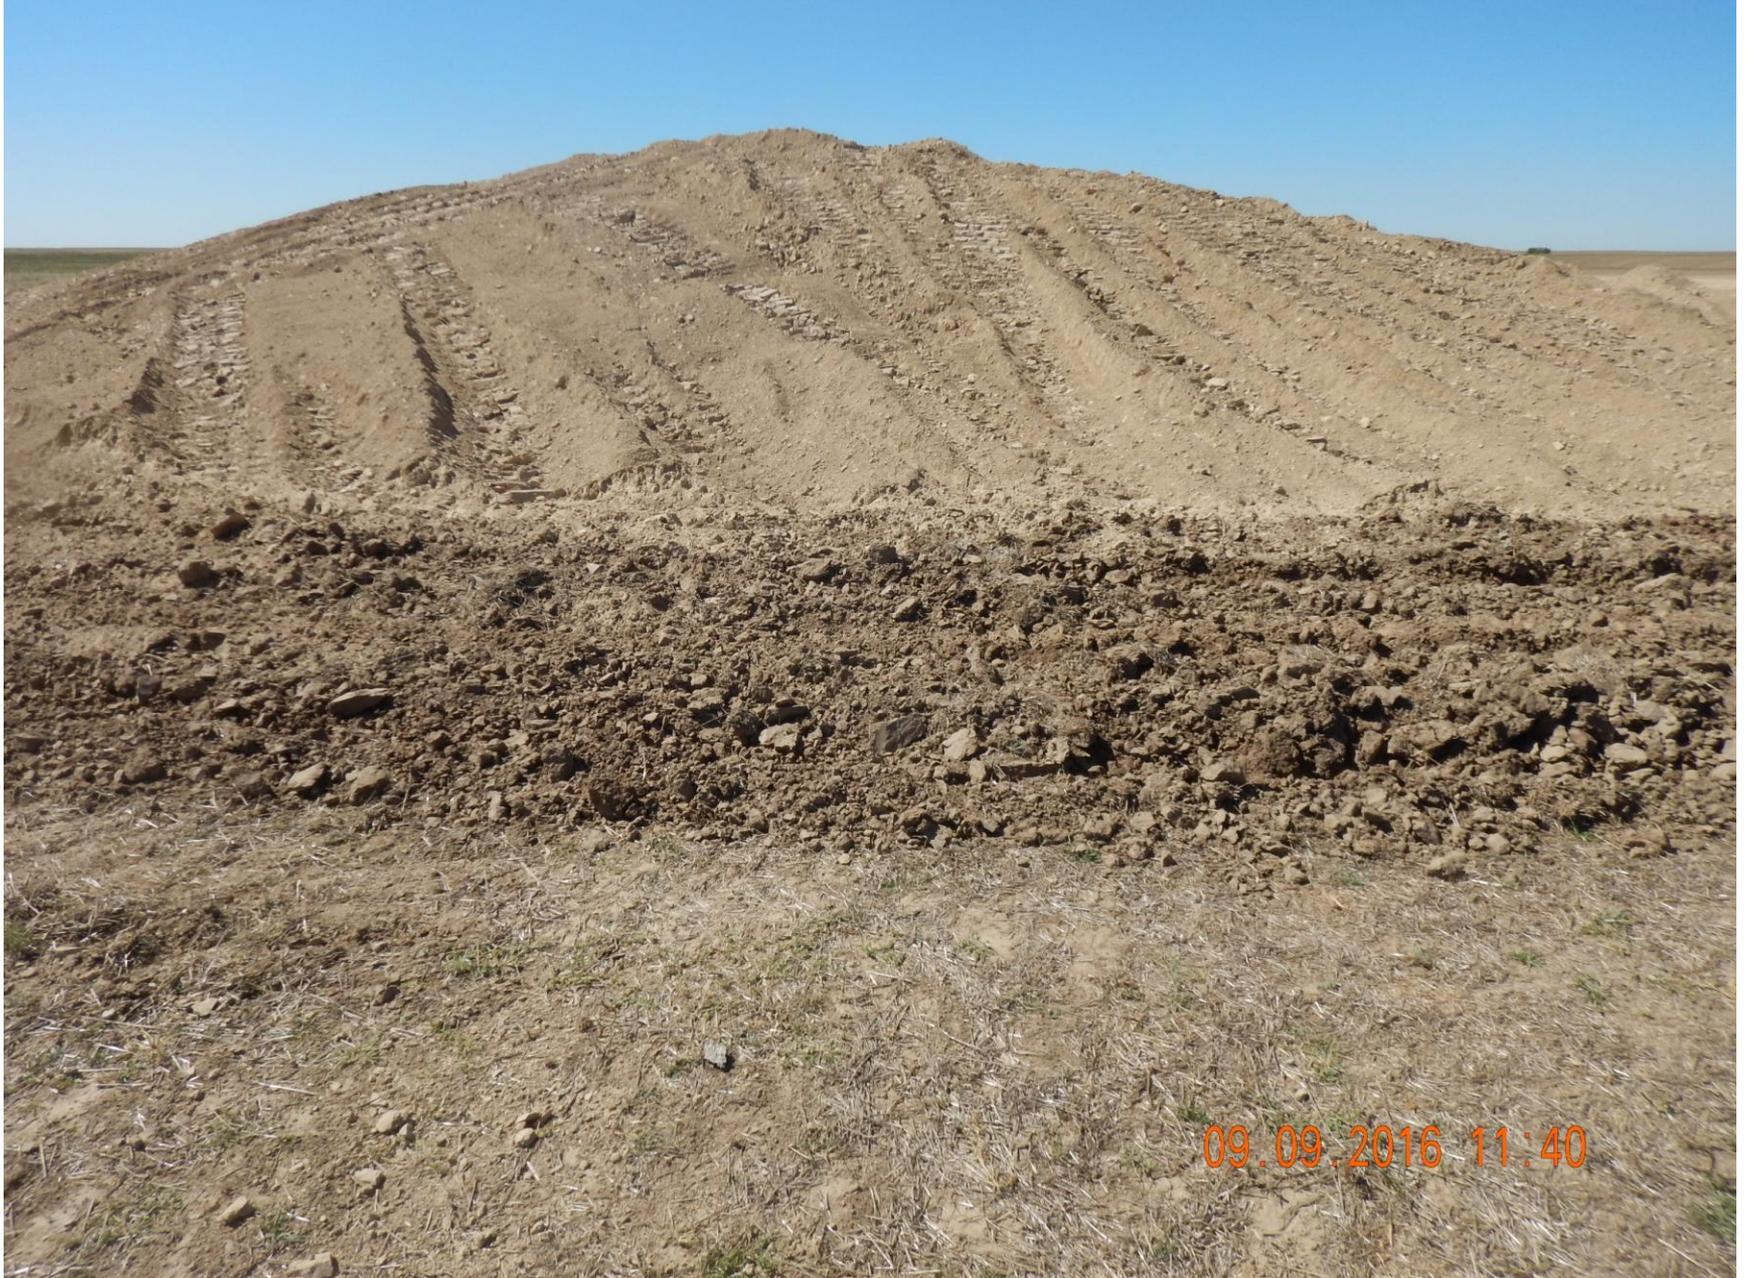
Figure 17: Photo taken from the northeast end of the location, facing southwest. Photo shows surface roughening used as a stormwater and sediment control BMP on the northeast end of the location. Surface roughening is a BMP that should be used in conjunction with other BMPs. However, with as large as the surface roughening is, and with the topography of this portion of the location being relatively flat, surface roughening alone appears to be sufficient. It is unclear what soil stockpile seen in photo is topsoil, or soil from pits.

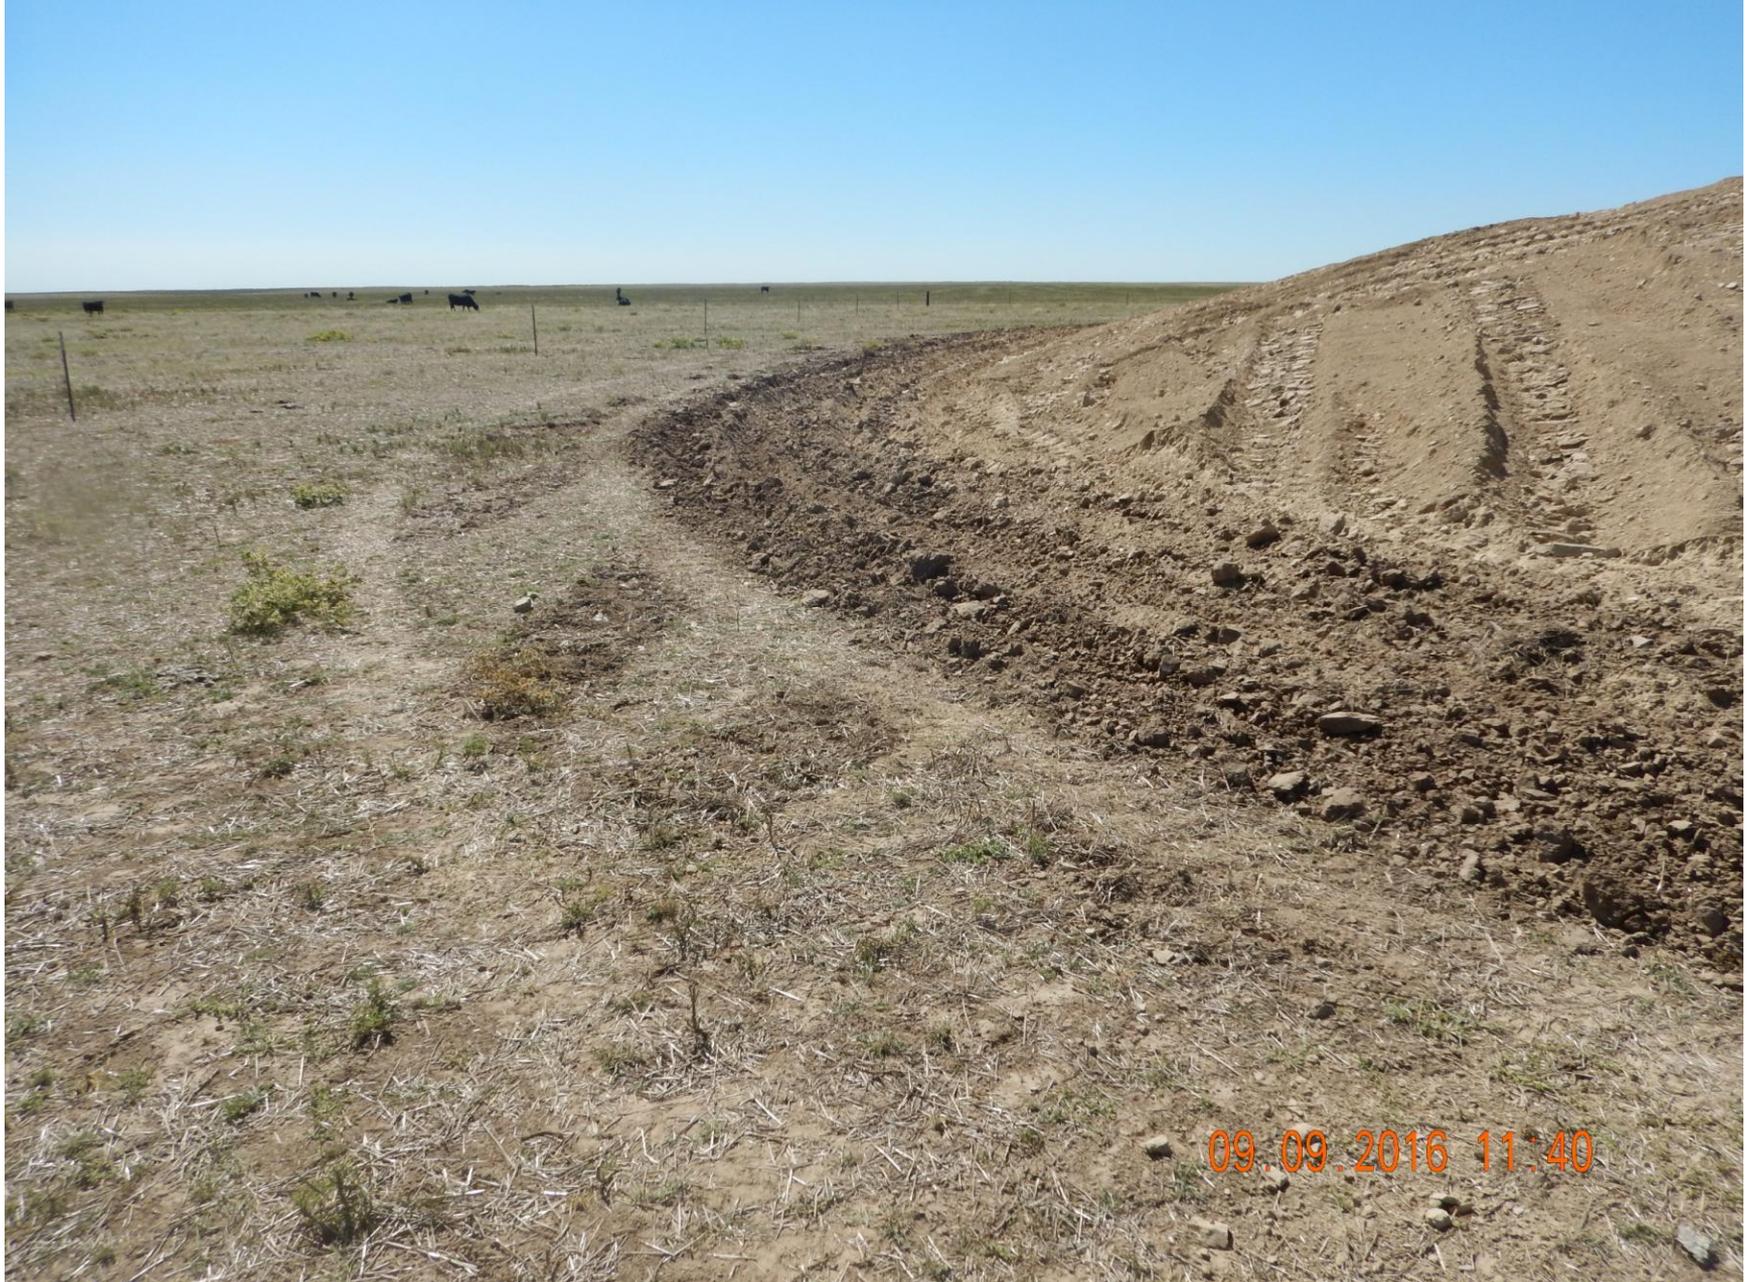
Figure 18: Photo taken from the northeast end of the location, facing south. Photo shows surface roughening used as a stormwater and sediment control BMP on the northeast end of the location. Surface roughening is a BMP that should be used in conjunction with other BMPs. However, with as large as the surface roughening is, and with the topography of this portion of the location being relatively flat, surface roughening alone appears to be sufficient. It is unclear what soil stockpile seen in photo is topsoil, or soil from pits.

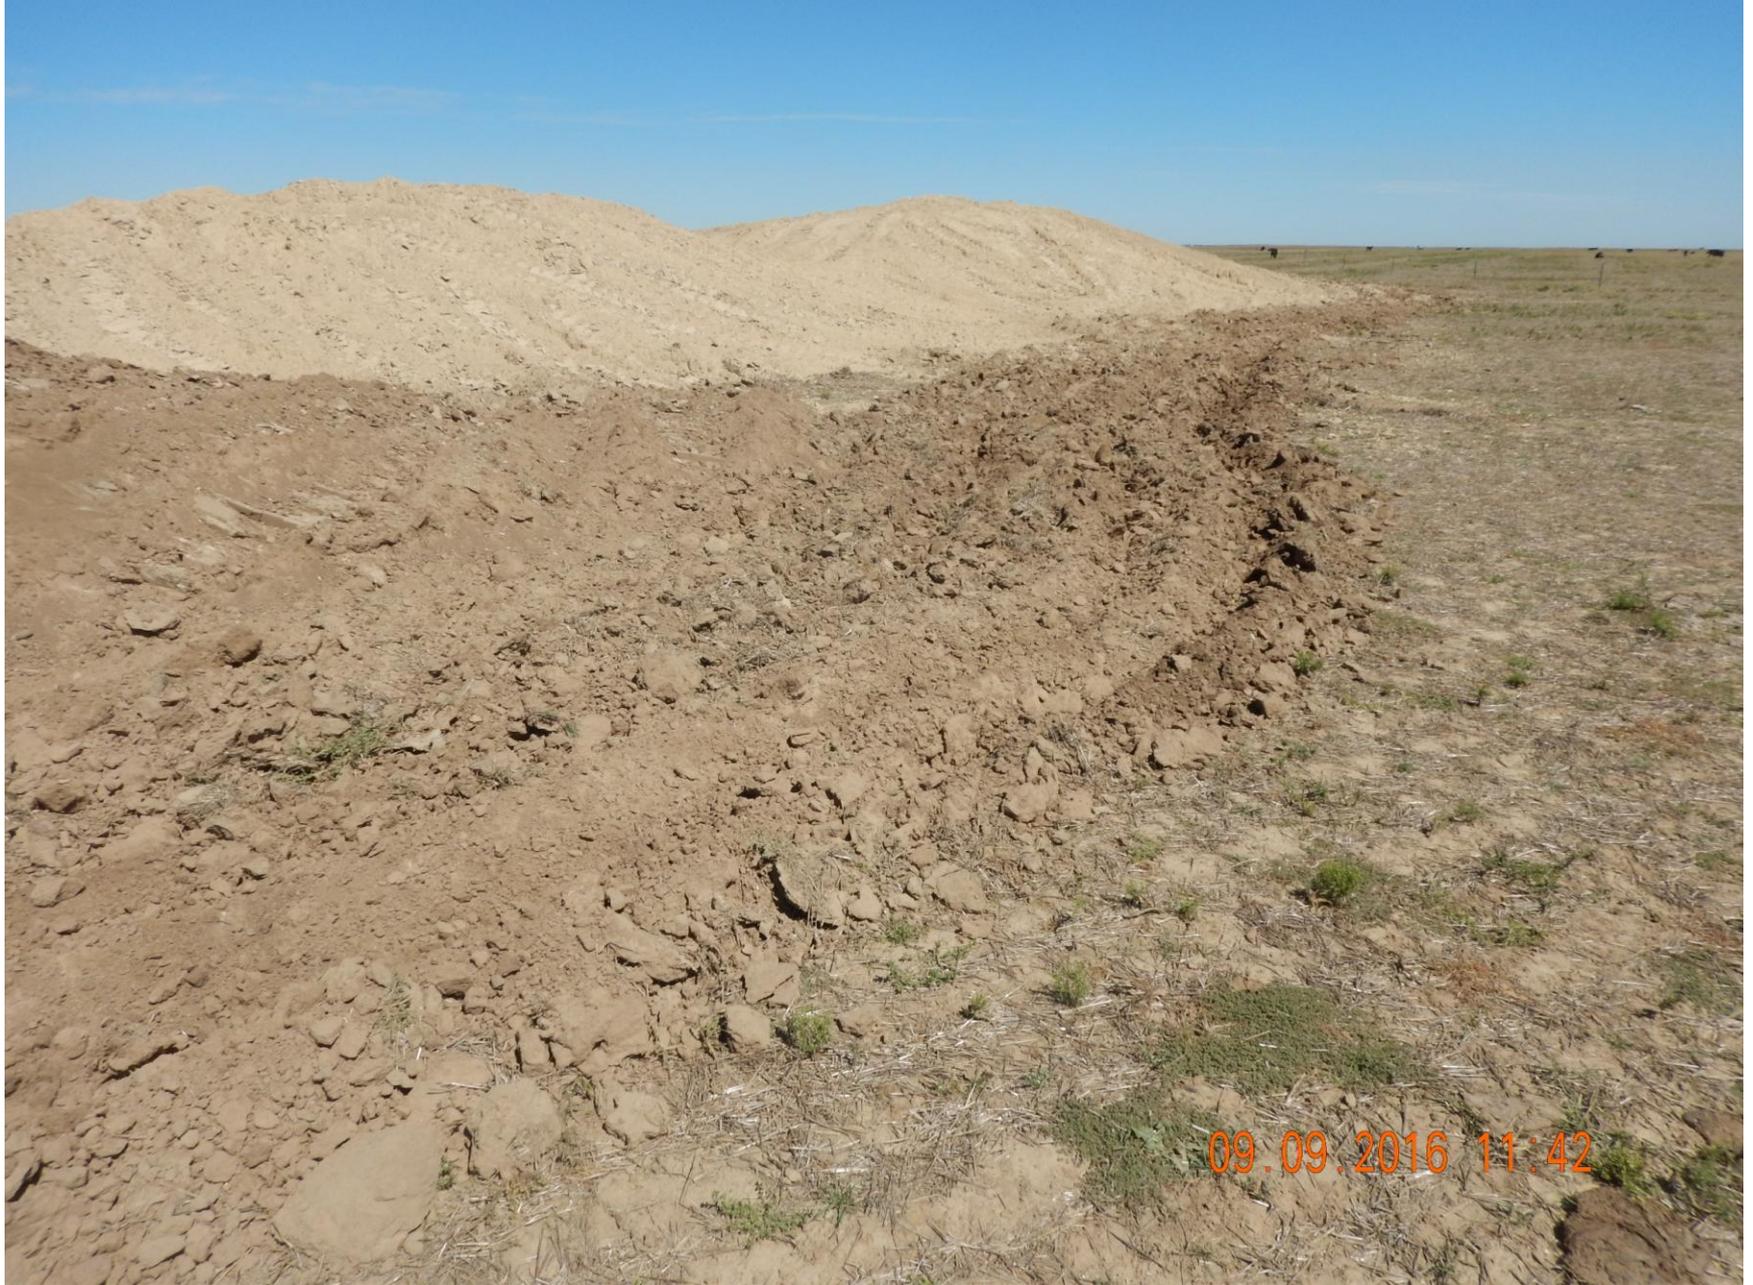
Figure 19: Photo taken from the southeast end of the location, facing north. Photo shows surface roughening used as a stormwater and sediment control BMP on the northeast end of the location. Surface roughening is a BMP that should be used in conjunction with other BMPs. However, with as large as the surface roughening is, and with the topography of this portion of the location being relatively flat, surface roughening alone appears to be sufficient. It is unclear what soil stockpile seen in photo is topsoil, or soil from pits.

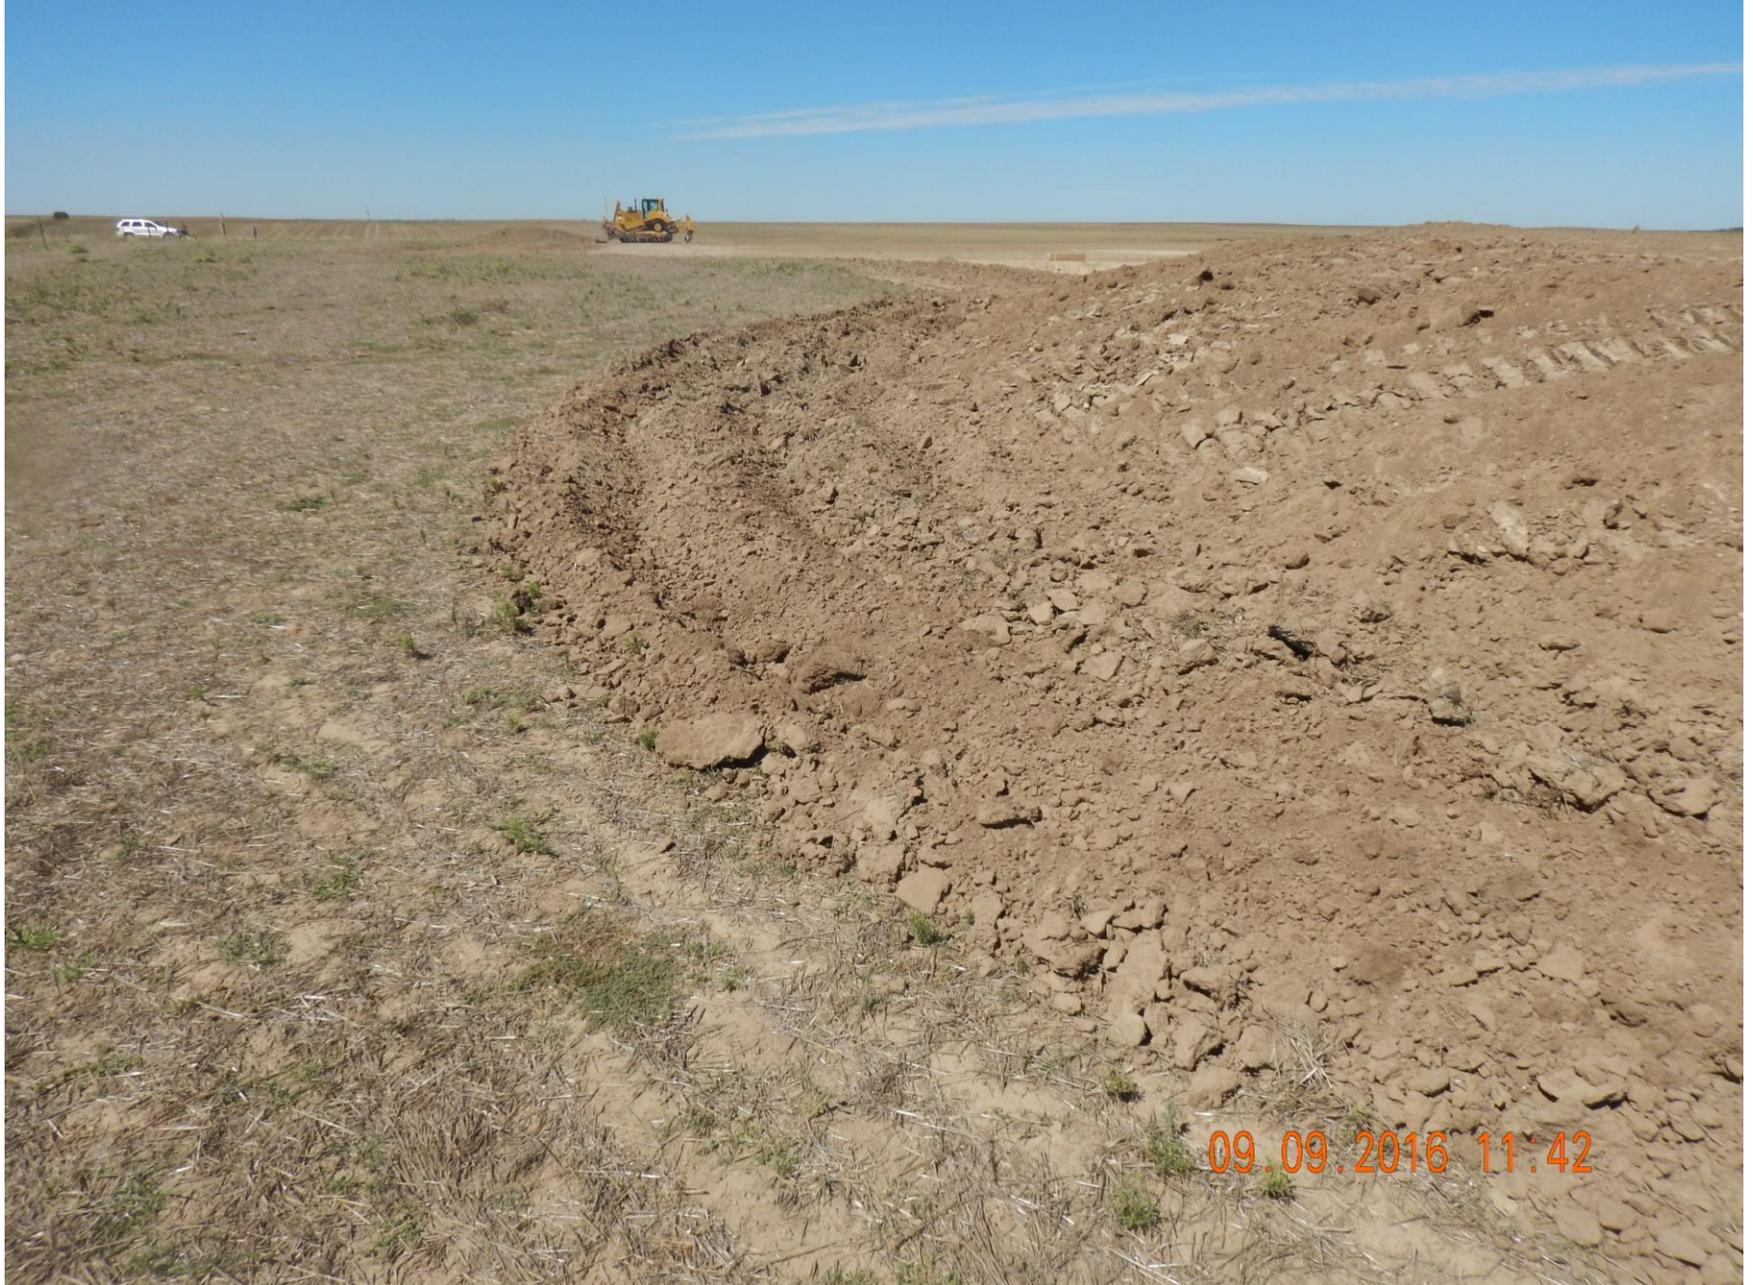
Figure 20: Photo taken from the southeast end of the location, facing west. Photo shows surface roughening used as a stormwater and sediment control BMP on the northeast end of the location. Surface roughening is a BMP that should be used in conjunction with other BMPs. However, with as large as the surface roughening is, and with the topography of this portion of the location being relatively flat, surface roughening alone appears to be sufficient. It is unclear what soil stockpile seen in photo is topsoil, or soil from pits.

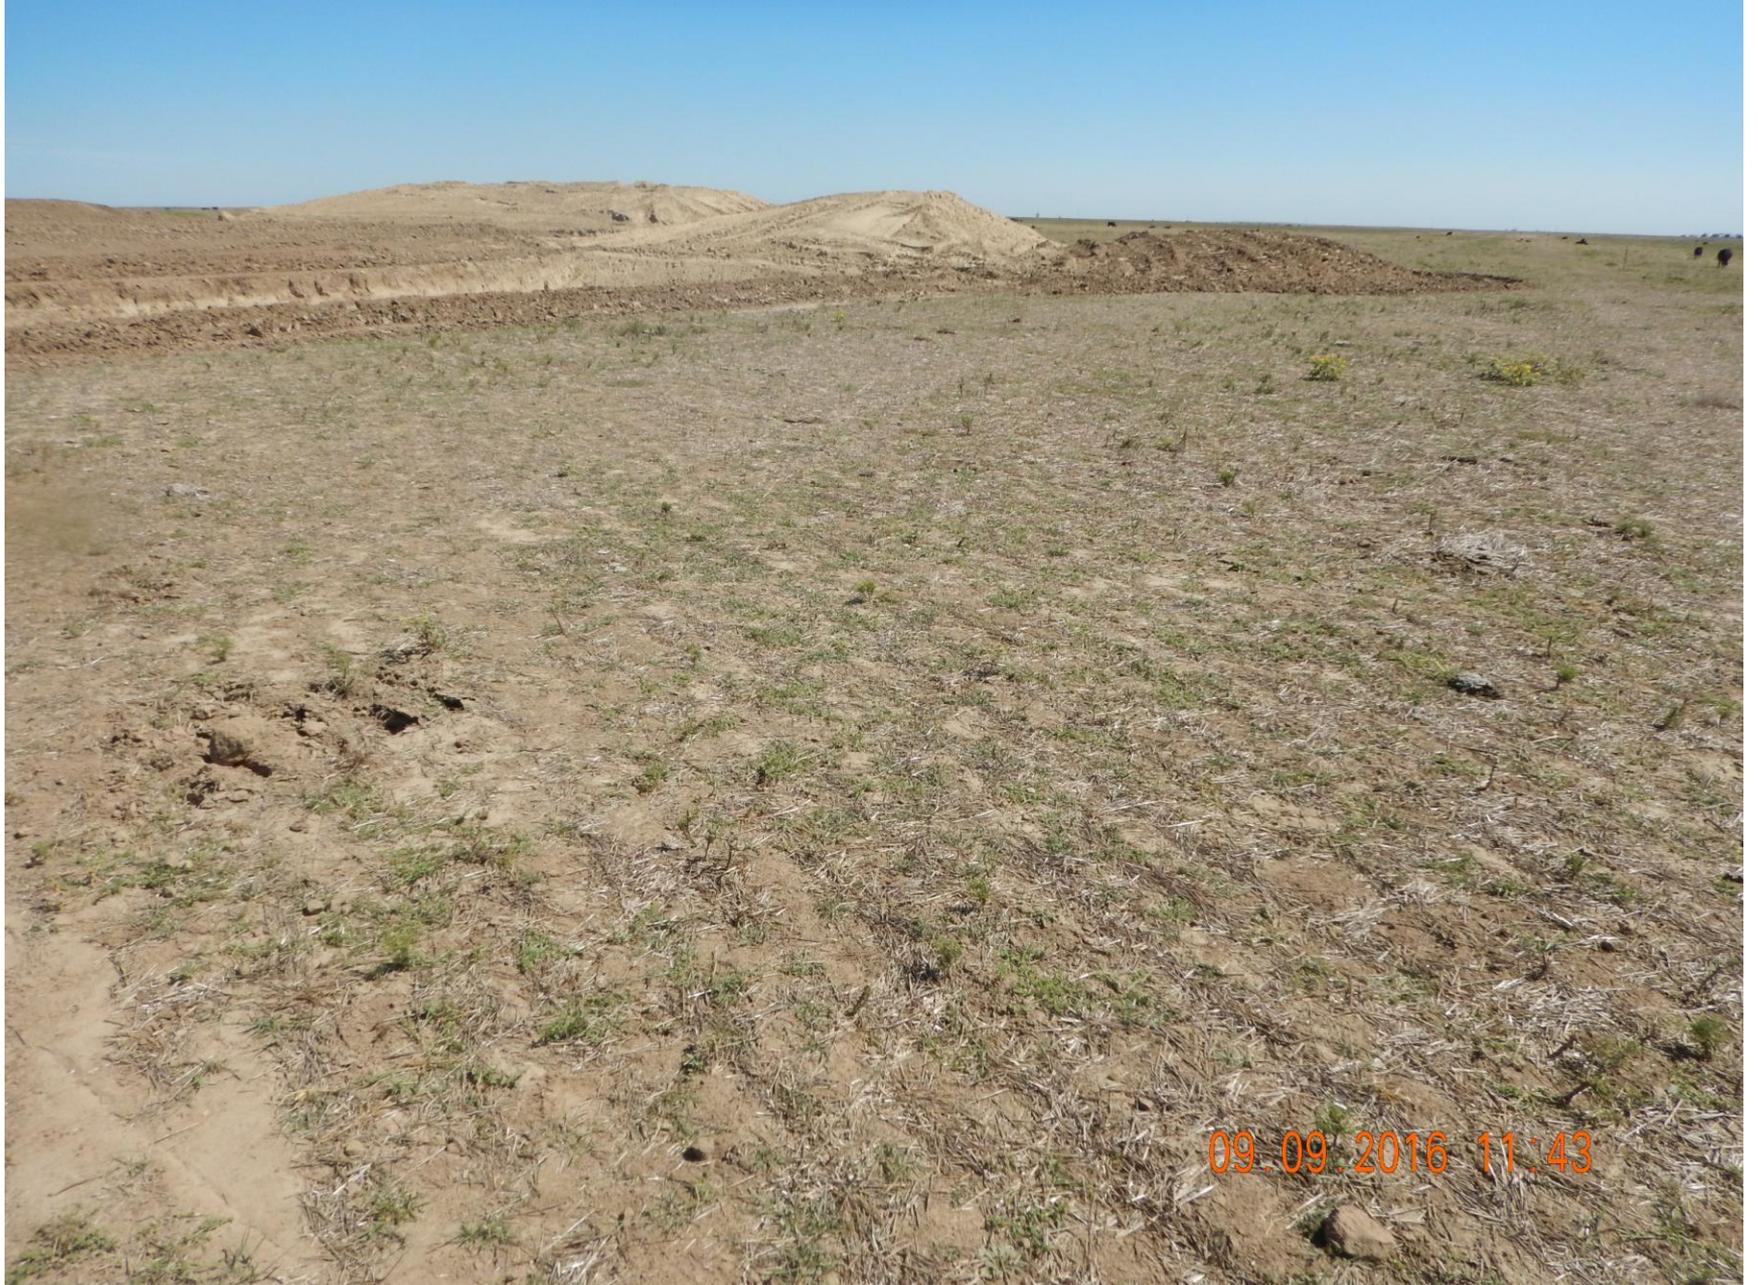
Figure 21: Photo taken from the east end of the location, facing northeast. Photo shows soil stockpiles on location. It is unclear what soil stockpile seen in photo is topsoil, or soil from pits.

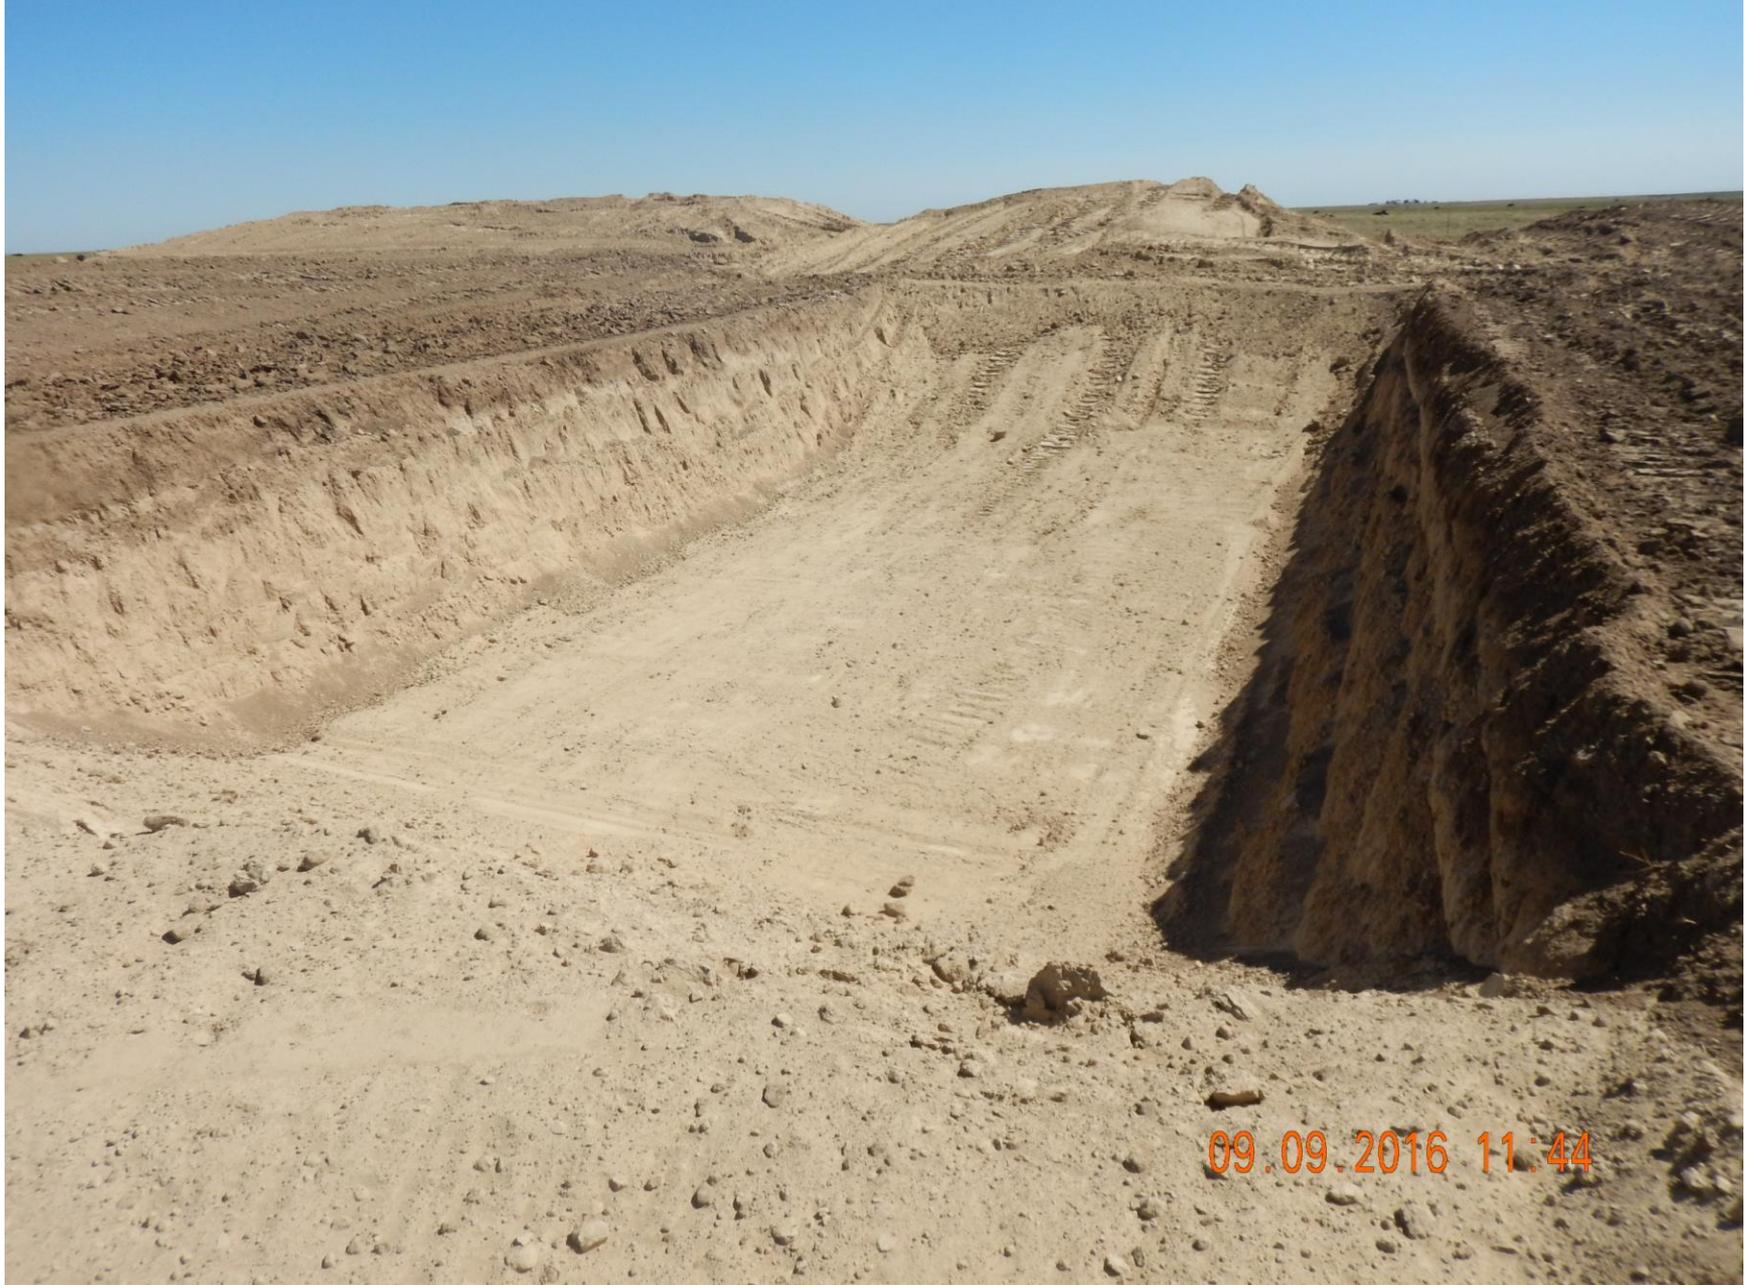
Figure 24: Photo taken from the east end of the location, facing east. Photo shows what appears to be the freshwater pit.

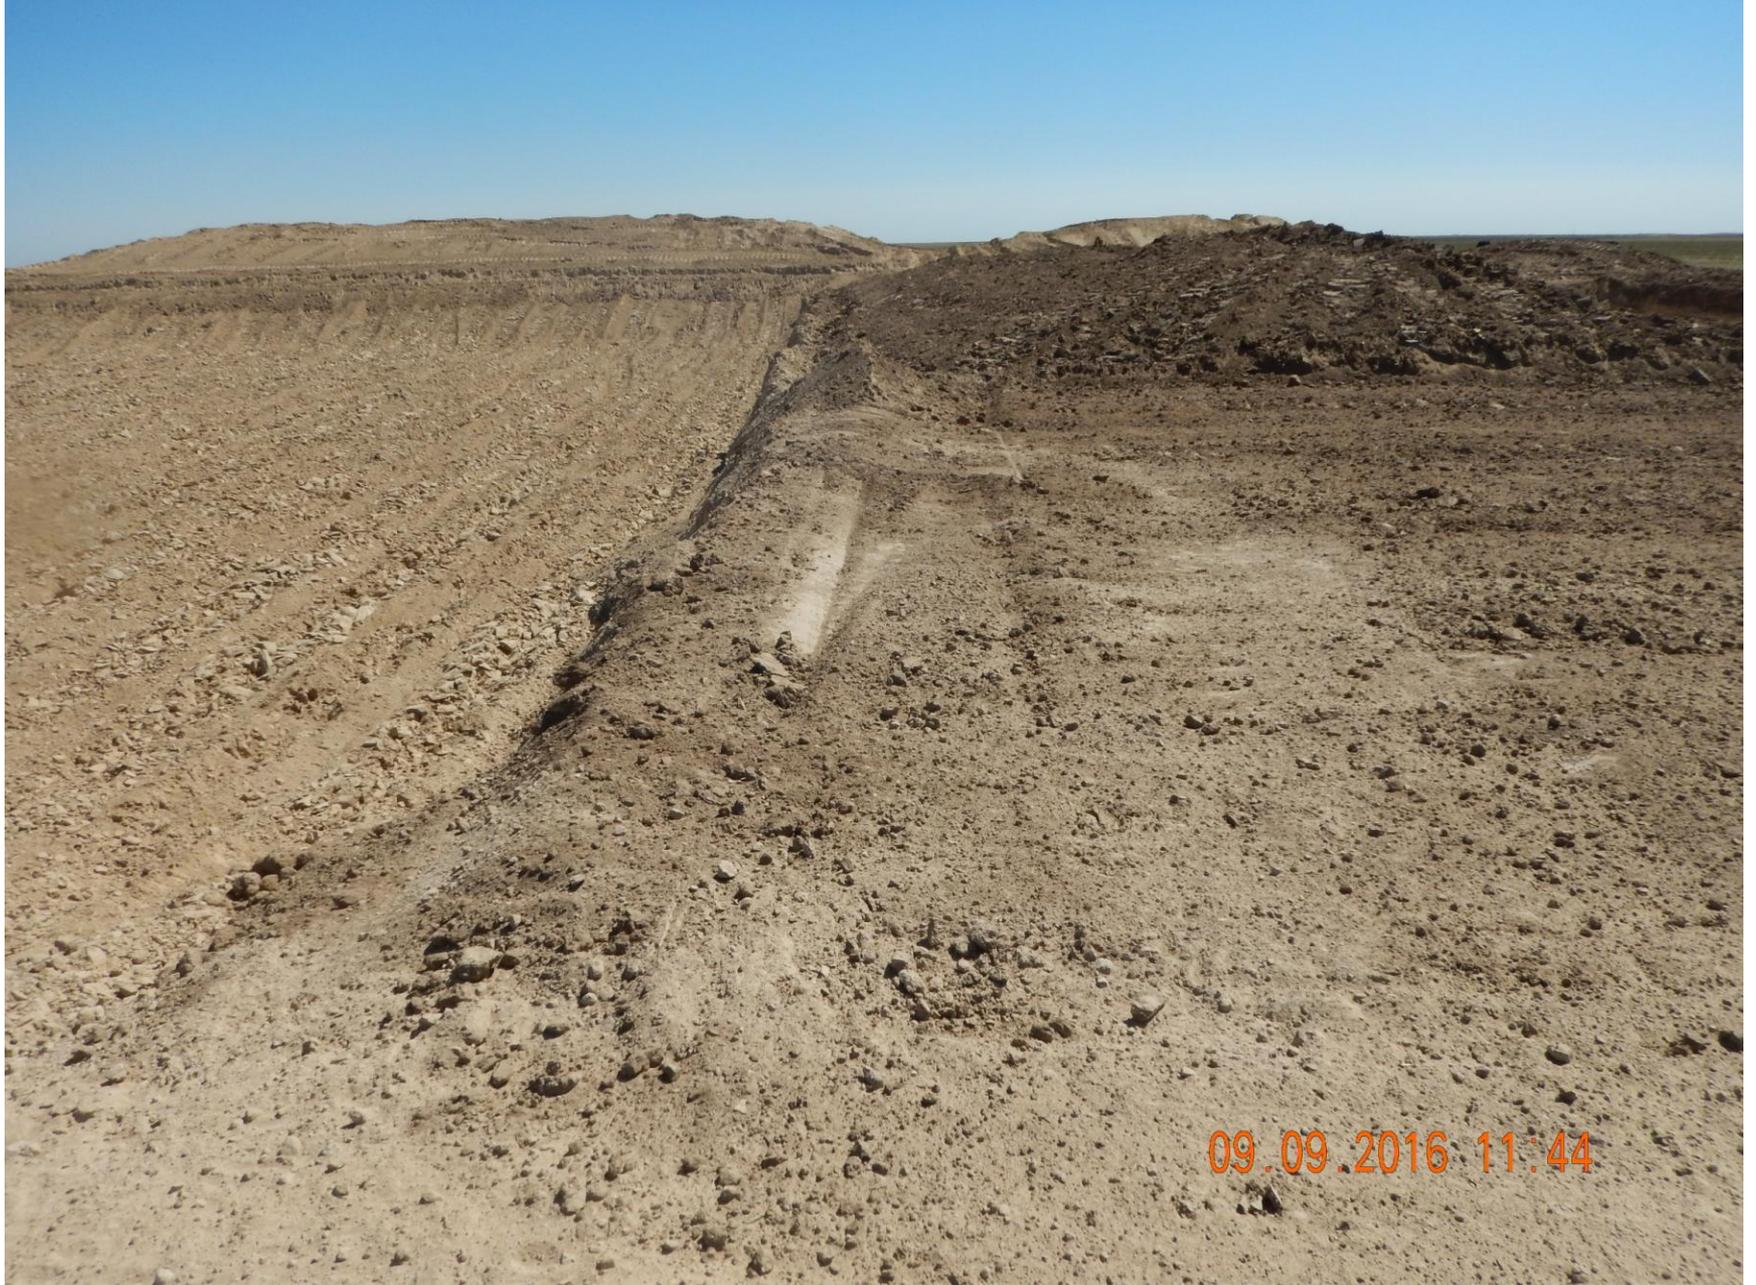
Figure 25: Photo taken from the east end of the location, facing east. Photo shows what appears to be the a reserve pit, and possible topsoil stockpile.
