Construction Inspection

09/09/2016

Operator: Grynberg Petroleum Co

Location ID: 386901

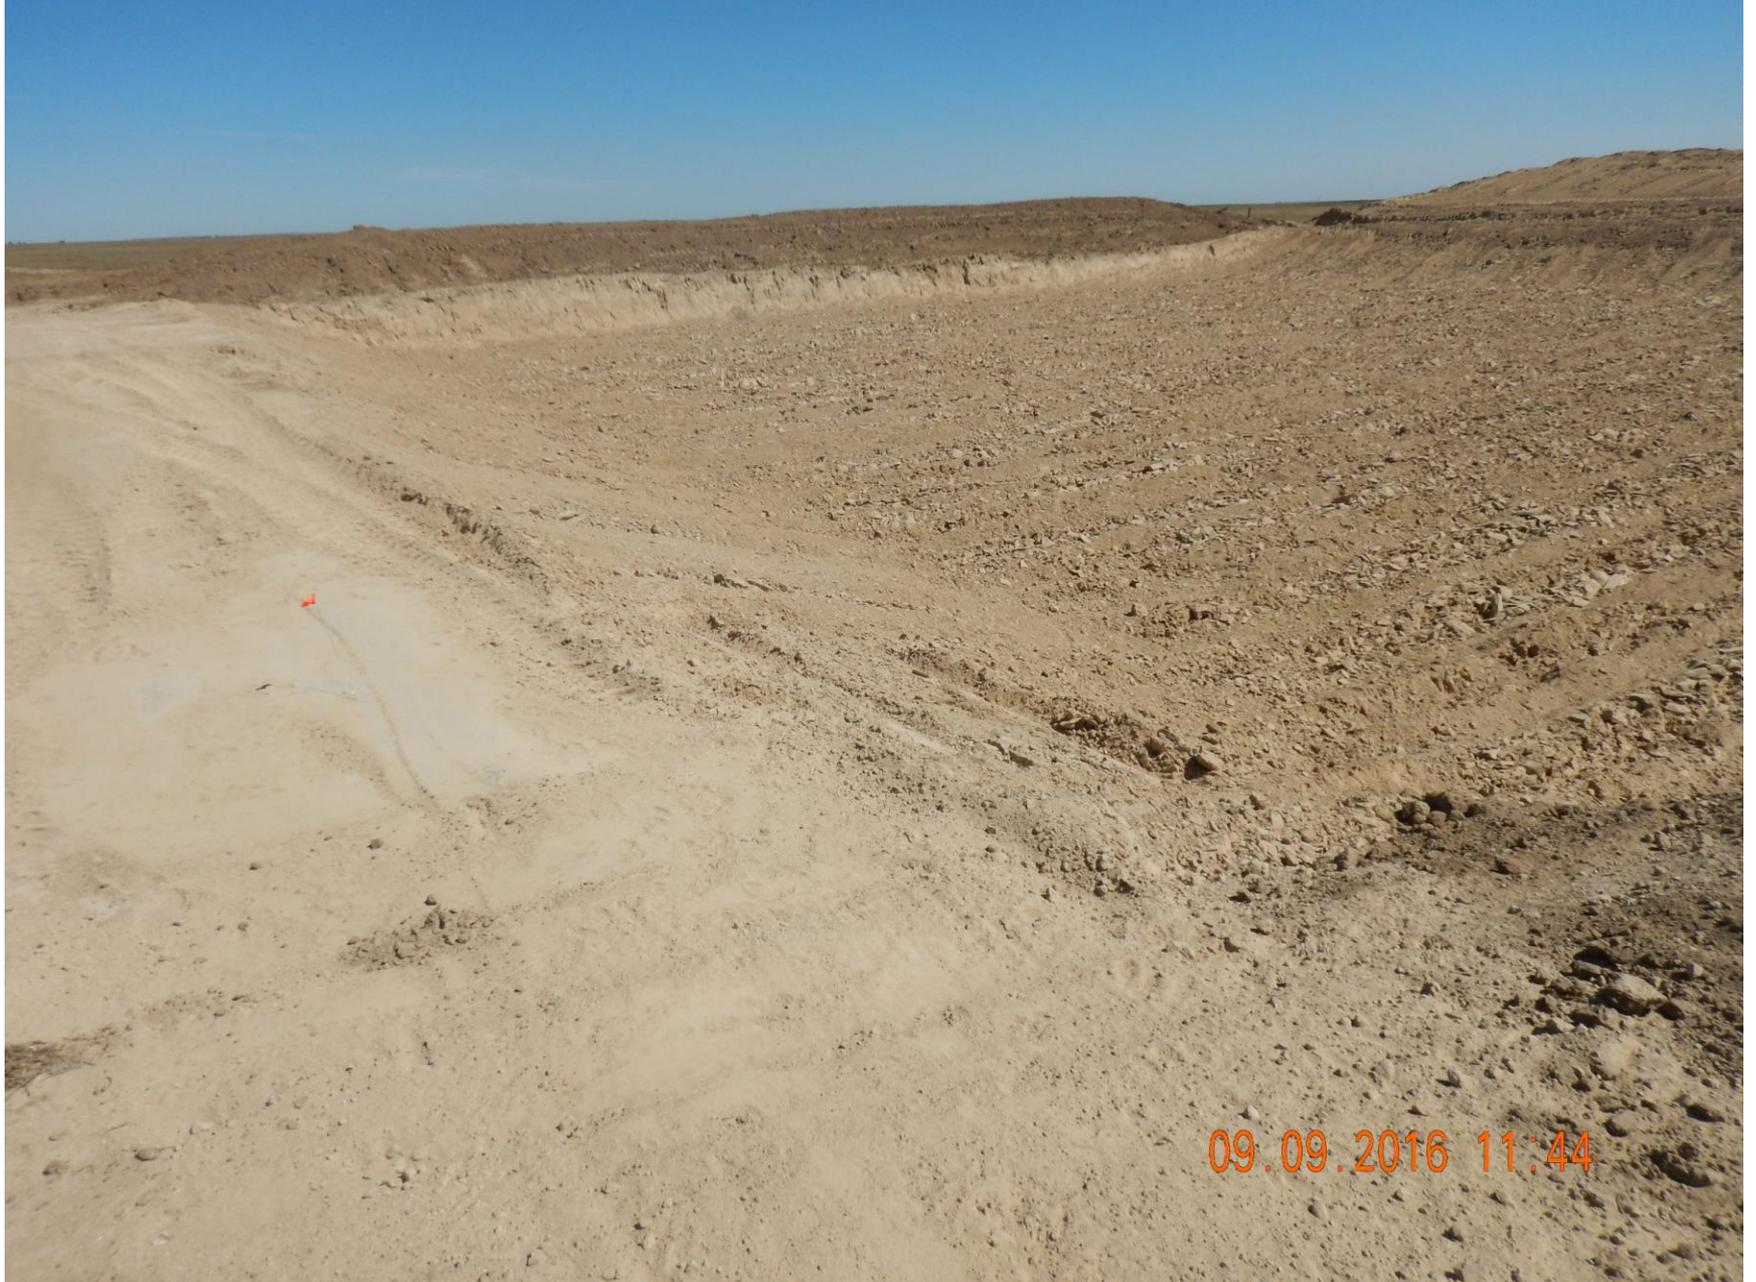
Figure 26: Photo taken from the east end of the location, facing northeast. Photo shows what appears to be a reserve pit, and possible topsoil stockpile.

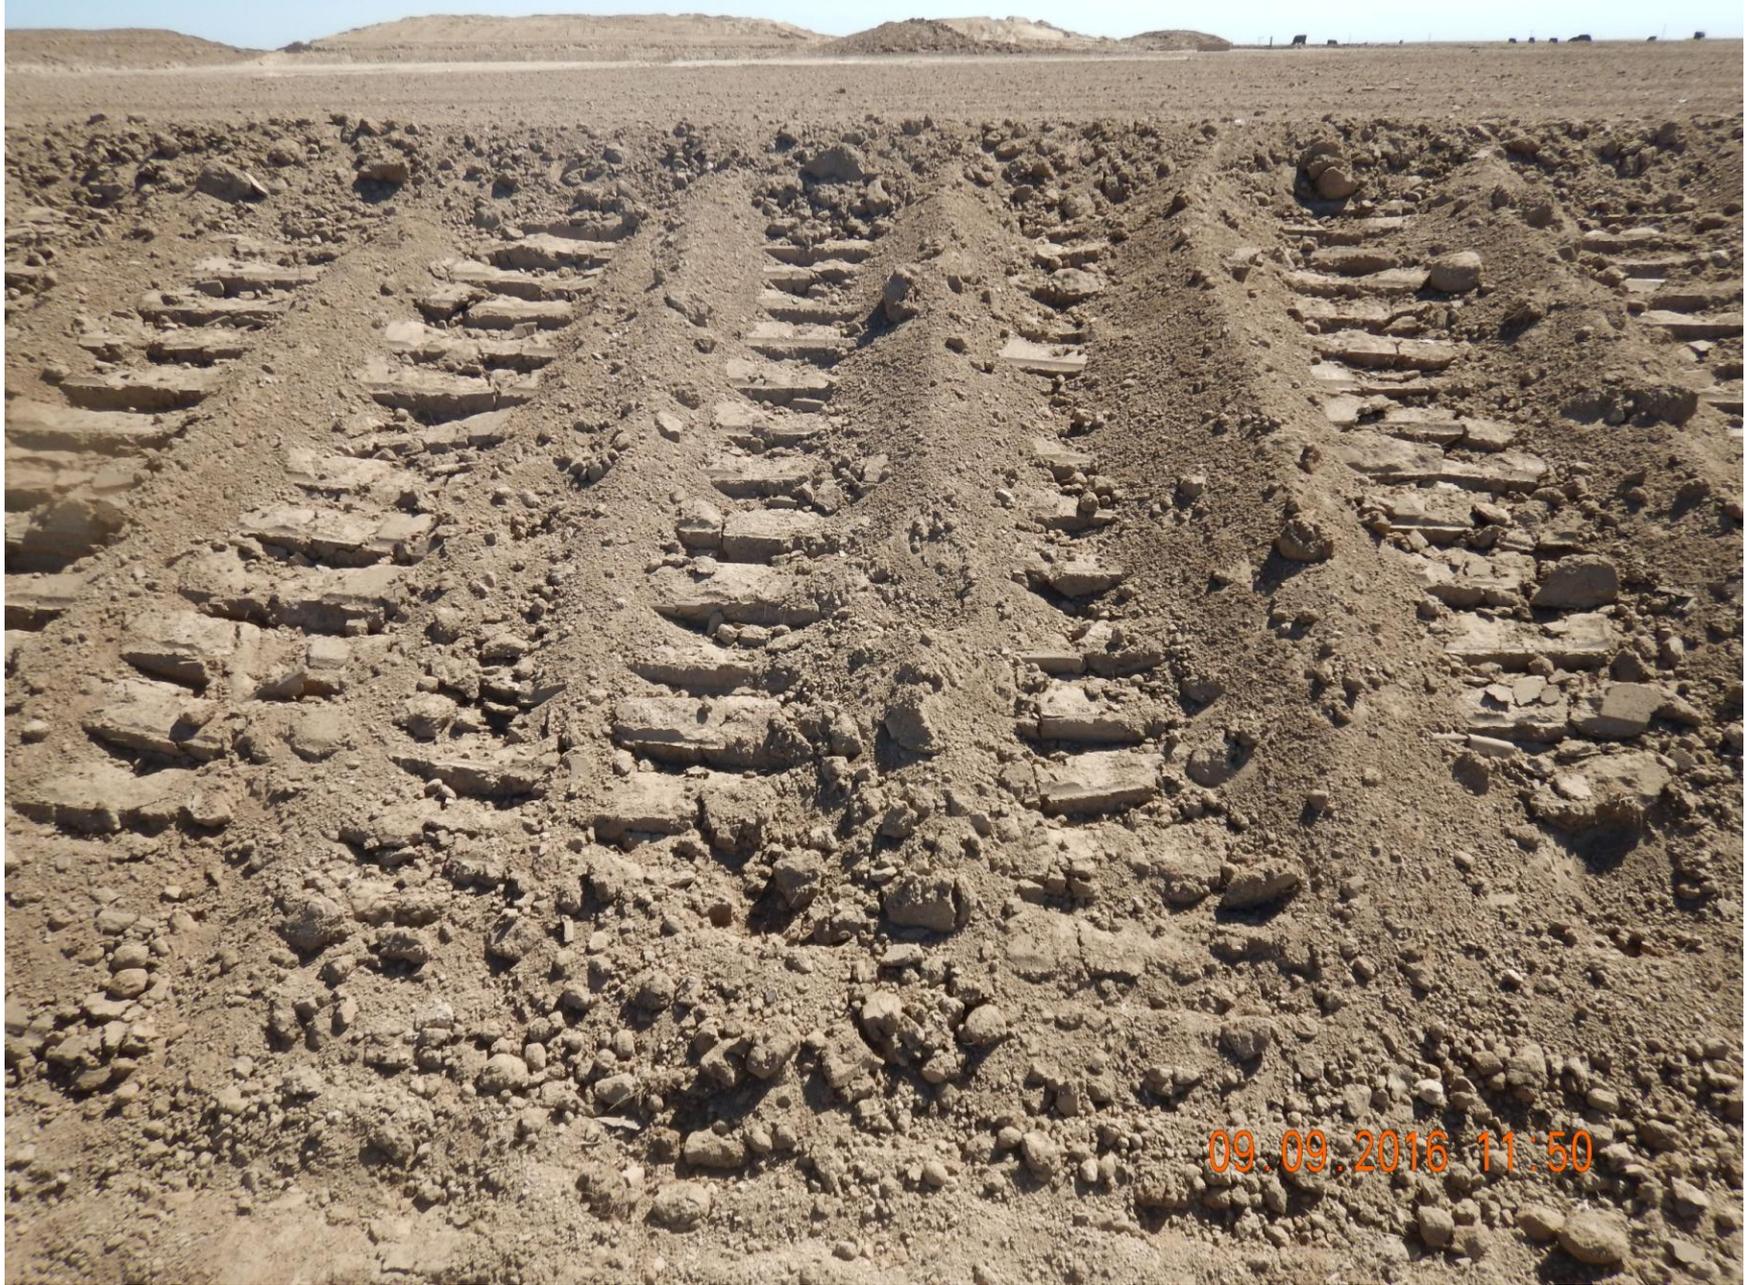
Figure 31: Photo taken from the west end of the location, facing east. Photo shows slopes have been improperly tracked and remain largely unstabilized.
