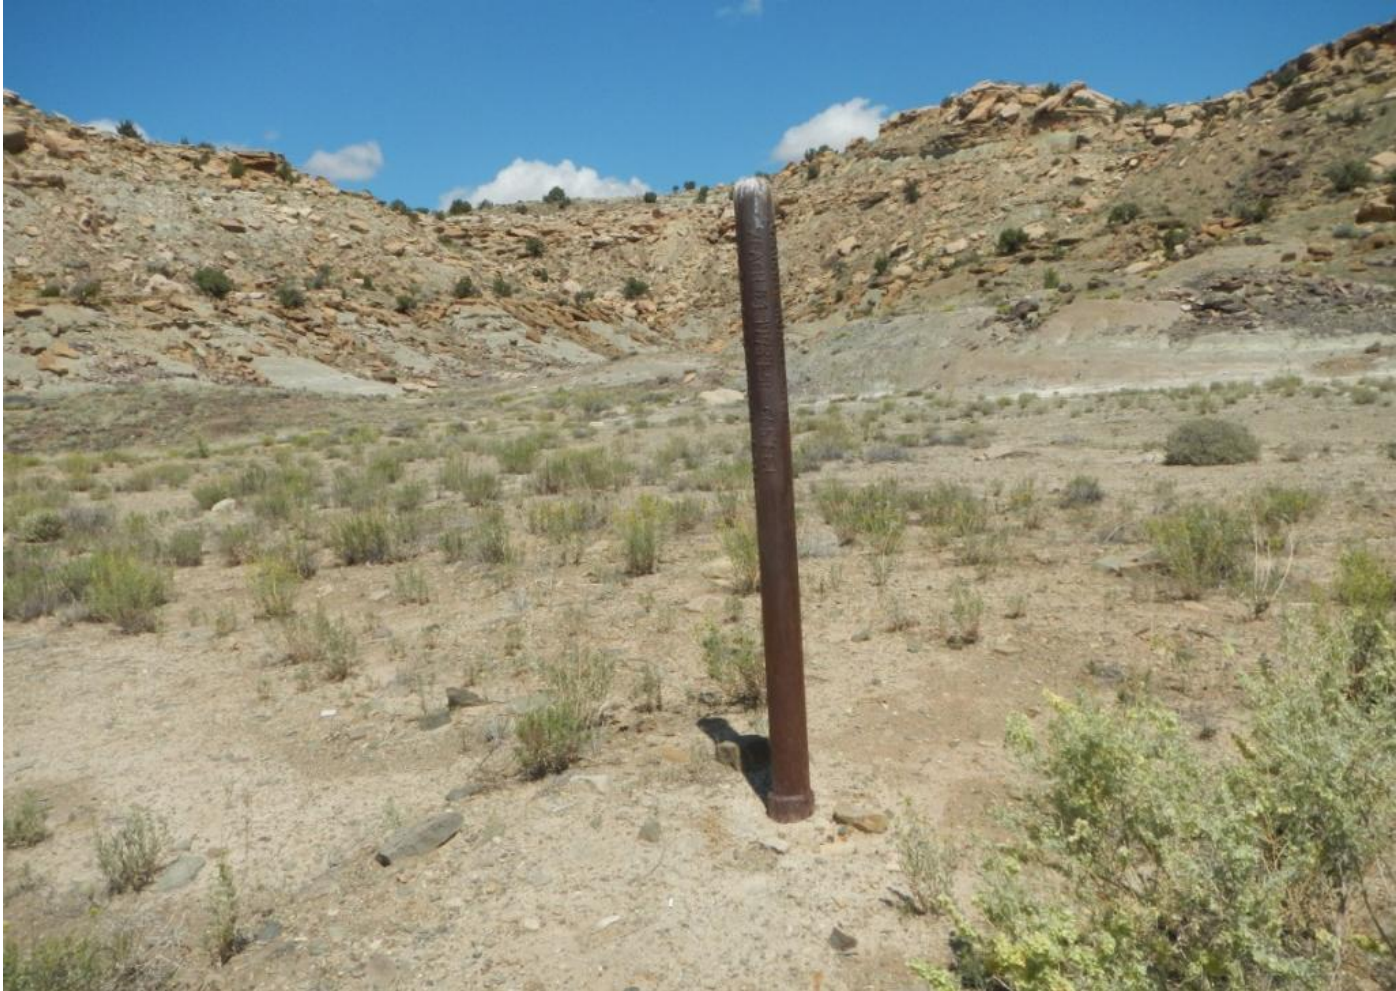
Photo 1. View from the dry hole marker facing northward.

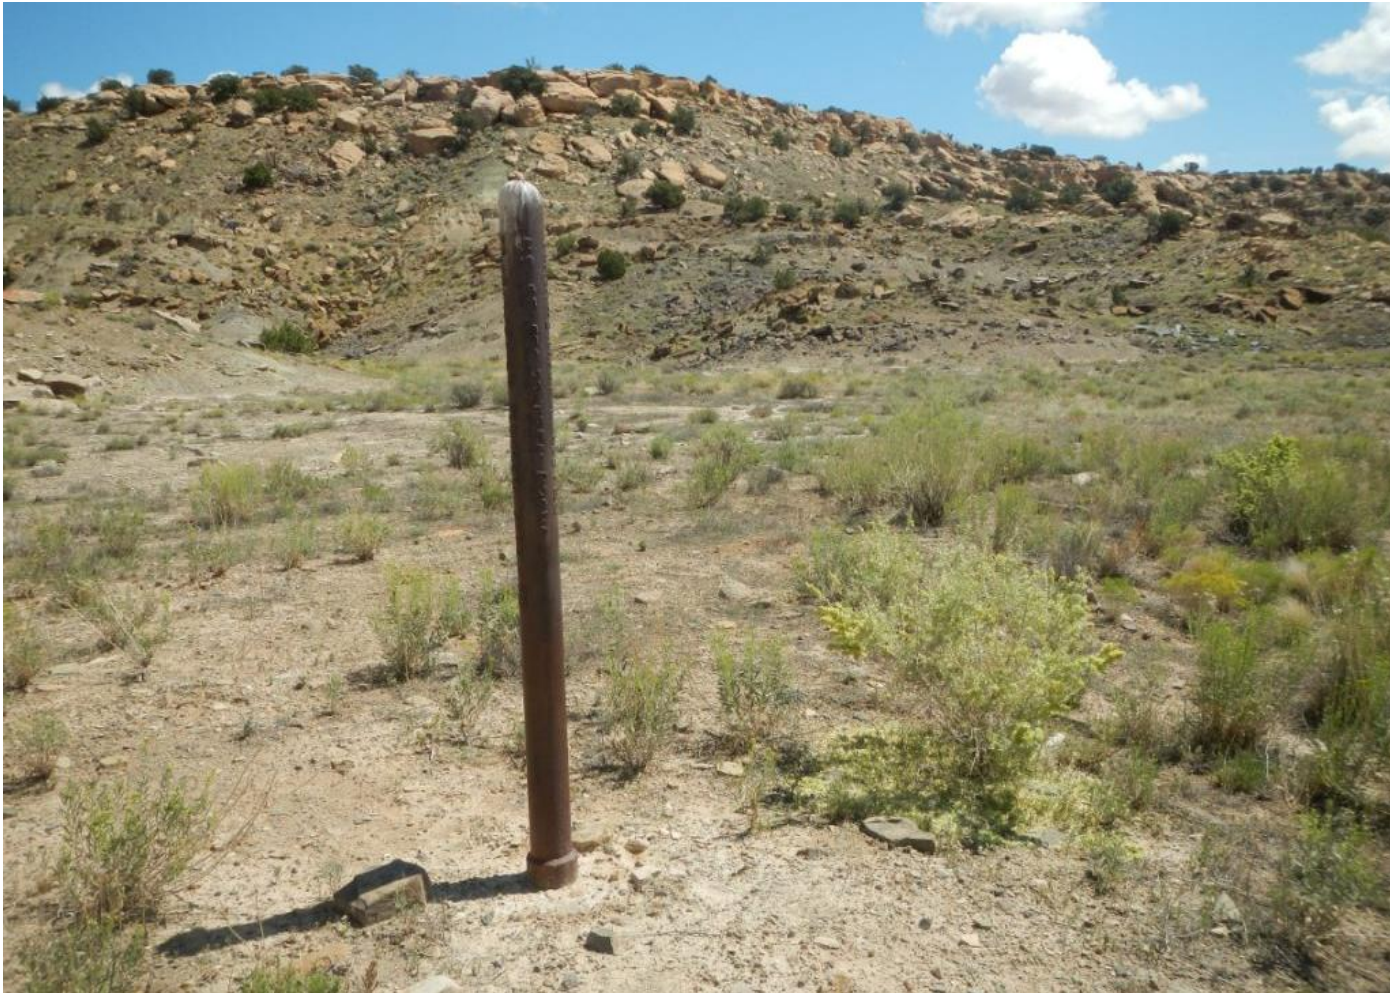
Photo 2. View from the dry hole marker facing eastward.

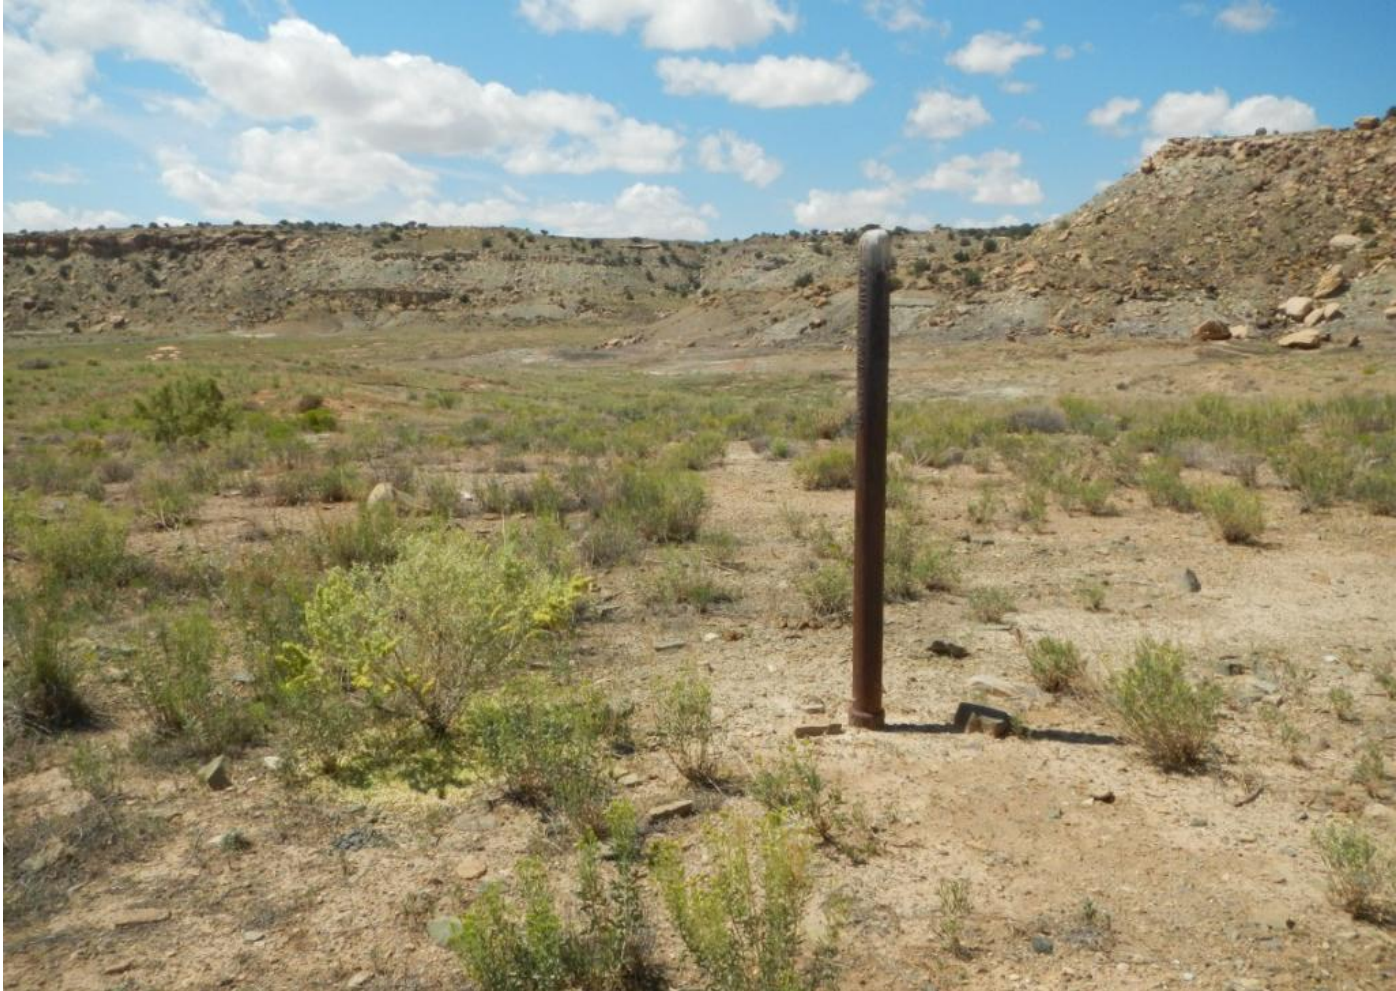
Photo 3. View from the dry hole marker facing westward.

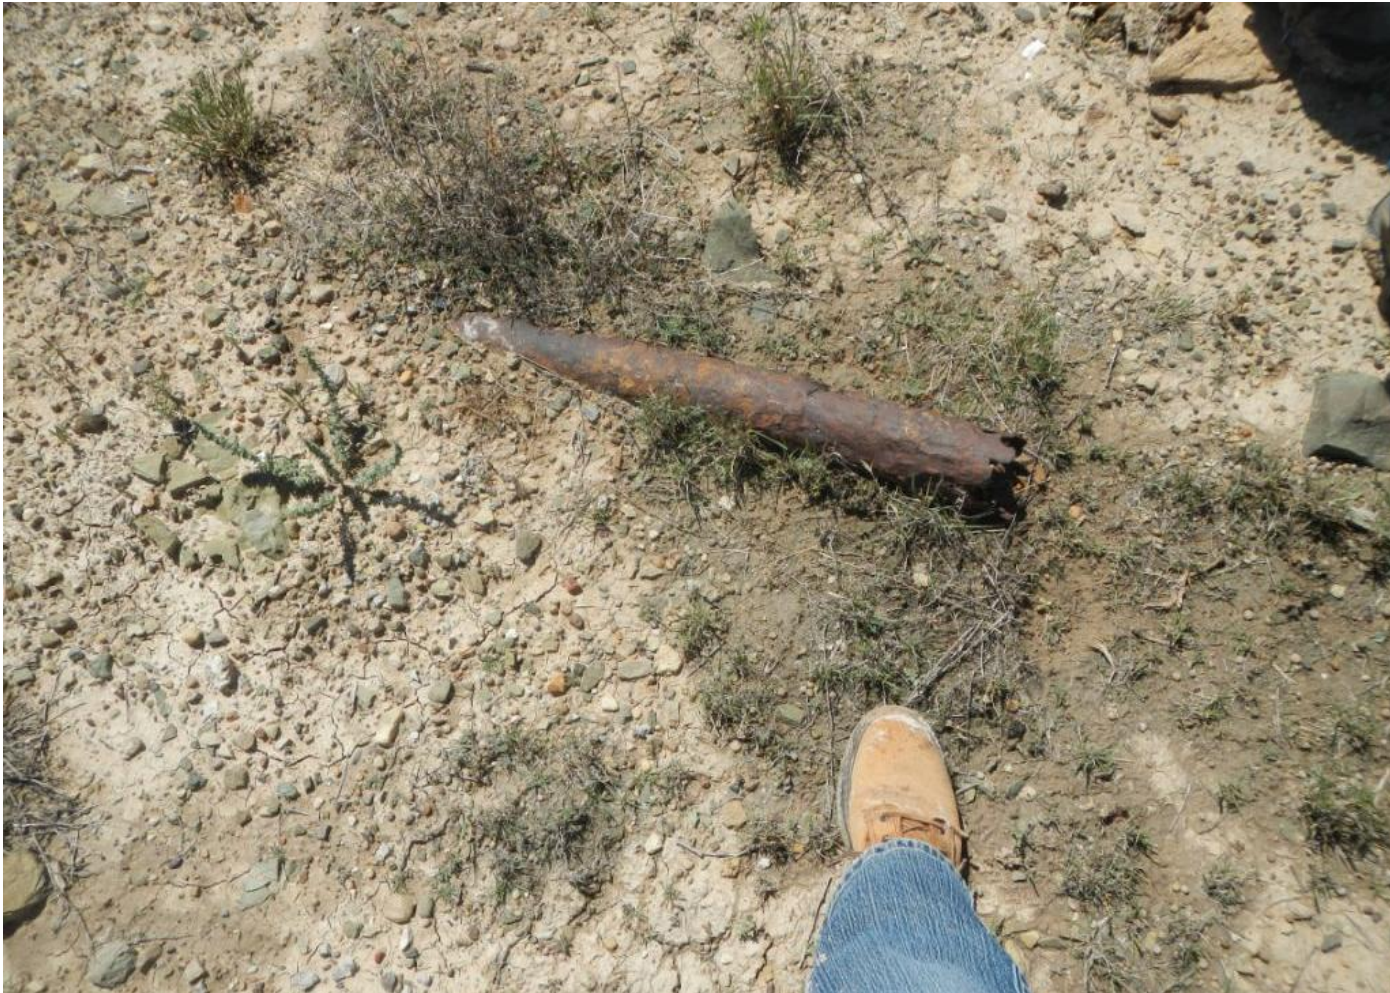
Photo 4. View of metal debris in the project area.

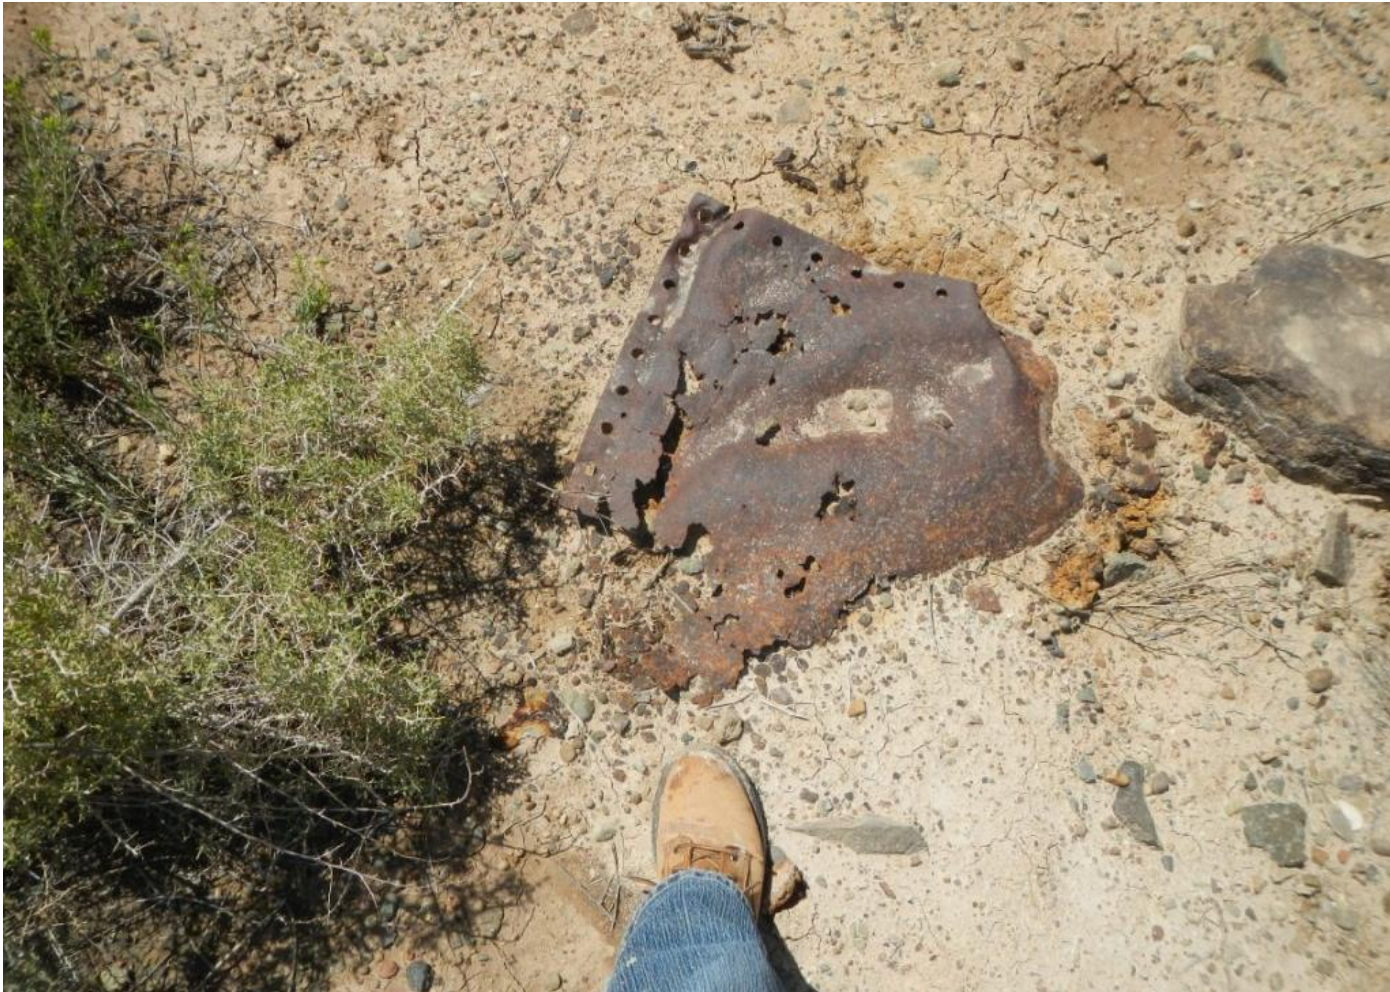
Photo 5. View of more metal debris in the project area.

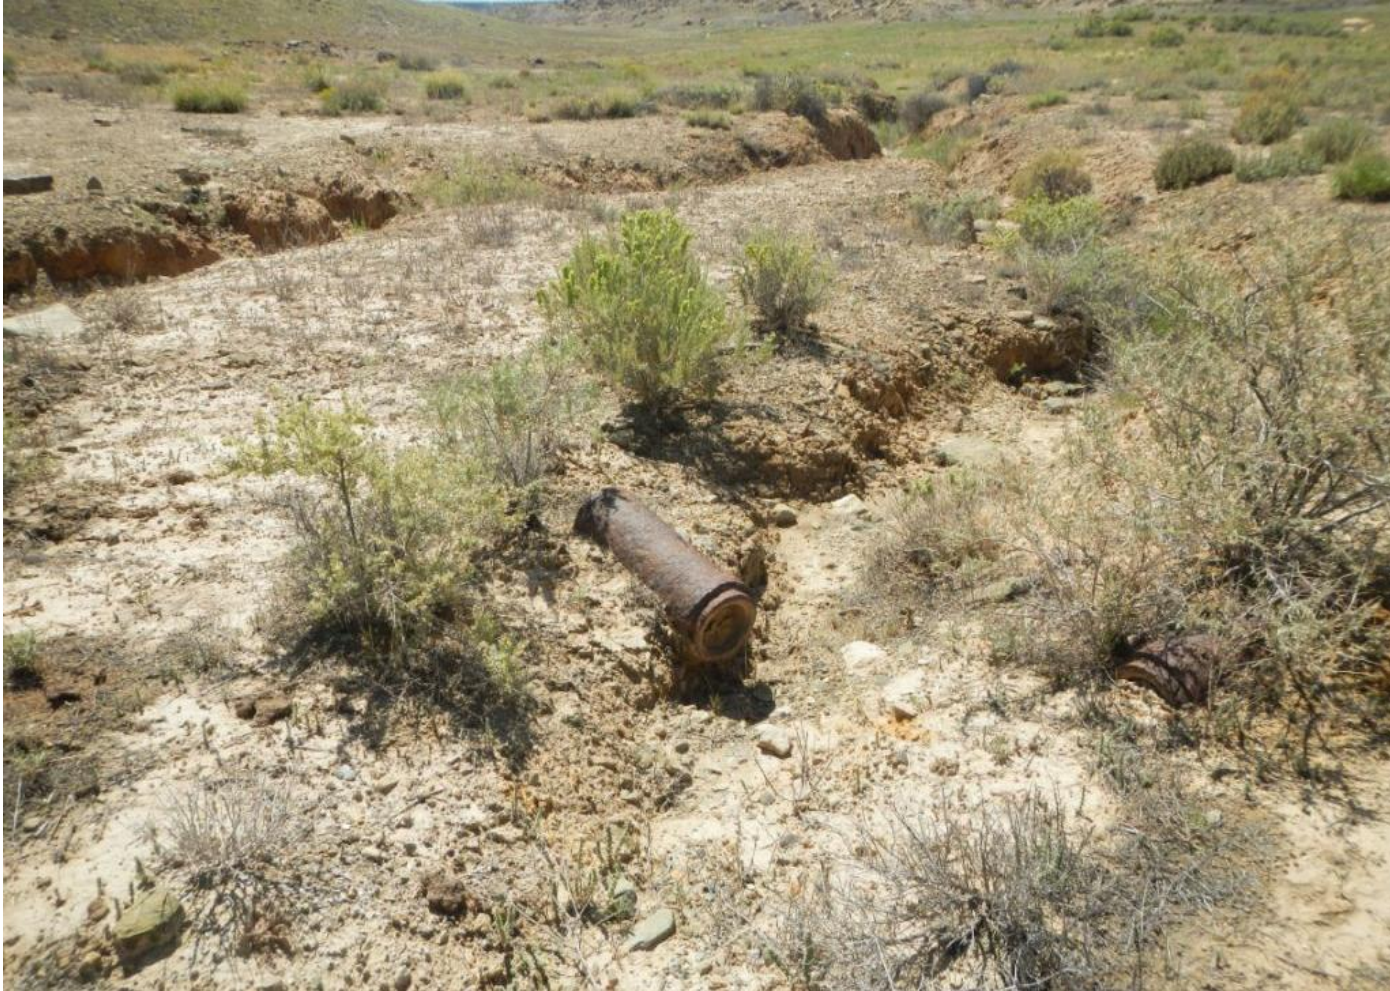
Photo 6. View of erosional downcutting and metal debris in the project area.
