Final Reclamation Inspection Overview: 059-06018

Final Reclamation Inspection

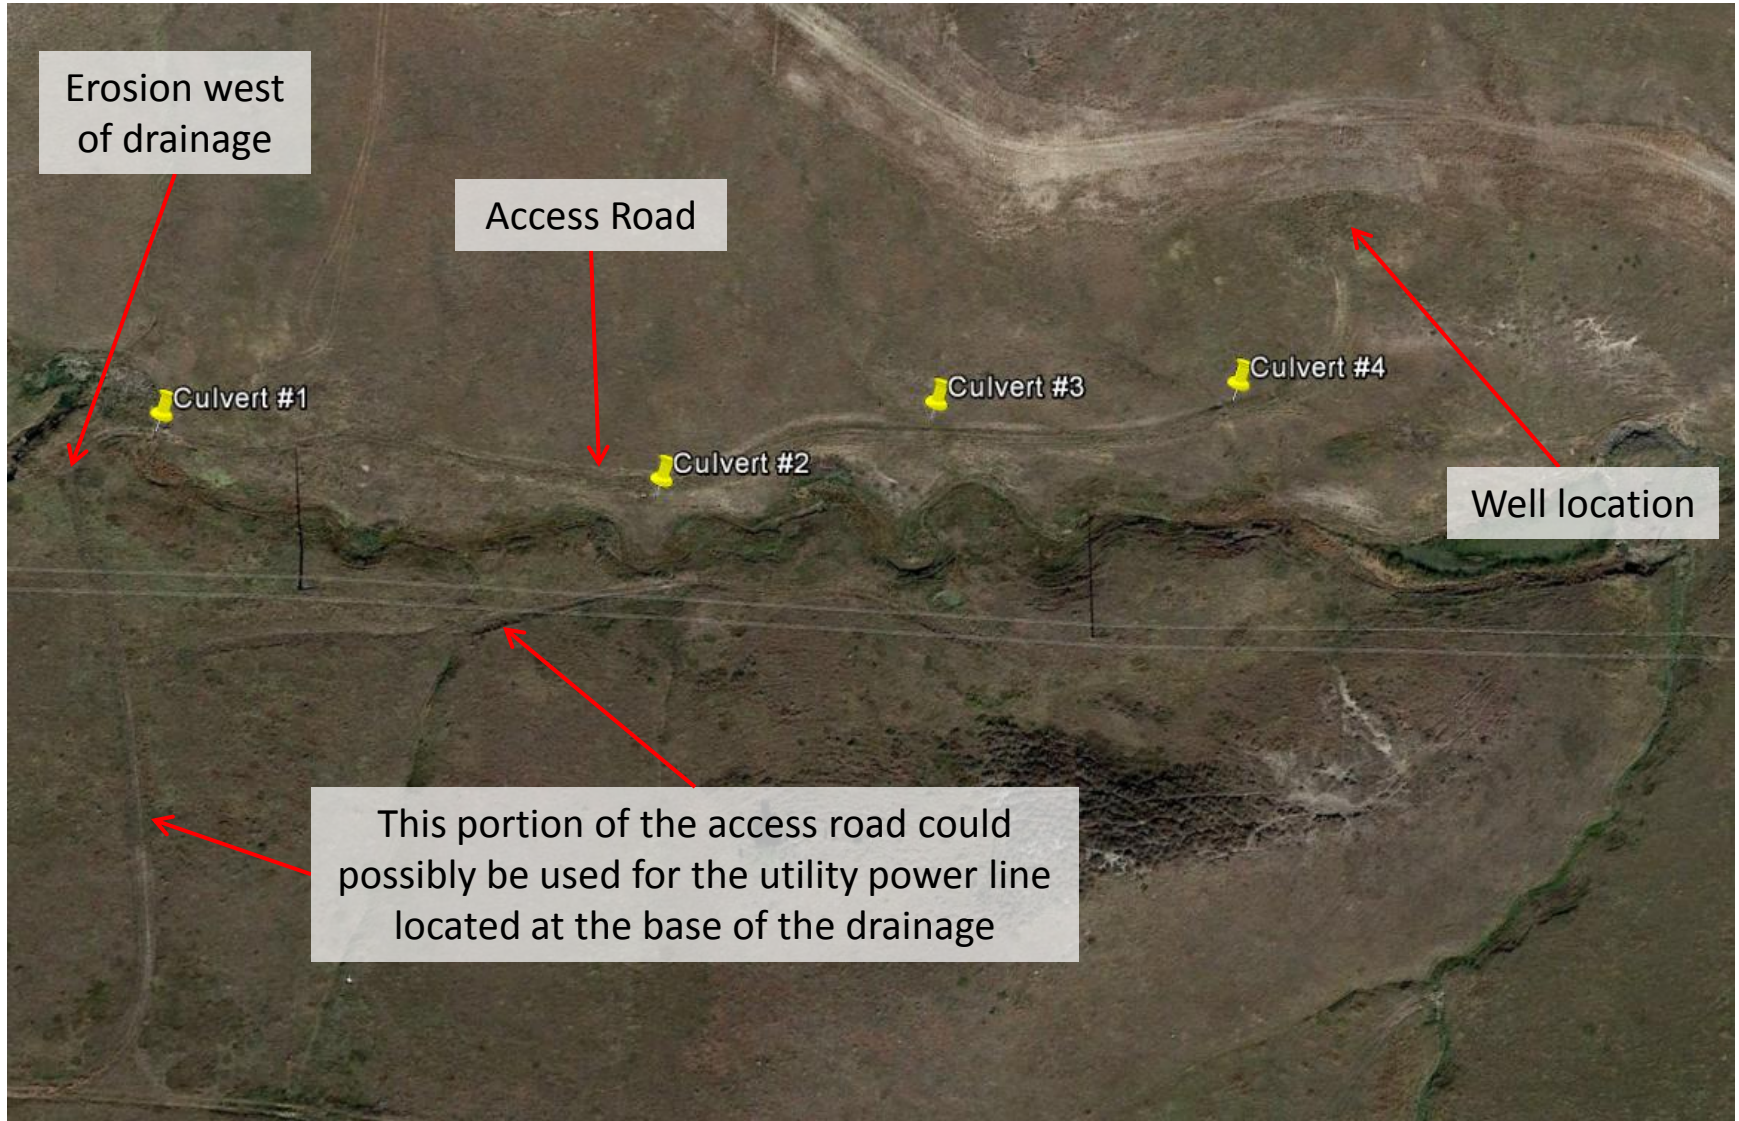
Google Earth aerial imagery taken 10/9/2015 illustrating area of interest. The access road, starting to the west of Culvert #1 to the well location, has not been re-contoured. Erosion needs to be controlled around the drainage by Culvert #1. Culverts need to be removed and access road re-contoured per Rule 1004. A Colorado List B noxious weed was observed along the access road and at the well location. Refer to the following photos from the 9/8/2016 inspection.

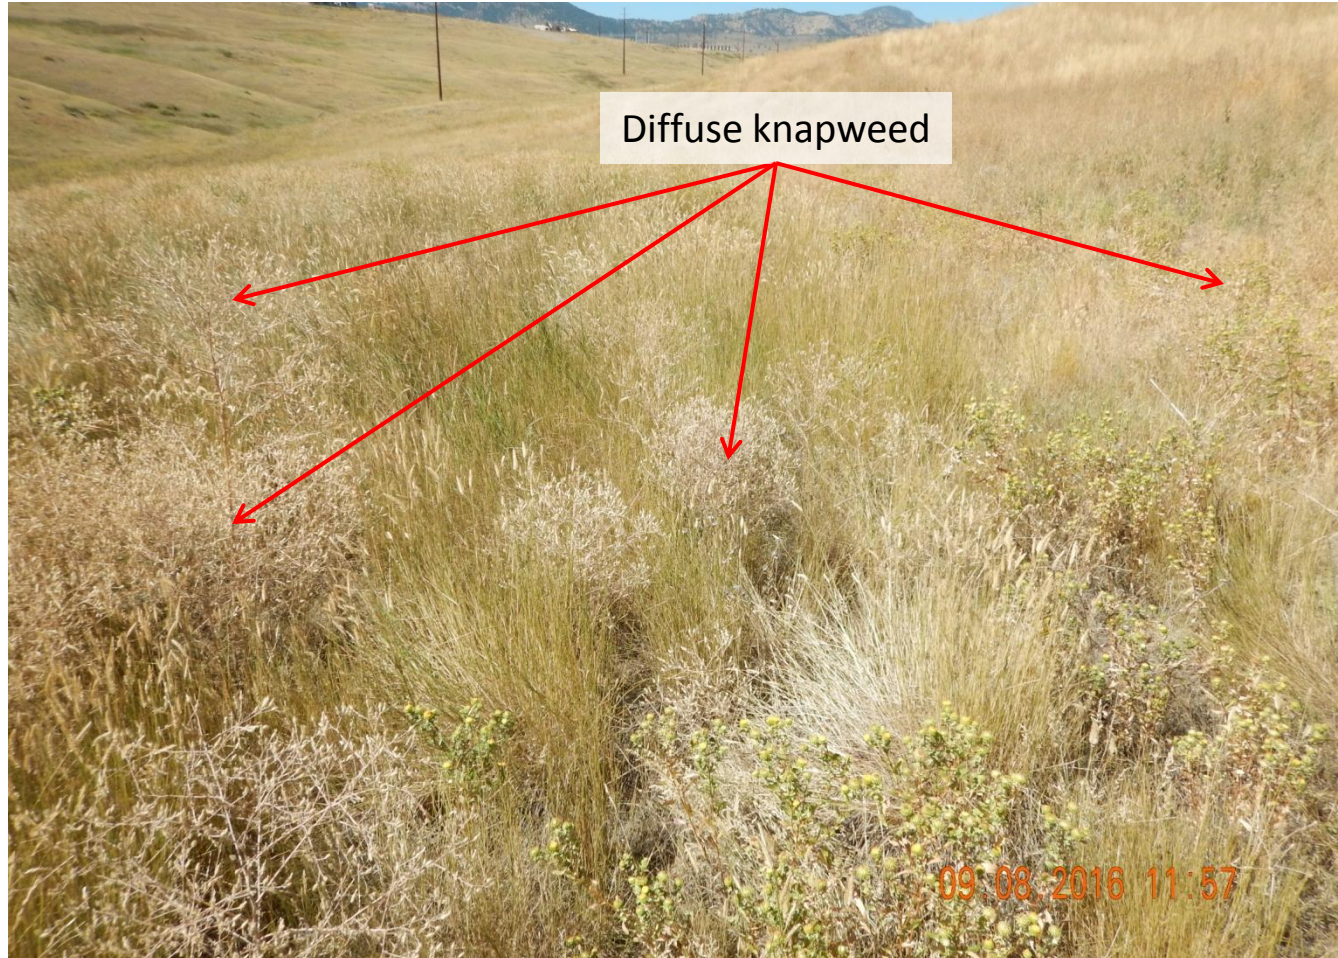
Photo 2. Photo taken from approximate center of location, facing West. Perennial vegetation has established at location but the location is inundated with a Colorado List B noxious weed, Diffuse knapweed (*Centaurea diffusa*).

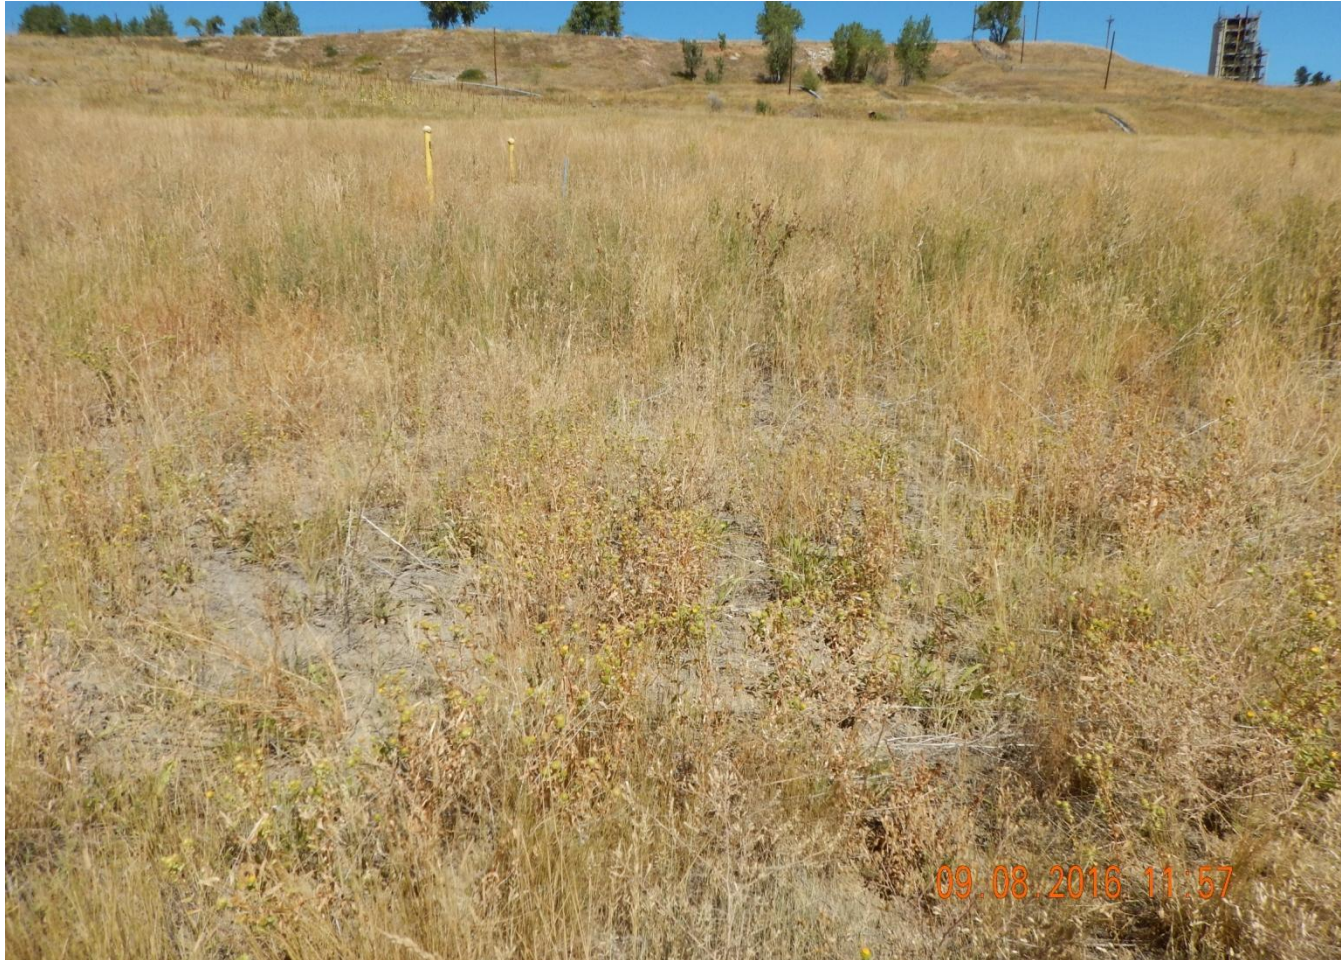
Photo 3. Photo taken from approximate center of location, facing North. Perennial vegetation has established at location but the location is inundated with a Colorado List B noxious weed, Diffuse knapweed (*Centaurea diffusa*).

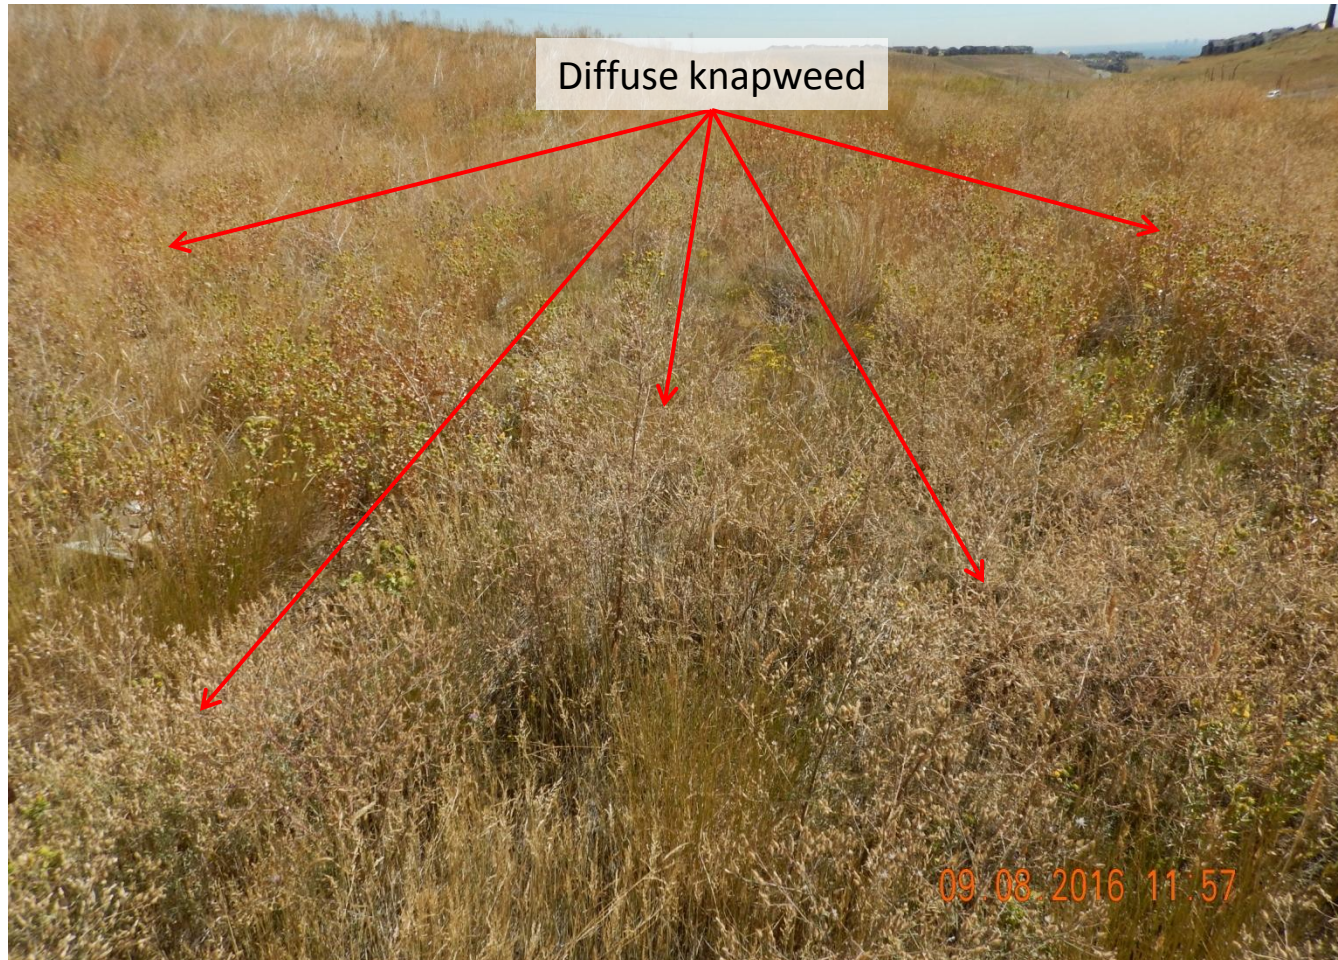
Photo 4. Photo taken from approximate center of location, facing East. Perennial vegetation has established at location but the location is inundated with a Colorado List B noxious weed, Diffuse knapweed (*Centaurea diffusa*).

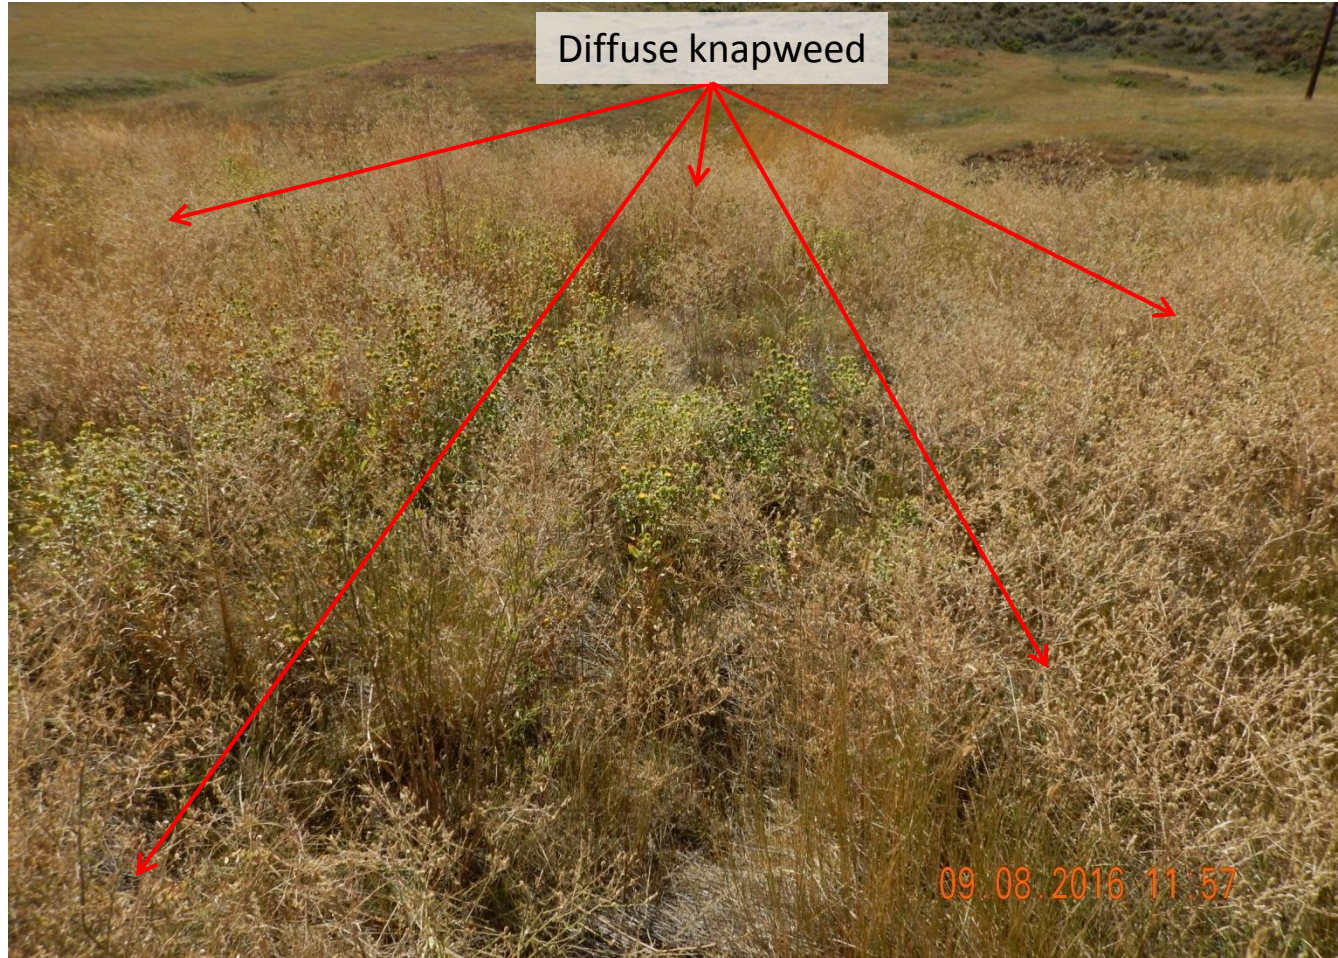
Photo 5. Photo taken from approximate center of location, facing South. Perennial vegetation has established at location but the location is inundated with a Colorado List B noxious weed, Diffuse knapweed (*Centaurea diffusa*).

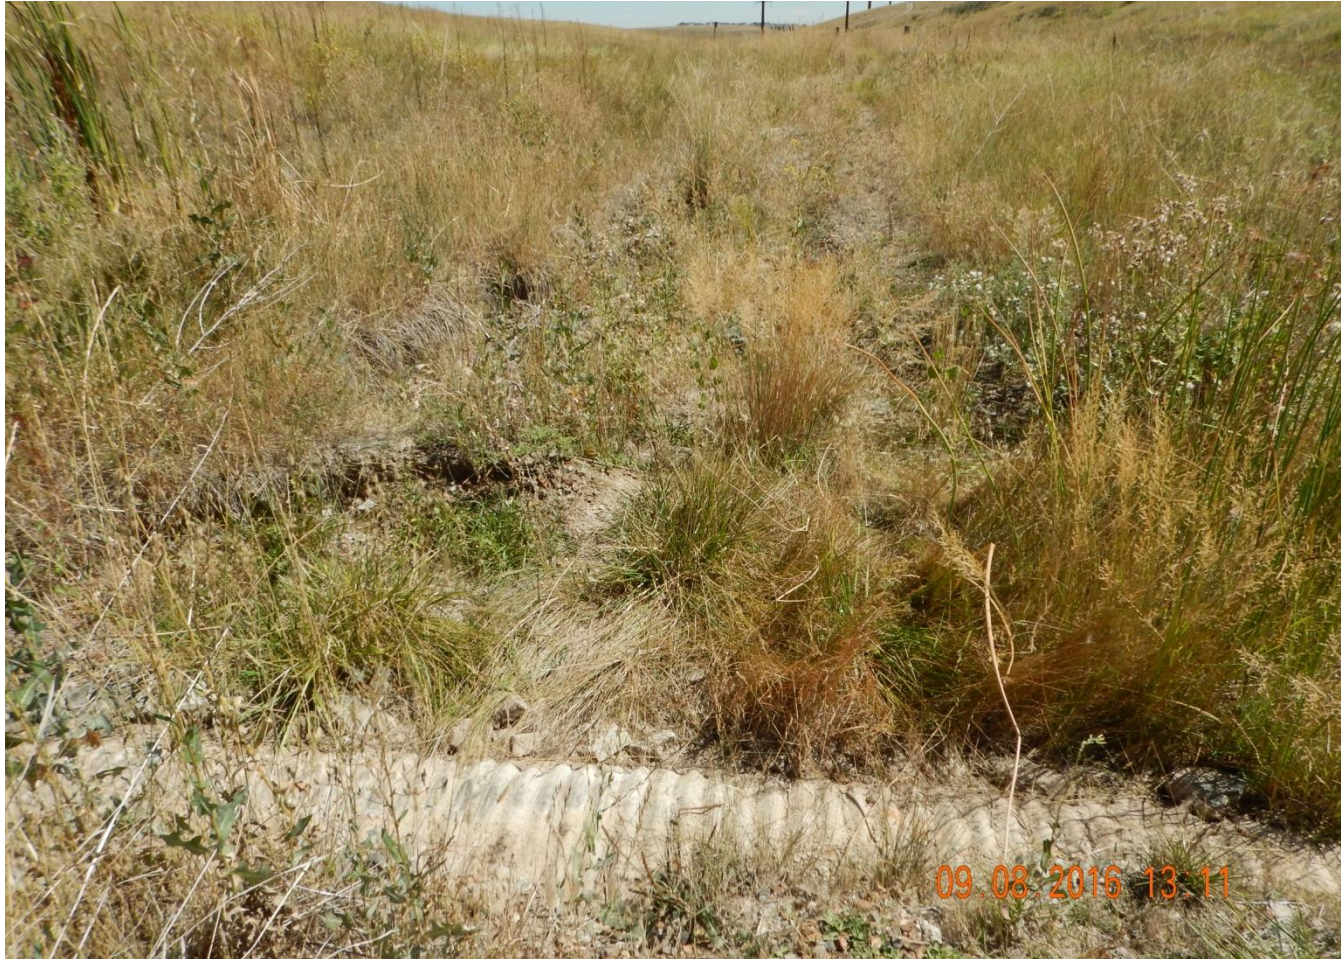
Photo 7. Photo taken from Culvert #1, facing East. Culvert needs to be removed to establish natural flows, need to remove gravel used to arm the culvert and reseed with native, perennial vegetation that is representative.

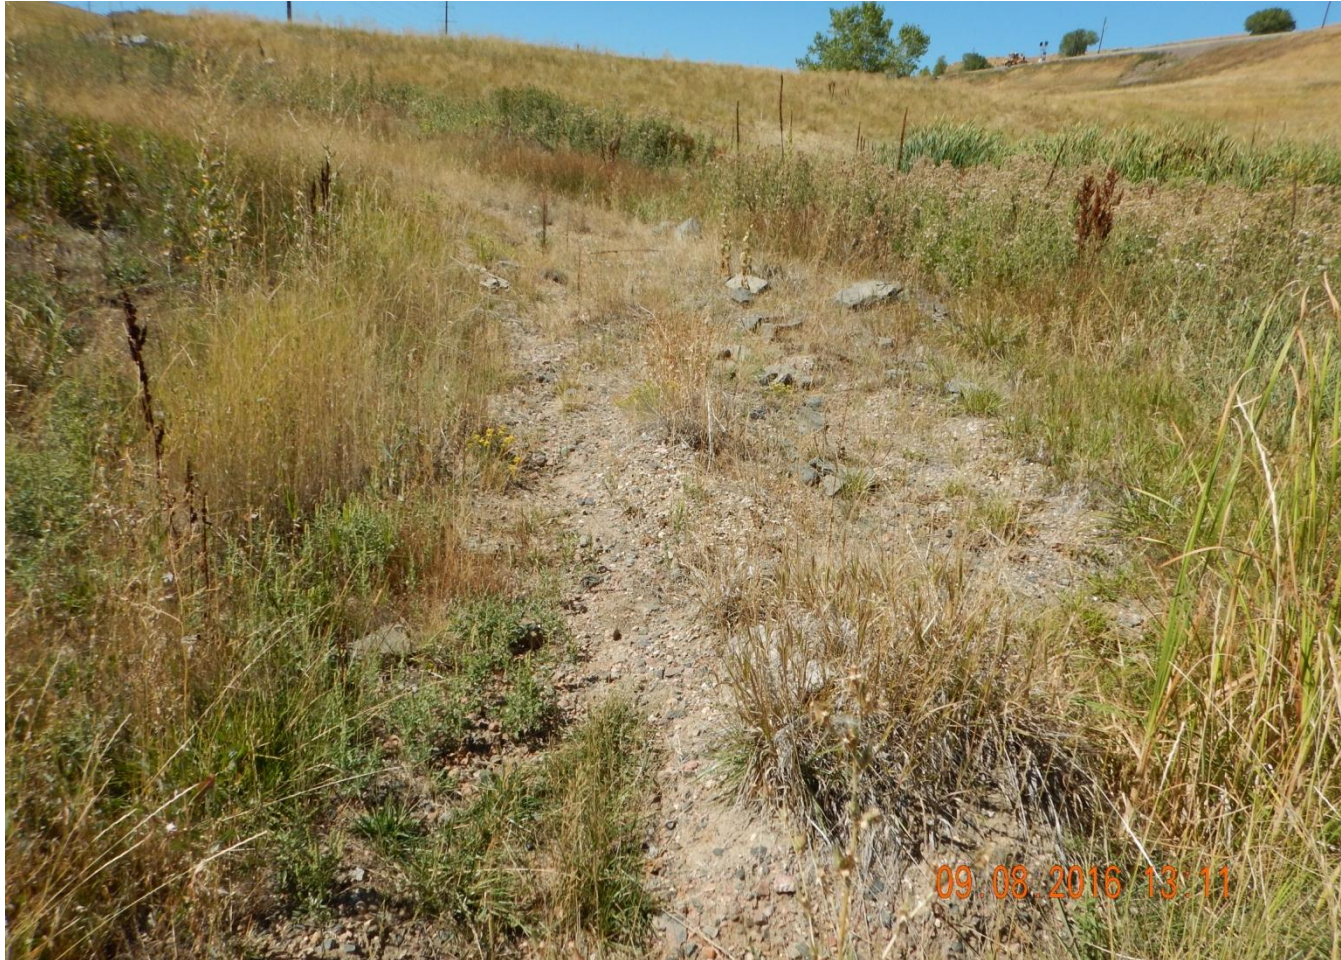
Photo 8. Photo taken from Culvert #1, facing West. Access road needs to be stabilized with native, perennial vegetation to prevent further erosion.

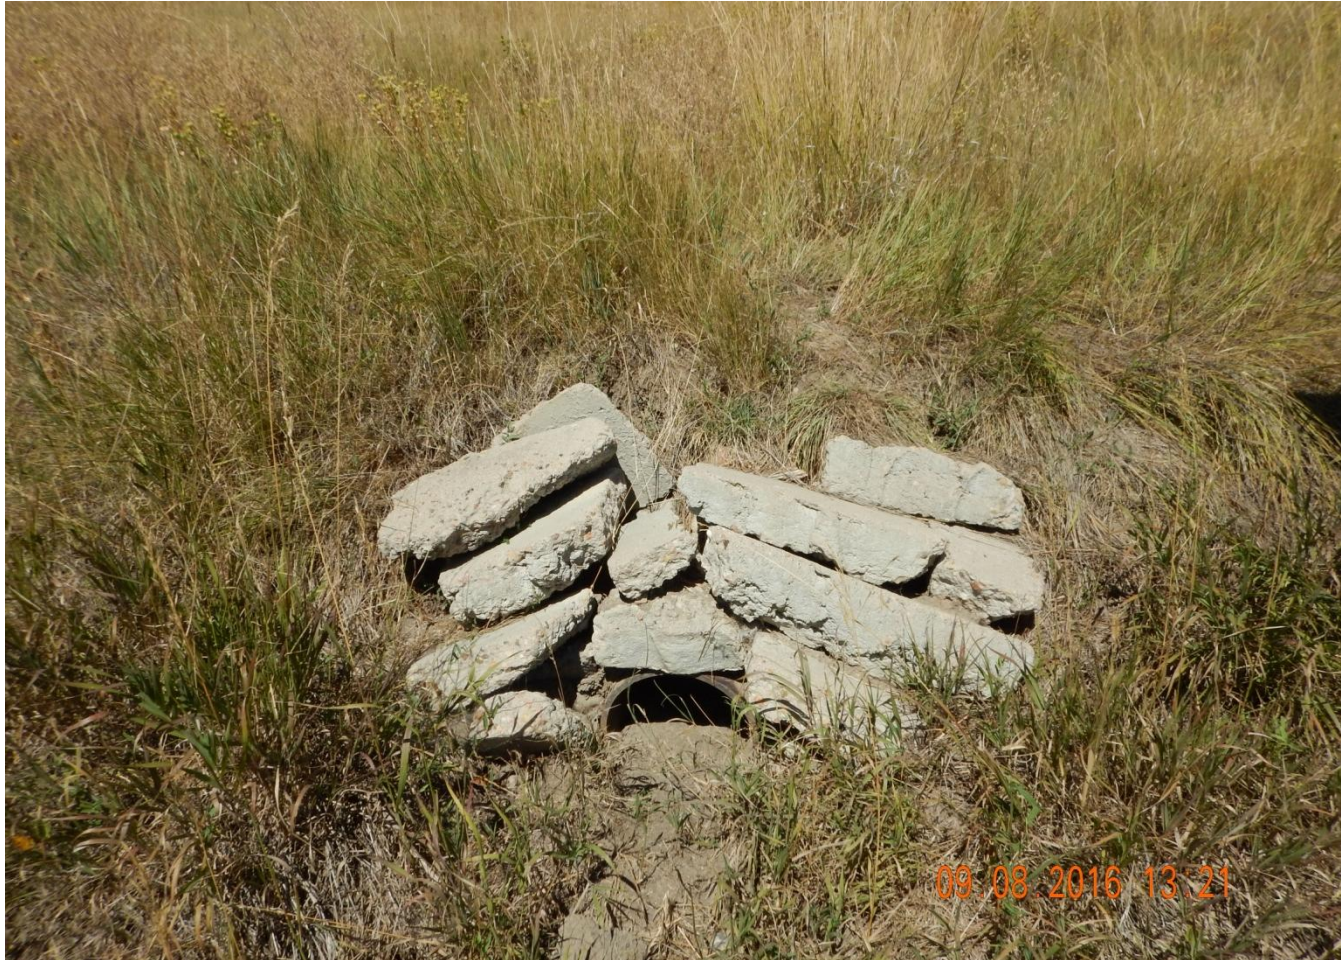
Photo 9. Photo taken of Culvert #2 that remains behind and needs to be removed.

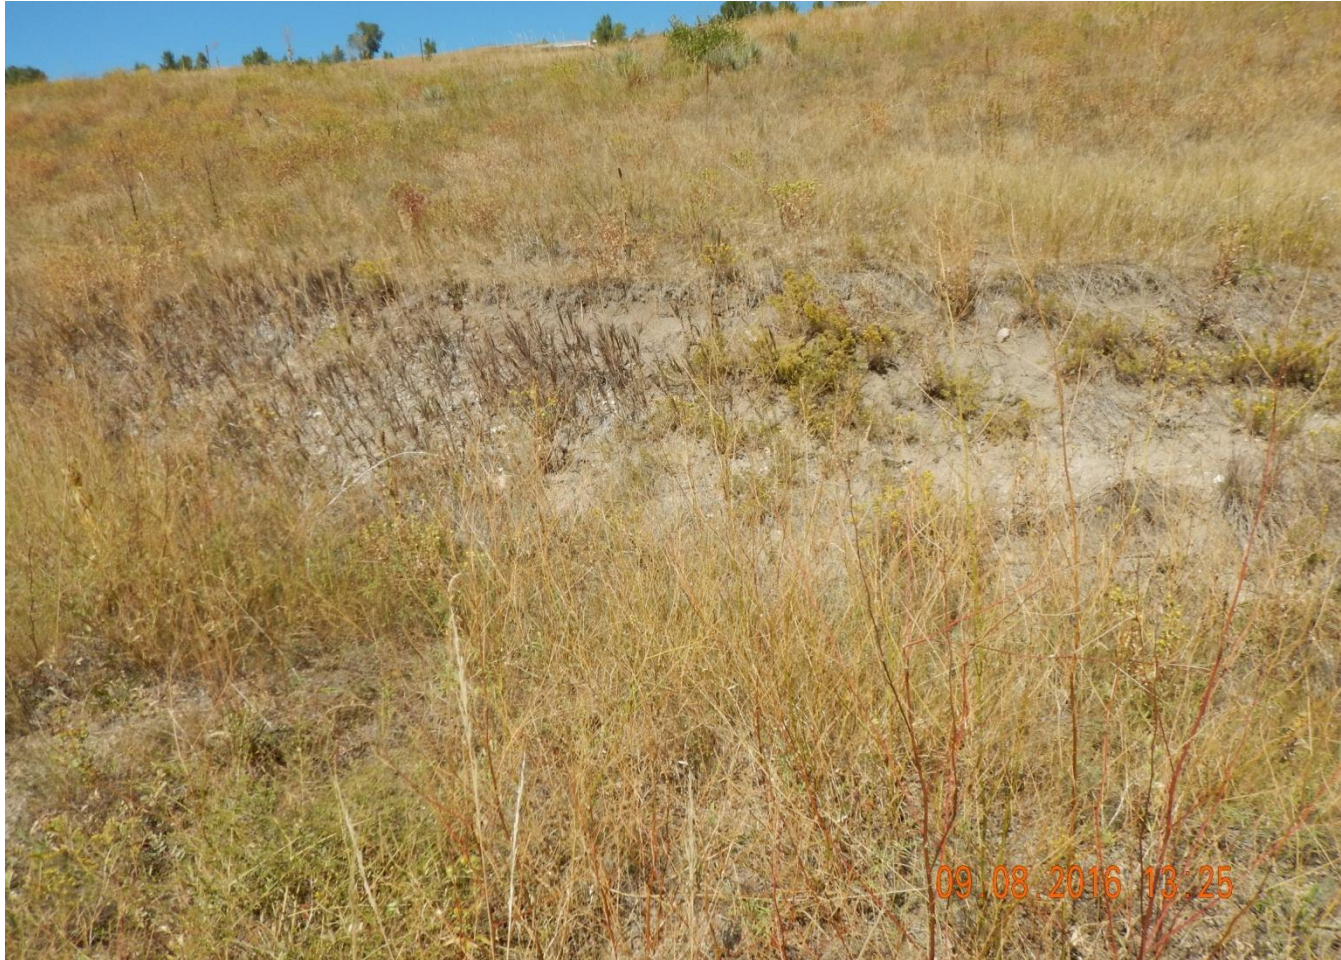
Photo 10. Photo taken along the access road, facing North. Access needs to be re-contoured to the surrounding landscape which will help to prevent erosion which is noticeable along several portions of the access road.

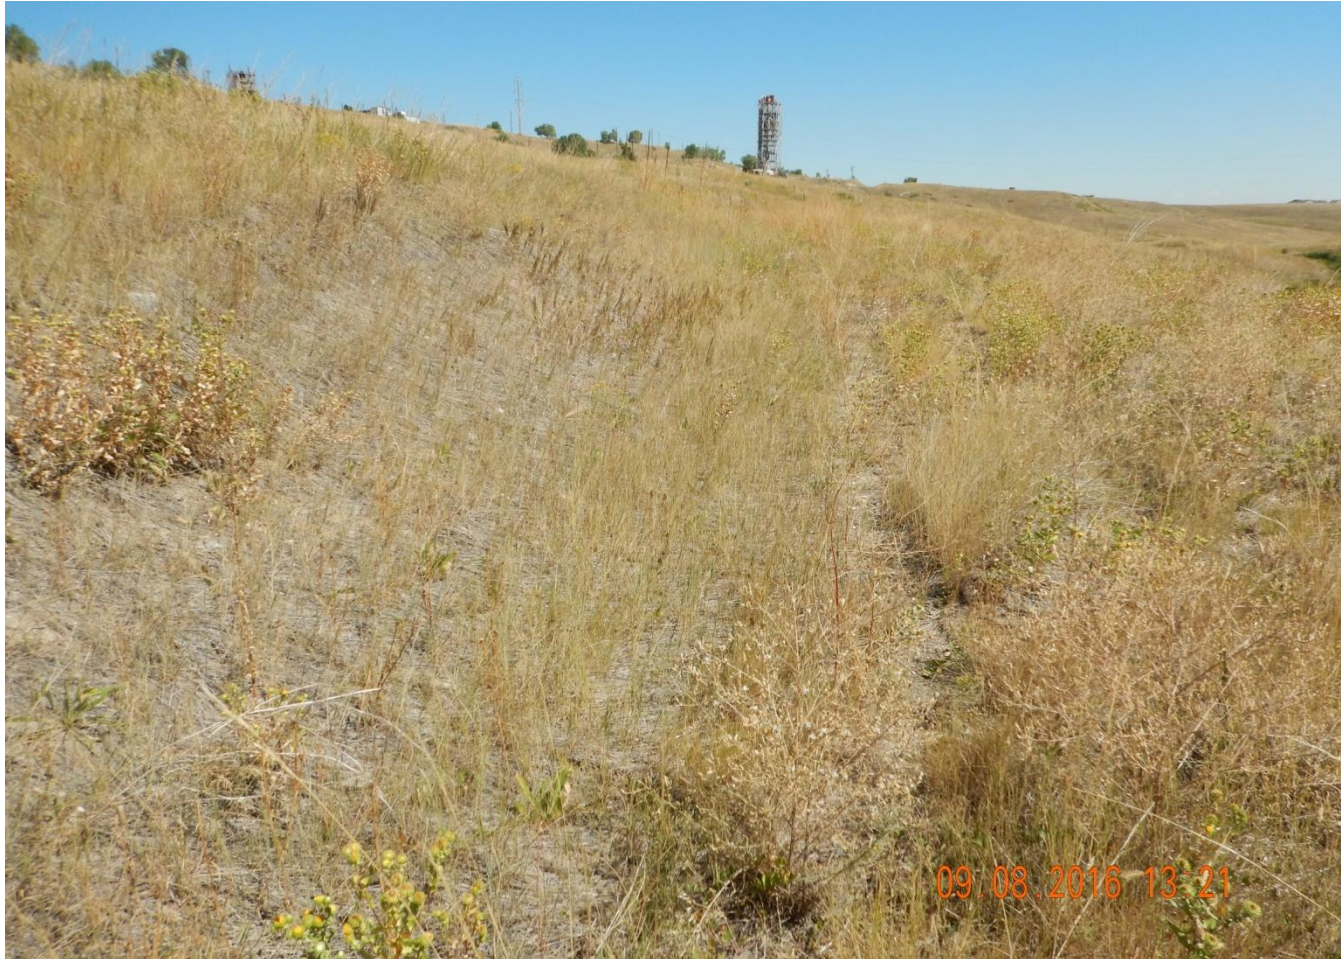
Photo 11. Photo taken along the access road, facing East. Diffuse knapweed and a few individuals of Spotted knapweed were observed throughout the entire access road.
