# Final Reclamation Inspection

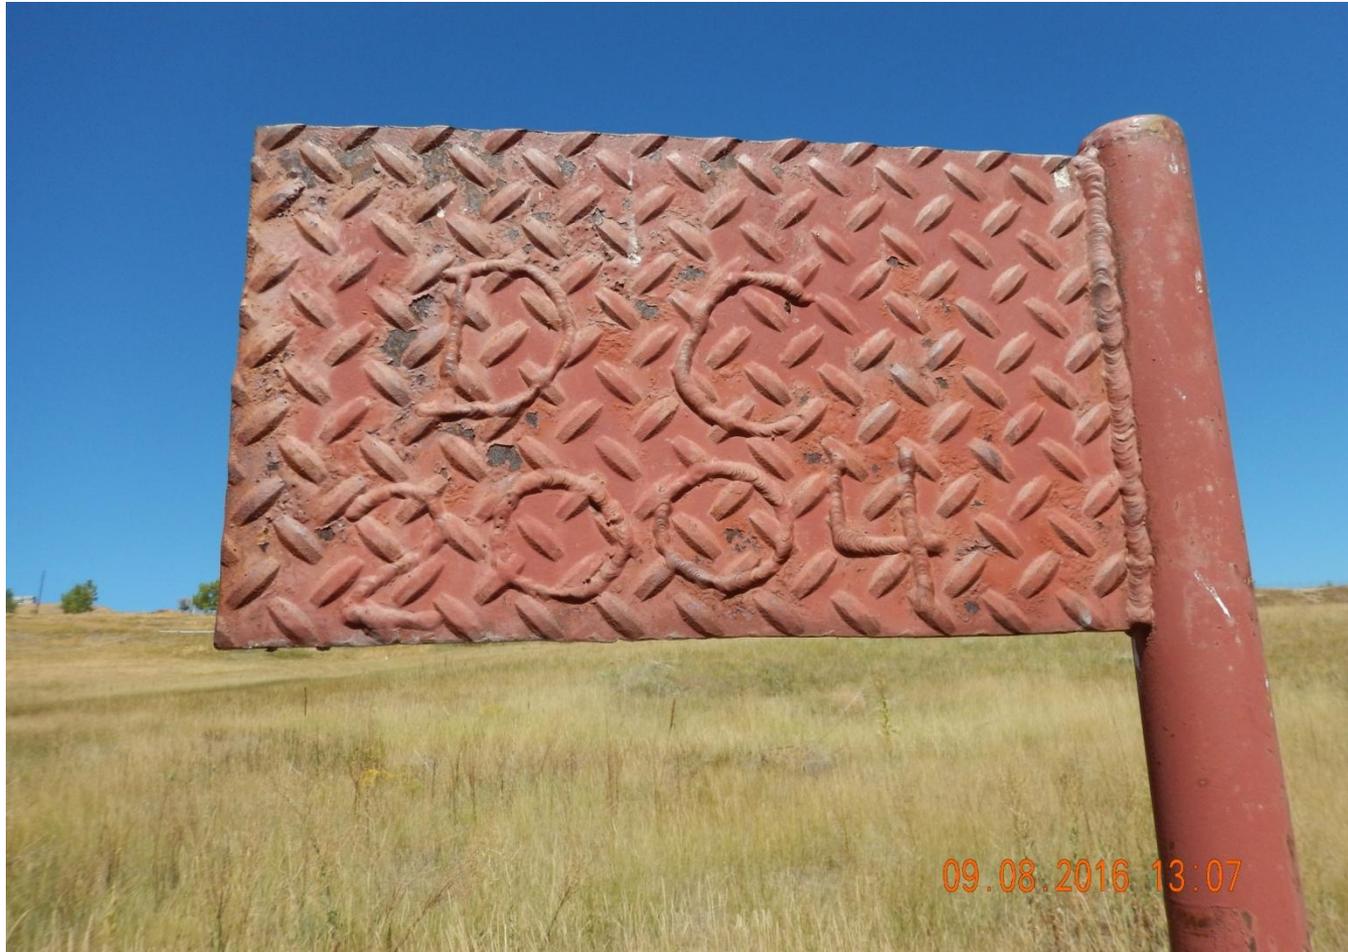
**Photo 1.** Photo taken of well sign at approximate center of well location.

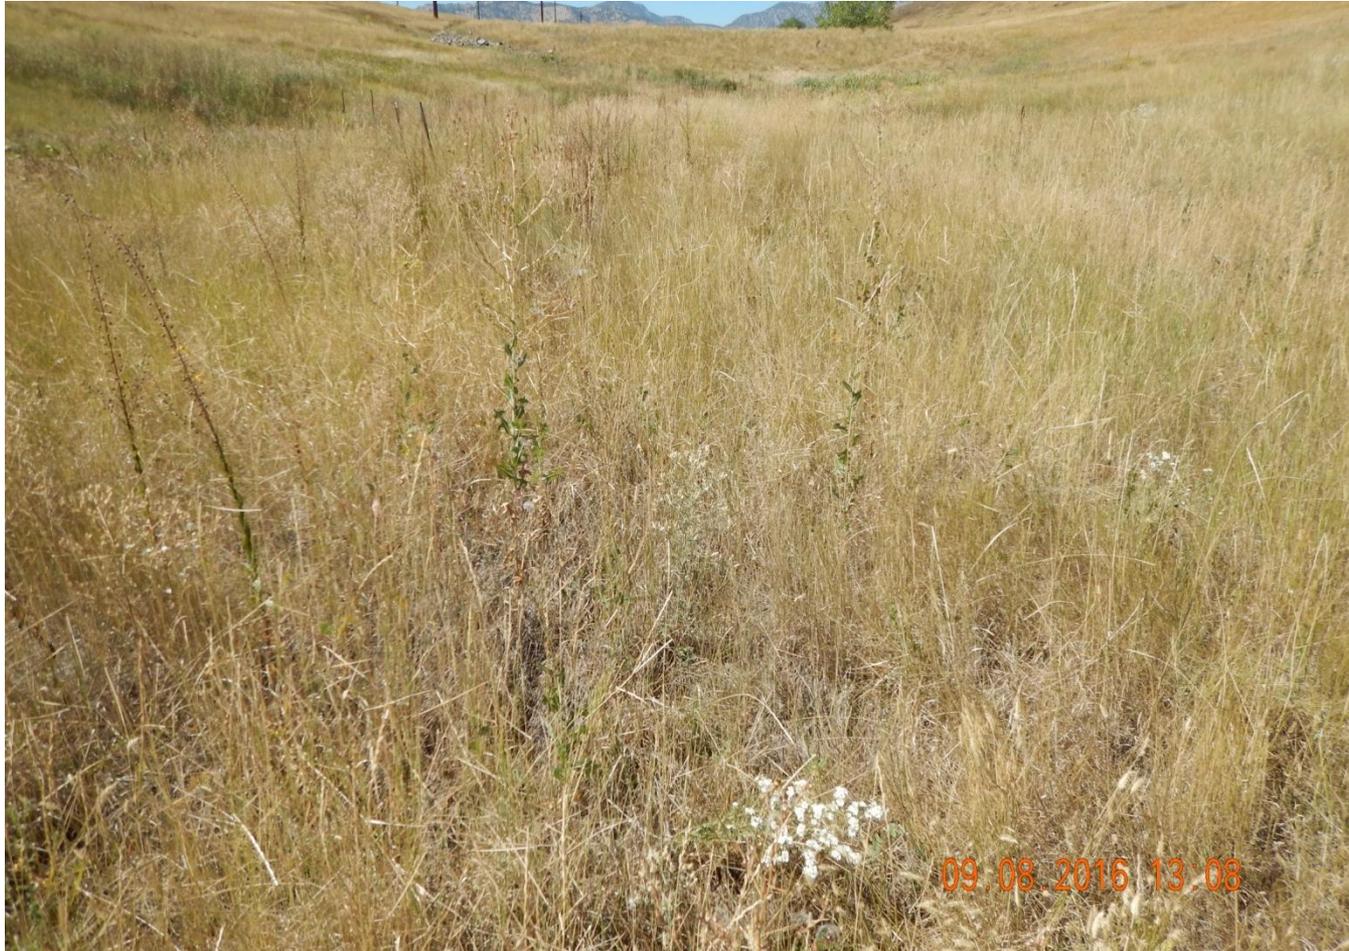
**Photo 2.** Photo taken from approximate center of location, facing West. Perennial vegetation has established at location but an area lacks vegetative growth. See Photos 6 and 7.

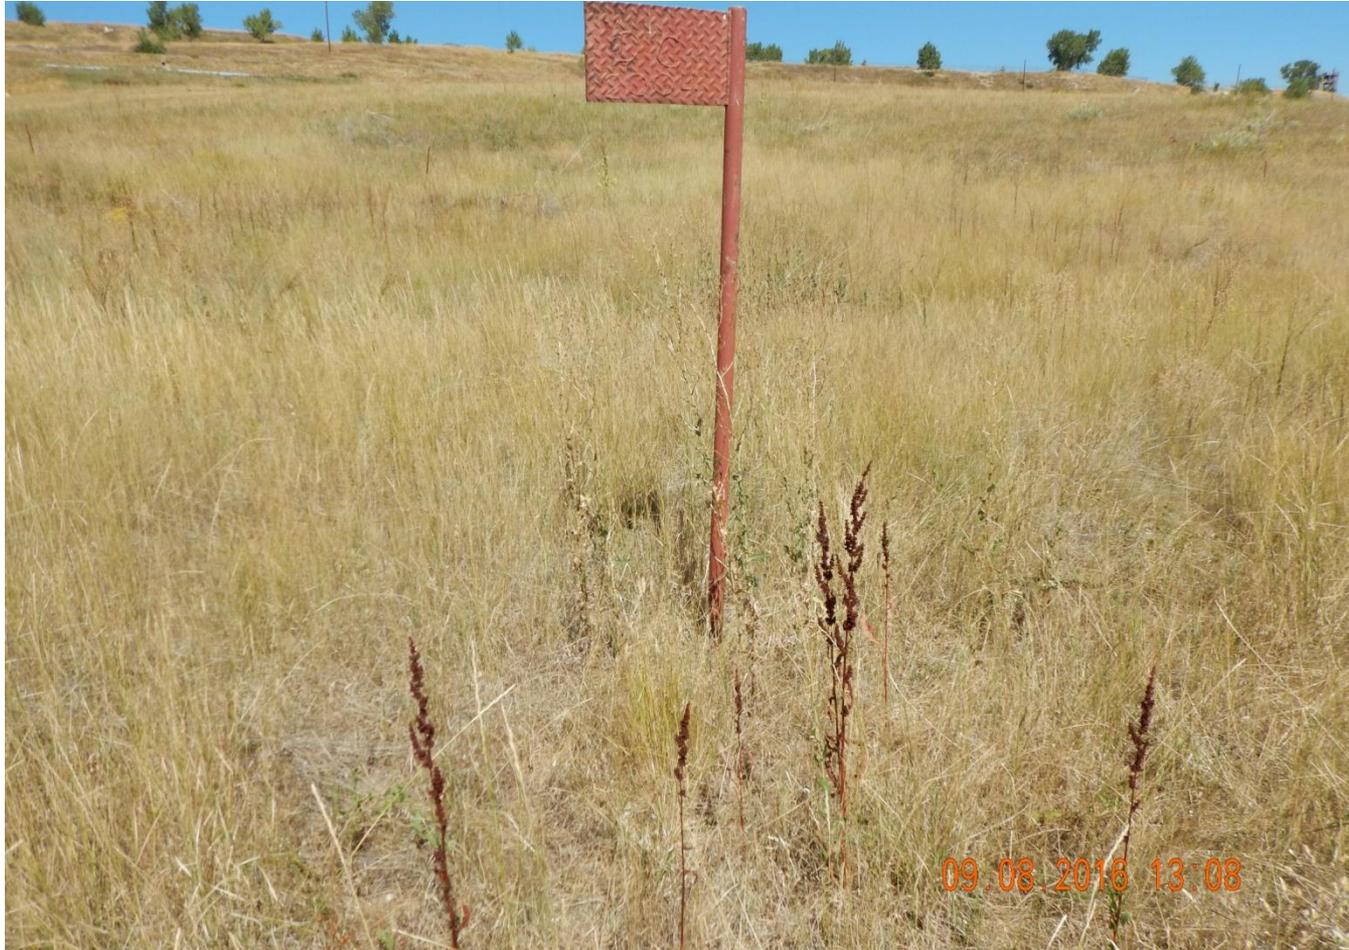
**Photo 3.** Photo taken from approximate center of location, facing North. Perennial vegetation has established at location but an area lacks vegetative growth. See Photos 6 and 7.

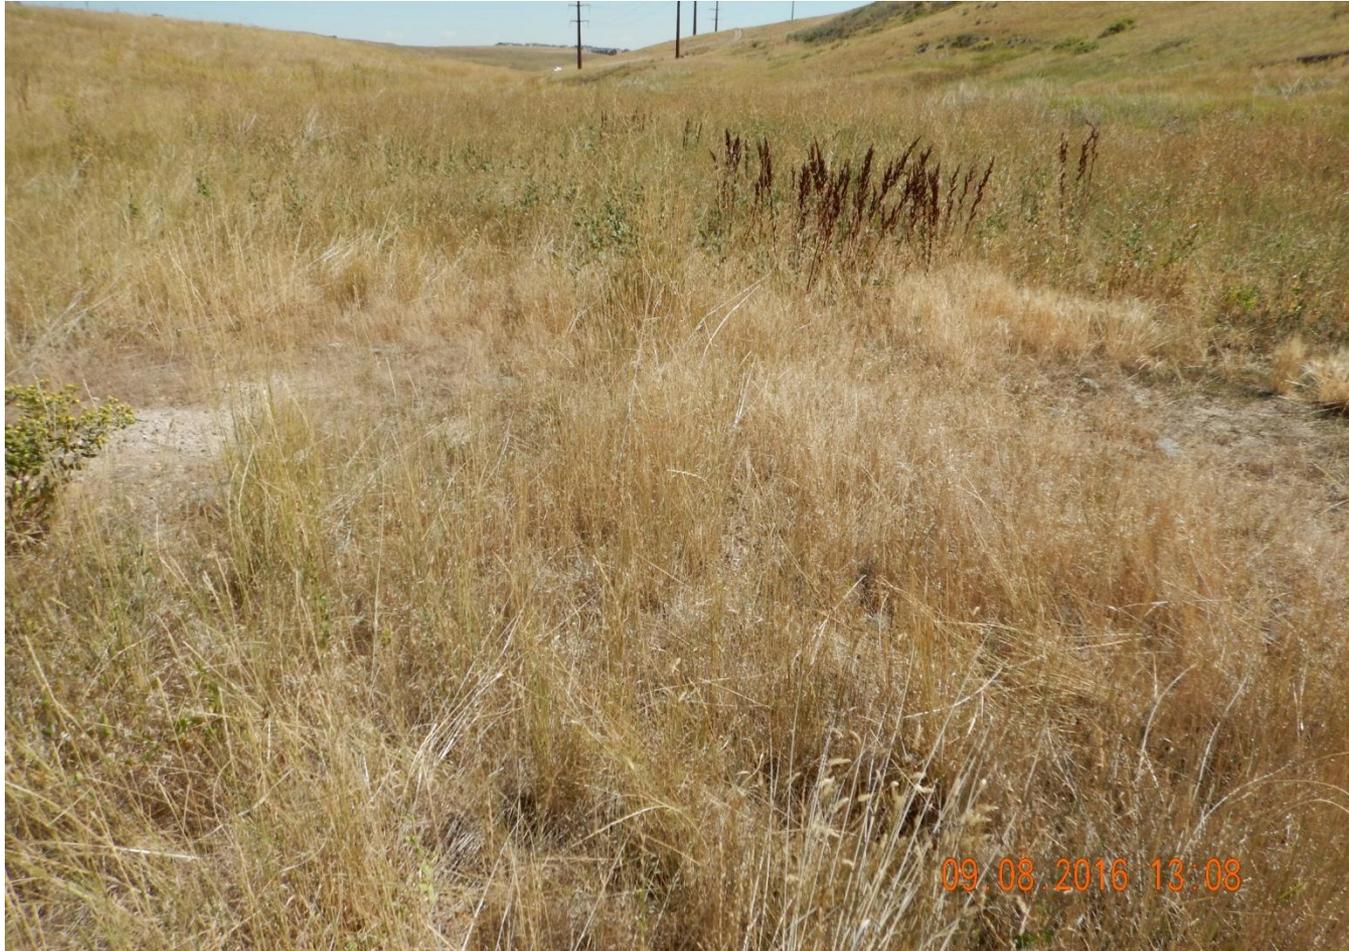
**Photo 4.** Photo taken from approximate center of location, facing East. Perennial vegetation has established at location but this area lacks vegetative growth. Refer to photos 6 and 7.

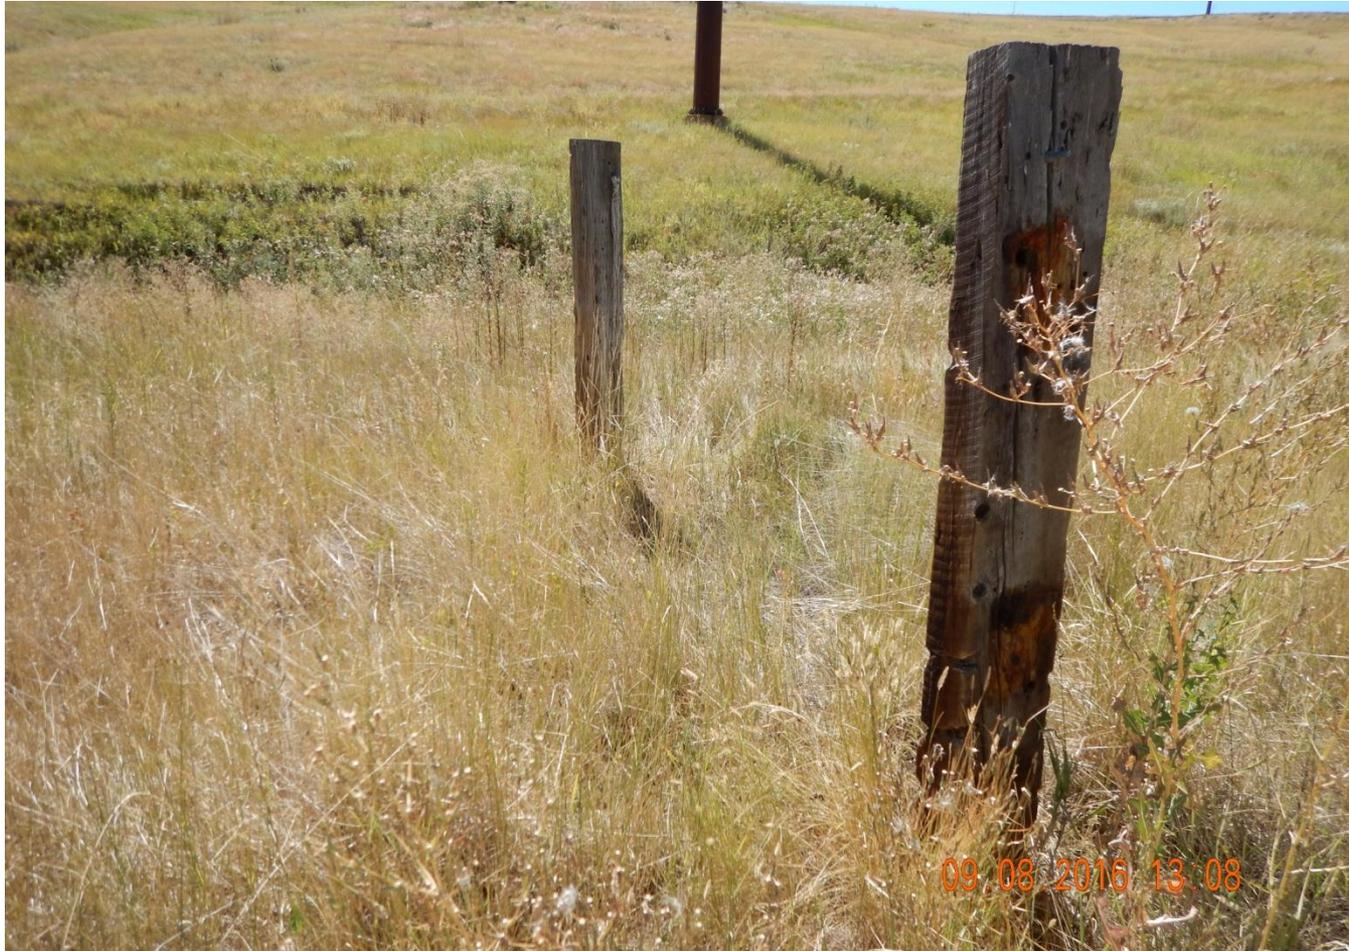
**Photo 5.** Photo taken from the western location. Need to remove all debris from location, if this is from oil and gas operations.

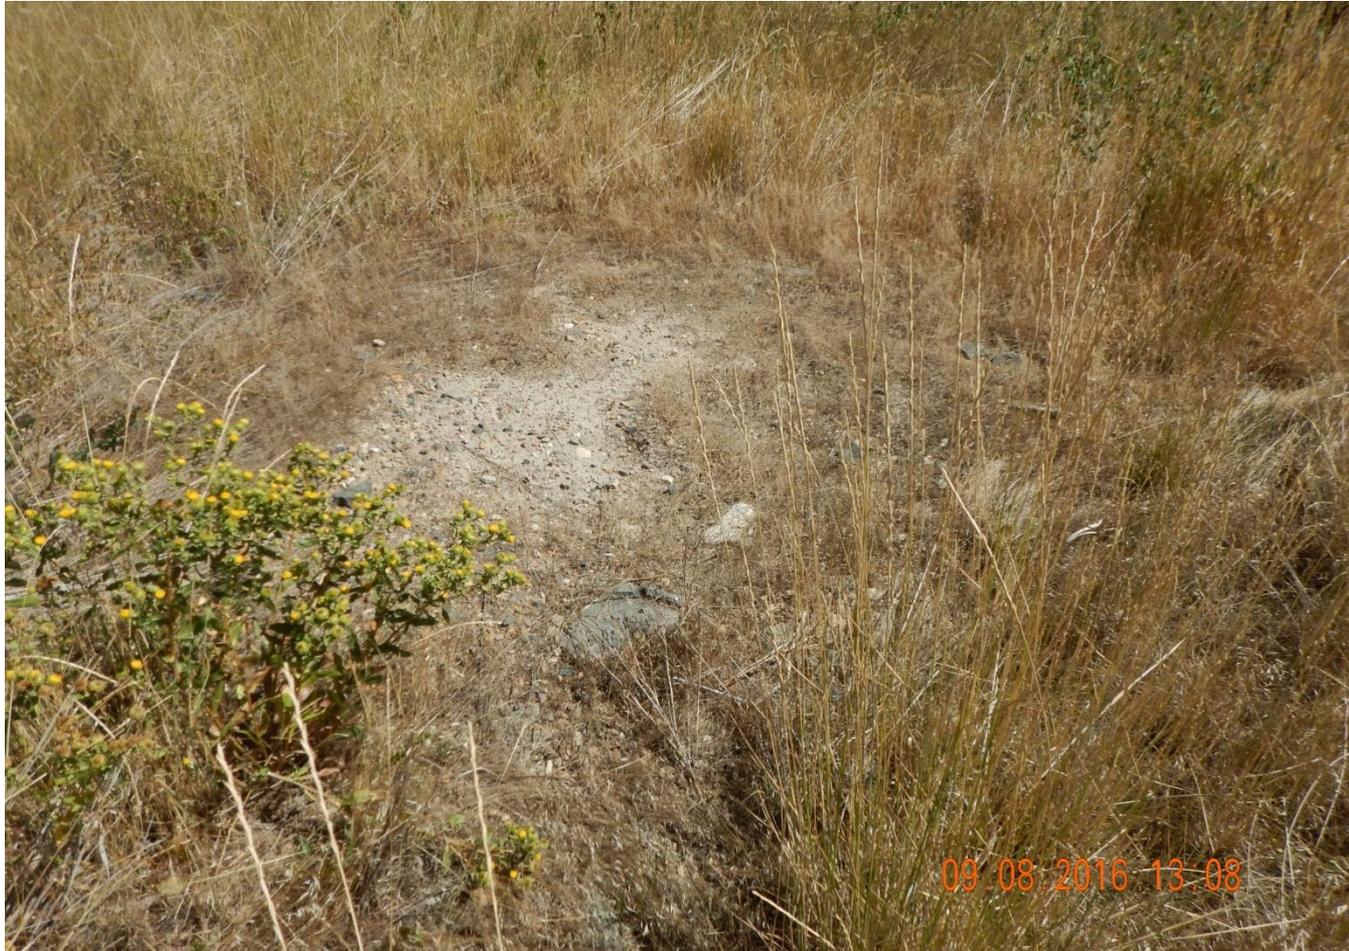
**Photo 6.** Photo taken from the eastern location. Location lacks any vegetative growth where it would appear the wellhead may have been.

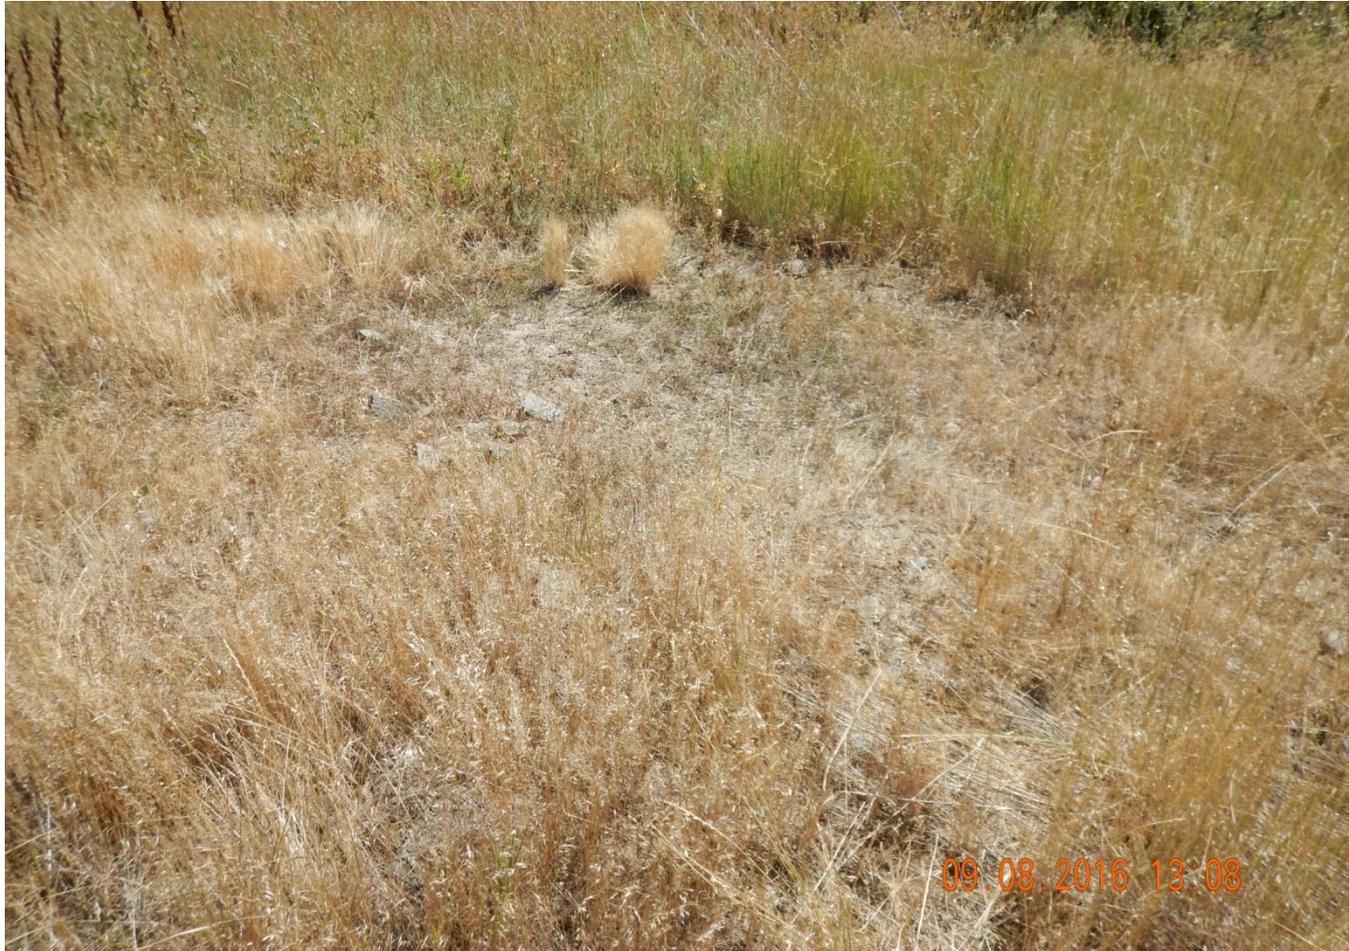
**Photo 7.** Photo taken from the eastern location. Location lacks any vegetative growth and the vegetative is not representative of surrounding areas, mainly cheatgrass along this portion of the location.
