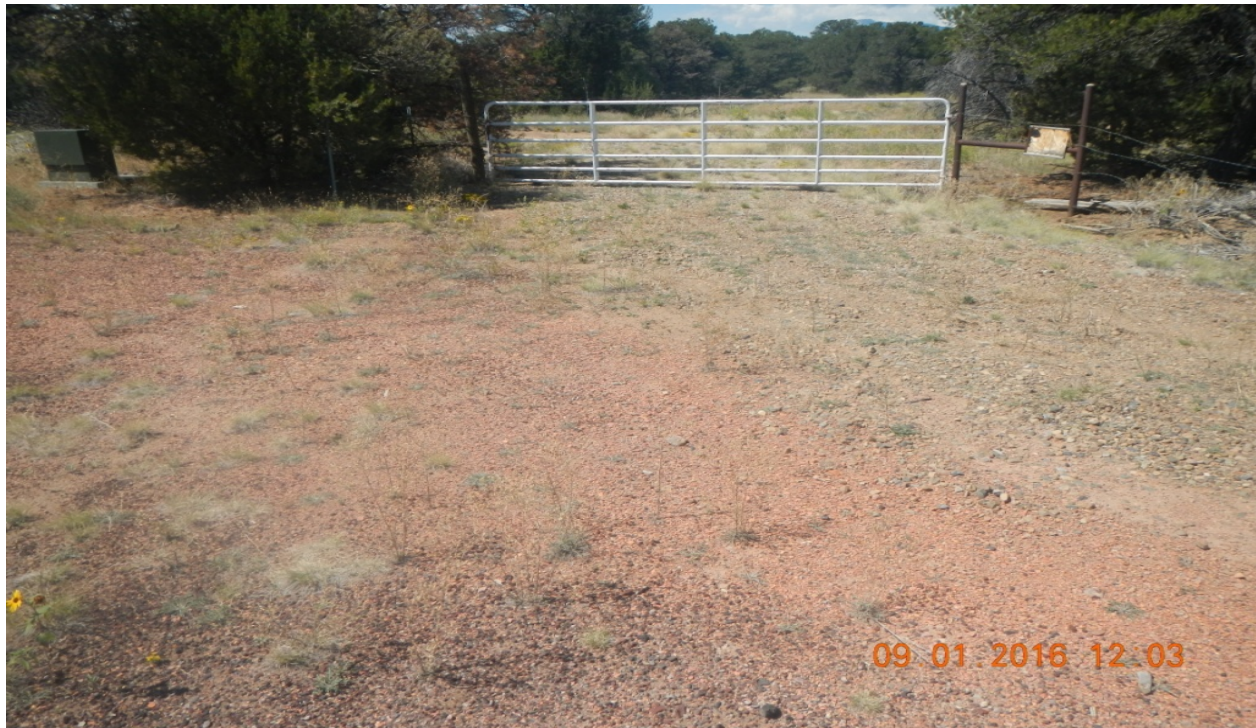
photo 1: Facing toward the beginning of the access road.

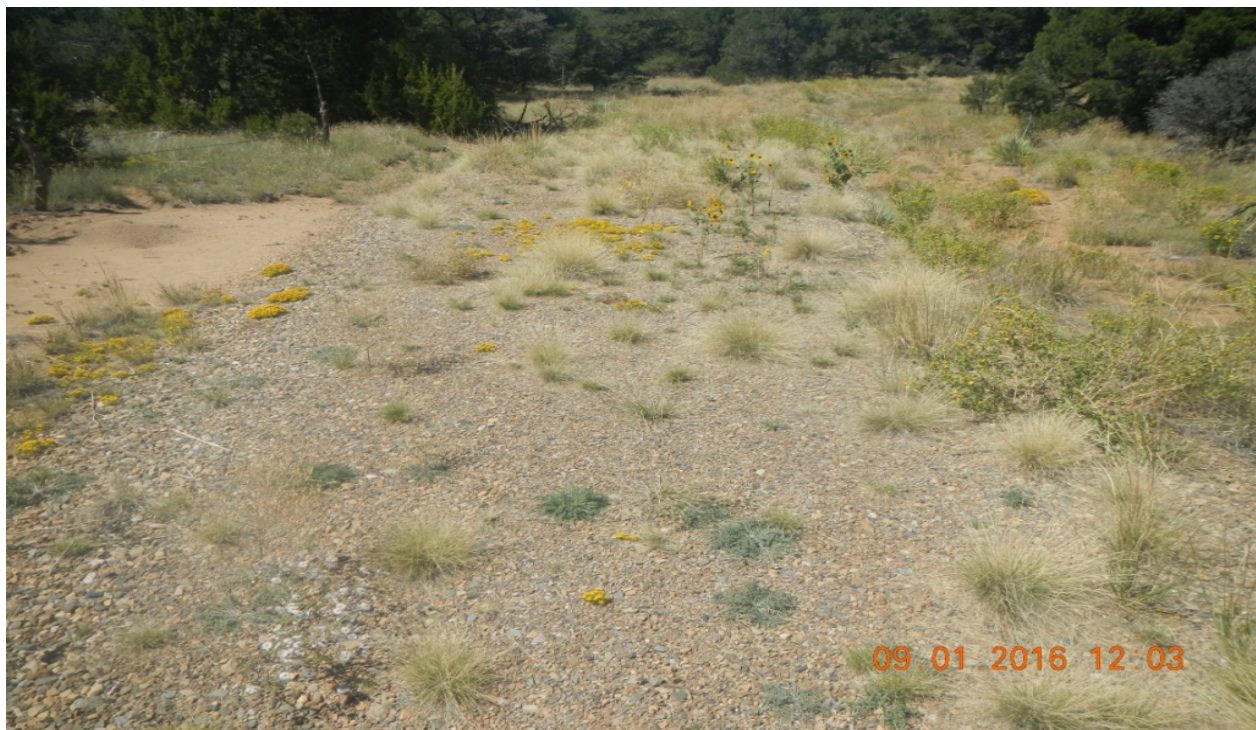
photo 2: Facing west along the access road. The access road has not been reclaimed and there is noxious weed infestation along the road.

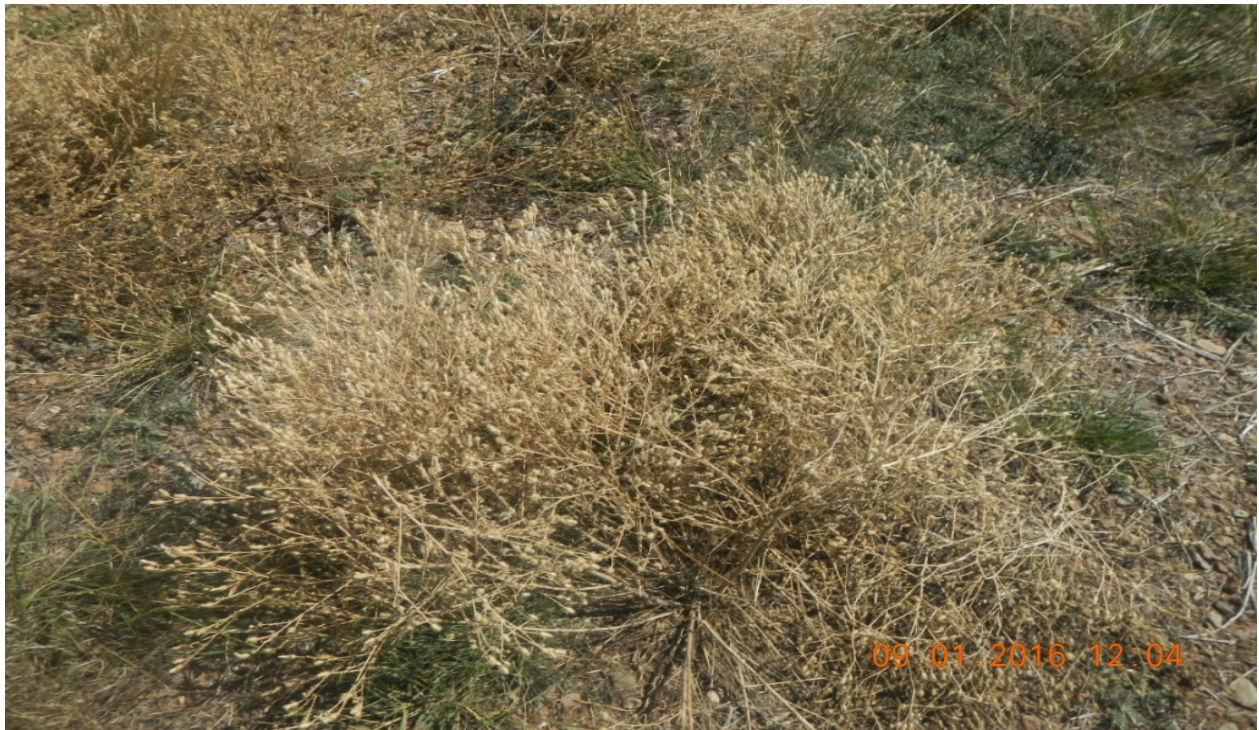
photo 3: There is Diffuse and Spotted knapweed (List B noxious weeds) growing along the access road and at the location.

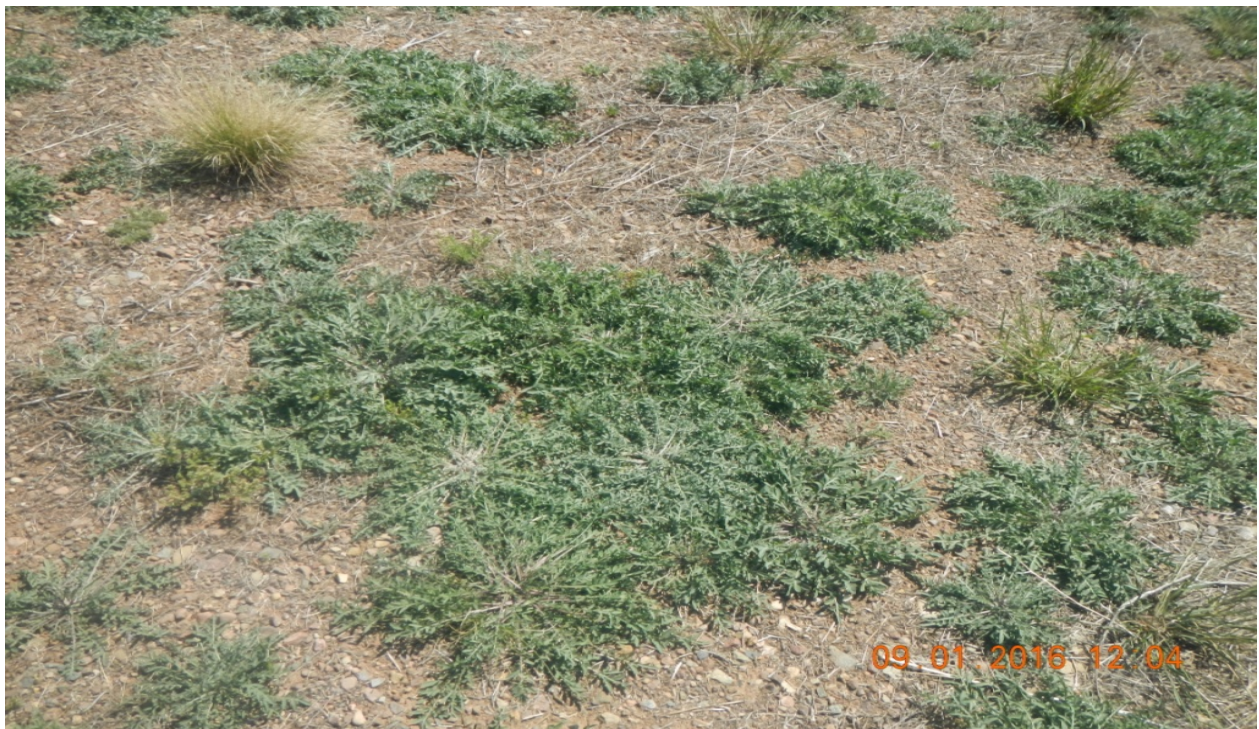
photo 4: There is new growth of Diffuse knapweed throughout the location and access road.

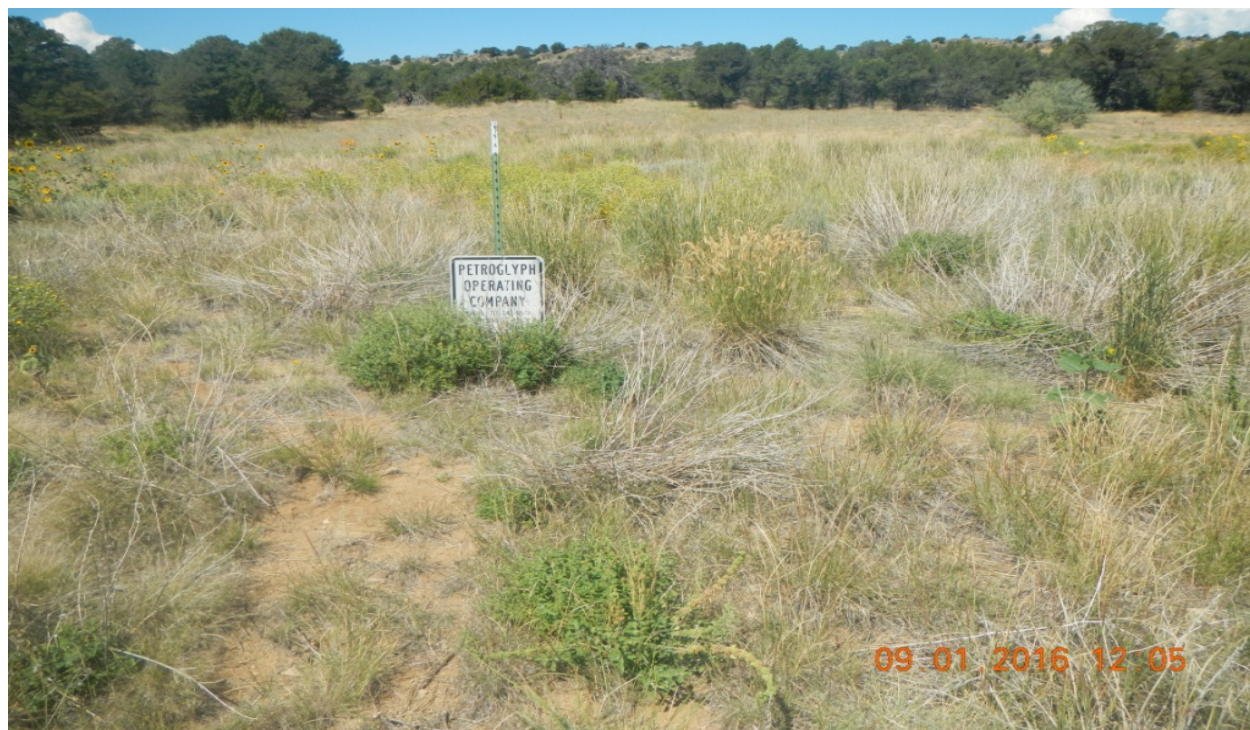
photo 5: Facing northwest toward the location.

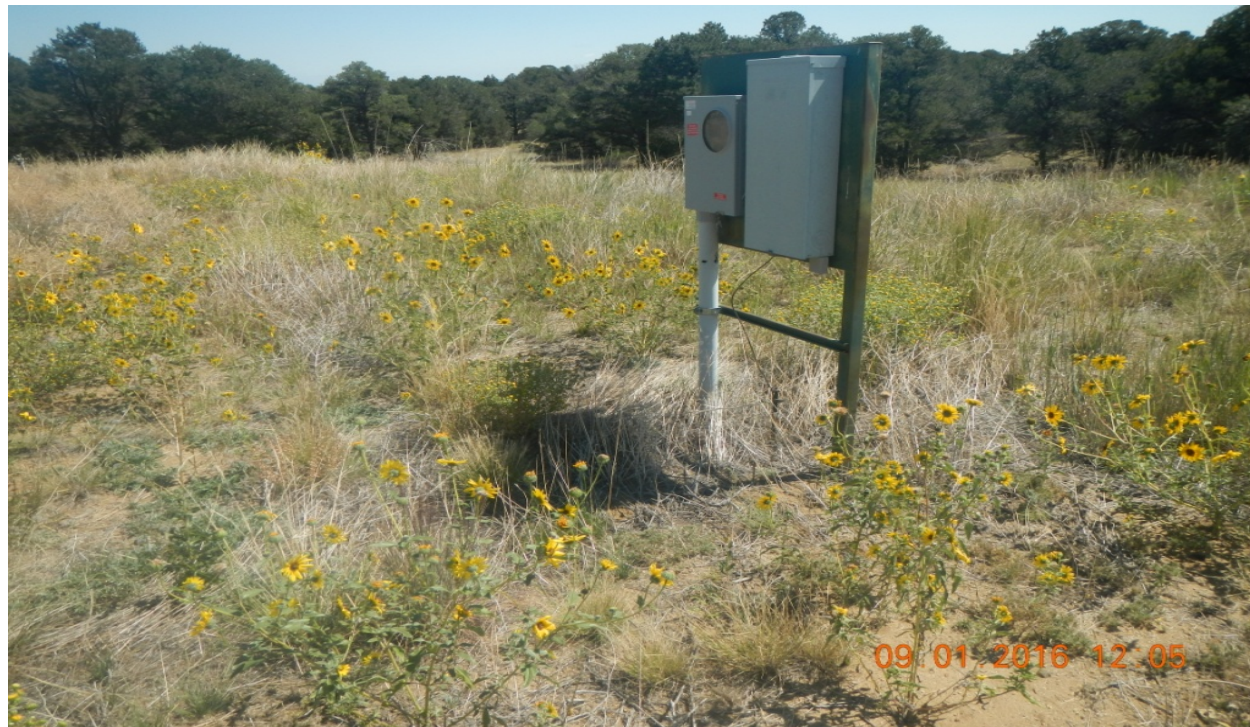
photo 6: An electrical utility remains at the southeast side of the location.

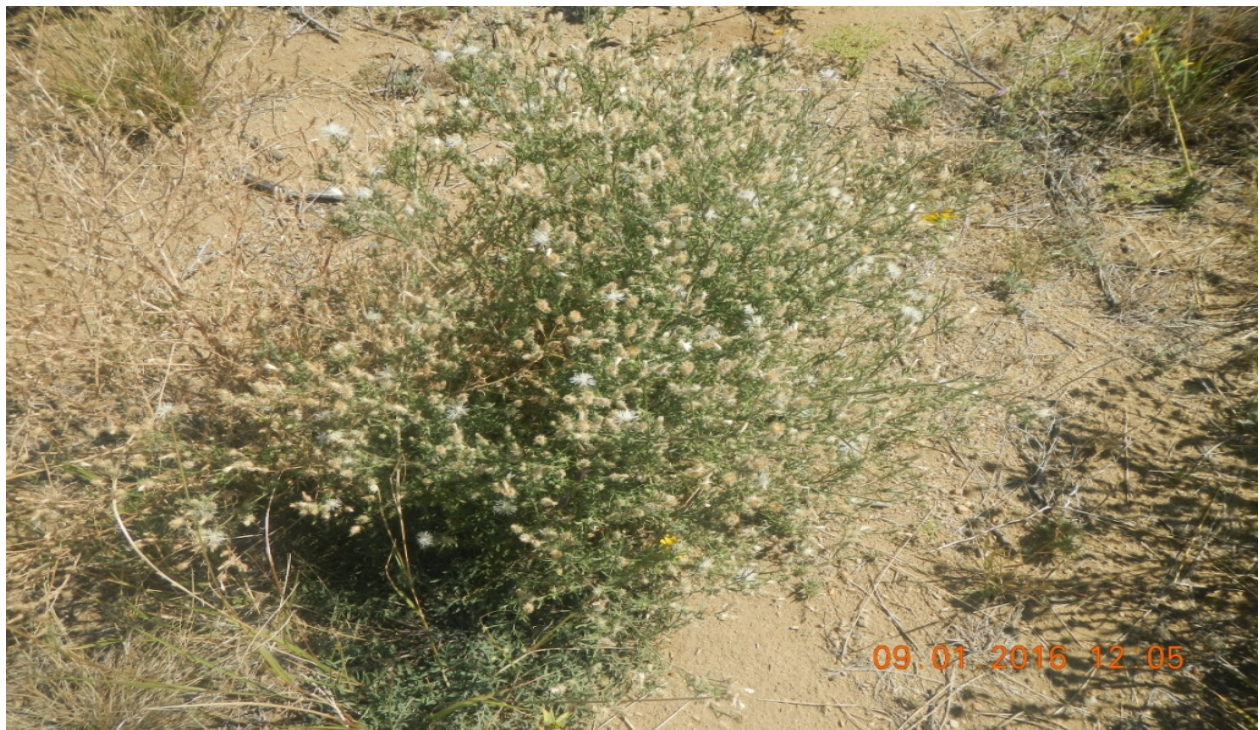
photo 7: There is Diffuse and Spotted knapweed (List B noxious weeds) growing throughout the location.

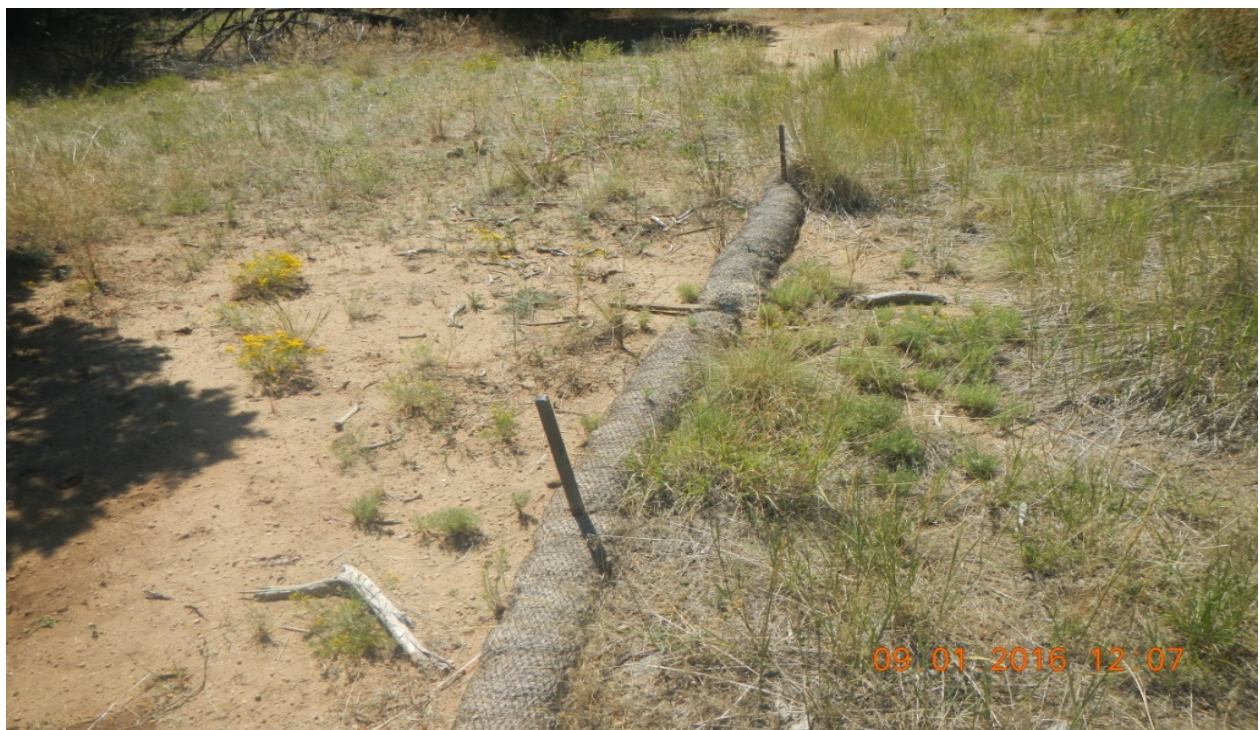
photo 8: There are degraded wattles around the east side of the location.

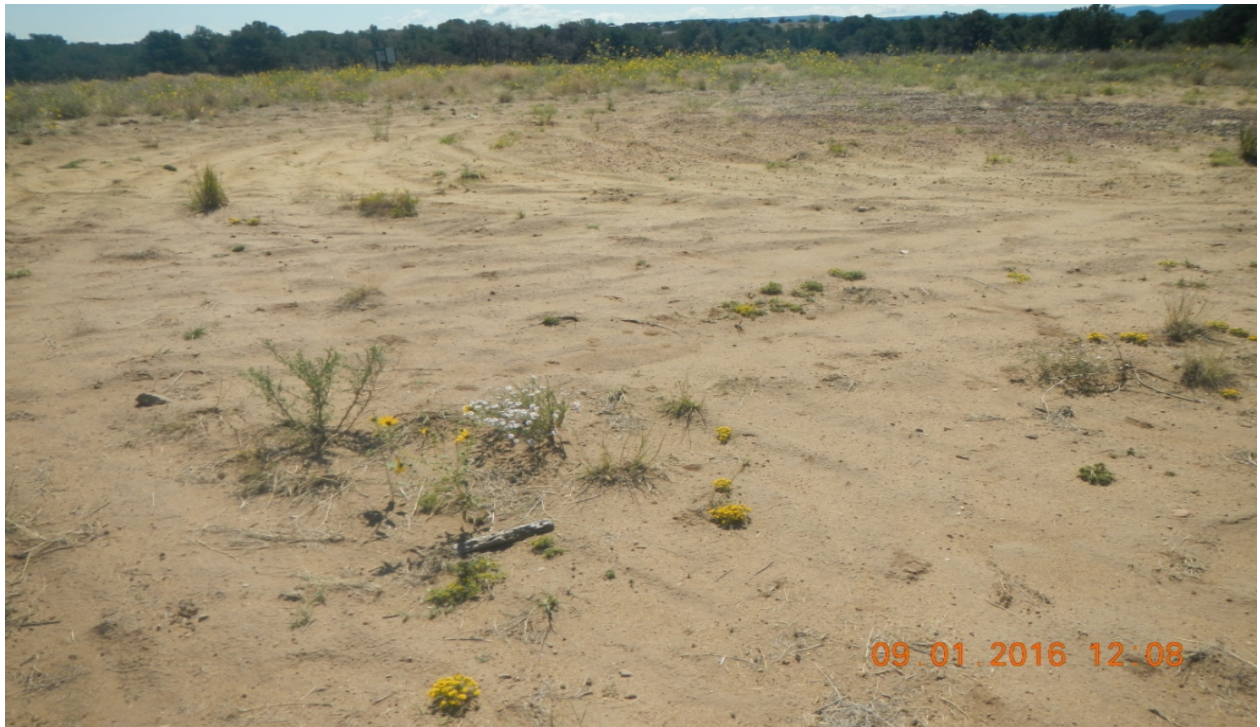
photo 9: North side of the location facing south.

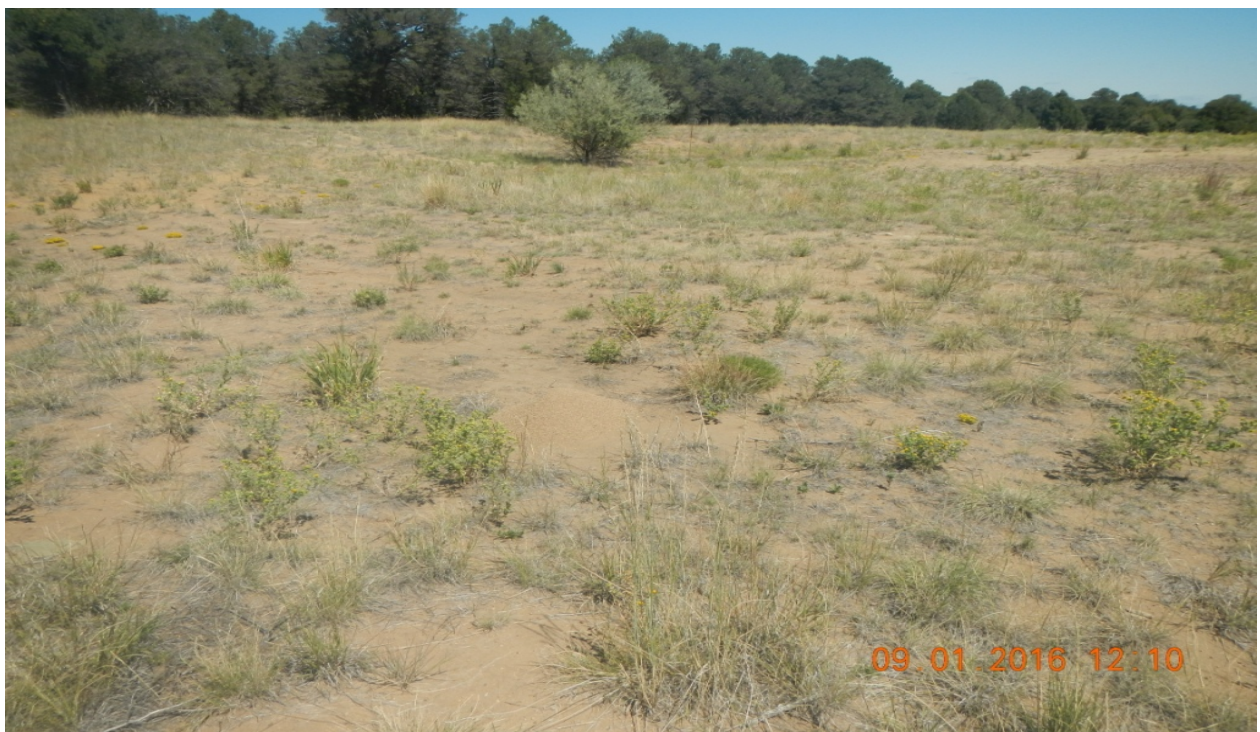
photo 10: Facing along the northwest side of the location.
