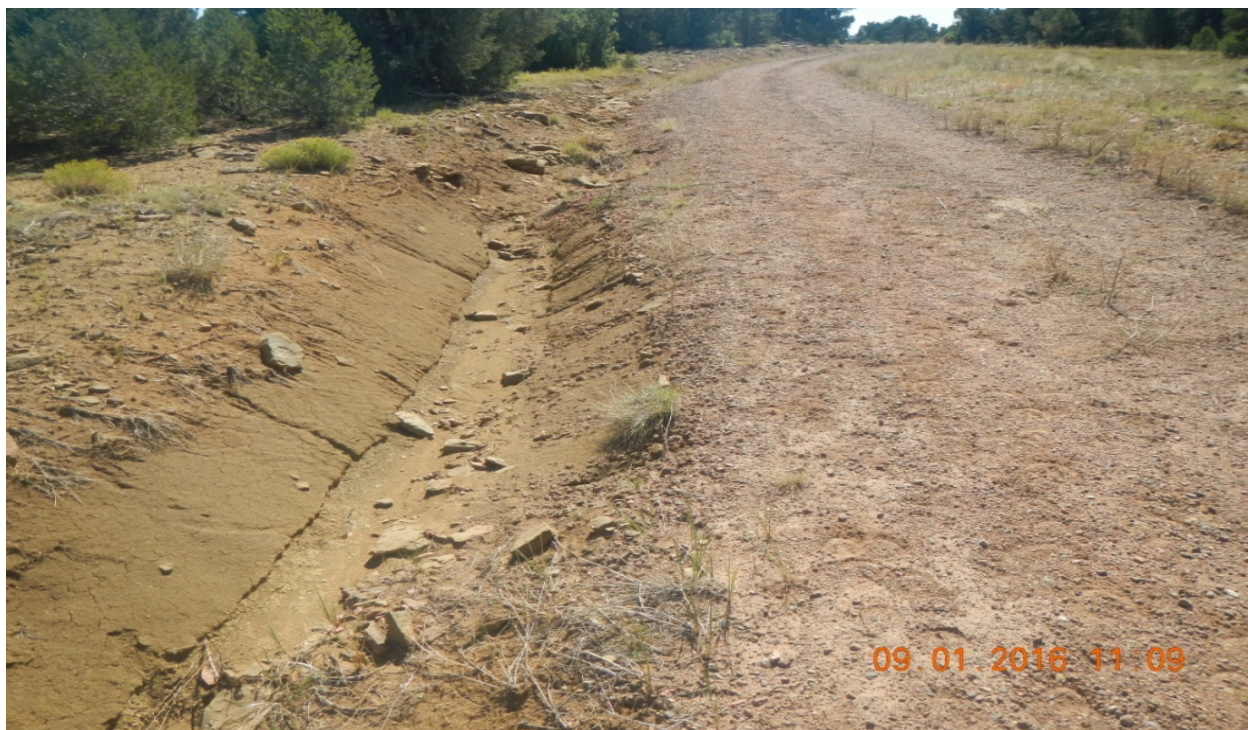
photo 1: Facing southwest along the access road toward the location. There is erosion occurring along the side of the access road.

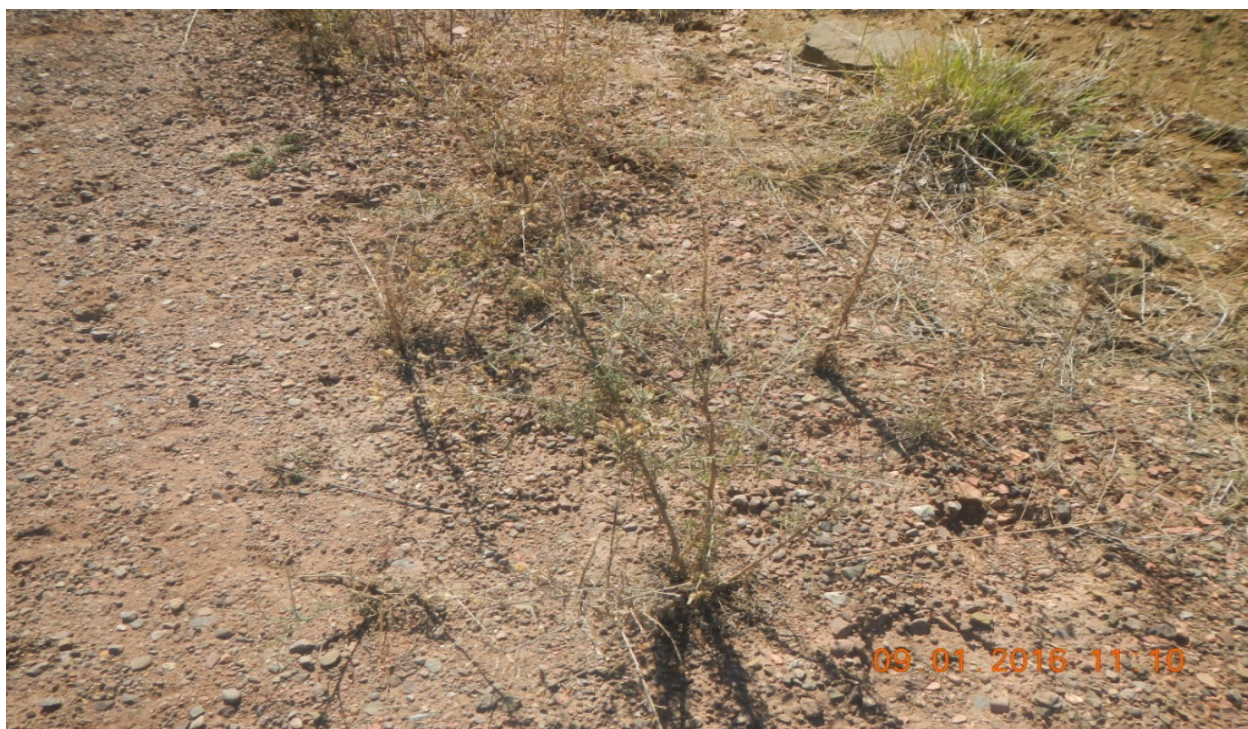
photo 2: There is noxious weeds (Diffuse knapweed) growing along the access road.

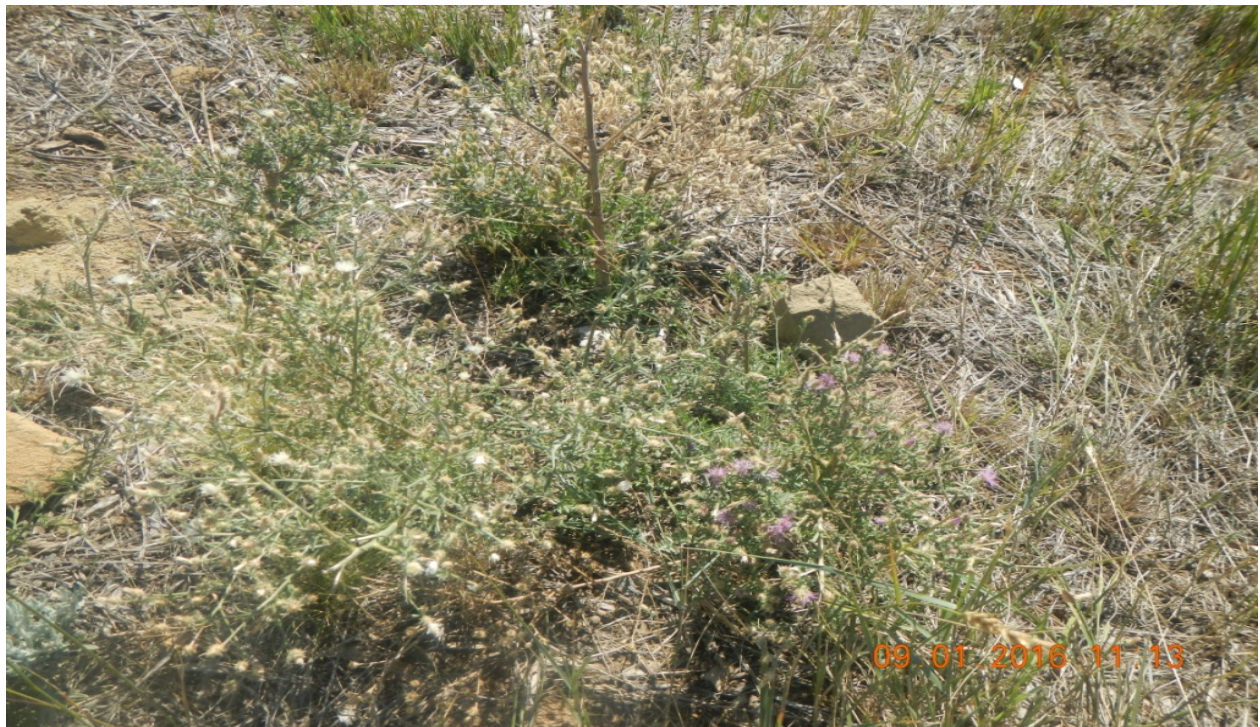
photo 3: There is List B noxious weeds (Diffuse knapweed) found growing throughout the location.

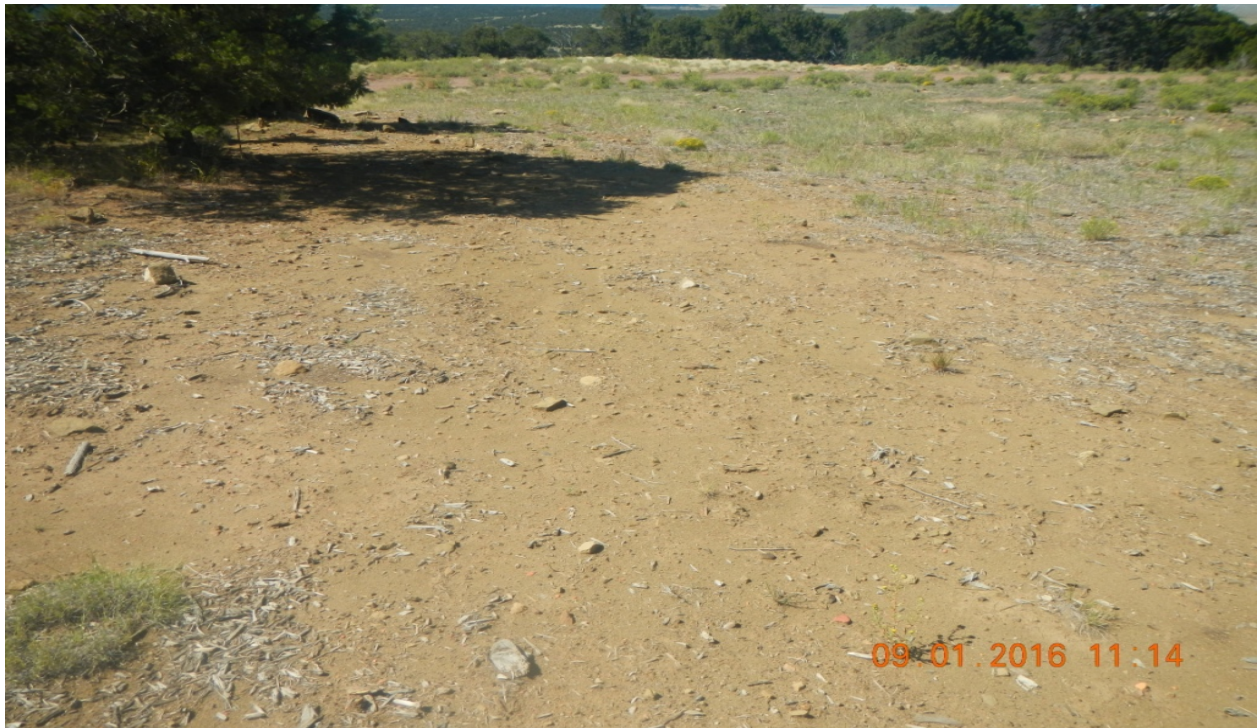
photo 5: East side of the location facing west. Vegetation has not adequately established.

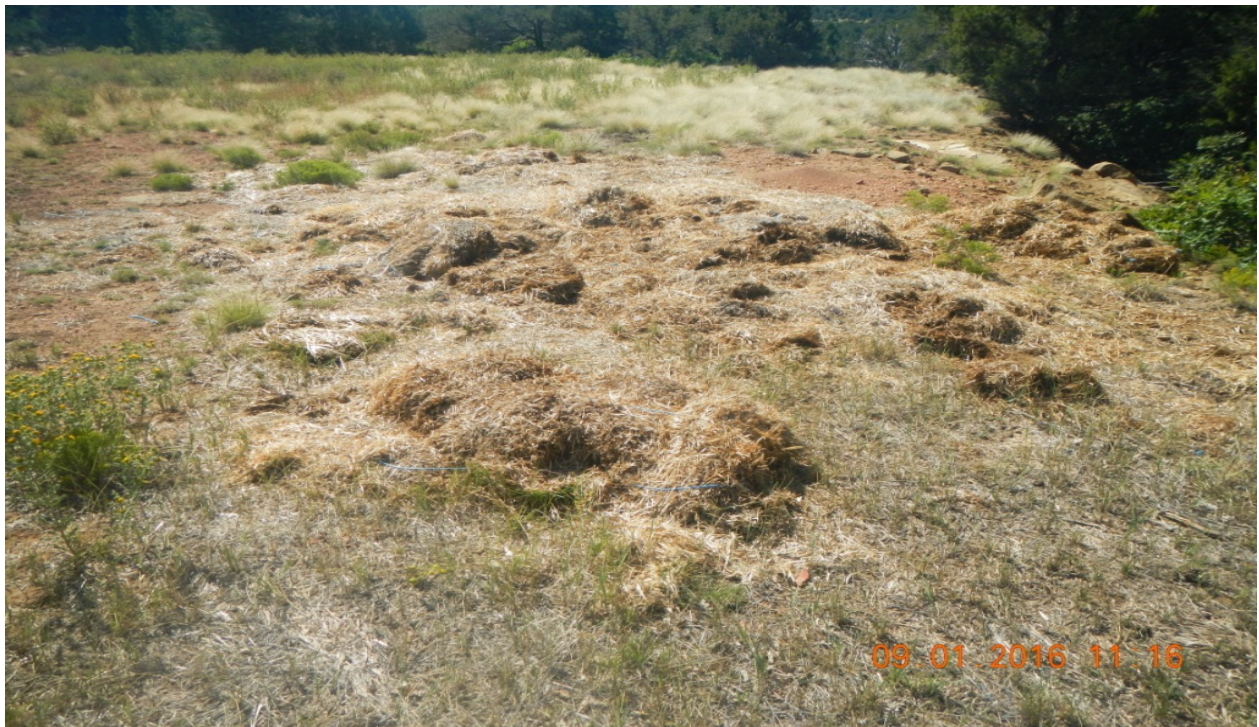
photo 6: There is straw debris left in piles at the west side of the location.

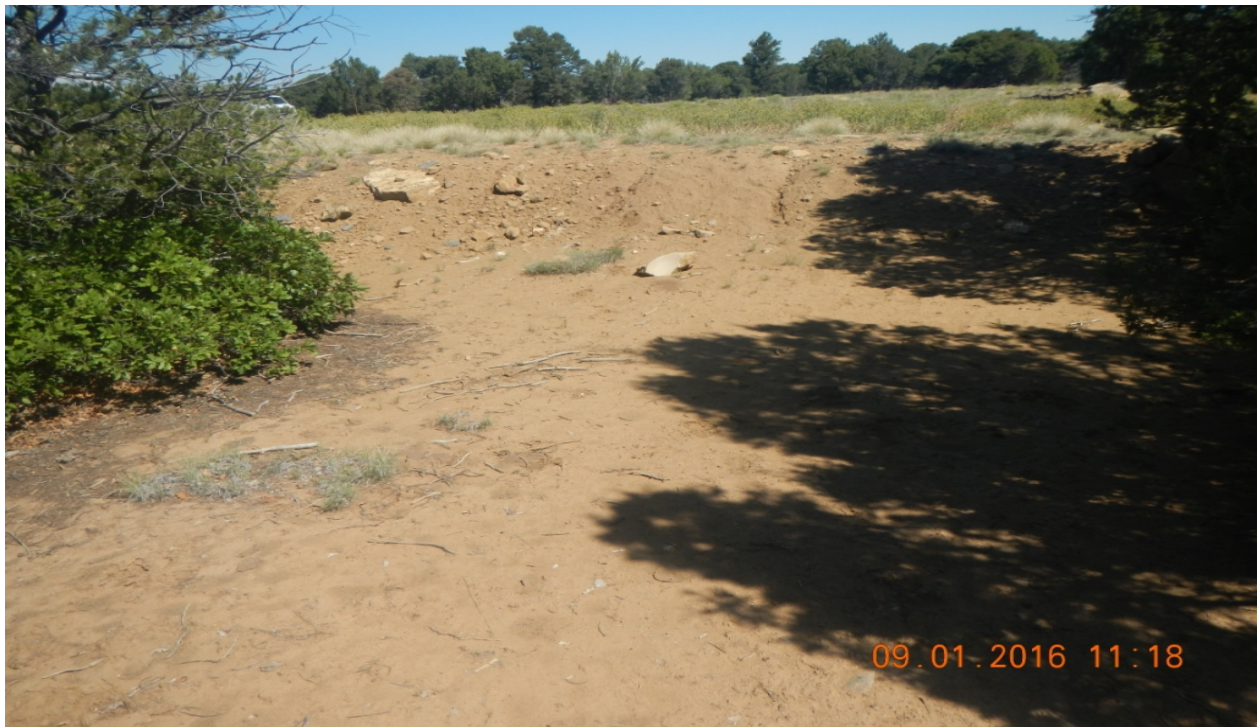
photo 8: South side of the location facing north. There is erosion transporting sediment off location in this area.

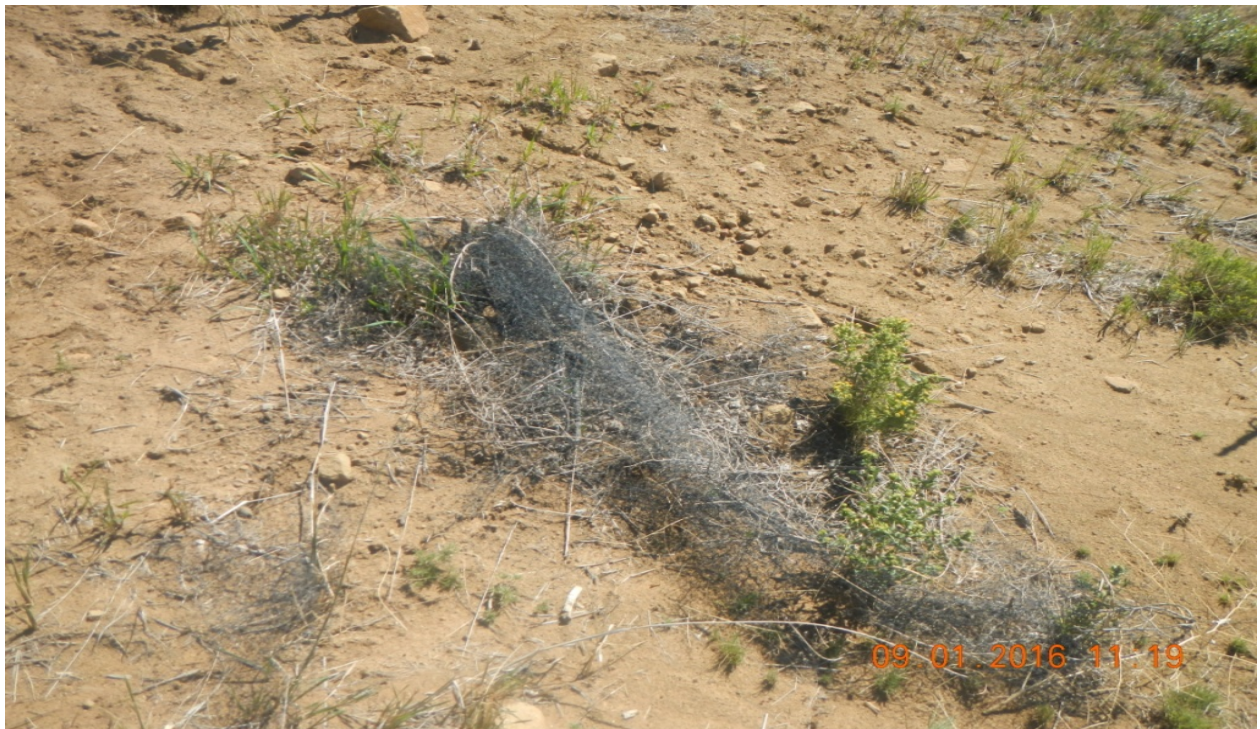
photo 10: There is plastic netting debris along the southeast cut slope.

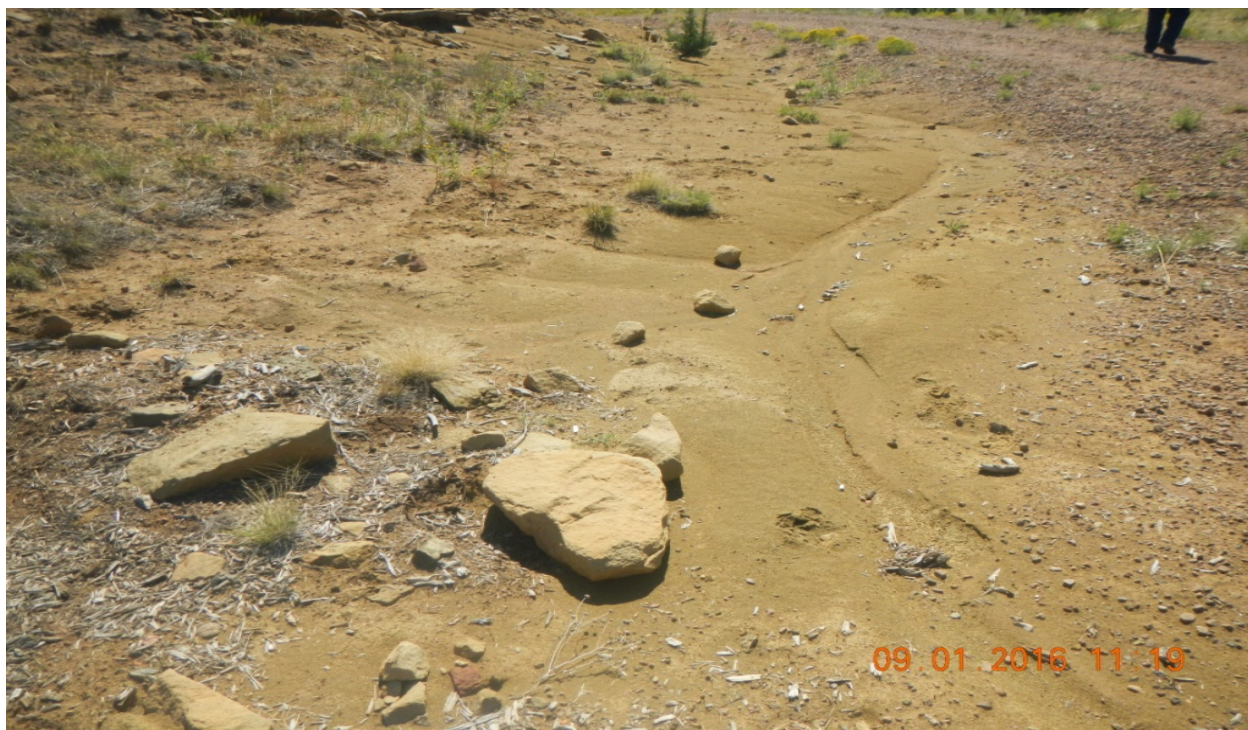
photo 11: There are signs of erosion along southeast side of the location.
