# Reclamation Inspection

09/08/2016

Operator: Chandler & Associates

Location ID: 378092

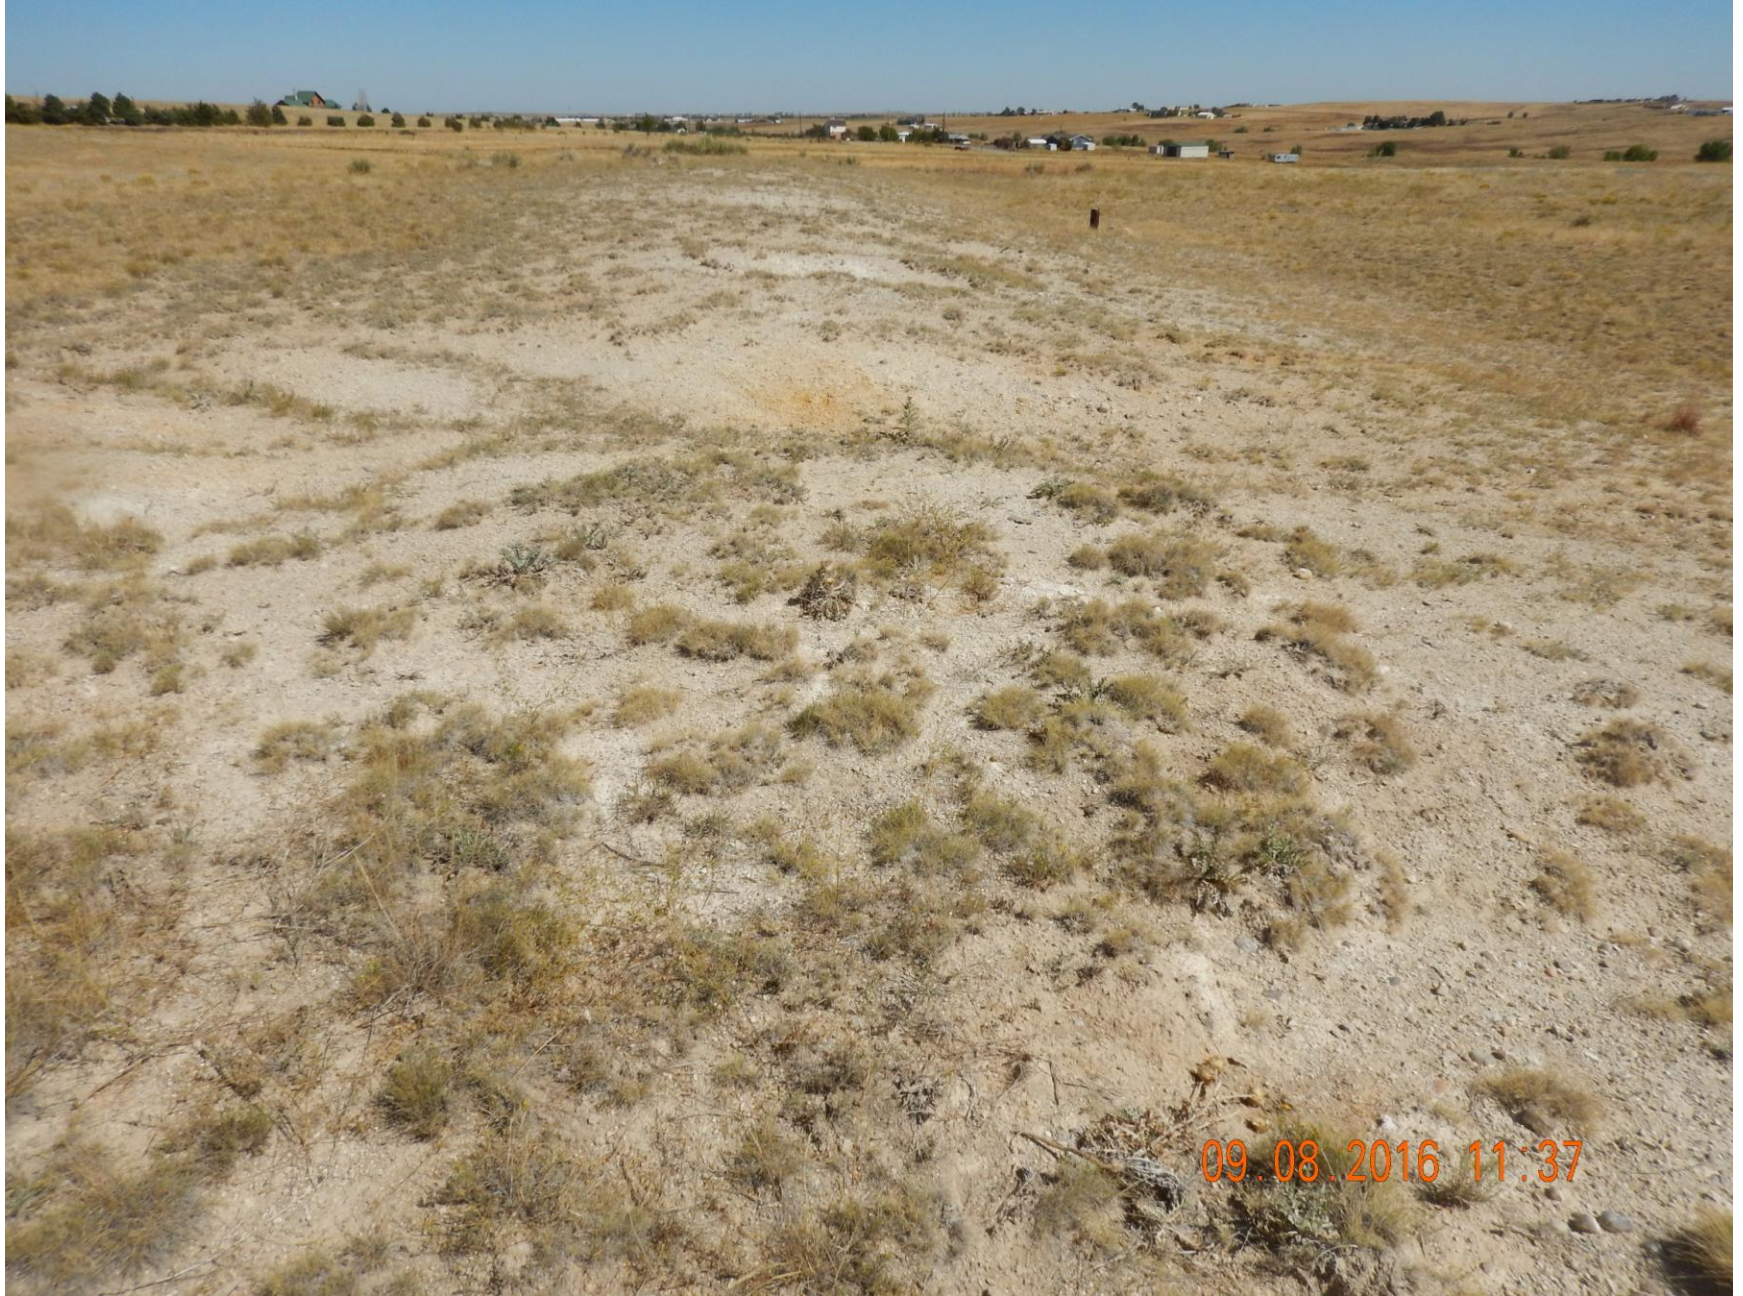
**Figure 1:** Photo taken from the southwest corner of the location, facing north. Photo shows large unvegetated portions of the west end of the location caused by erosion.

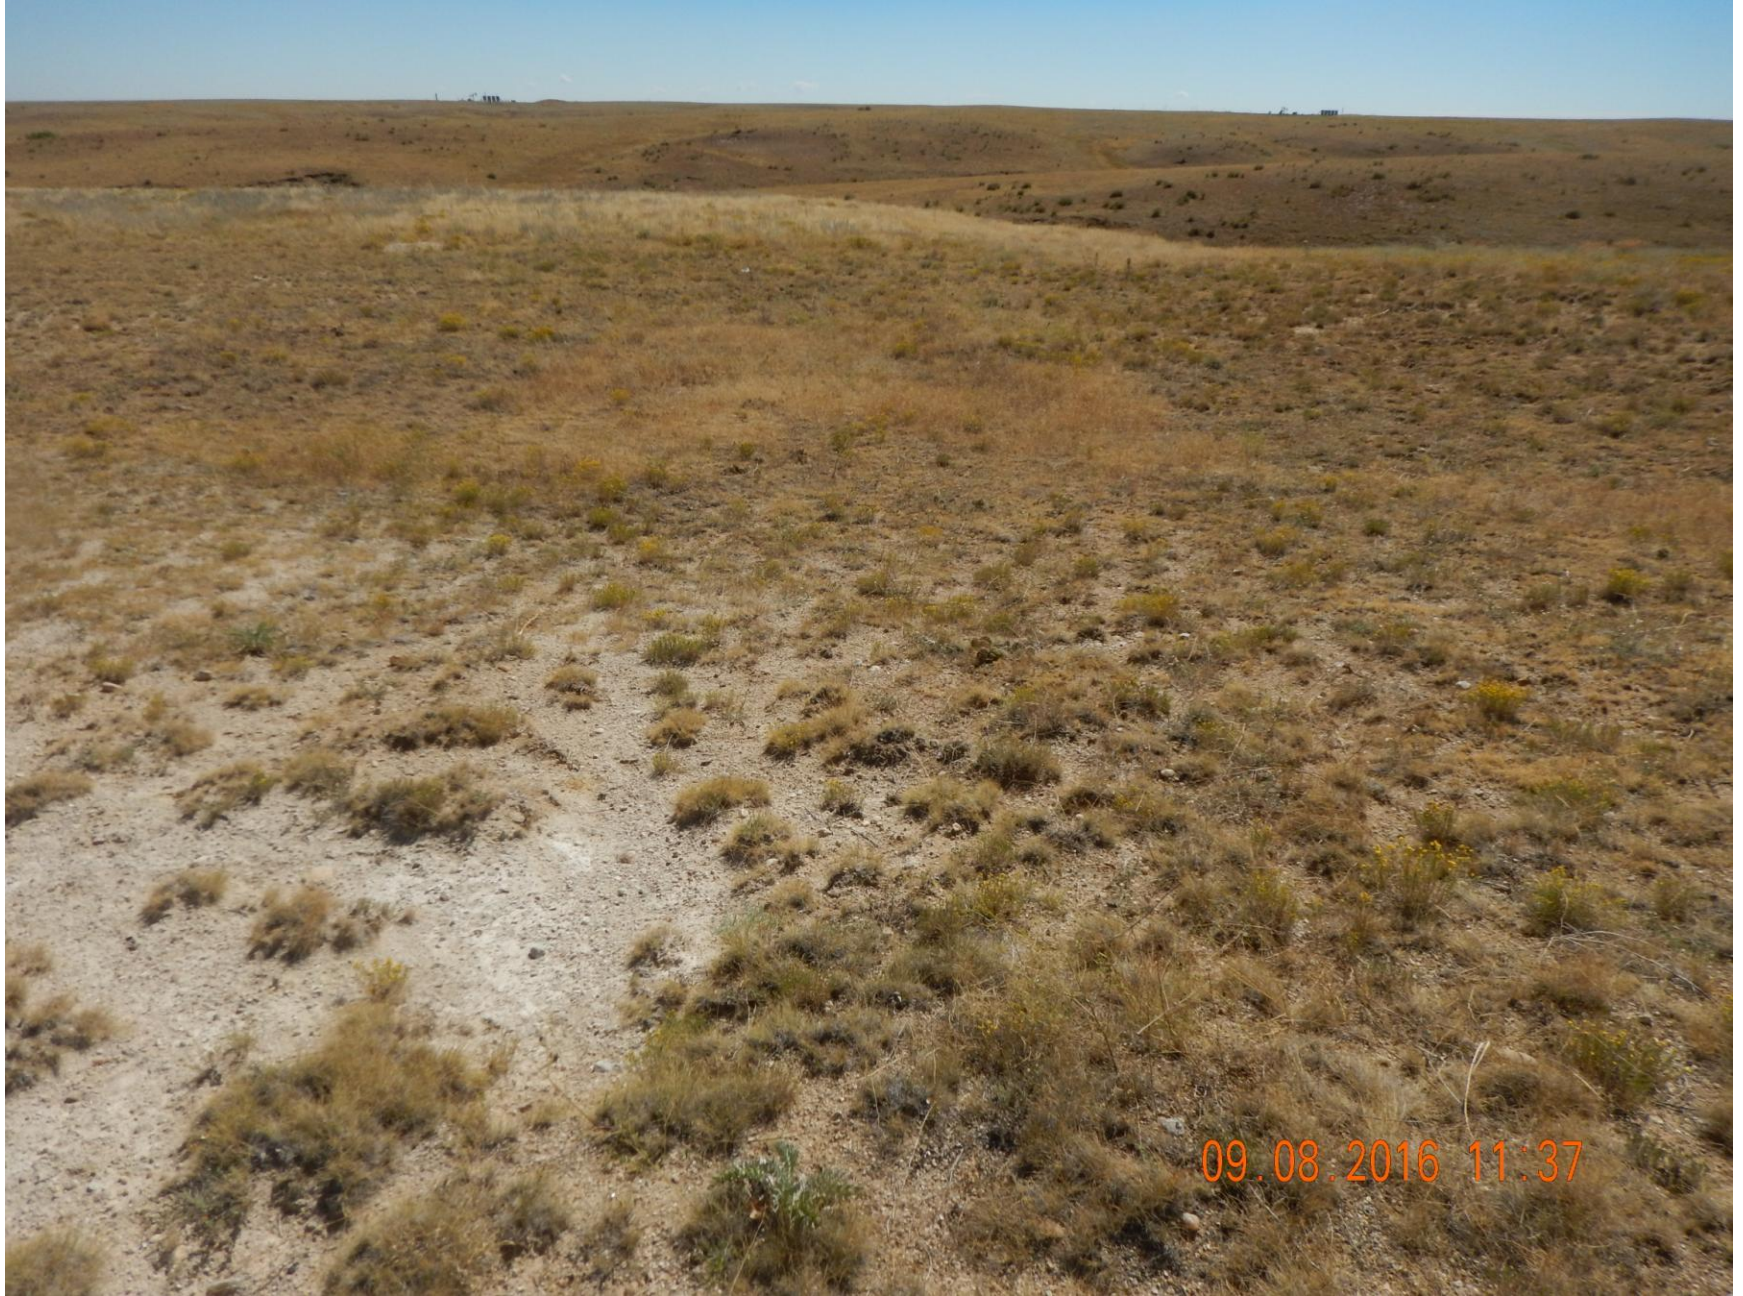
**Figure 2:** Photo taken from the southwest corner of the location, facing east. Photo shows vegetation over the reclamation area.

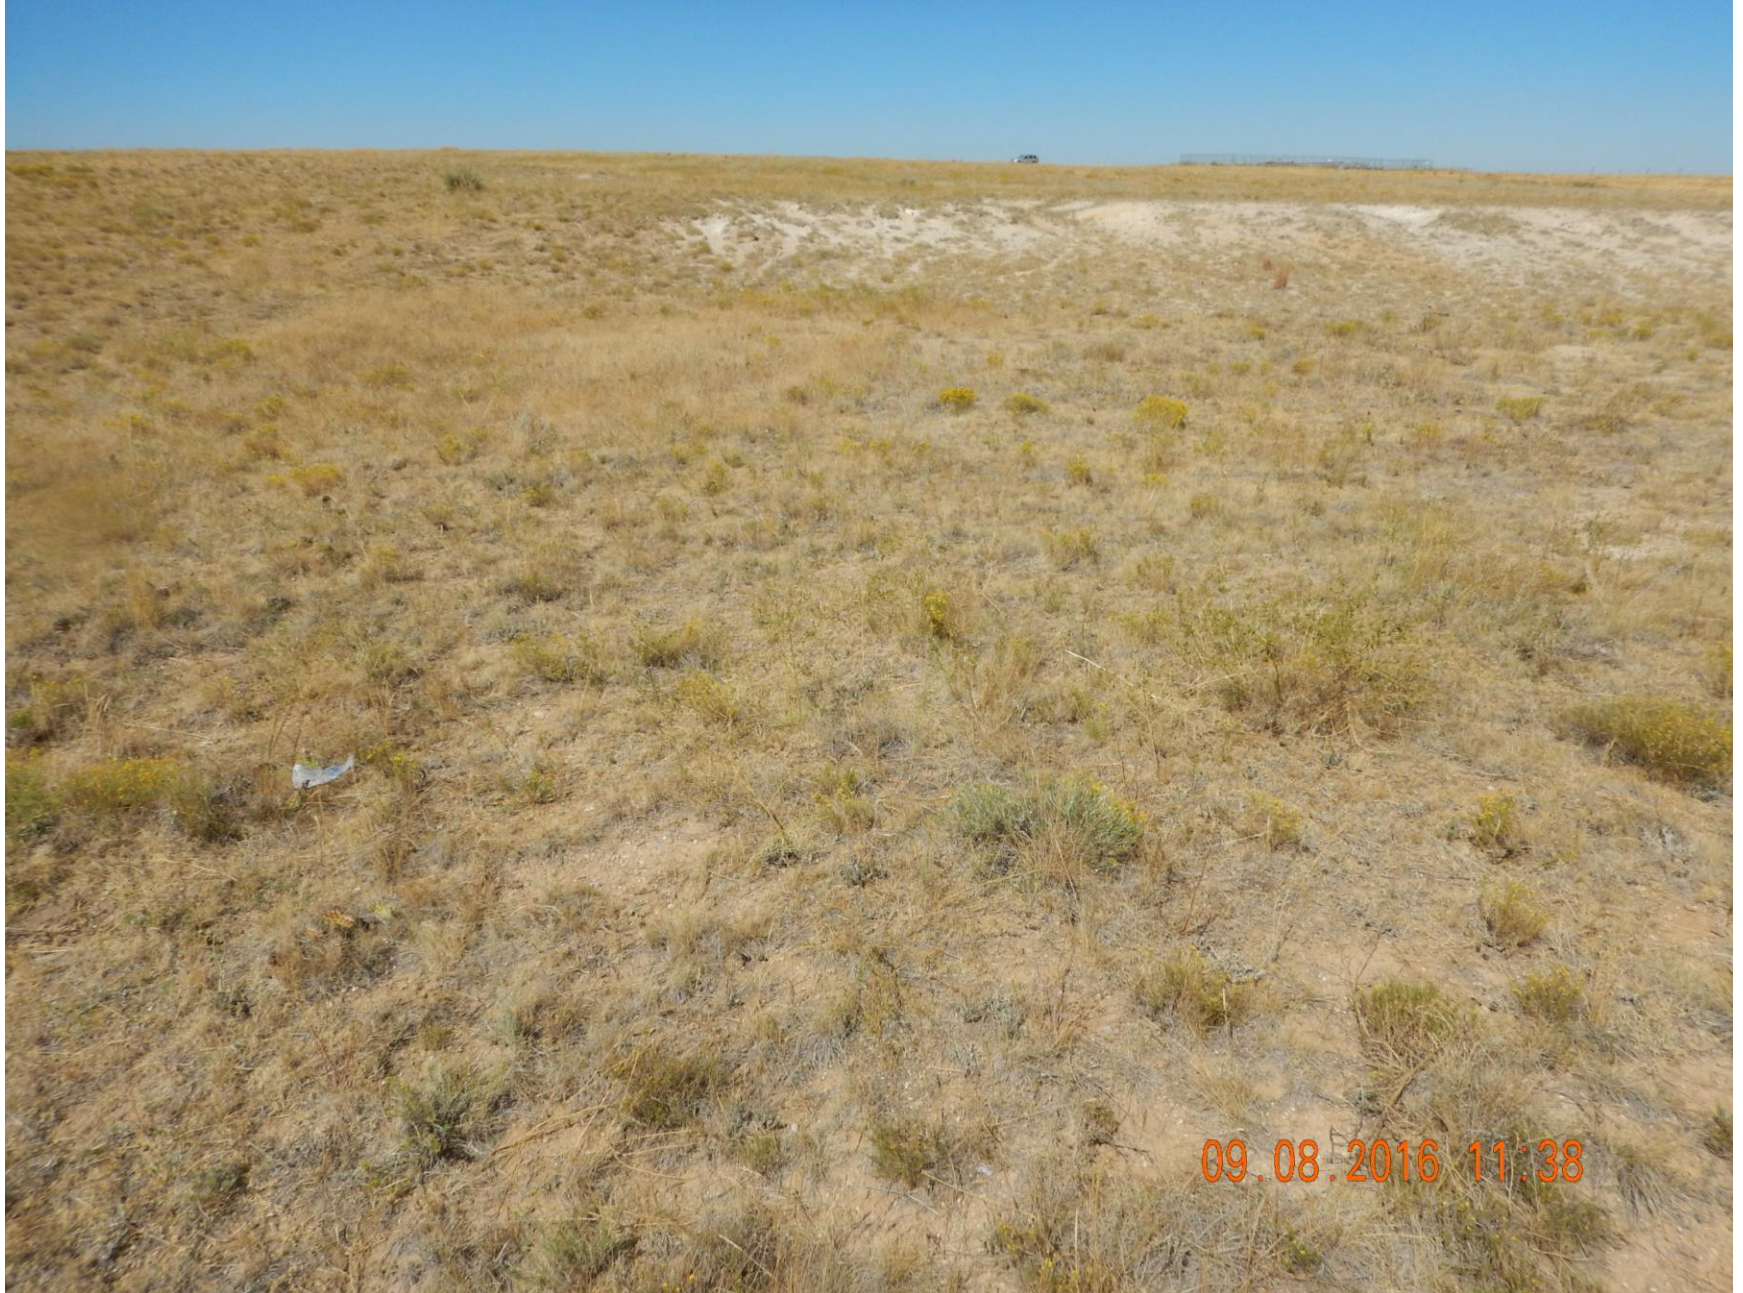
**Figure 3:** Photo taken from the southeast corner of the location, facing west. Photo shows vegetation over the reclamation area. Note location has not achieved uniform vegetative cover.

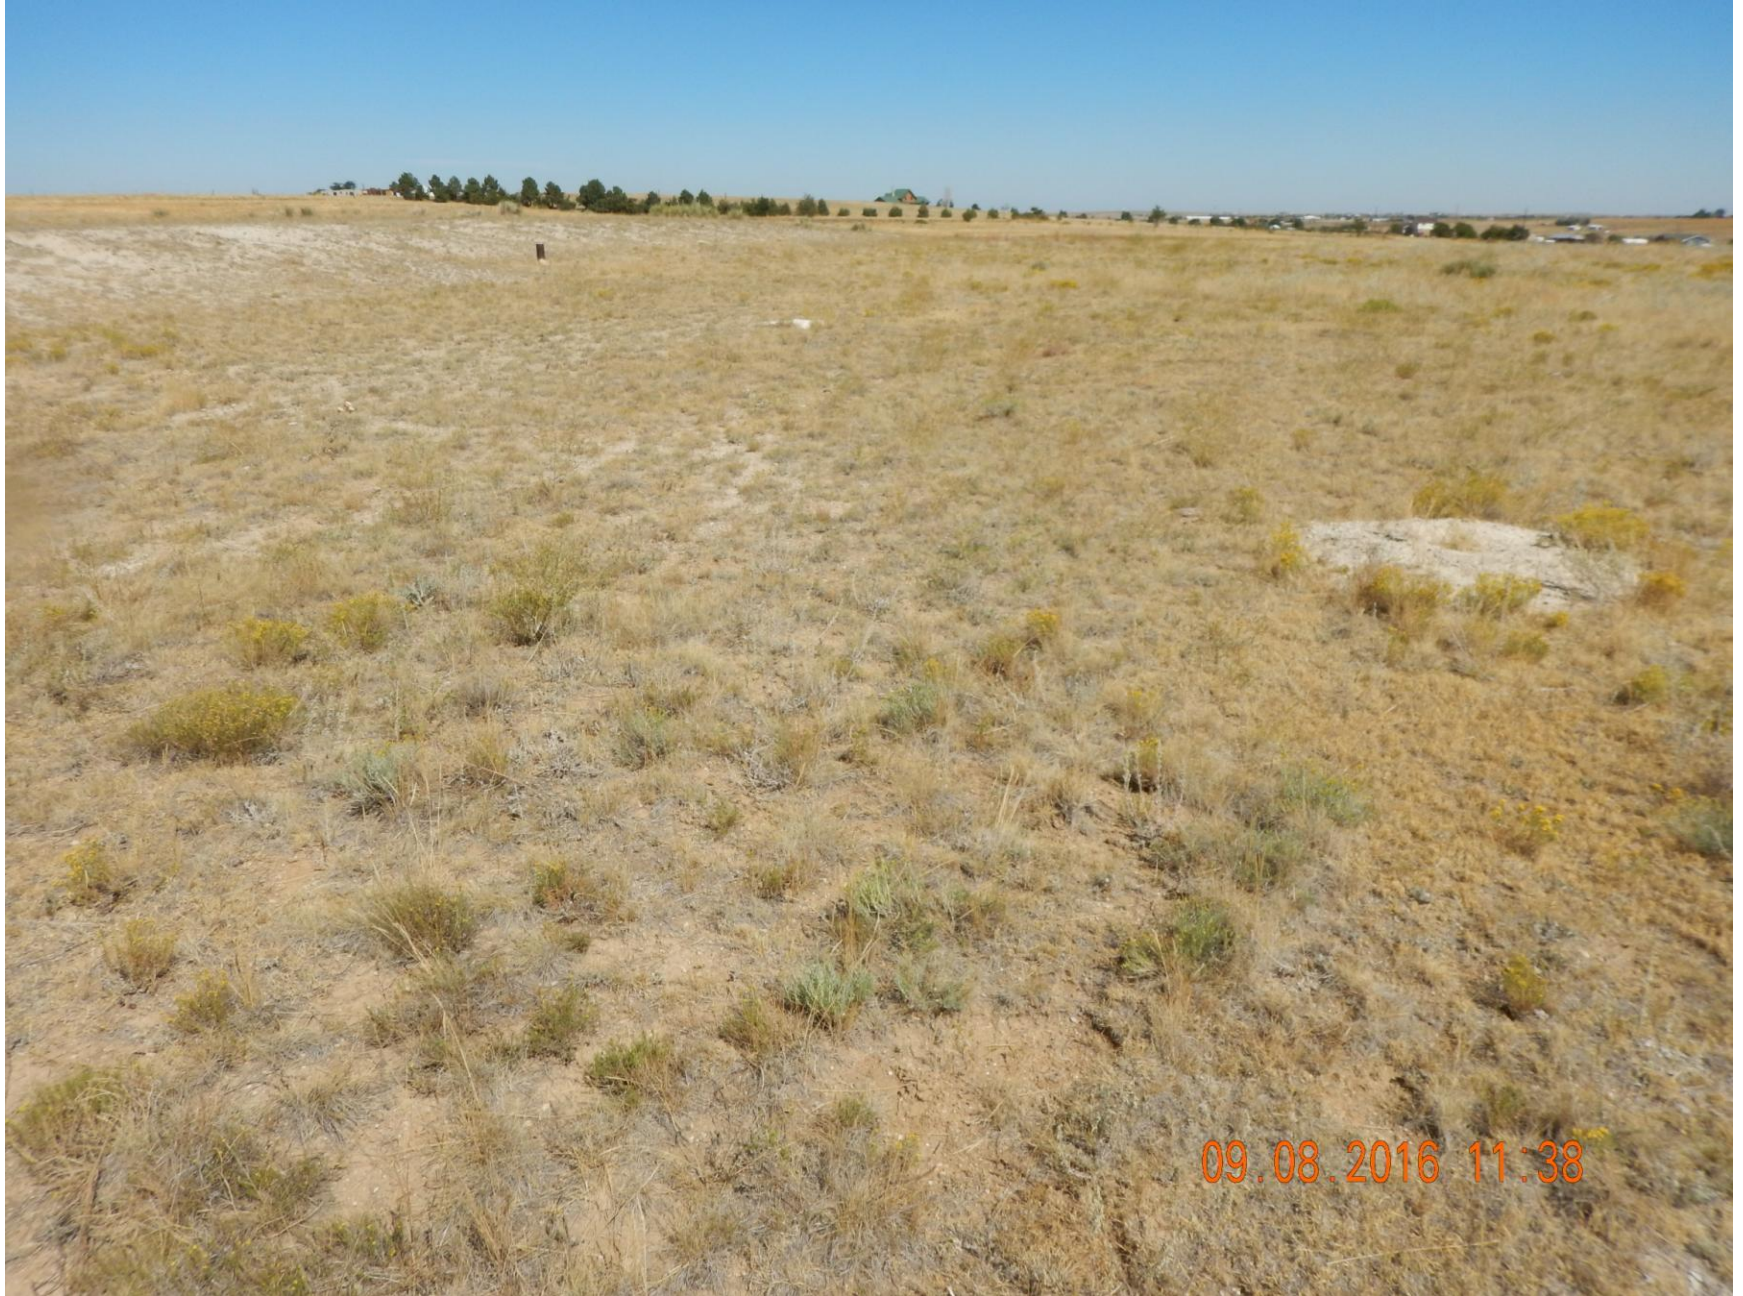
**Figure 4:** Photo taken from the southeast corner of the location, facing north. Photo shows vegetation over the reclamation area. Note location has not achieved uniform vegetative cover.

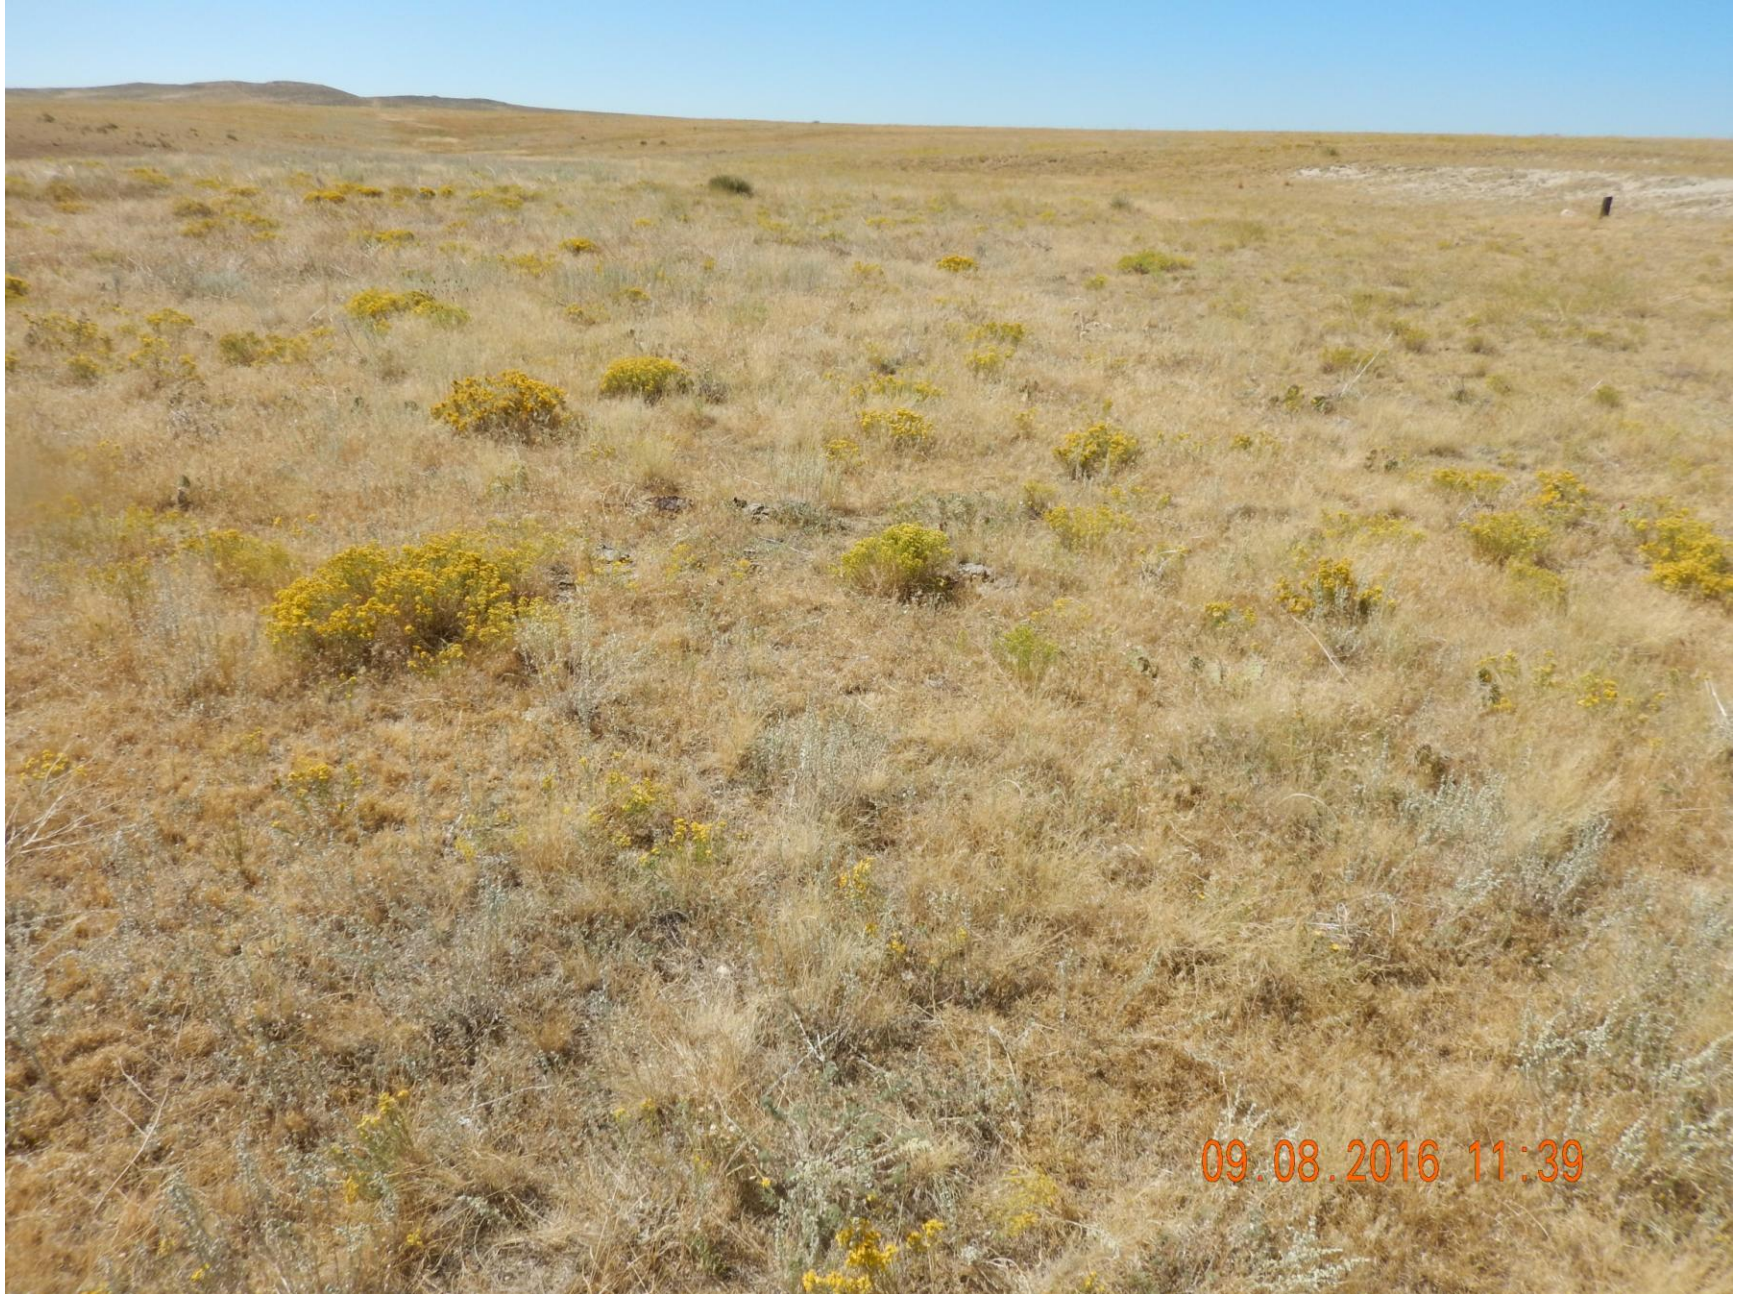
**Figure 5:** Photo taken from the northeast corner of the location, facing south. Photo shows vegetation over the reclamation area. Note location has not achieved uniform vegetative cover.

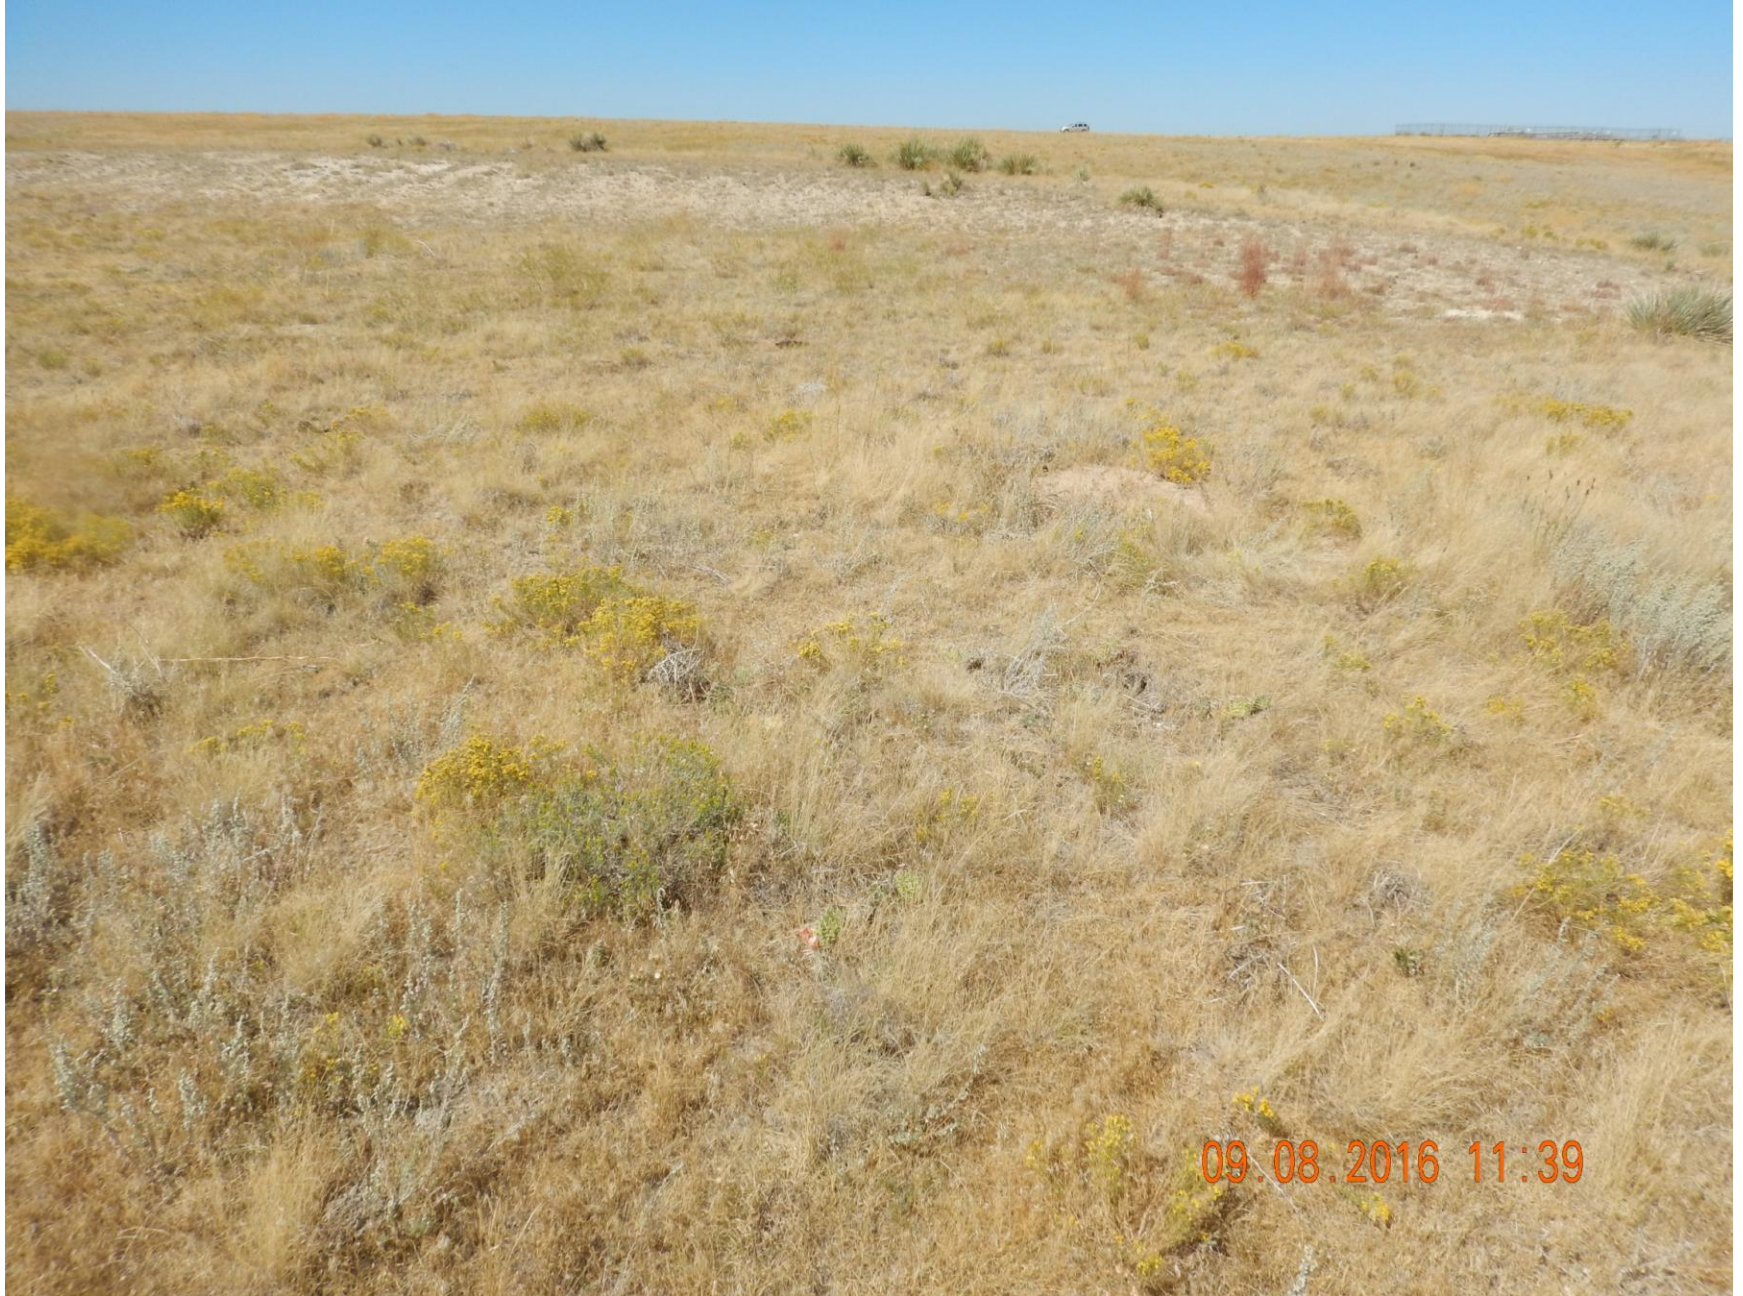
**Figure 6:** Photo taken from the northeast corner of the location, facing west. Photo shows vegetation over the reclamation area. Note location has not achieved uniform vegetative cover.

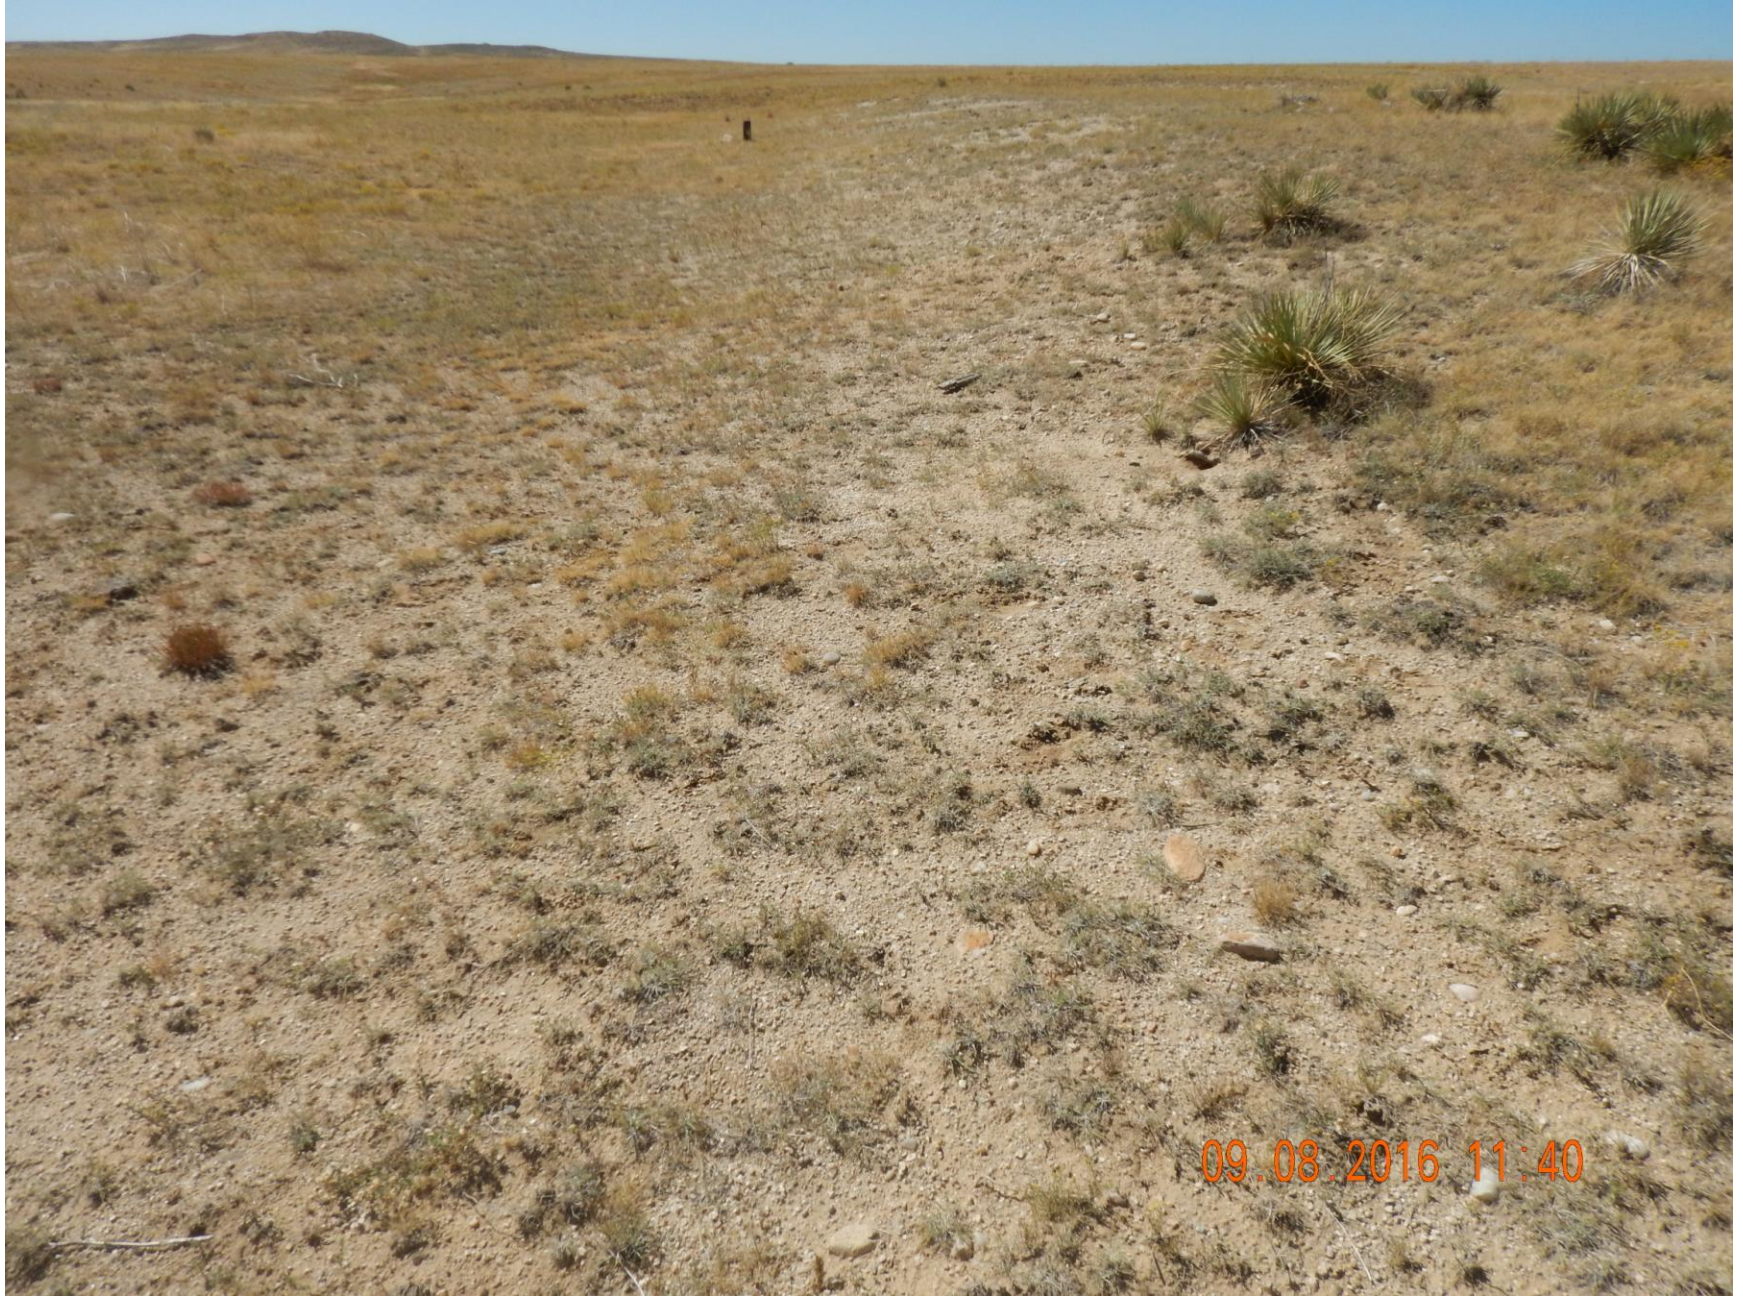
**Figure 7:** Photo taken from the northwest corner of the location, facing south. Note location has not been recontoured or achieved uniform vegetative cover.

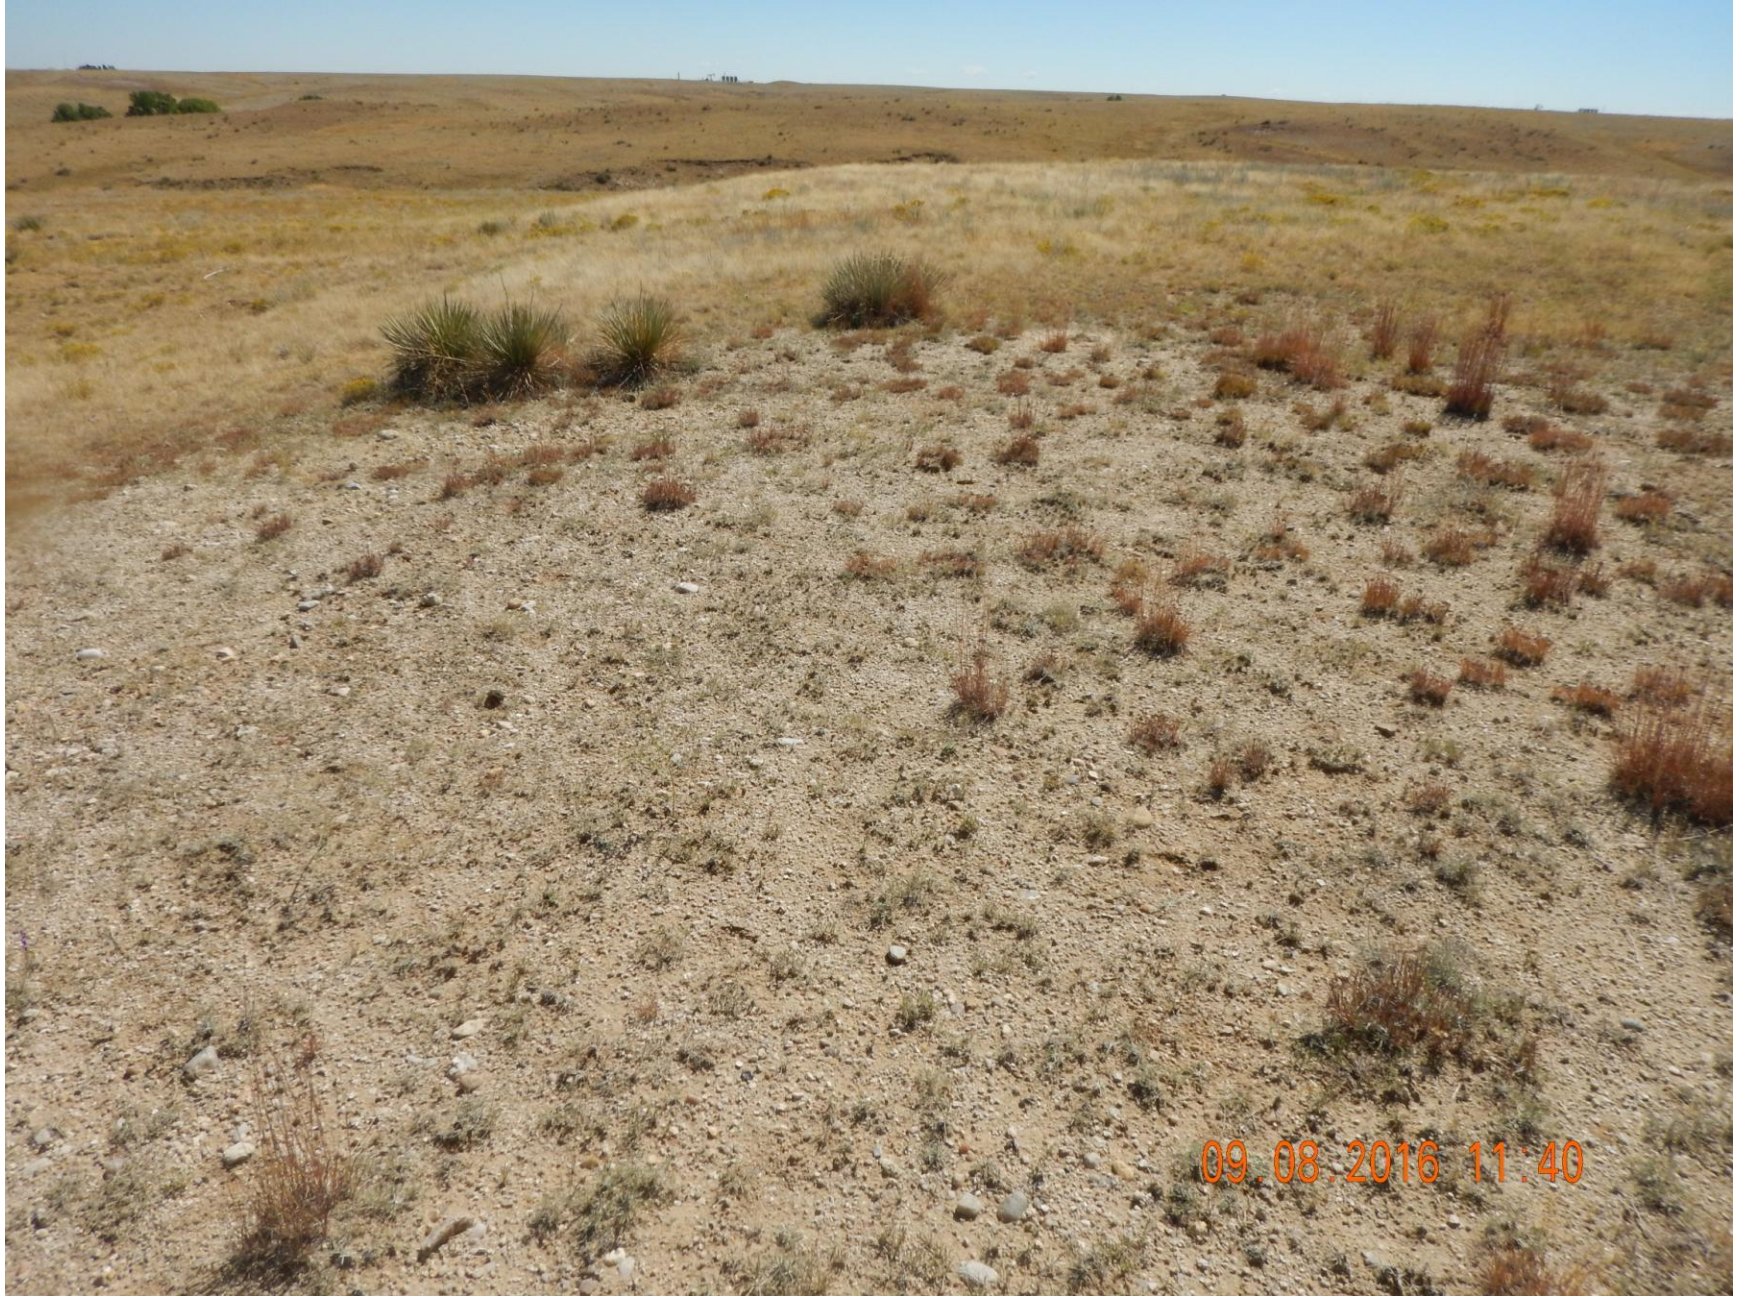
**Figure 8:** Photo taken from the northwest corner of the location, facing east. Note location has not achieved uniform vegetative cover.

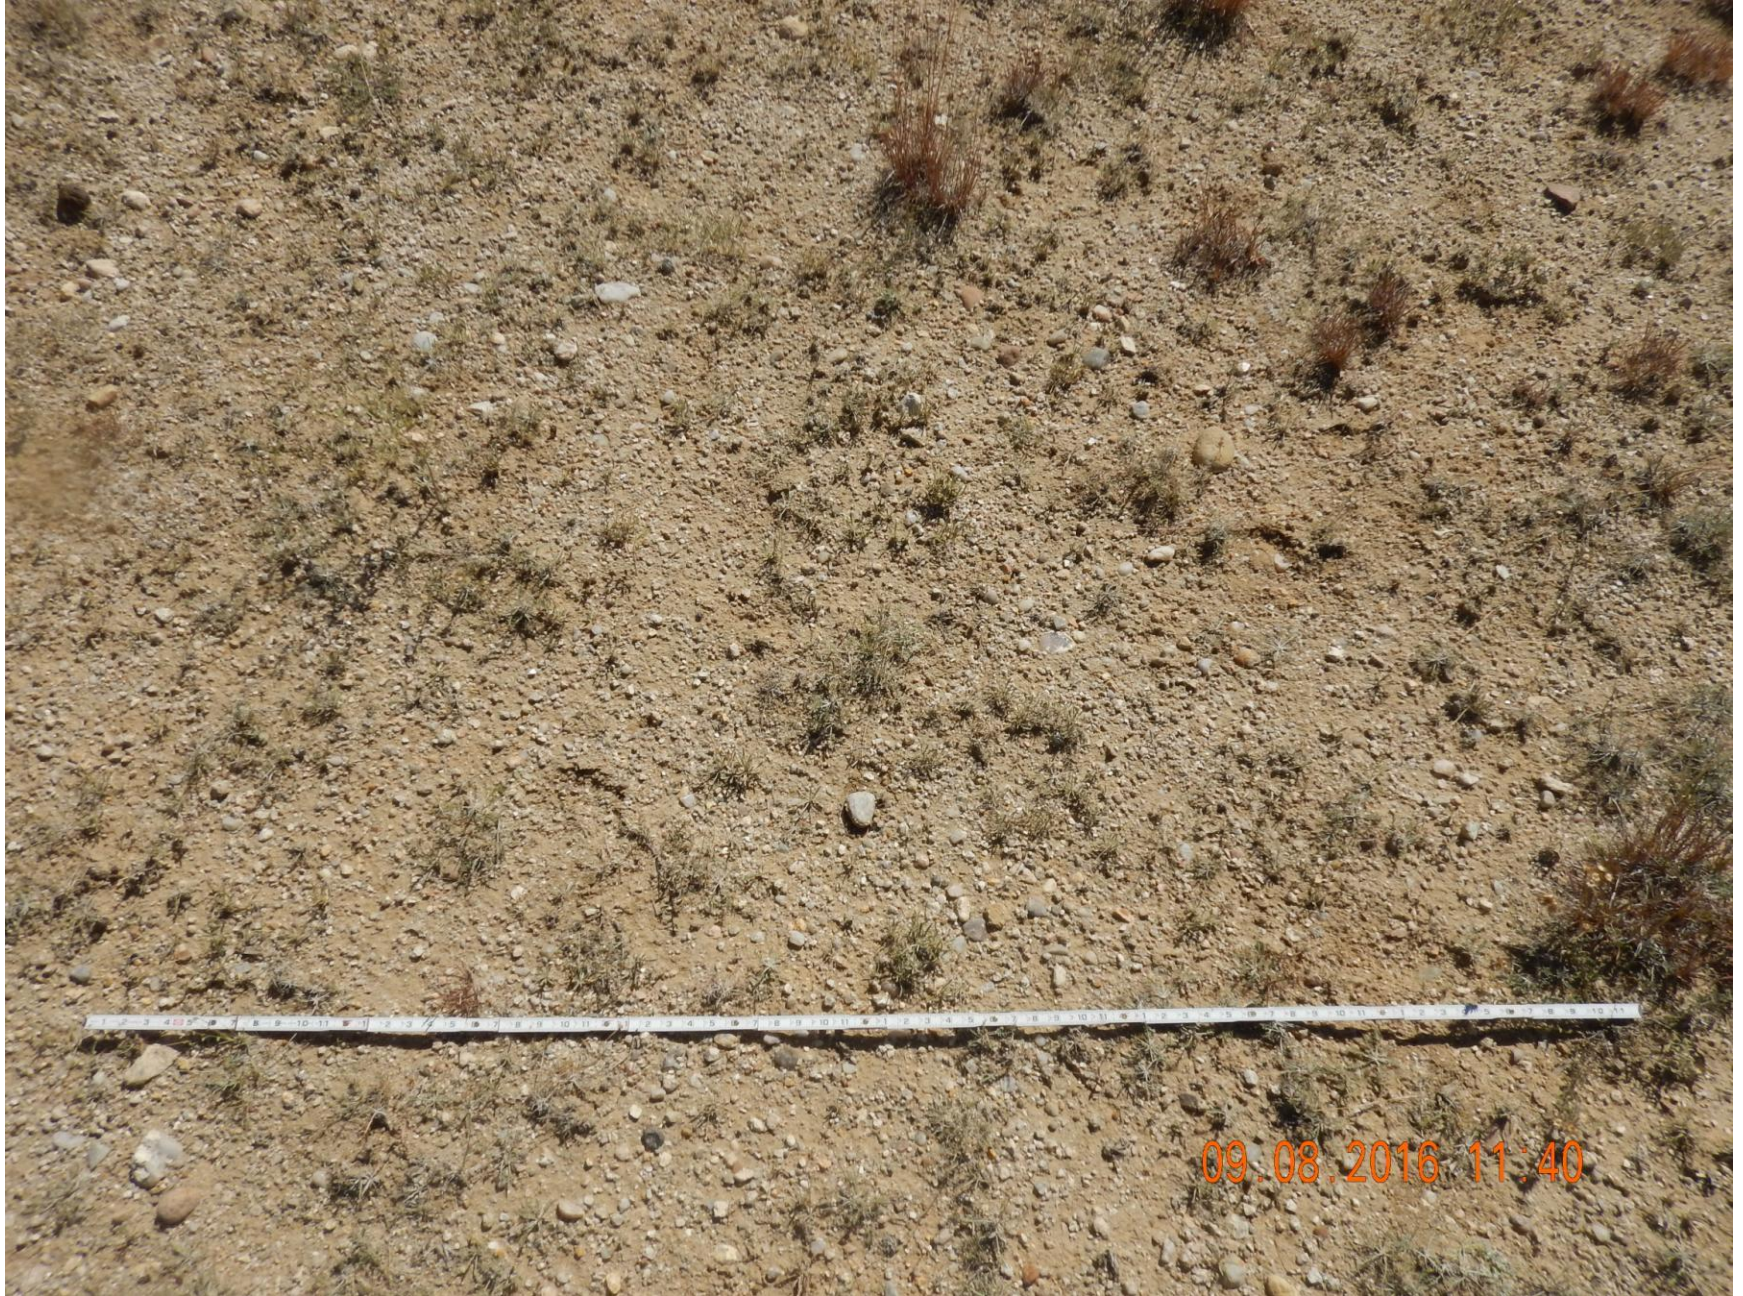
**Figure 9:** Photo taken from location. Photo shows location has not achieved uniform vegetative cover. 6' measuring stick for reference.

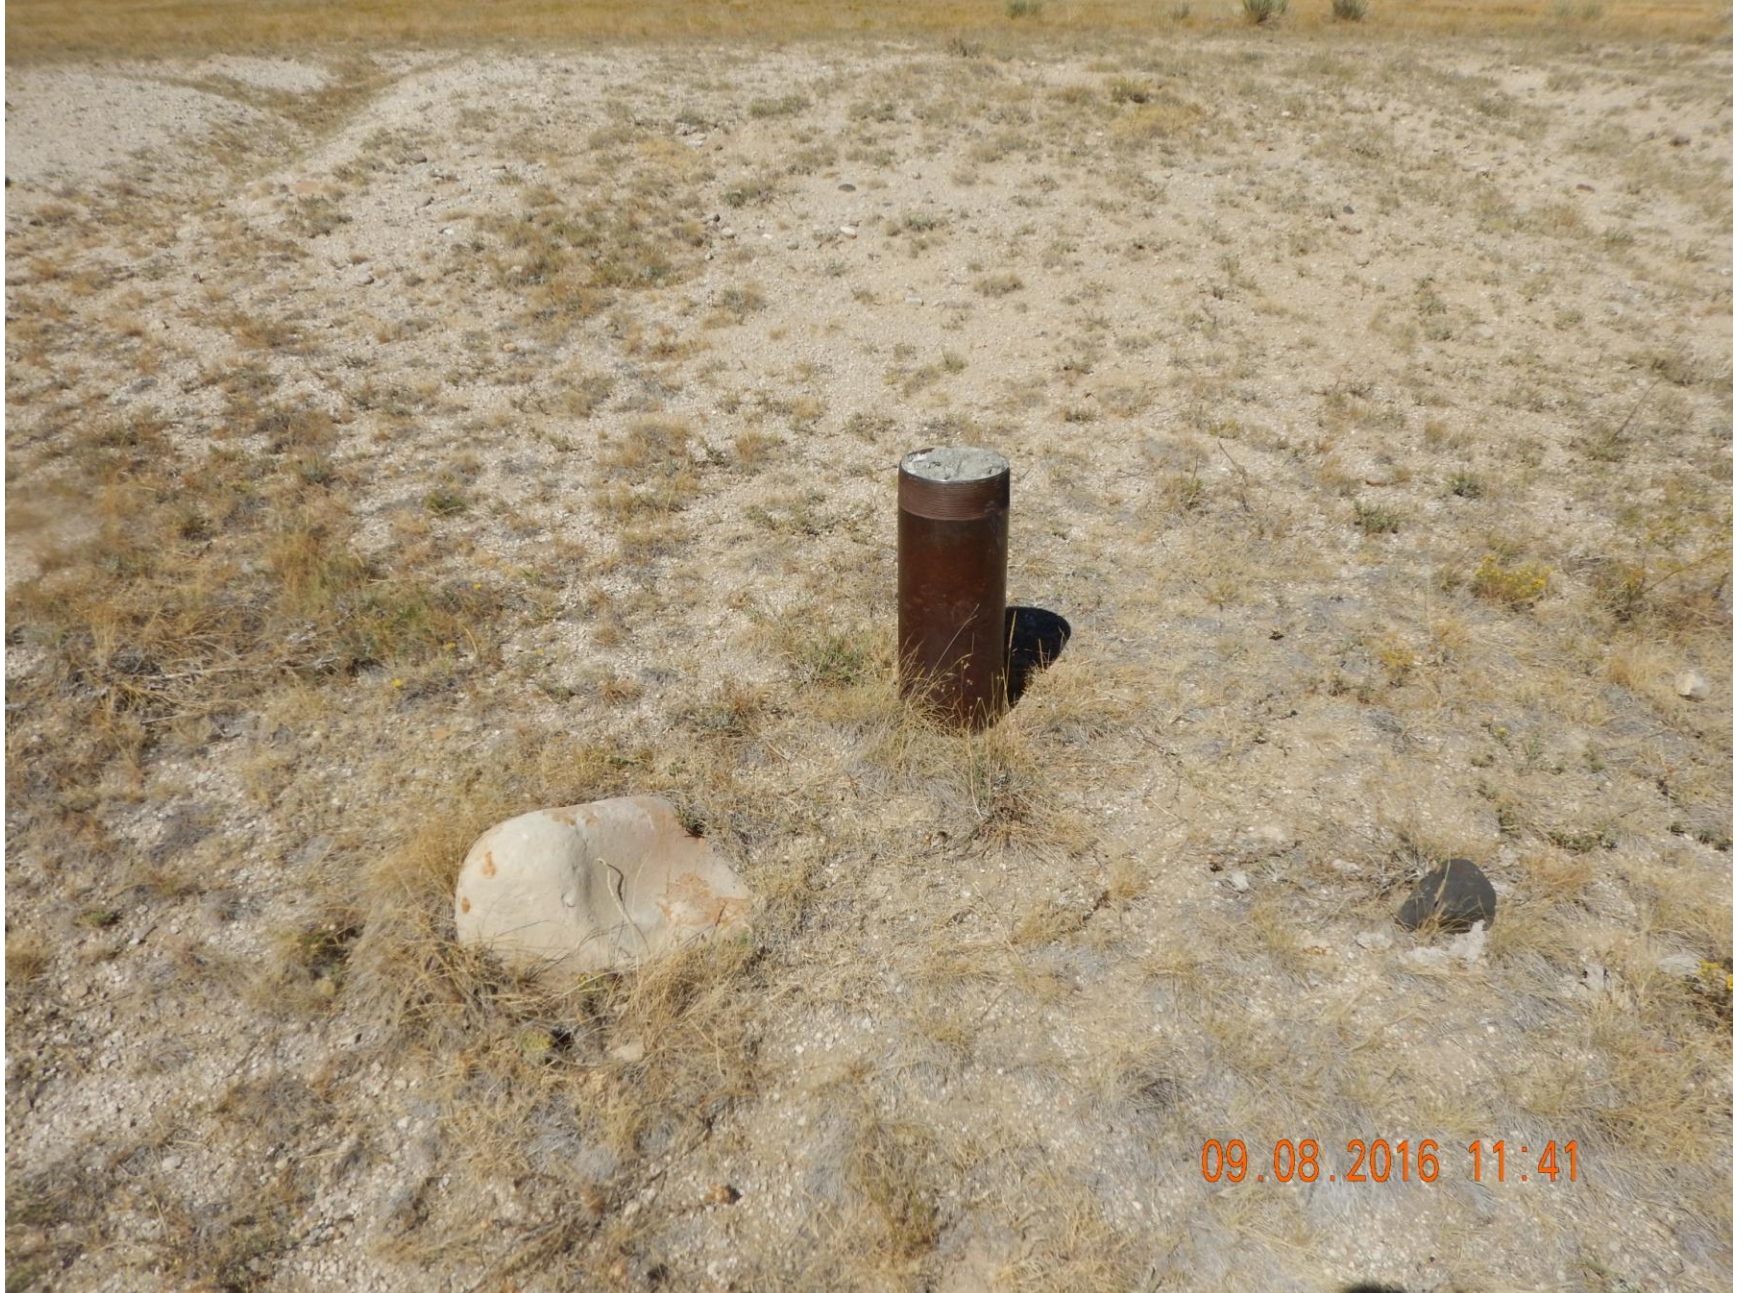
**Figure 10:** Photo shows casing still remaining on location. Note erosion on slope behind casing.
