# Reclamation Inspection

09/08/2016

Operator: Chandler & Associates

Location ID: 378092

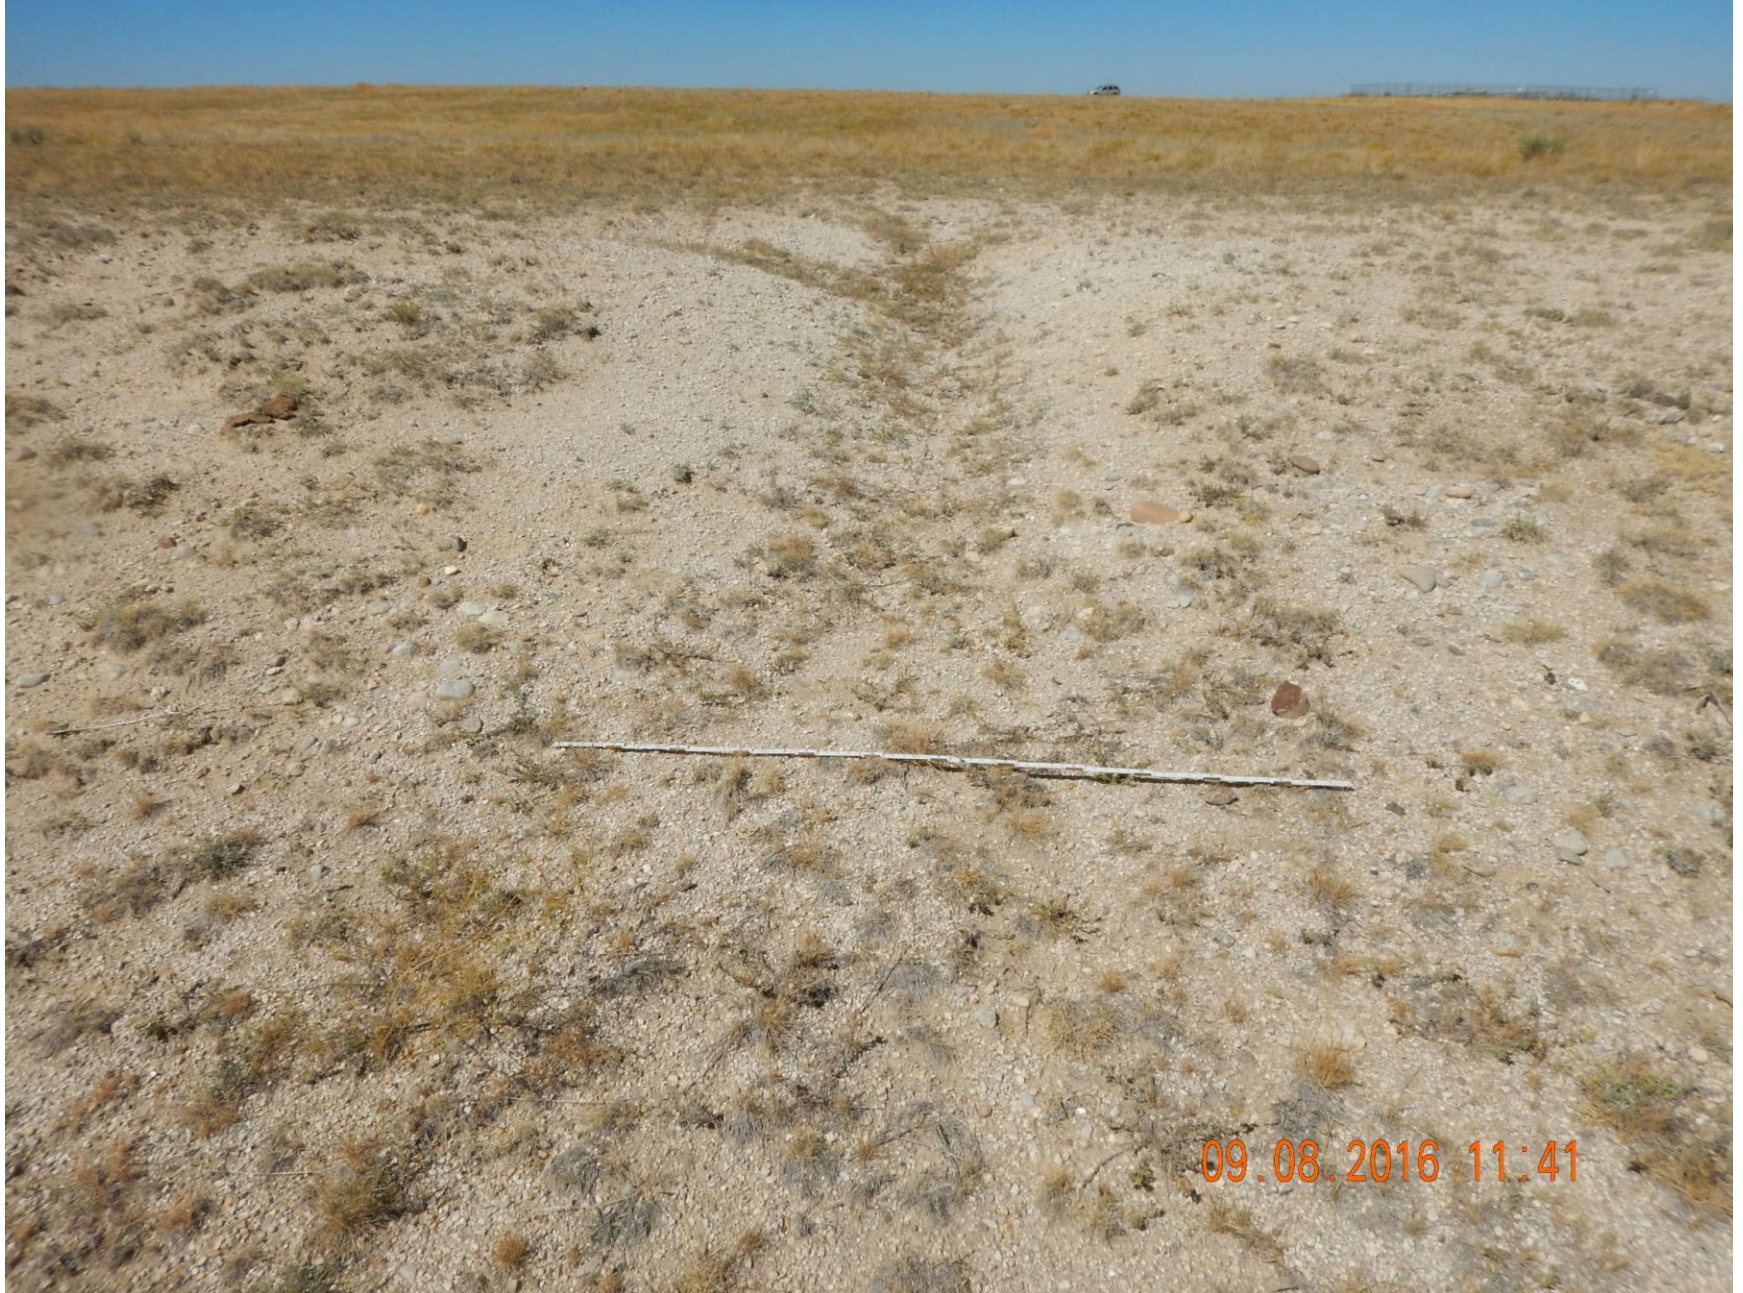
**Figure 11:** Photo taken from the west end of the location, facing west. Photo shows stormwater erosion occurring on slopes. 6' measuring stick for reference.

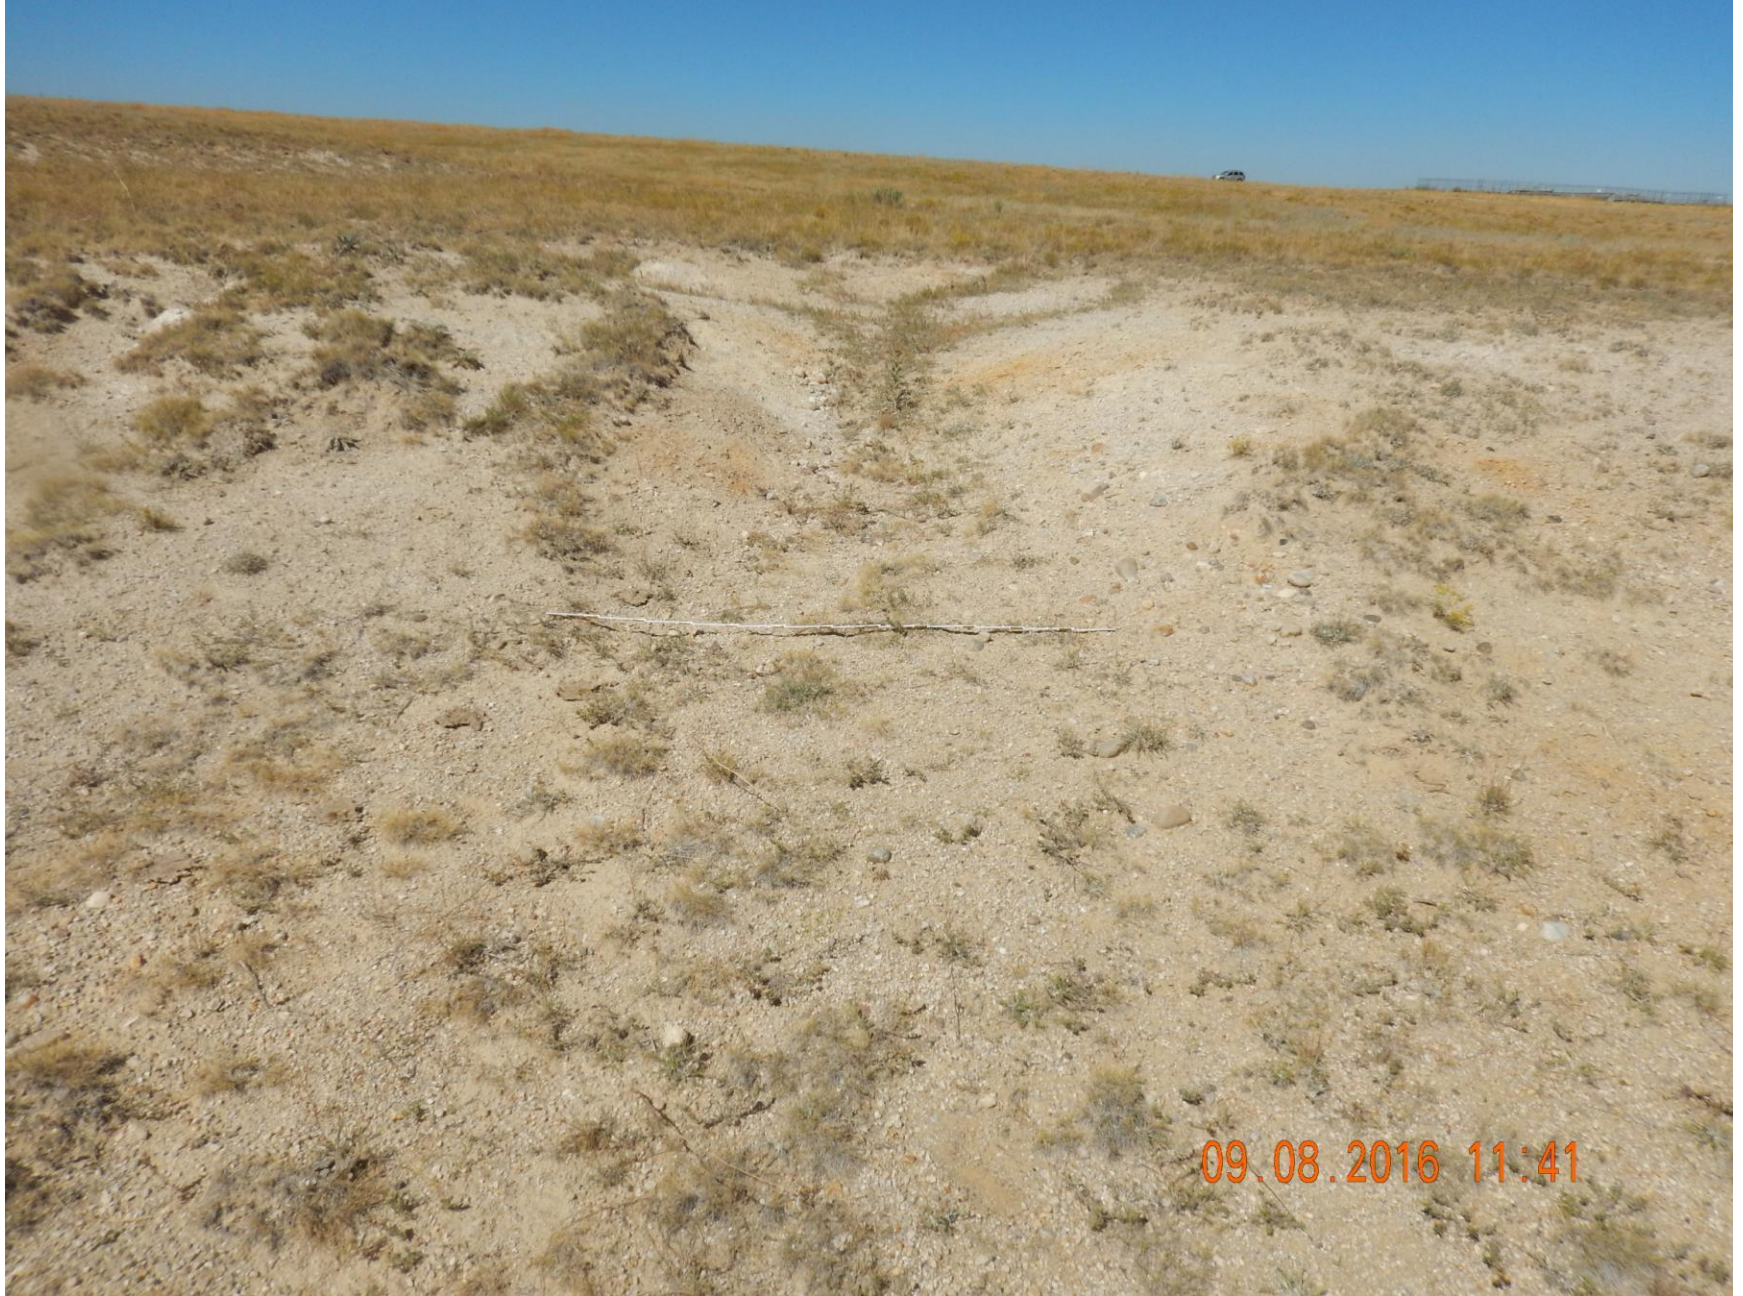
**Figure 12:** Photo taken from the west end of the location, facing west. Photo shows stormwater erosion occurring on slopes. 6' measuring stick for reference.

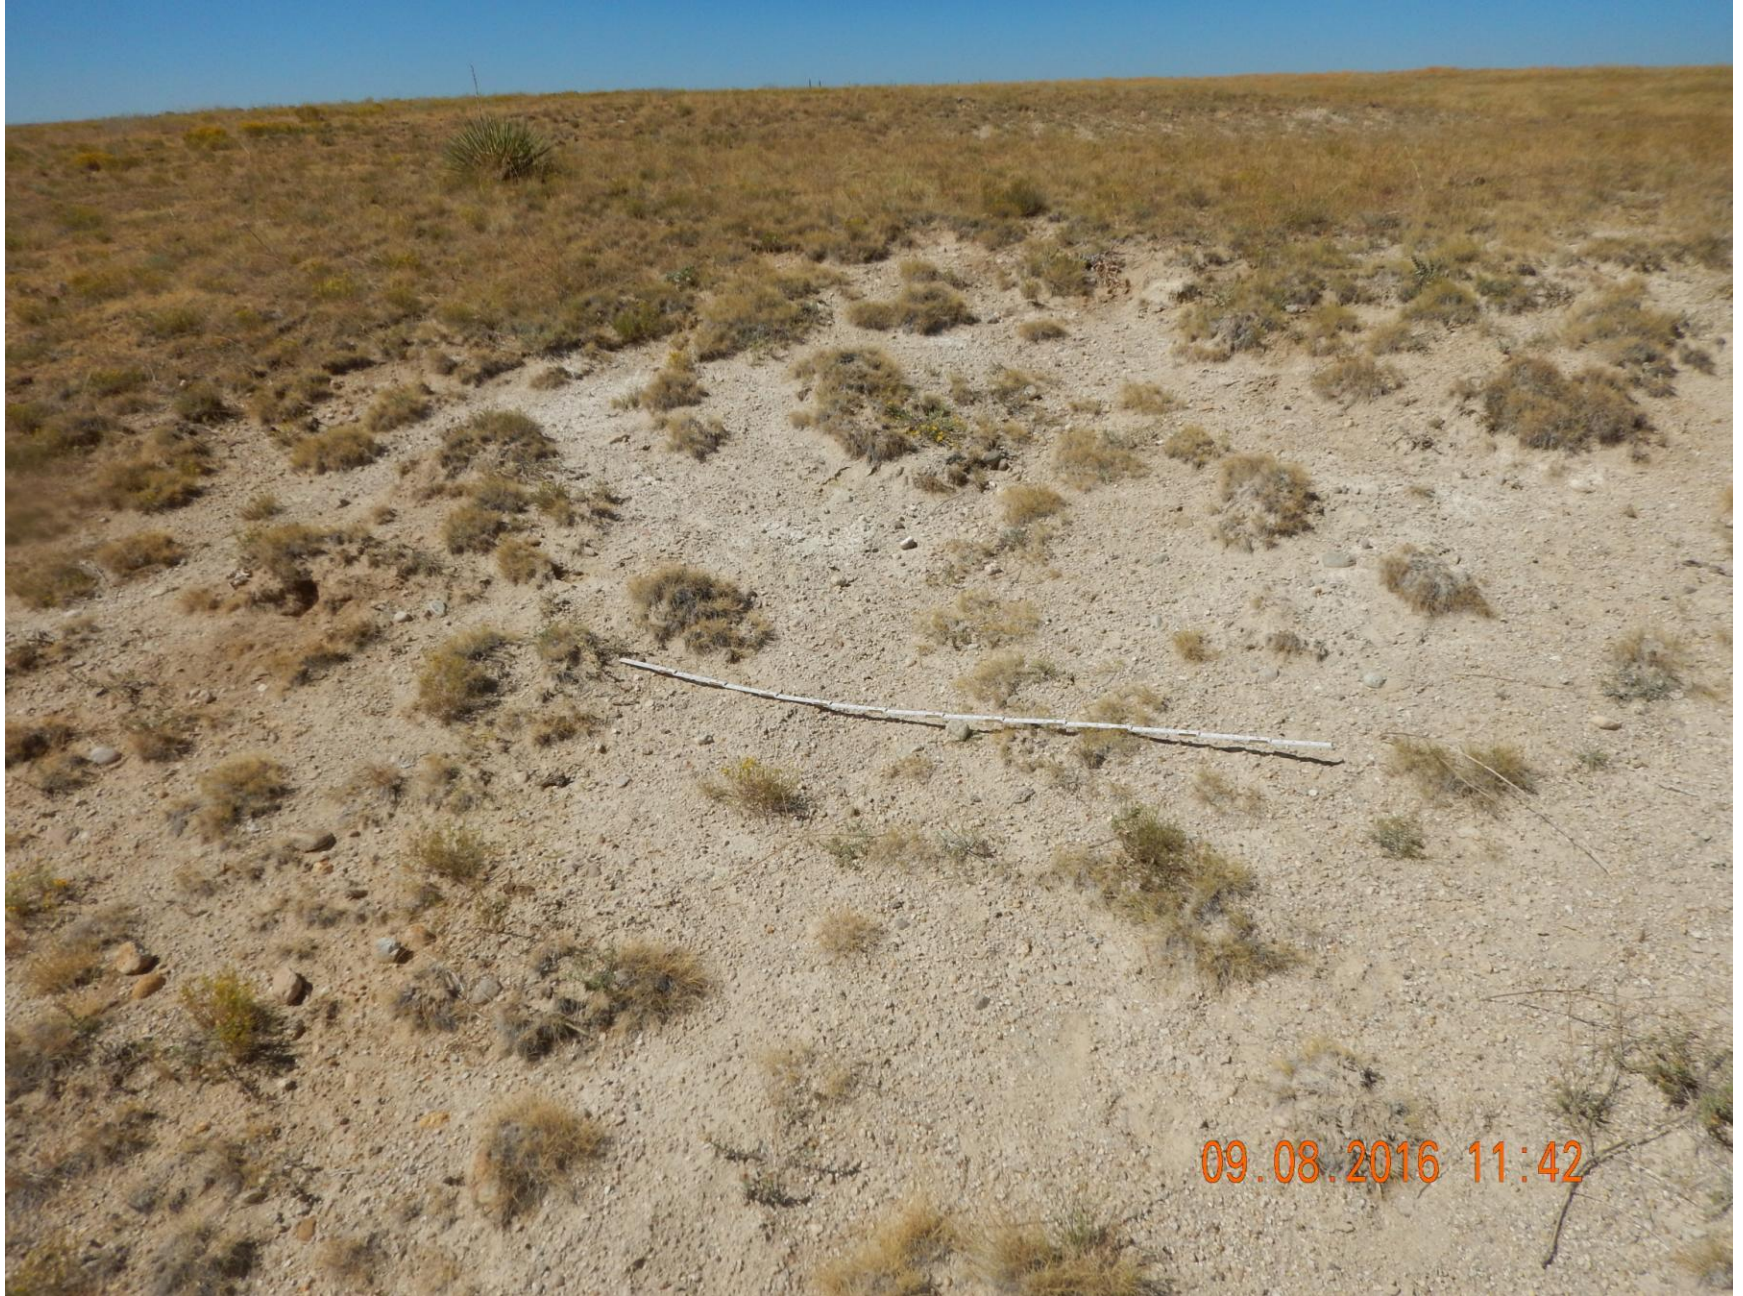
**Figure 13:** Photo taken from the southwest end of the location, facing southwest. Photo shows stormwater erosion occurring on slopes. 6' measuring stick for reference.
