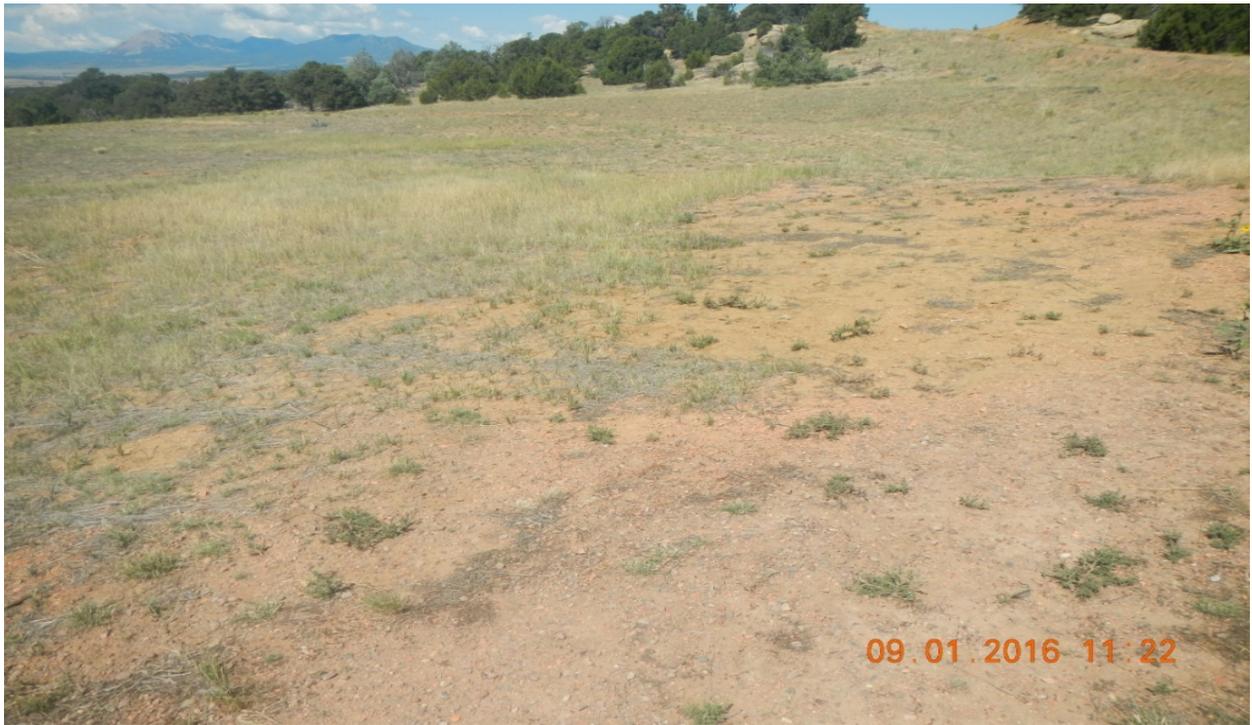
photo 1: Facing northwest toward the location.

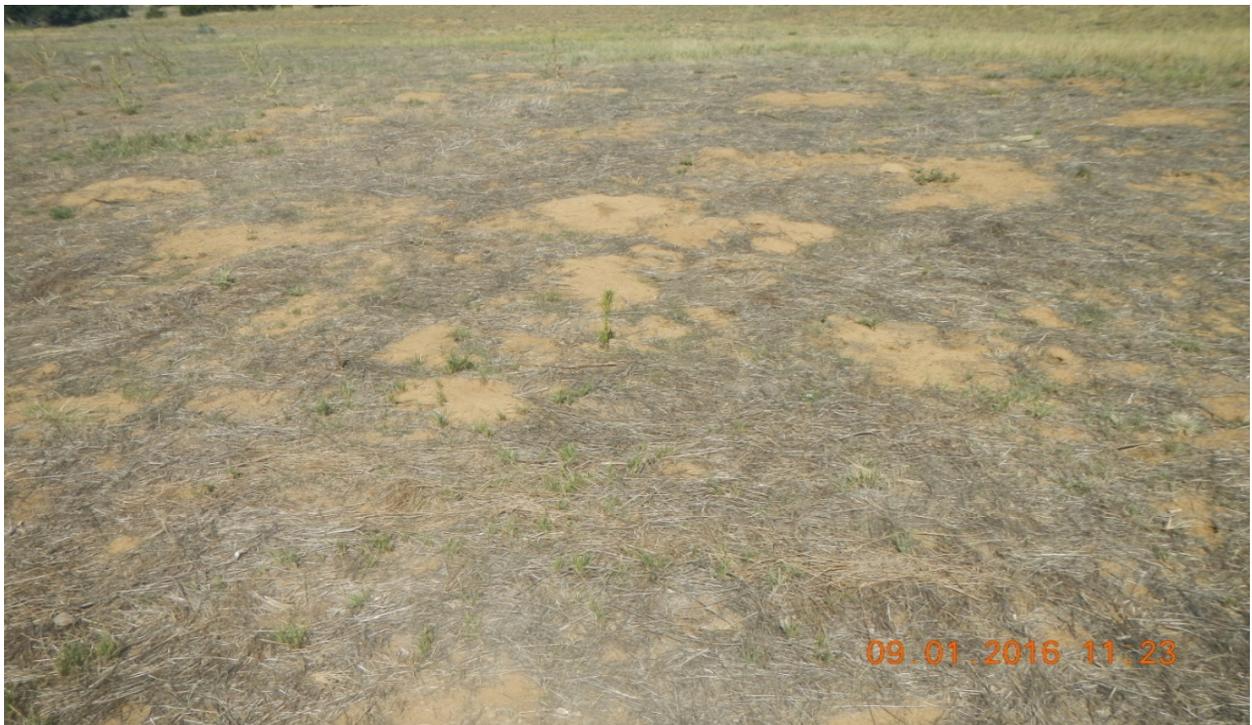
photo 2: View of vegetation growth at the southeast side of the location. There is little to no vegetation growth in this area.

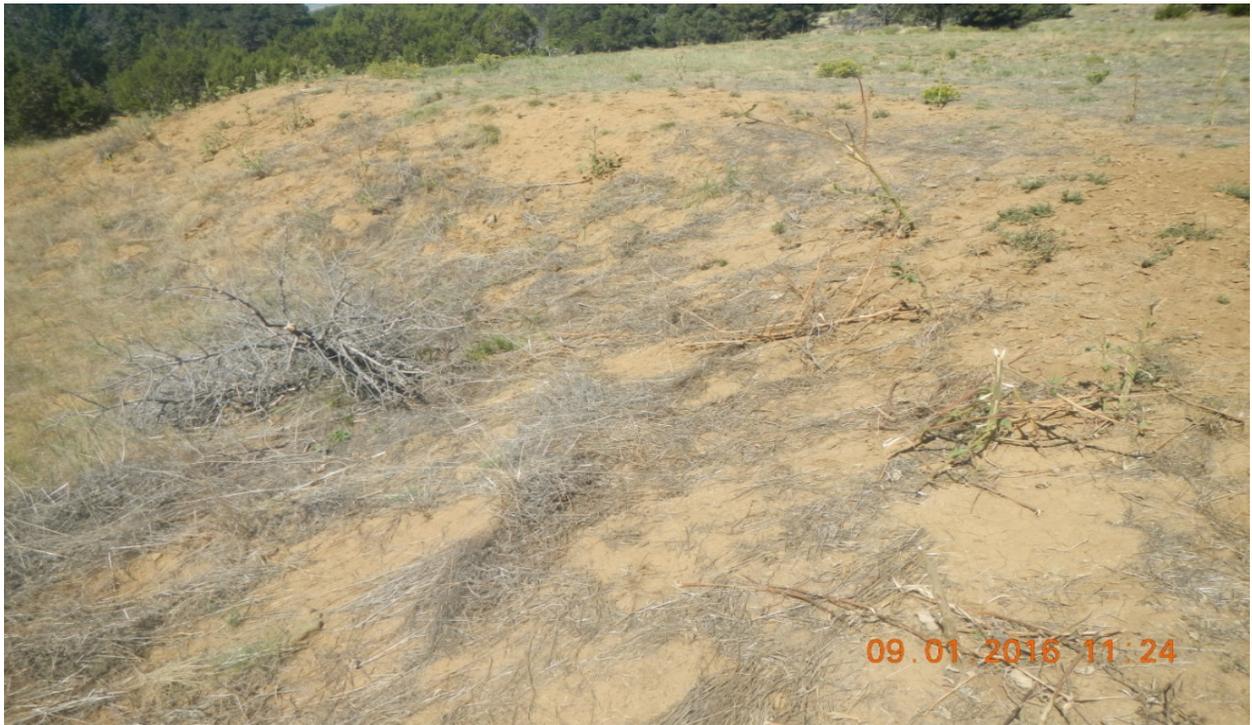
photo 3: Facing west along the south side of the location (fill slope).

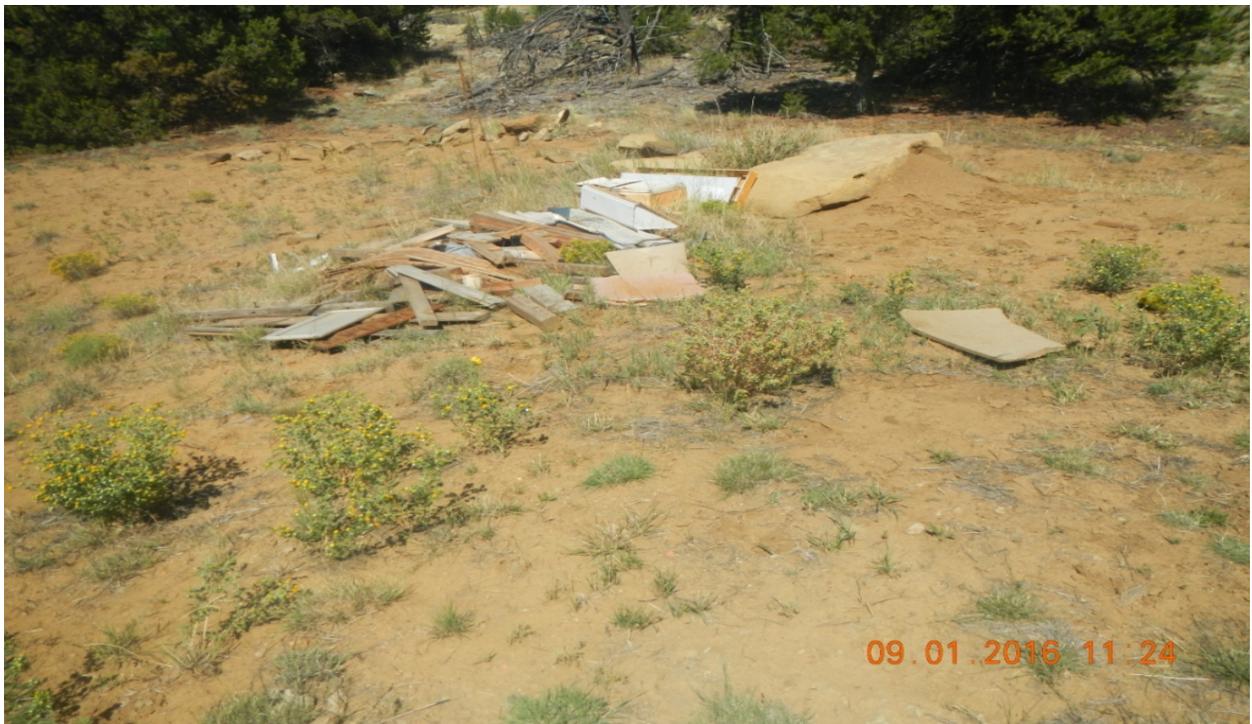
photo 4: There is trash debris in a pile at the northwest side of the location.

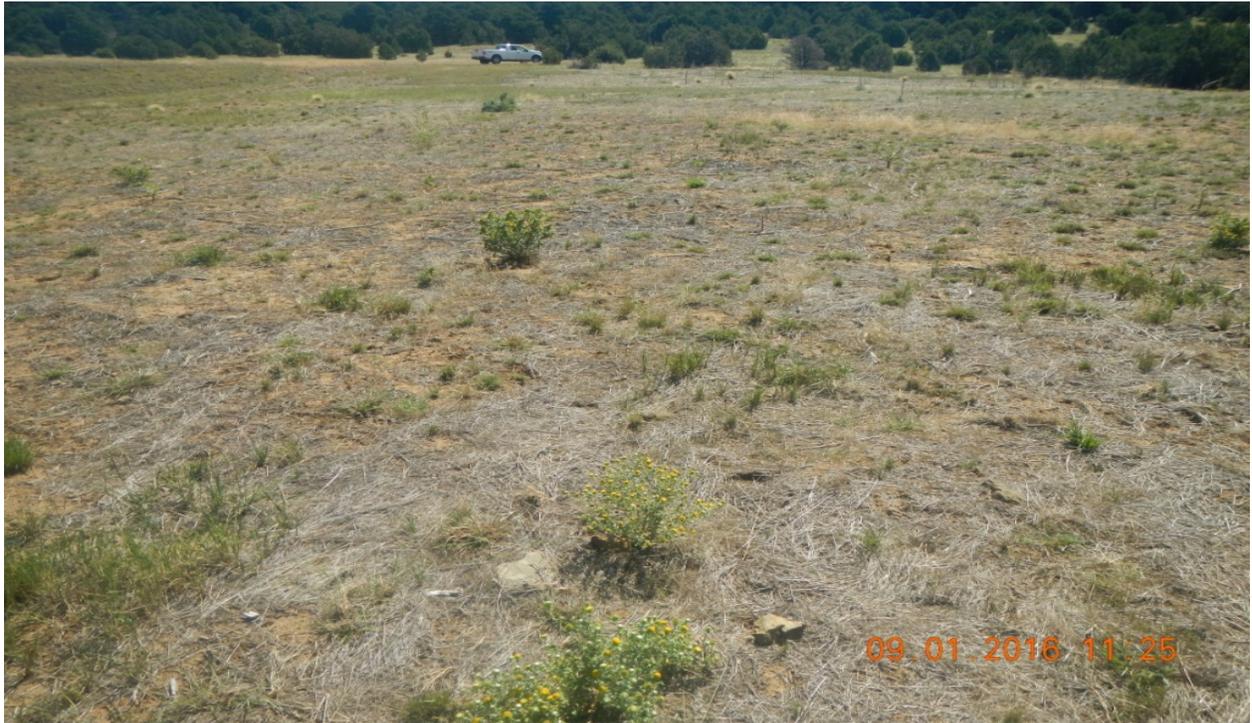
photo 5: Northwest side of the location facing southeast.

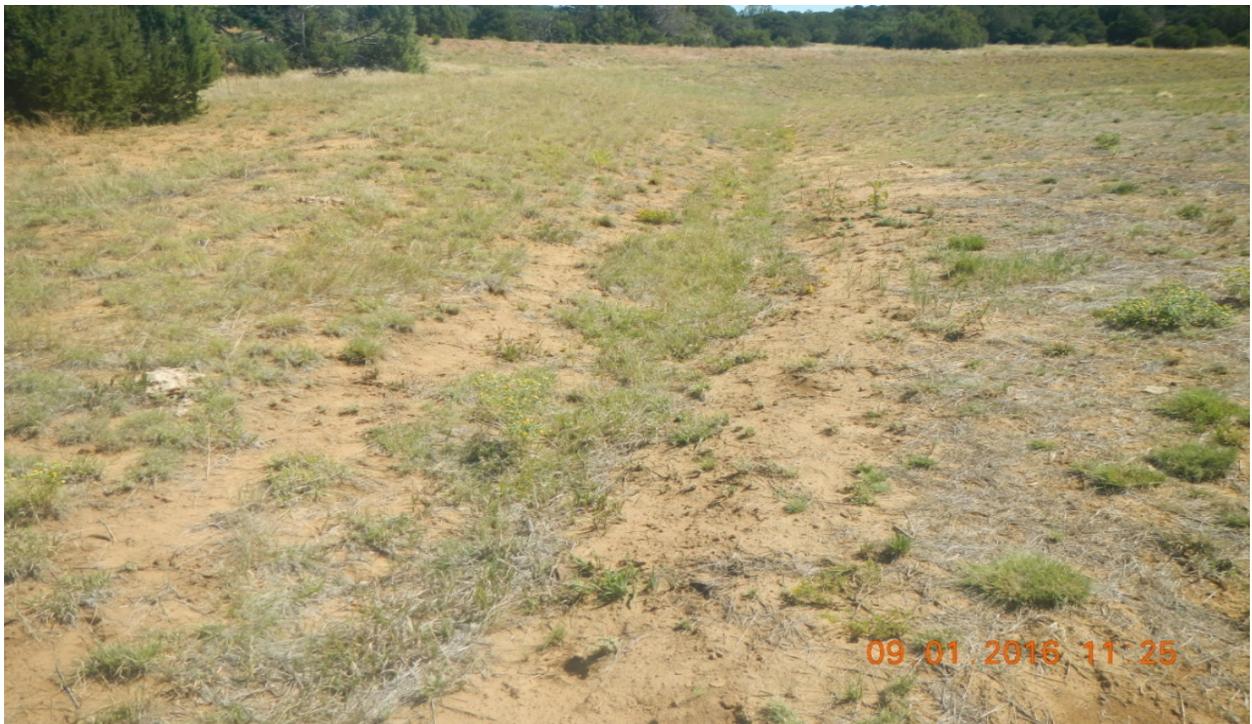
photo 6: Northwest side of the location facing east toward the cut slope.

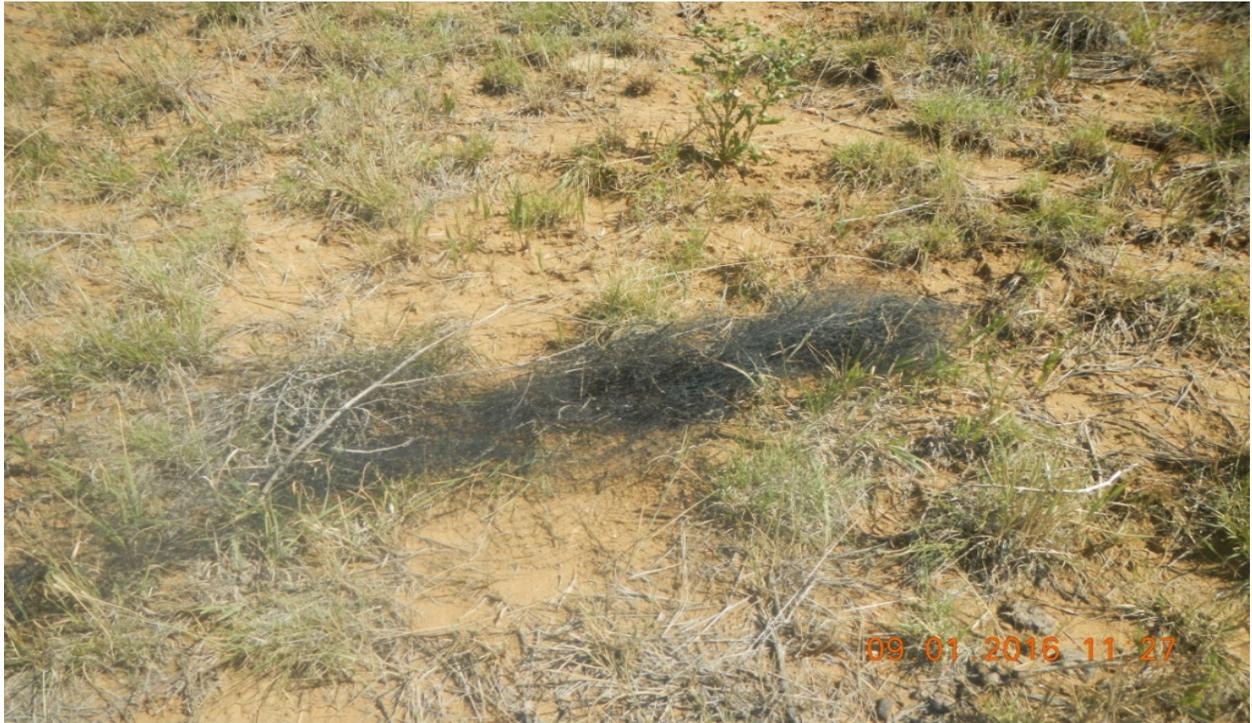
photo 7: There is plastic debris along areas of the cut slope.

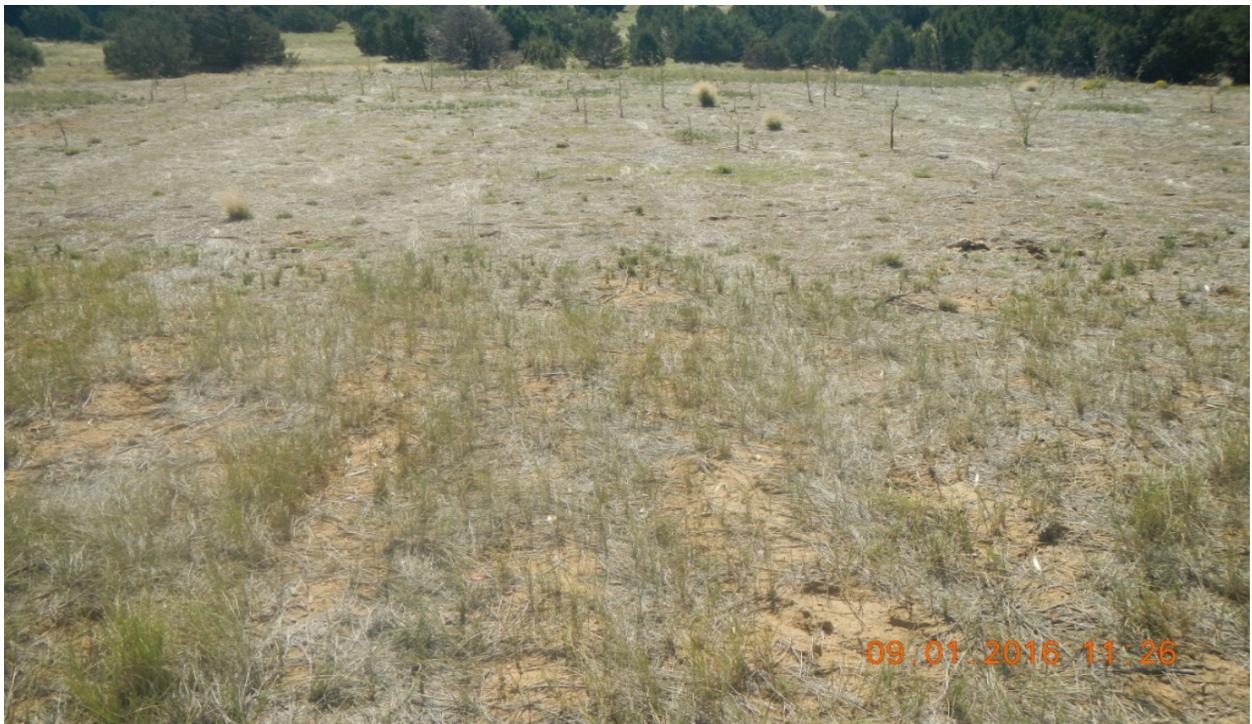
photo 8: North side of the location facing south.

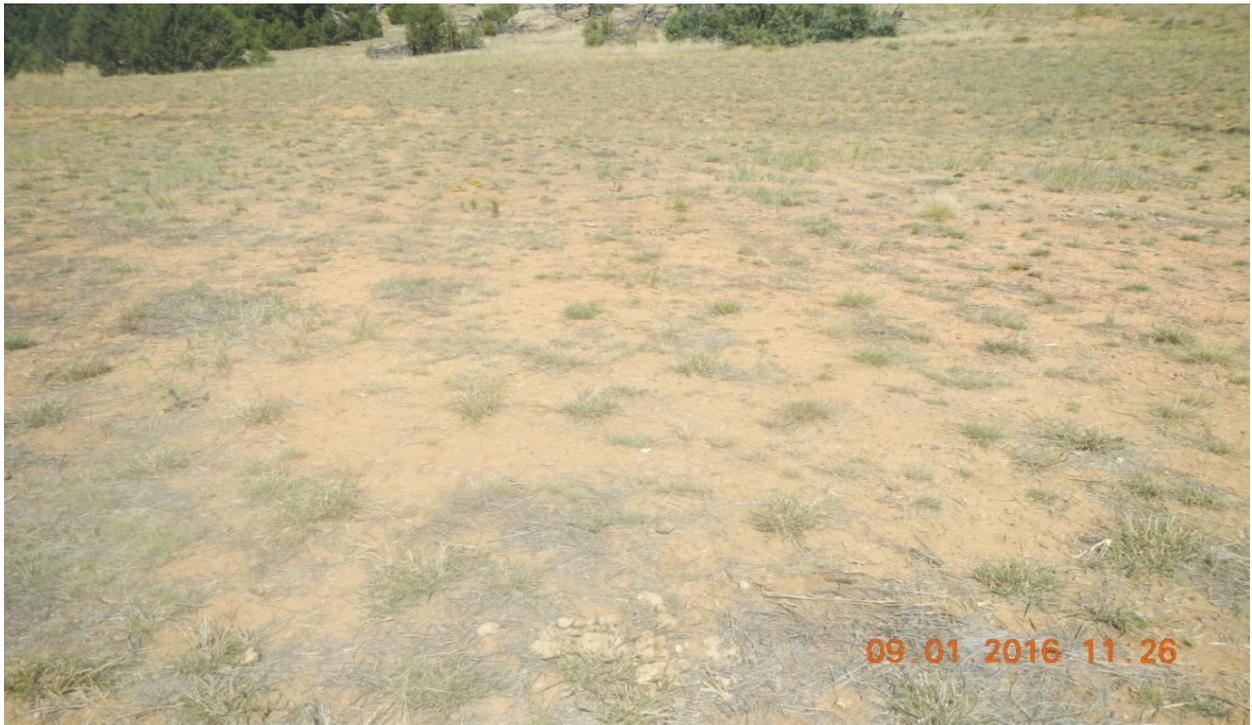
photo 9: Center of the location facing north.

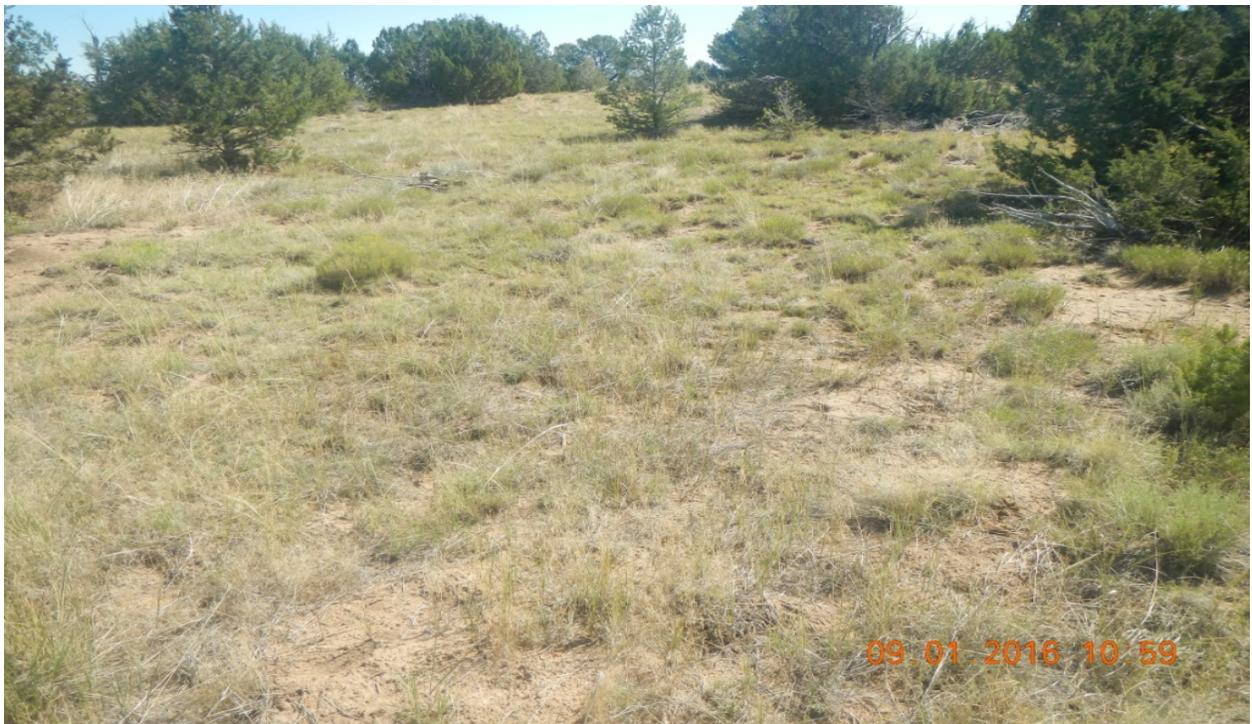
photo 10: Facing toward the nearby undisturbed reference area.
