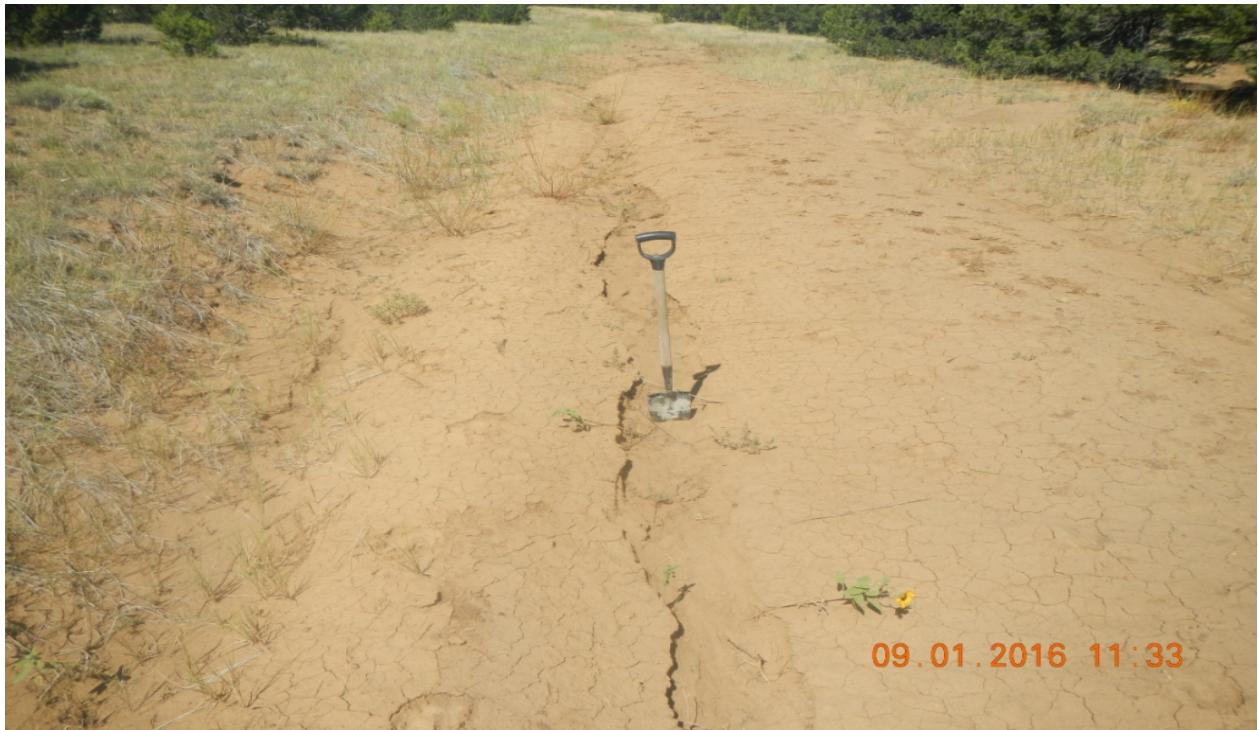
photo 1: Facing northwest along the access road toward the location. There is an erosion channel which is developing along the road near the location.

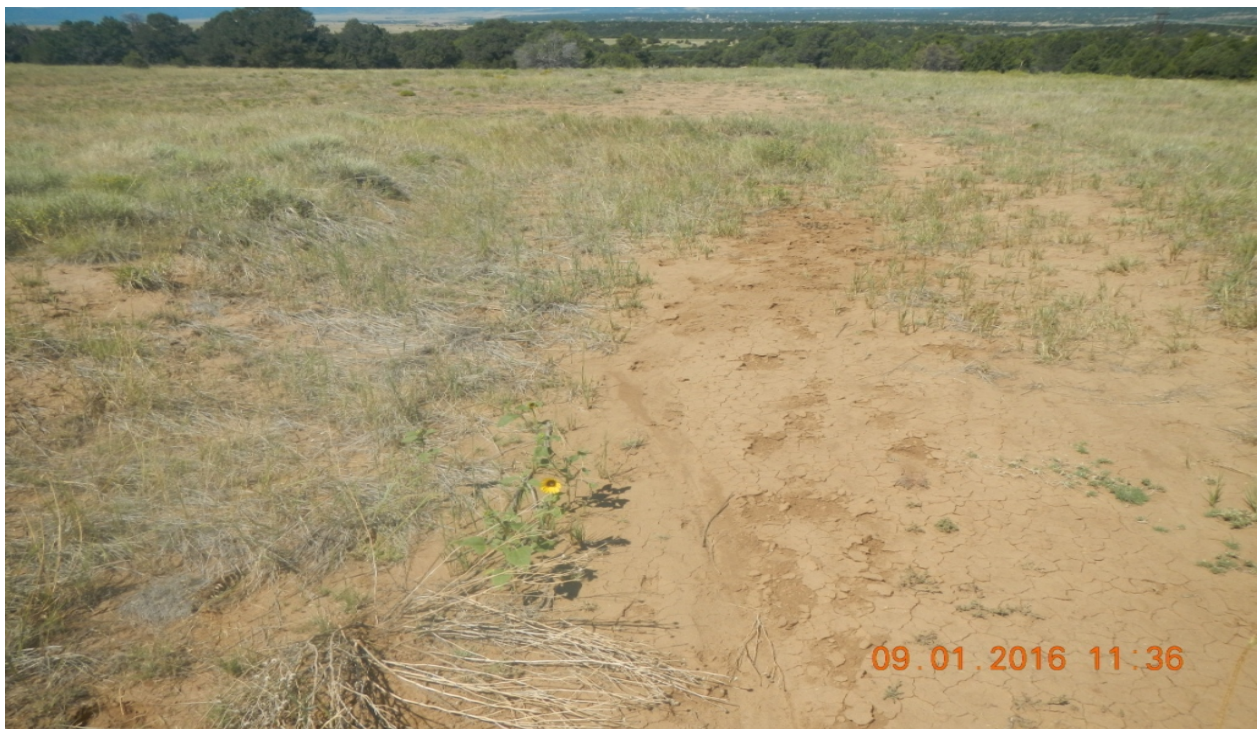
photo 2: Facing northwest toward the location.

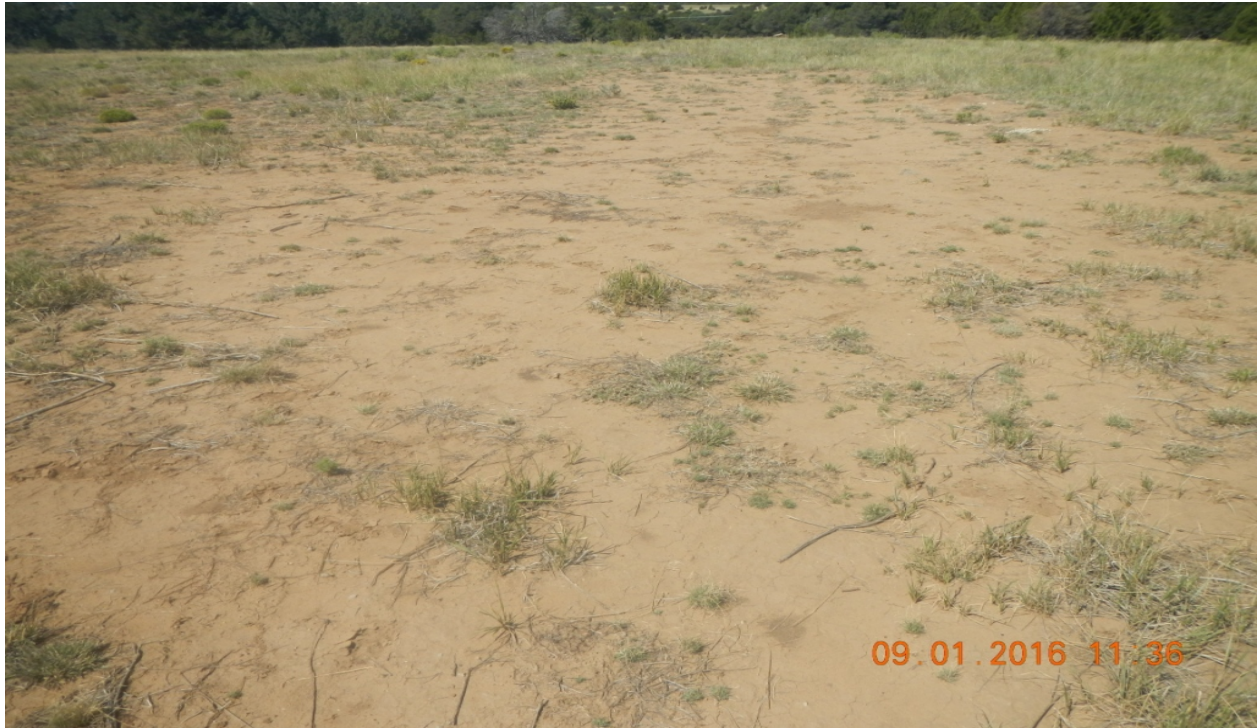
photo 3: Facing toward the east side of the location. Vegetation has not adequately established in this area.

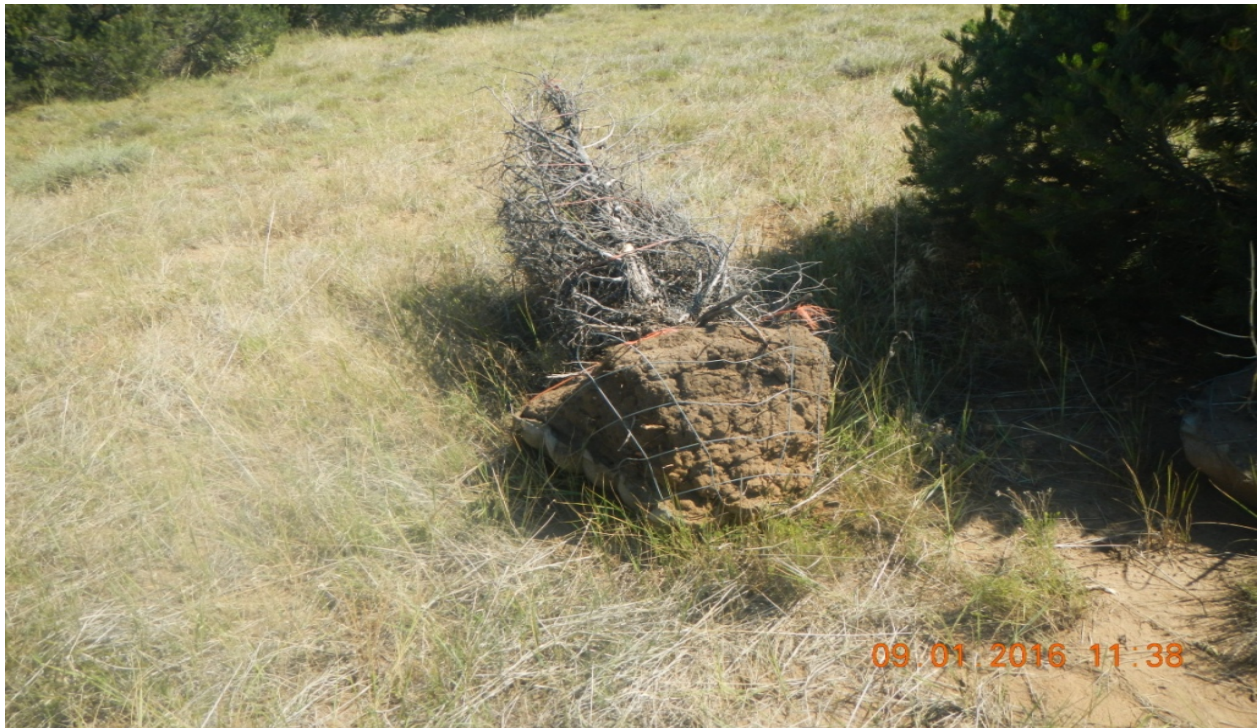
photo 4: There is a transplanted tree at the location which is now debris.

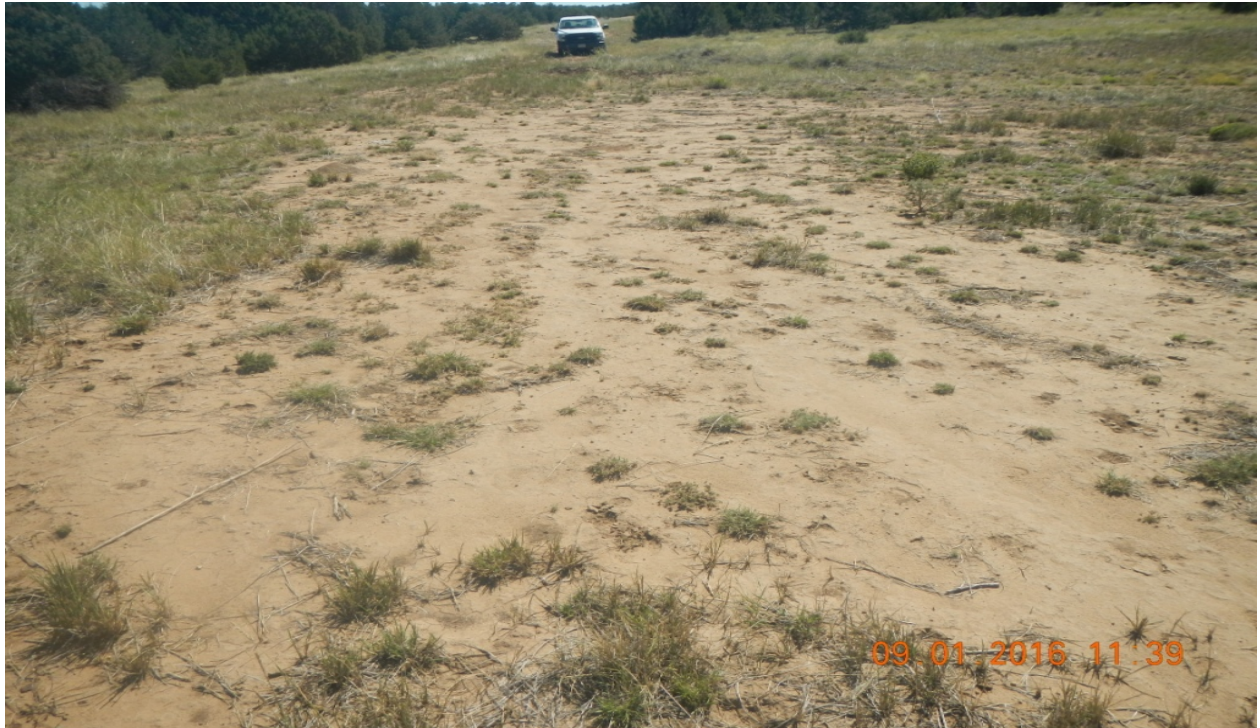
photo 5: Center of the location facing southeast.

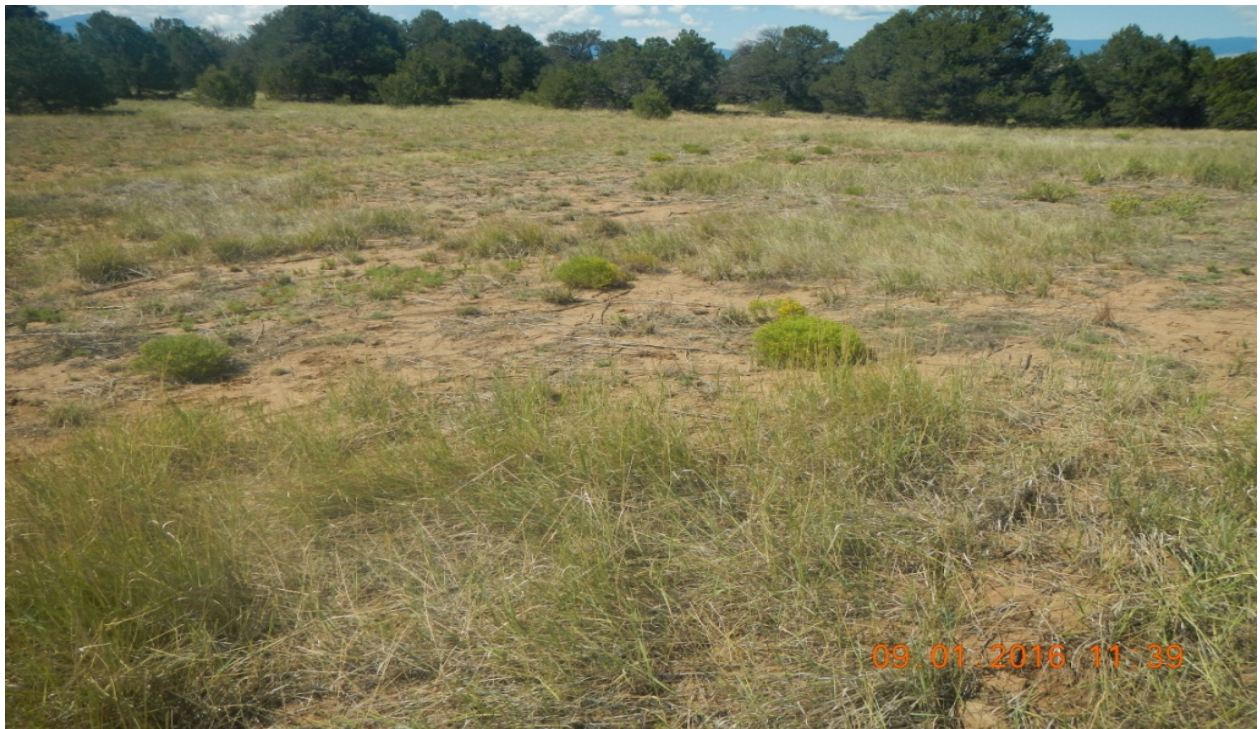
photo 6: Center of the location facing west.

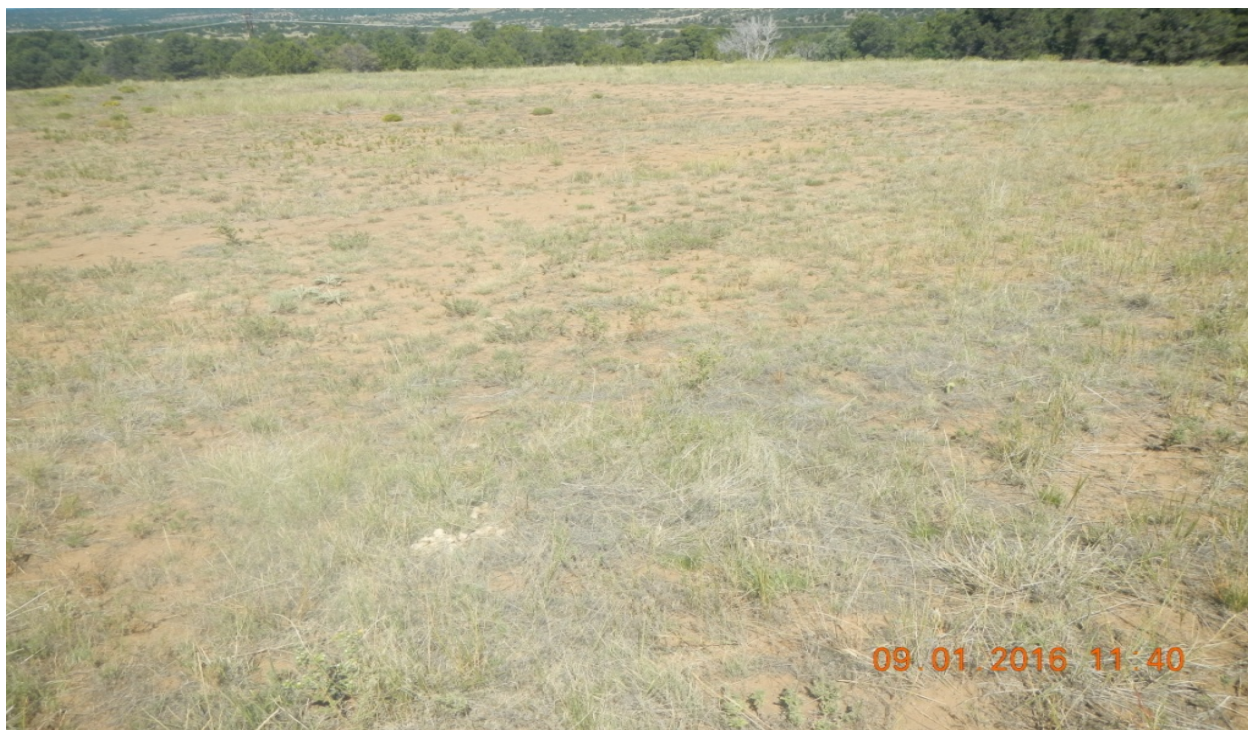
photo 7: South side of the location facing north.

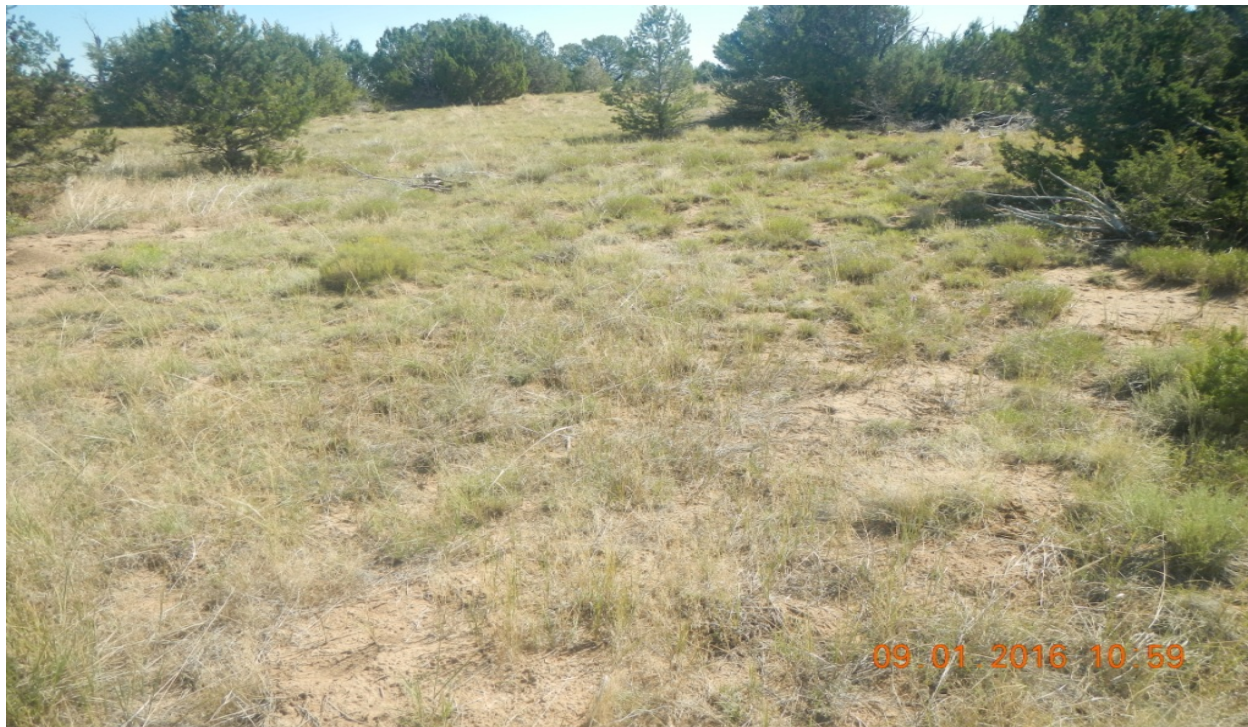
photo 8: Facing toward the nearby undisturbed reference area.
