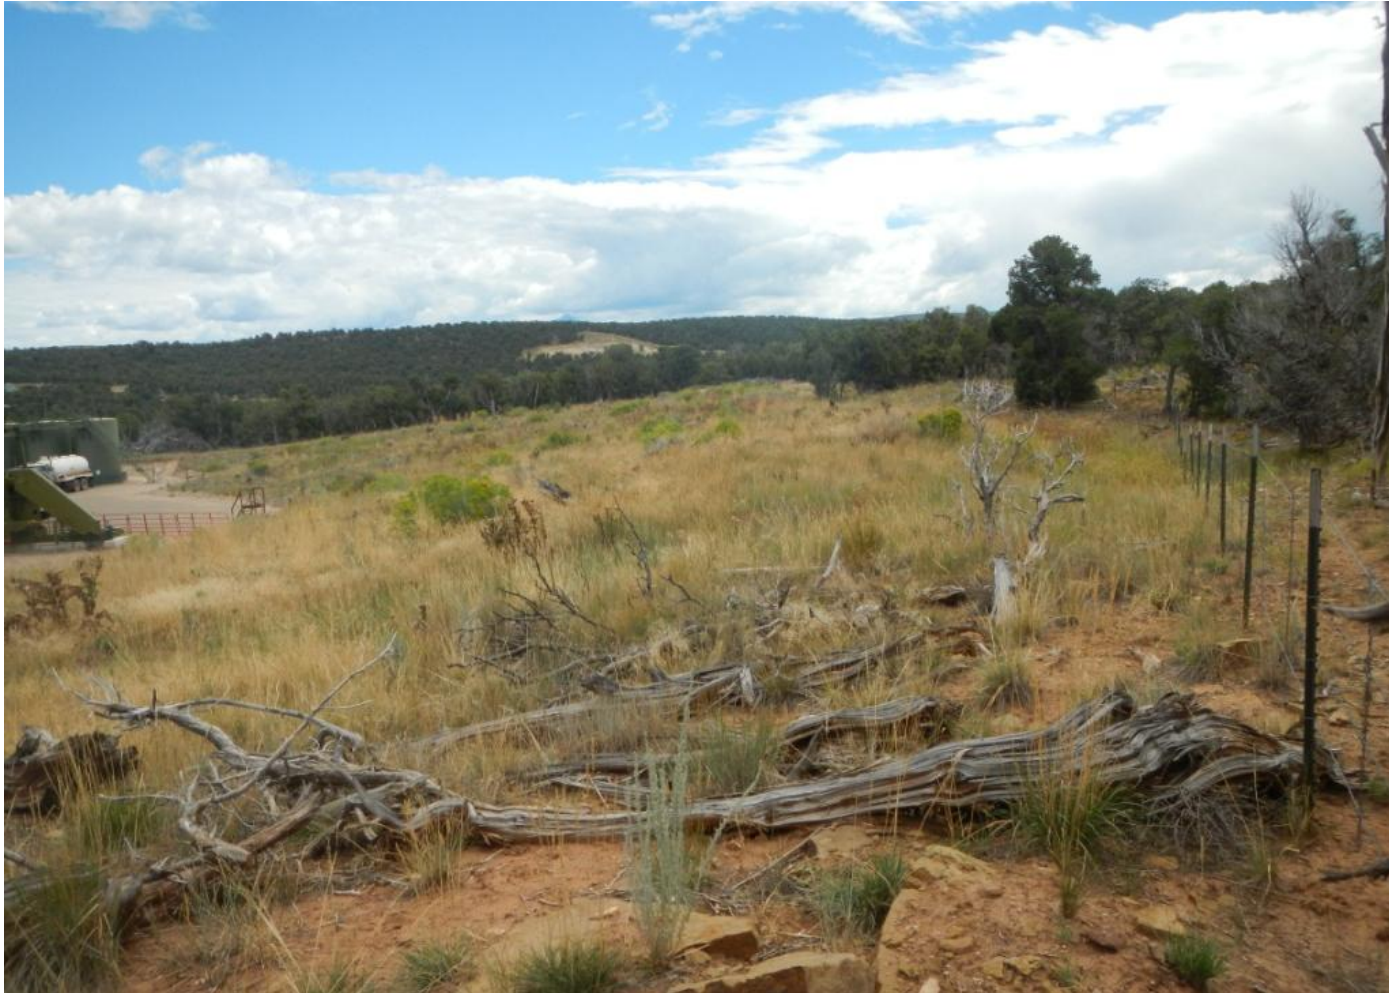
Photo 3. View of southern portion of the project area from the southwestern corner facing eastward. Revegetation is progressing in the interim reclamation areas. With desirable species such as James gallets (*Pleuraphis jamesii*), penstemon (*Penstemon* sp.), and western wheatgrass (*Pascopyrum smithii*). However portions of the project area are infested with weeds that need to be controlled (see photos below).

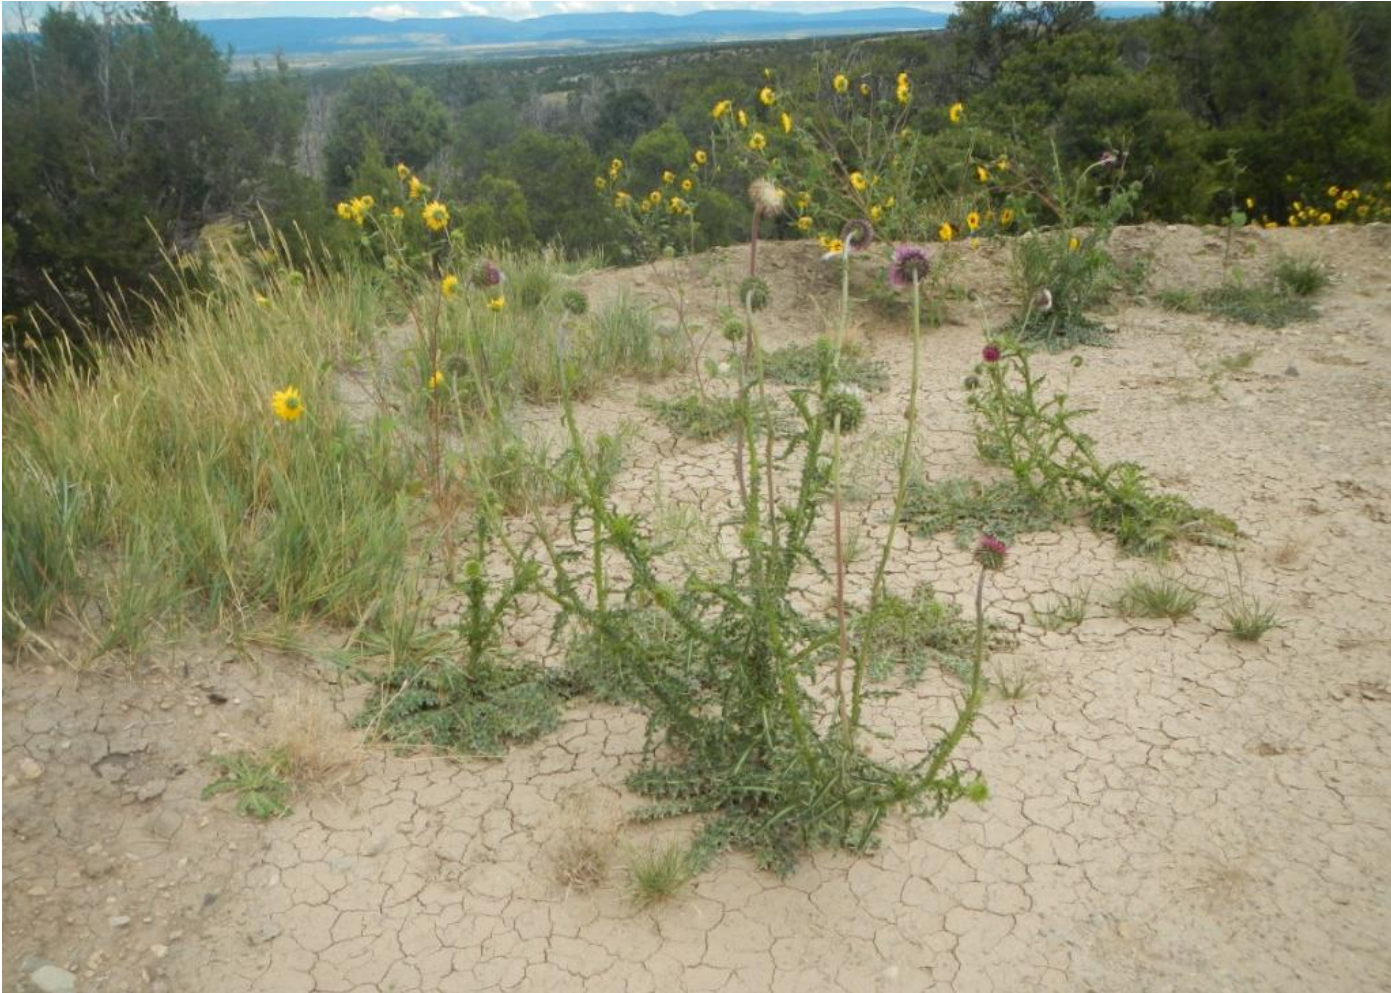
Photo 4. View of musk thistles (*Carduus nutans*) in the northwestern corner of the well pad.

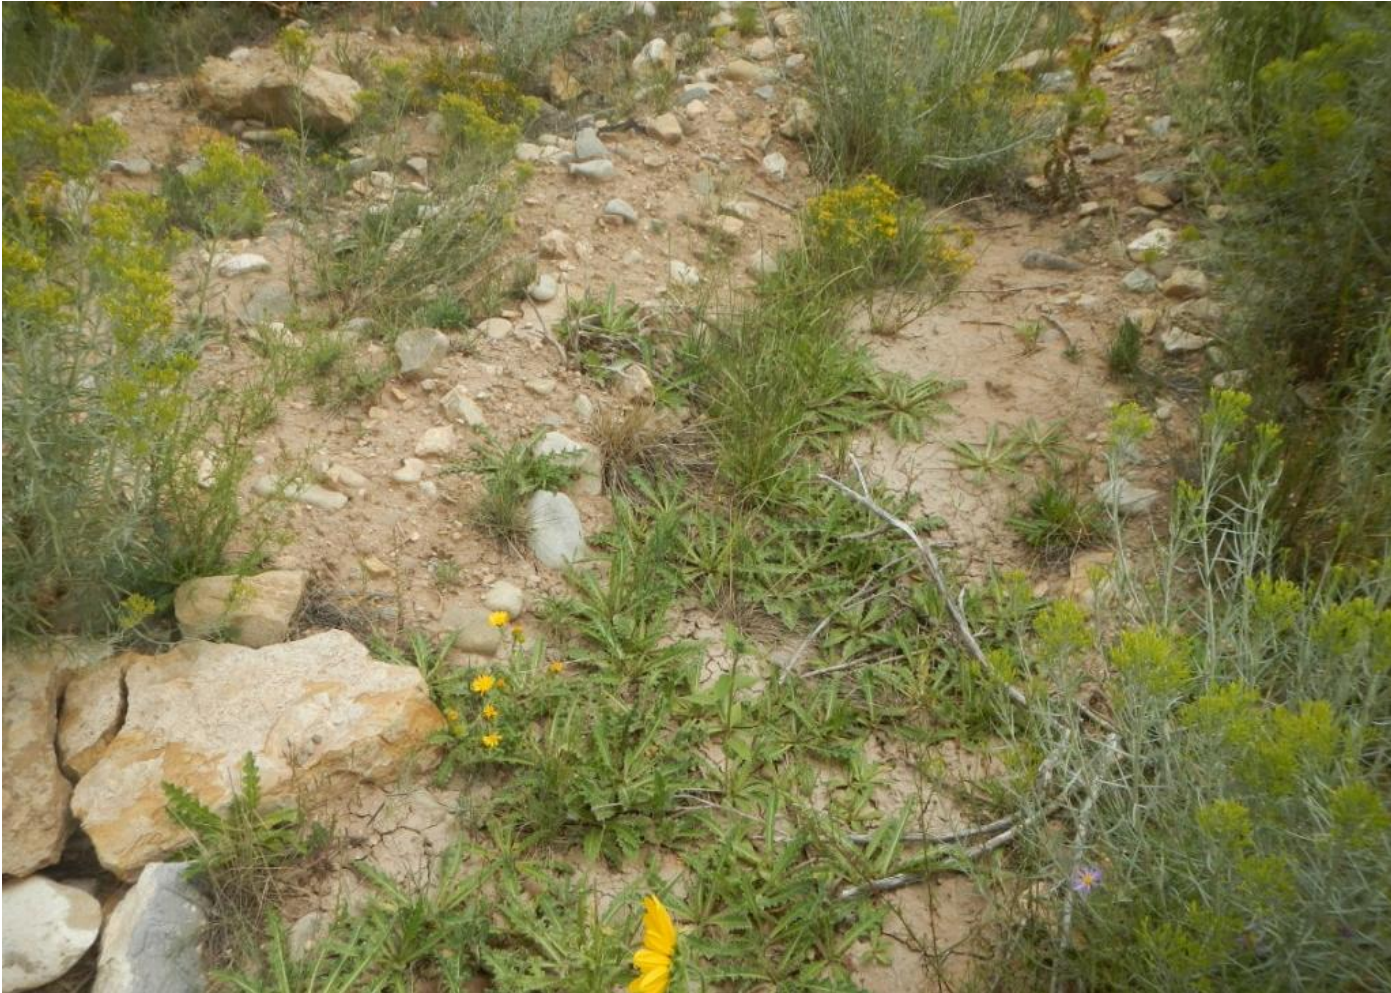
Photo 5. View of a cluster of musk thistle rosettes growing along the northern edge of the well pad.

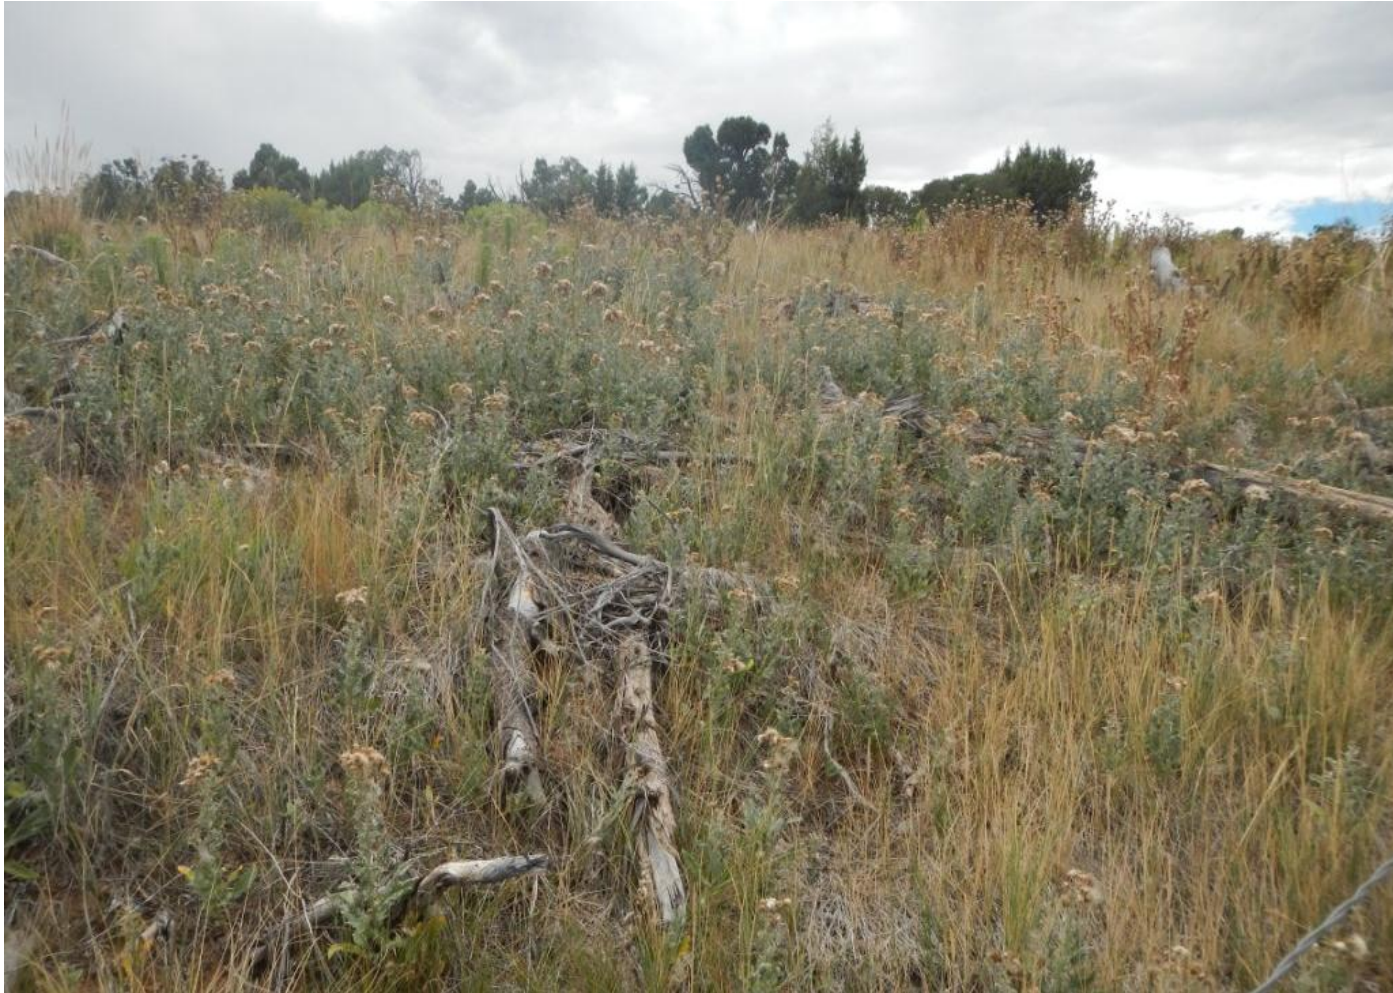
Photo 6. View of infestation of Canada thistle (*Cirsium arvense*) in the southern portion of the project area.

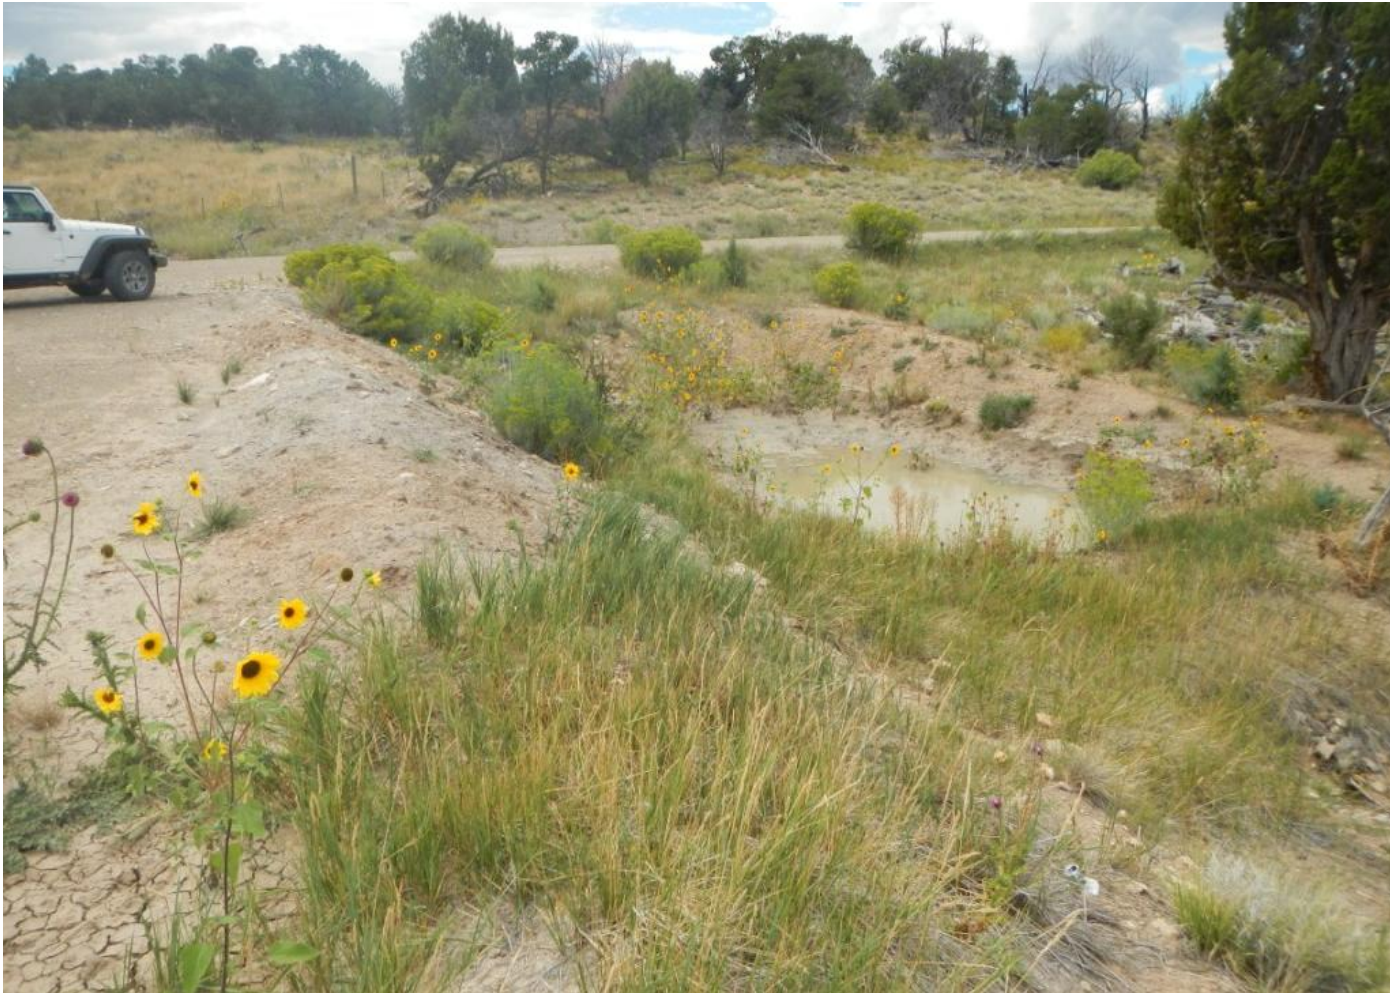
Photo 7. View of silt trap in the western portion of the project area.

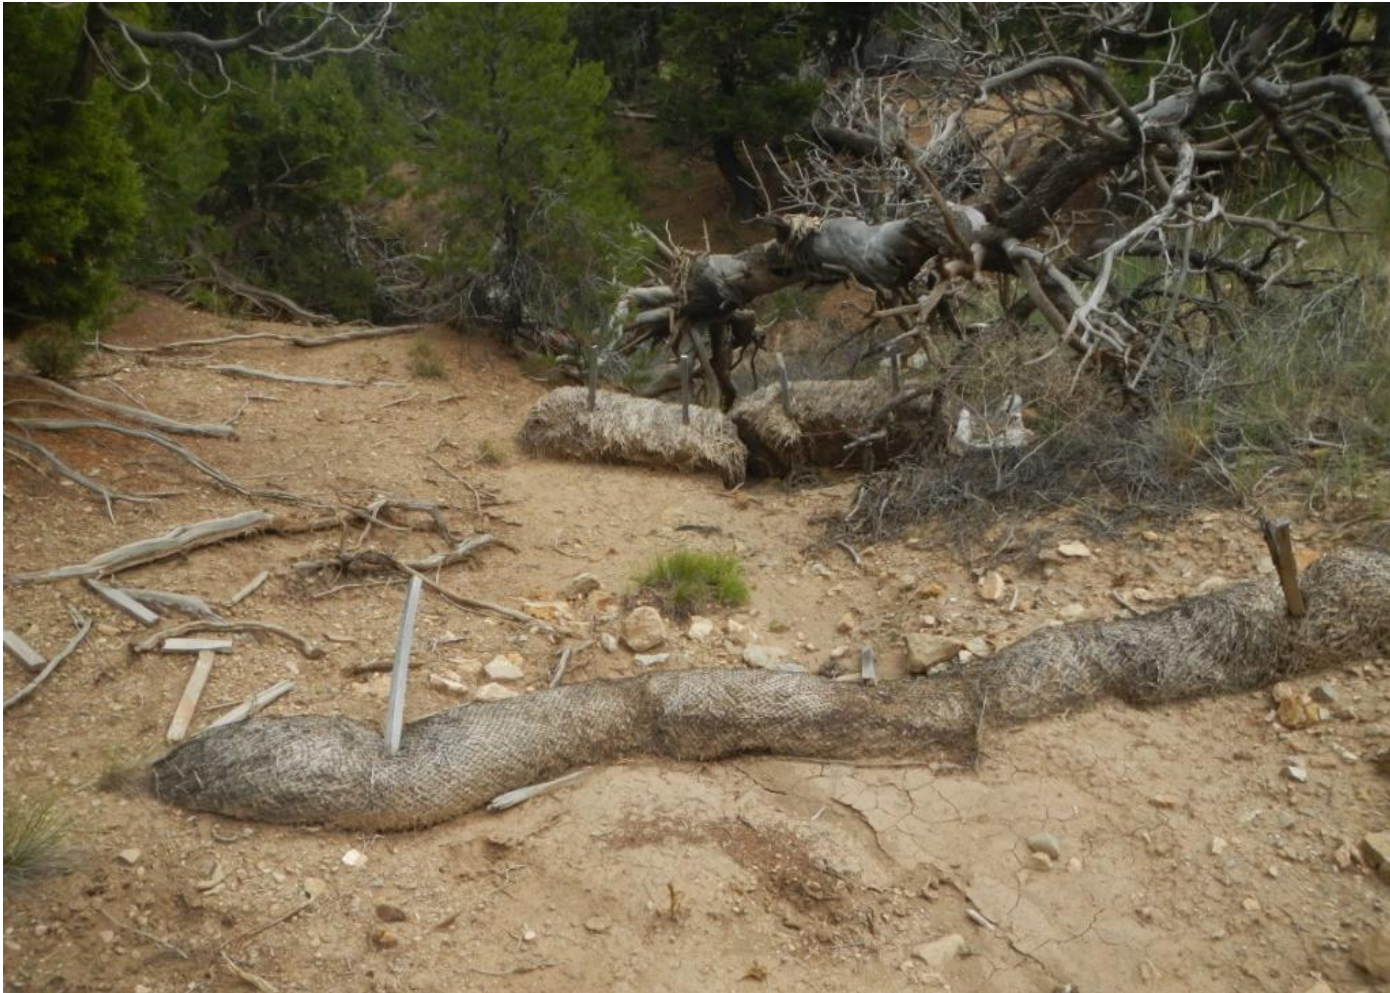
Photo 8. View of wattles and hay bales in the northwestern corner in disrepair.

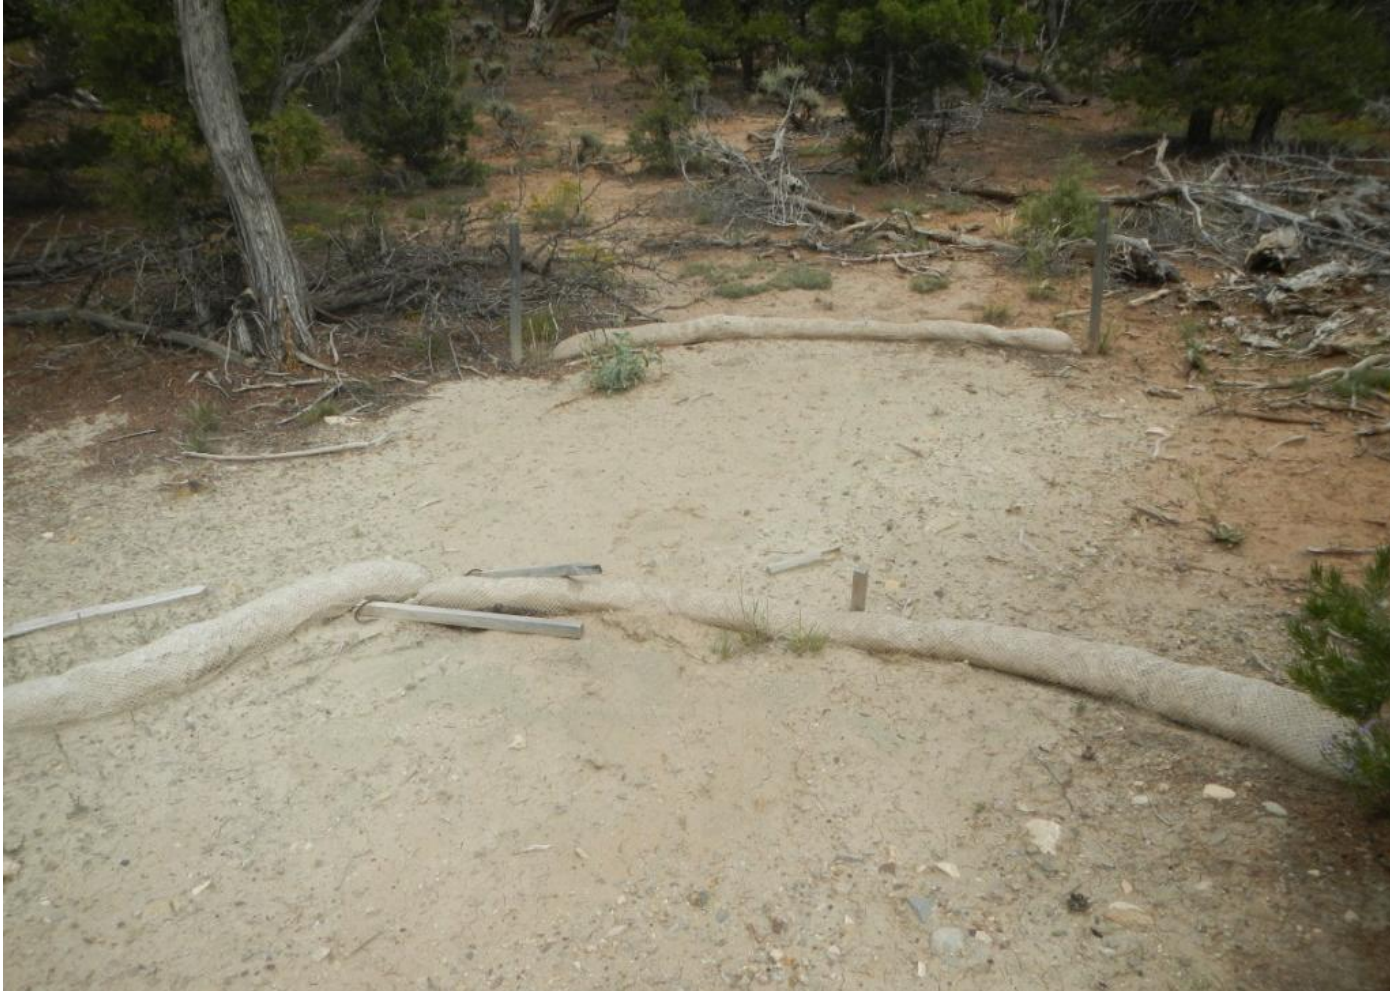
Photo 9. View of wattles in the northeastern corner of the well pad in disrepair.

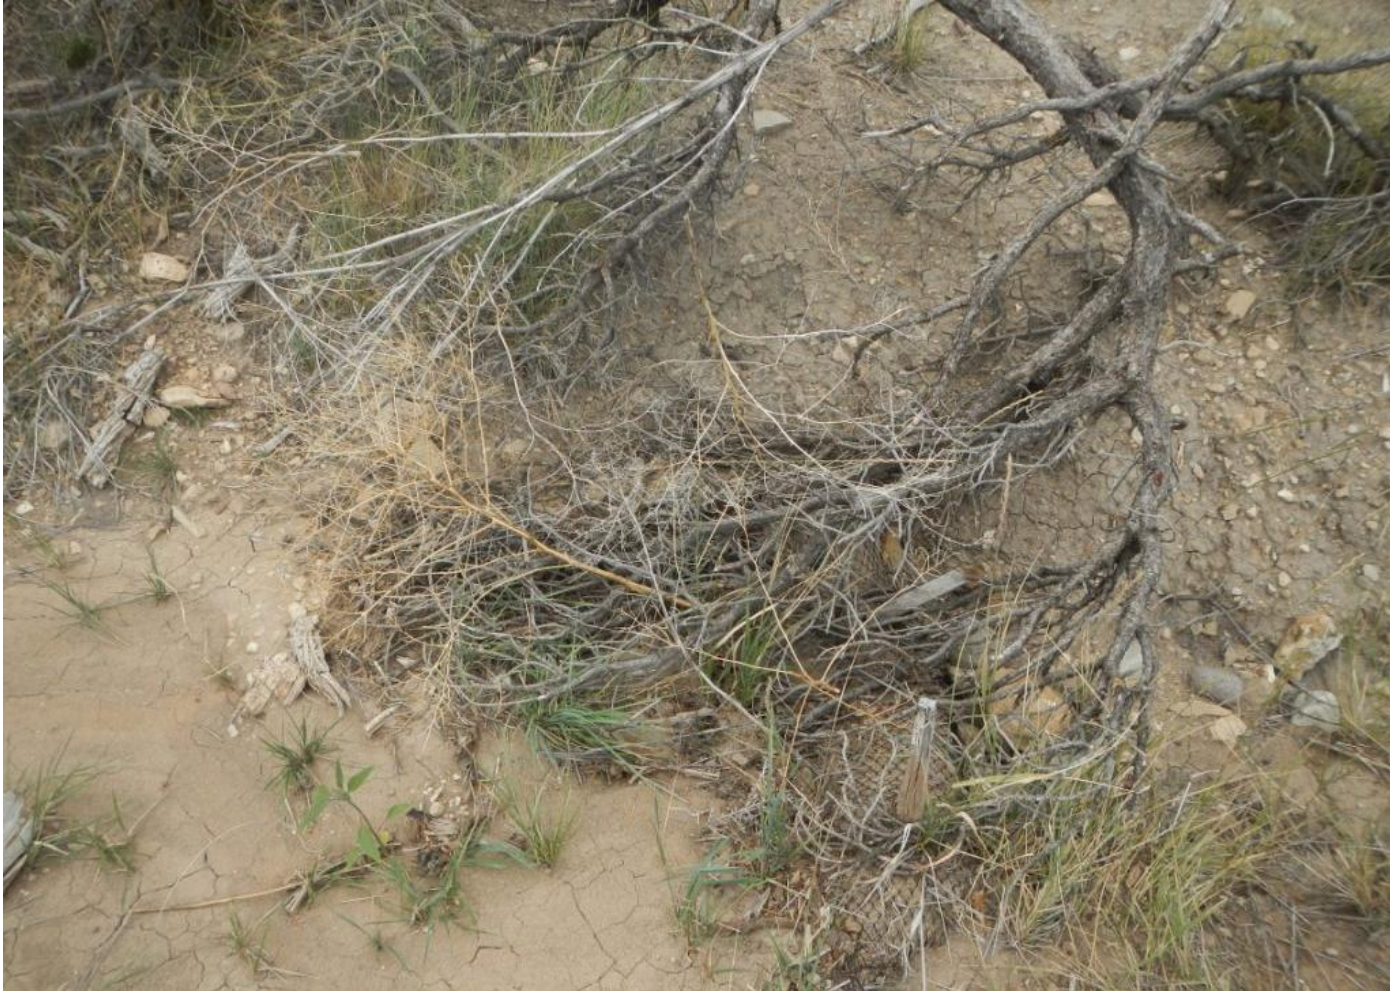
Photo 10. View of straw wattle on the southwestern edge of the project area that is filled with sediment.
