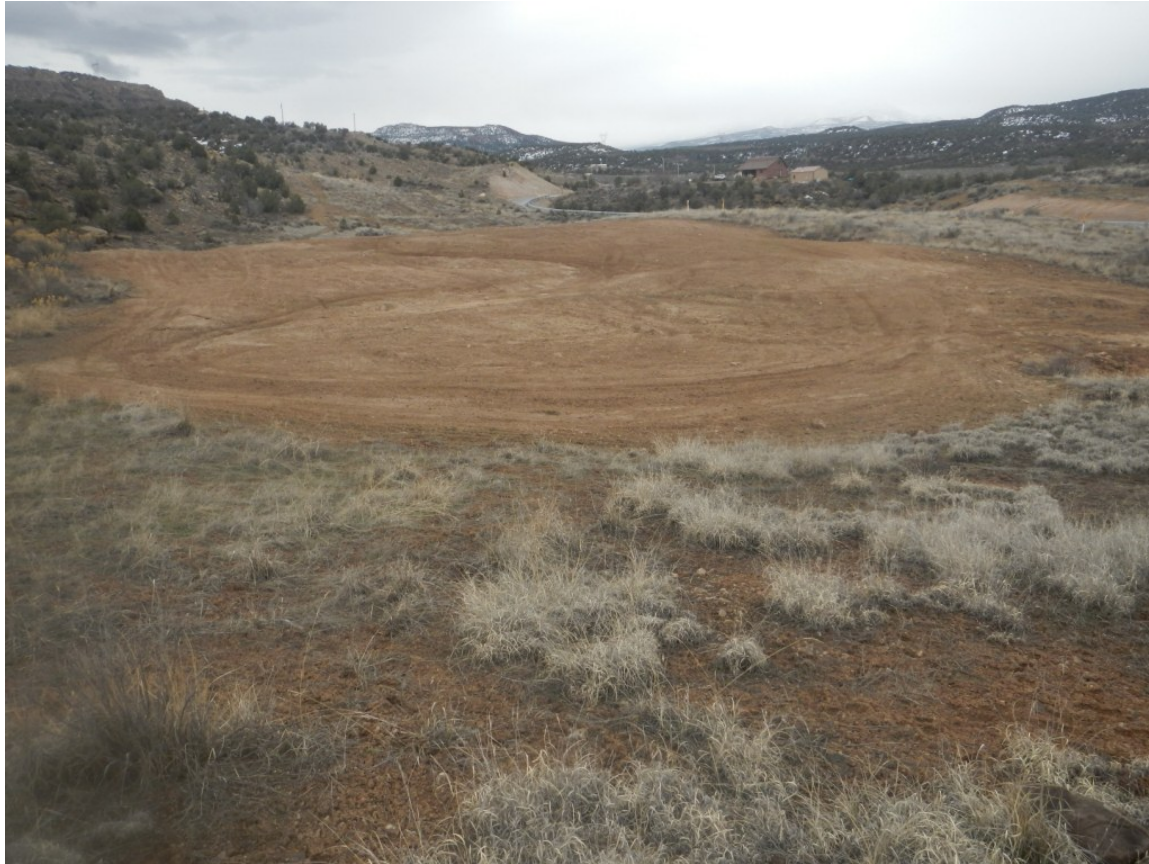
Photo#1: Overview of Location to South

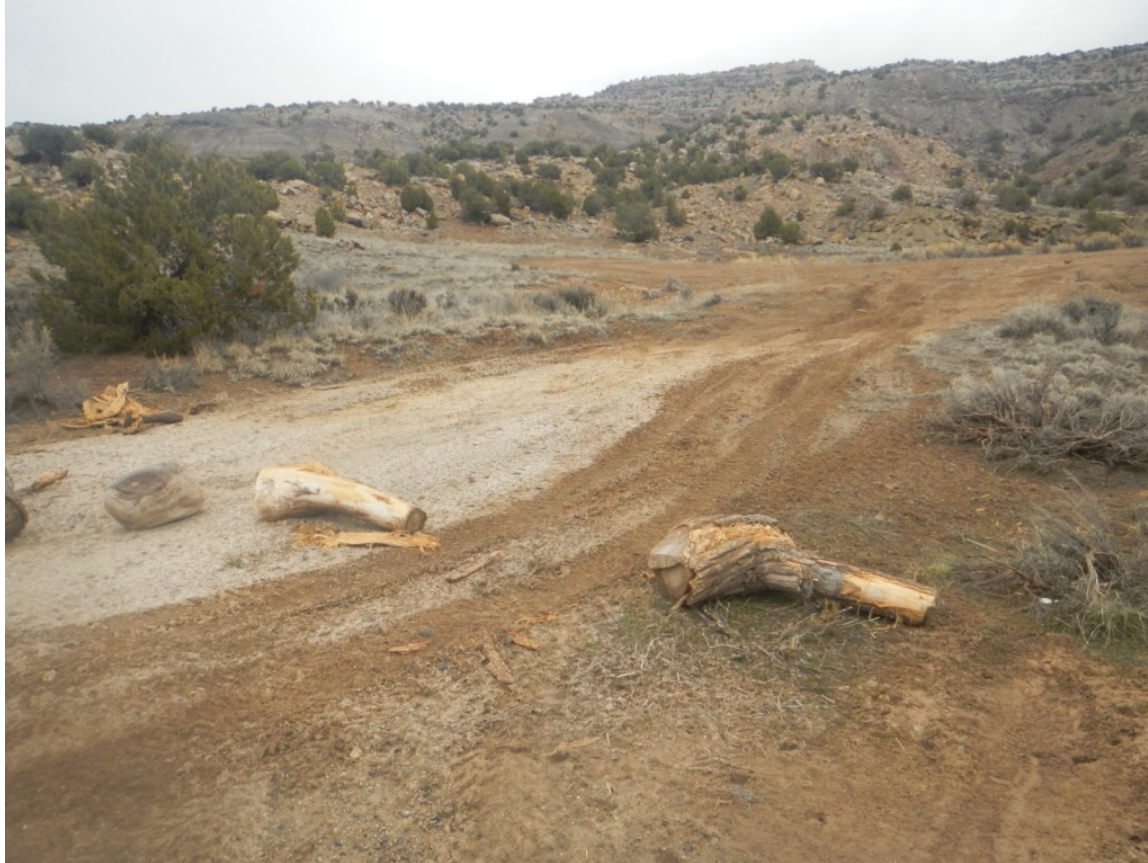
Photo#2: Location is Open to Traffic. Land Owner put Logs at entry and No Trespassing Sign in attempt to stop incursions.

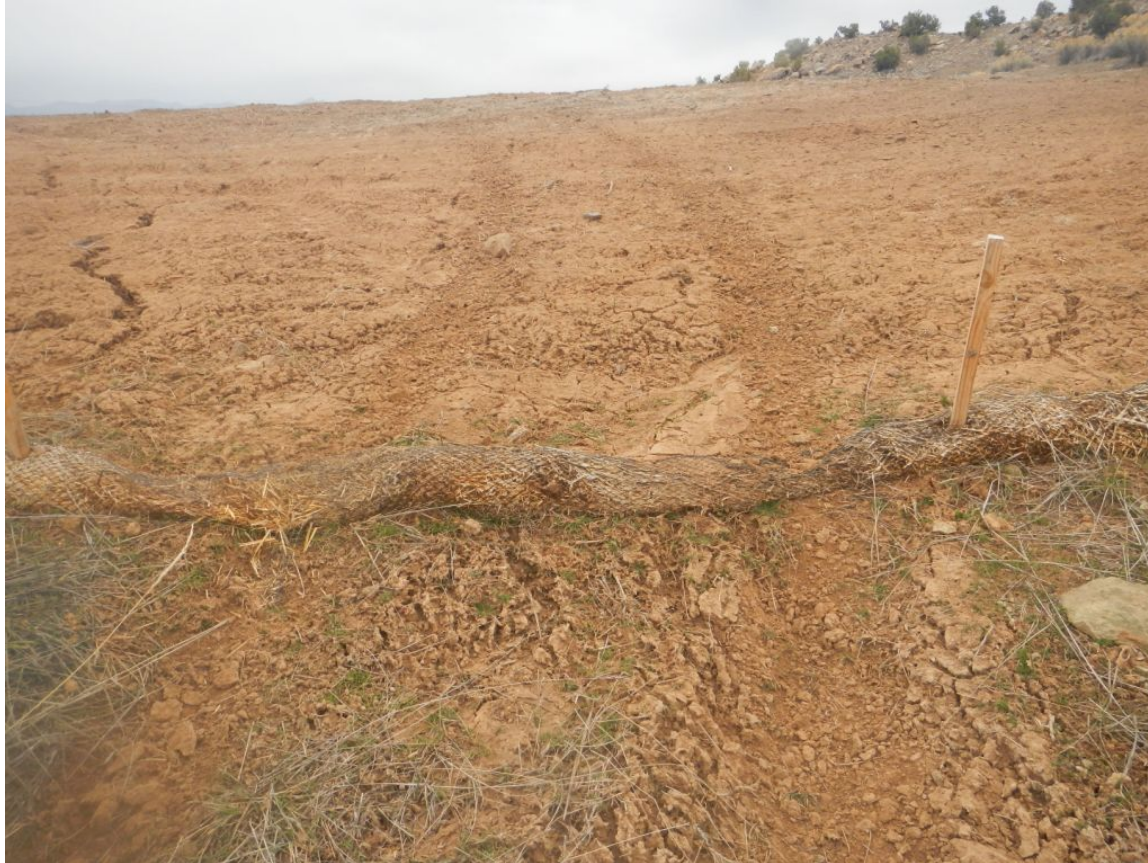
Photo#3: Evidence of ATV Traffic on Location.

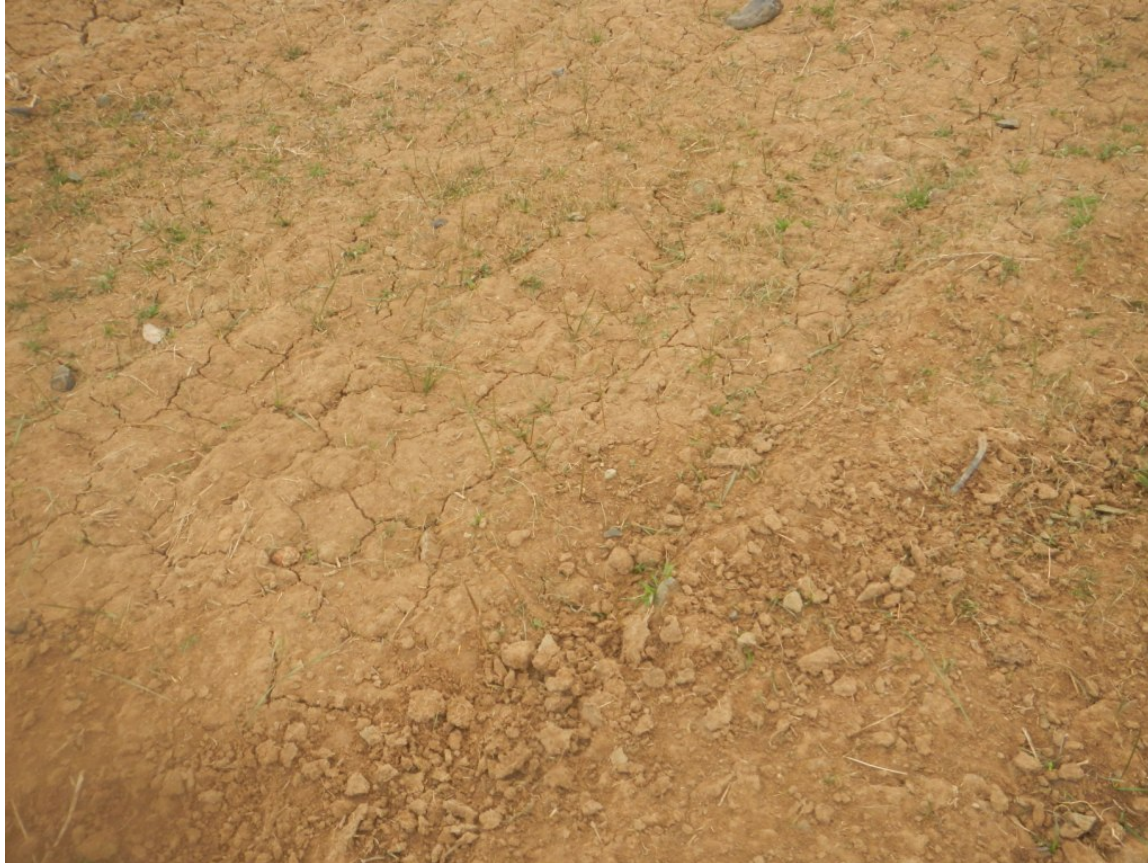
Photo#4: Vegetation is emerging.

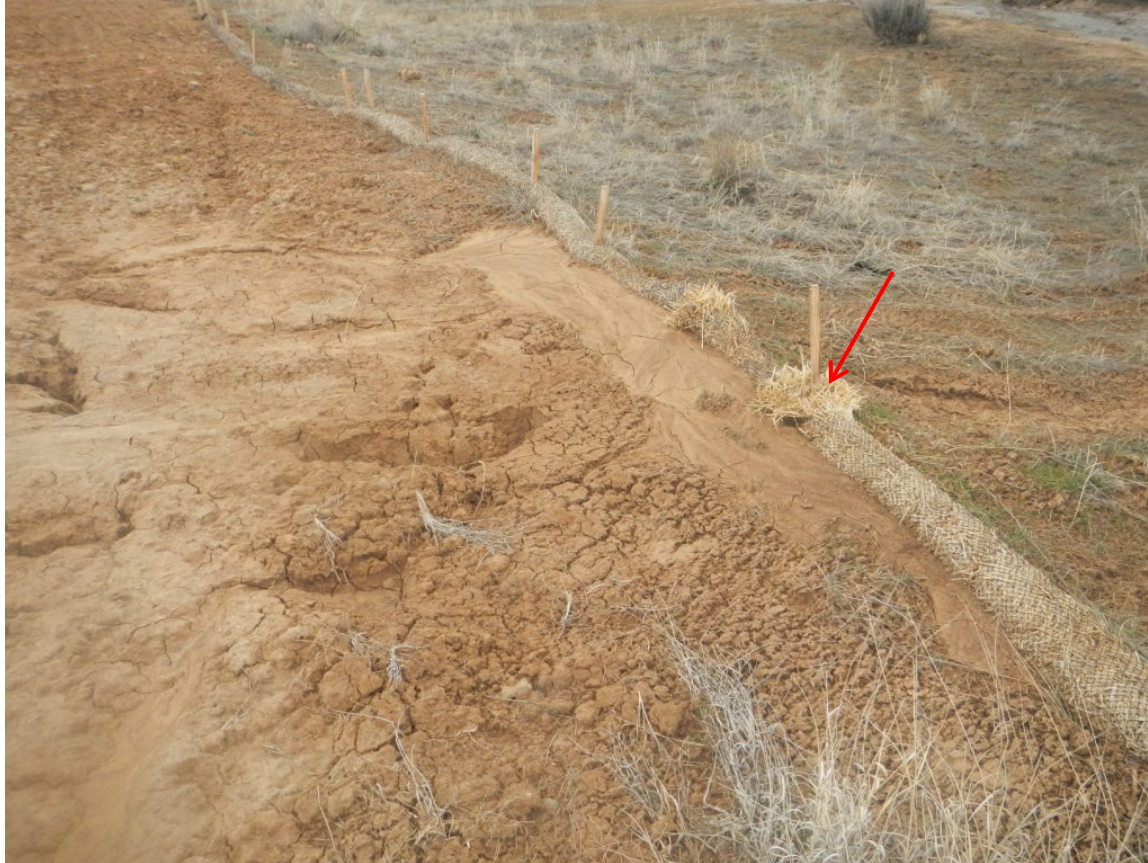
Photo#5: Wattles are being overwhelmed by excessive Runoff from Location; also more evidence of ATV damage to BMPs.

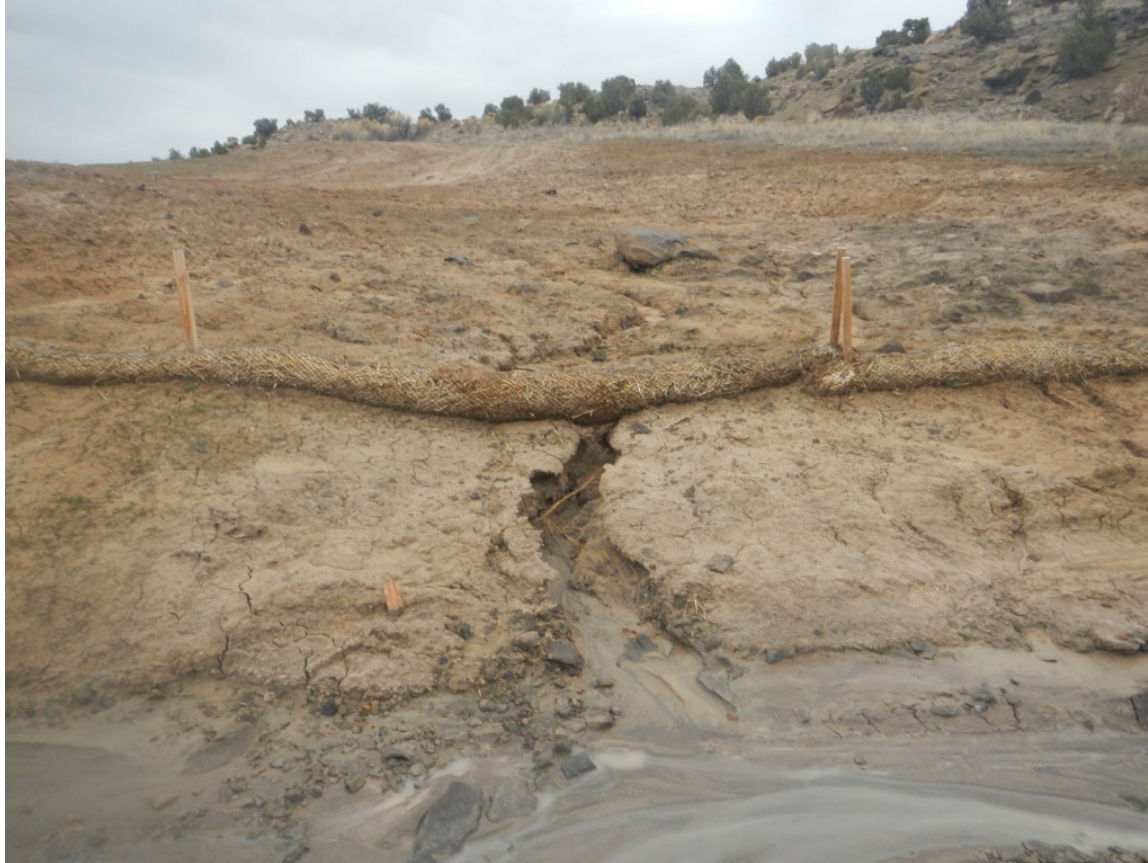
Photo#6: Stormwater undercutting Wattles at South end of Location.

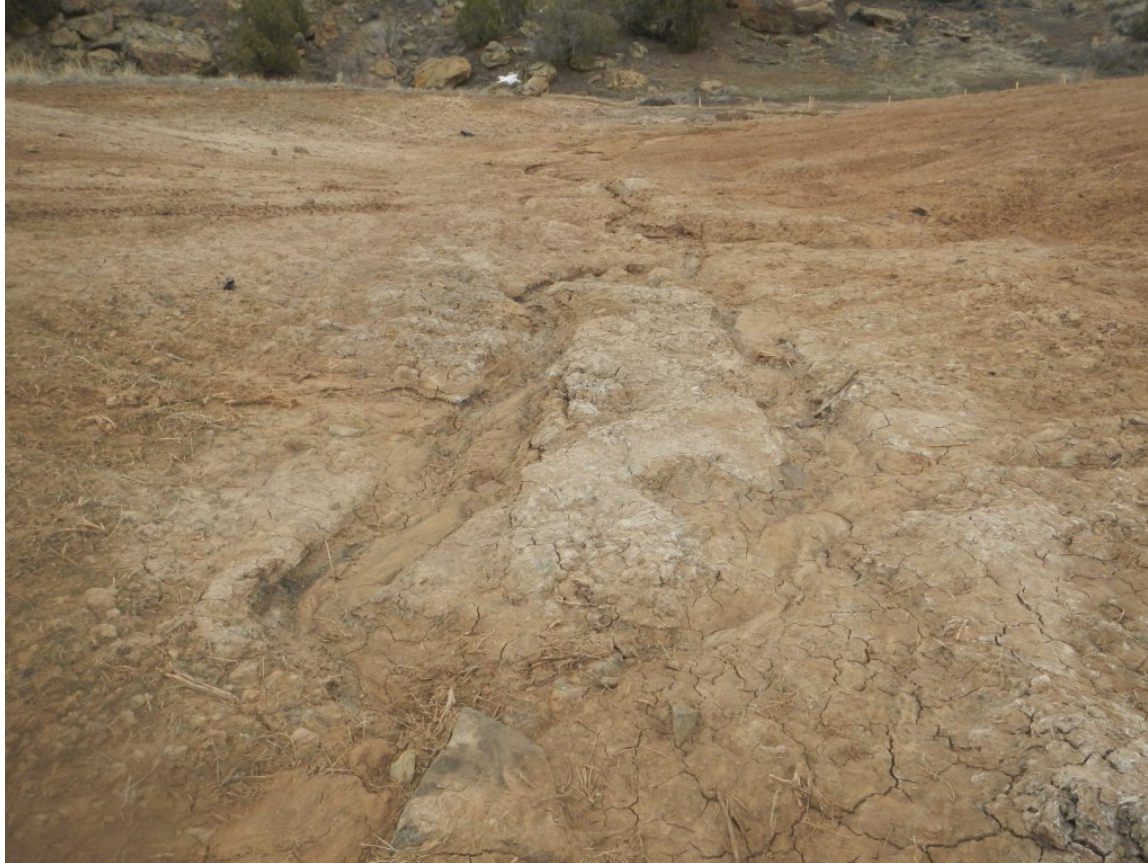
Photo#7: Revegetating areas and drainage swales need stabilizing BMPs installed until vegetation is established.

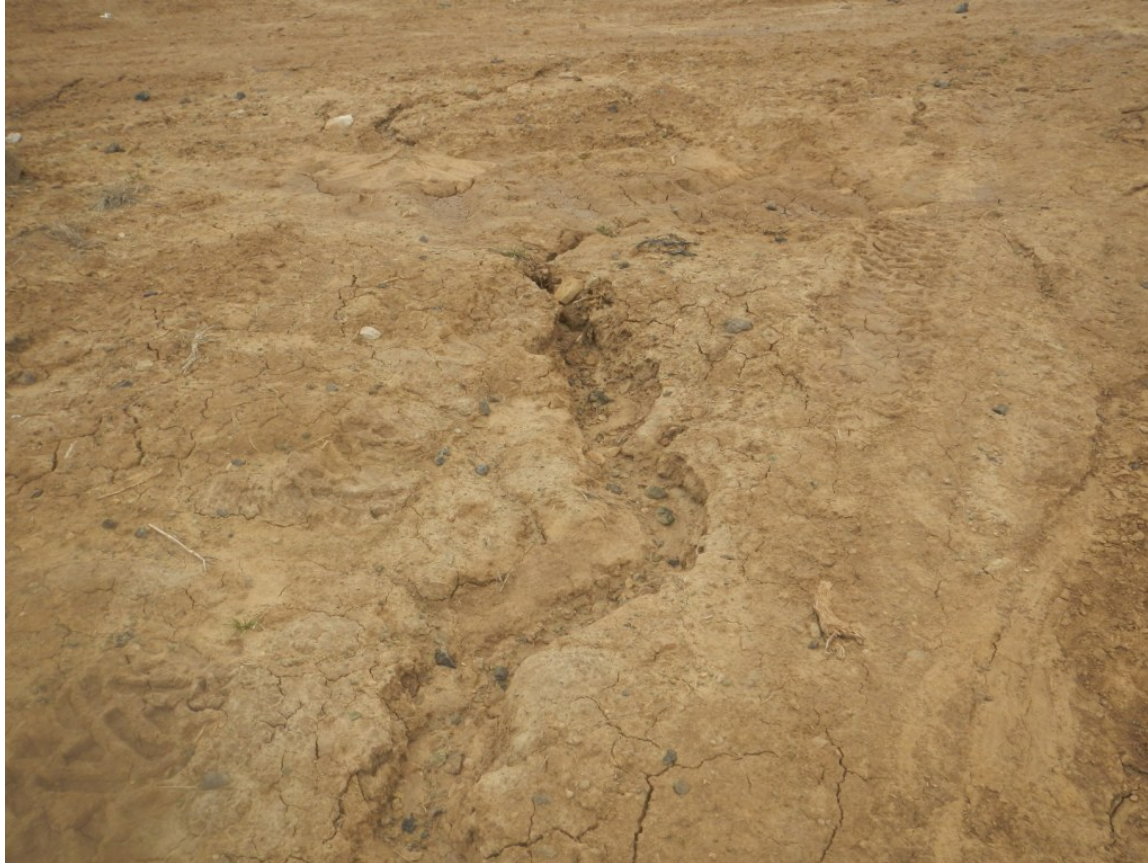
Photo#8: Erosion, channeling, flowing from center of Location to West.
