On September 2, 2016 COGCC Environmental Field Inspection of DIVERSIFIED ENERGY LLC
(Diversified) Bingham Location ID: 313094.

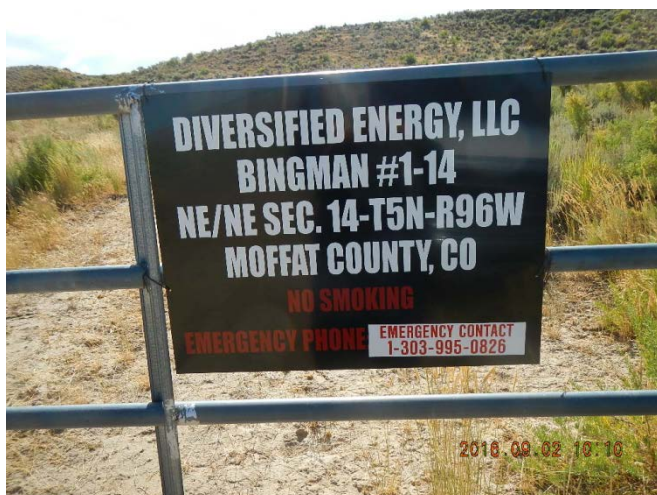
Location sign.

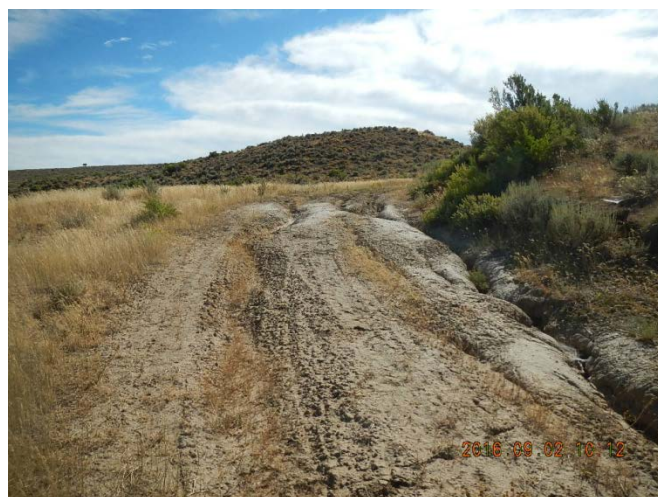
View walking up lease road.

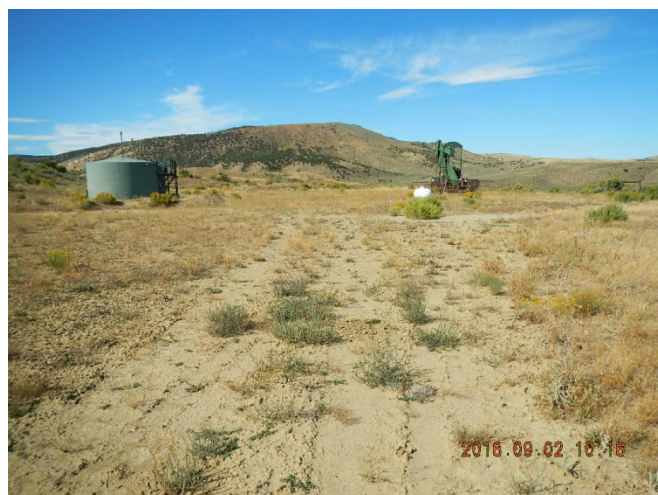
Looking west across Location.

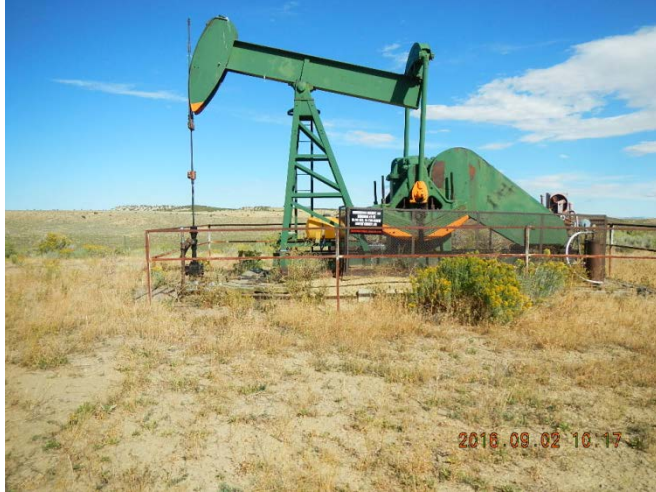
Bingham 1-14 well.

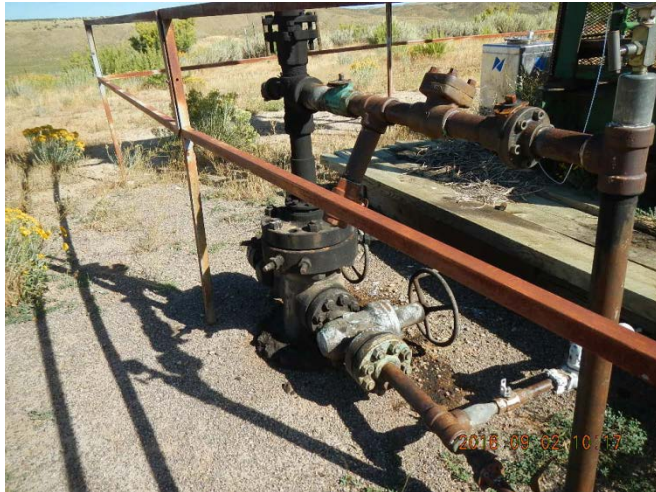
Oil staining on soil around well head.

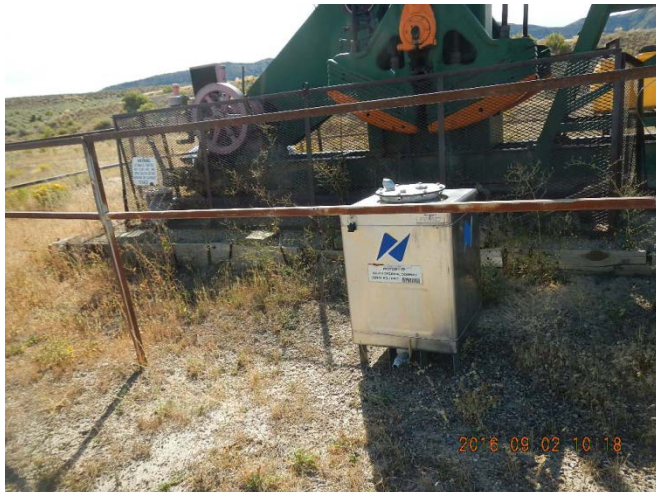
Stainless steel chemical container.

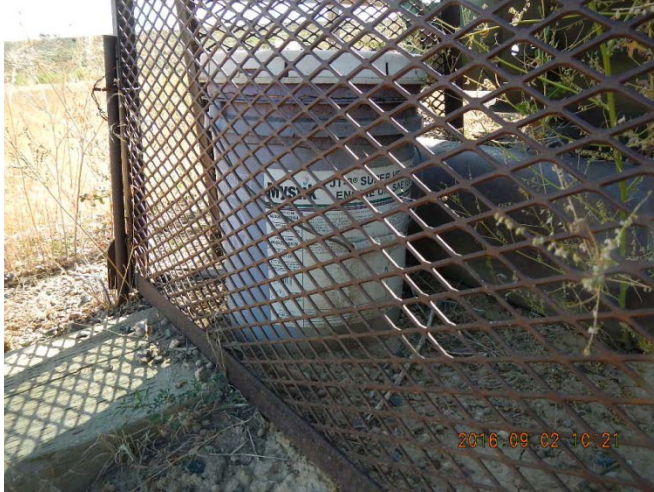
5-gal container at well head.

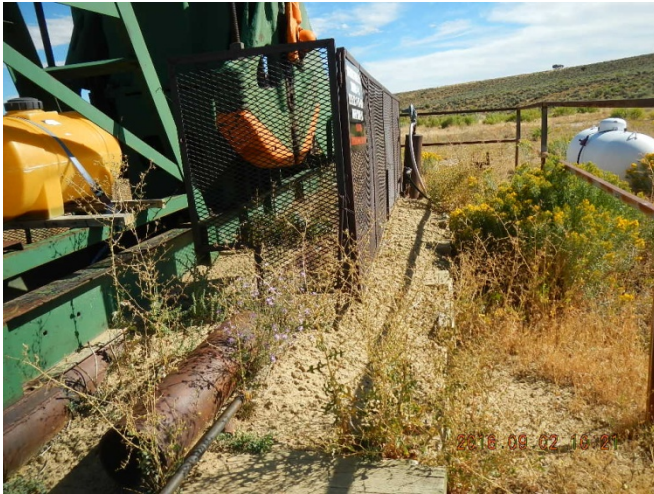
Vegetation (weeds).

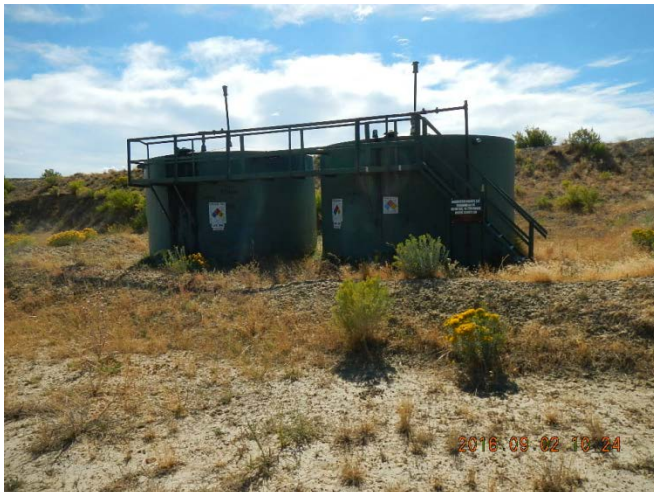
Tank battery, berm vegetation (weeds)..

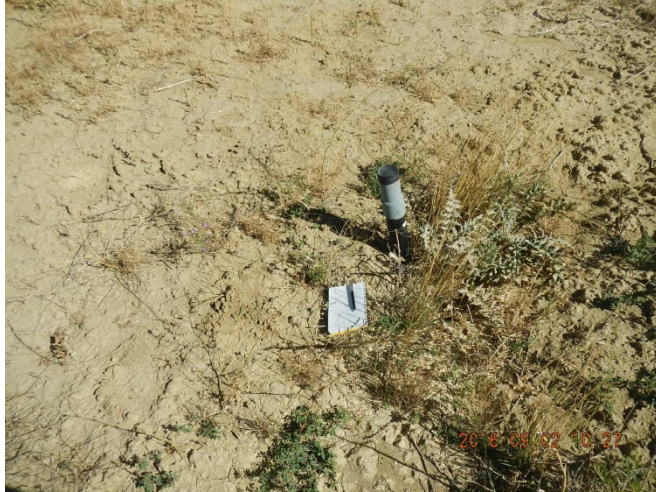
Black poly riser south side of tank battery.

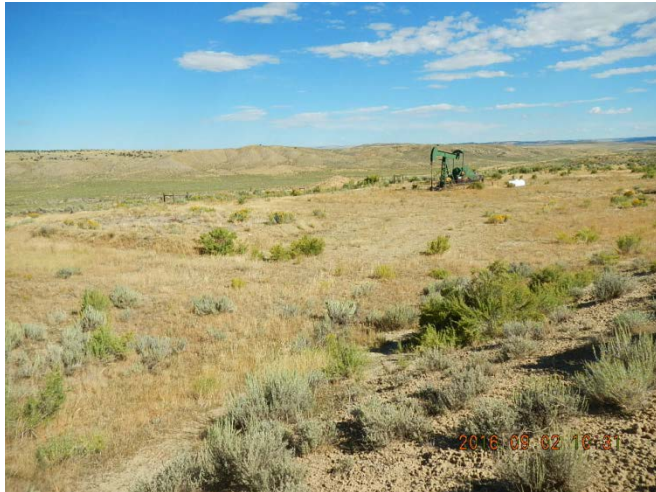
Land treatment area.

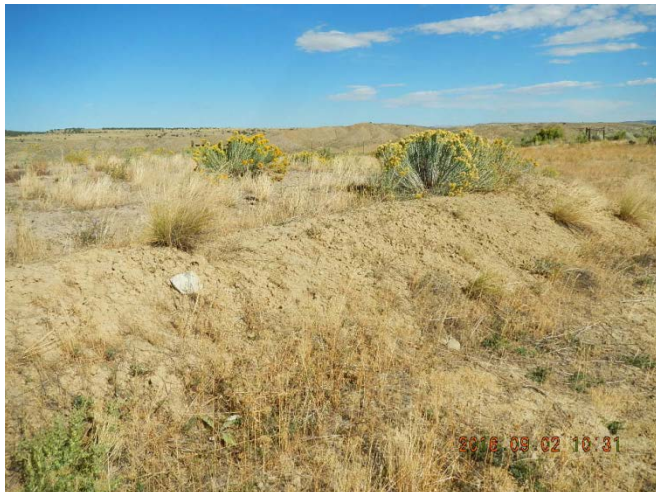
Land treatment area.

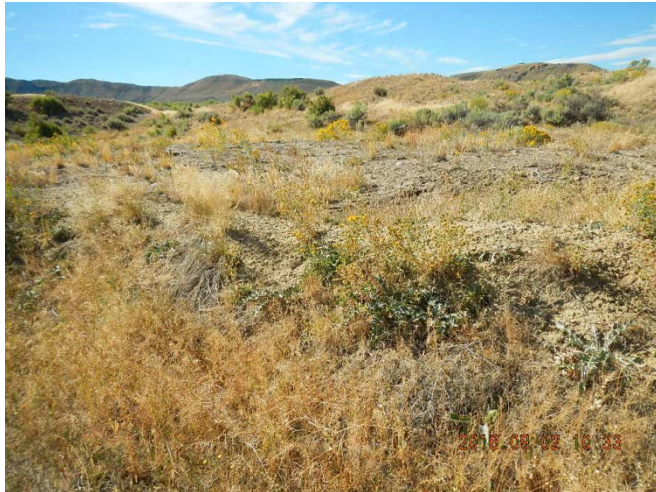
Land treatment area.

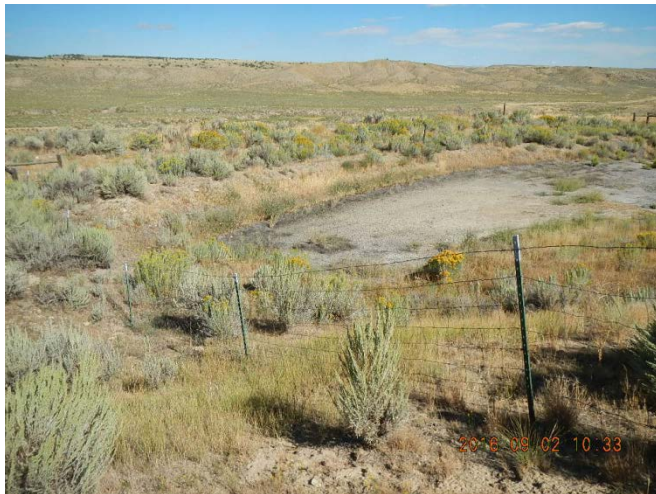
Pit Facility 285519.

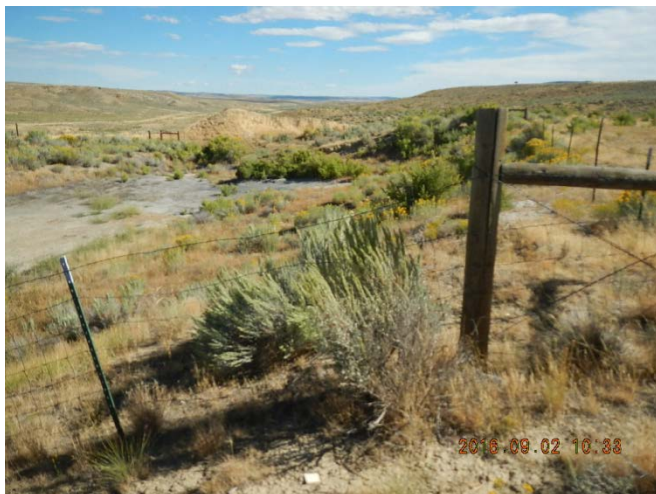
Pit Facility 285519.

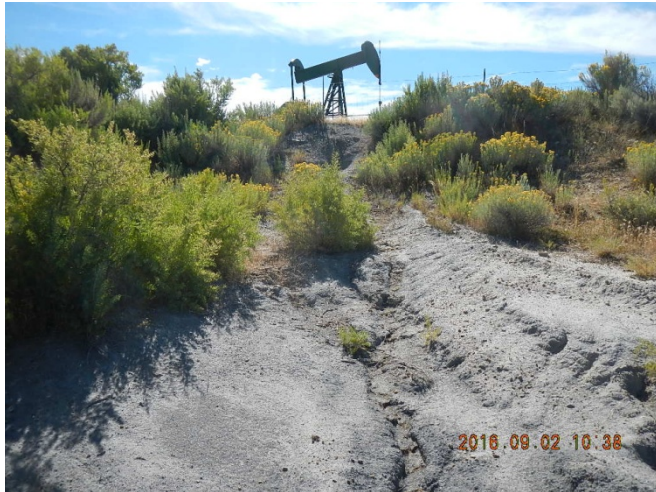
Surface flow to Pit Facility 285519.

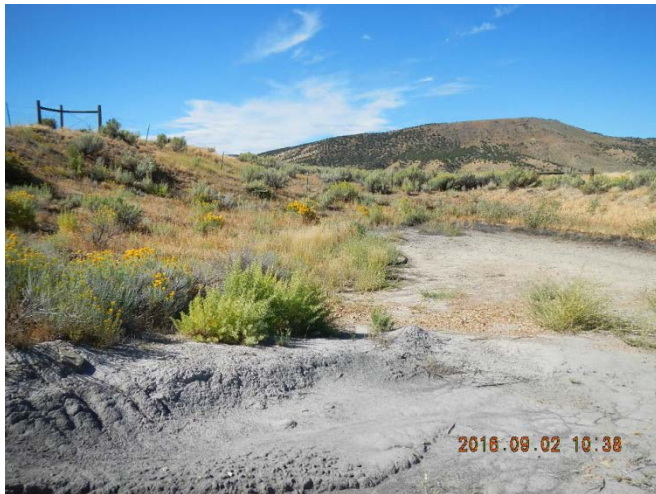
Surface flow into Pit Facility 285519. Note black poly pipe in center of photo.

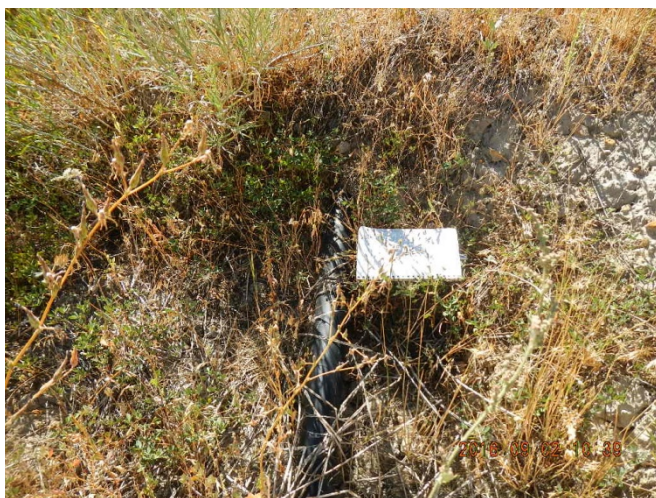
Black poly pipe protruding from pit wall.

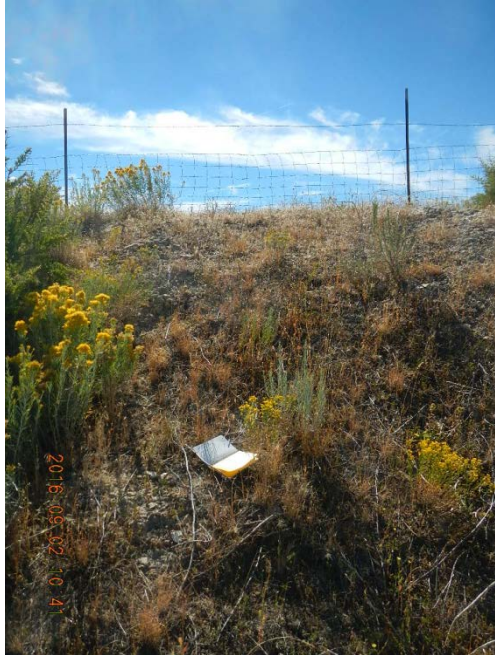
Area of surface disturbance and mended fence along (black poly pipe).

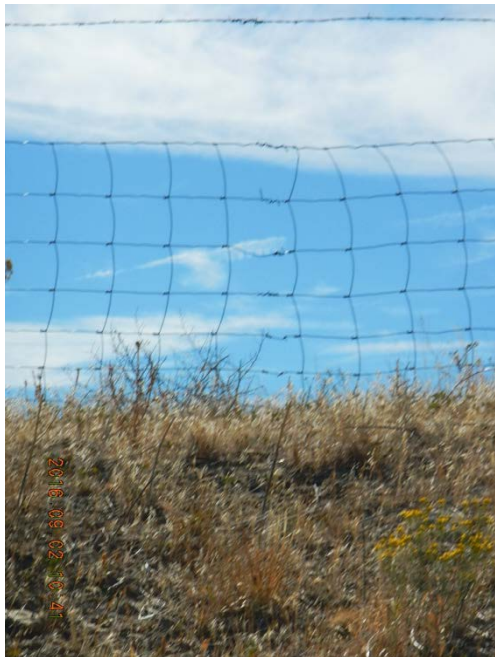
Mended fence.

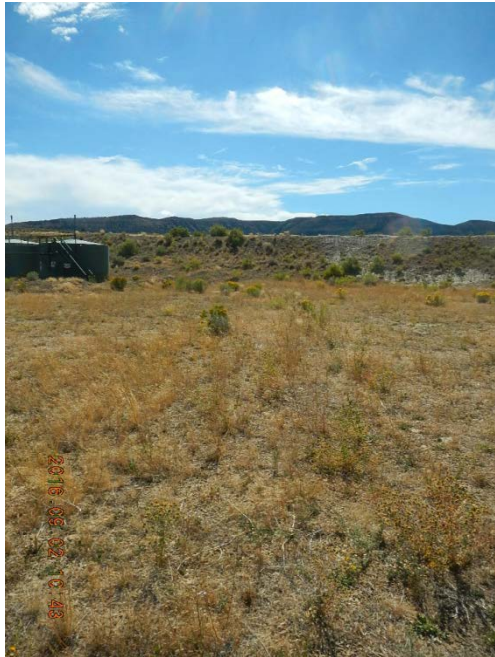
Raised disturbed area from Pit Facility to tank battery.

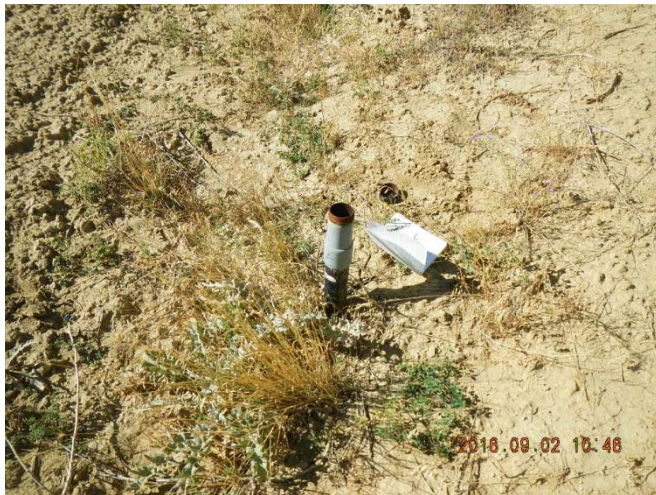
Riser on south side of the tank battery.
