Robidoux 13-7

Inspection# 673403652

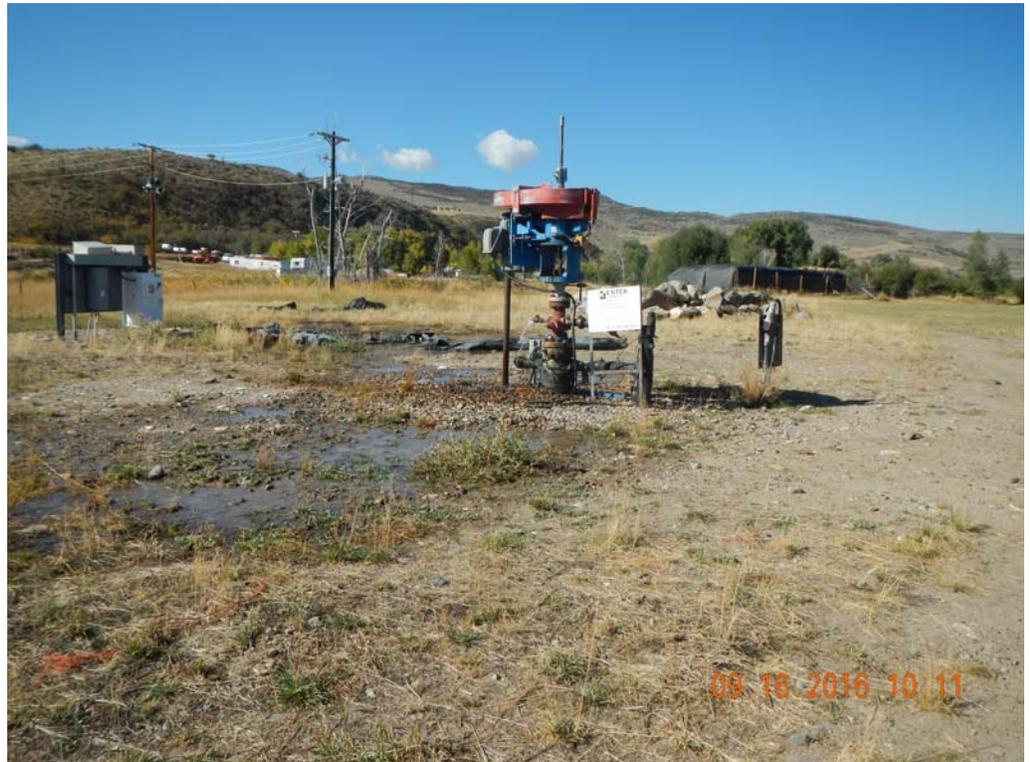
Well free flowing from tubing valve on left at time of arrival on location.

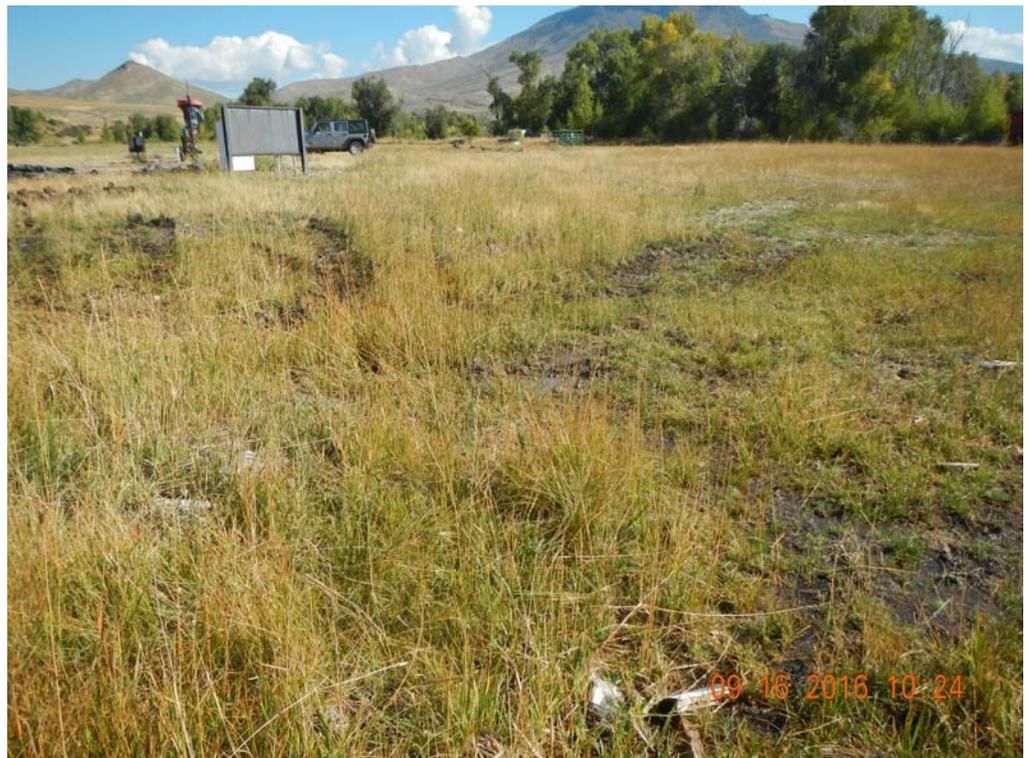
Spill pathway looking north towards wellhead.

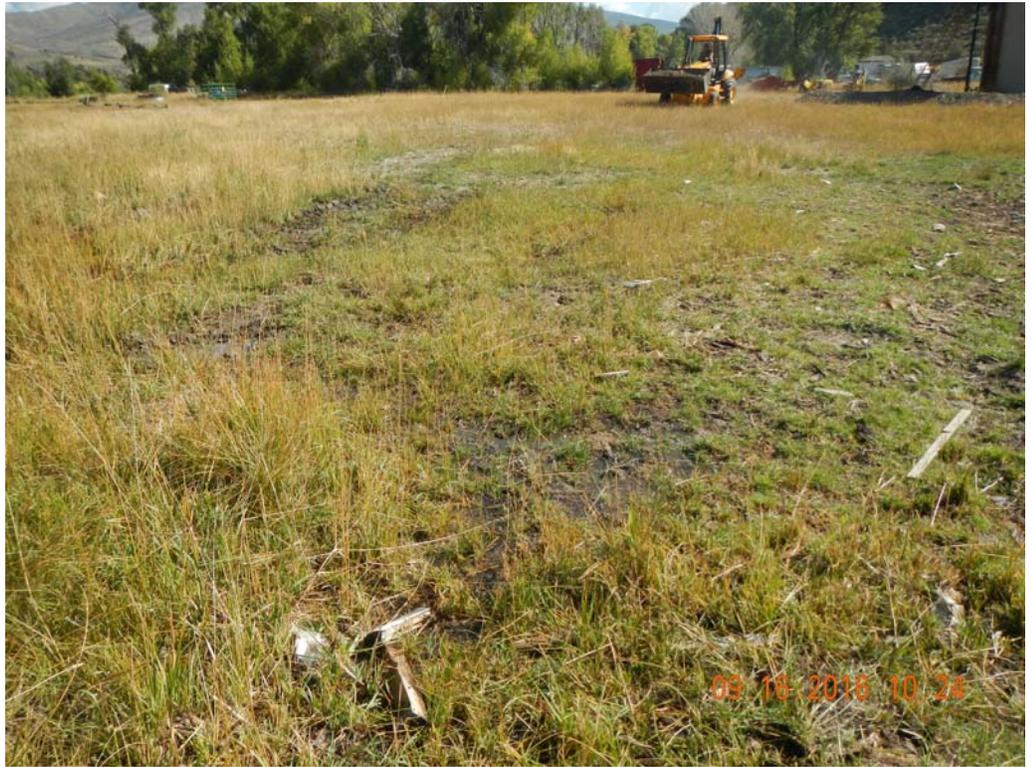
End of spill pathway.

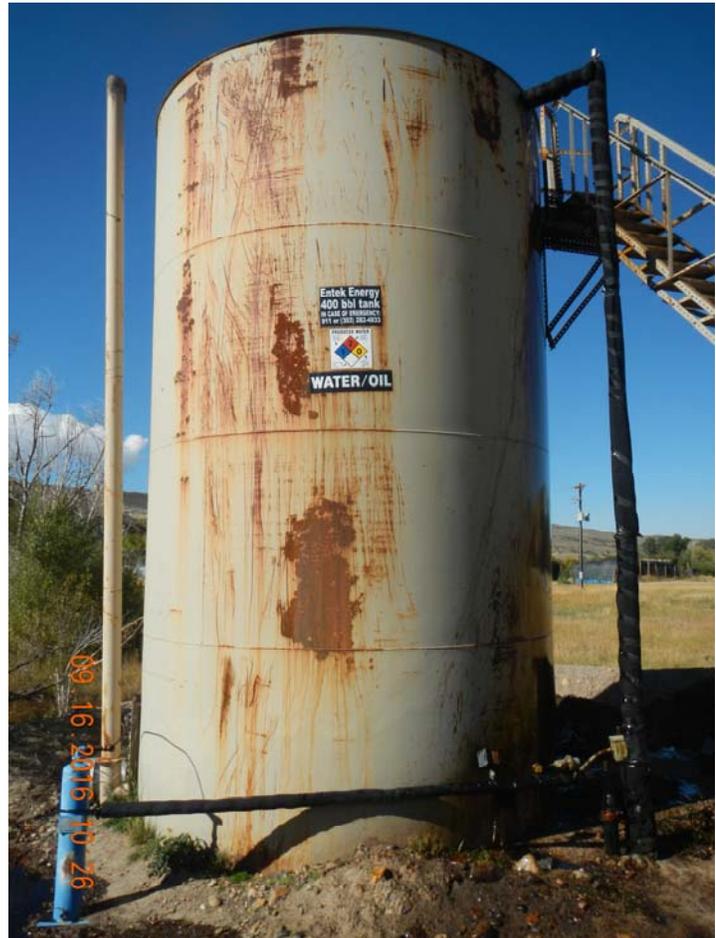
Tank label (NFPA diamonds) incomplete.

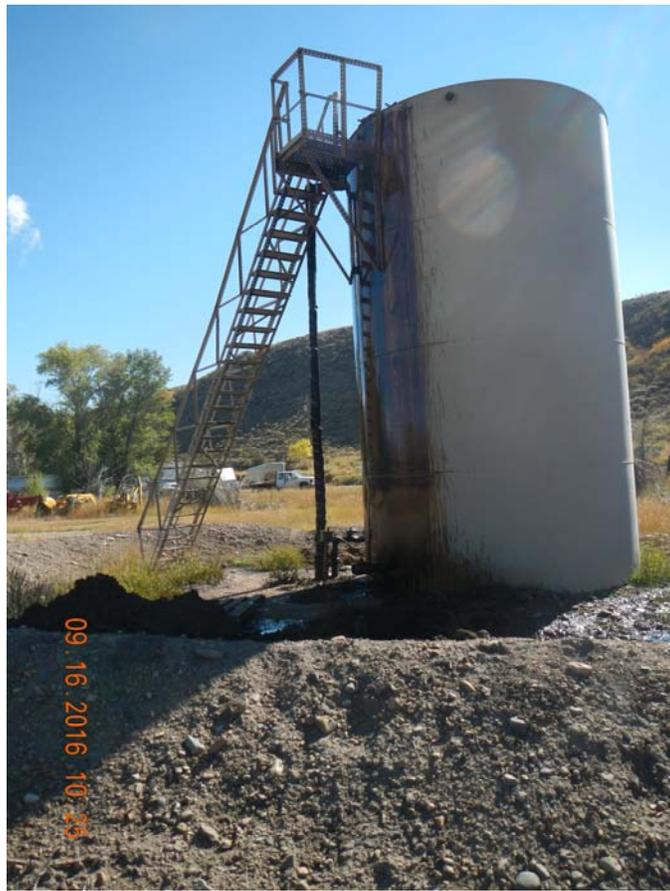
Overflow path.

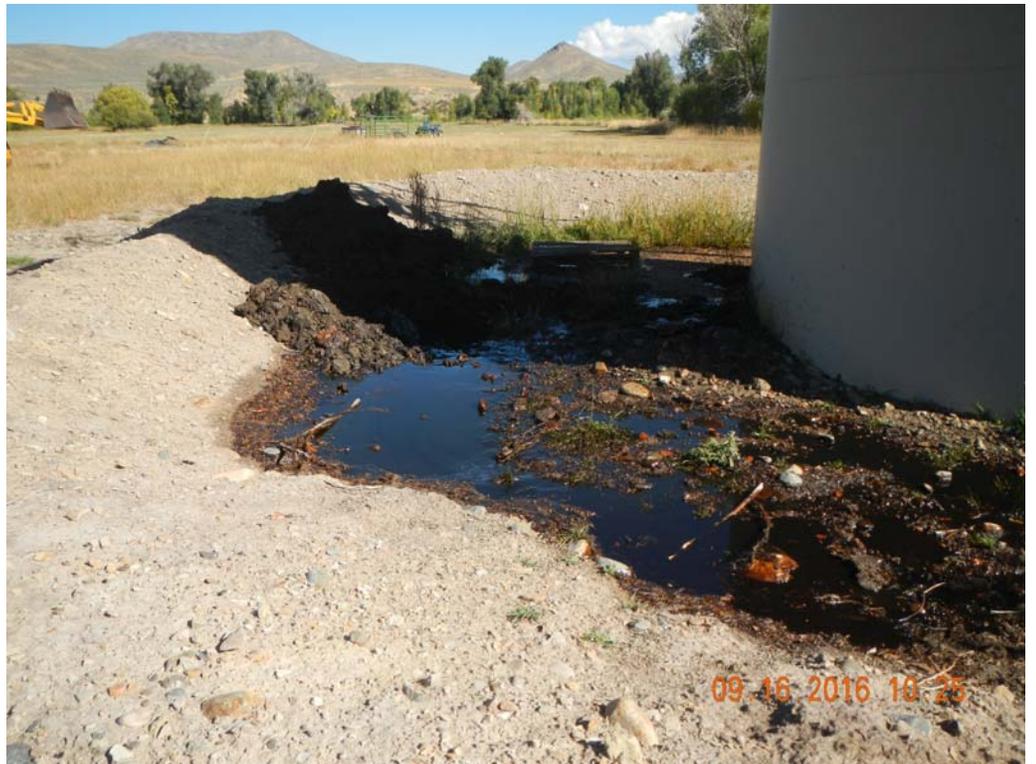
Spill contained in berm.

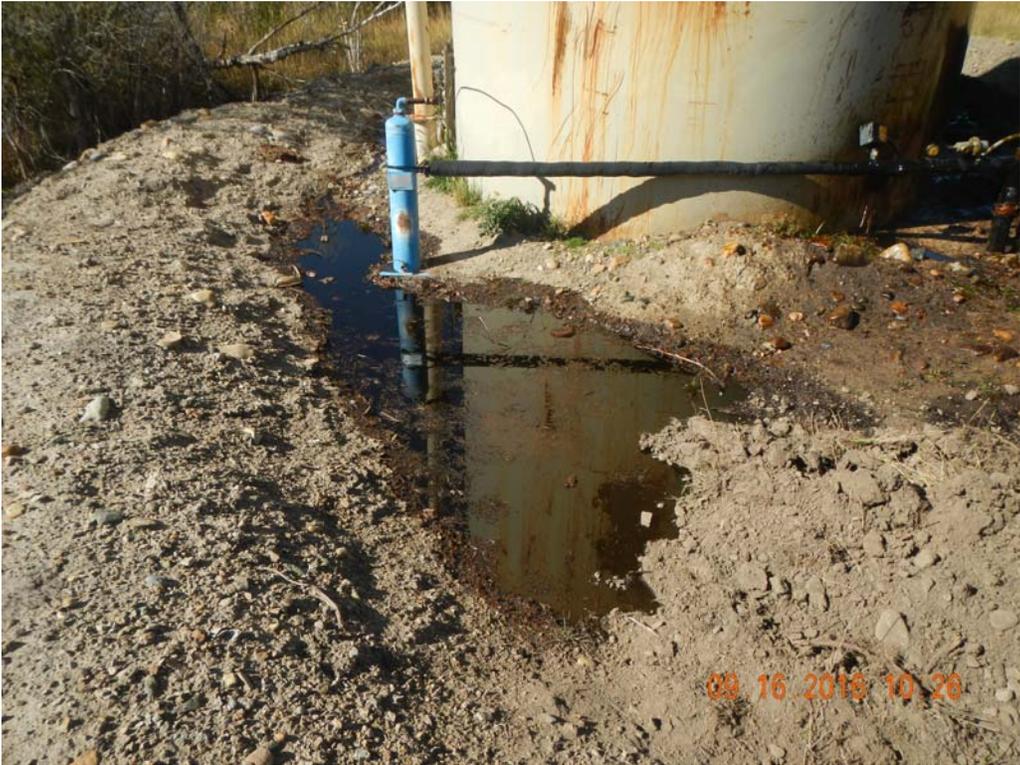
Spill contained in berm.

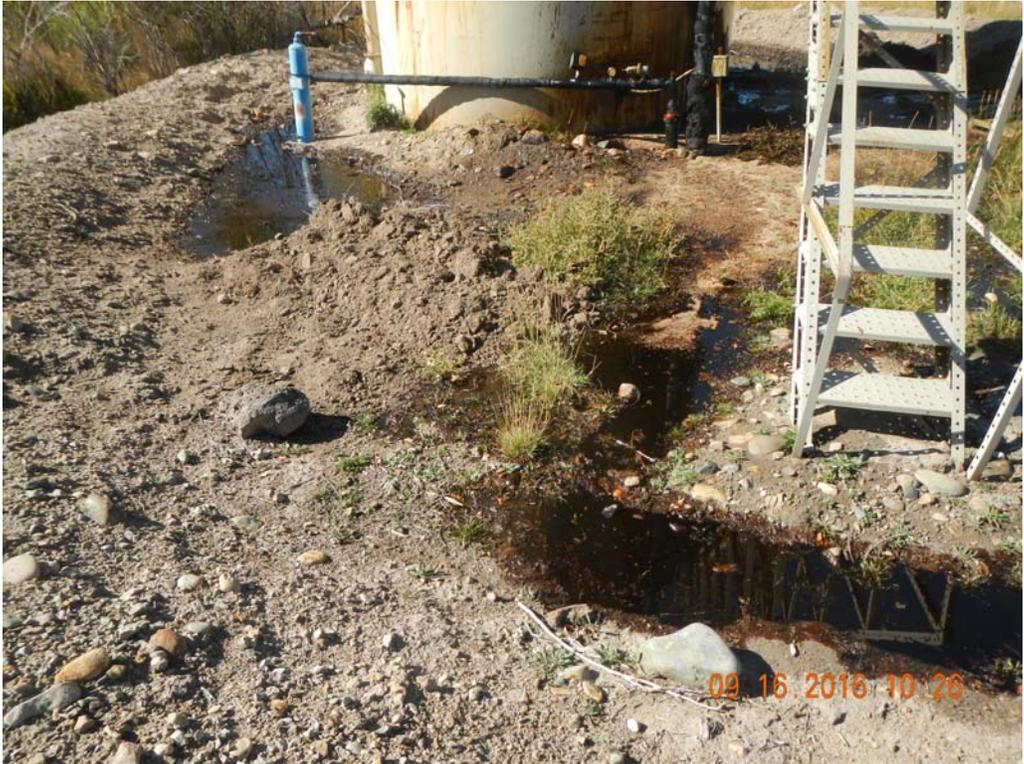
Spill contained in berm.

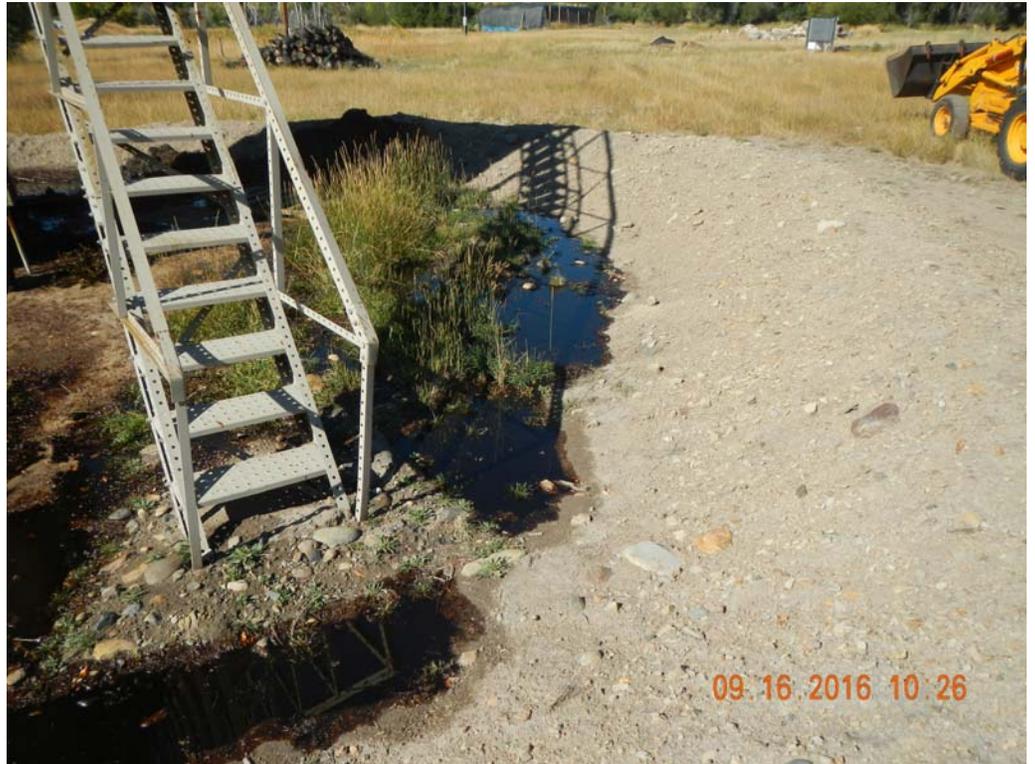
Spill contained in berm.

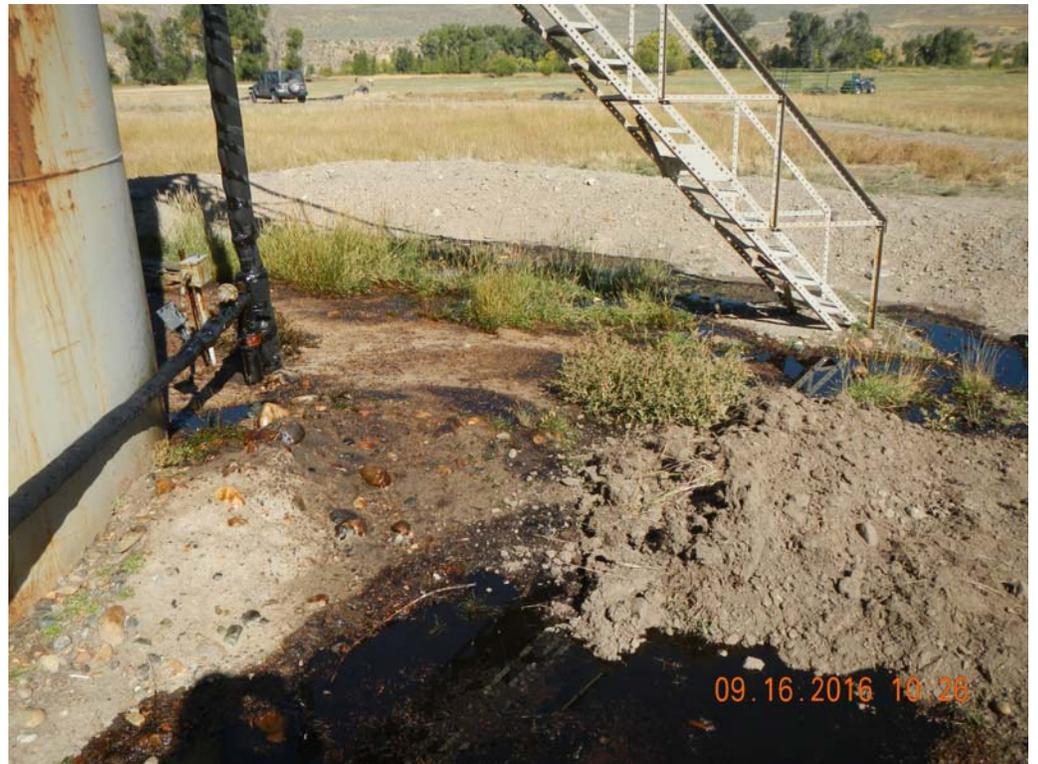
Material added to spill, in berm.

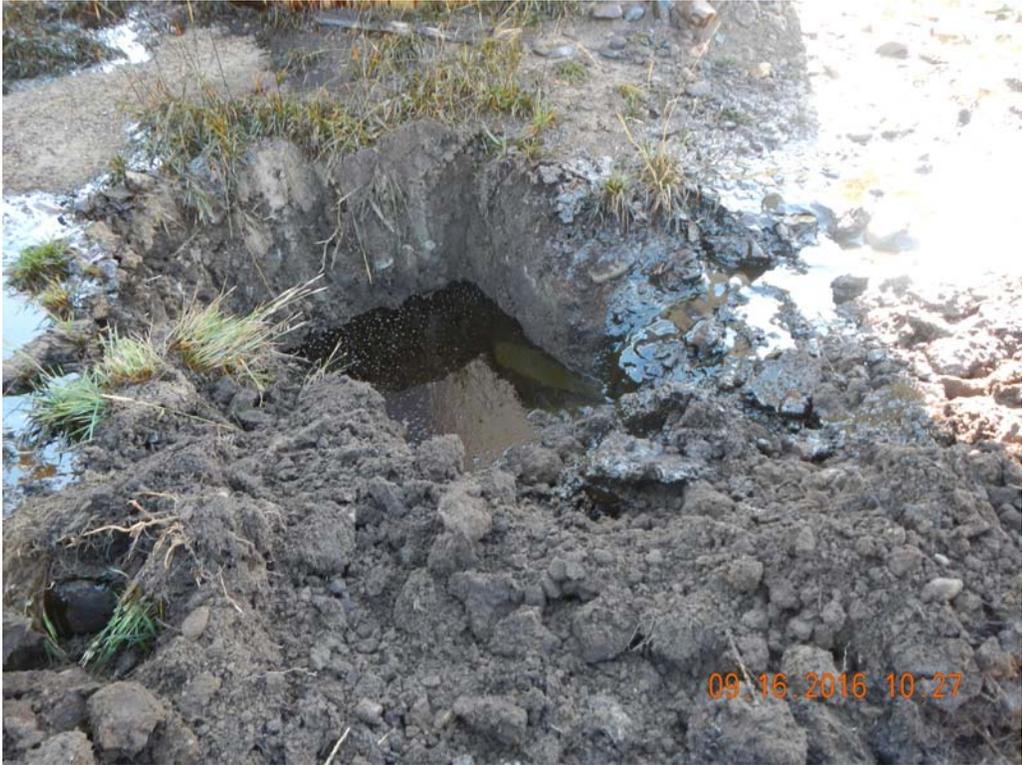
Surface disturbance, in berm.
