Bayswater Exploration & Production
(Operator # 10261) Cockroft Farms
Land Application Site (COGCC Facility
ID 441086)
COGCC Site Inspection – 9/21/2016

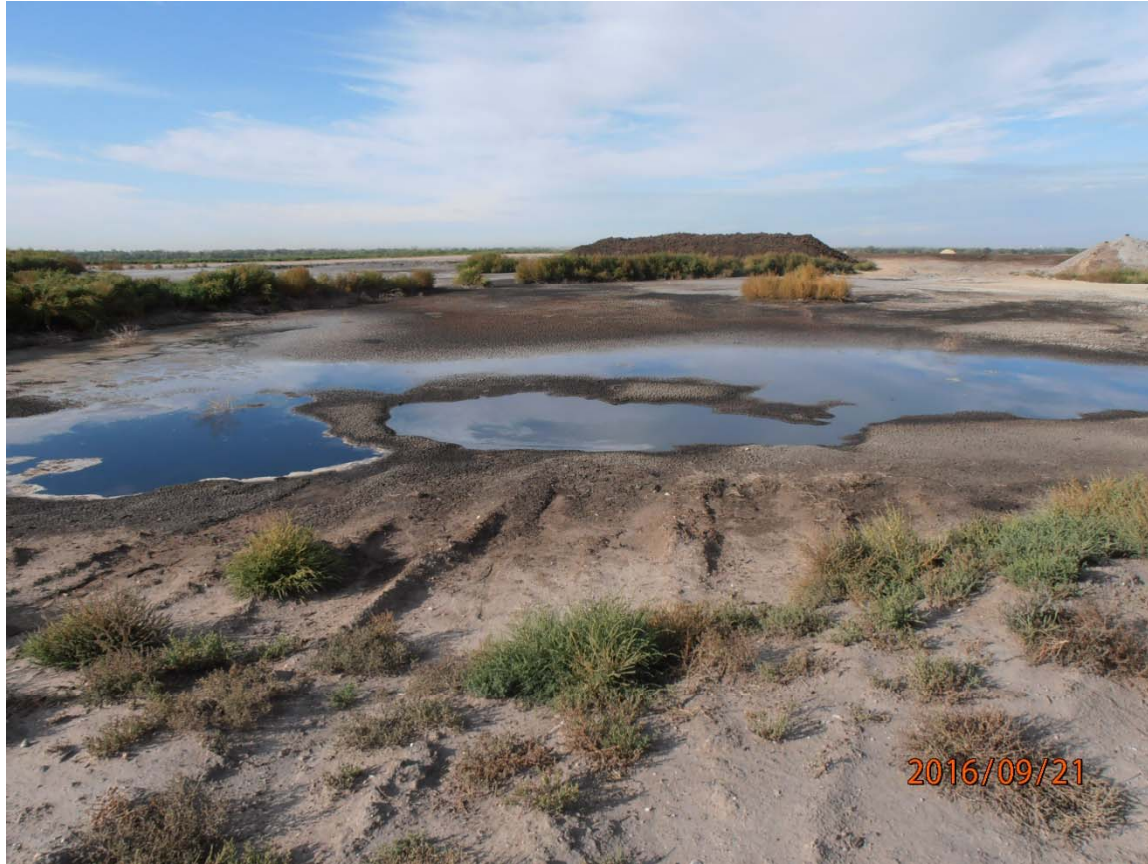
Photo 1 taken in Section A, looking west (40.395985 / -104.471801)

Area where fluids were removed, current fluid appears to be stormwater and/or irrigation runoff

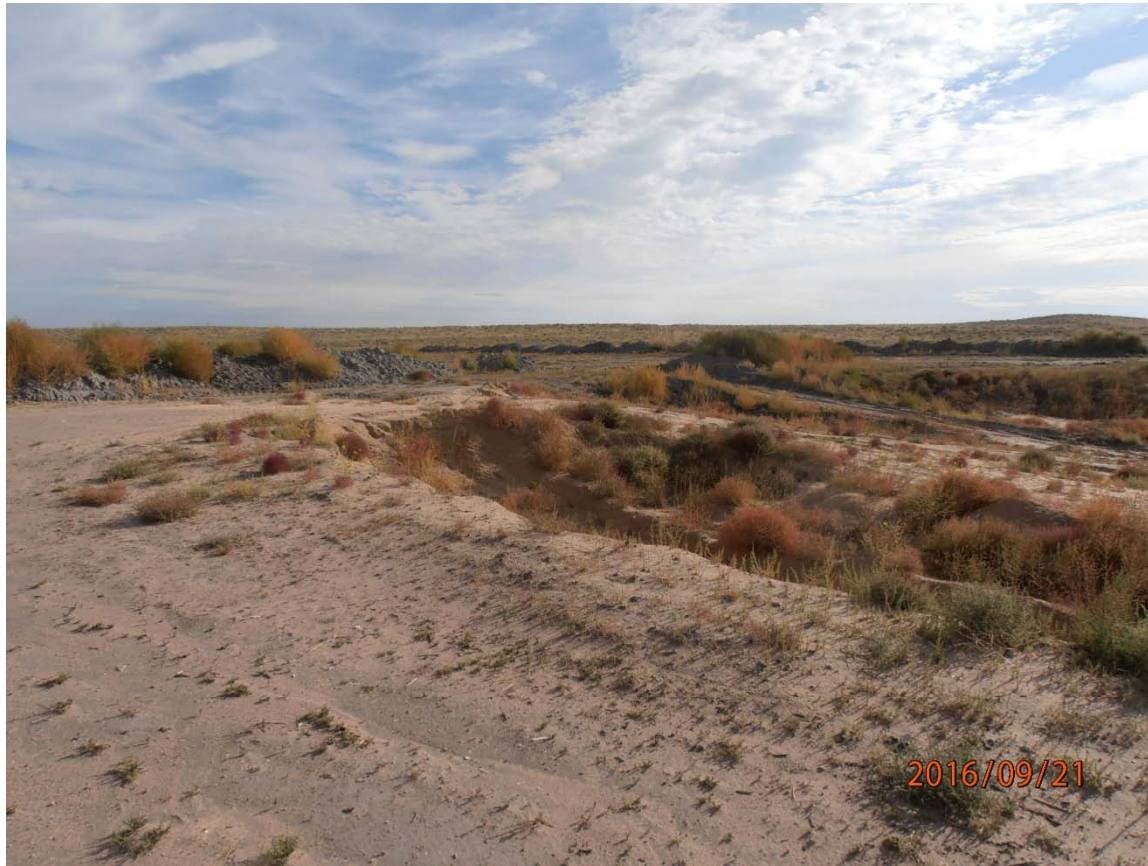
**Photo 2 taken in northeast corner Section A looking northeast
(40.395267 / -104.470958)**

Stockpiled drill cuttings in Section A.

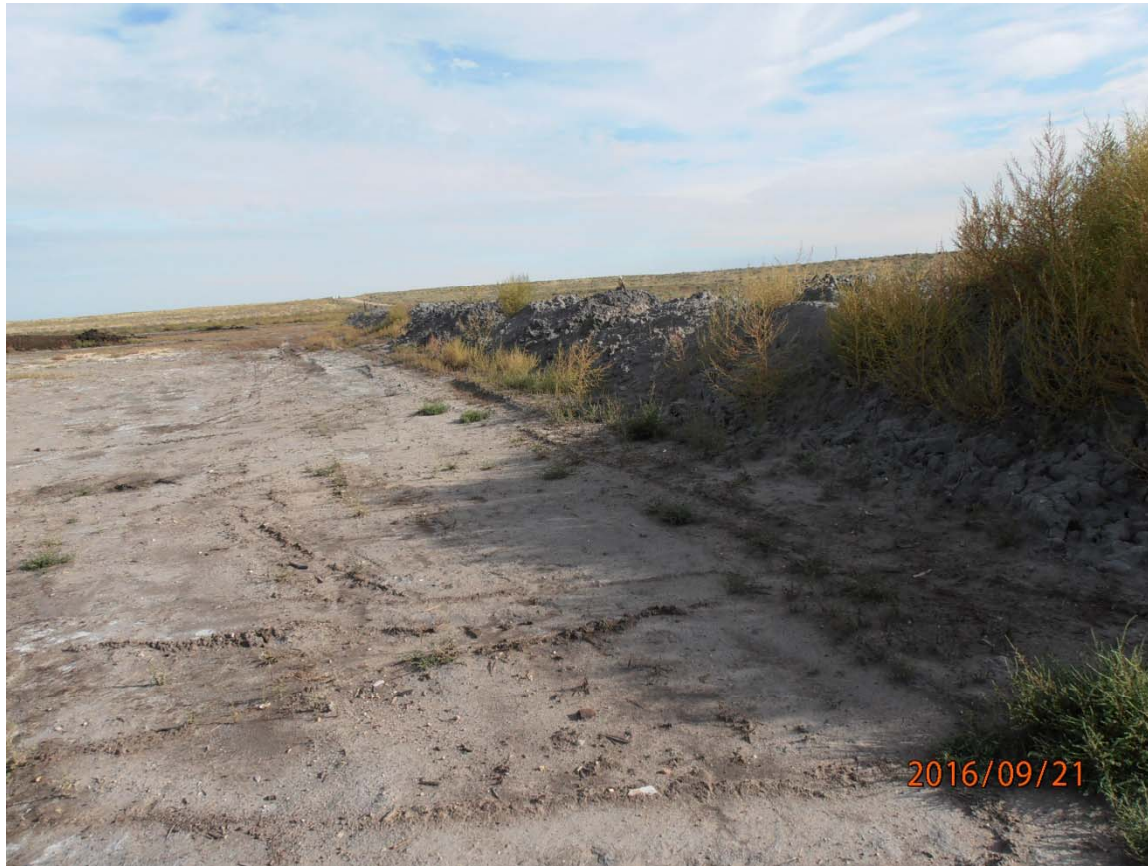
Photo 3 on east end of Section A looking north (40.395037 / - 104.470281)

Stockpiled drill cuttings

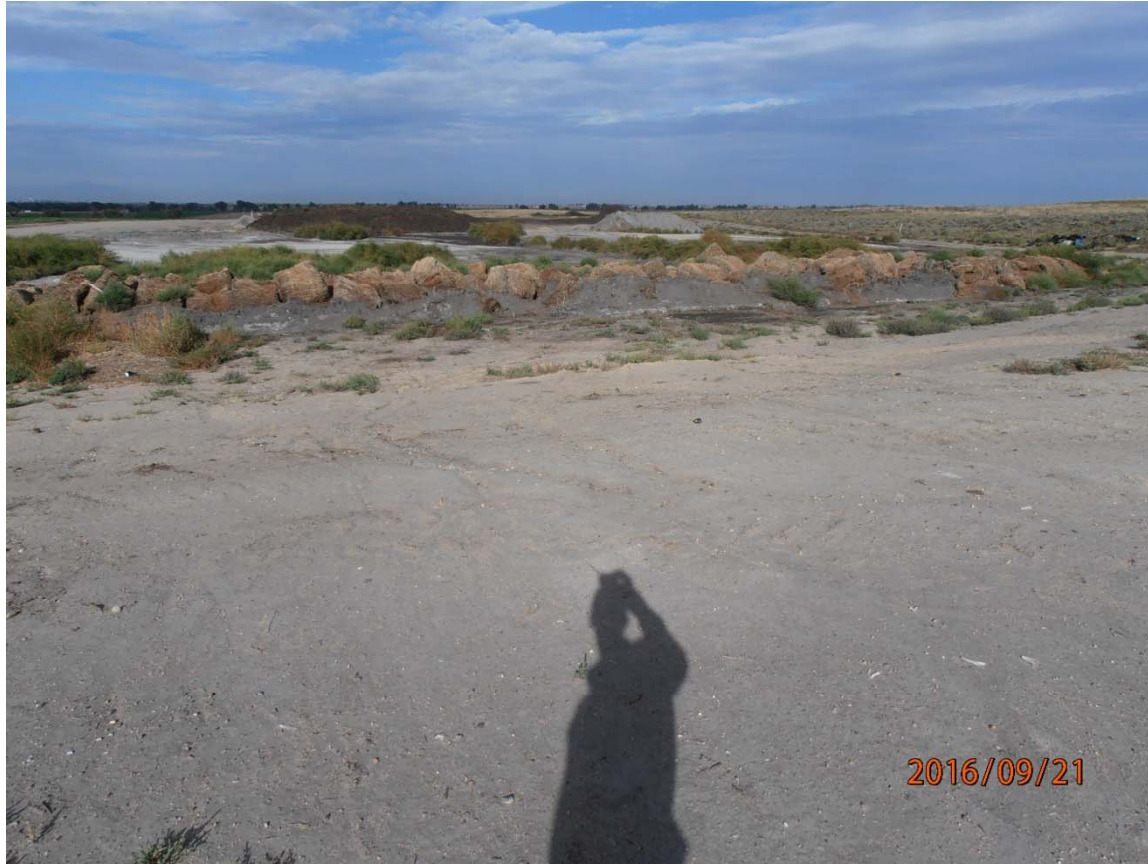
Photo 4: Cuttings intermixed with straw bales and manure piles in distance, looking west (40.395496 / -104.471381)

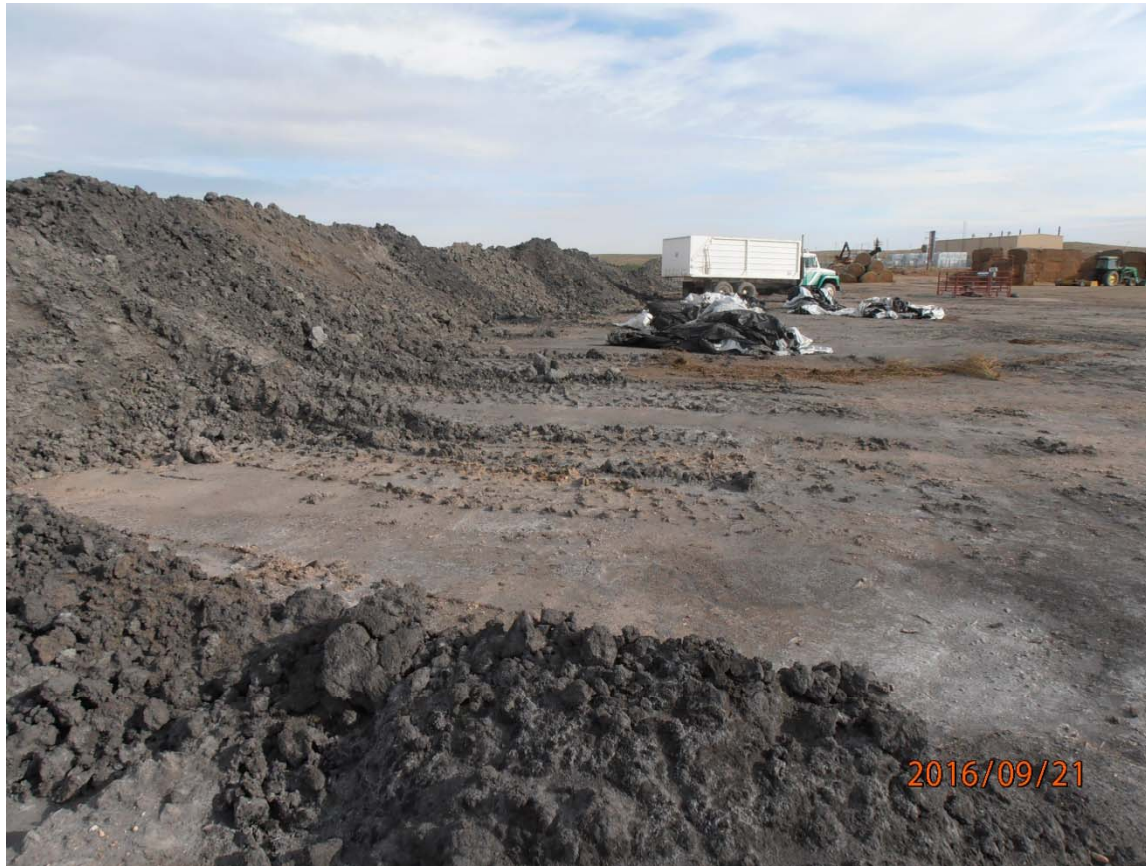
**Photo 5 looking north at cuttings adjacent the Cockroft 19V location
(wellhead is on the right side of photo) (40.388613 / -104.470883)**

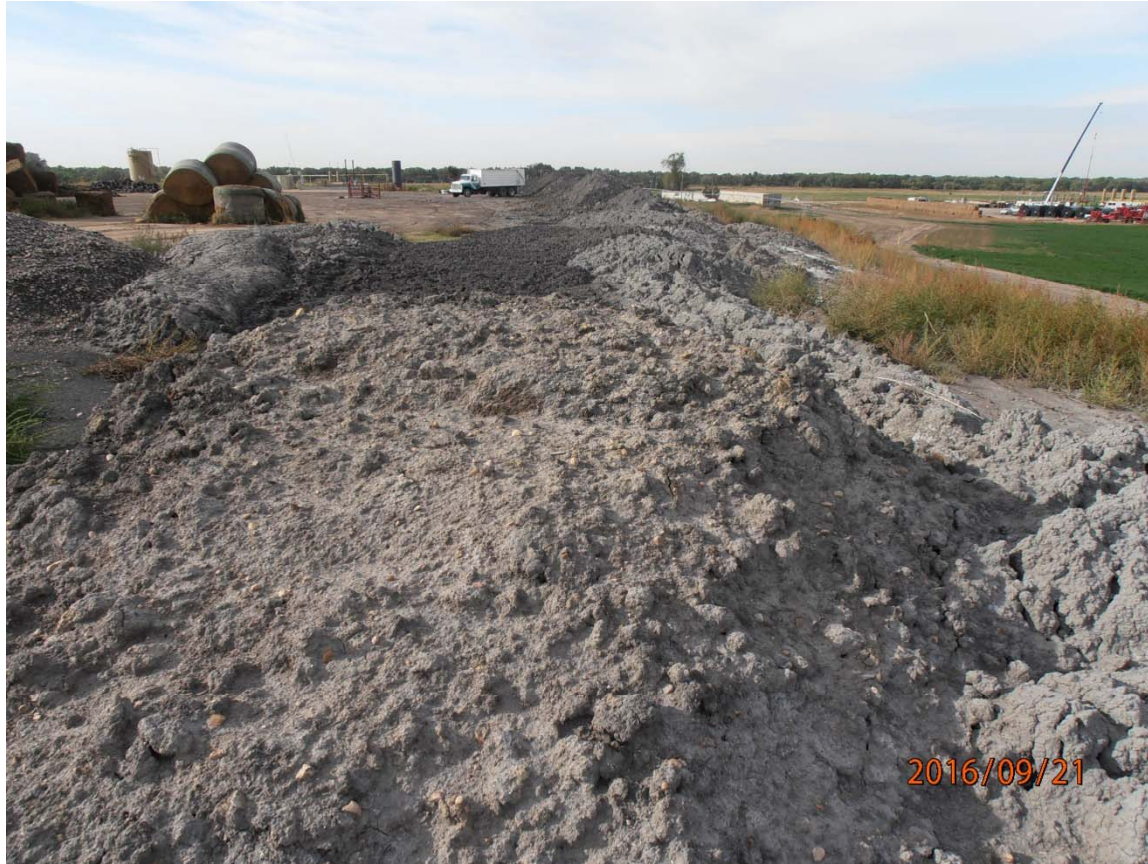
**Photo 5 looking south at cuttings adjacent the Cockroft 19V location
(wellhead is on the left distant side of photo) (40.389658 / -104.470427)**
