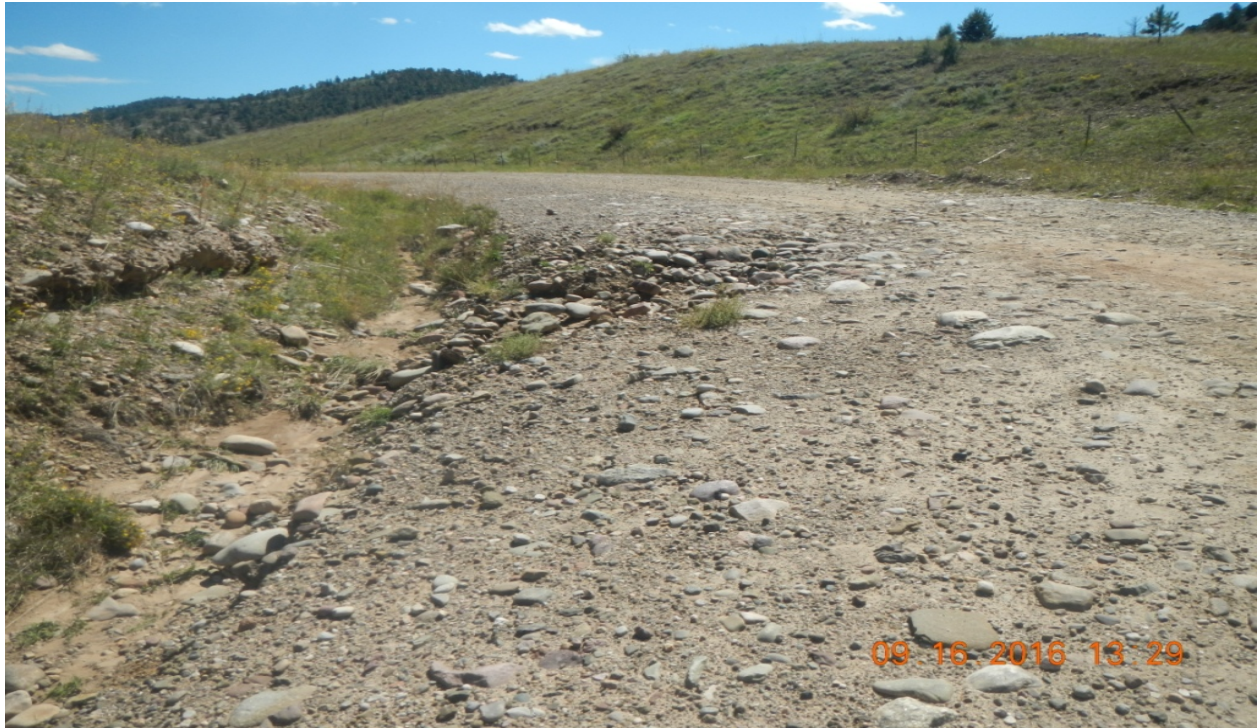
photo 1: Facing southeast along the access road toward the location. There is erosion occurring across the main road and there is no culvert present to divert stormwater.

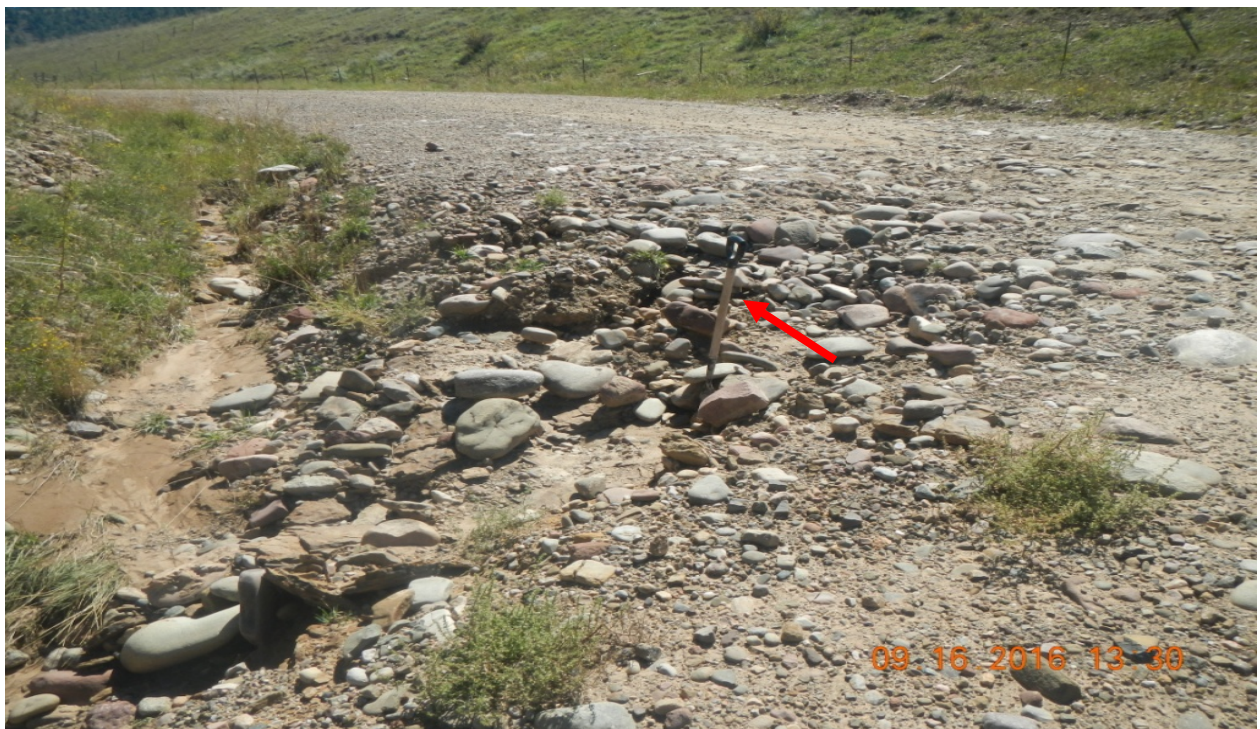
photo 2: There is erosion occurring across the main road and there is no culvert present to divert stormwater. Red arrow points to 3 ft. shovel.

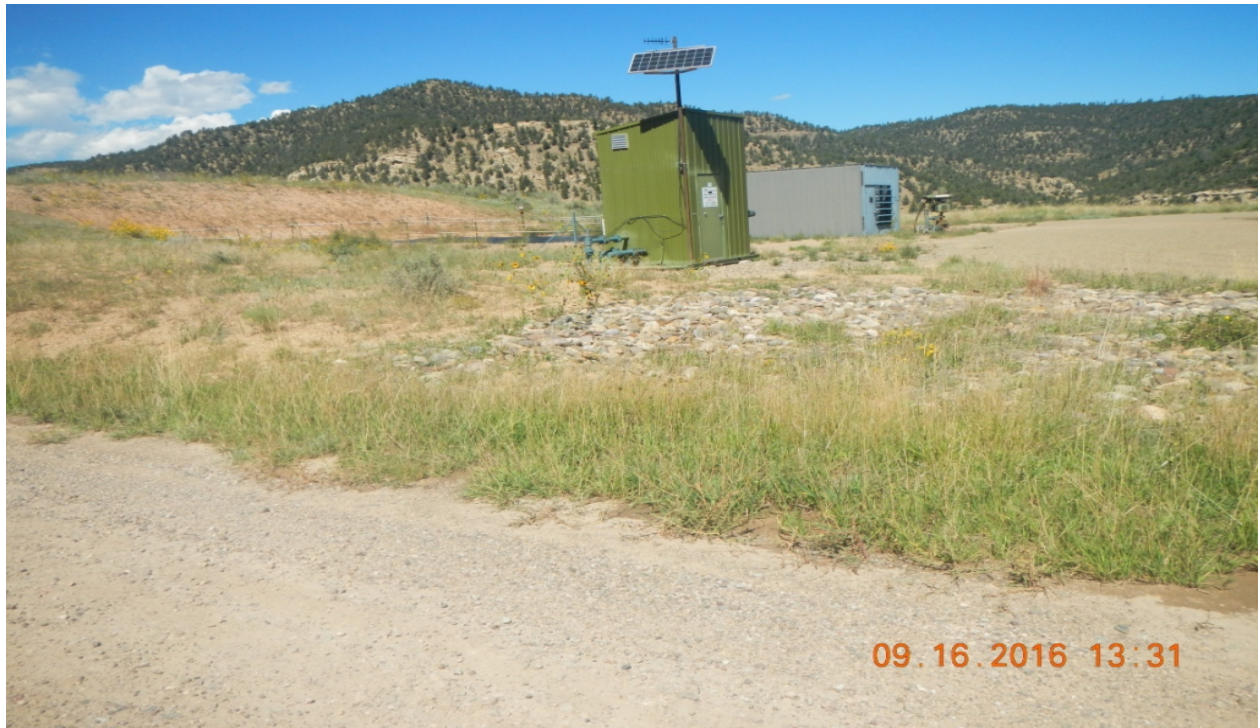
photo 3: Facing northwest toward the location off the main road.

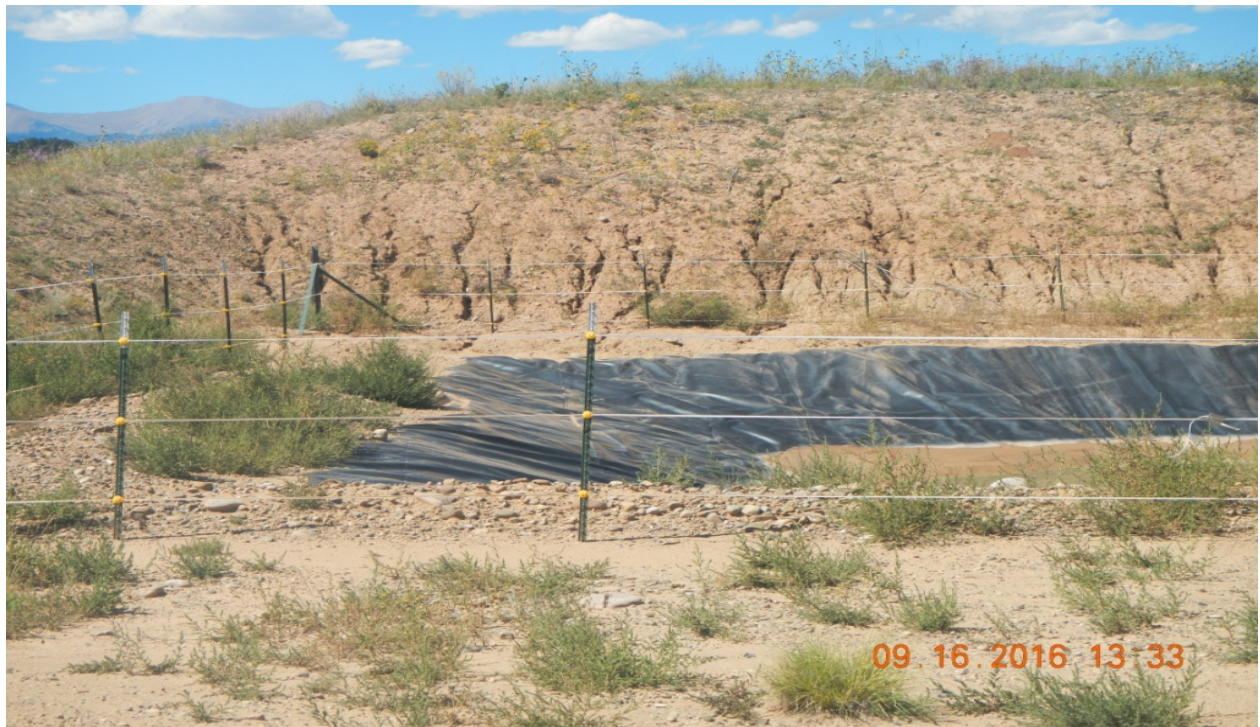
photo 4: Facing west toward the cut where there is signs of erosion.
