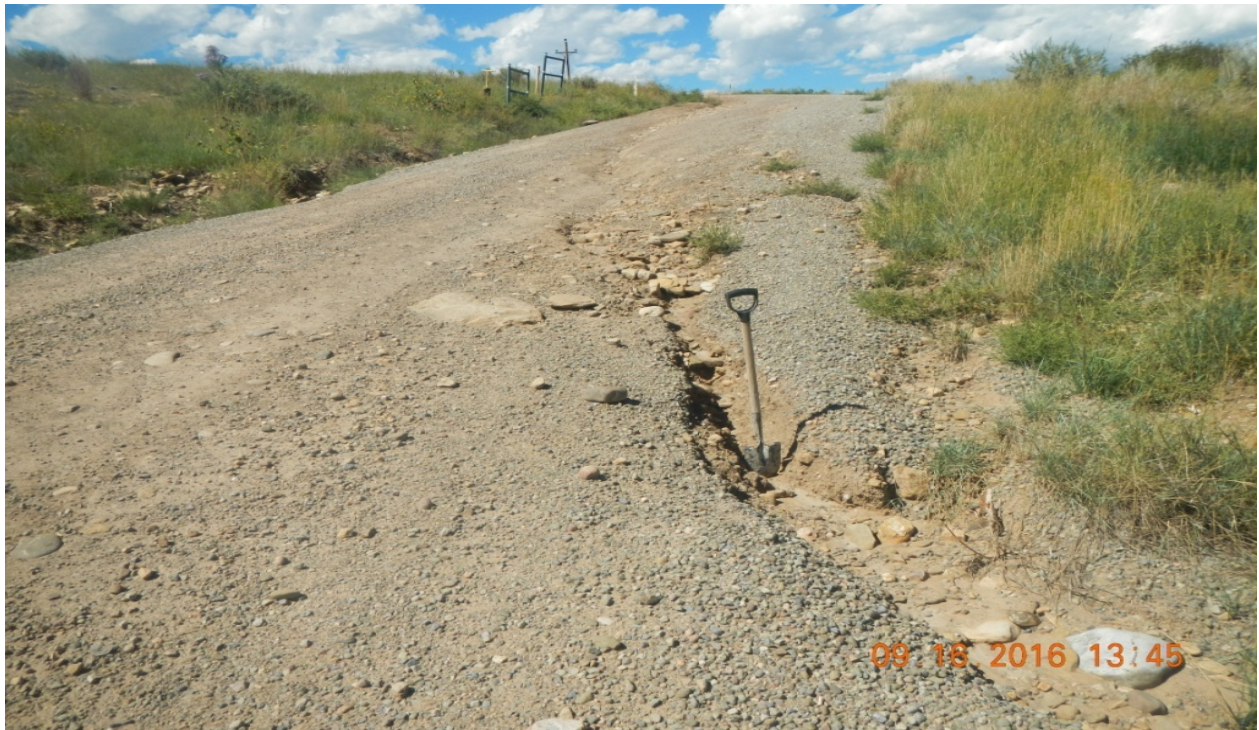
**photo 1:** There is an erosion channel along the main road near the location.

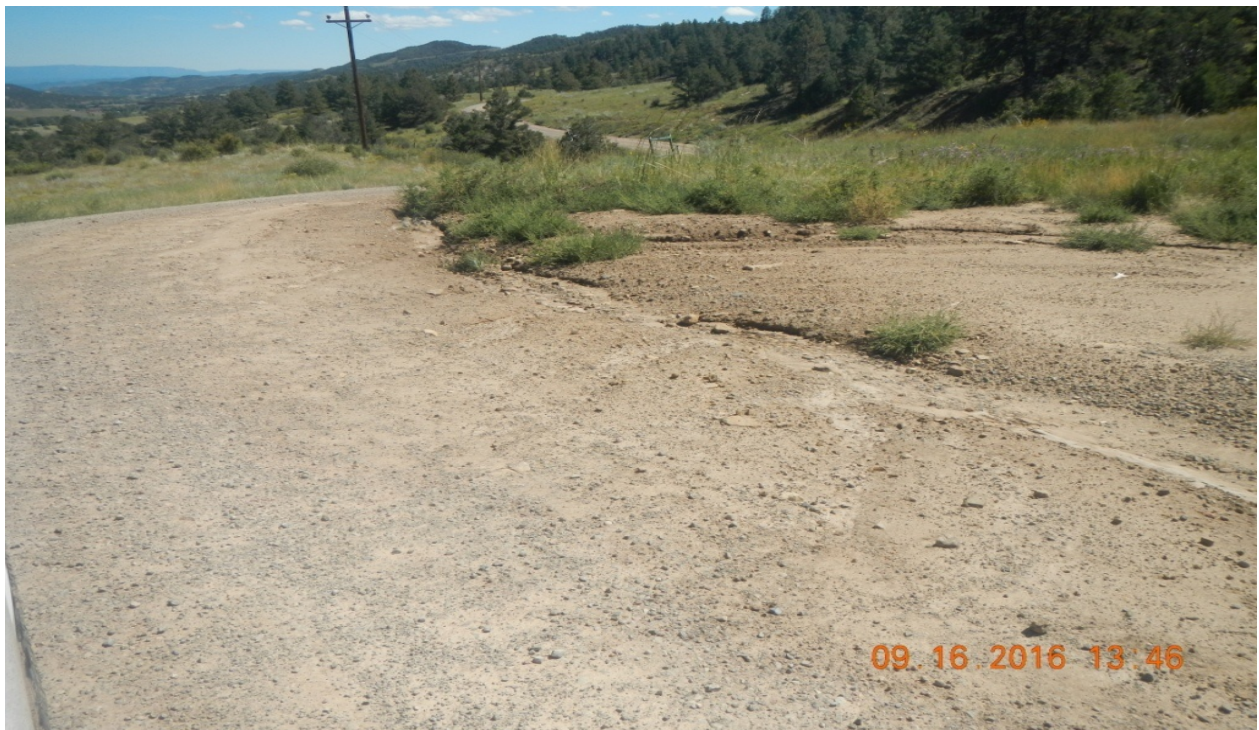
**photo 2:** Facing back toward the east at the location. There are signs of stormwater flowing toward the main road causing erosion.

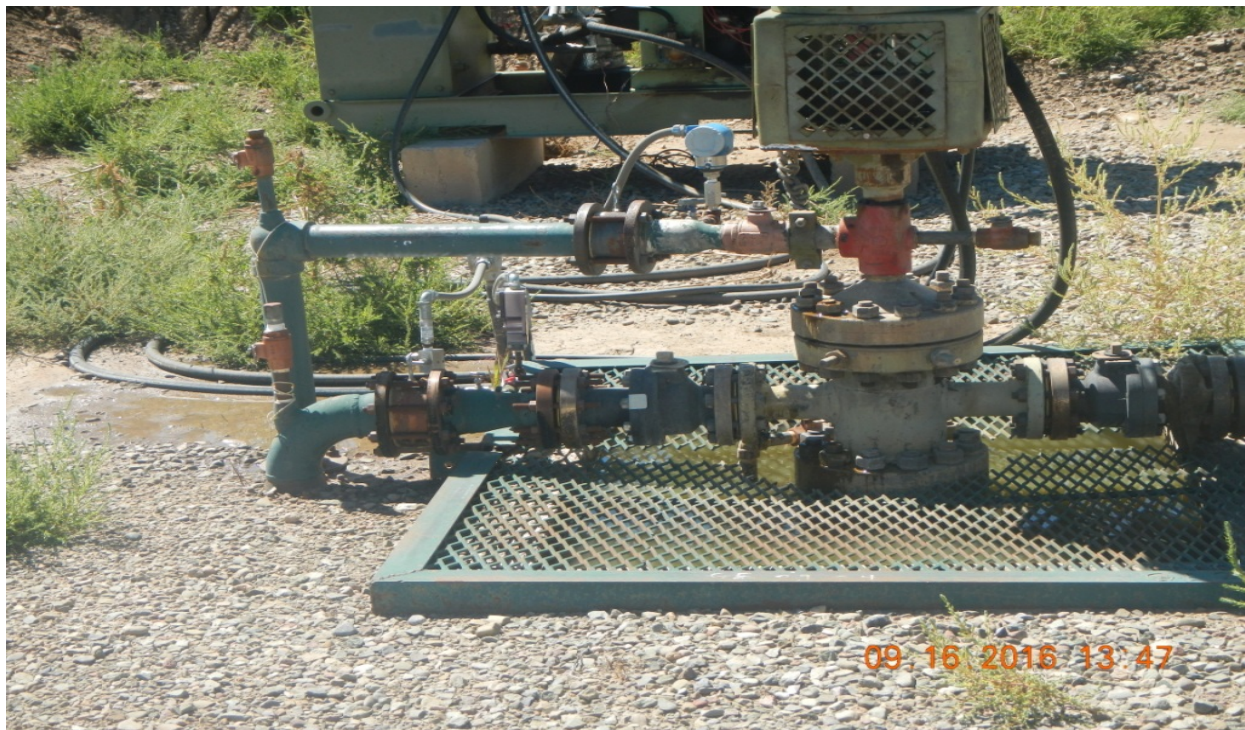
**photo 3:** There was a dripping water leak noticed at the well head.

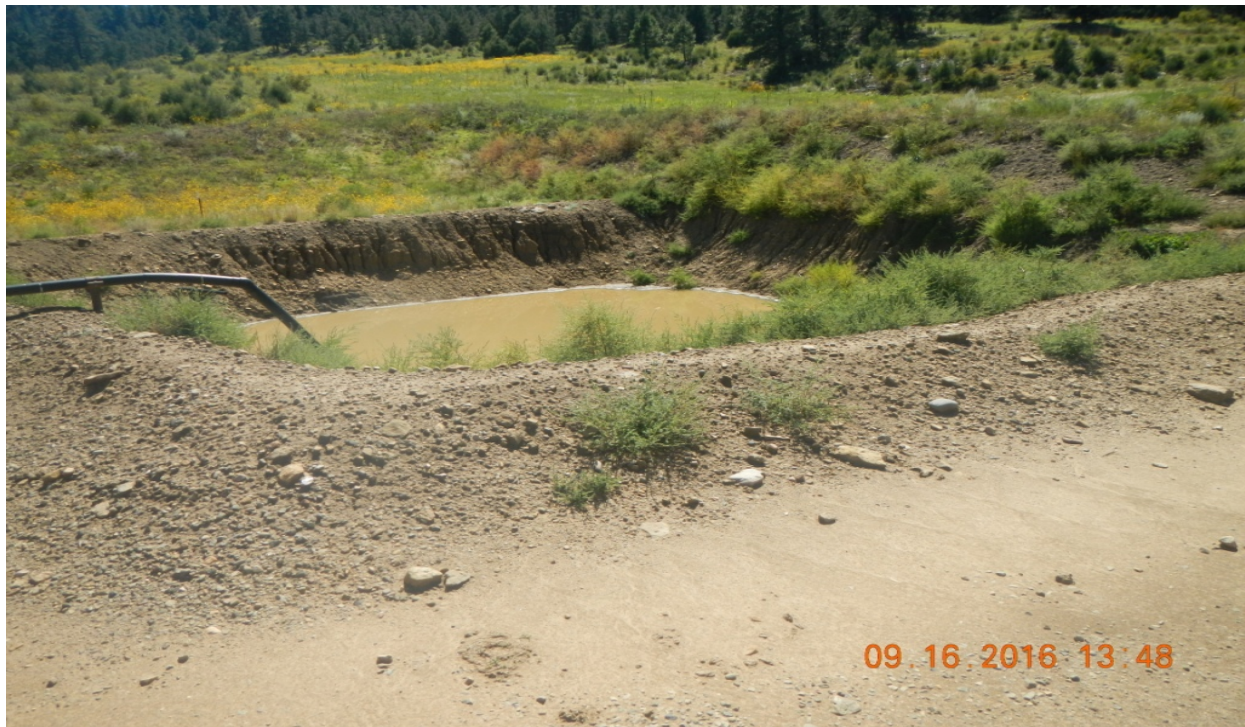
**photo 4:** Facing toward the pit at the southwest side of the location.
