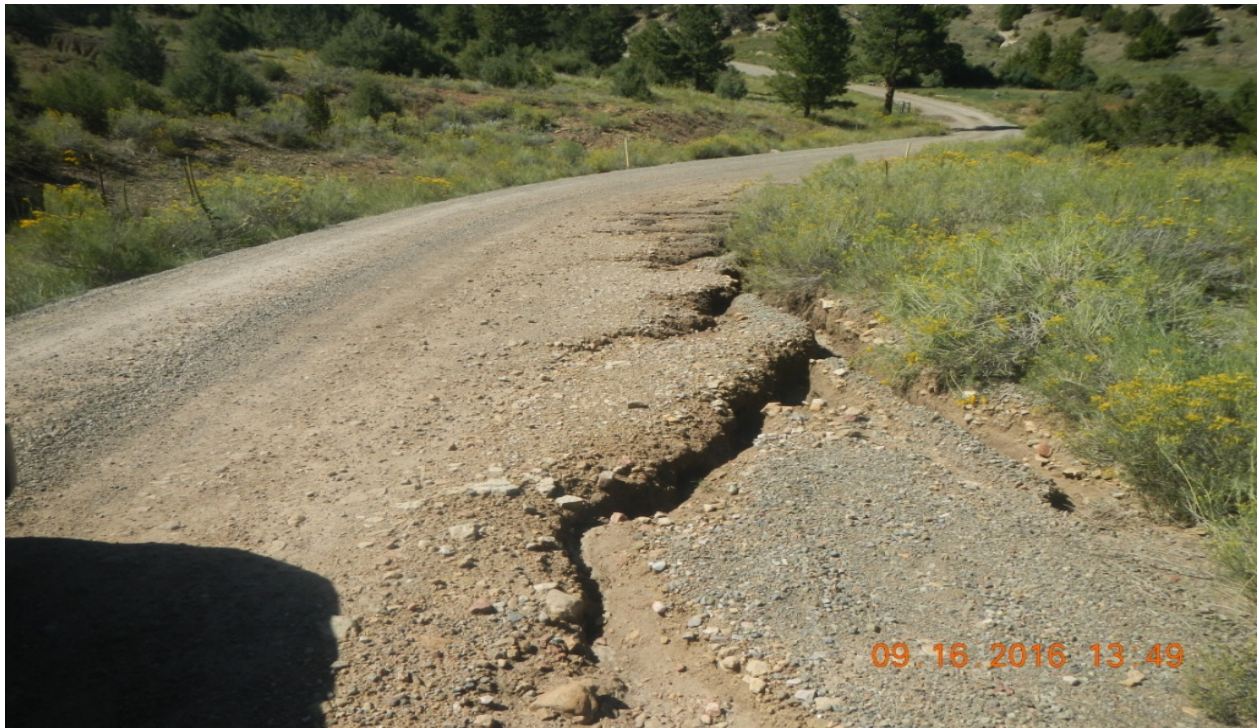
**photo 1:** Facing west along the main access road. There are signs of erosion occurring on the main road.

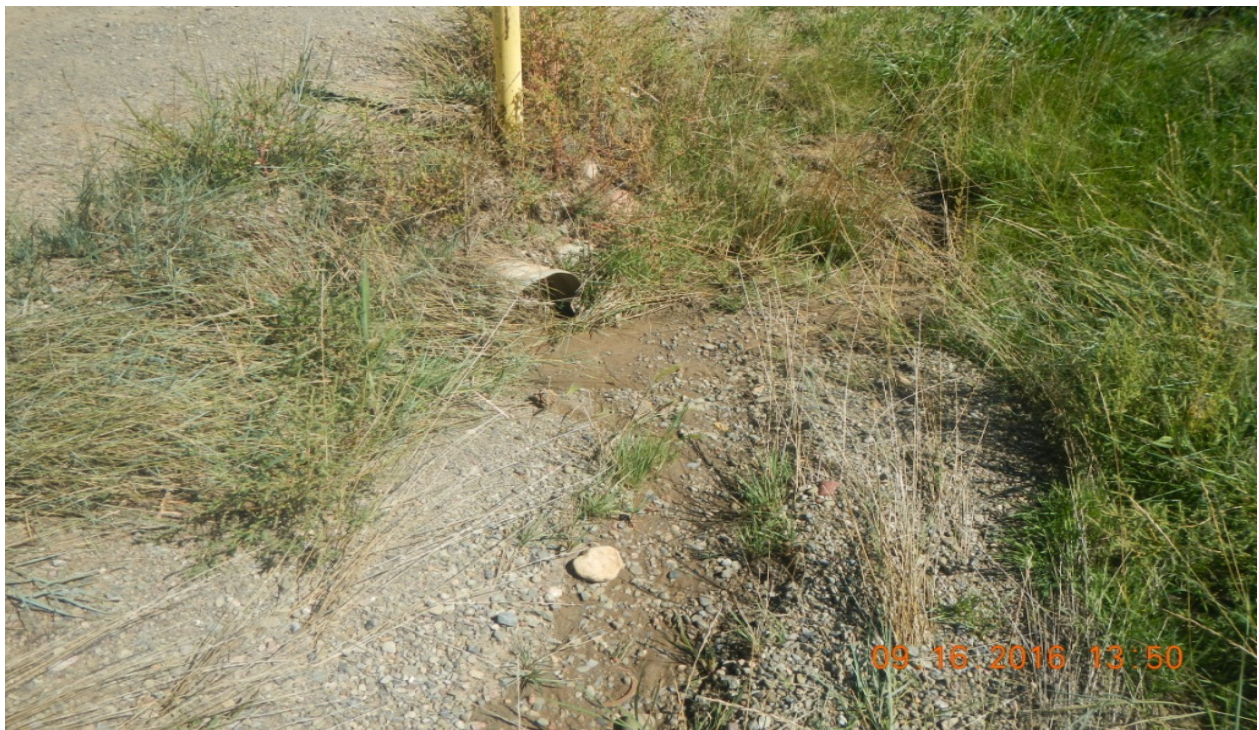
**photo 2:** The culvert along the access road is filling in with sediment.

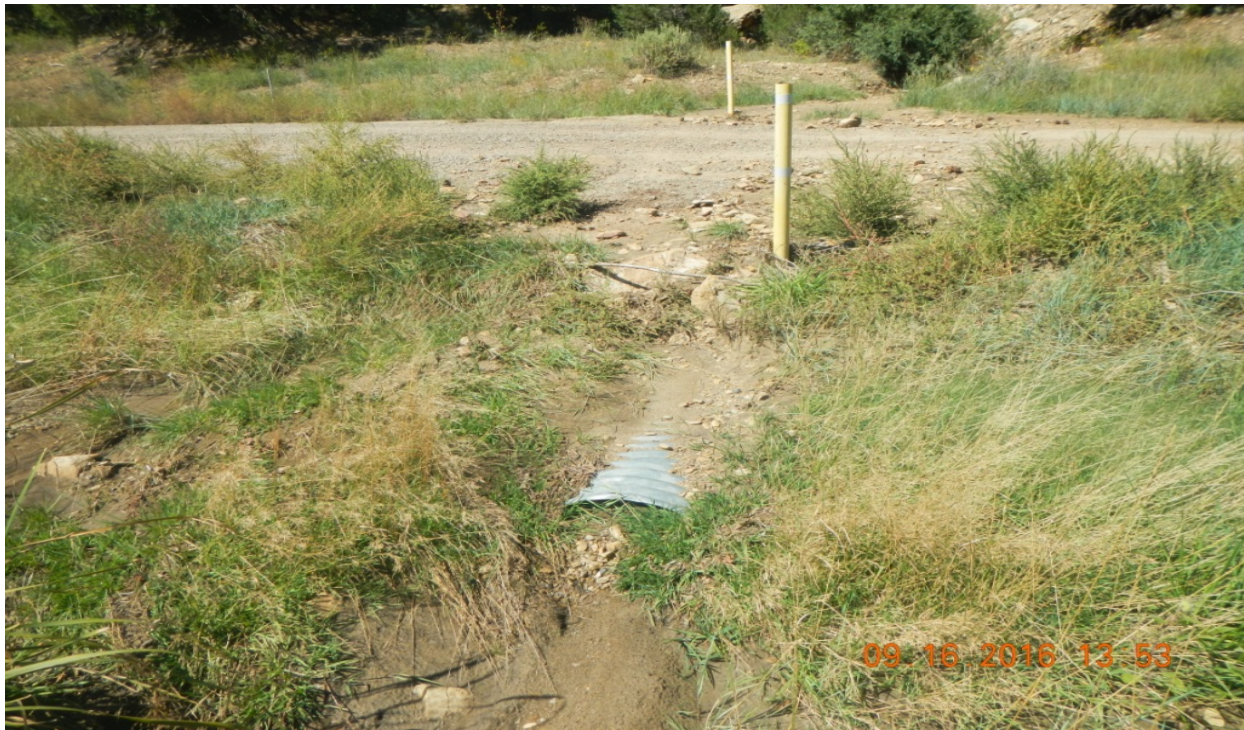
**photo 3:** The culvert along the main road has filled in with sediment.

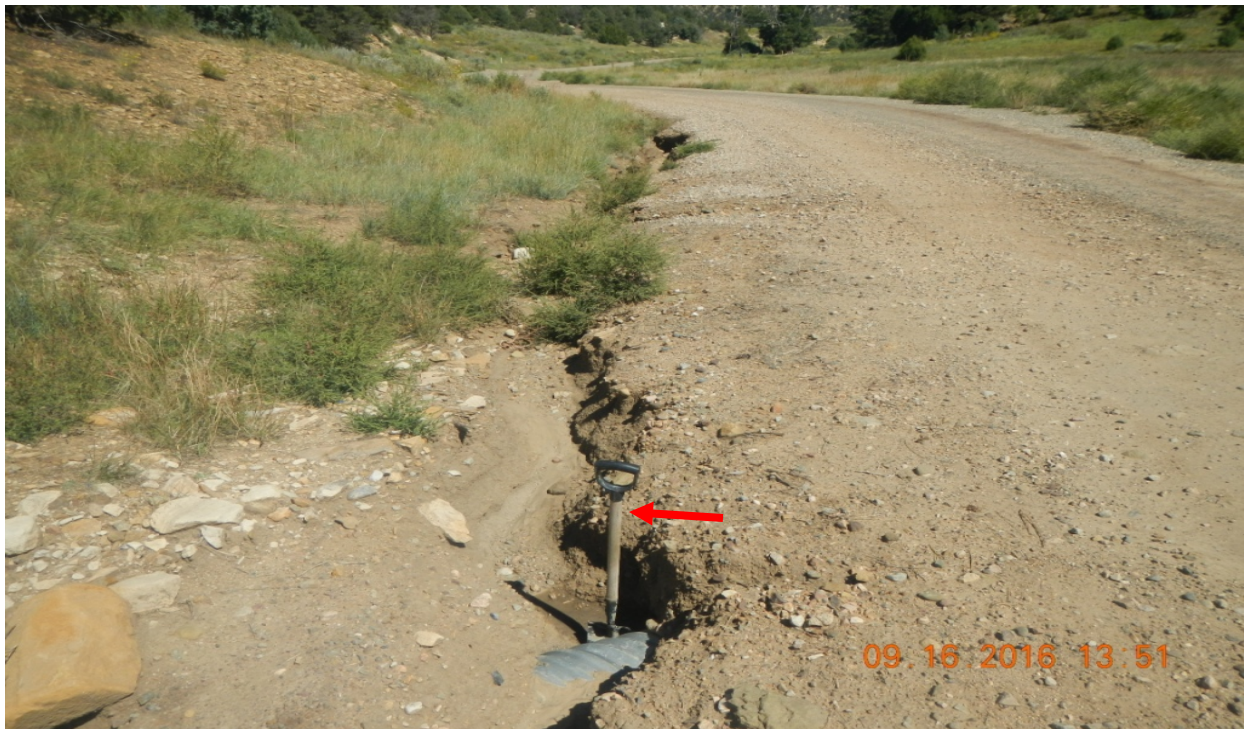
**photo 4:** There is erosion occurring along the access road. Red arrow points to 3 ft. shovel.

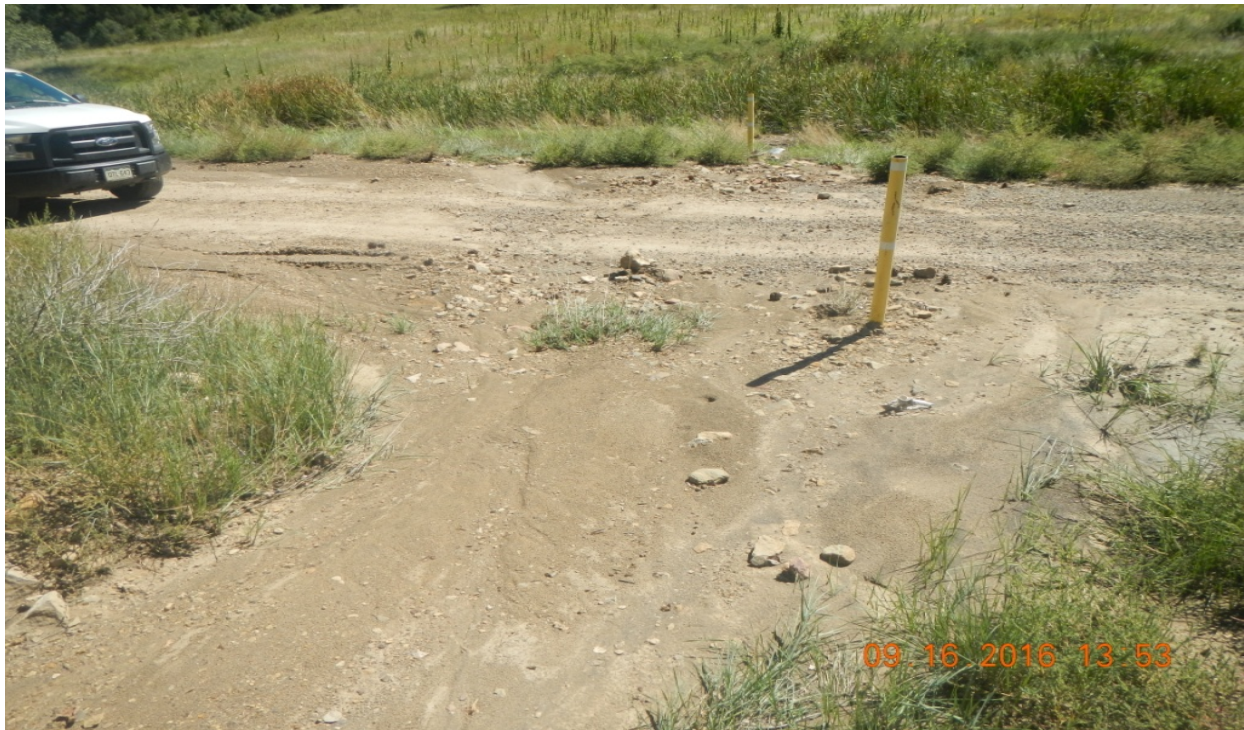
**photo 5:** The culvert along the main road is filled in with sediment.

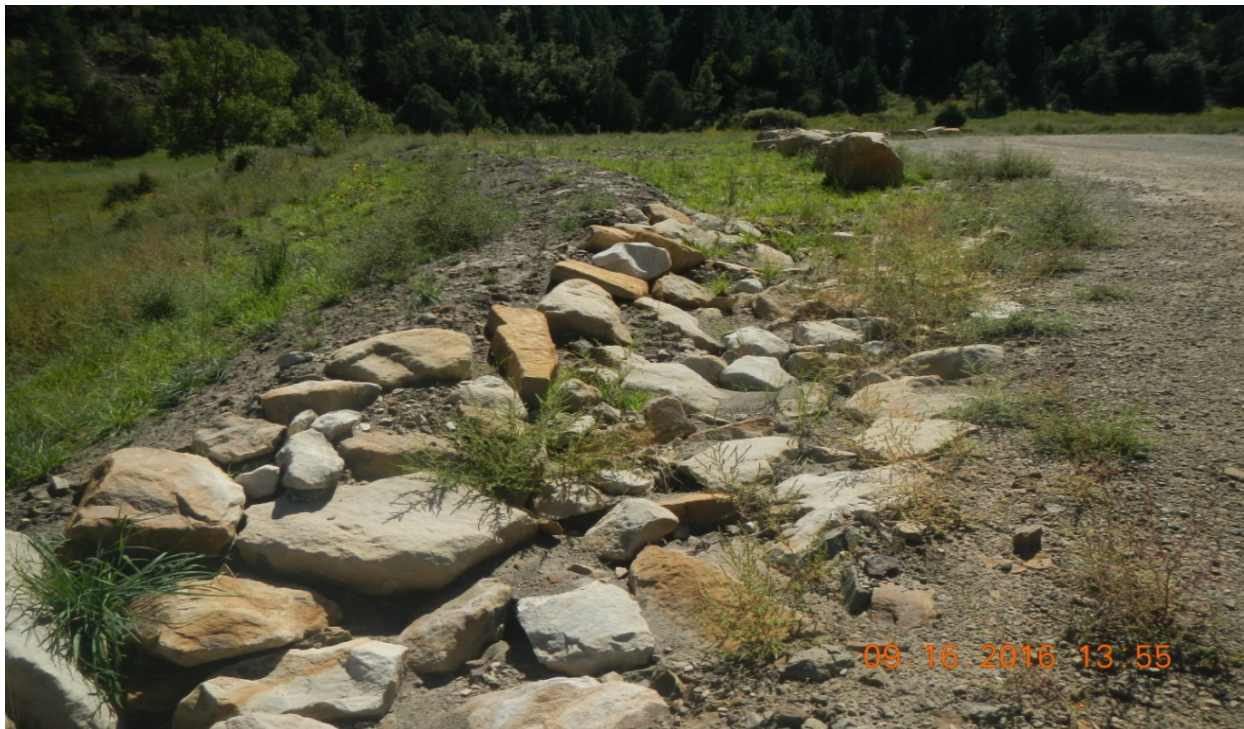
**photo 6:** Facing southwest along the fill slope of the location.

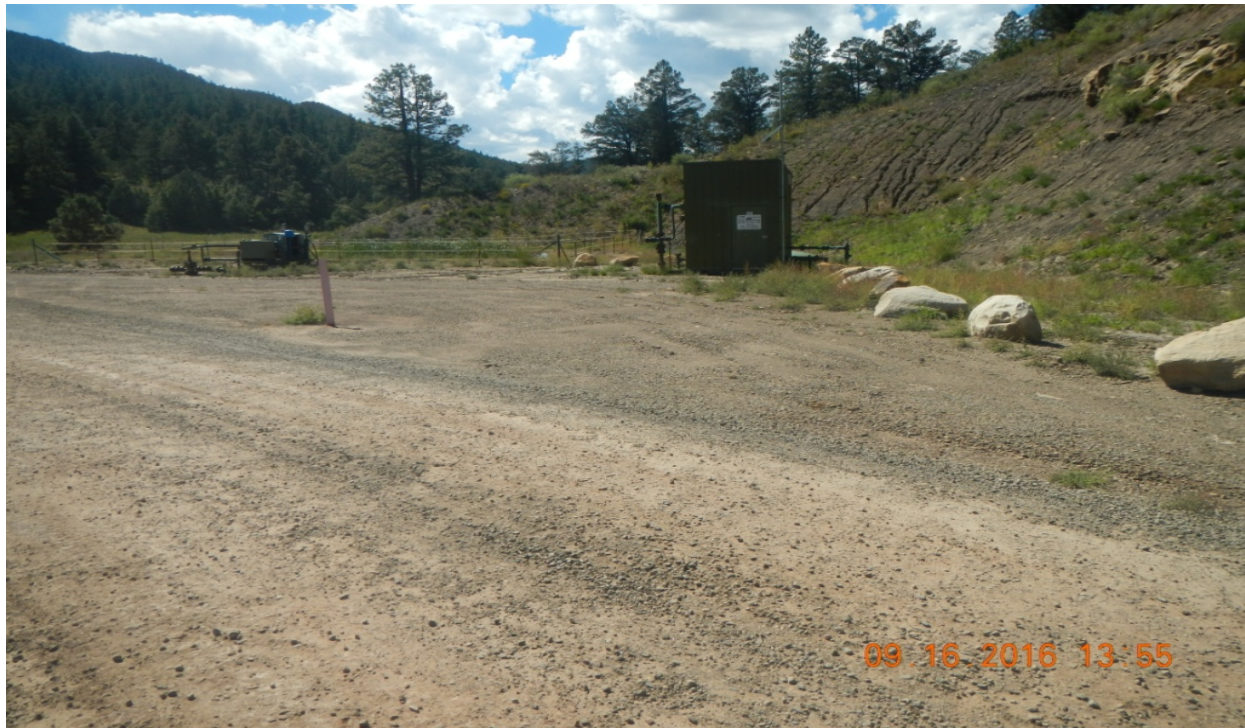
**photo 7:** Facing west toward the location.

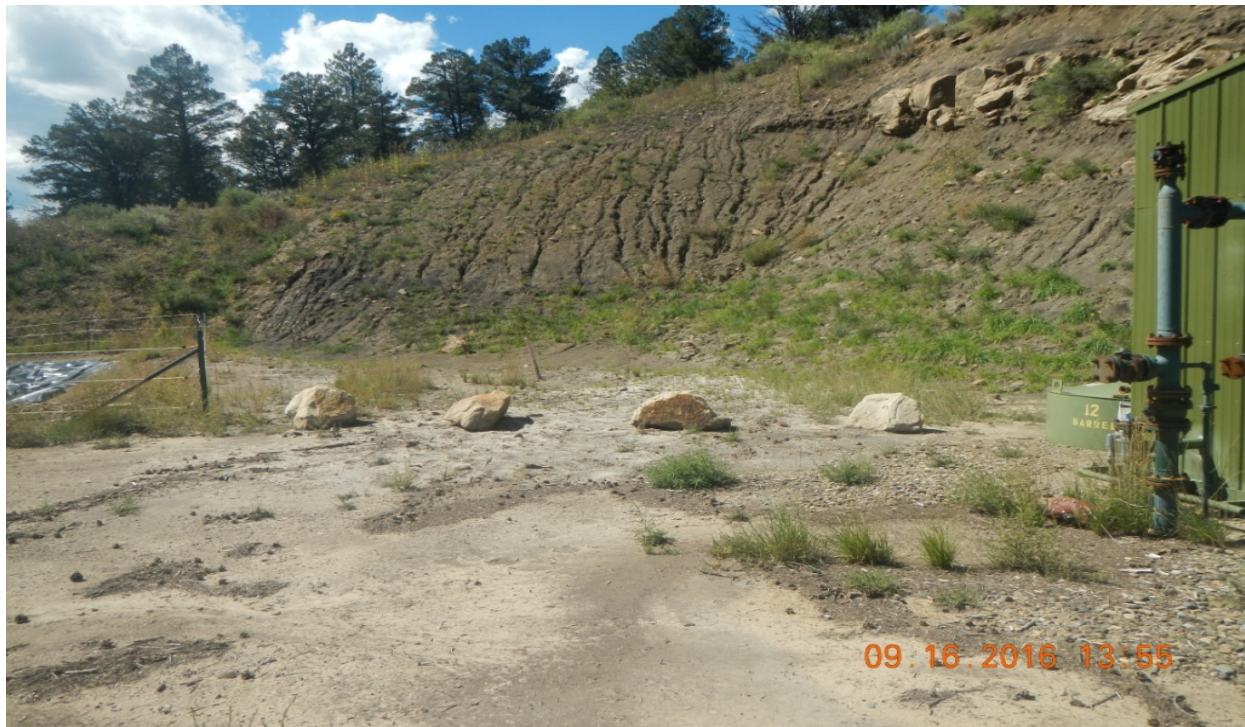
**photo 8:** Facing toward the northwest side of the location. There are signs of erosion along the cut slope.
