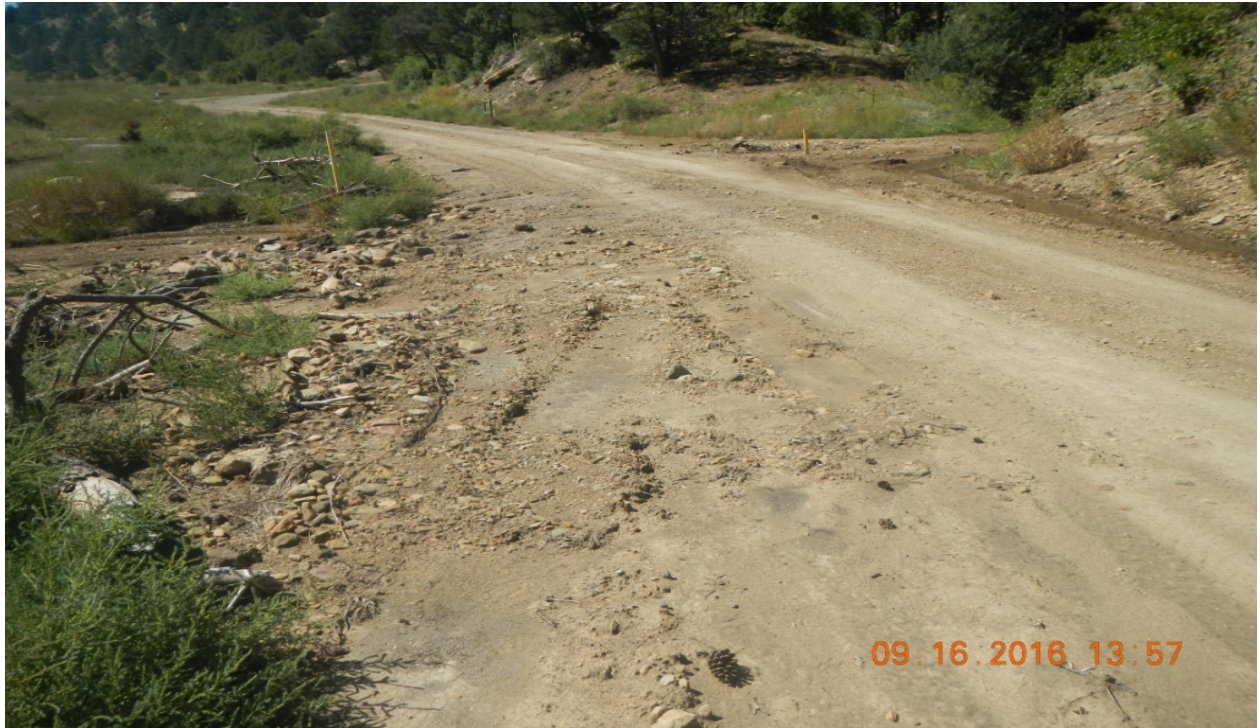
photo 1: Facing west along the main access road. Sediment has filled in the culverts. Stormwater flowed across the road which washed away gravel and deposited sediment on the road.

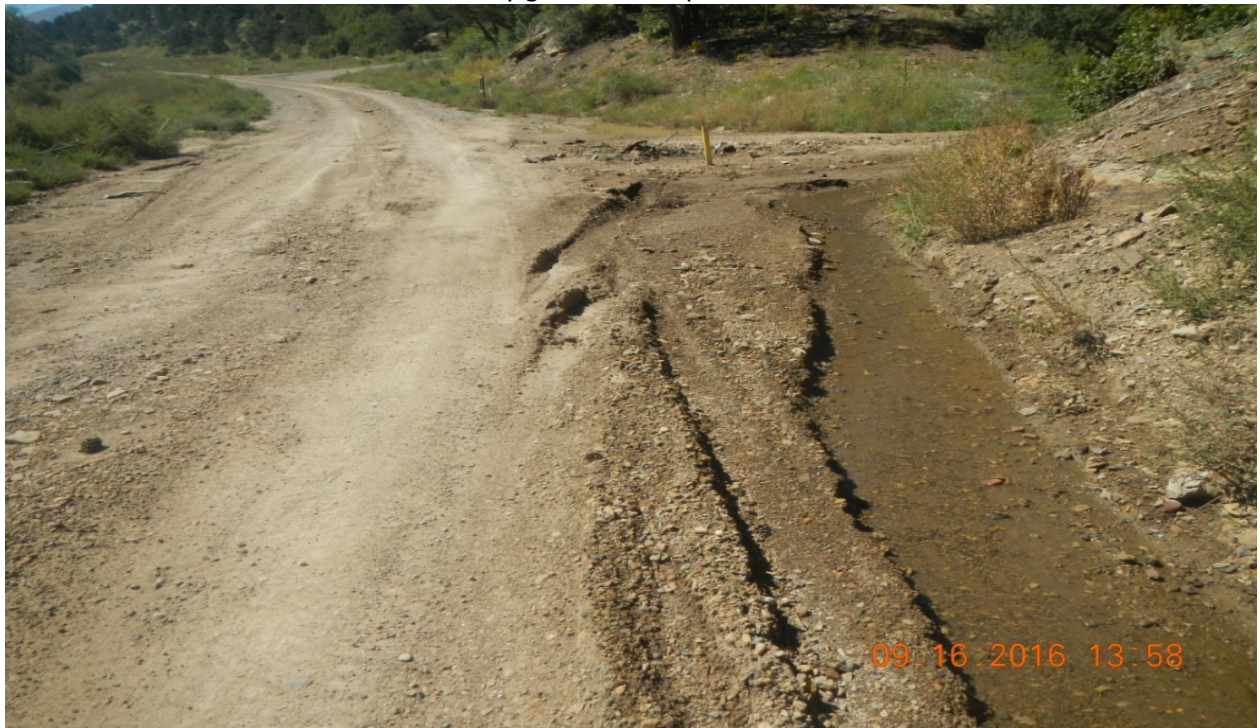
photo 2: Facing west along the main access road. Sediment has filled in the culverts. Stormwater flowed across the road which washed away gravel and deposited sediment on the road.

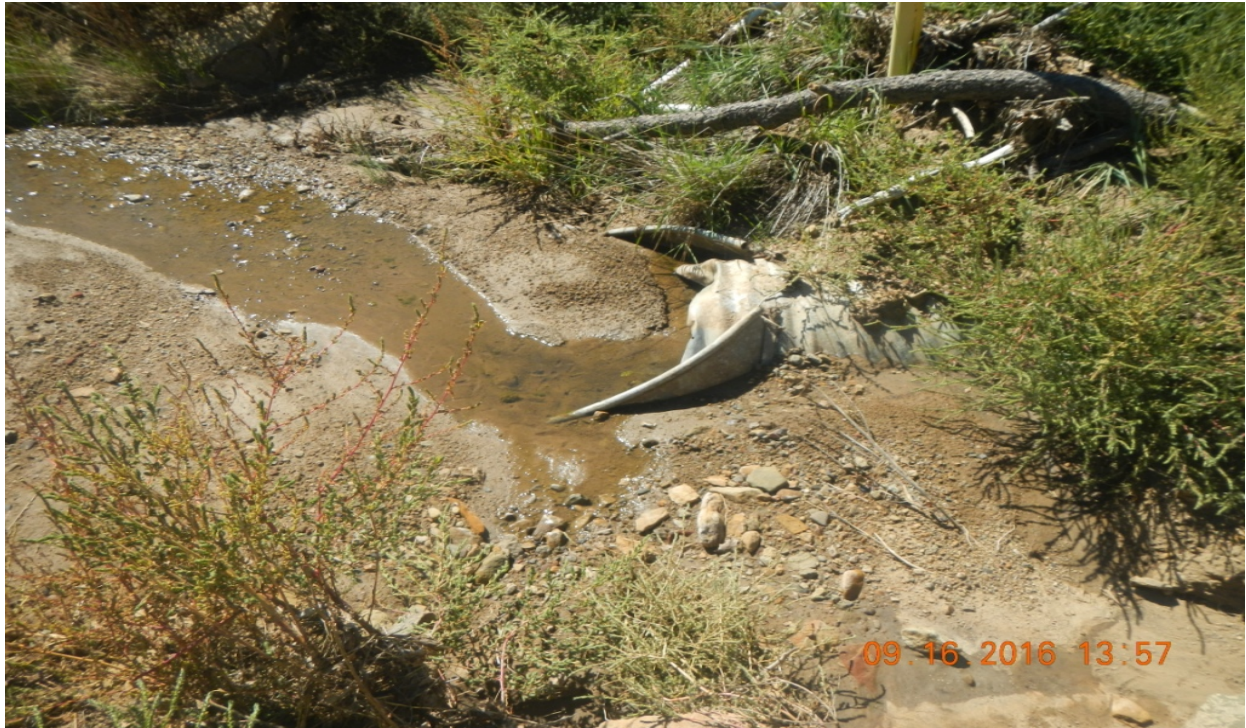
photo 3: The culvert along the main road has filled in with sediment.

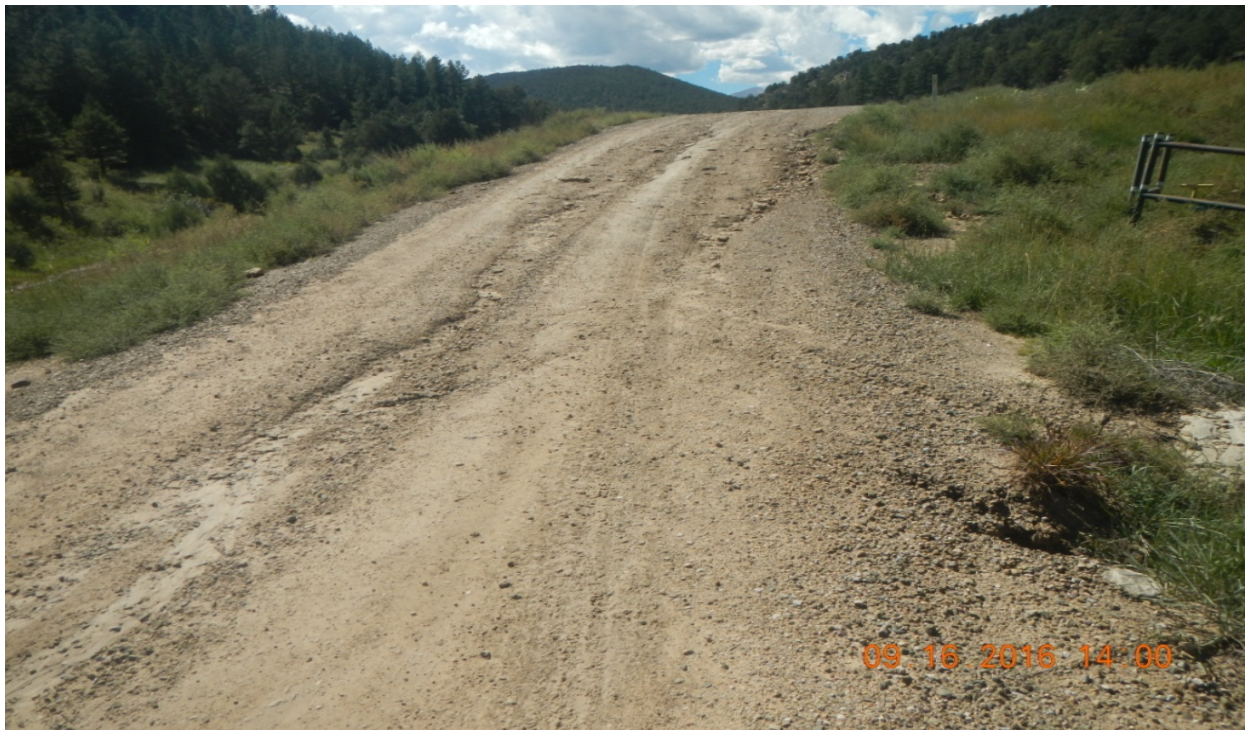
photo 4: Facing west along the main road near the location. There are signs of erosion occurring on the road.

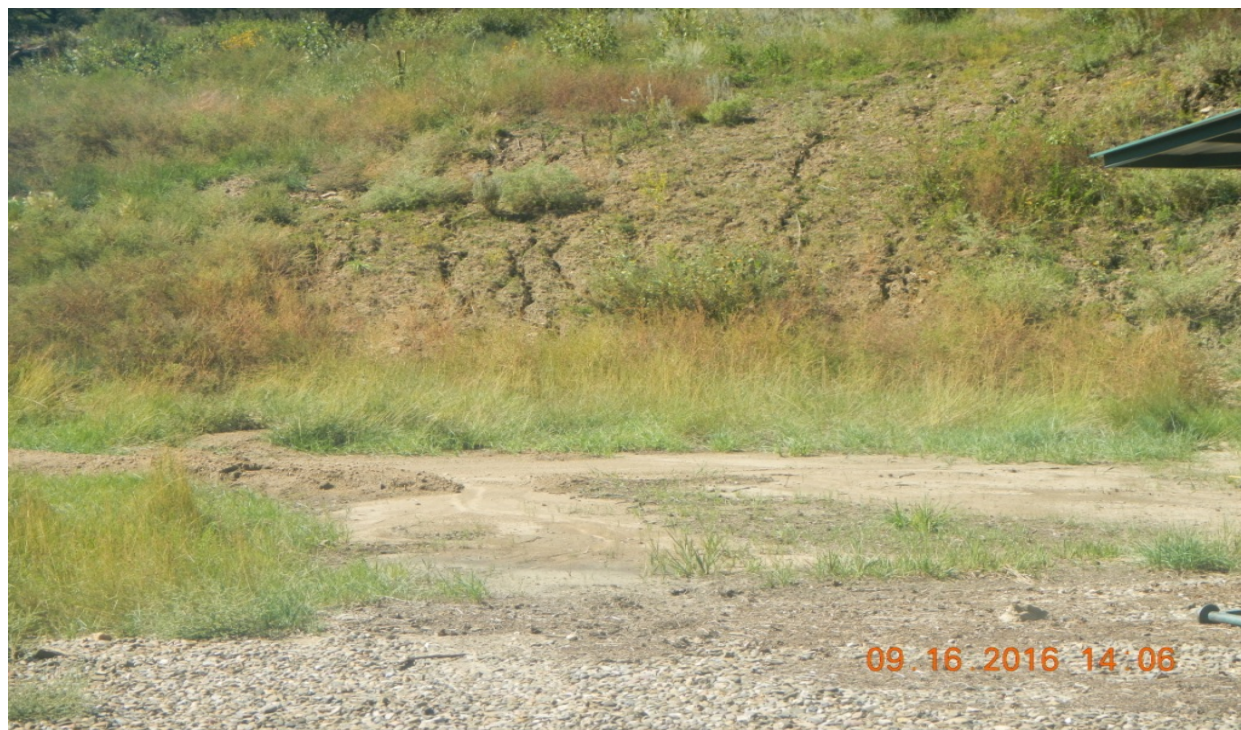
photo 5: Facing toward the northwest cut slope. There are signs of erosion in this area.

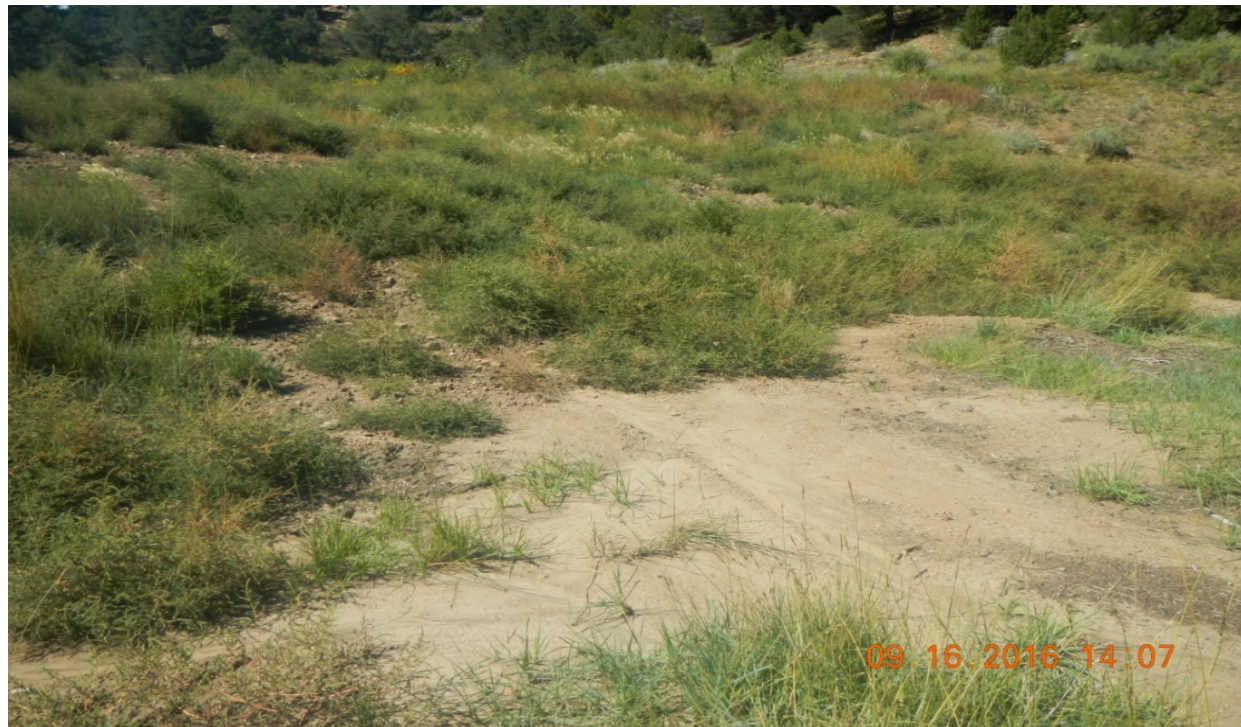
photo 6: The vegetation along the west side of the location is predominately weed growth.
