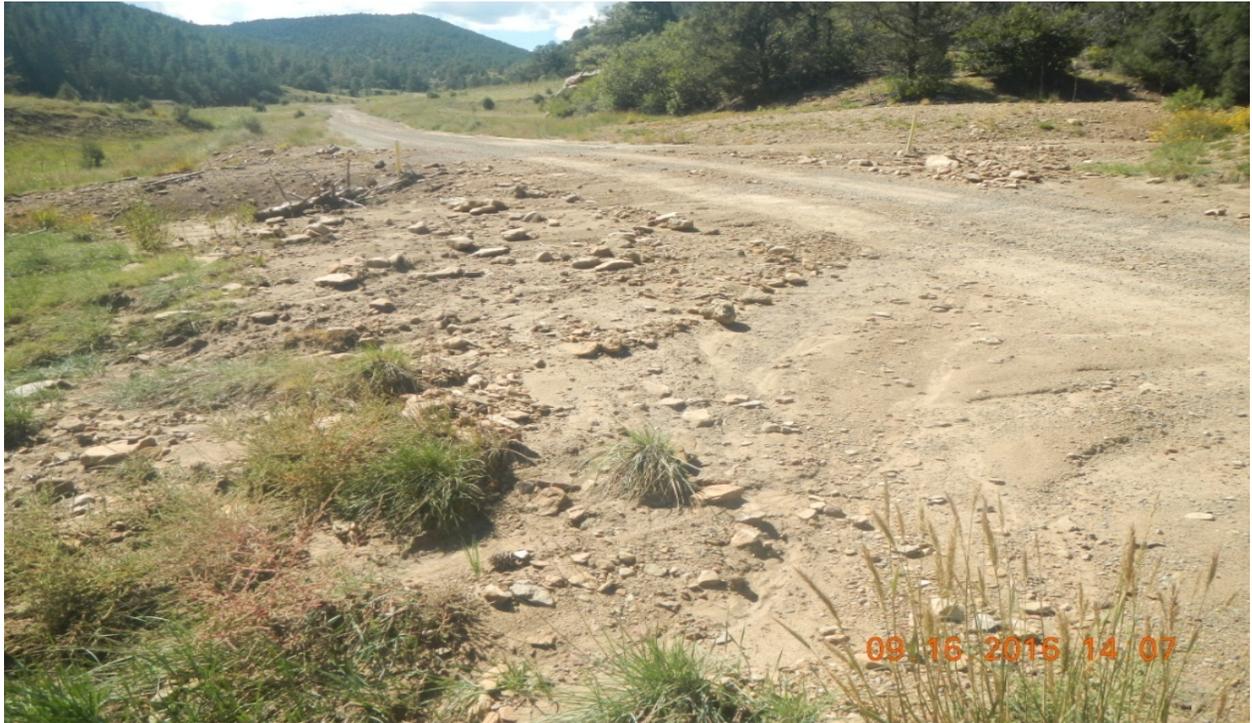
photo 1: Facing west along the main access road. The culverts are filled with sediment and stormwater washed away gravel and deposited sediment on the road.

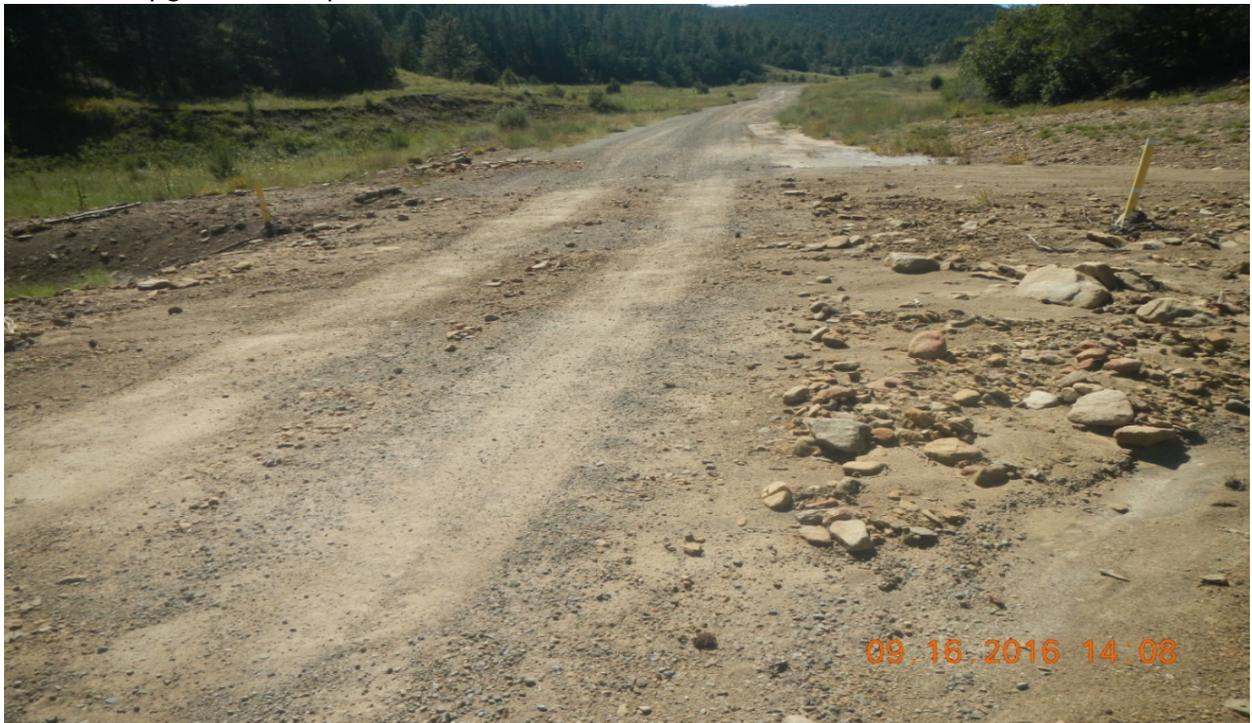
photo 2: Facing west along the main access road. The culverts are filled with sediment and stormwater washed away gravel and deposited sediment on the road.

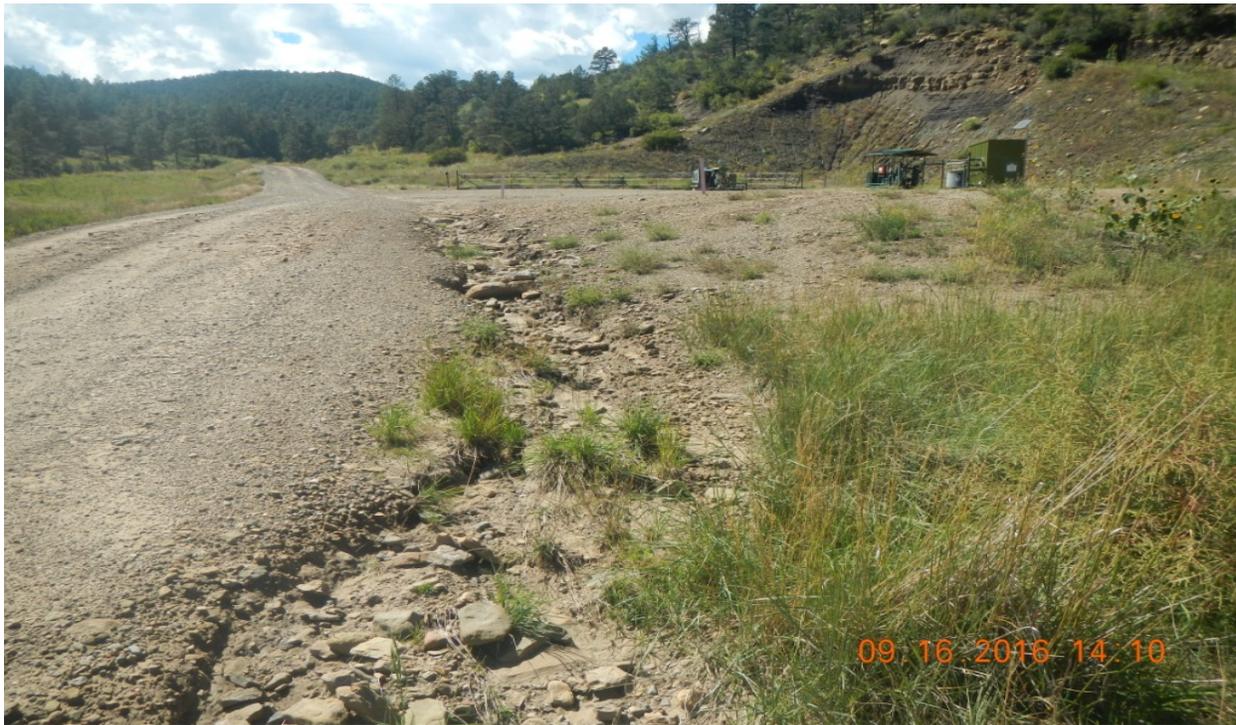
photo 3: Facing west toward the location. There are signs of erosion at this area.
