September 6, 2016

Inspection Photos: Chevron PR API#045-17284

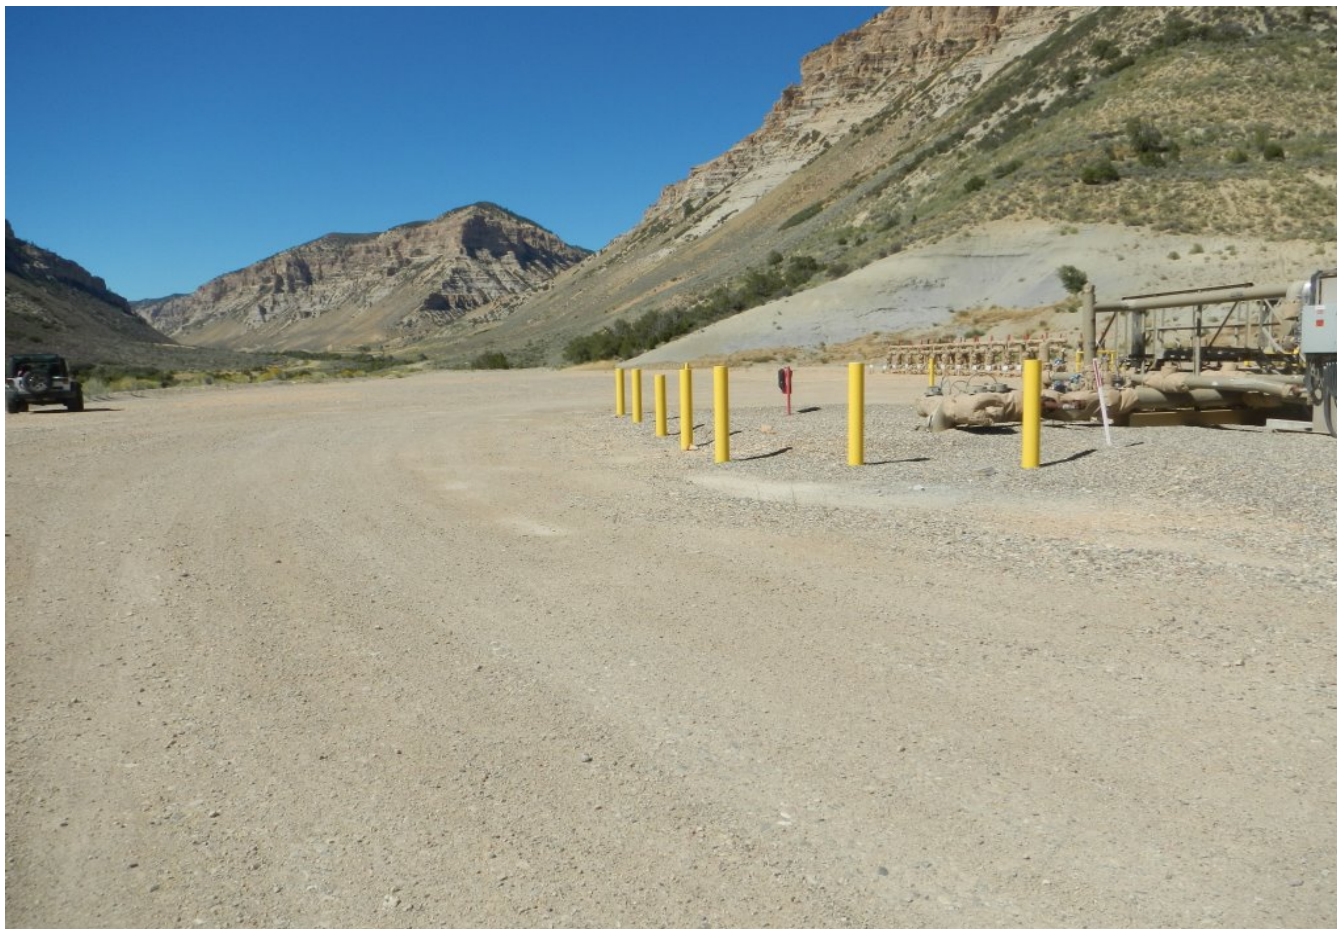
Photo#1: Over view of Location from Entry Road .

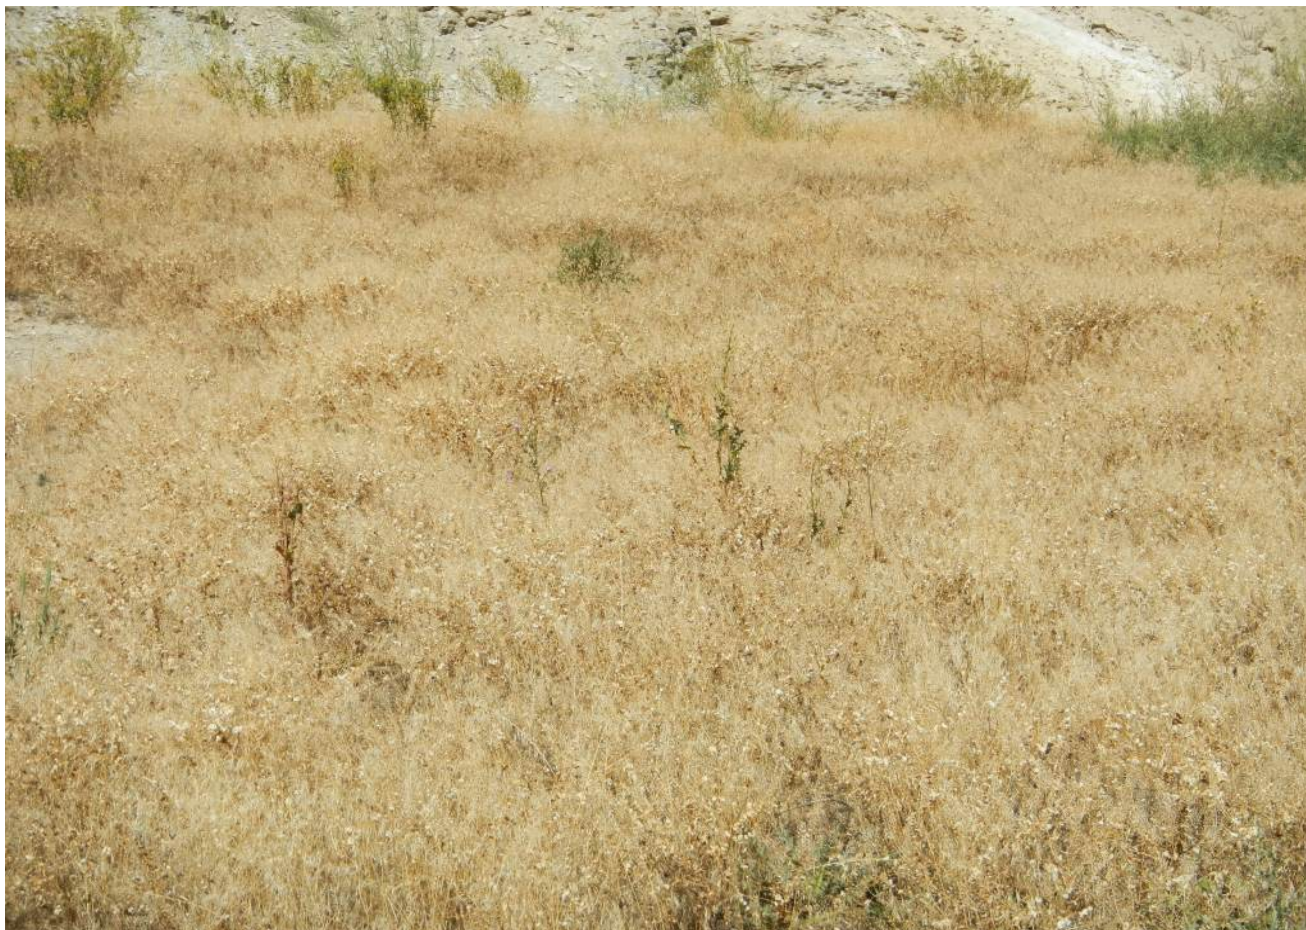
Photo#2: C List Weeds Established in Interim areas.

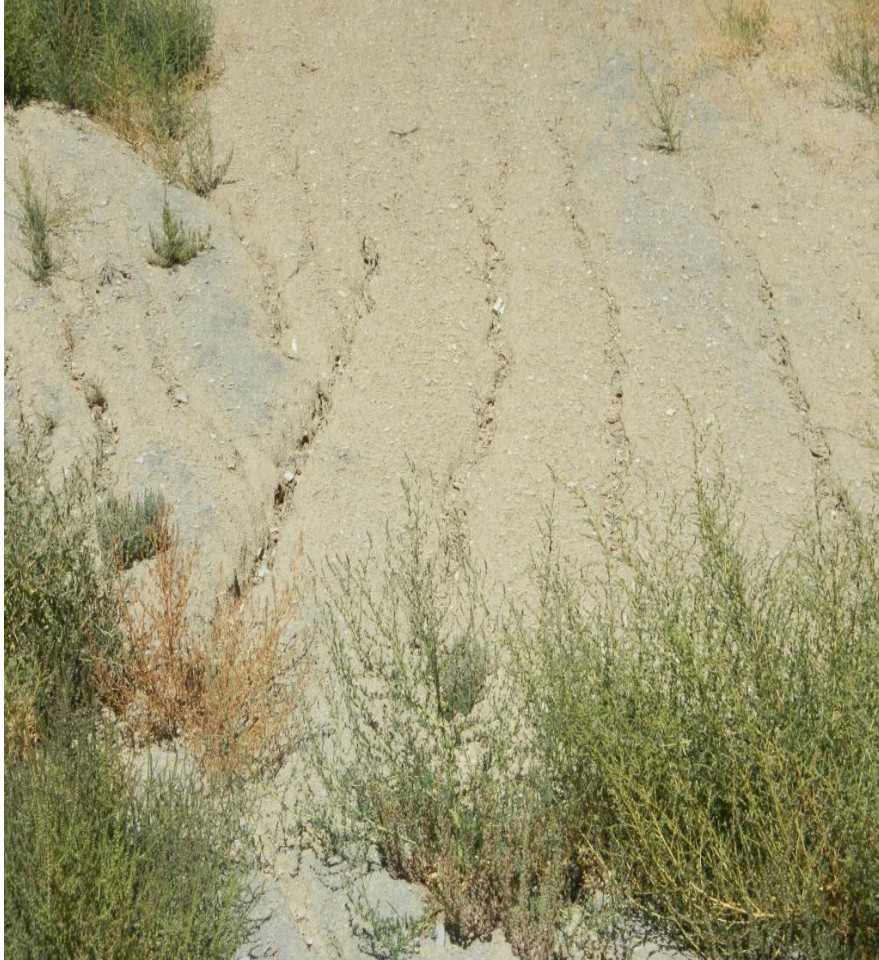
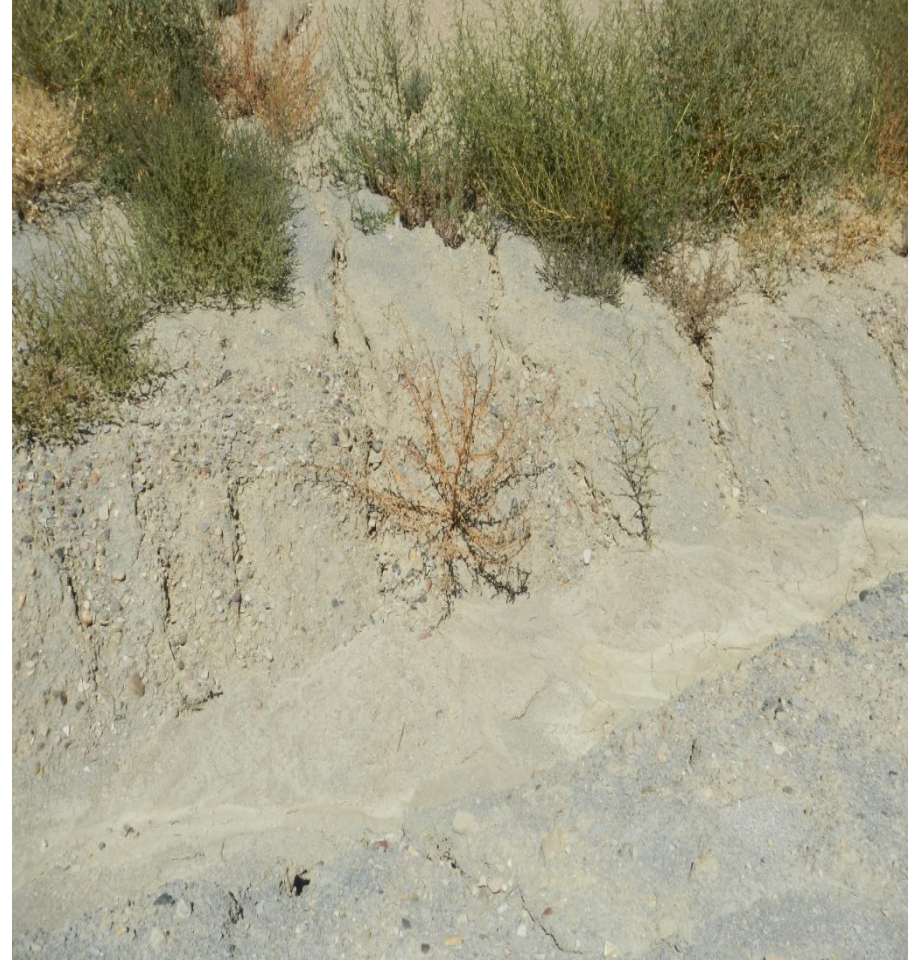
Photos #3 & 4: Rill erosion and Sediment Run On to Location.

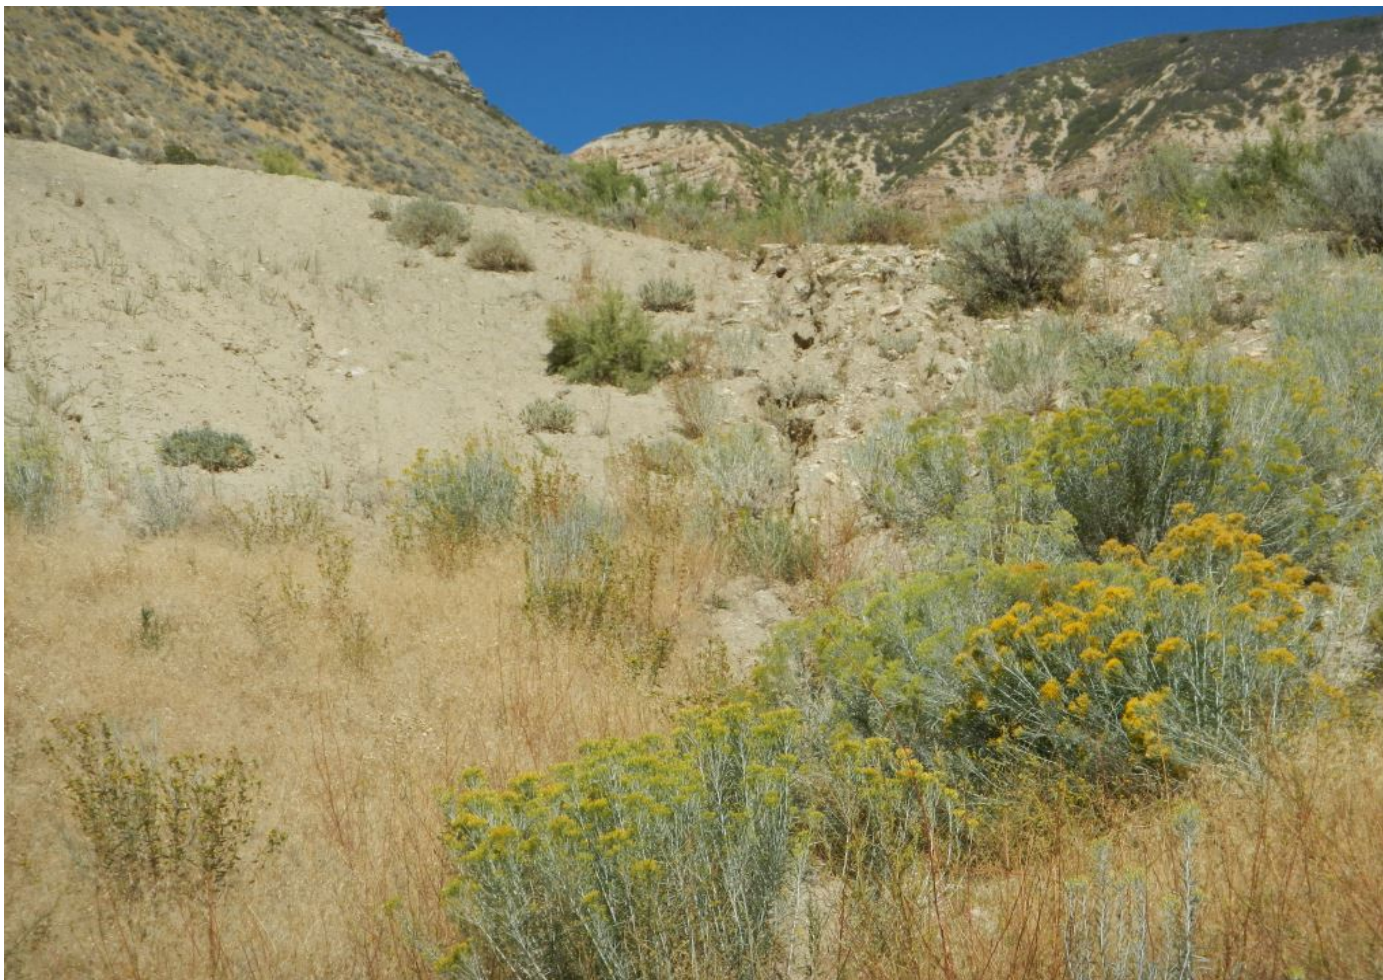
Photo#4: Erosion Channel developing at NE Corner of Cut Slope.

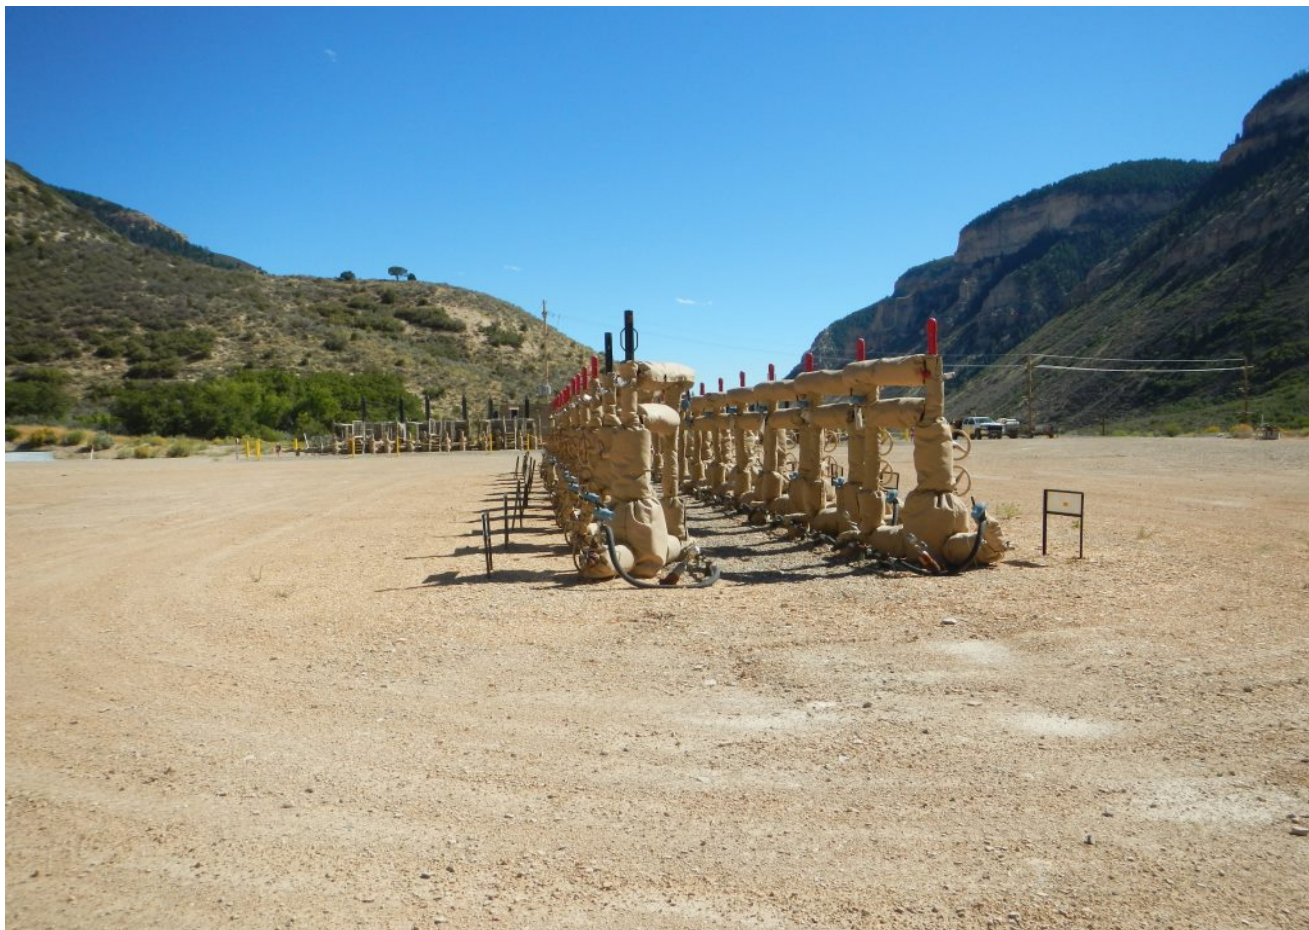
Photo#5: API# 045-17284 is now assigned to Location with 23 other Wells.
