**Reference Area Photographs**  
**Inspection Conducted on September 20, 2016**

**Hunter Ridge Energy Services #10442**  
**A27 CDP (Centralized Distribution Point )**

**Spill/Release Point ID #446199**

## Hunter Ridge A27 CDP Pipeline Release

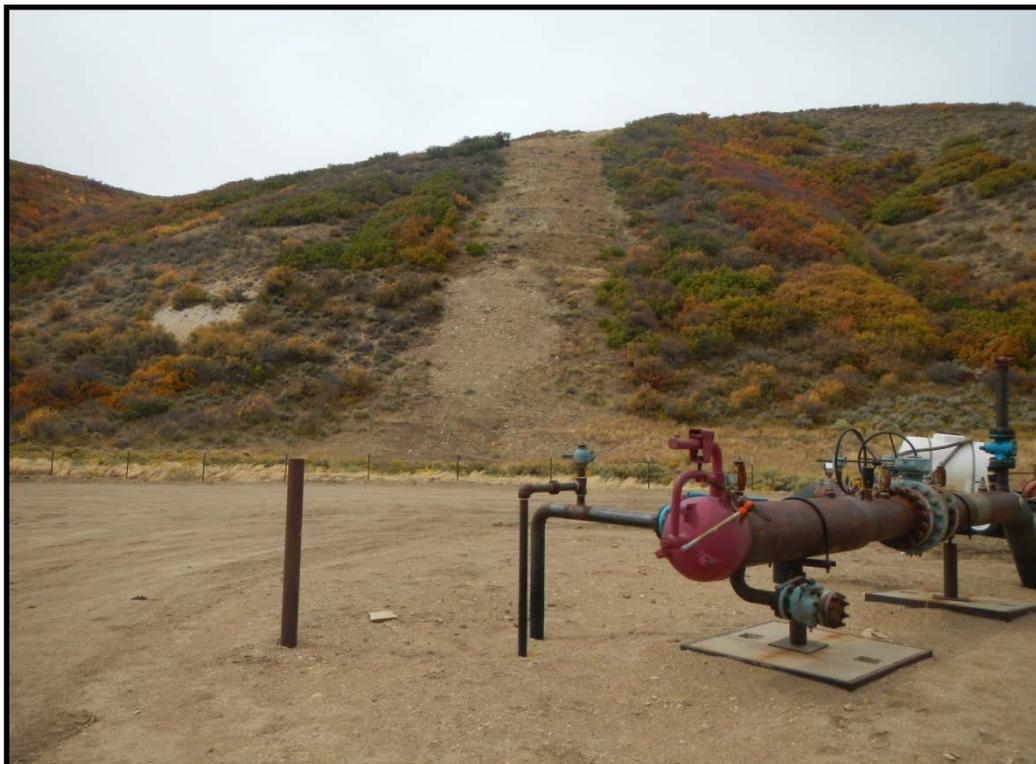
Disturbed soil indicates where the pipeline section has been replaced. Looking west from A27 CDP

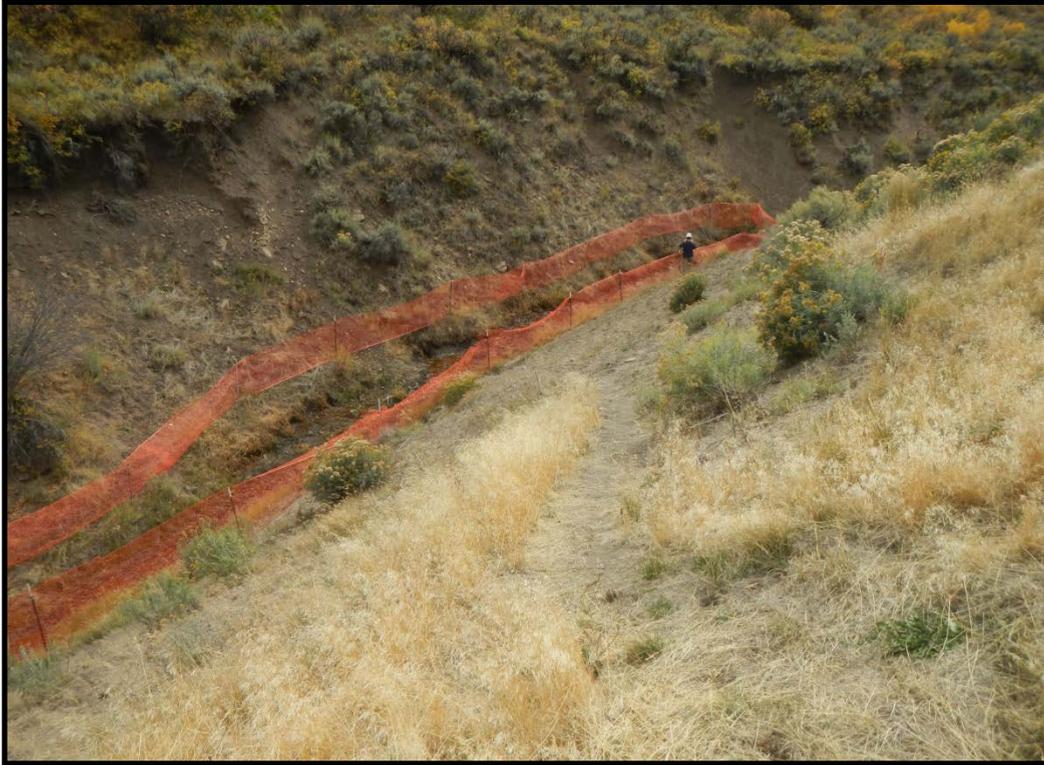
Impacted Springs

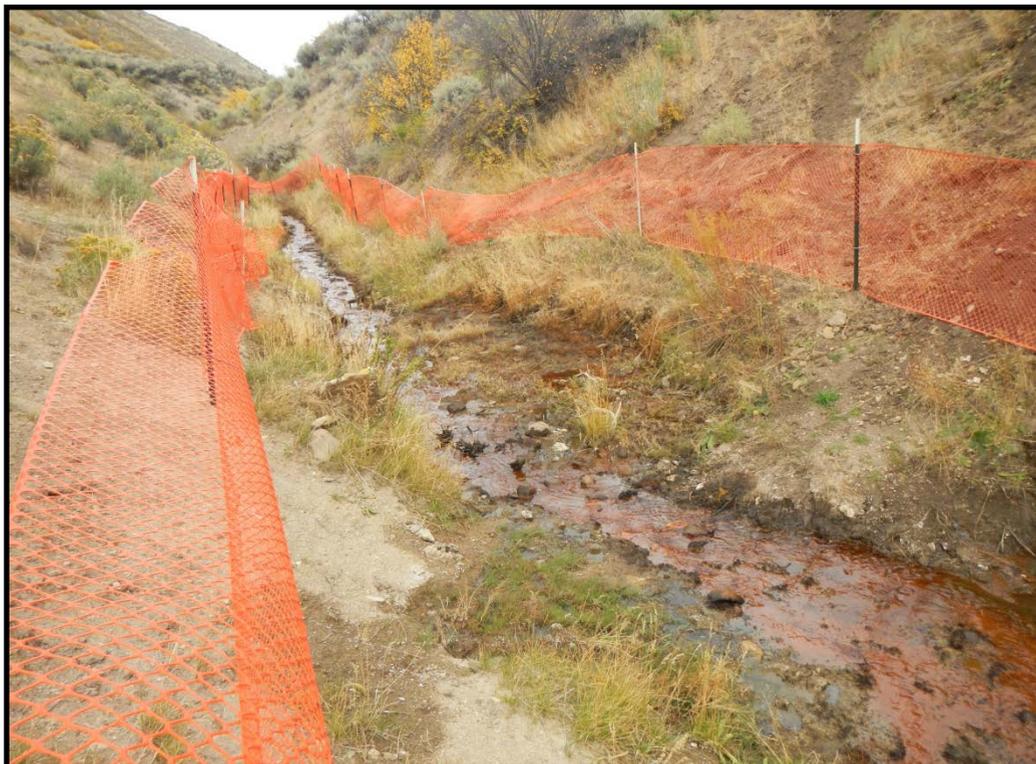
Free-product was not observed on the water. Creek bed has orange staining

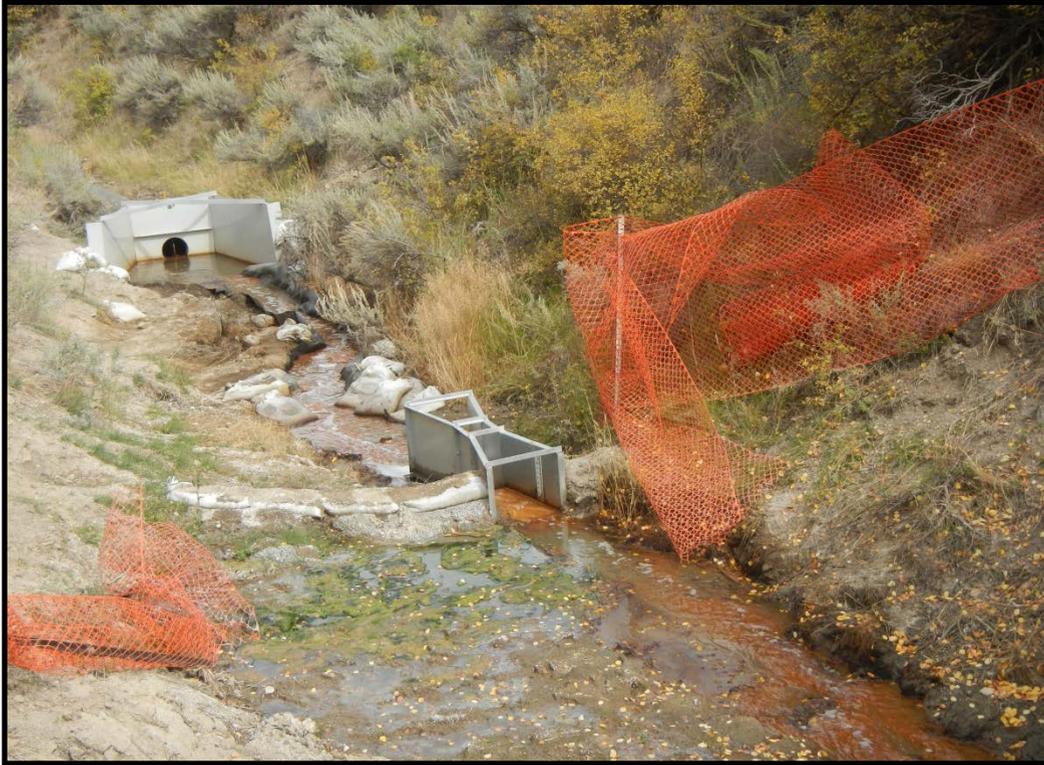
- 1) Weir to measure Springs discharge and 2) Water diversion to treatment system (separators and aerator)

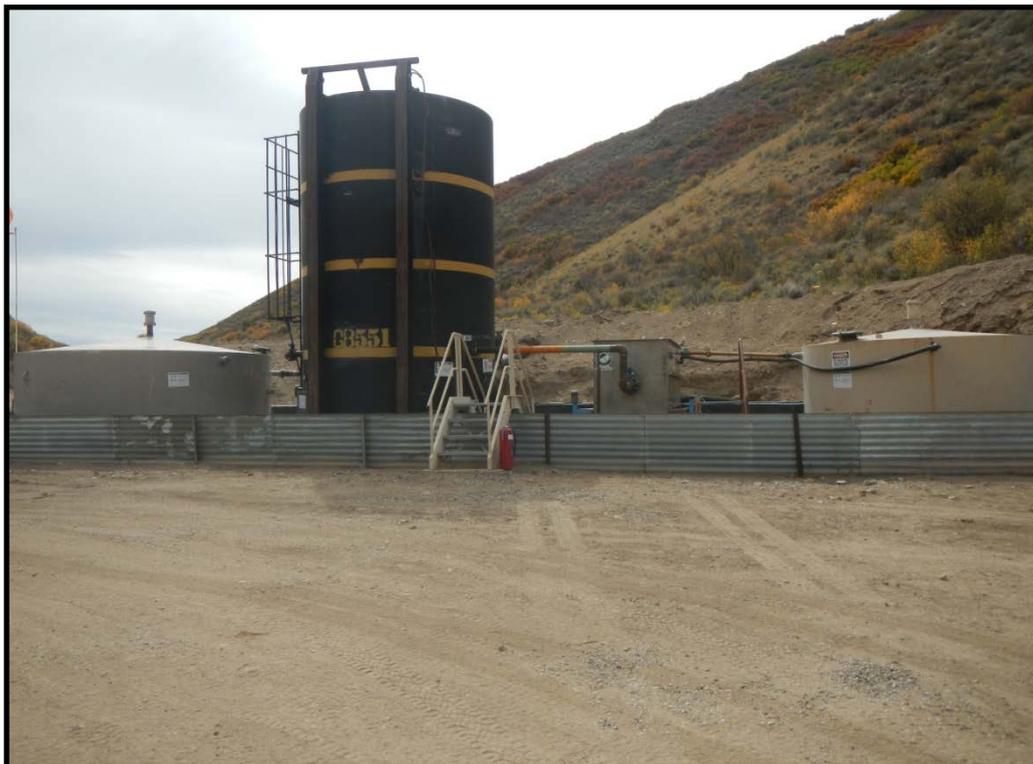
Separators (Gun Barrel at the center). According to Hunter Ridge, condensate recovery is diminishing, although spring flow rate has been fairly constant.

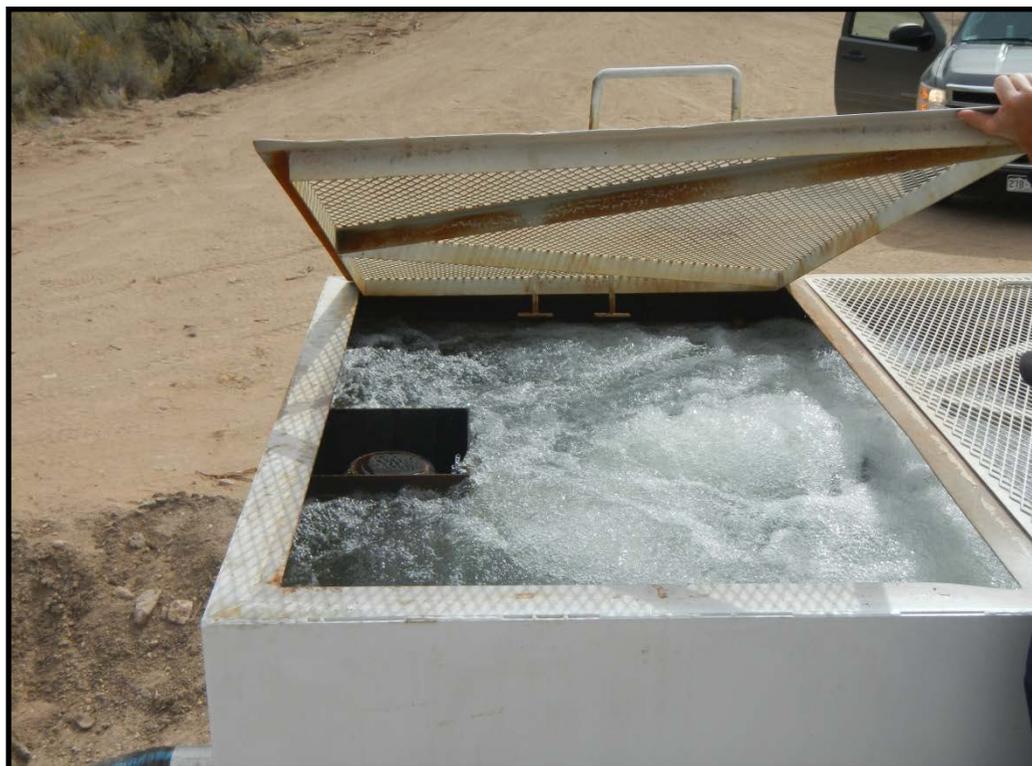
Aerator. Water is discharged back to the creek. Benzene concentration above Table 910-1

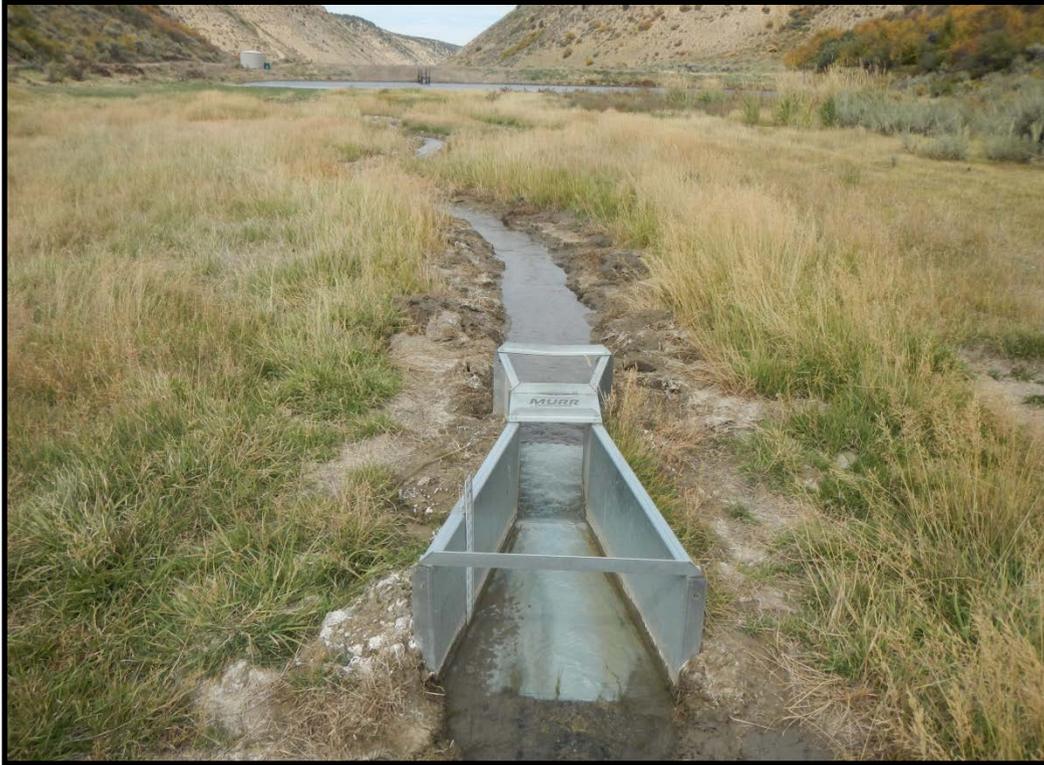
Weir to Measure total discharge to the Stock Pond: Flow from impacted springs plus additional flow from downstream (non-impacted) springs

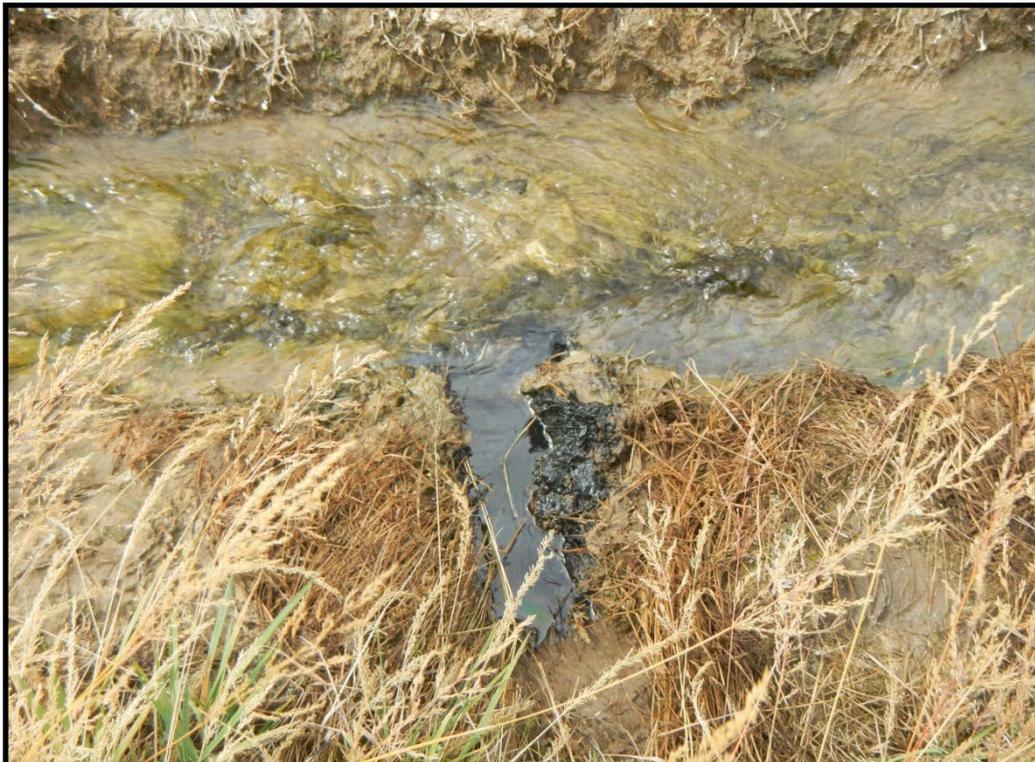
Black soil underneath the surface, by the creek

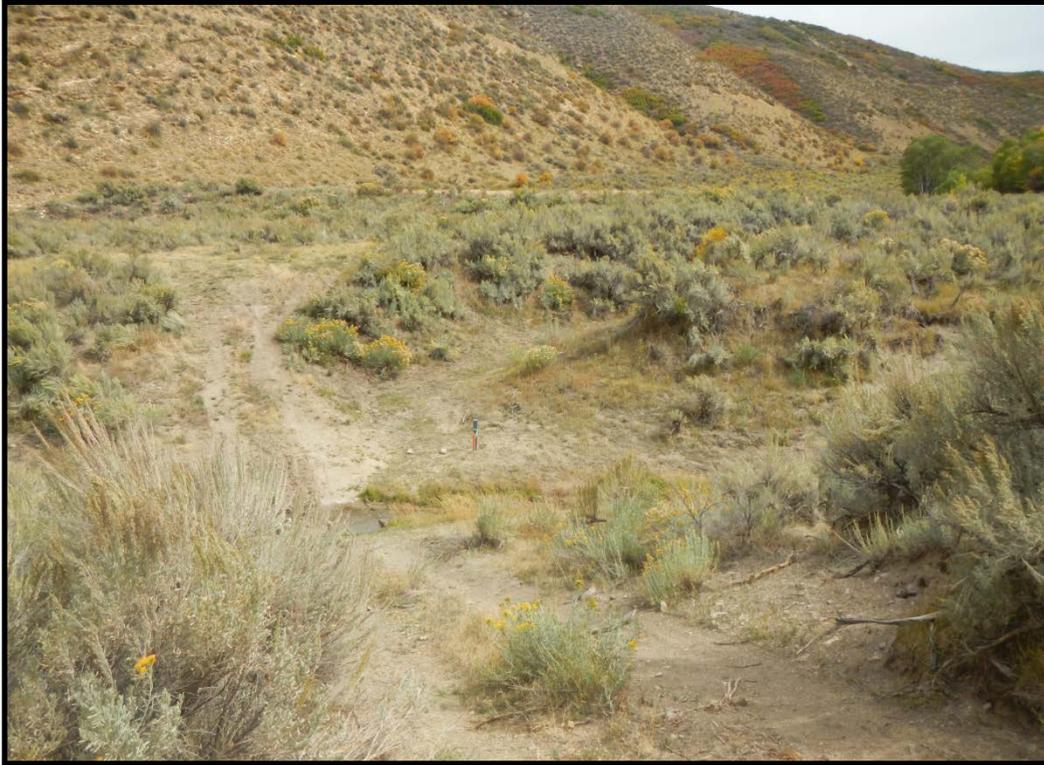
Monitoring well at the center of the valley, near the creek. According to Hunter Ridge, groundwater is non-detect for hydrocarbons.

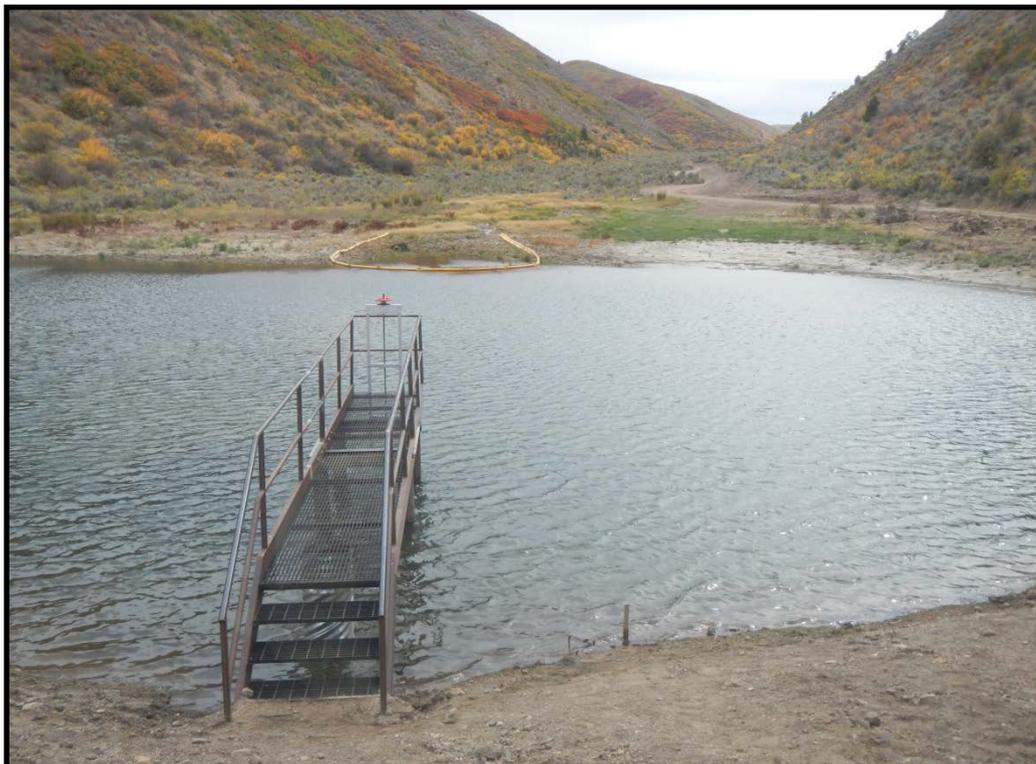
Stock pond, looking upstream (to the south).
