Stormwater Inspection

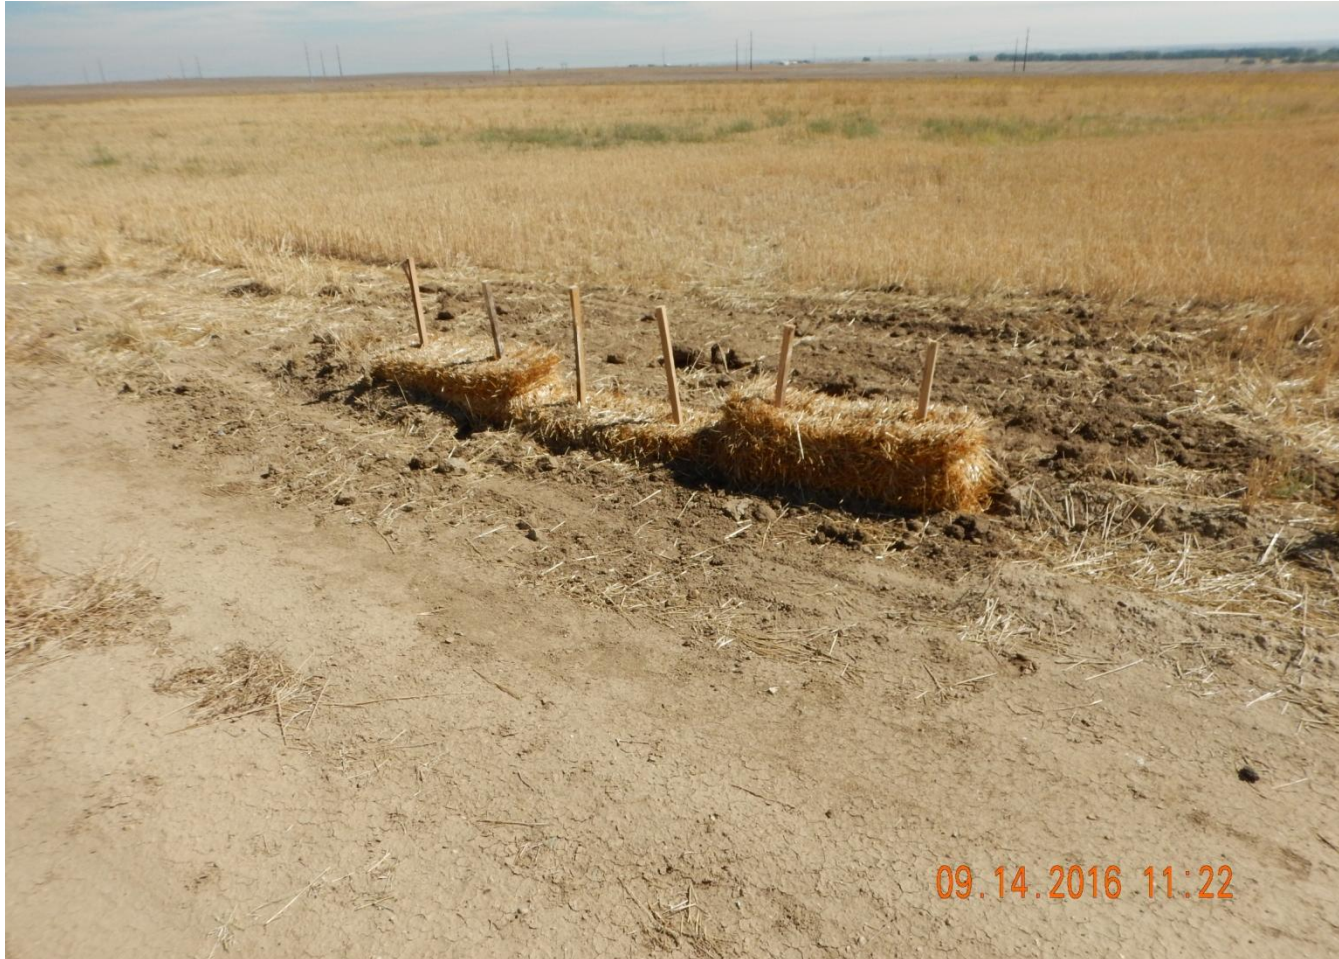
Photo 1. Photo taken from the lease road, facing East. Straw bales installed to control sedimentation from leaving lease road. Stormwater could possibly travel around straw bales because location lacks diversion features.

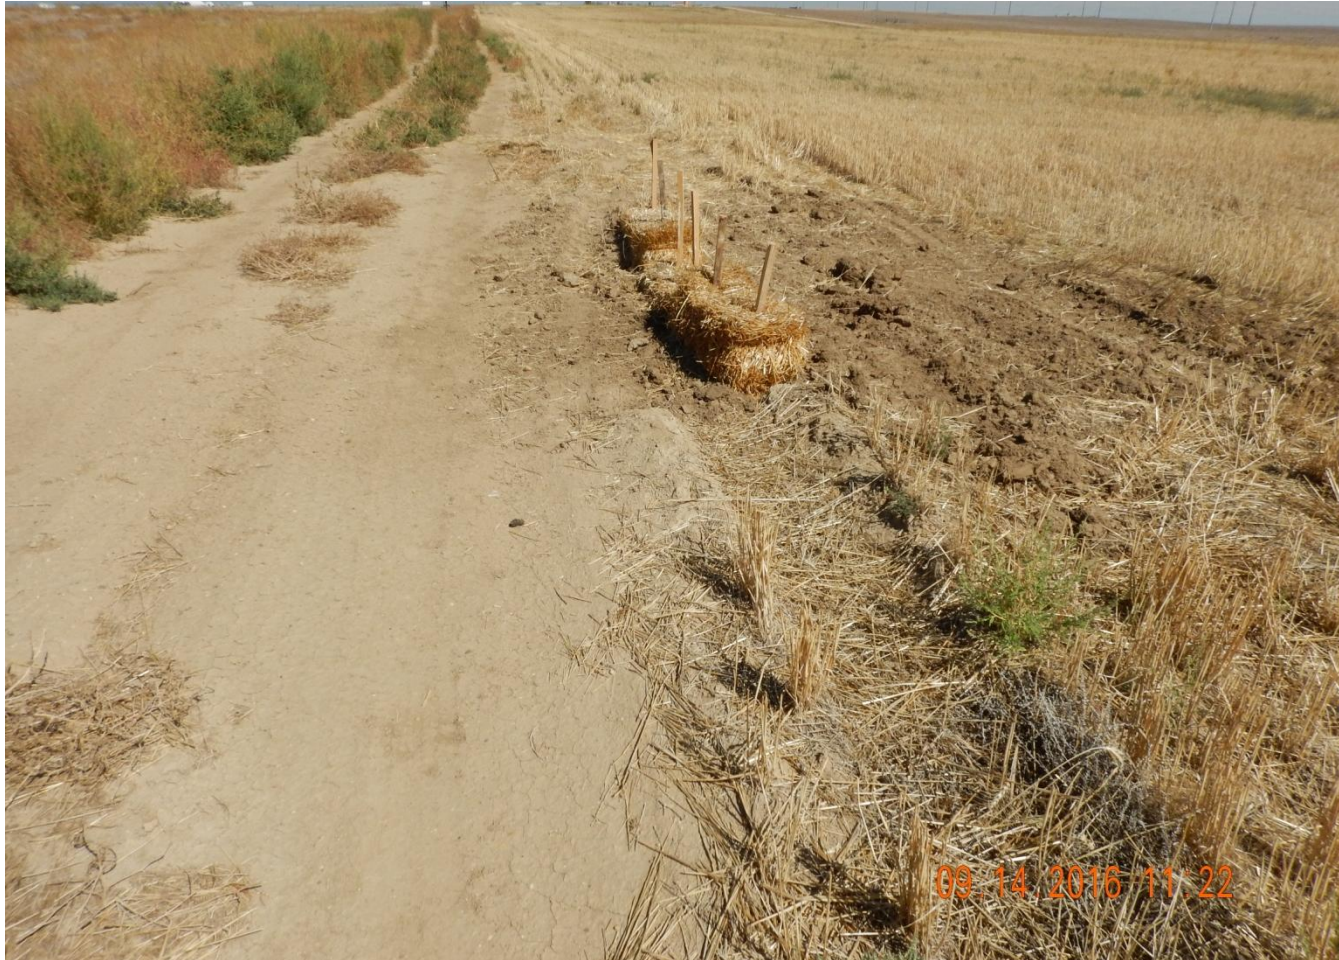
Photo 2. Photo taken from the lease road, facing North. Straw bales installed to control sedimentation from leaving lease road. Stormwater could possibly travel around straw bales because location lacks diversion features.
