Stormwater Inspection

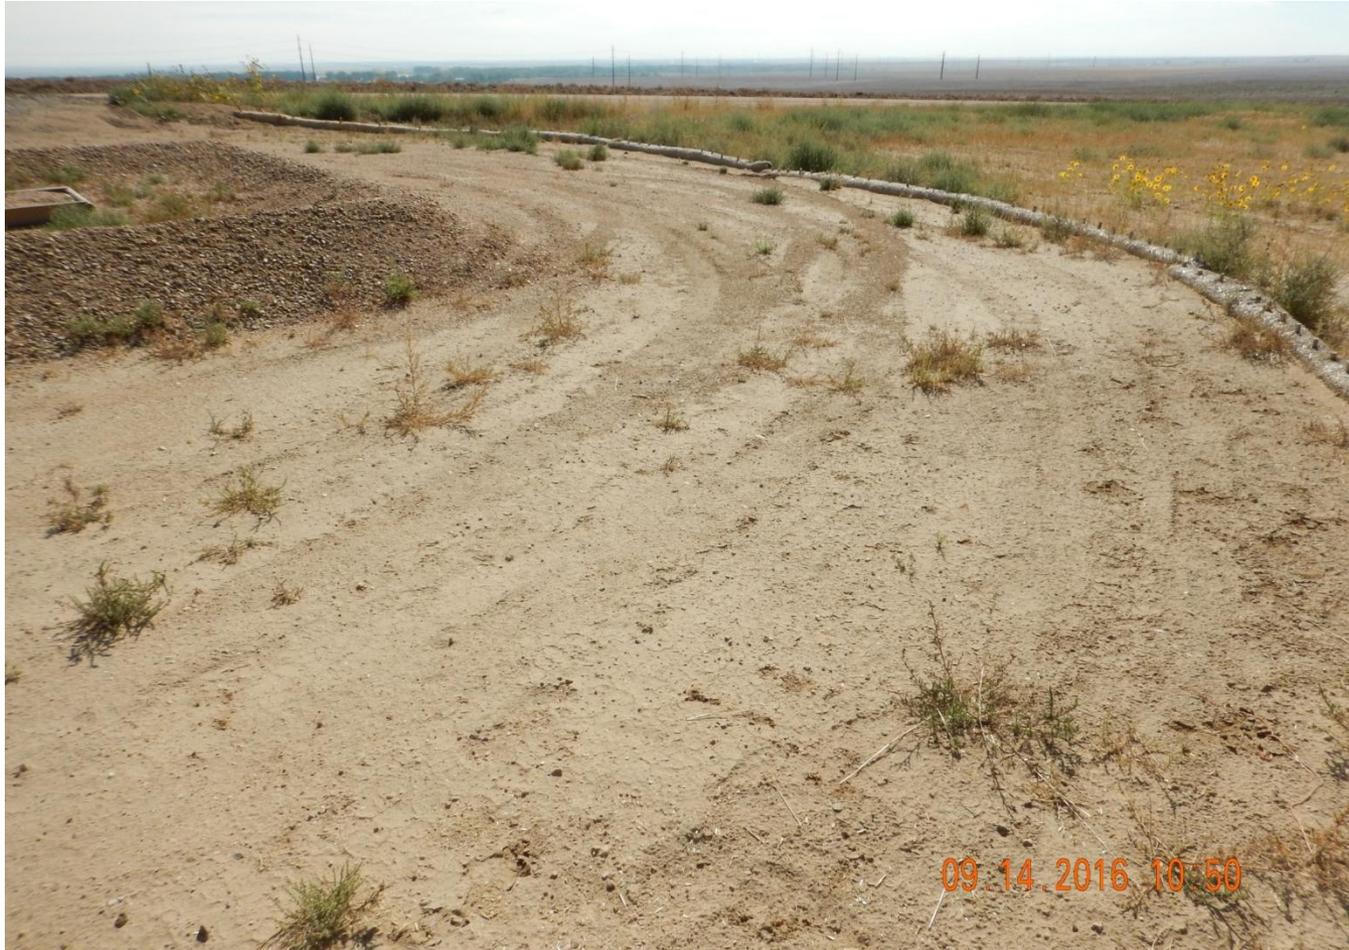
Photo 1. Photo taken from the western location, facing Southeast. Straw wattles installed to control sedimentation from leaving location.

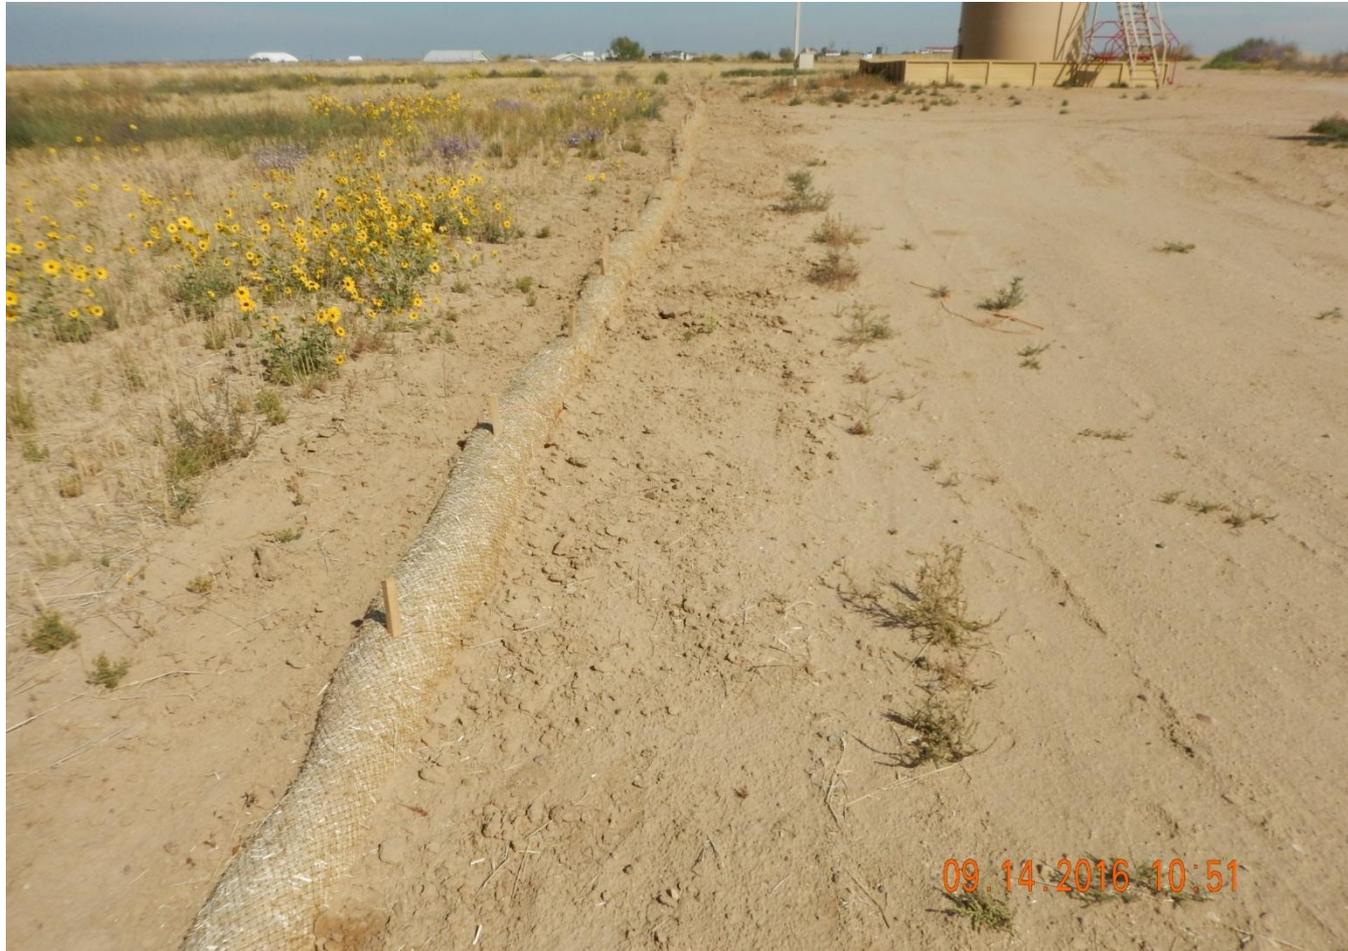
Photo 2. Photo taken from the western location, facing North. Straw wattles installed to control sedimentation from leaving location.

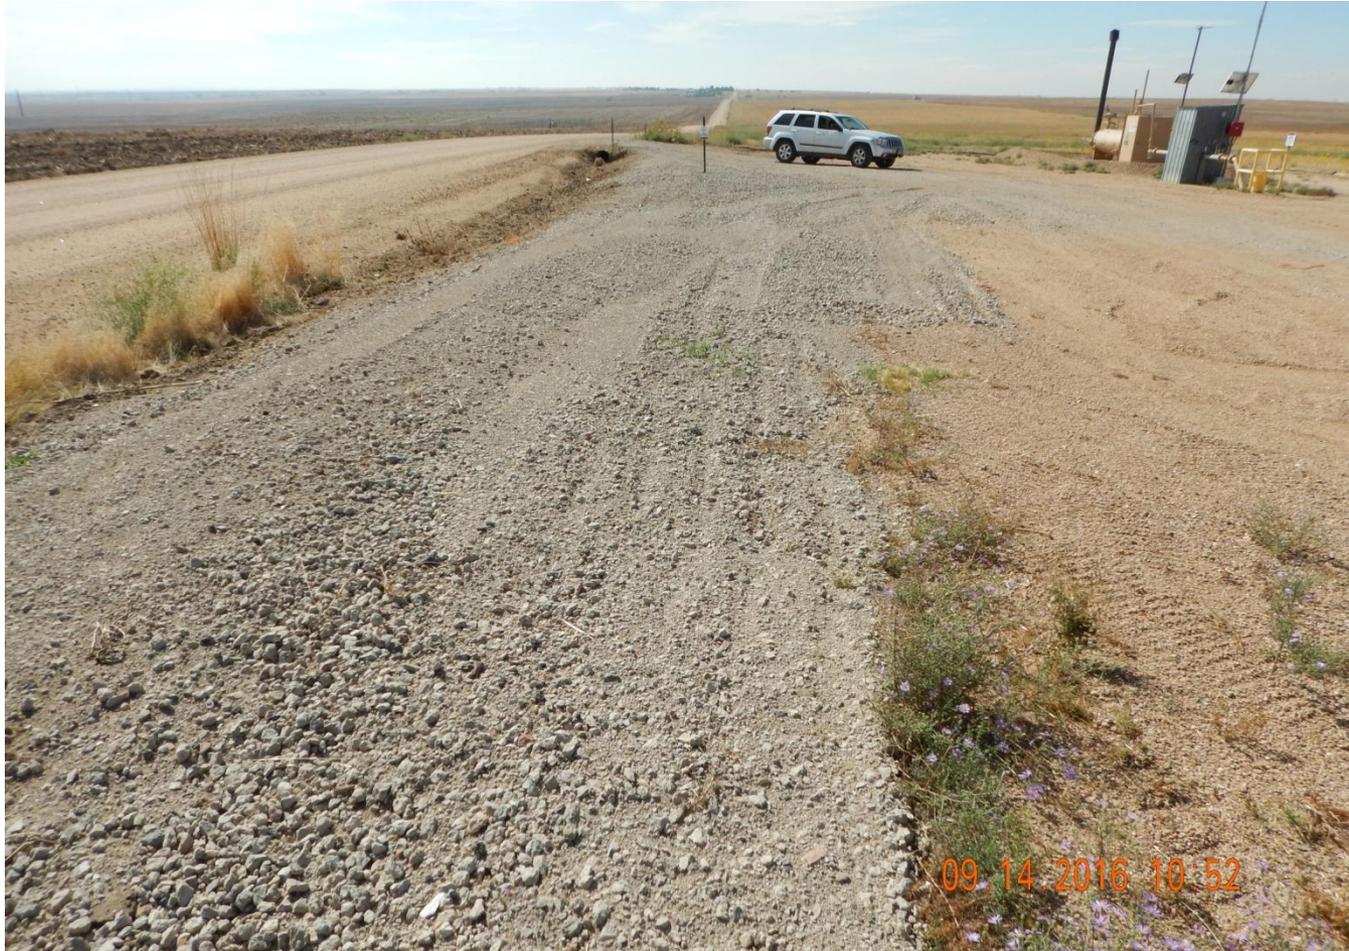
Photo 3. Photo taken from the eastern location, facing South. Gravel installed to stabilize location and prevent erosion.
