Stormwater Inspection

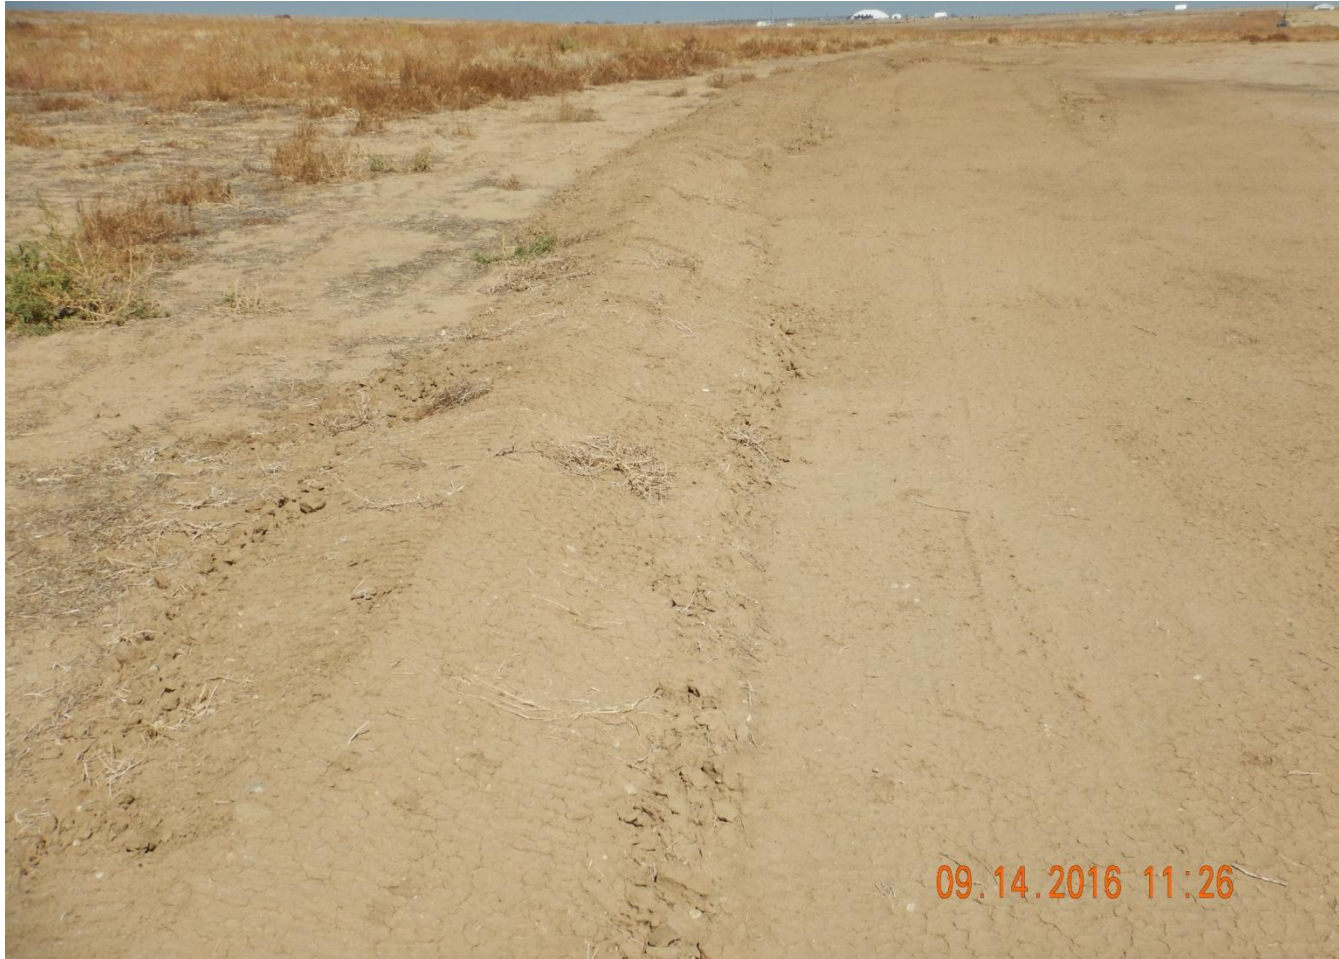
Photo 1. Photo taken from the western location, facing North. Berm was constructed to control run-on onto the location.

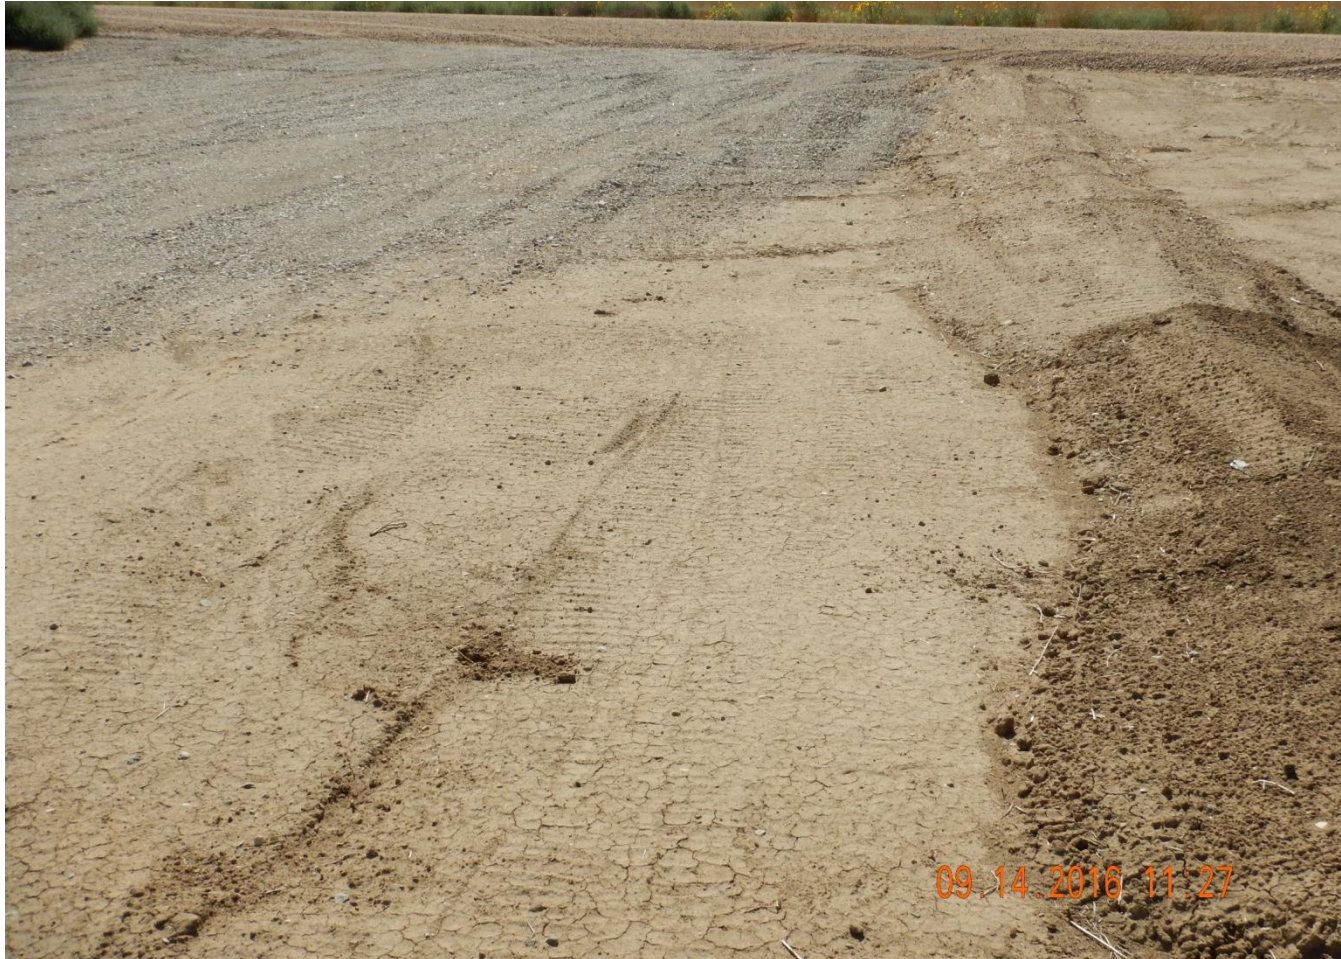
Photo 2. Photo taken from the western location, facing South. Berm was constructed to control run-on onto the location. Also, gravel installed to stabilize location and prevent erosion.

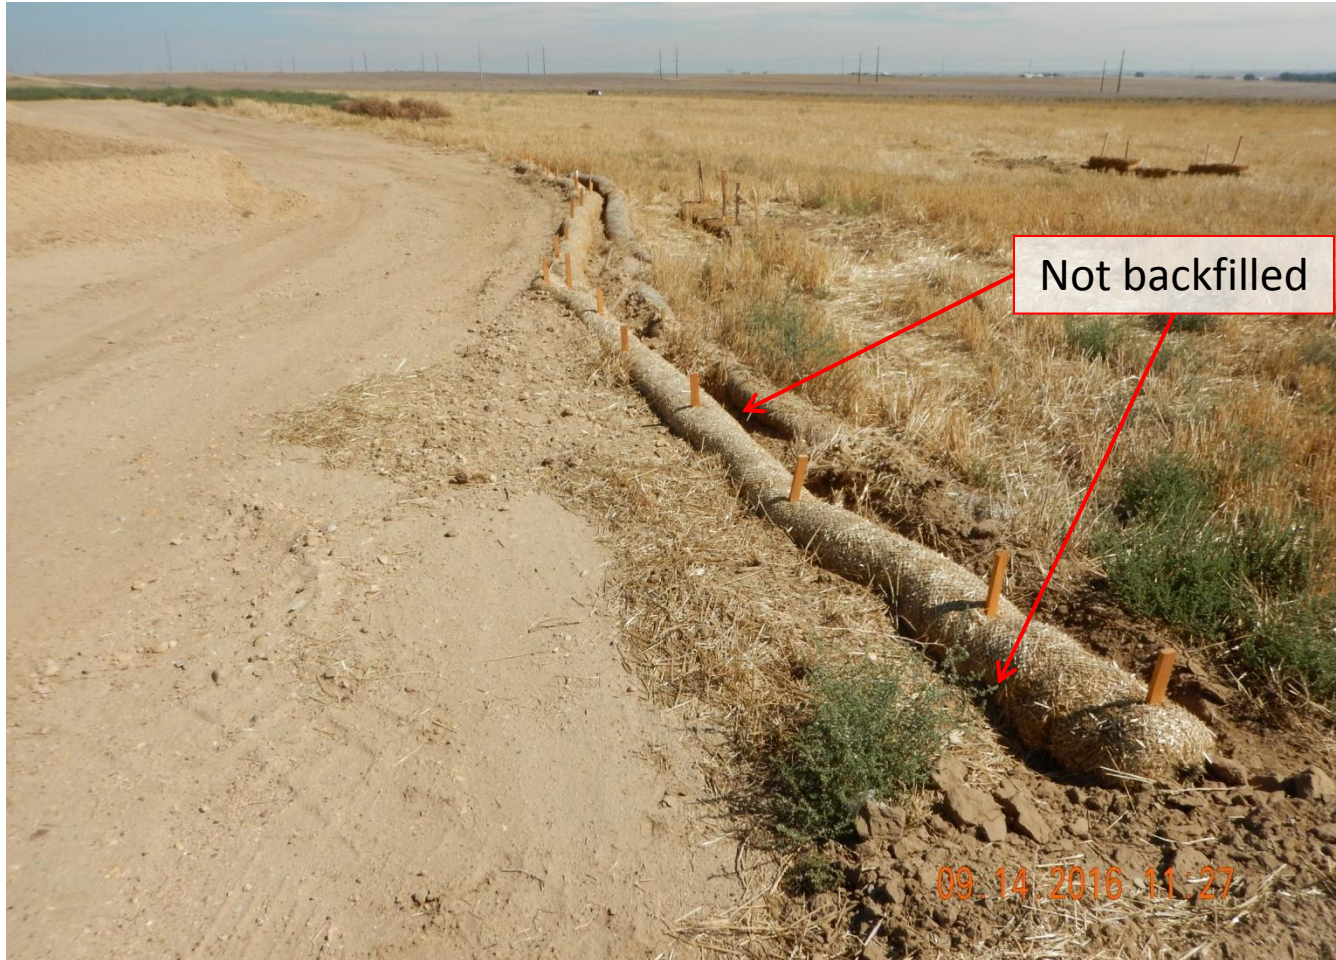
Photo 3. Photo taken from the southeast location, facing Northeast. Two sets of wattles were installed and used in conjunction with another BMP (i.e., straw bale). Wattle installation has some potential weak spots because areas were not properly backfilled.

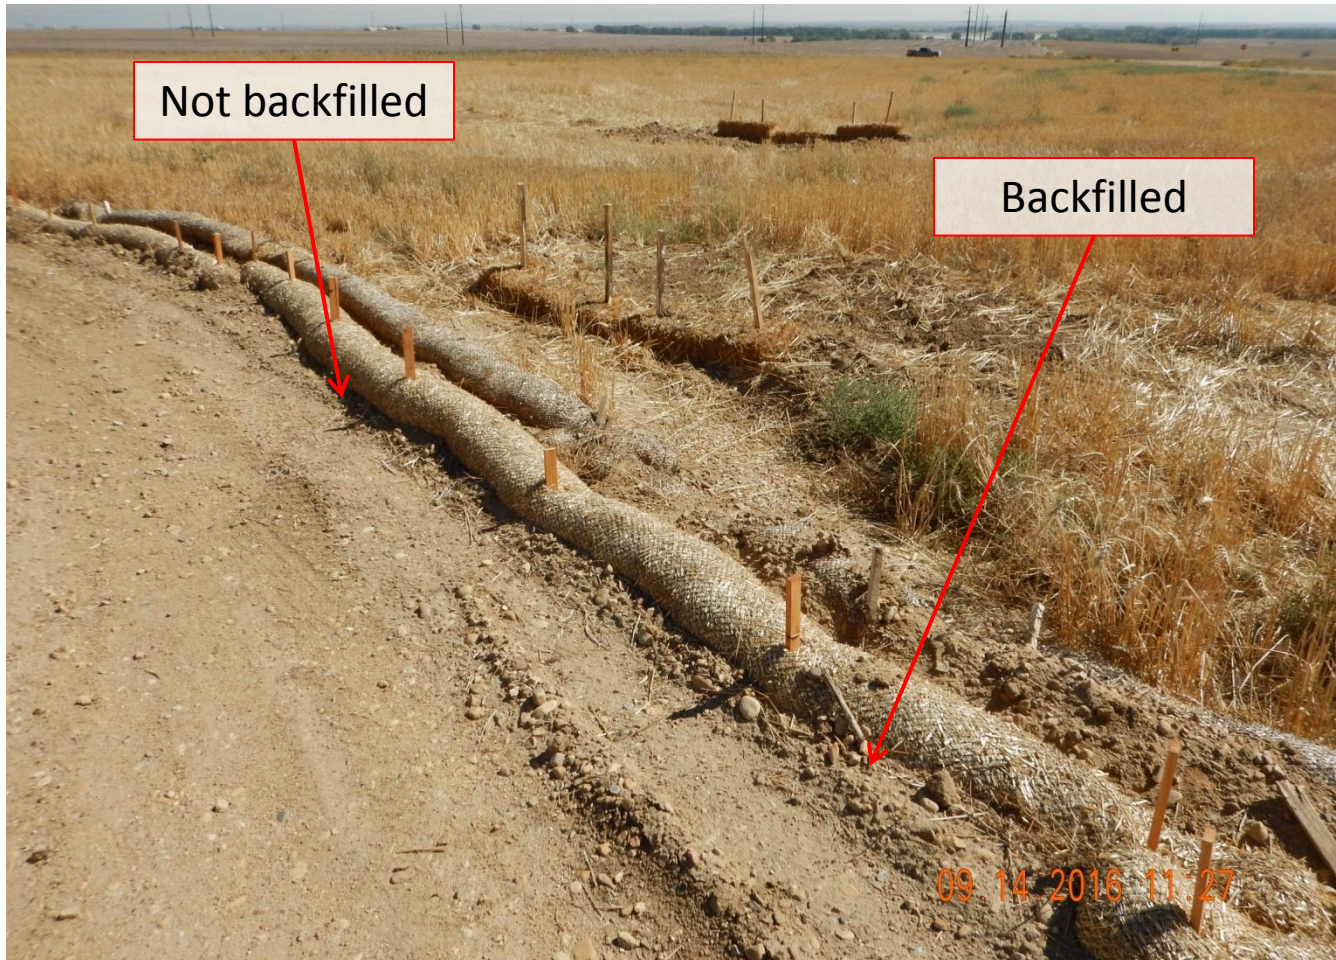
Photo 4. Photo taken from the southeast location, facing Northeast. Two sets of wattles were installed and used in conjunction with another BMP (i.e., straw bale). Wattle installation has some potential weak spots because areas were not properly backfilled.

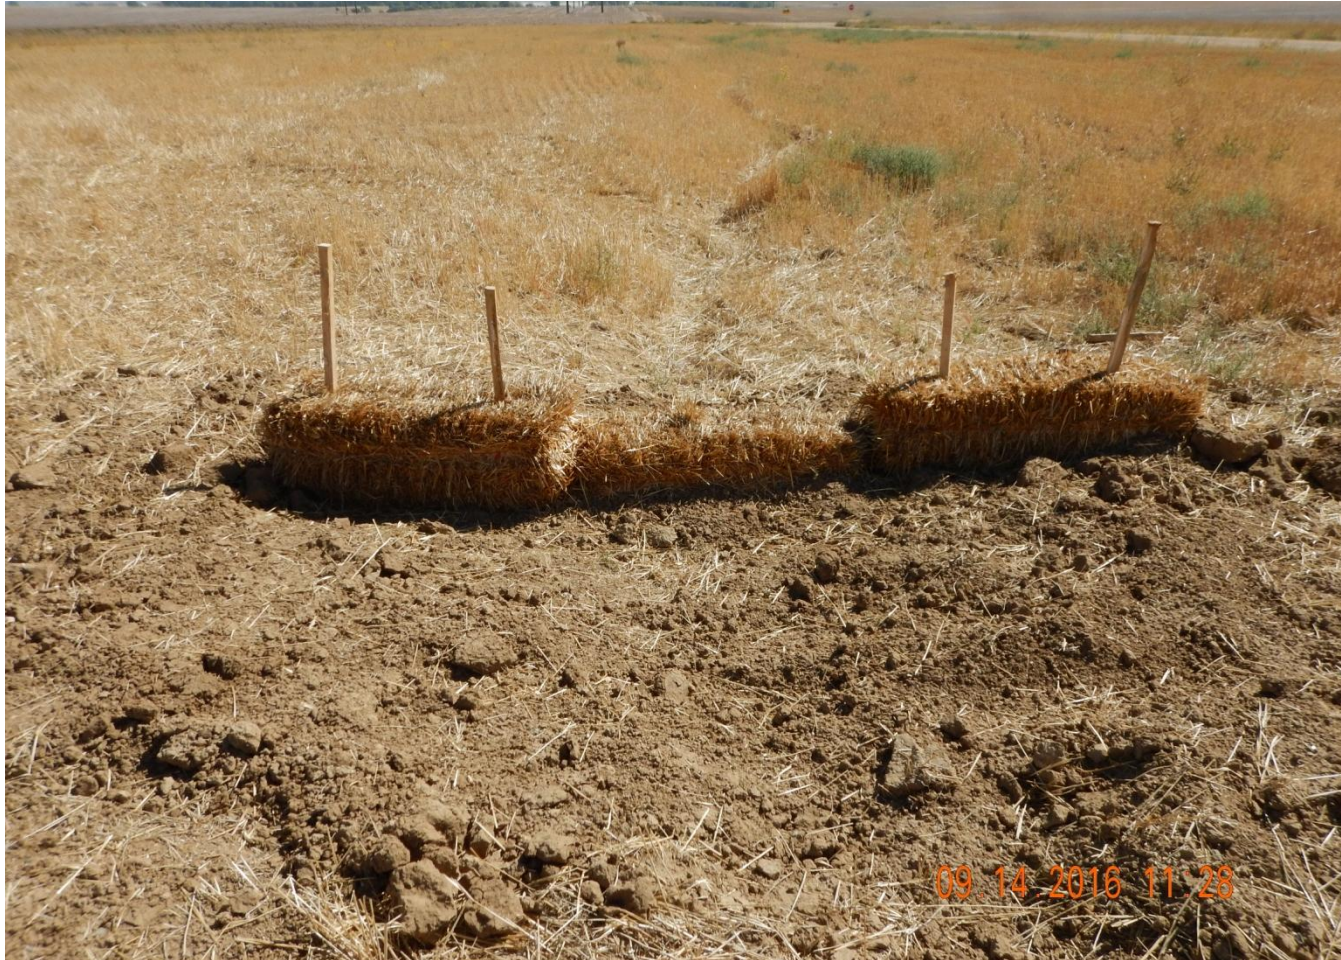
Photo 5. Photo taken east of wattles, facing East. Straw bale barrier BMPs installed in conjunction with the wattles.
