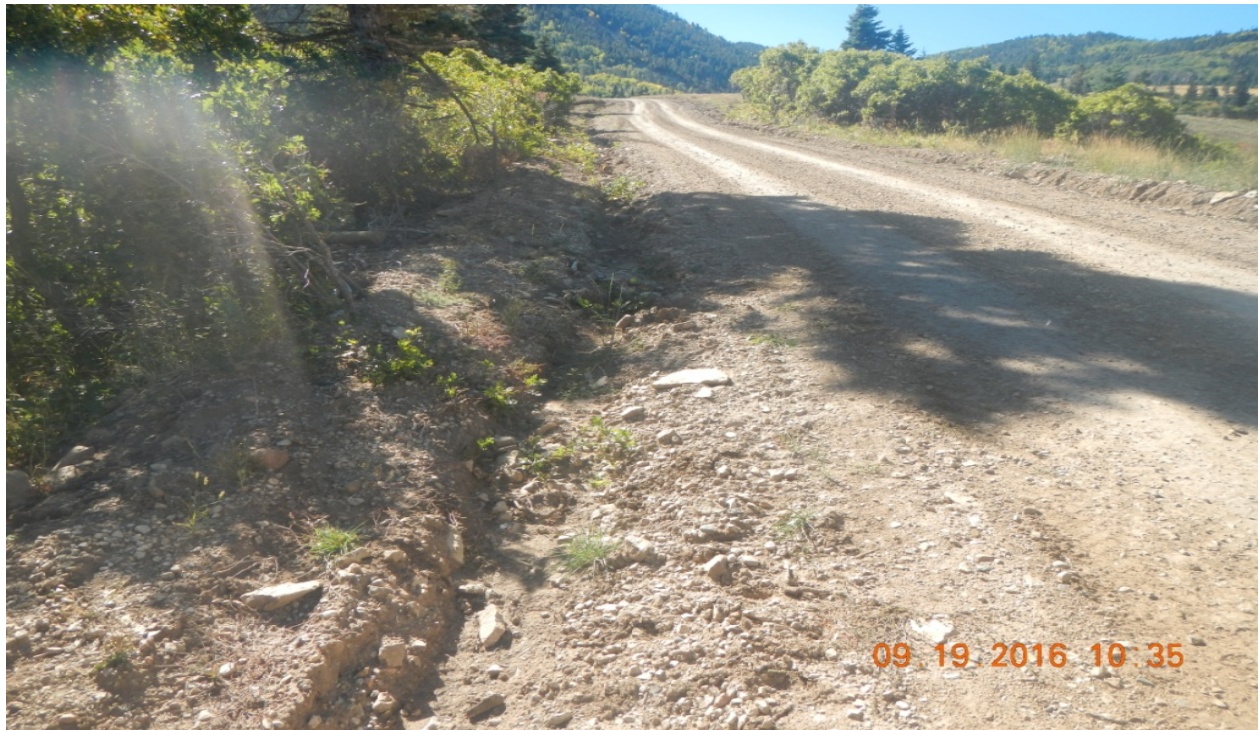
photo 1: Facing south along access road near the location. There are no BMP's to de-energize stormwater that flows down the side of the access road.

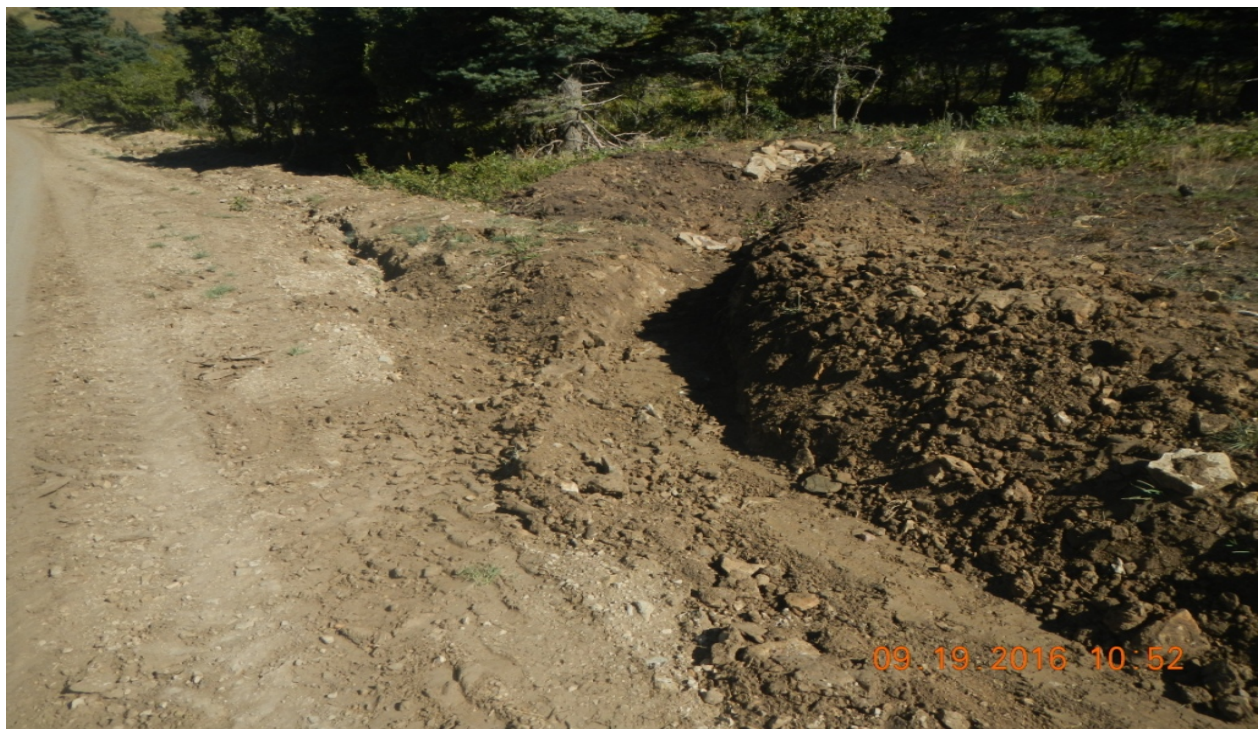
photo 2: Facing along the access road near the location. There is a sediment trap that has been installed.

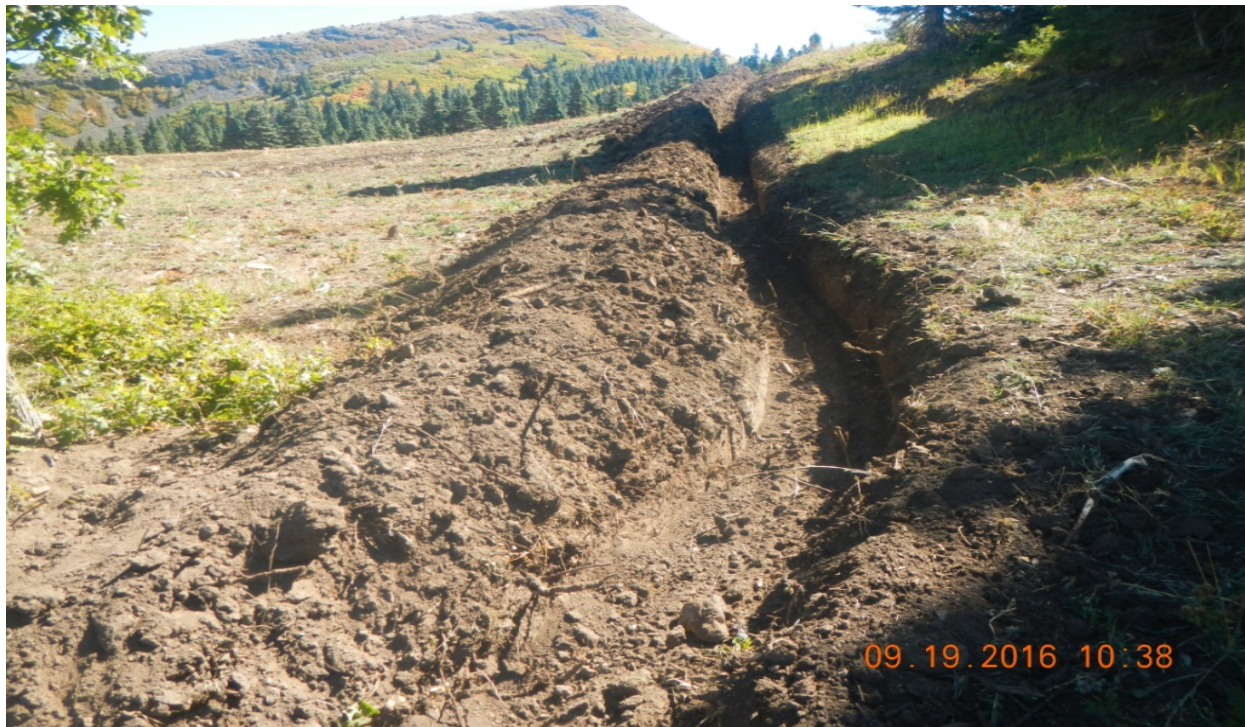
photo 6: A ditch has been installed along the south cut slope side of the location. Additional BMP's should be installed to de-energize stormwater flow within the ditch.

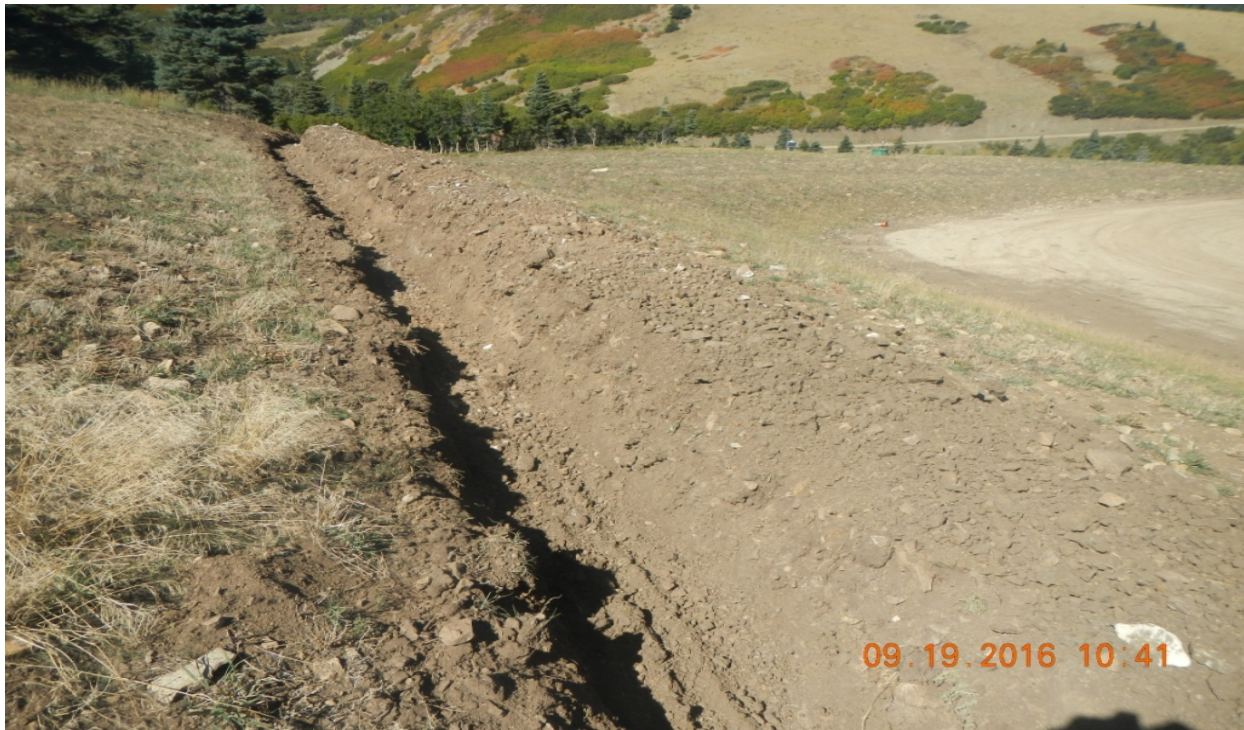
photo 7: Facing northwest along the south side of the location. Additional BMP's should be installed to de-energize stormwater flow within the ditch.
