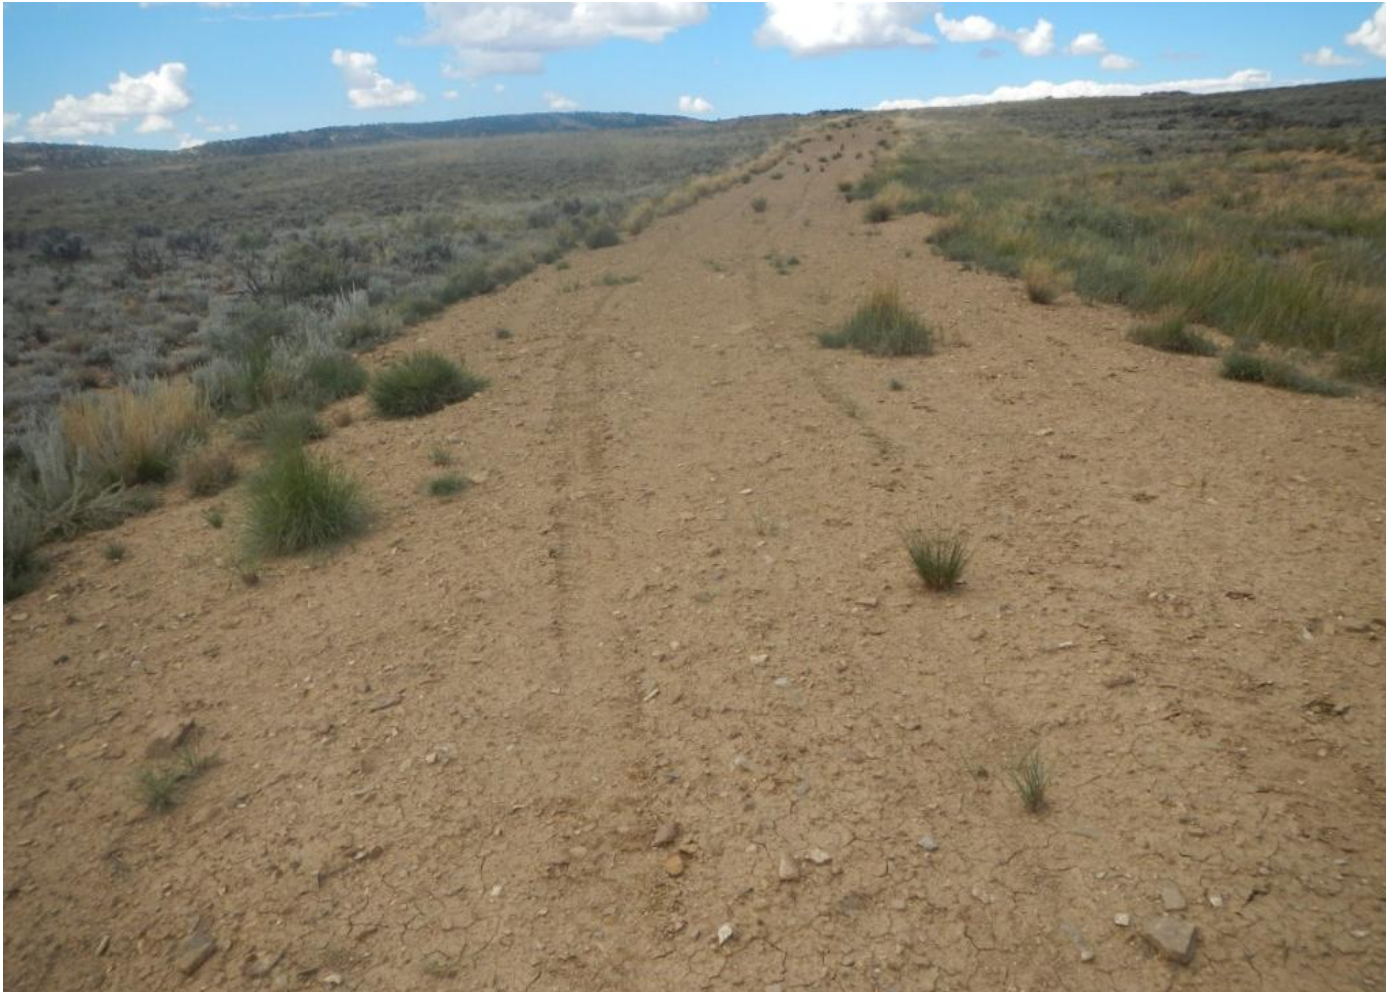
Photo 1. View from the end of the access near the well pad entrance facing westward. Access road has not been reclaimed and needs to be fully reclaimed.

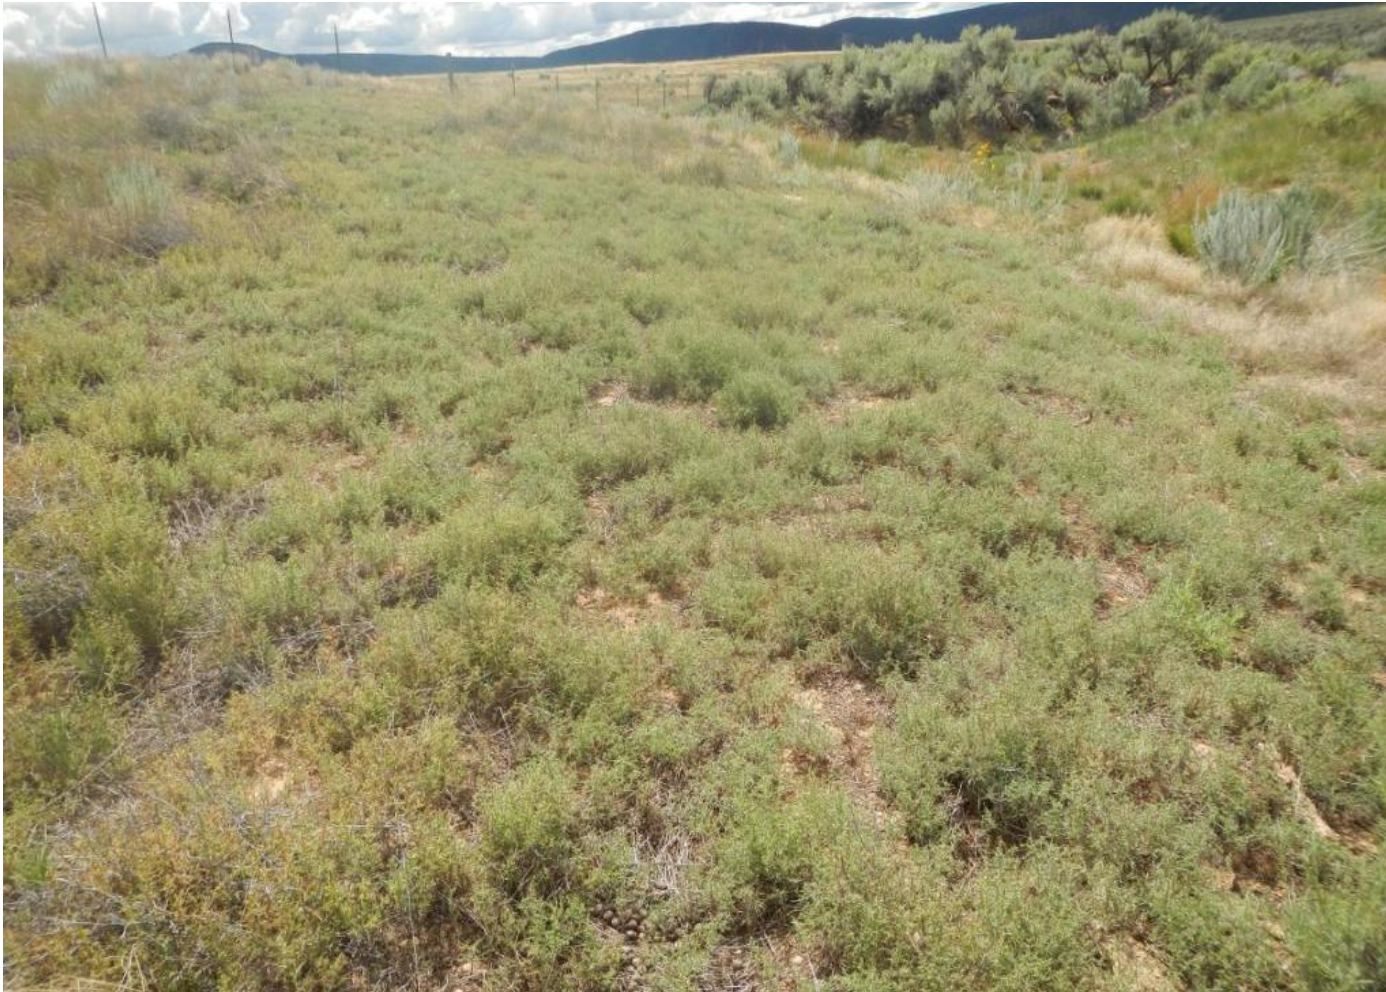
Photo 2. View of an area that is approximately 50 feet wide and 75 feet long where the access entered the well pad that has not revegetated and supports only a dense population of Russian thistle (*Salsola tragus*). This area needs to be re-seeded and likely mulched.

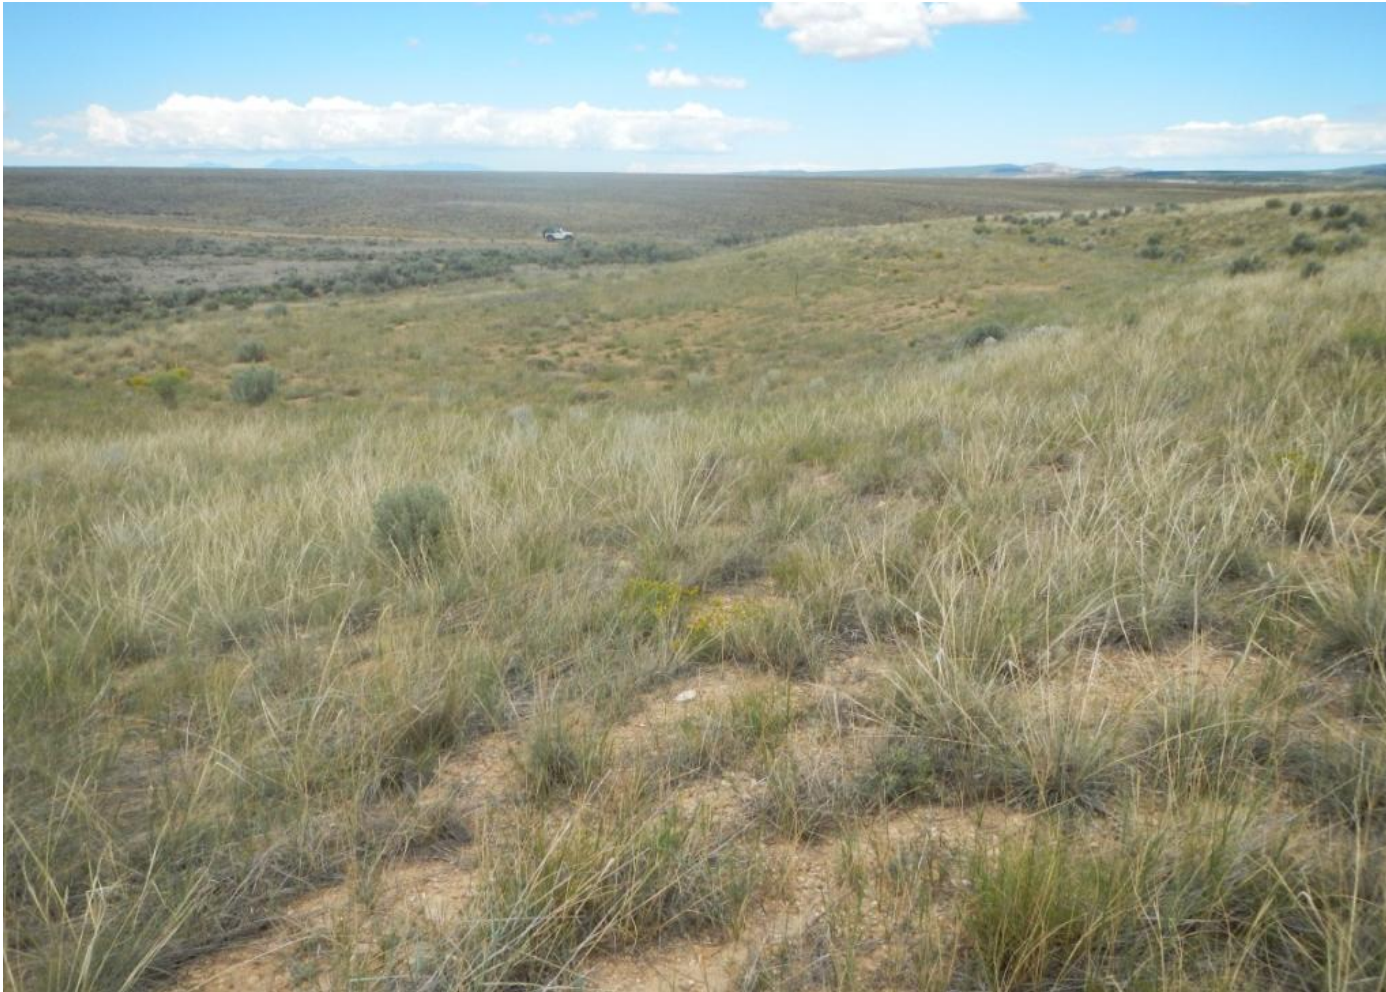
Photo 3. View of well pad from the southeastern corner facing center. Revegetation is progressing. Well pad contours do not match surrounding contours. Vegetation on the well pad is largely comprised of grasses such as needle and thread grass (*Hesperostipa comata*), western wheatgrass (*Pascopyrum smithii*), and cheatgrass (*Bromus tectorum*) along with subshrubs such as snakeweed (*Gutierrezia sarothrae*) and winterfat (*Krascheninekovia lanata*).
