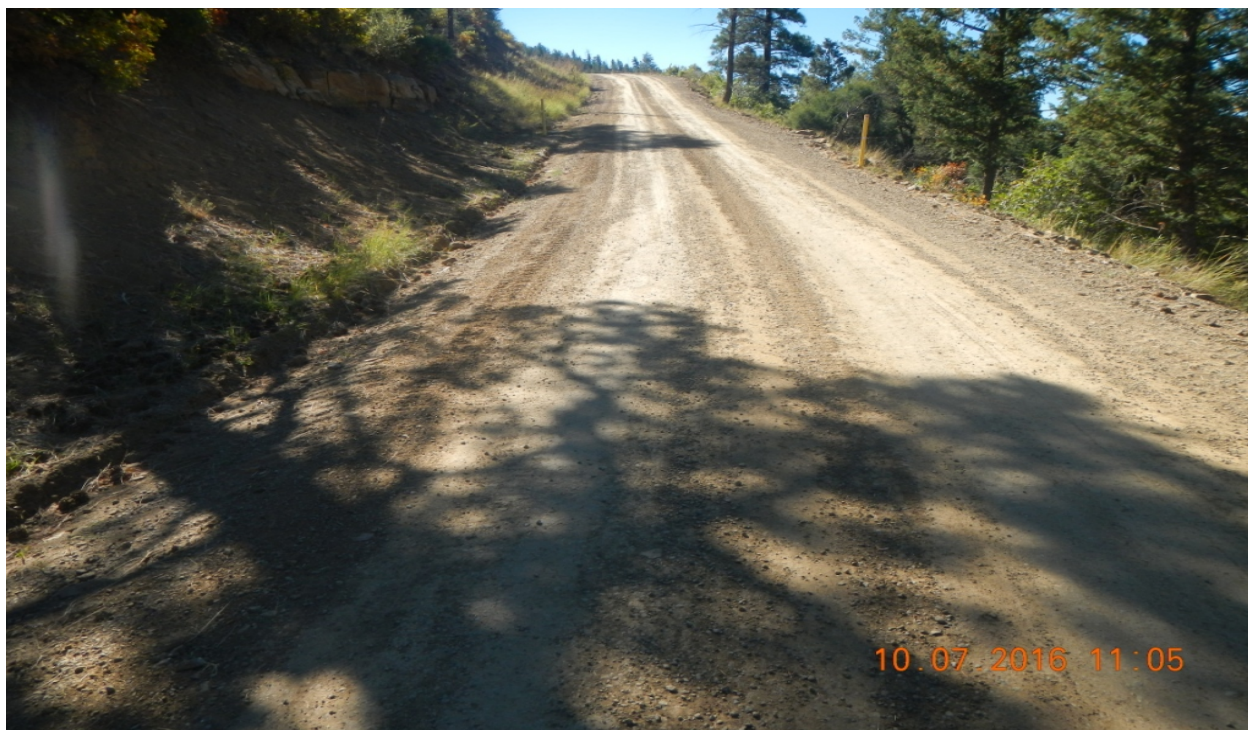
photo 1: Facing south along the main access road to the location. The road has been graded.

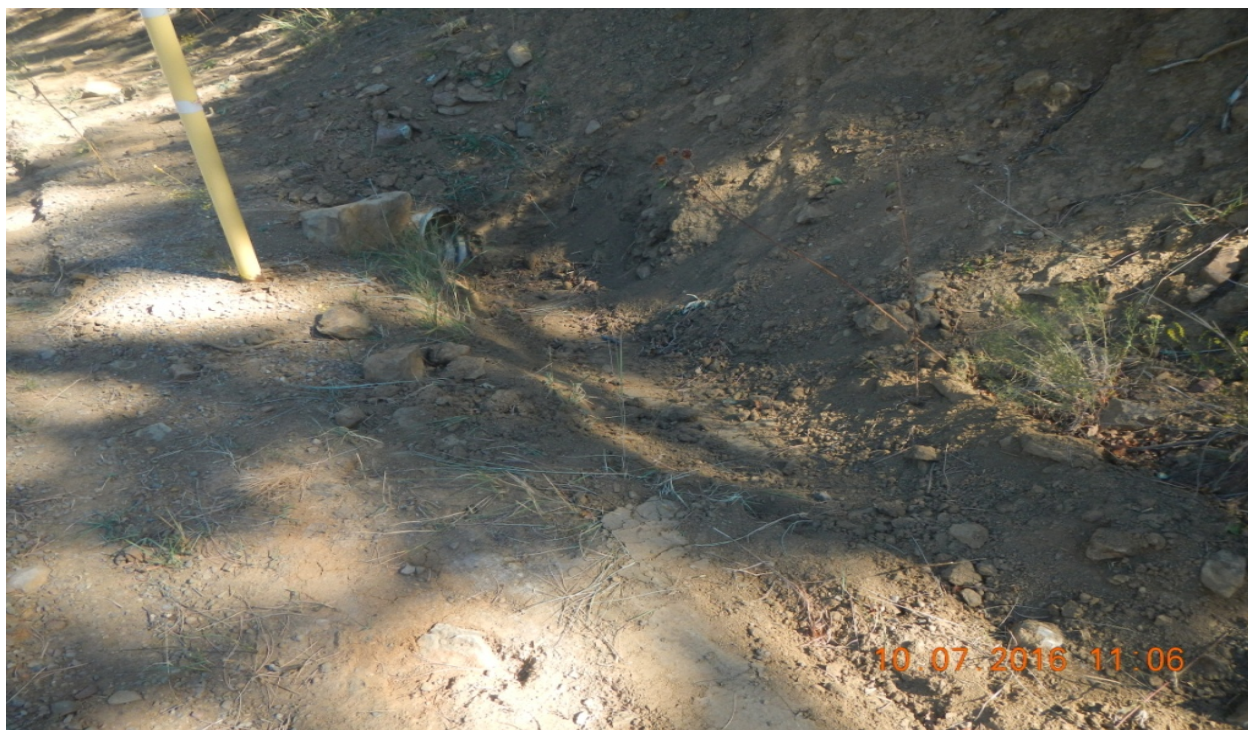
photo 2: The culverts have been cleaned and maintained.

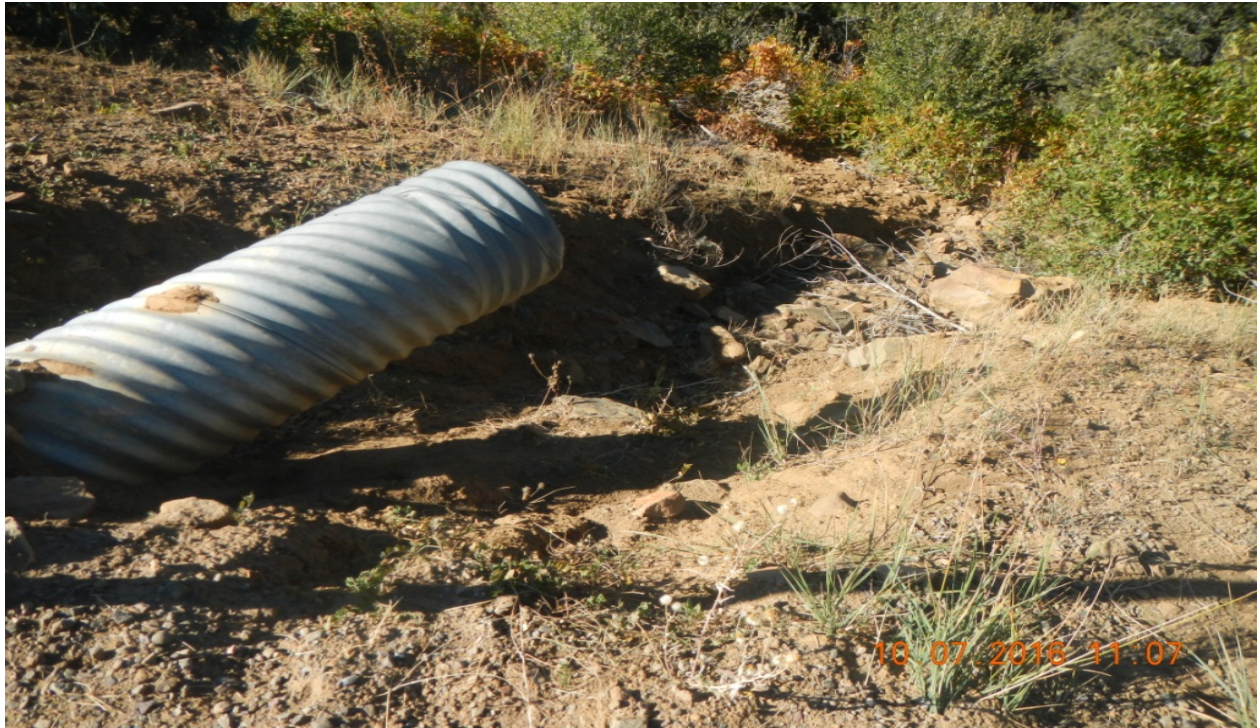
photo 3: It was noticed that some culverts do not have outlet protection which is a potential for erosion.

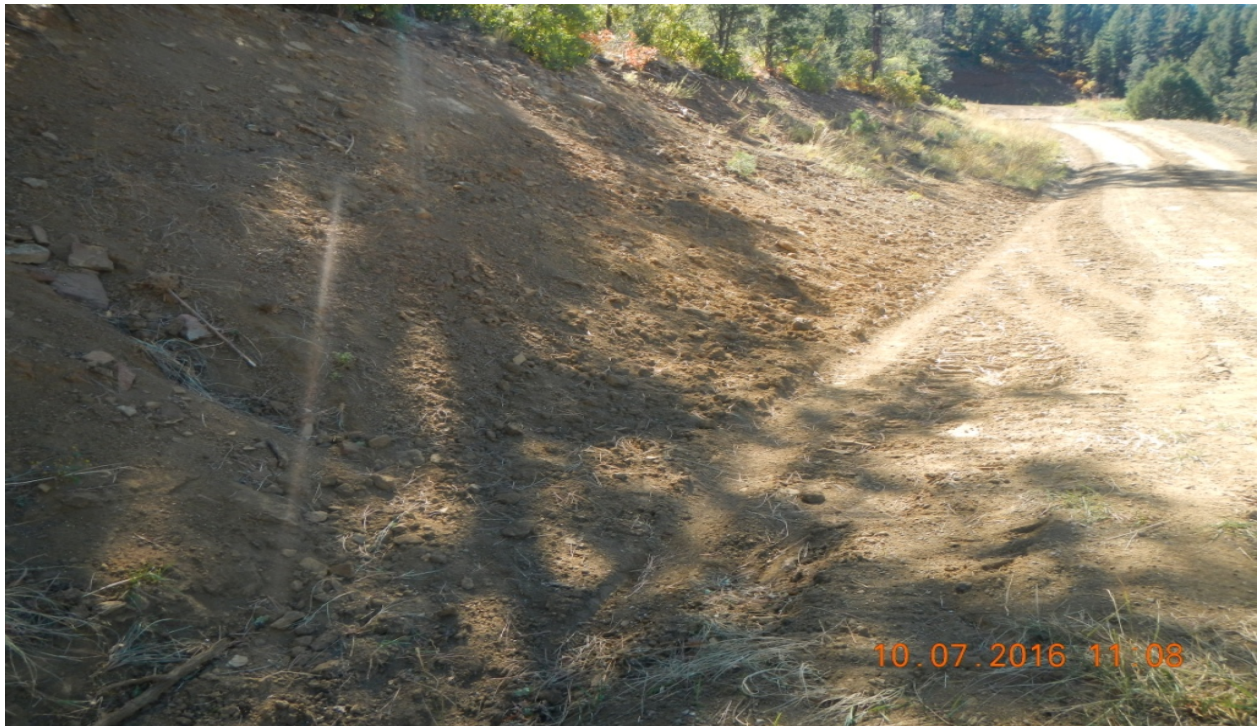
photo 4: The side of the access road was reggraded and seeded. Stormwater is now properly diverted.

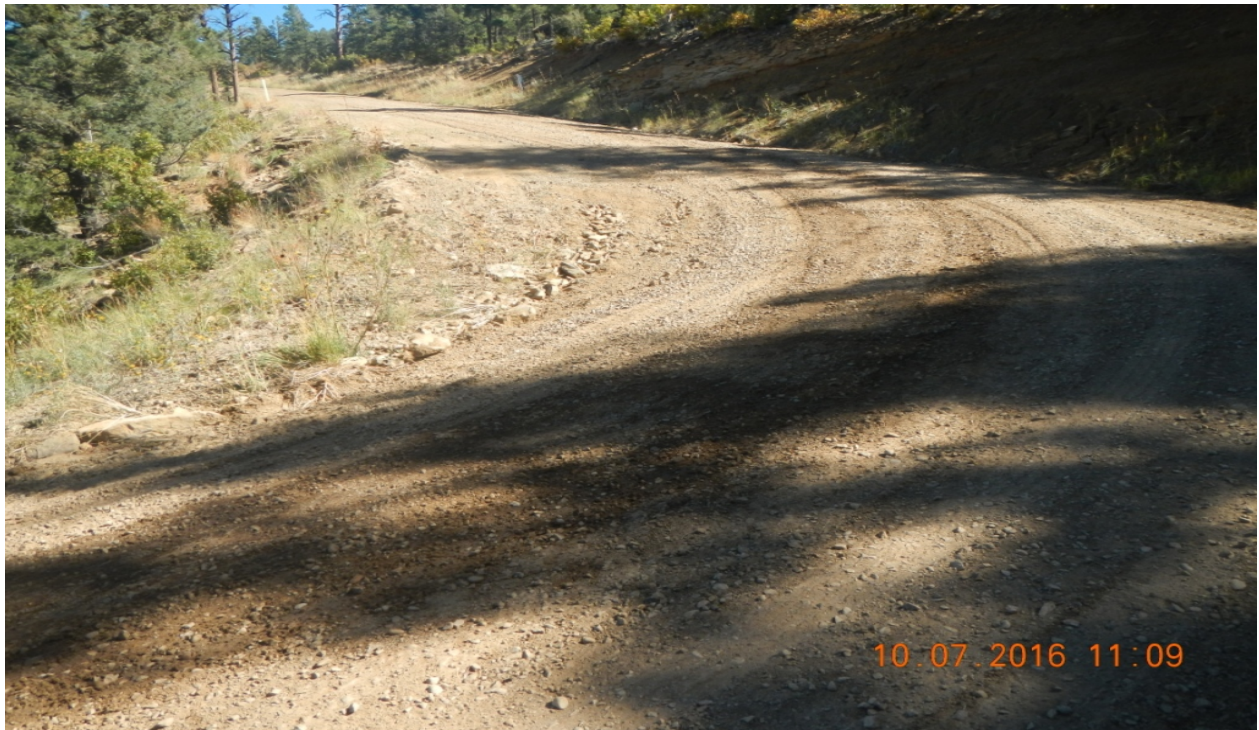
photo 5: The main road switches back to the northeast at this point. Erosion issues have been corrected.

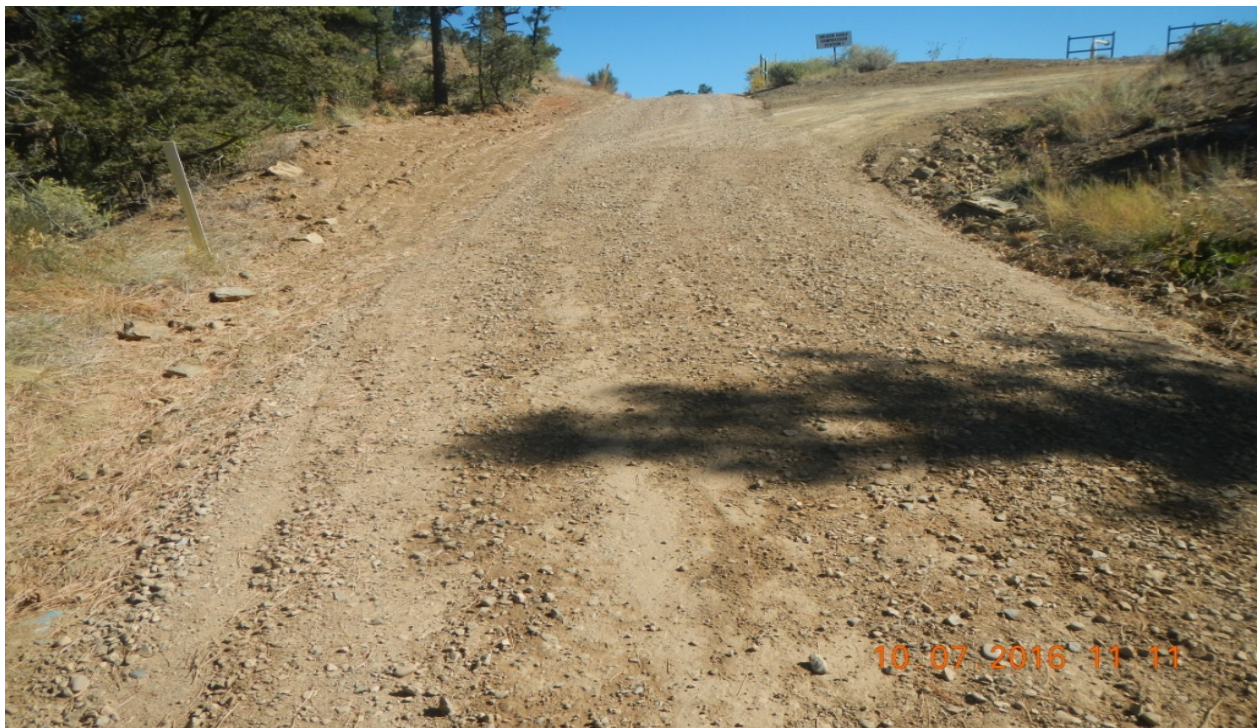
photo 6: Facing northeast along the main access road. Erosion issues have been corrected.

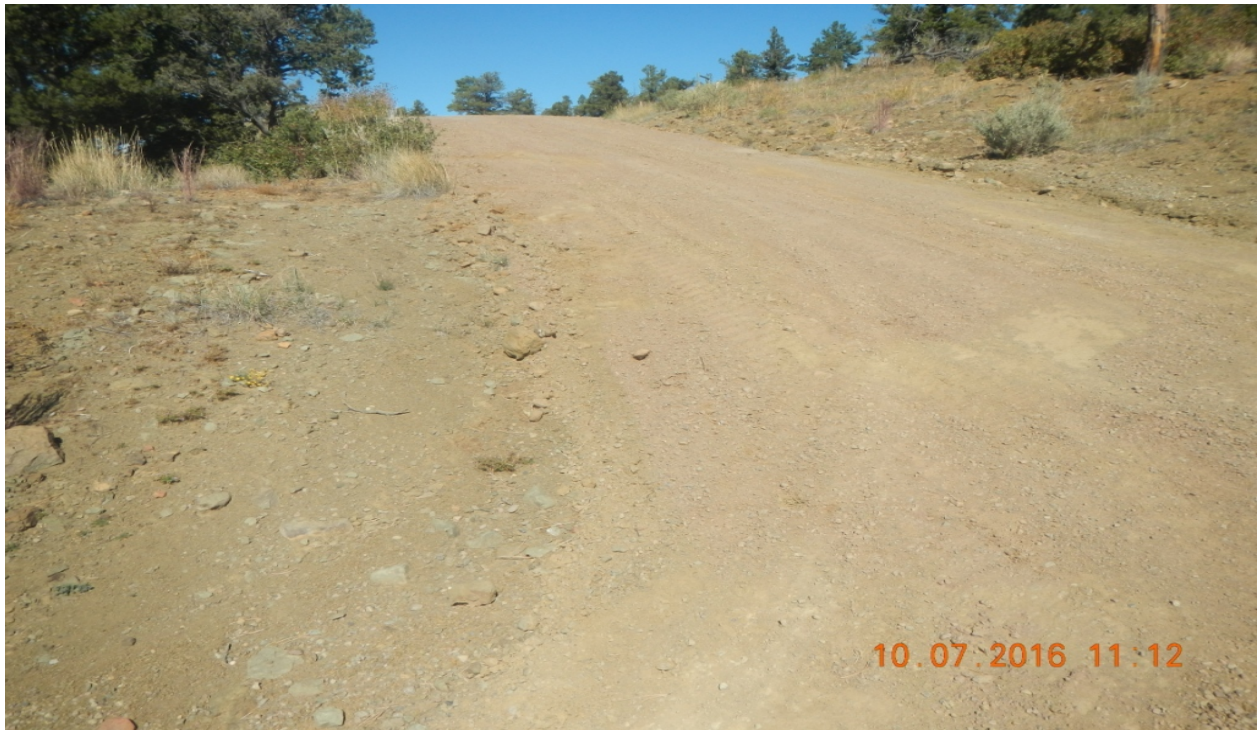
photo 7: Facing northwest toward the access road to the location. Erosion issues have been corrected.

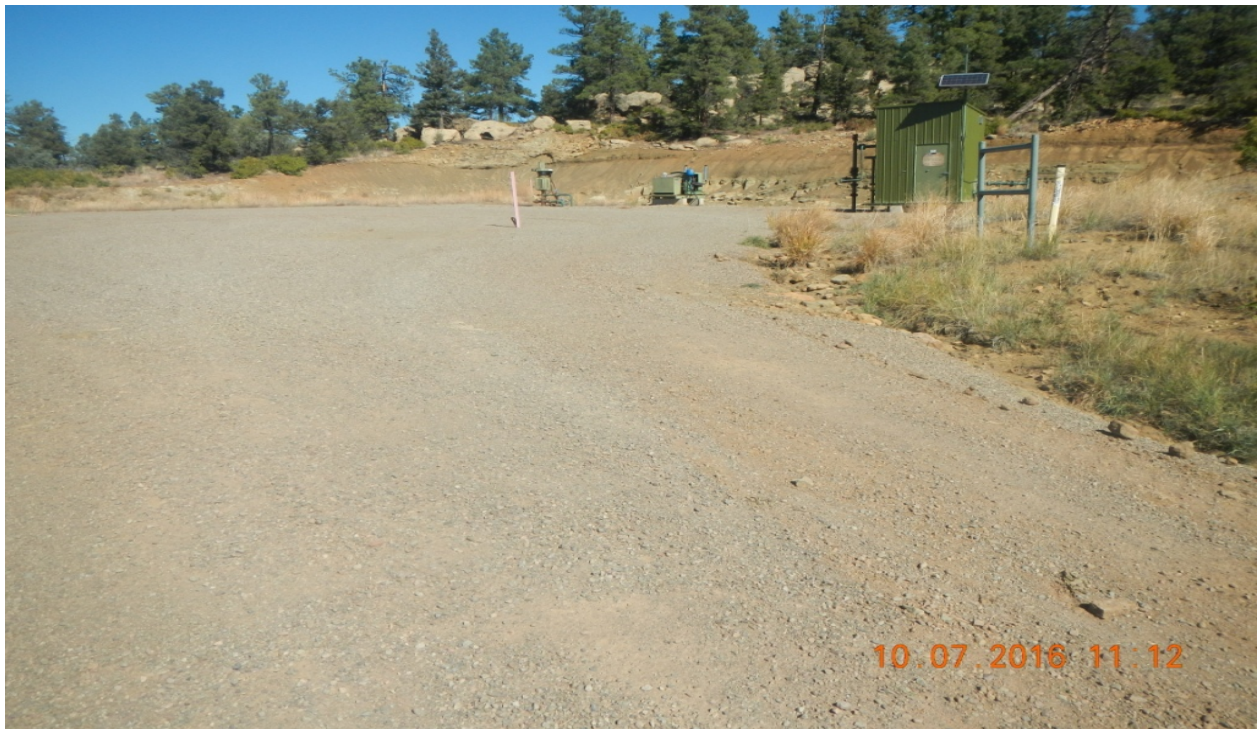
photo 8: Facing north at the location.
