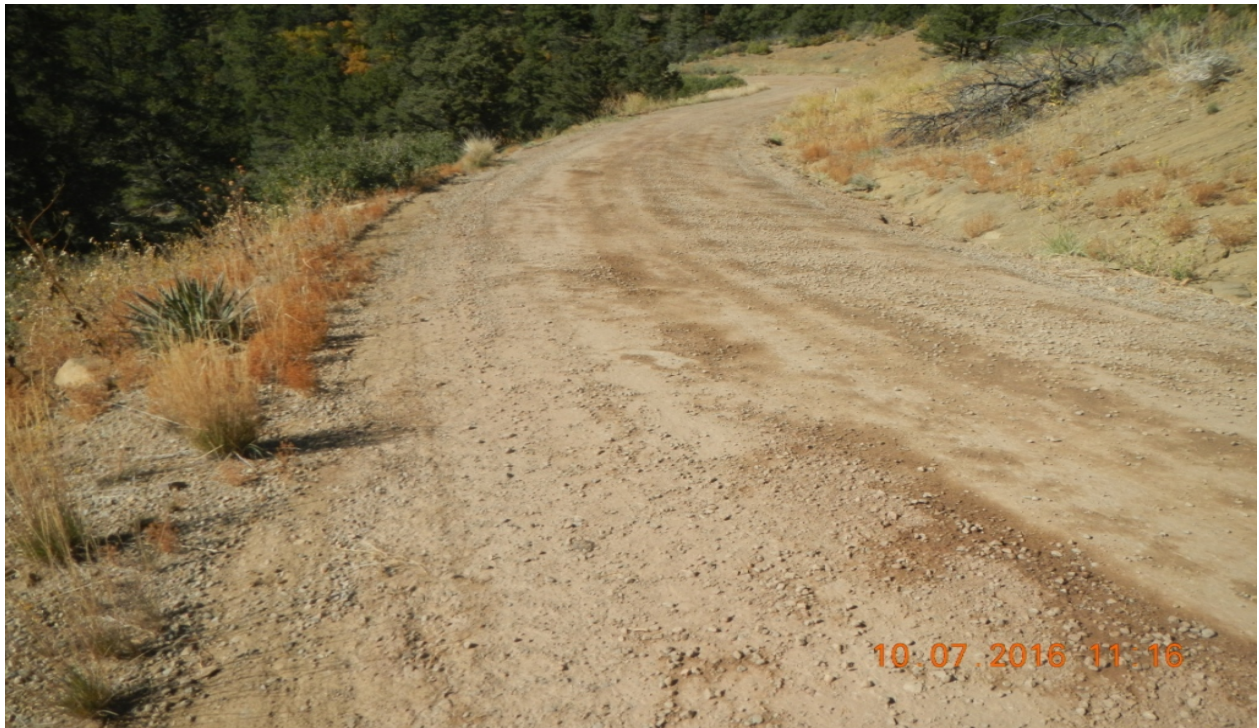
photo 1: Facing southwest along the main access road. Erosion issues have been corrected.

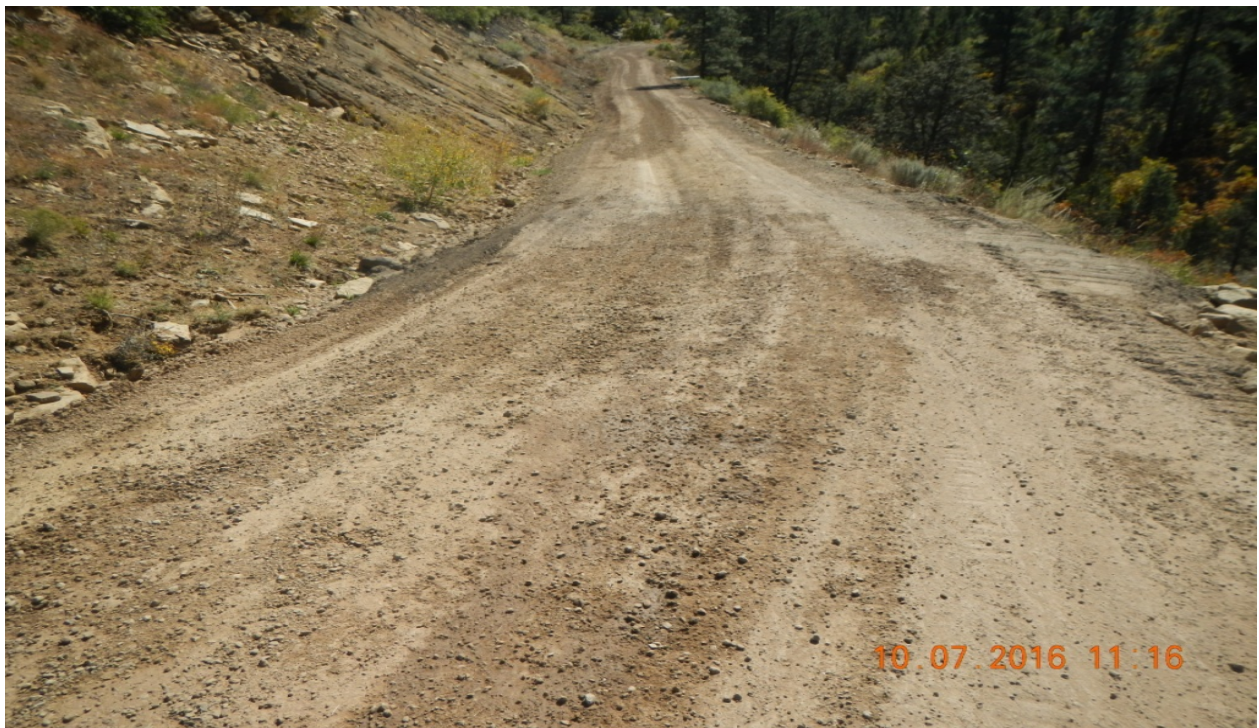
photo 2: Facing southeast along the main access road. Erosion issues have been corrected.

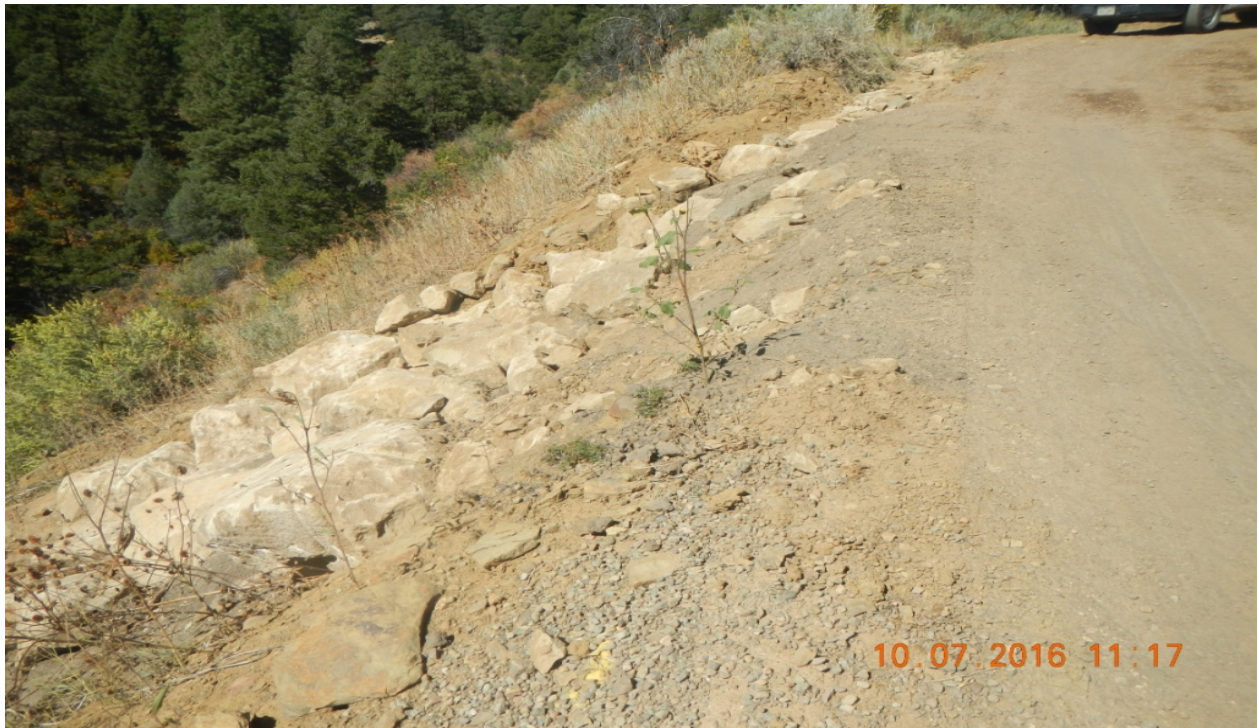
photo 3: Rock rip/rap has been installed along the road.

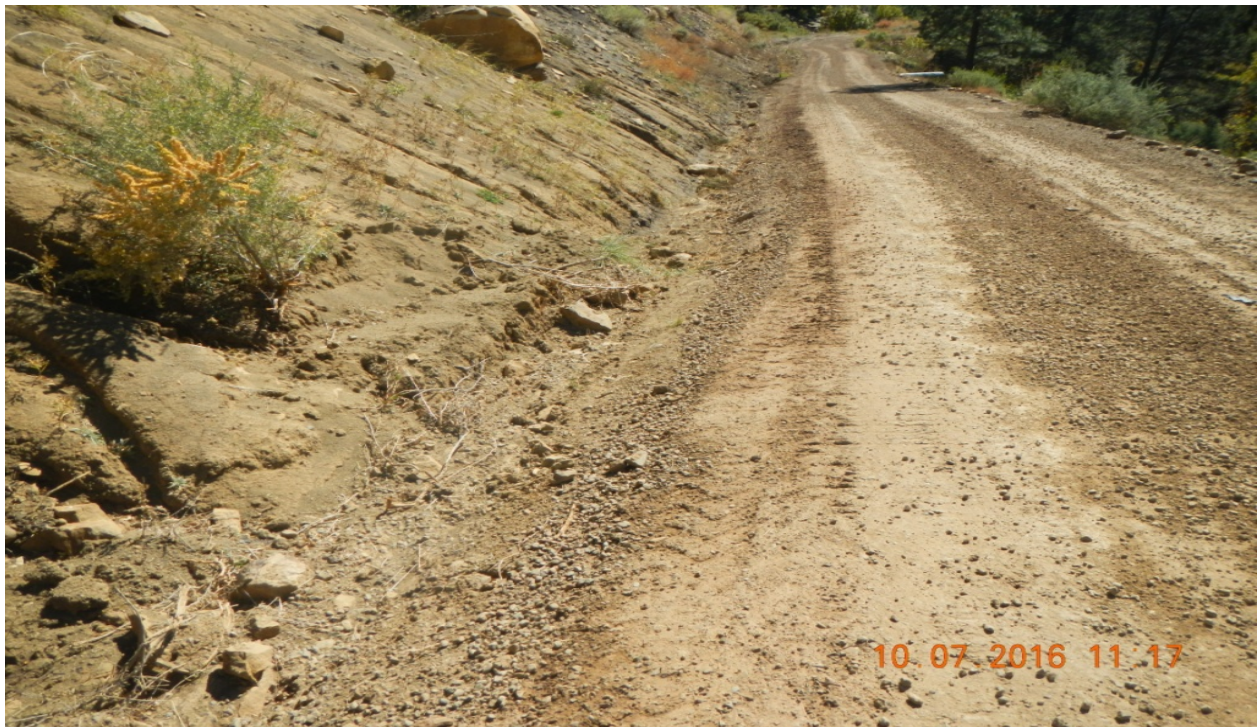
photo 4: Facing southwest along the main access road. Erosion issues have been corrected.
Note: Stormwater flow along the access road should be de-energized by installing check dams, ect..

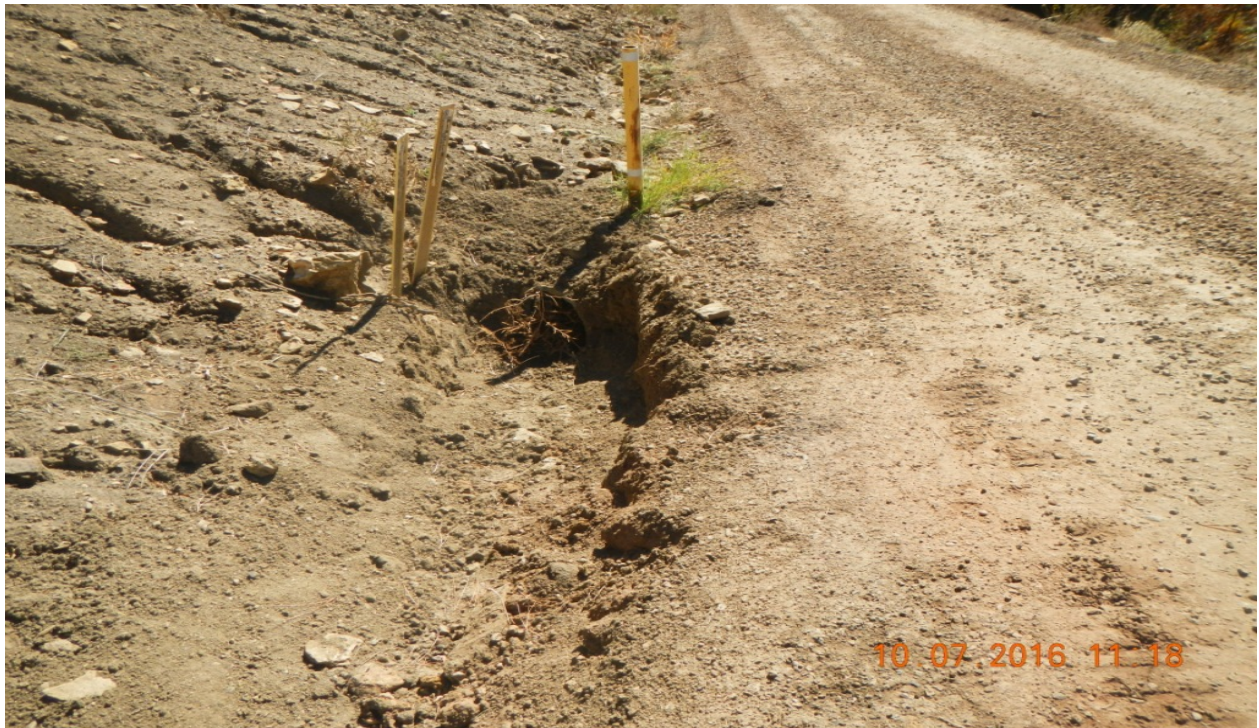
photo 5: The main road switches back to the northeast at this point. Erosion issues have been corrected.

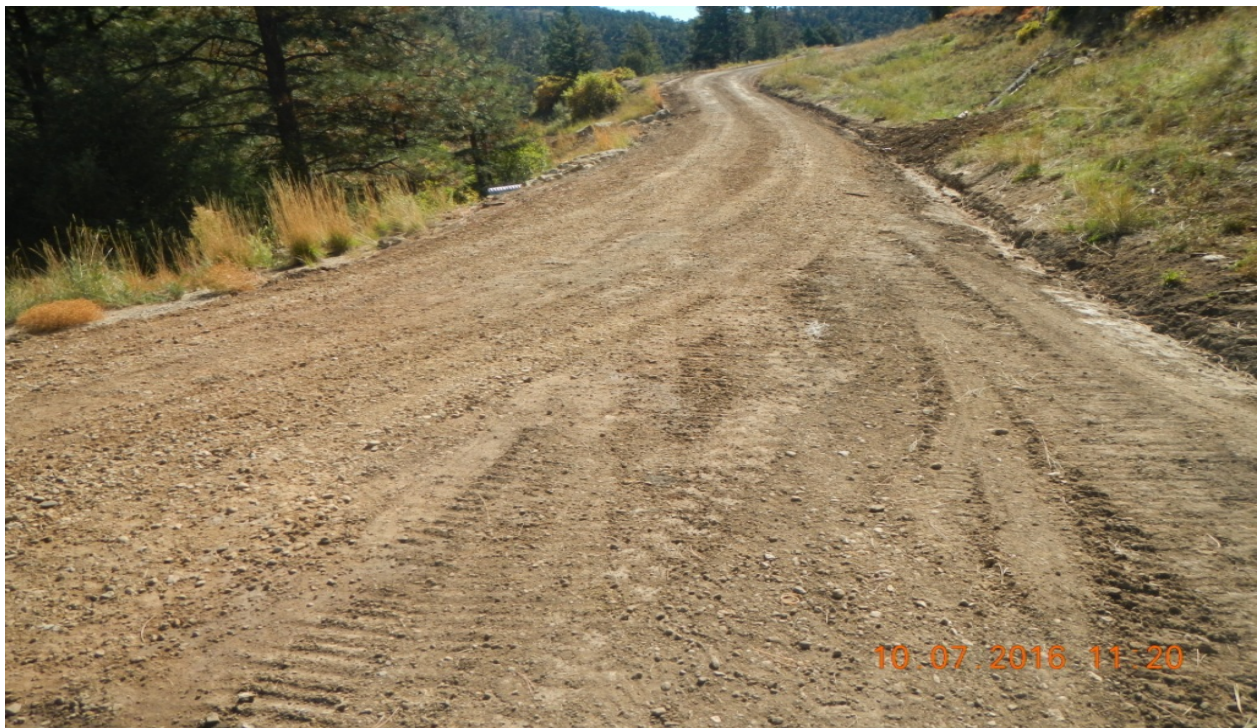
photo 6: Facing southeast along the main access road. Erosion issues have been corrected.

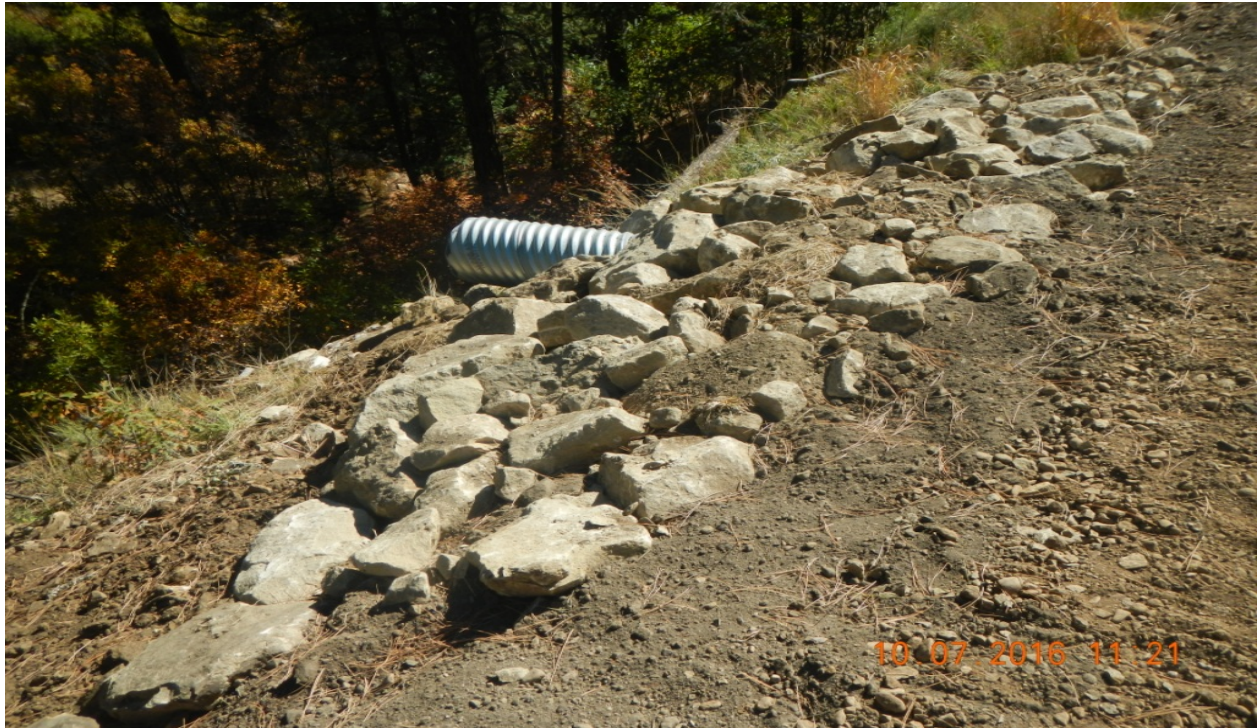
photo 7: A culvert has been installed where water was flowing across the road. Outlet protect has been placed at the culvert.

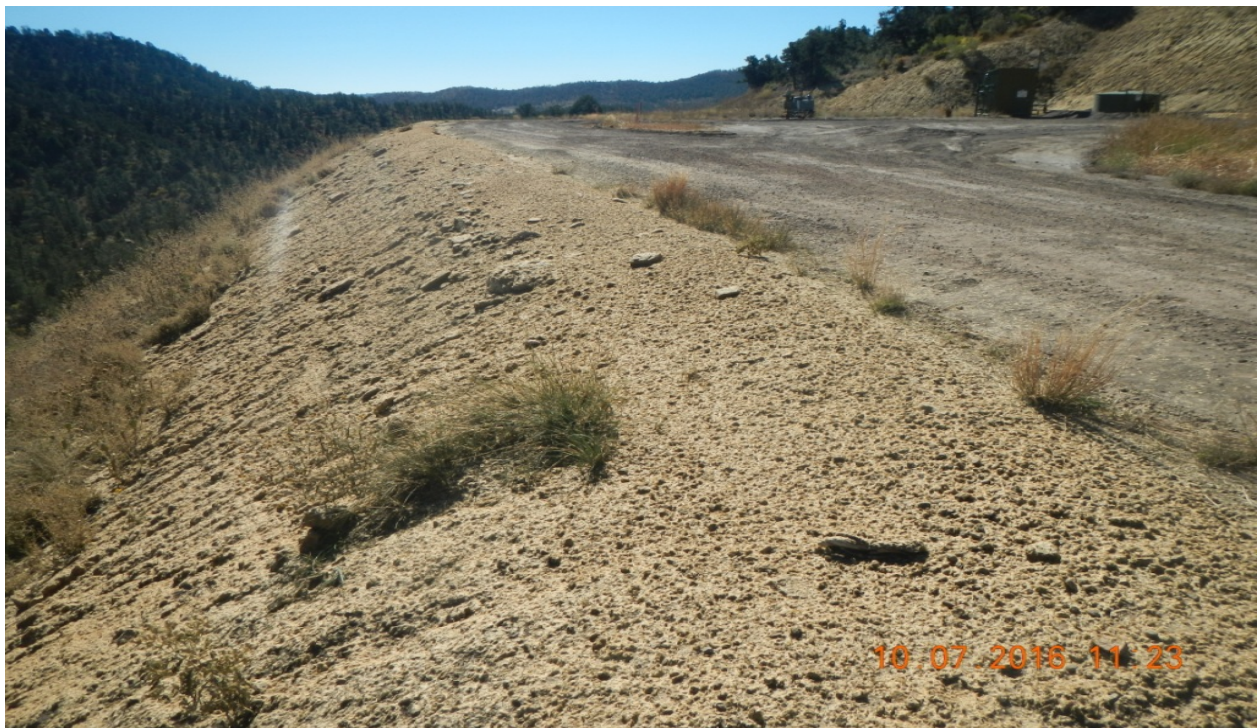
photo 8: Facing southeast at the location. The location has been seeded and hydro-mulched.

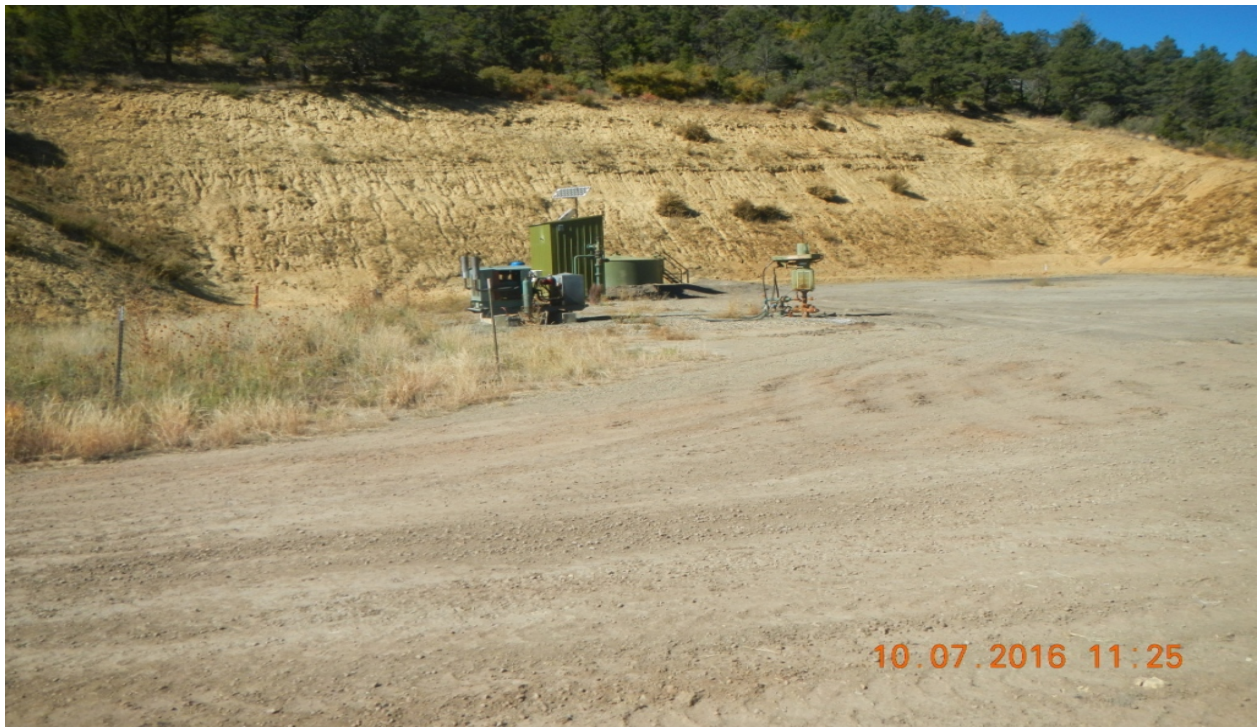
photo 10: Facing west toward the cut slope which has been seeded and hydro-mulched.
