Report

SUBJECT: Spaur Well Flash Fire
Injured: [REDACTED]
Location: Spaur Well Pad, Weld Co, CO.

REFERENCE: Our File Number: 16-227

DATED: October 7, 2016

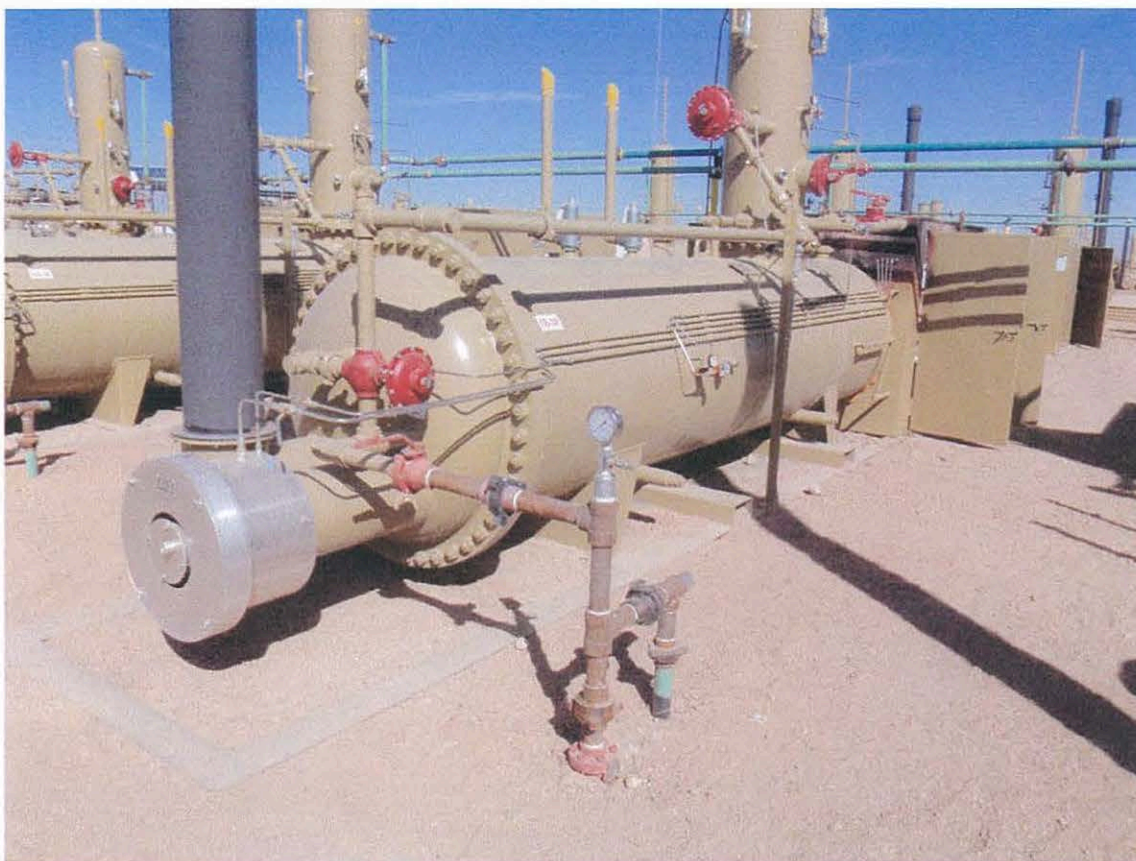
2. The separator generally measured 24 feet by 4 feet and set east to west. The east end valves were enclosed in a metal box, 8 1/2 feet long, by 4 feet 8 inches wide, by 6 feet tall. All five doors were open. (See photo one in appendix).

1. Looking northeast at subject separator.

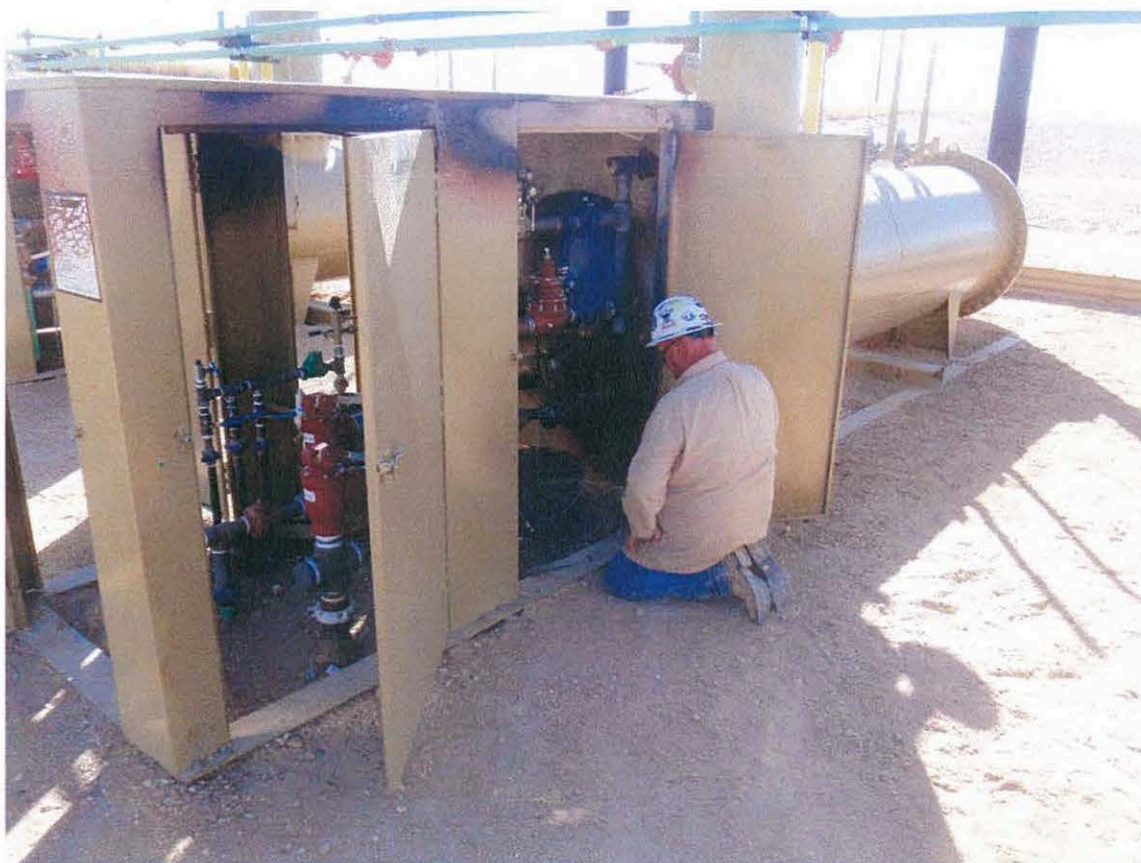
3. The fire occurred in this east end metal enclosure. The worst damage was to the west, near the end of the separator. The damage lessened, moving east. J.D. showed the position [REDACTED] was in, when the flash fire occurred. (See photo two in appendix).

2. Separator enclosure. Subject at [REDACTED] position during incident.

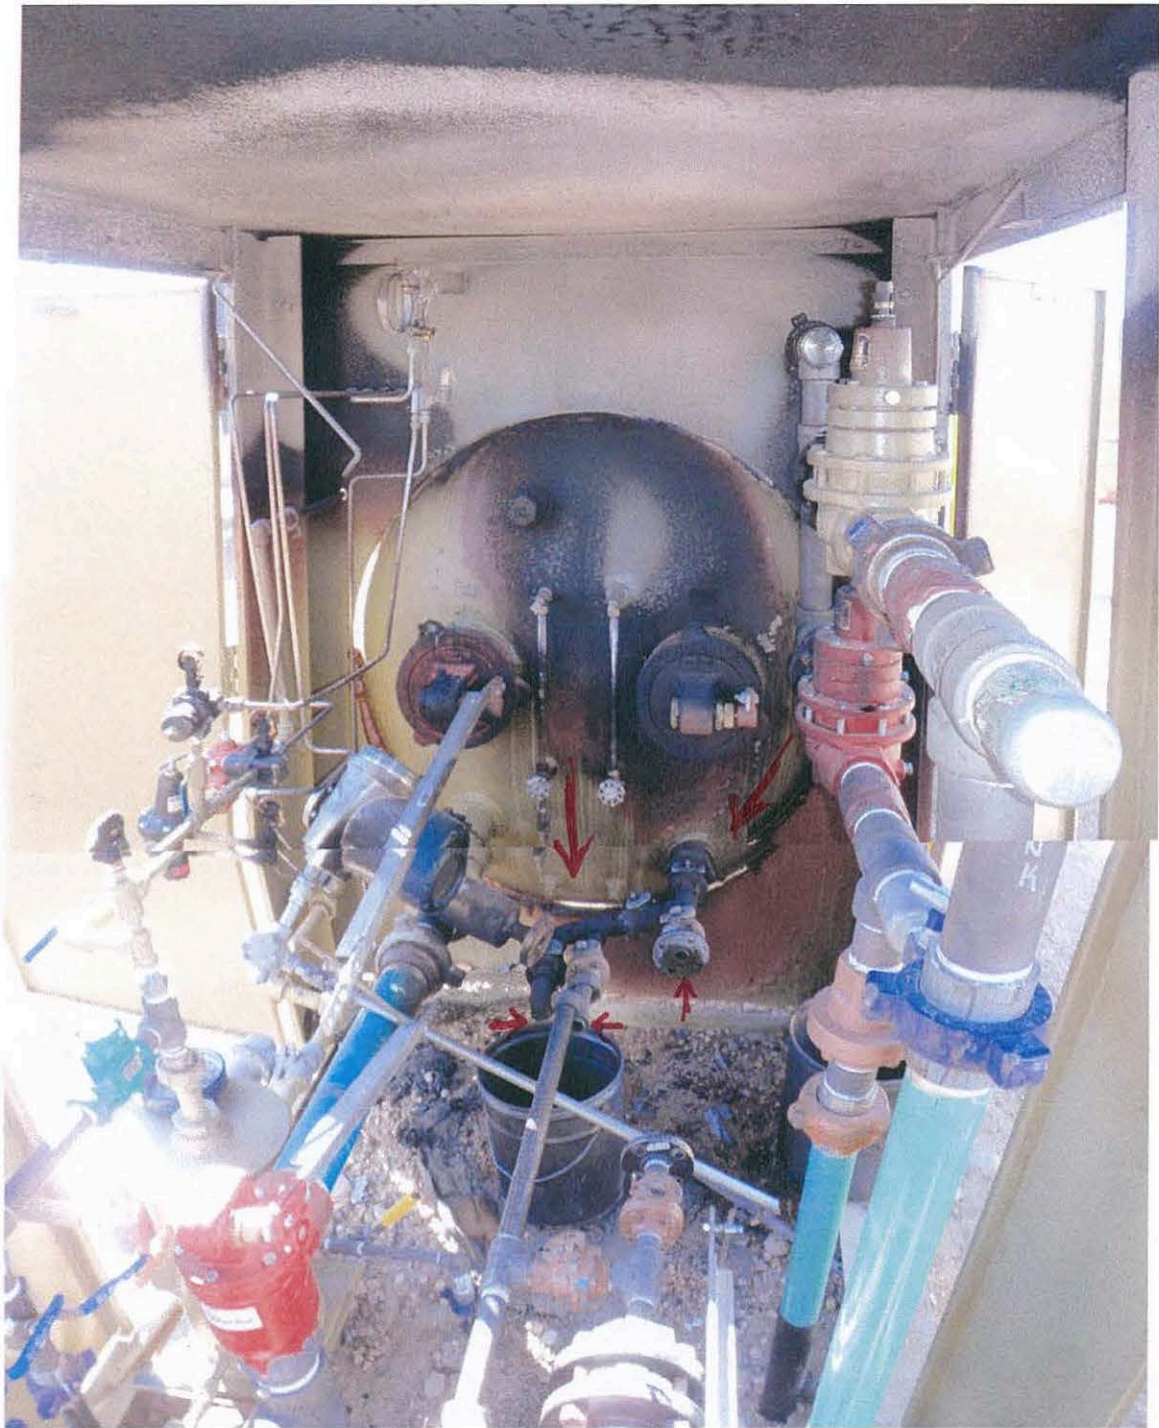
4. Inside the enclosure, the end of the separator showed fire damage, as well as above and below. Two buckets were still present under the lower valves. Under the left bucket was a partially burned plastic drip pan. This plastic drip pan was secured as evidence. (See photos three - six in appendix).

3. Looking west inside separator enclosure.

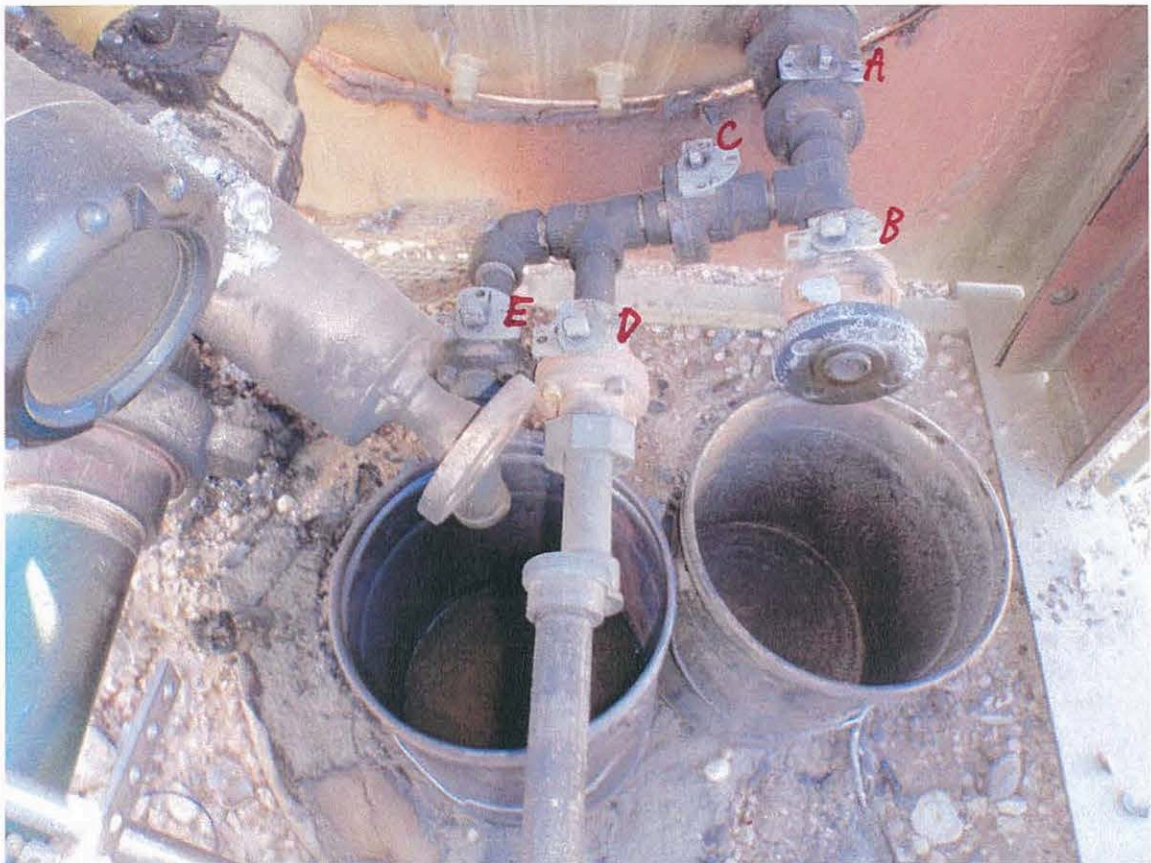
4. Valves used for draining and buckets.

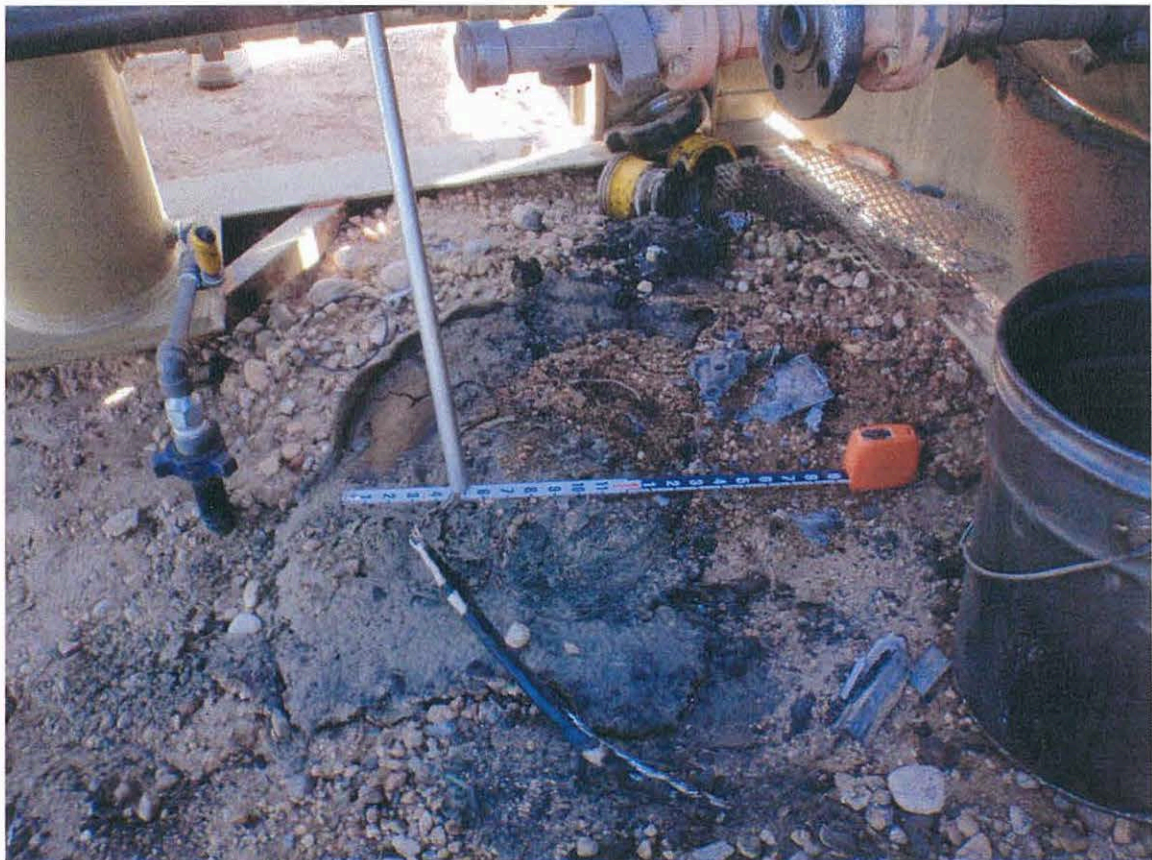
[REDACTED] and JD had performed this operation many times in the past. The one thing different was the plastic drip pan on the ground. This suggests that a metal bucket sitting on the ground is almost an adequate ground. The plastic drip pan insulated the bucket from the separator and ground. The dripping, charged condensate transferred this static charge to the insulated bucket. [REDACTED] allowed this static to discharge when he made electrical contact; either by the second bucket touching the insulated bucket and separator; or through his body by touching the insulated bucket and valve B simultaneously. A small static discharge is enough energy to ignite a flammable atmosphere.

5. Plastic drip pan under bucket.

In the future, a plastic drip pan should not be used. The use of plastic in the oil field should be avoided. Oil fluids flowing out of a pipe will create static electricity. Plastics can make it worse. If a drip pan must be used, it should be metal. In addition, the metal catch bucket should be electrically connected to the separator. A copper wire with alligator clips or other bonding method is suggested. As long as all metals are at the same potential, a static discharge cannot occur.

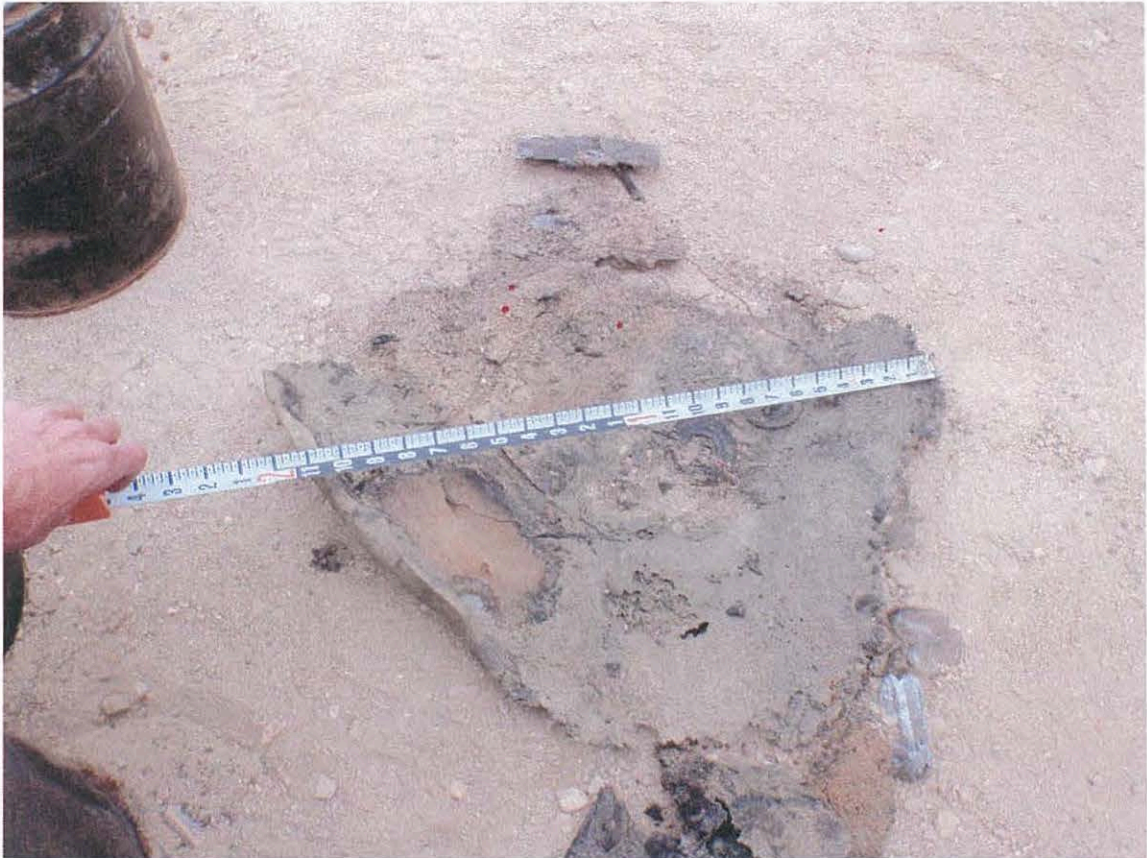
6. Plastic drip pan.

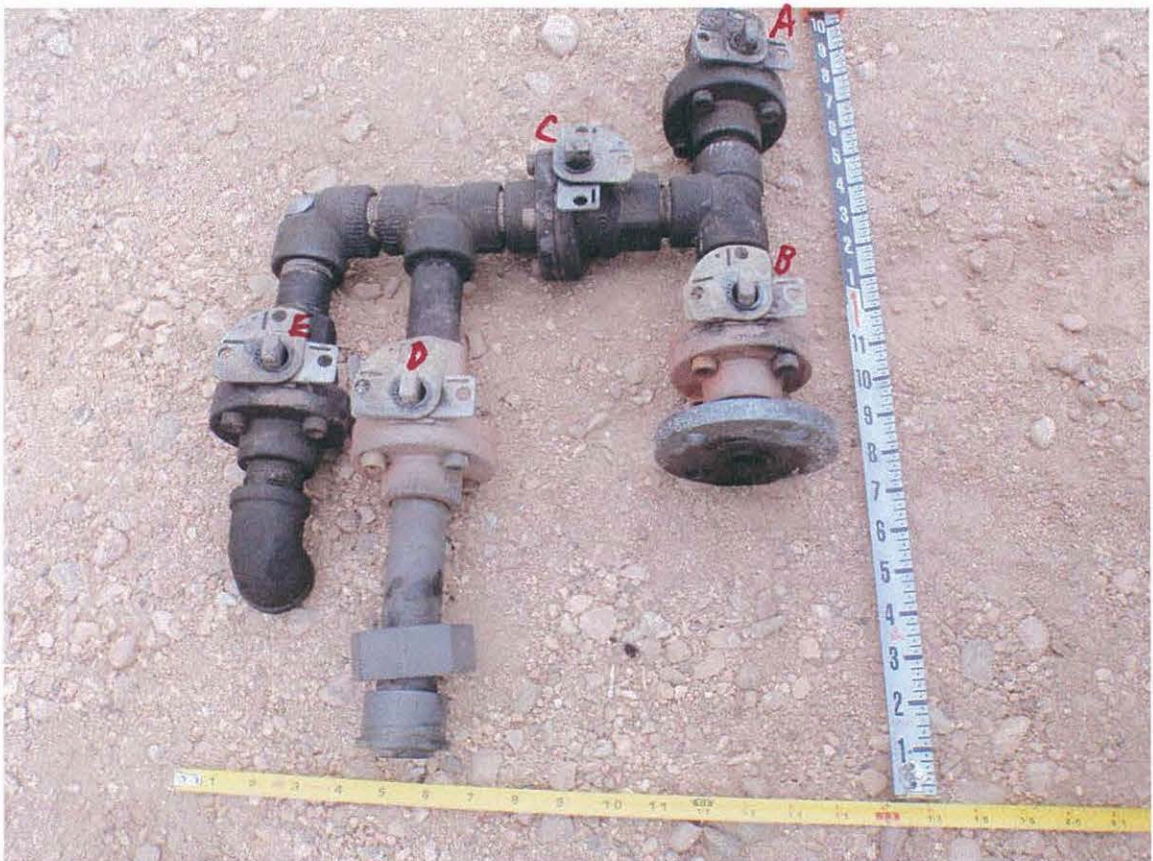
5. The position of the valves was documented. As found, vapors and liquid would flow out of all three openings. This valve manifold and the buckets were secured as evidence. (See photo seven in appendix).

7. Valves used for draining.

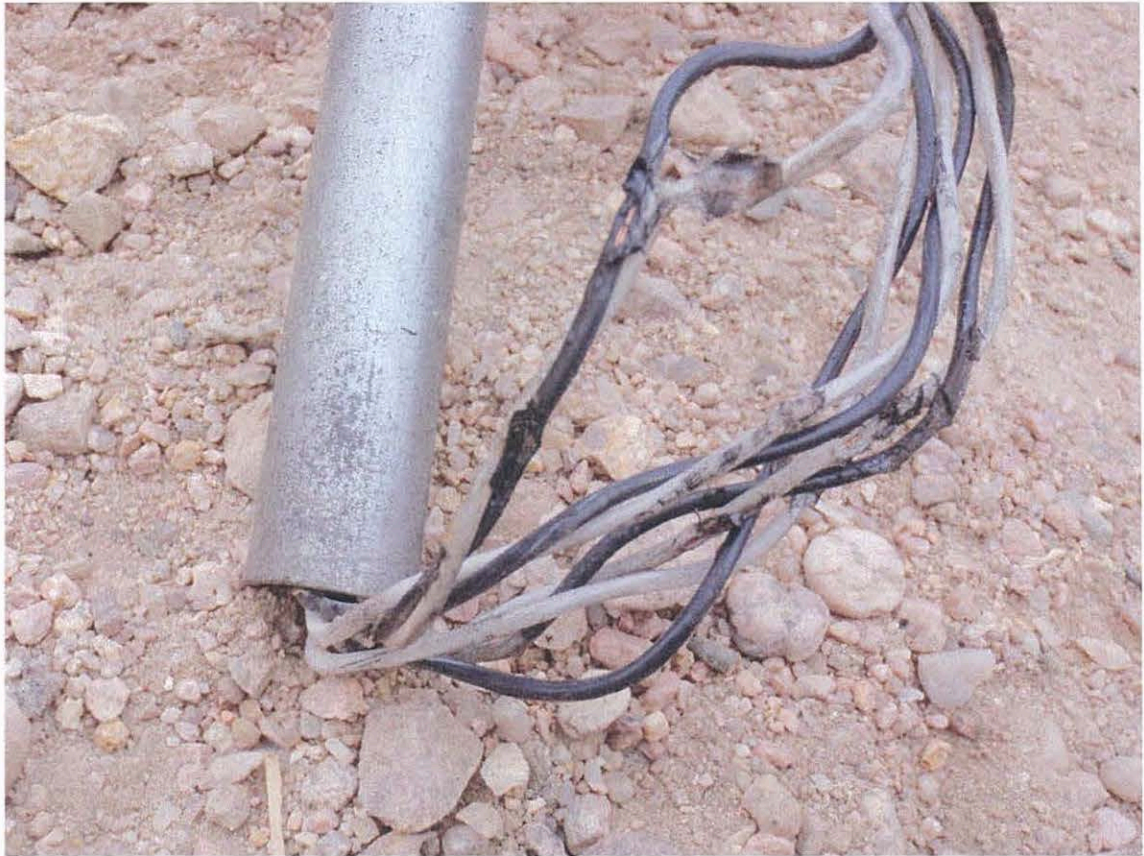
6. After the incident, the flow meter's electrical conduit and wires were exposed. Close examination showed minor melting of insulation and mechanical damage. There was no arcing and no signs of electrical activity. (See photo eight in appendix).

8. Meter's electrical wires show minor melting of insulation and mechanical damage, but no arcing.
