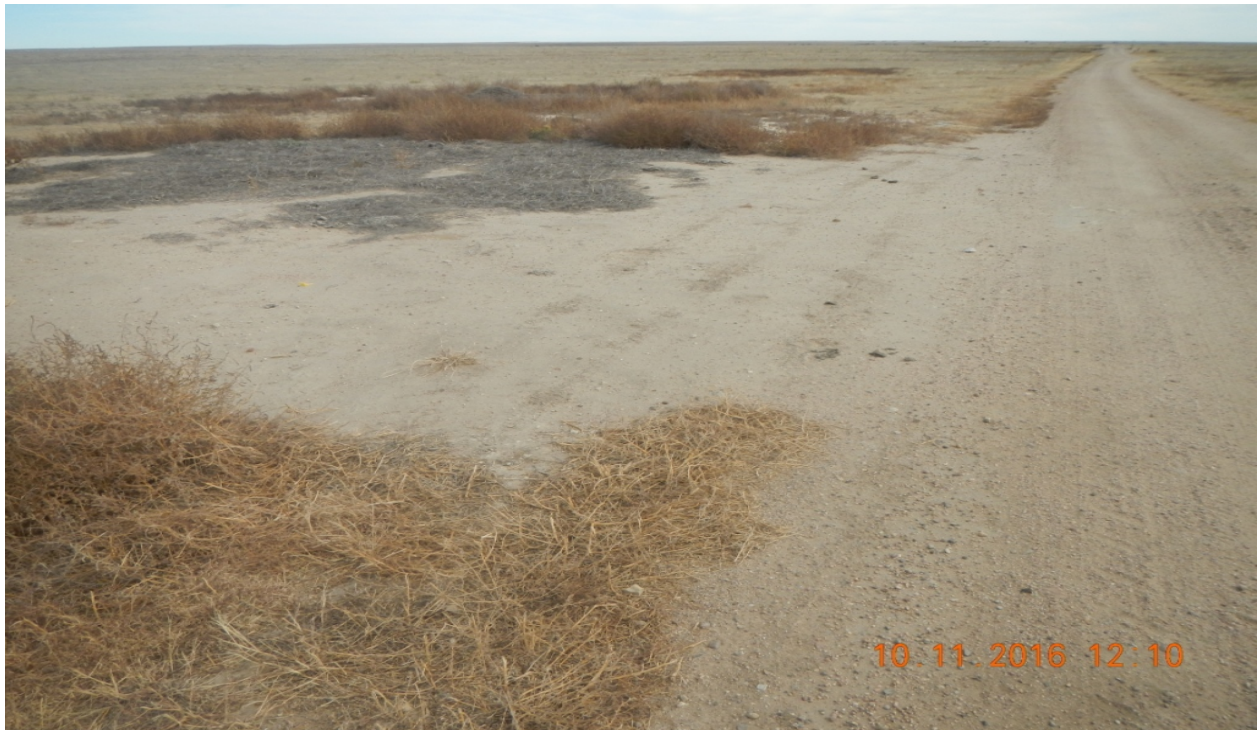
**photo 1:** Facing northeast toward the location from the access road.

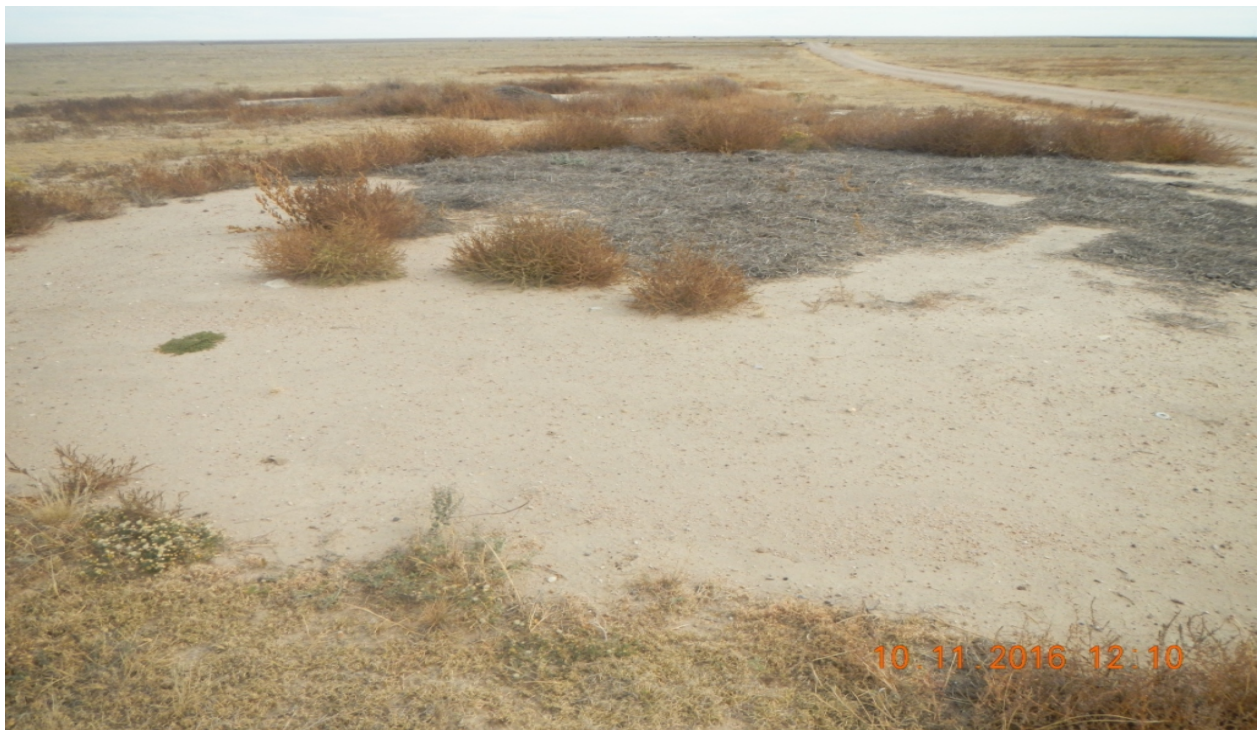
**photo 2:** Facing east toward the location.

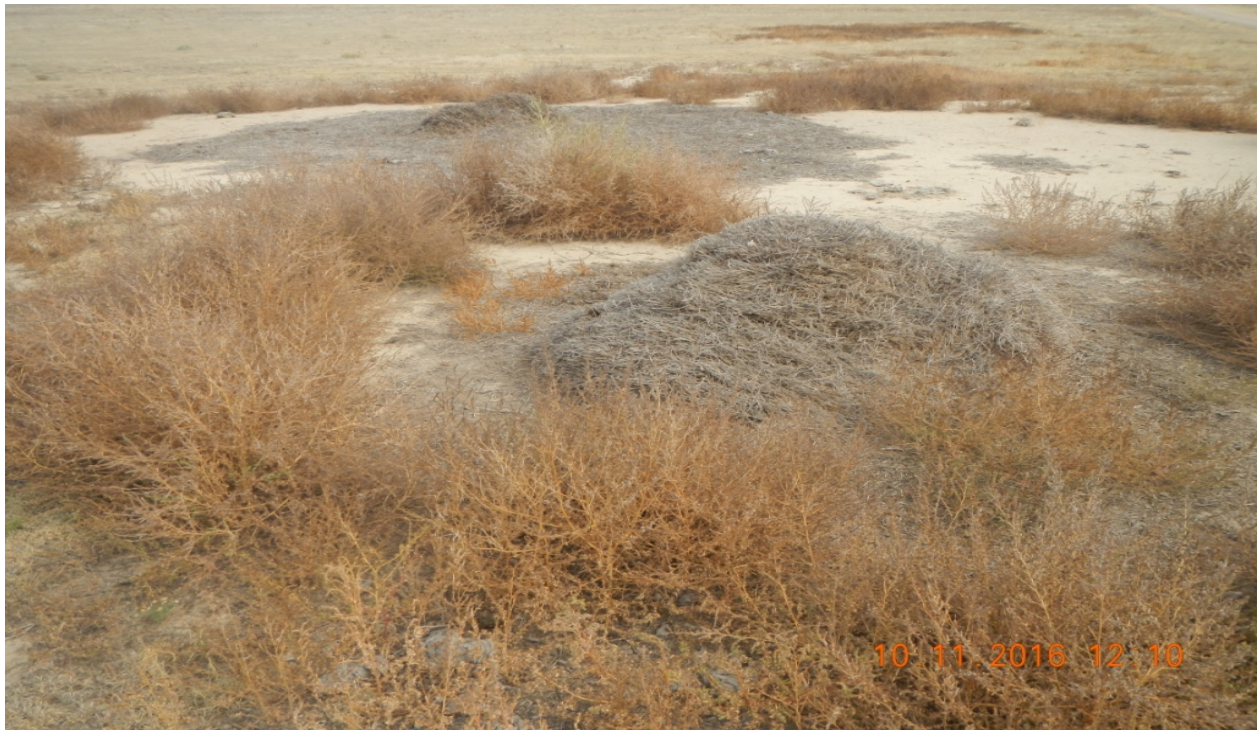
**photo 3:** There are piles of debris that remain on location and reclamation has not been performed.

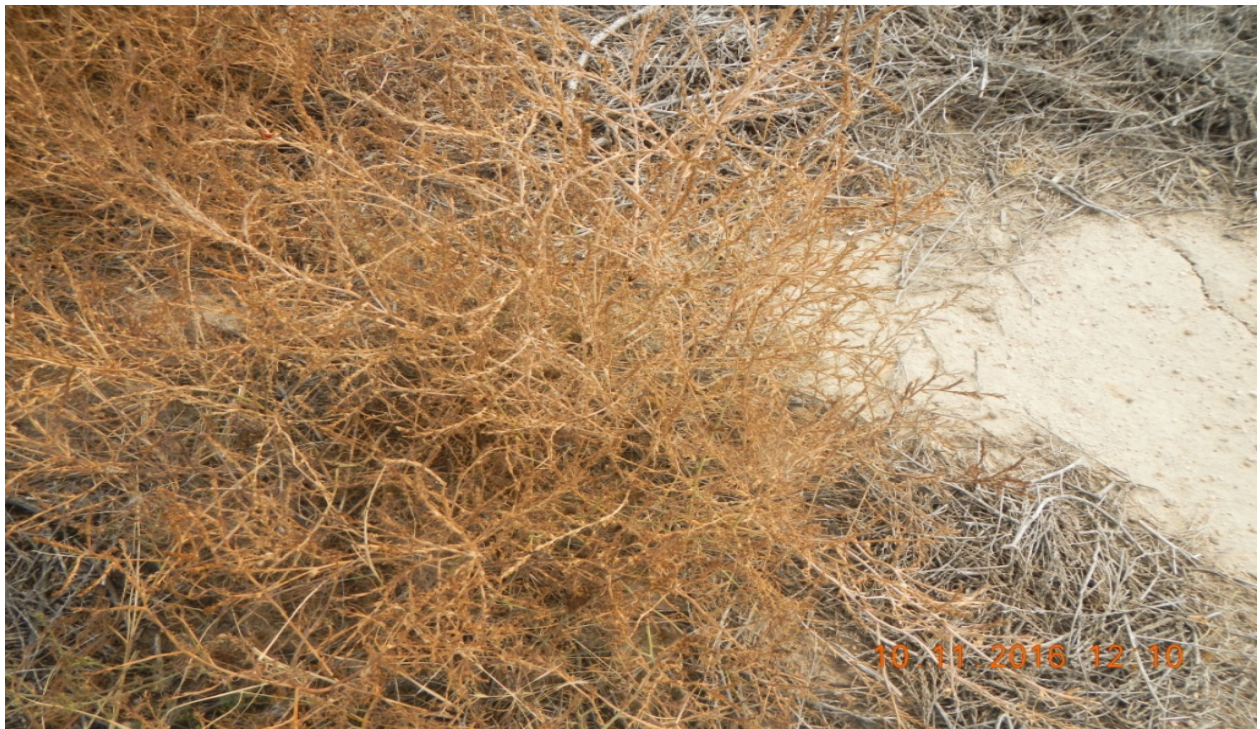
**photo 4:** There is undesirable weed growth (Russian thistle) throughout the location.

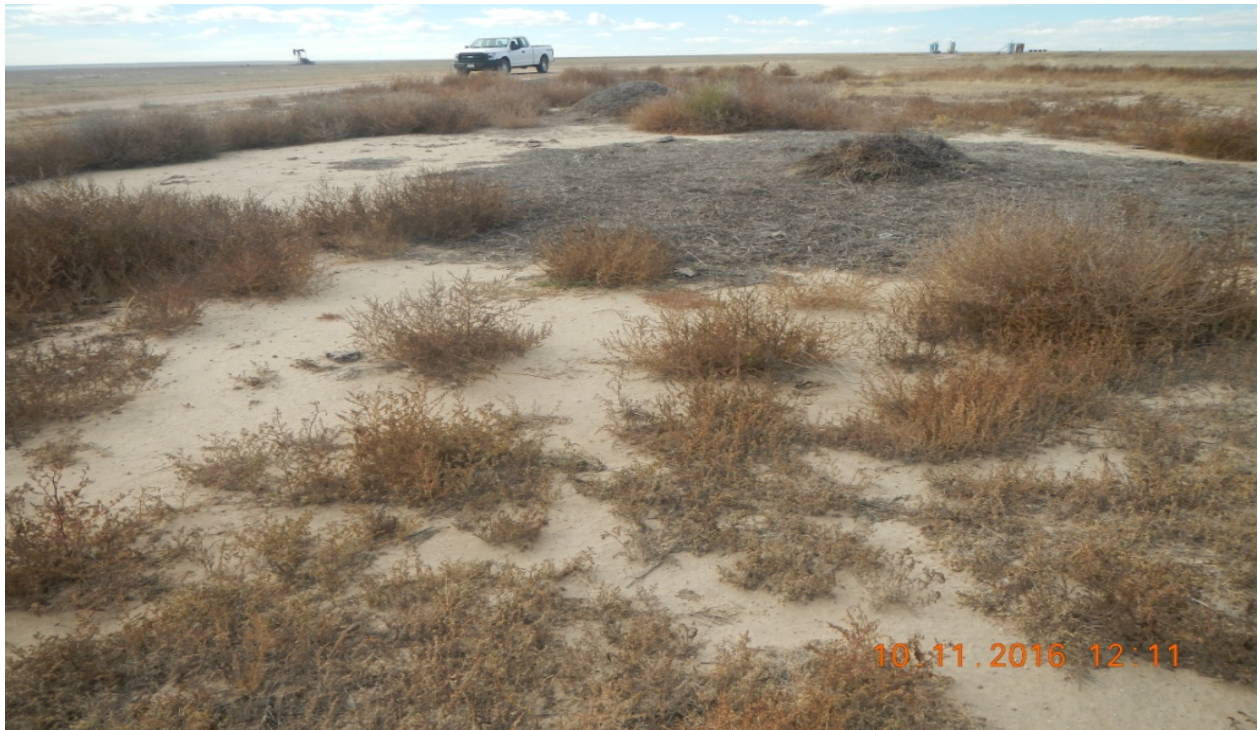
**photo 5:** Facing southwest toward the location.

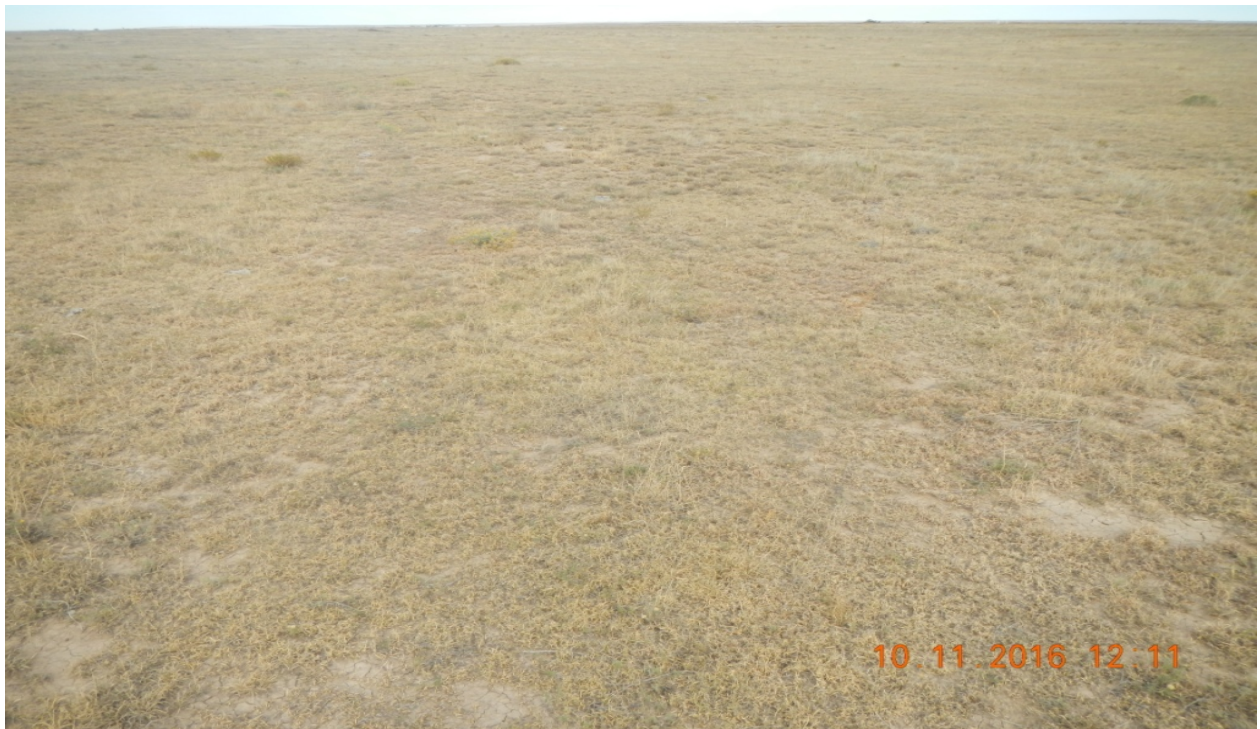
**photo 6:** Facing north toward the surrounding reference area.
