Construction Inspection

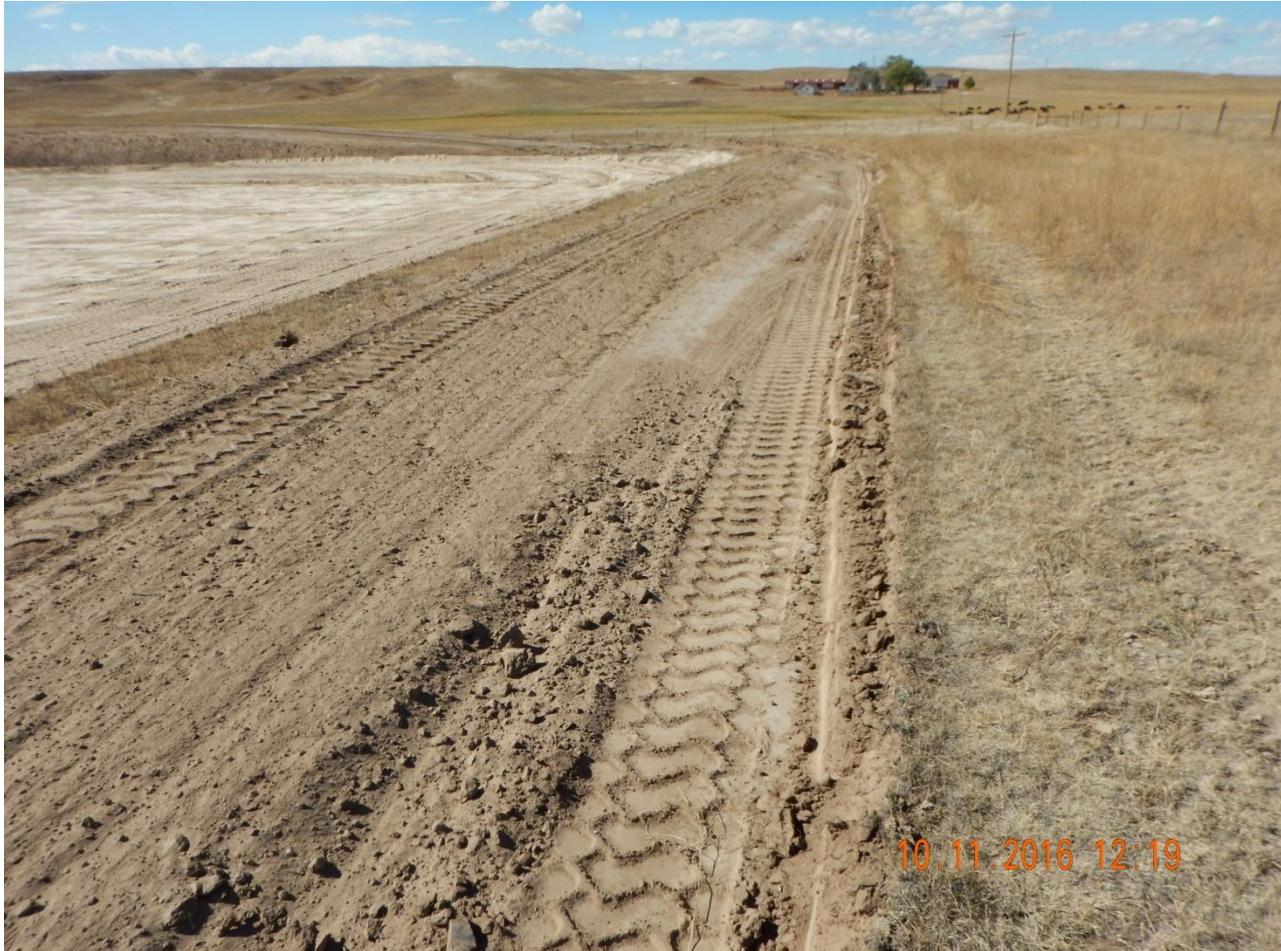
Photo 1. Photo taken from northern location, facing West. Ditch and berm constructed along northern location to control run-on onto location.

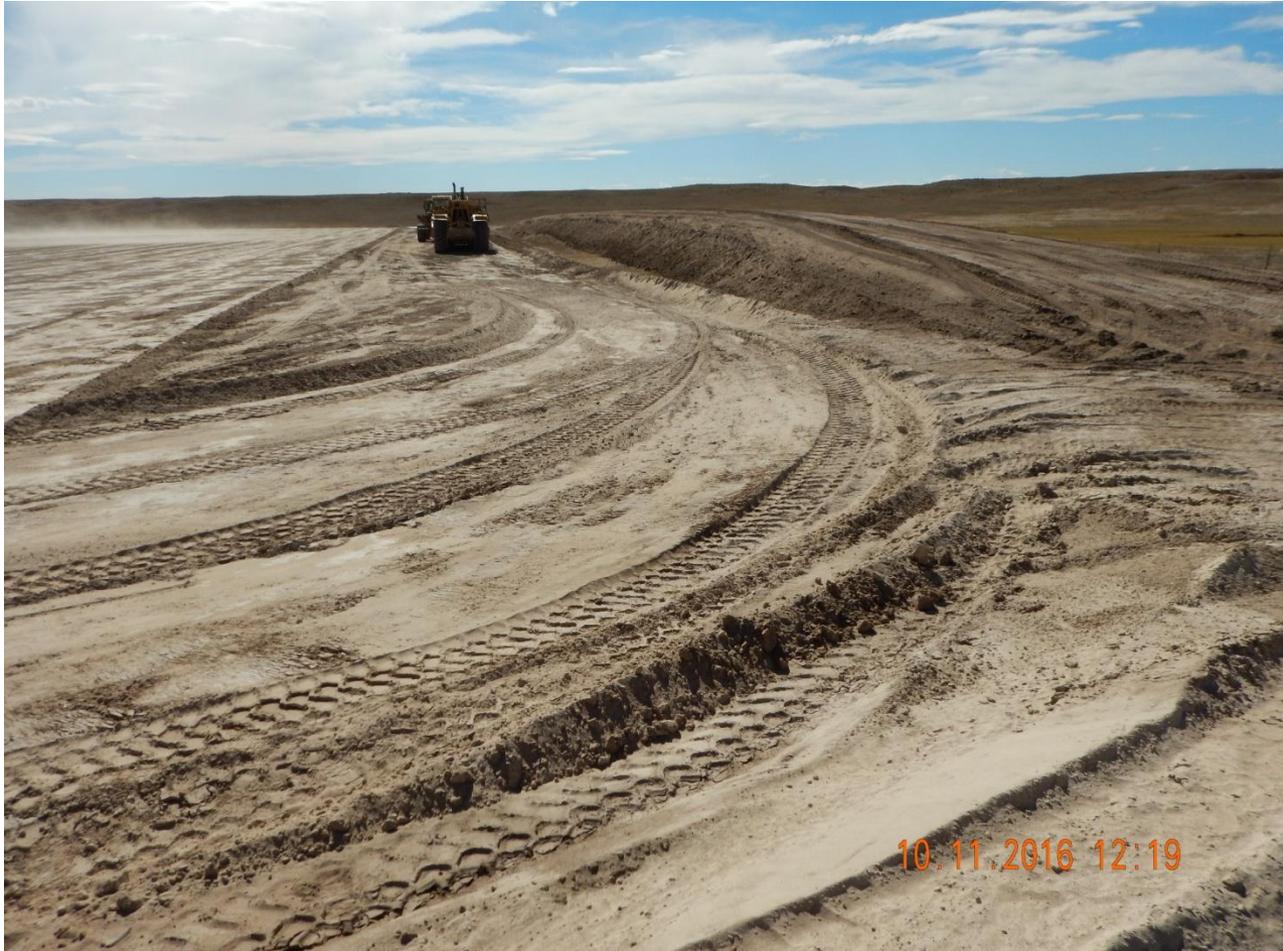
Photo 2. Photo taken from northern, facing South, towards topsoil pile.

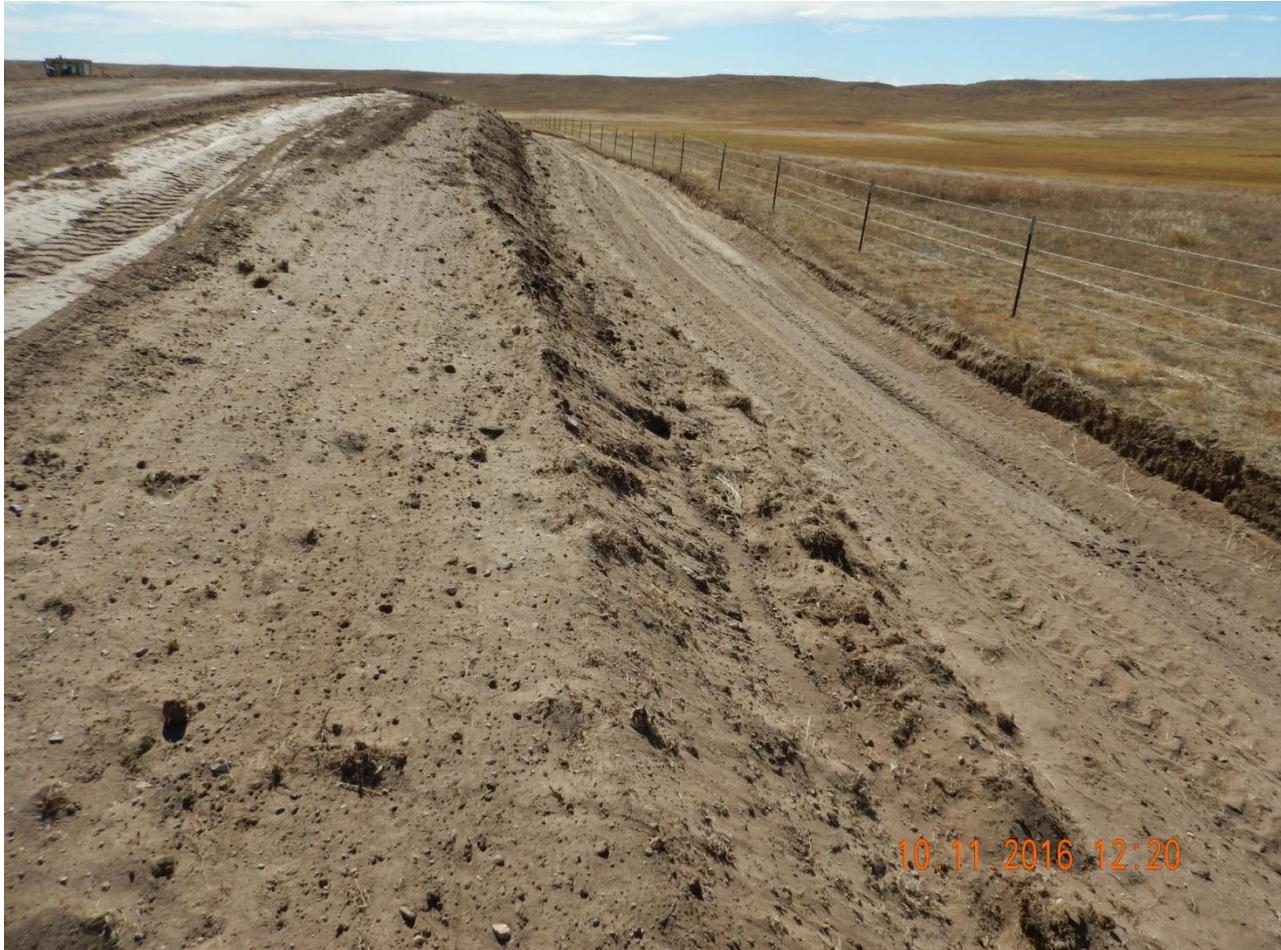
Photo 3. Photo taken from western topsoil pile, facing South. Ditch and berm constructed around outer perimeter of topsoil pile to control run-off.

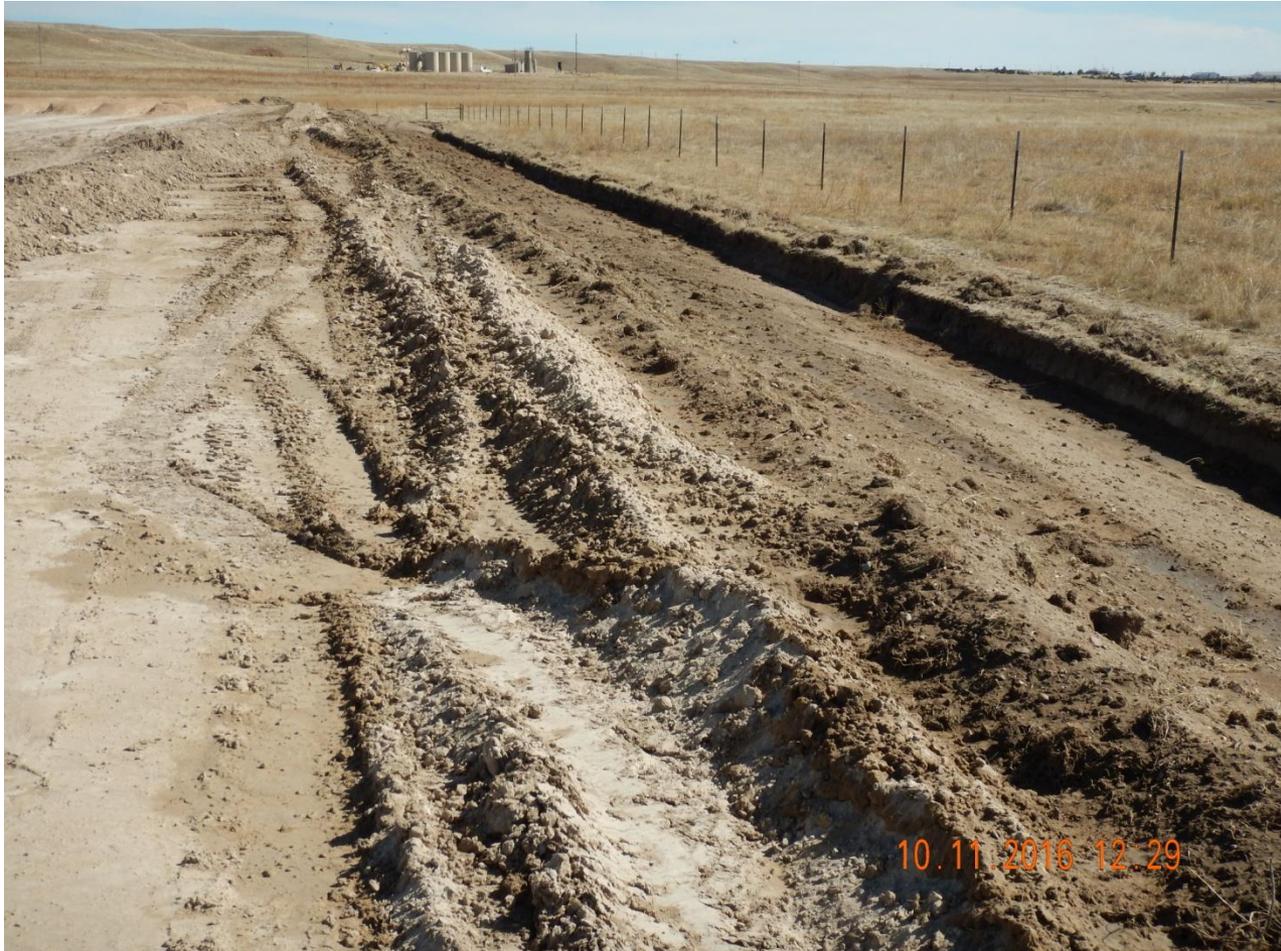
Photo 4. Photo taken from southern location, facing East. Ditch and berm constructed along southern location to control run-off. Contractor mentioned that additional BMPs would be installed along the southern location.

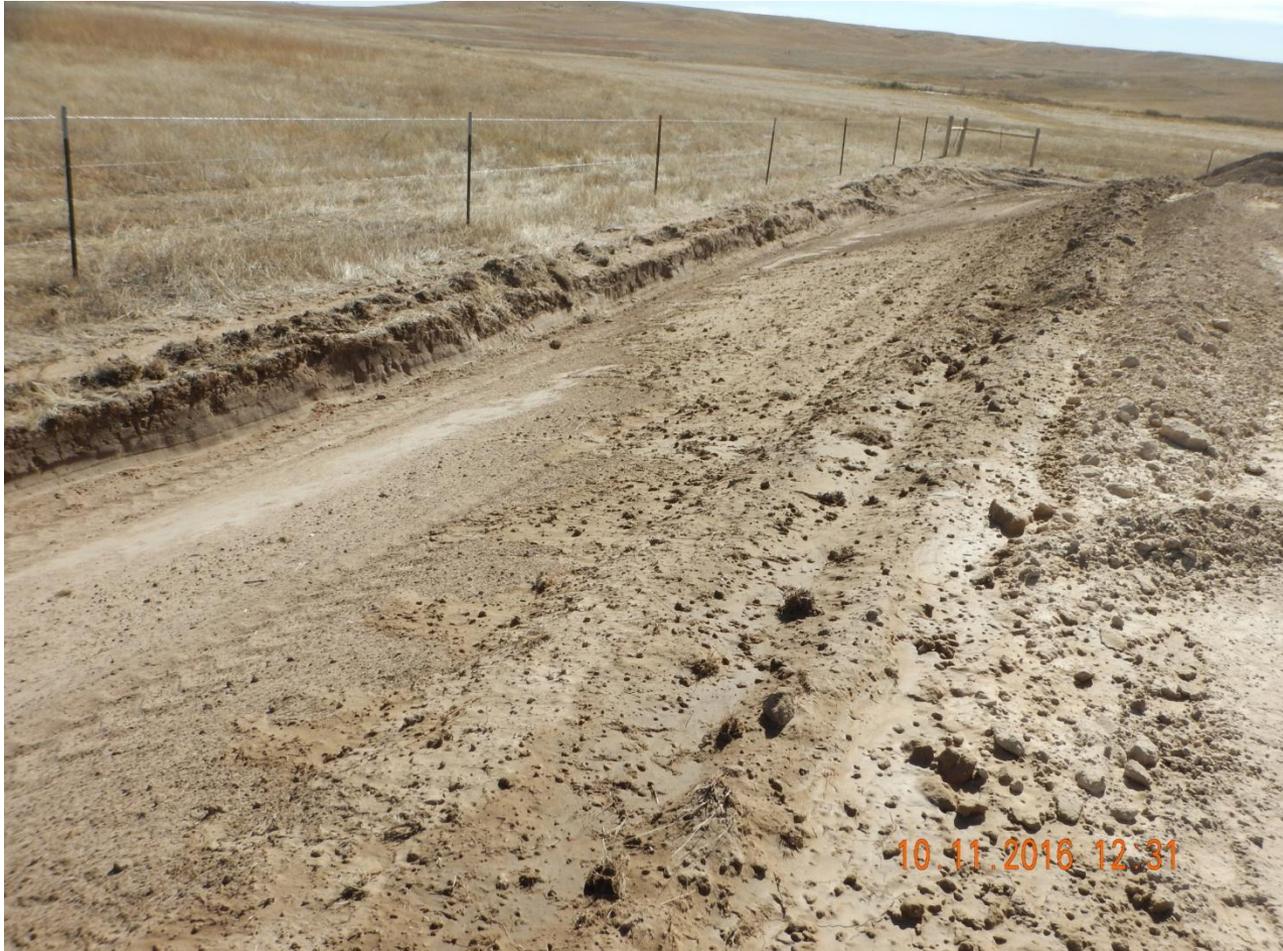
Photo 5. Photo taken from eastern location, facing South. Ditch and berm constructed along eastern location to control run-off.
