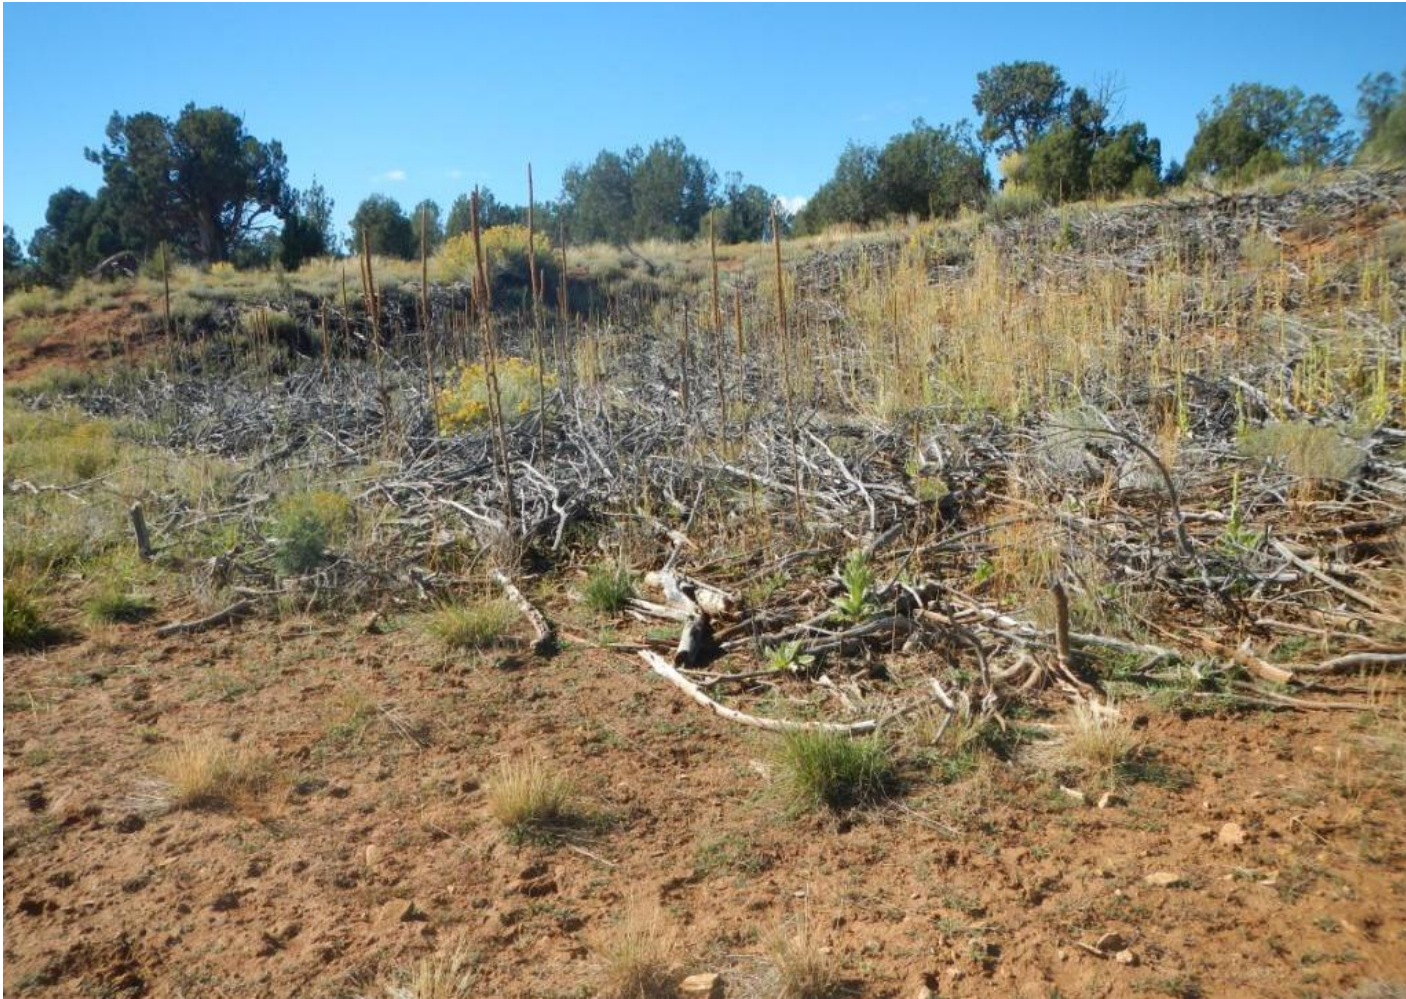
Photo 1. View of wood debris in the southwestern portion of the project area.

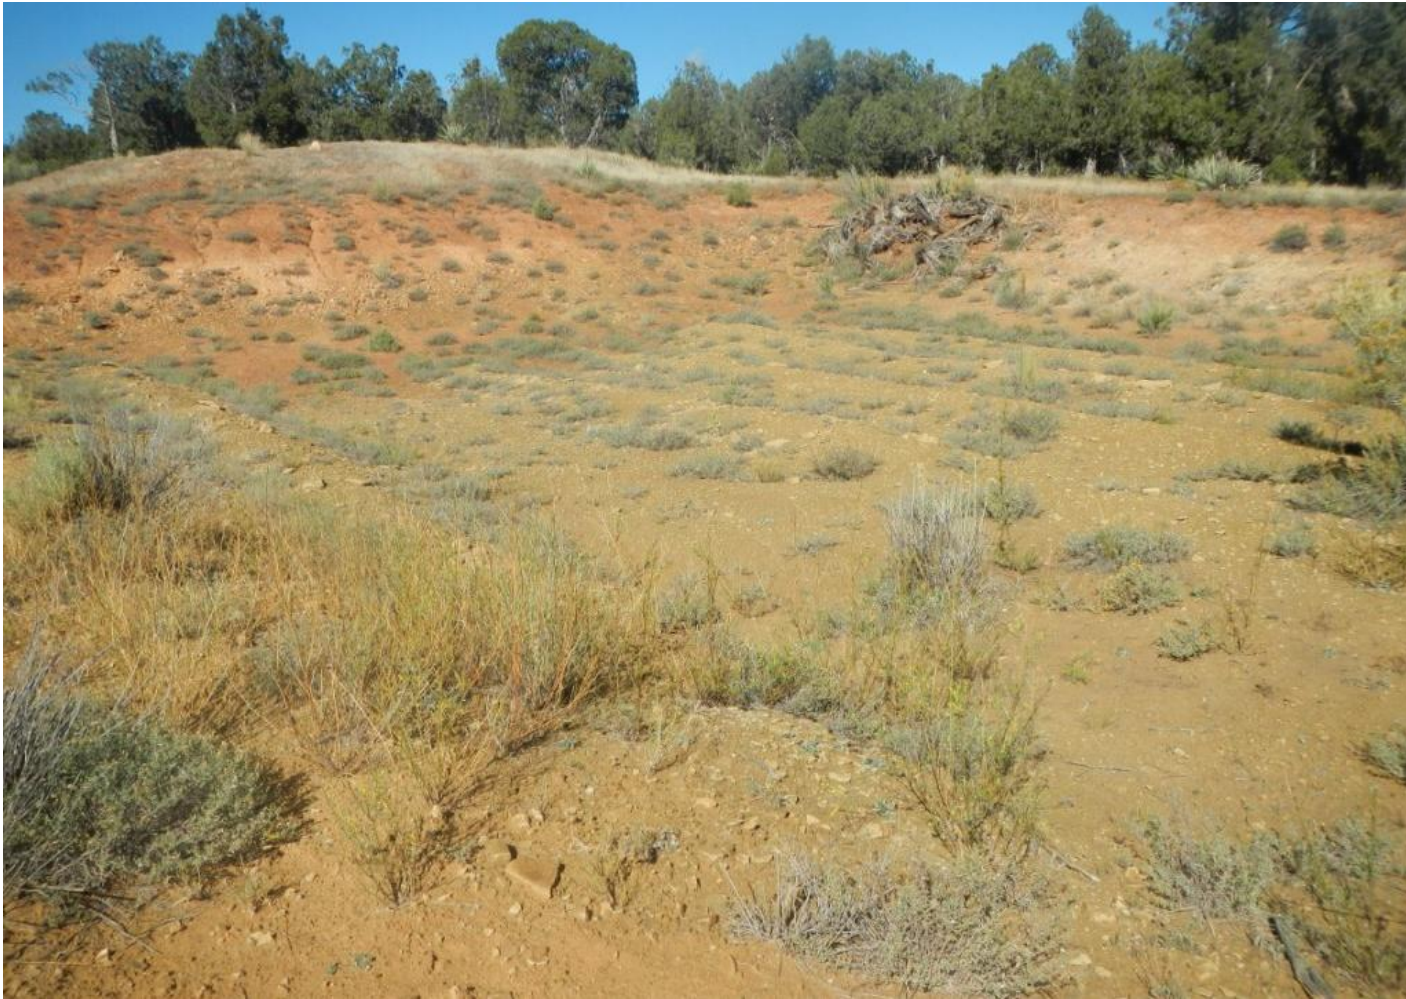
Photo 2. View of unknown soil management area in the northern portion of the project area. Area is bermed and soil is in rows.

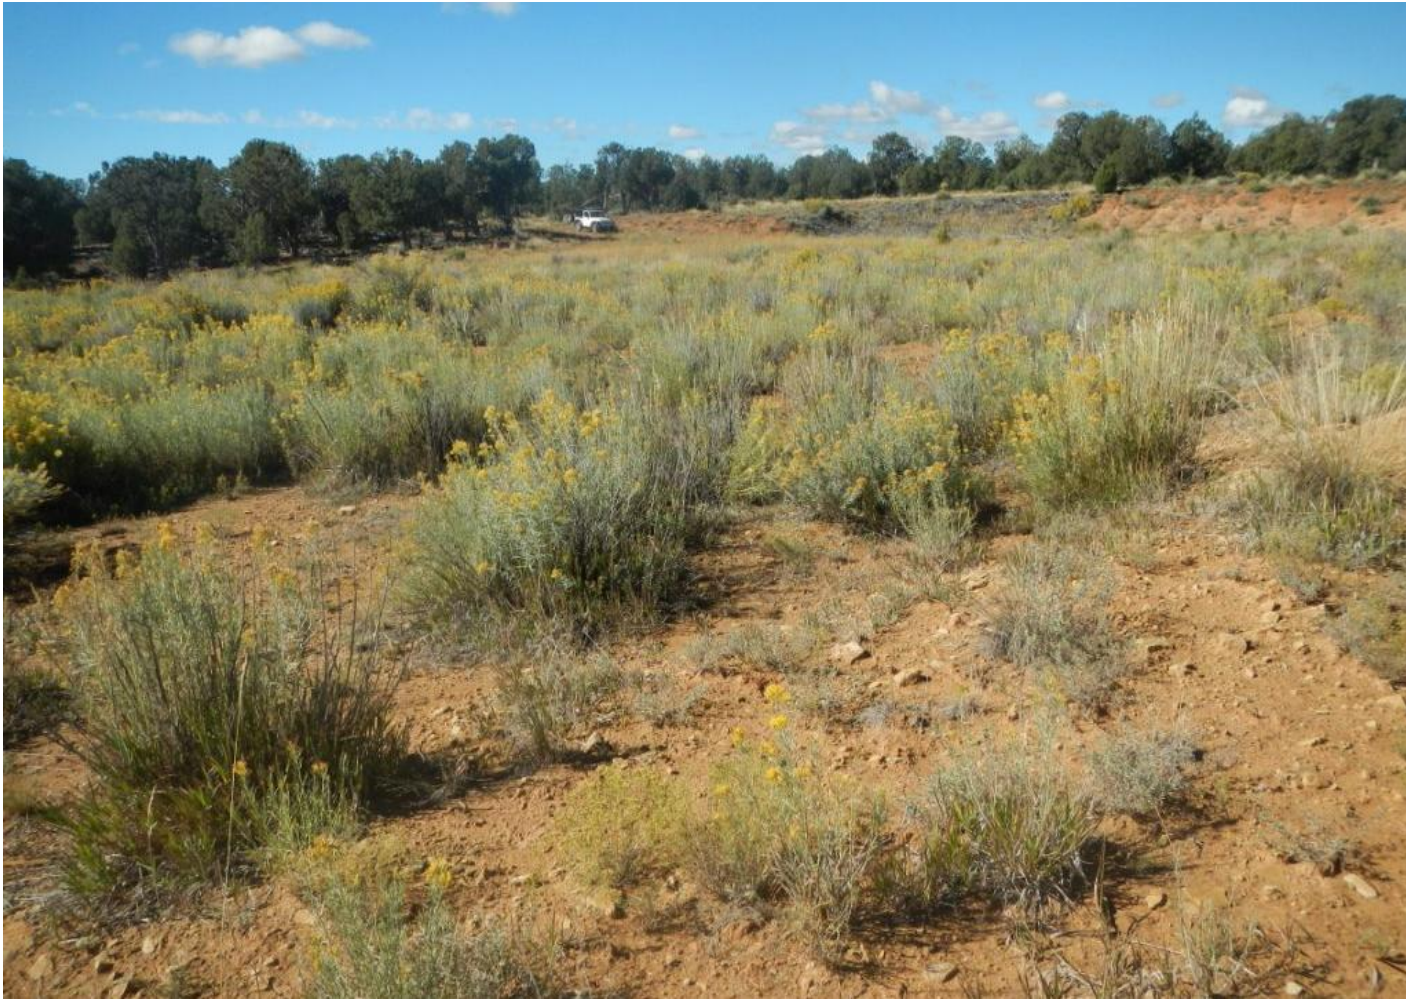
Photo 3. View of the project area from the northeastern corner facing center.

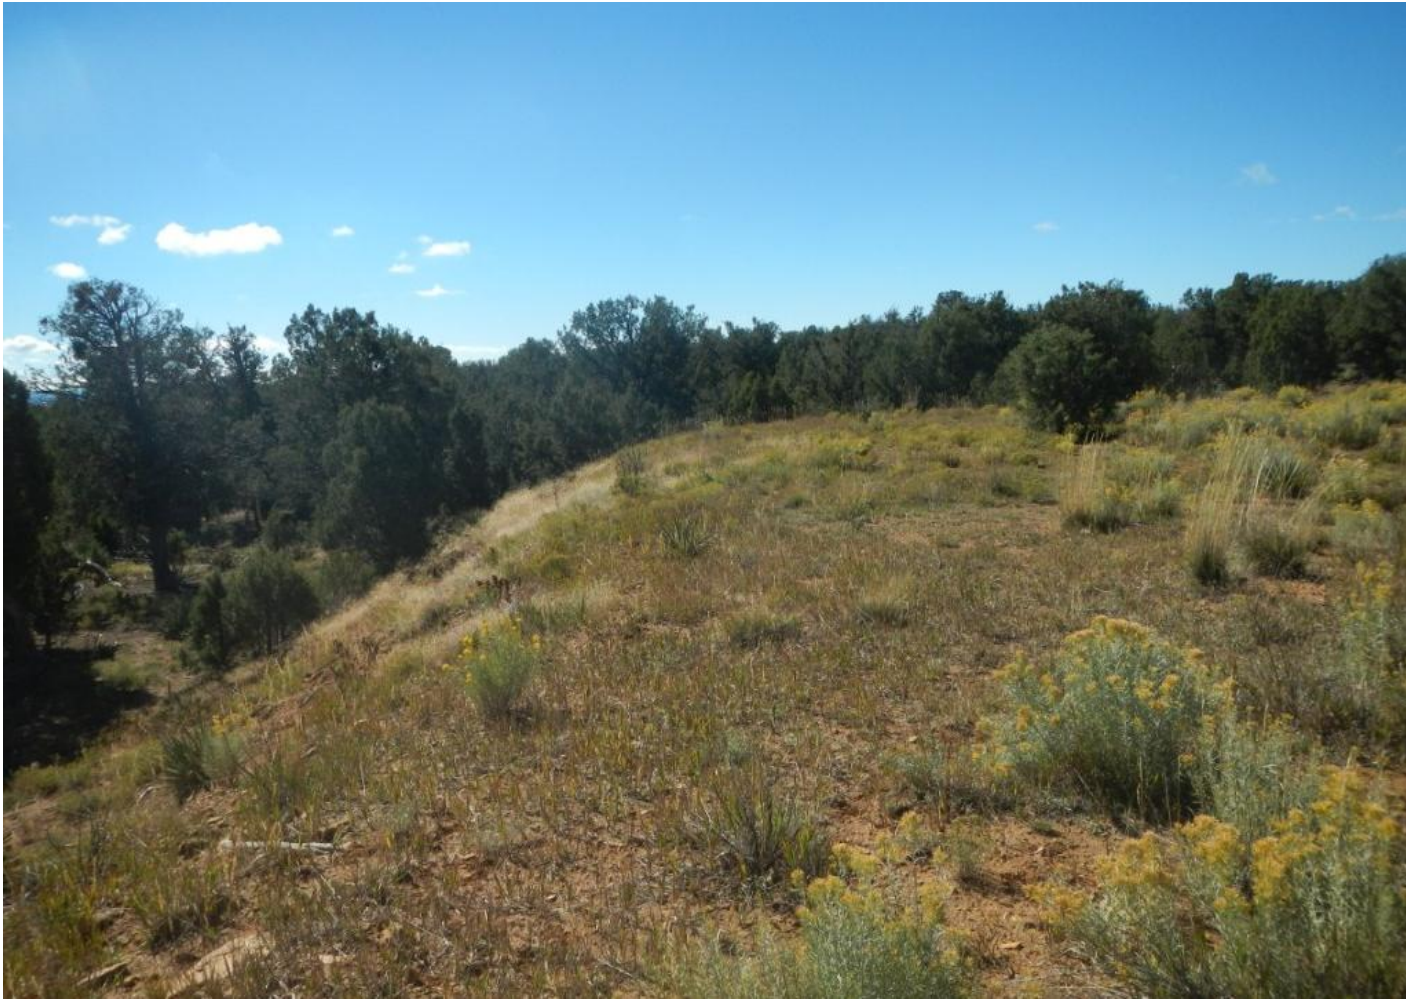
Photo 4. View of the eastern portion of the project area form the northeastern corner facing center.

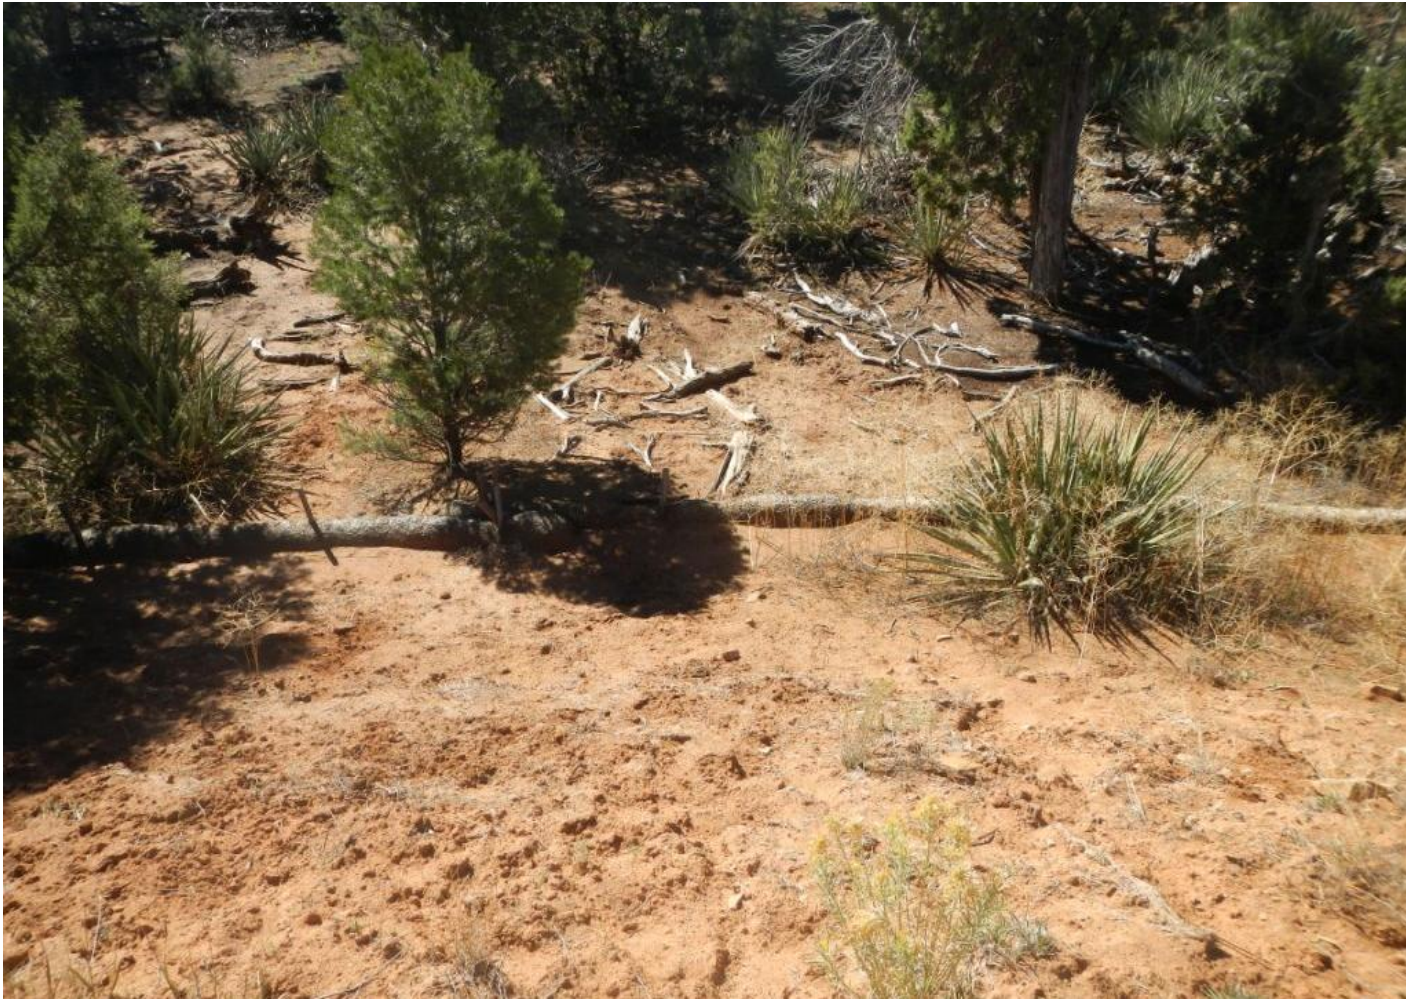
Photo 5. View of straw wattles on the northern edge of the project area.

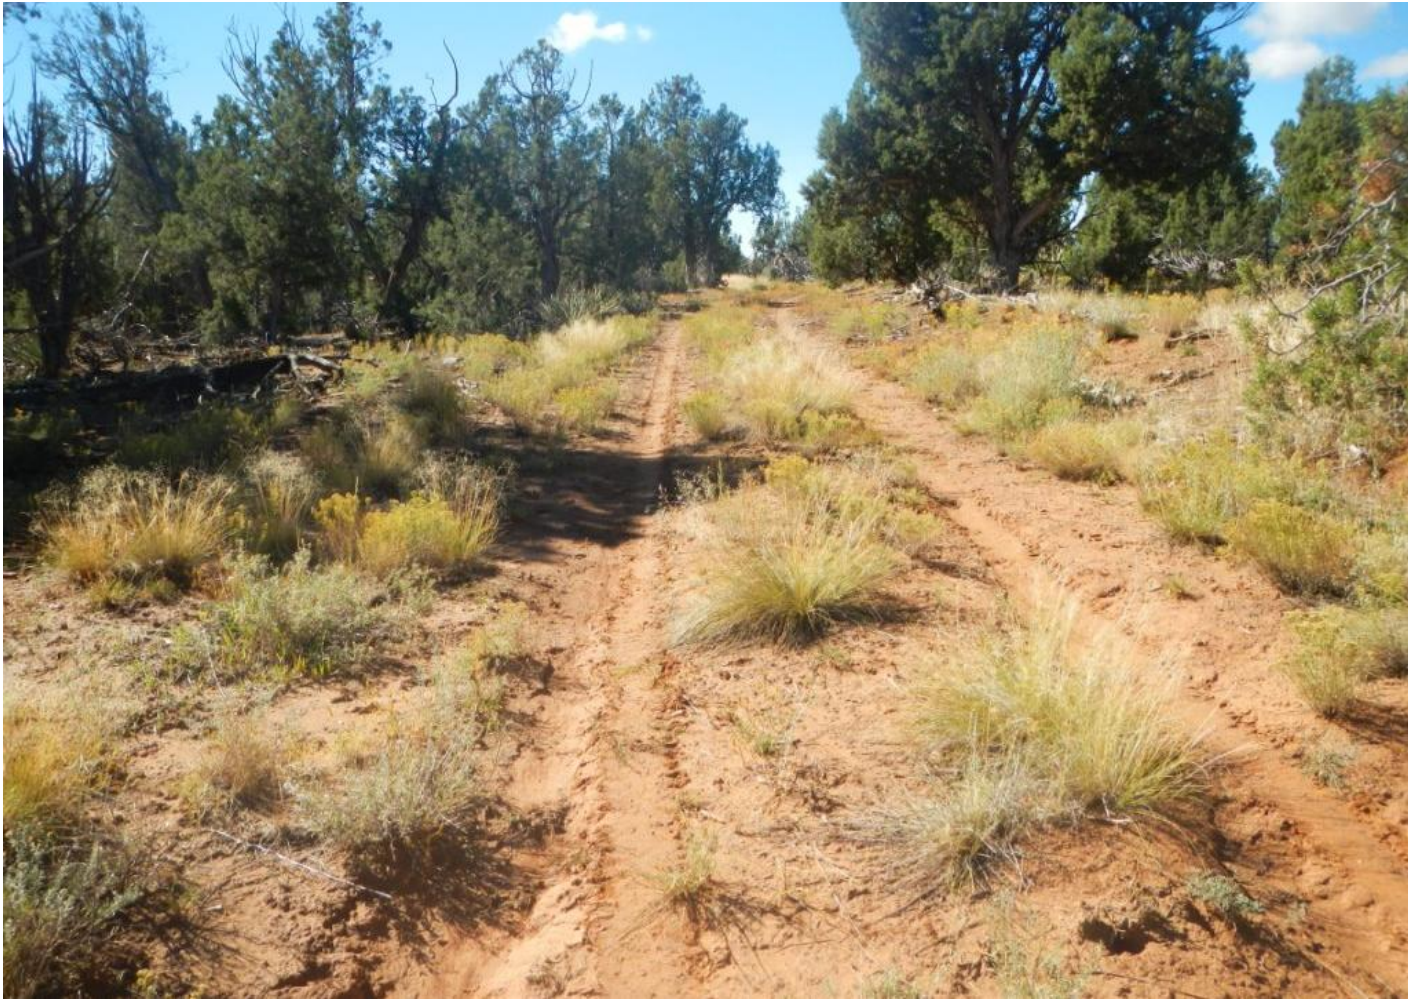
Photo 6. View of access road that is still in place from well pad entrance facing southward.
